Re: Miller Bridge Piers, Horseshoe Bend National Military Park  
Documentation for stabilization and repair scenarios  
WJE No. 2018.4595

This letter report and the accompanying conceptual drawings and cost estimate provide documentation of the stabilization and repair scenarios for the Miller Bridge Piers identified by the National Park Service for further evaluation.

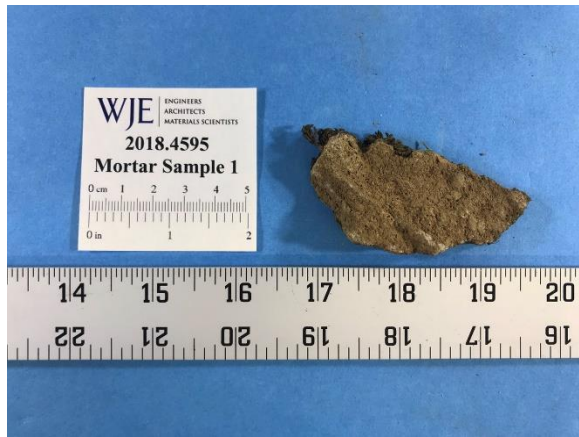
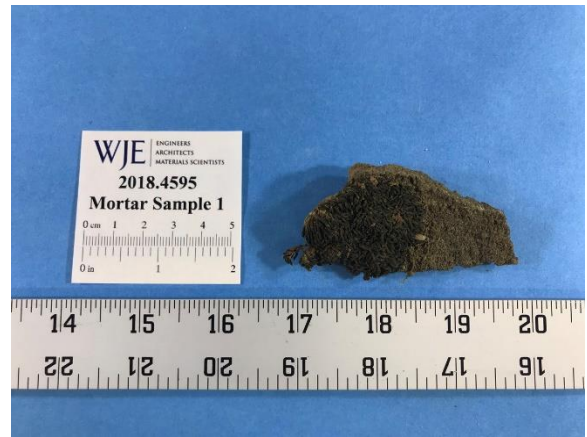
*Figure 1. Images of Mortar Sample 1, as-received. Note the dark deposits on the surface of the mortar in the right image.*

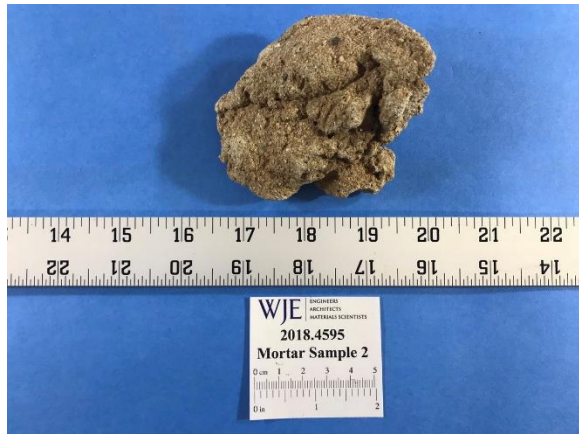
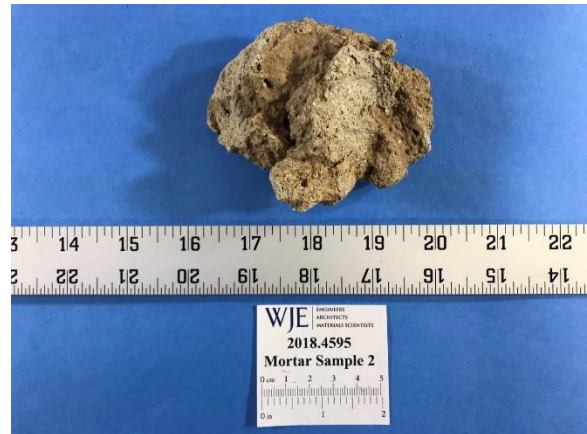
Sample 2 exhibits deterioration in the form of increased paste porosity and a loss of paste-aggregate bond strength. The paste is soft and highly absorptive of water, compared to harder and less absorptive paste in Samples 1 and 3. Cracking is rare in each sample, and when observed, is along the exposed surfaces of the samples. Each sample exhibits fully carbonated paste, with secondary calcite deposits observed in void spaces due to dissolution of calcium in the paste that has redeposited within the matrix.

*Figure 2. Images of Mortar Sample 2, as-received. Note the dirt deposits on the surface of the mortar in both images and the beige coloration of the samples.*

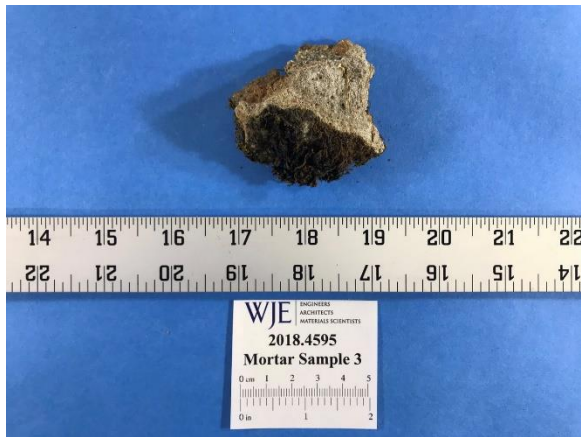
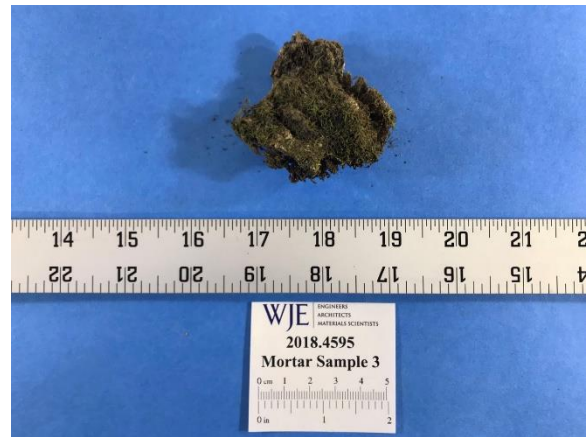
*Figure 3. Images of Mortar Sample 3, as-received. Note the dark deposits on the surface of the mortar in the images.*

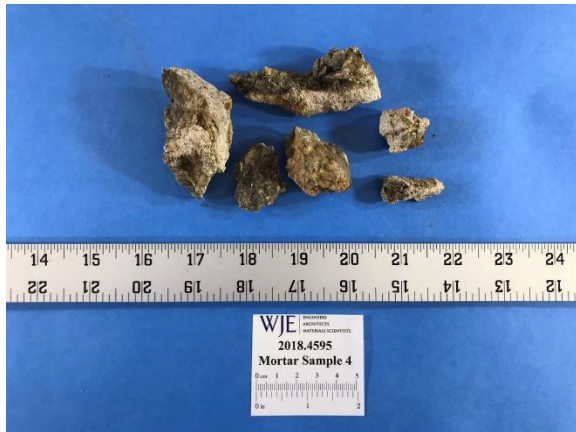
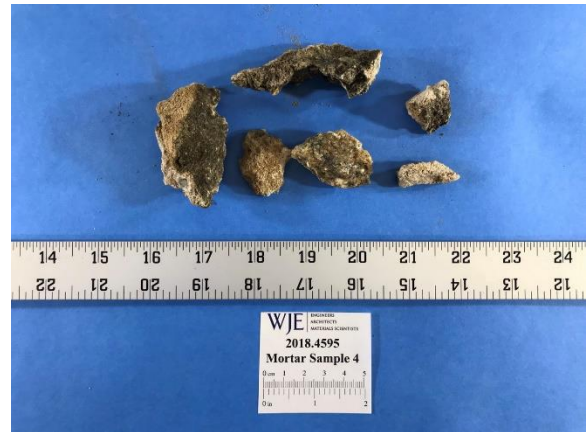
*Figure 4. Images of Mortar Sample 4, as-received. Note the dark deposits on the surfaces of the mortar in the images.*

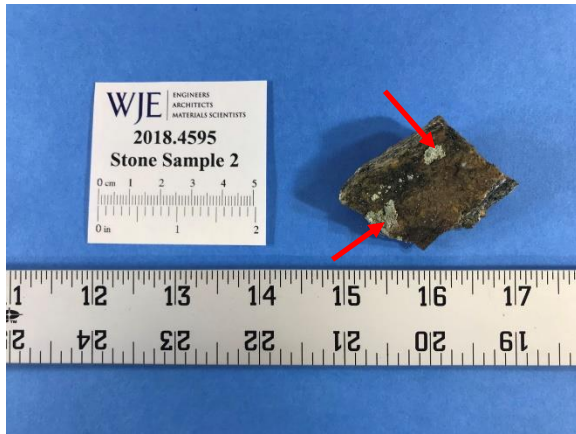
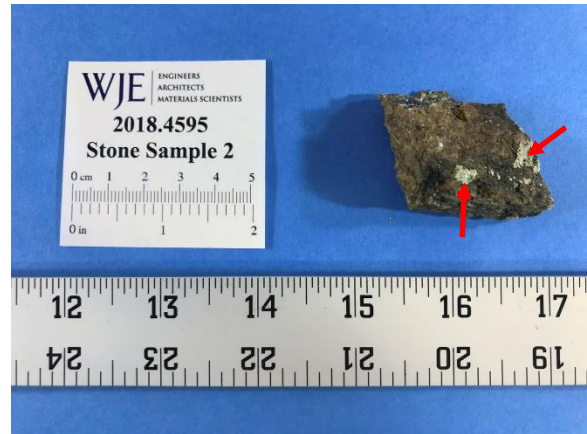
*Figure 6. Images of Stone Sample 2, as-received. Note the overall dark brown to black appearance of the samples, as well as biological and/or organic growth (red arrows).*

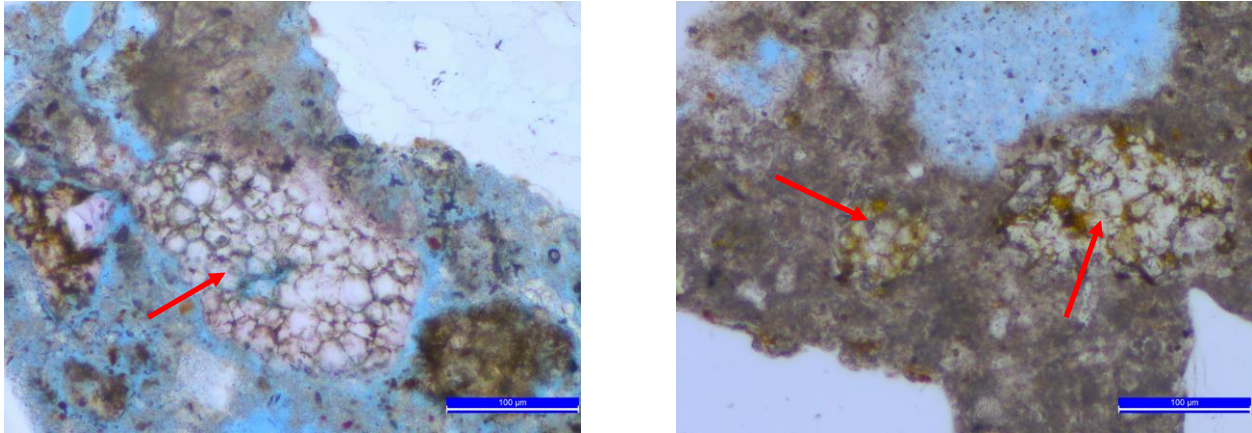
*Figure 7. Images of coarse portland cement particles in Mortar Sample 2 (left) and Mortar Sample 3 (right). Also note the presence of a higher amount of blue dyed epoxy in the left image as compared to the right image, indicating a higher paste porosity. PPL images<sup>1</sup>.*

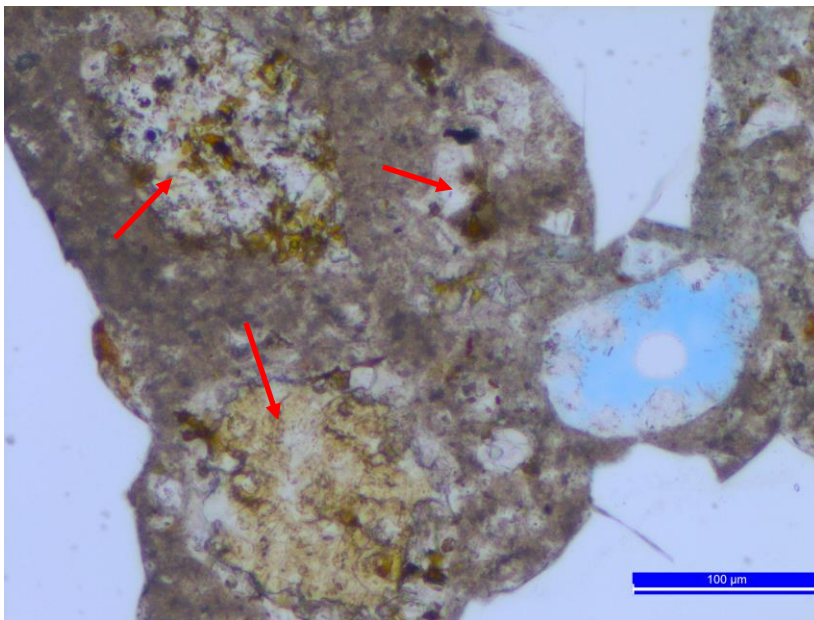
*Figure 8. Examples of underburned limestone used in the production of the cement observed in the mortar samples (red arrows). Note the presence of some of the original characteristics of the limestone structure in the particles. PPL image*

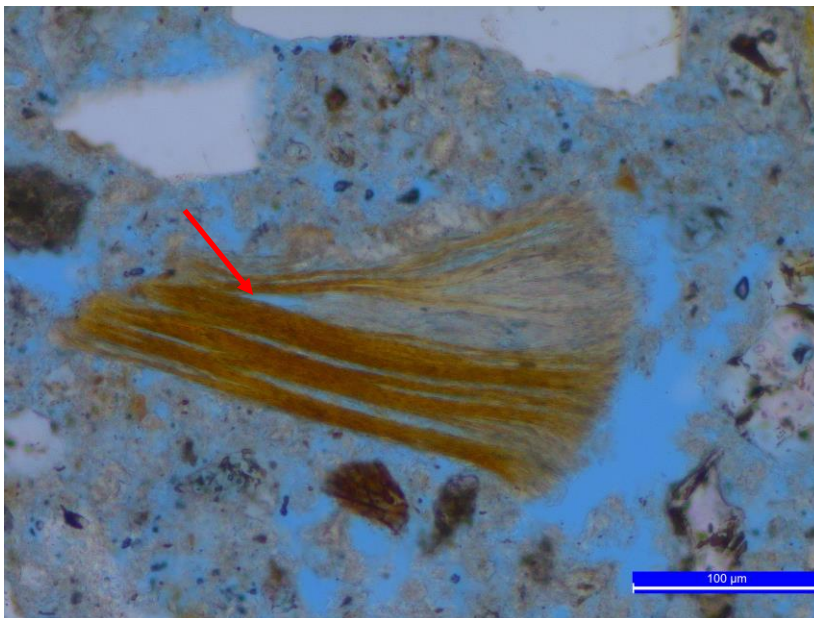
*Figure 12. Mortar Sample 2 exhibits a porous paste structure, as shown by the absorption of a large amount of blue dyed epoxy (the overall blue coloration of the image). Red arrow points to biotite mica, part of the sand within the mortar.*
