Manassas National Battlefield Park  
Manassas, Virginia

# The Stone House—Historic Structure Assessment Report

## *Manassas National Battlefield Park*

2015

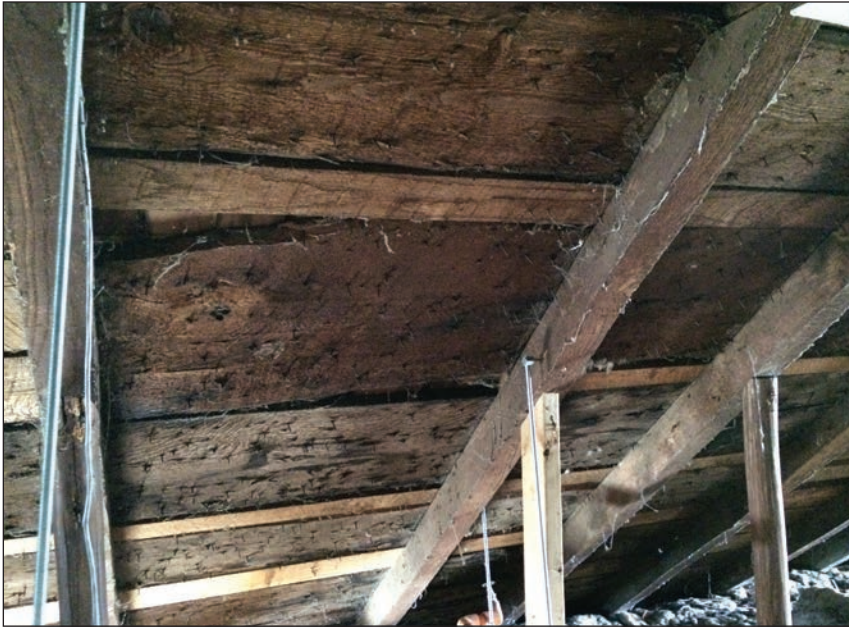
For this reason the roof covering has been given a rating of Critical.

Figure 59: Sheathing, shingles and shoring of the roof of the Stone House.

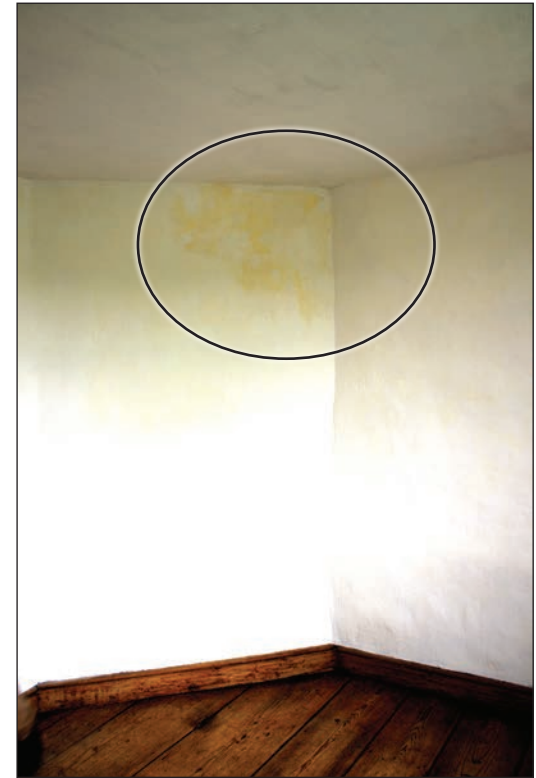
Figure 64: Water staining in room 302.

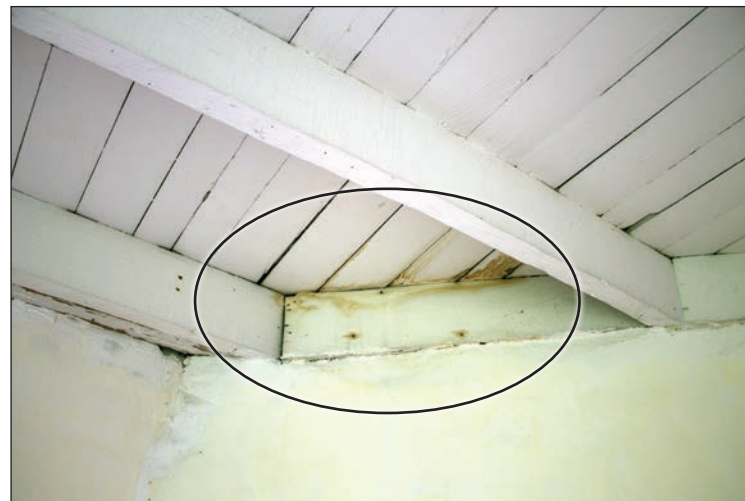
Figure 65: Water staining in room 303.

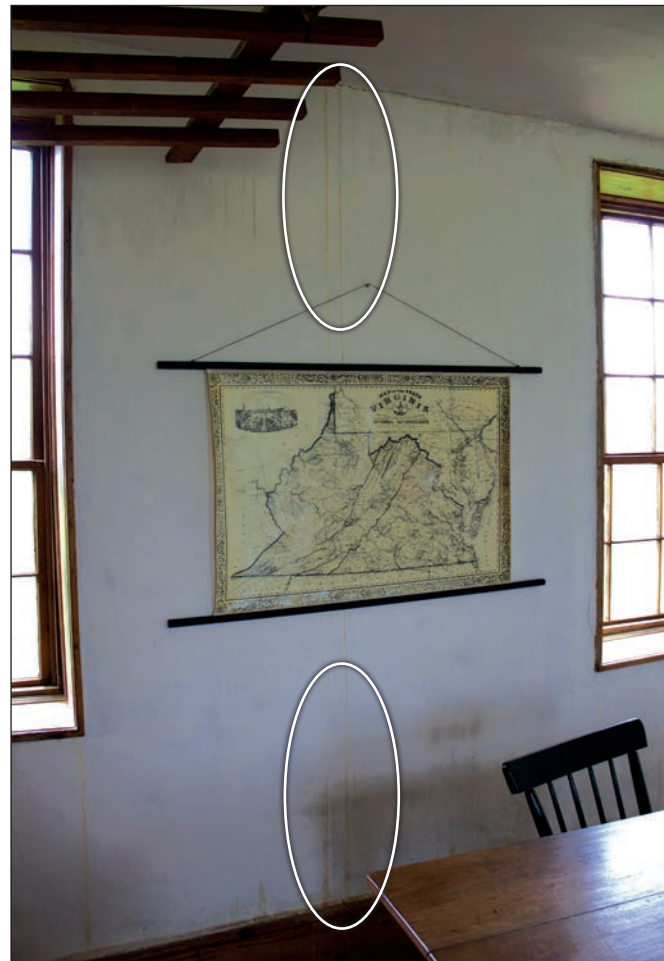
Figure 66: Water staining in room 104.

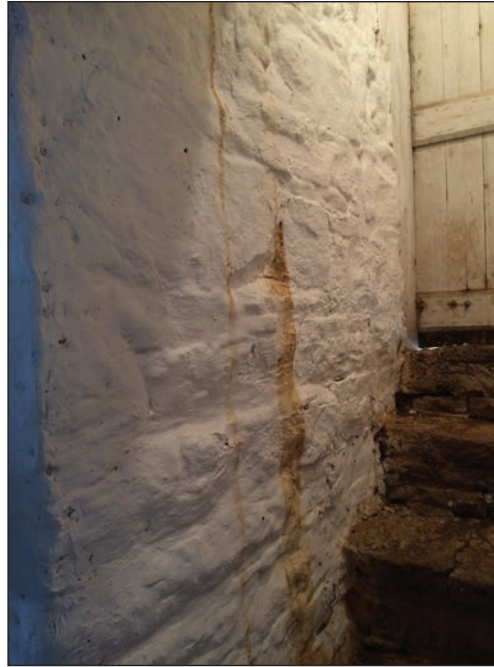
Figure 67: Water staining in basement wall, room 001.

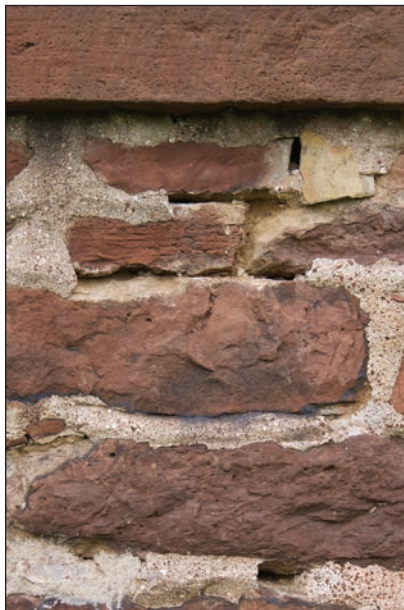
Figure 68: North elevation detail – mortar lost.

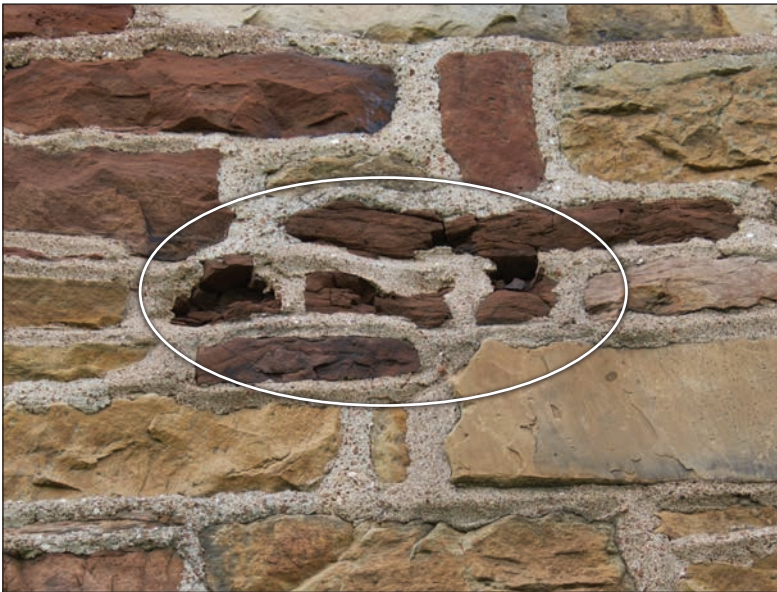
Figure 72: Spalling stone.

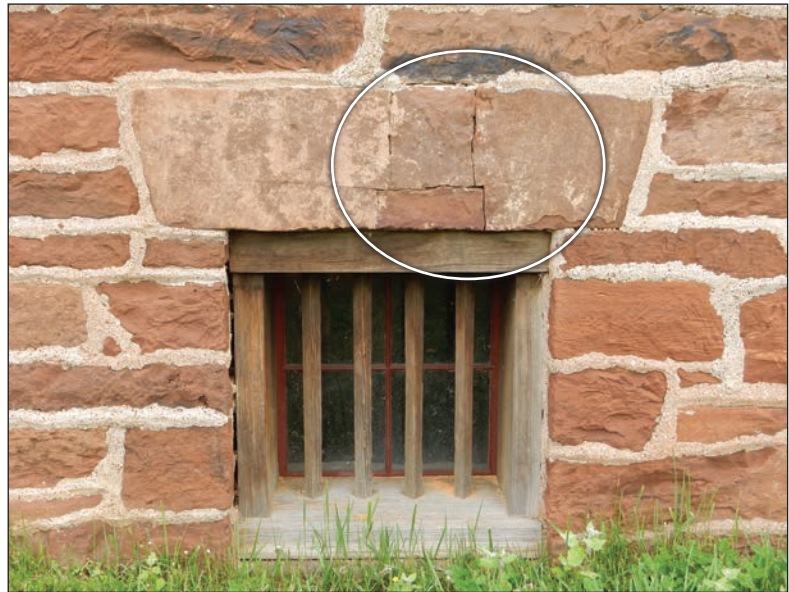
The exterior masonry walls of the Stone House are composed of face-dressed, red and yellow sandstone with mortar that includes decomposed sandstone from the nearby Youngs Branch. The mortar has been patched and repointed several times in the history of the Stone House. The most recent repointing occurred in 1961. At the time of this report, the mortar has degraded significantly and allows water to infiltrate the building envelope and run down the interior walls, as can be evidenced by staining. In some places on the exterior the mortar is lost completely. In other places, Portland Cement may have been used to repair failing mortar in the past. At some locations the stone is spalling. With the exception of window 105, all the stone window sills on the first floor are fractured. The stone lintel at the basement window on the west elevation (window 005) is fractured. The fractures appear to be caused by downward pressure.

Figure 73: Fractured lintel, window 005.

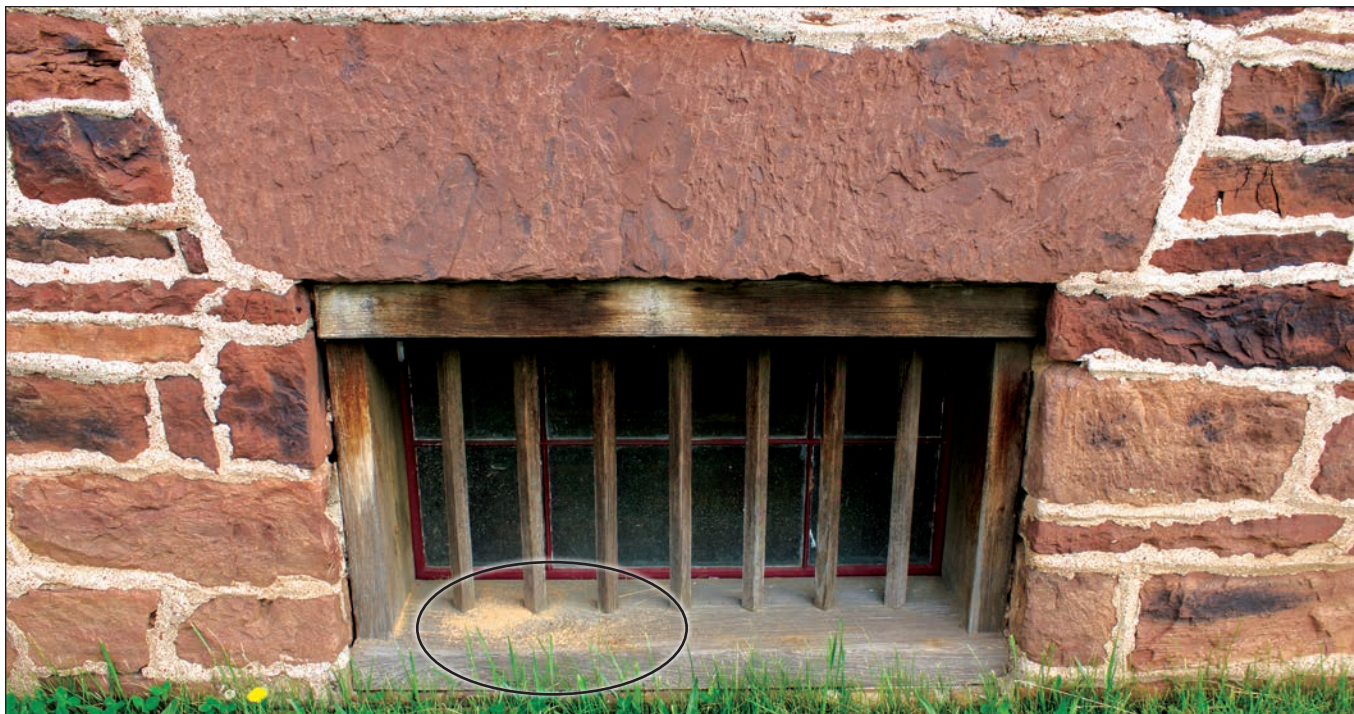
All three of the basement window wooden grille frames on the south and west elevations of the Stone House have active insect infestations. Carpenter bees have drilled into the underside of the top frame and sawdust has accumulated on the lower frame. These frames were installed in 1961. With continued infestation, the bees could undermine the integrity of the frame and cause the grille to fail.

Figure 74: South elevation – window 001—sawdust accumulation.

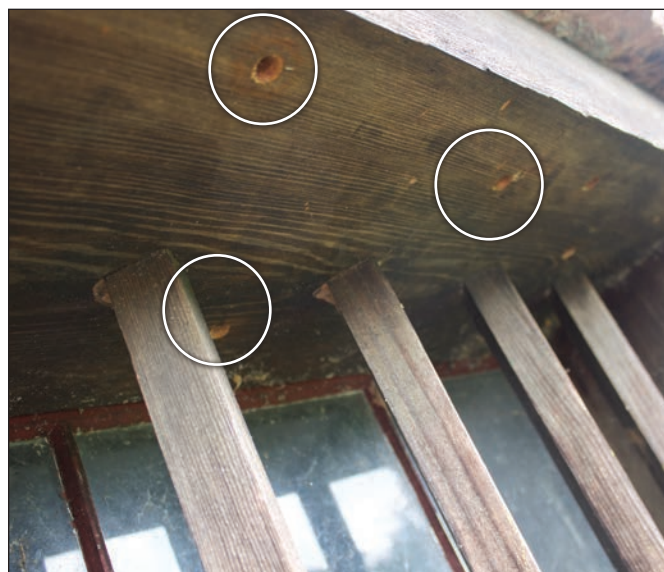
Figure 76: South elevation upper frame – window 002—carpenter bee damage.

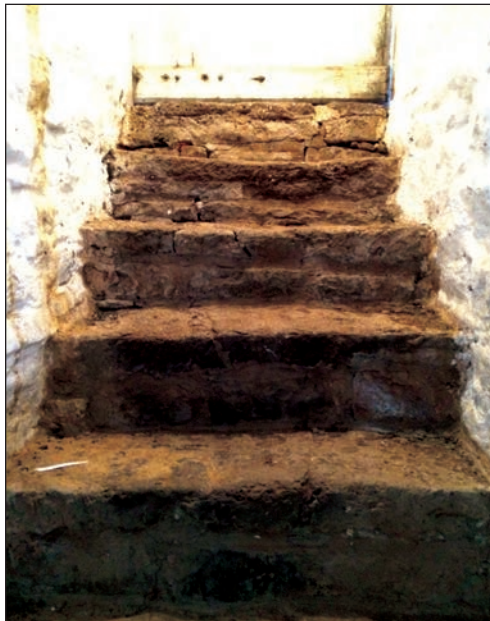
The stairs leading from the west elevation exterior to the basement are composed of stone. The stairs appear to be original to the house. At present the mortar in the stone has deteriorated to the point of failure and the stones appear to be crumbling. In addition, the threshold at the top of the stairs on the exterior appears unsupported by the flagstones at grade.

Figure 77: Stairs from basement west side, 001.

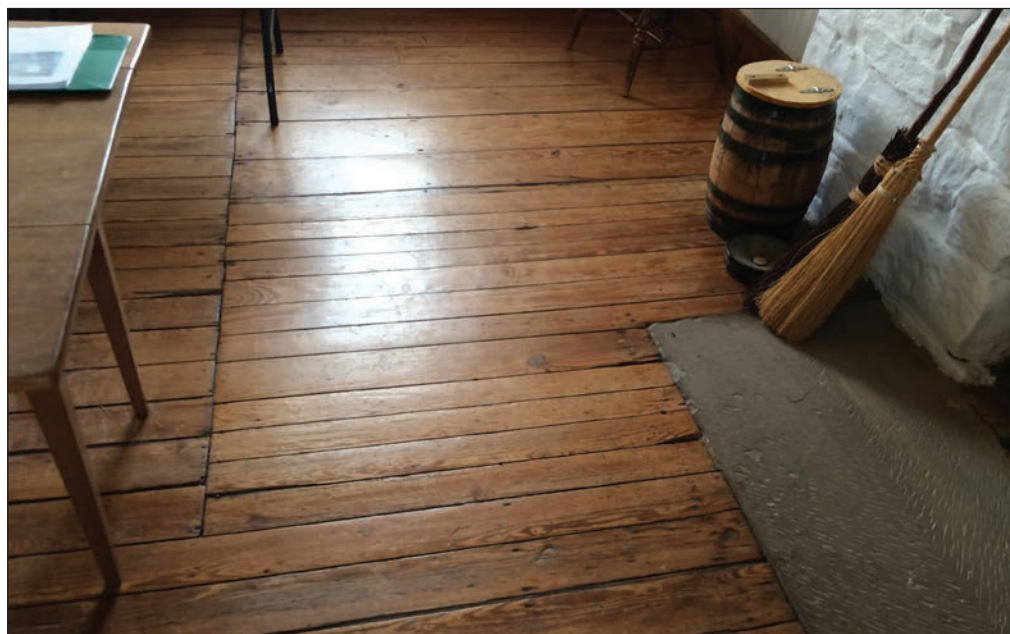
Figure 84: Evidence of wood floor replacement after basement fire, Tavern Room, 104.

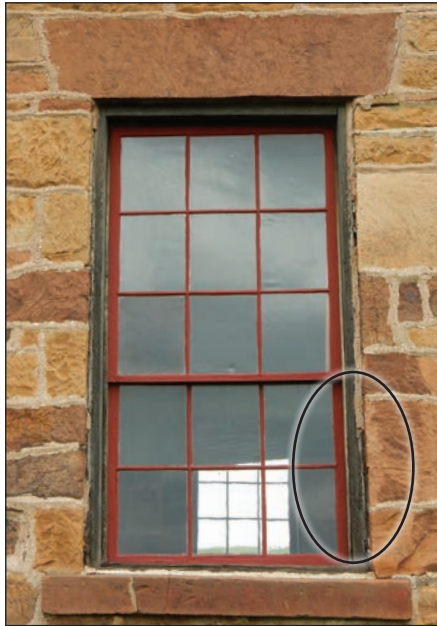
The first floor windows are nine-over-six light, single-hung with wooden sash. Deterioration of the sills and frames is evident. Mortar flashing is lost around the frames.

Figure 93: Window 101, first floor, south elevation. Lost mortar flashing (circled).

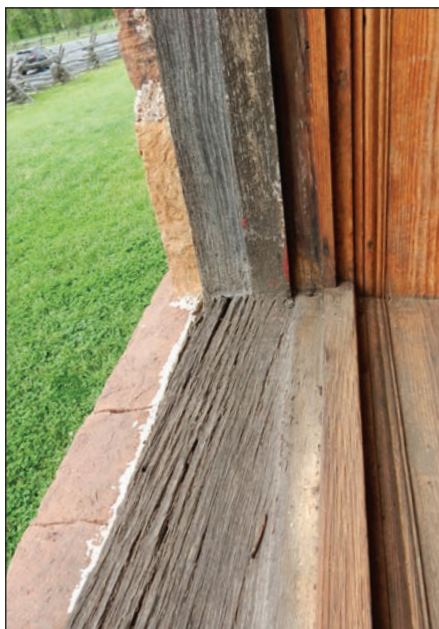
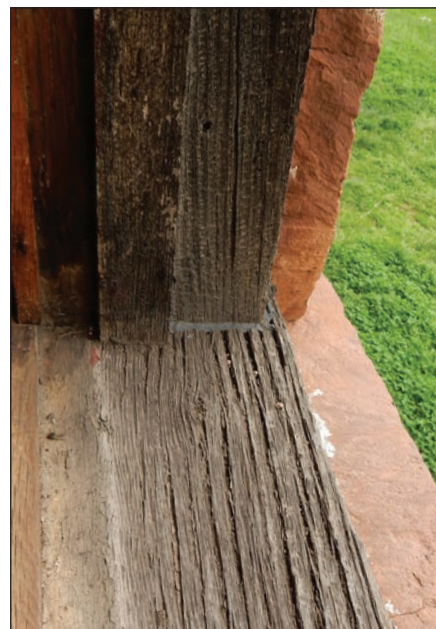
**Figure 100:** First floor window 102 representative of sill condition of south elevation windows 101, 102, and 103. Require linseed oil application.

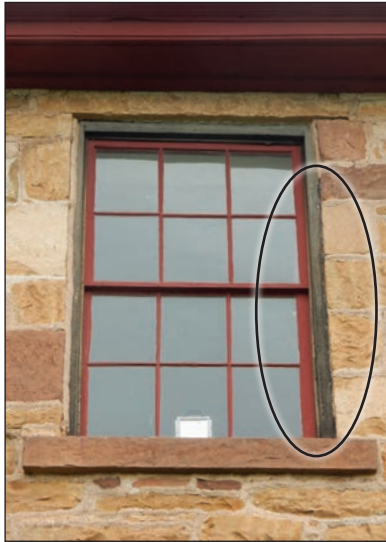
**Figure 101:** Window 201, second floor. Incomplete mortar flashing (circled).

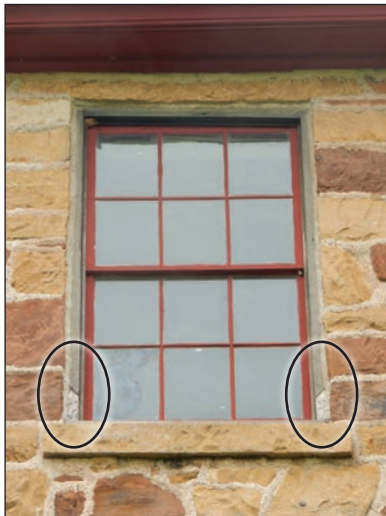
**Figure 105:** Window 205, second floor. Dutchman repairs (circled).

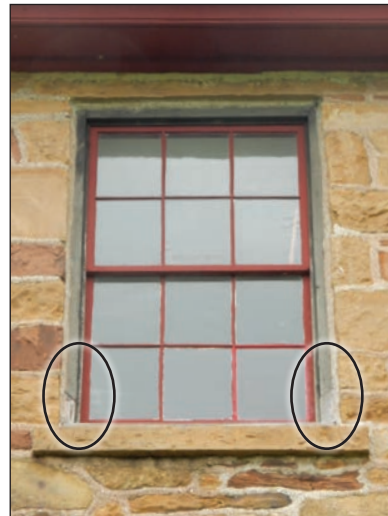
**Figure 106:** Window 206, second floor. Dutchman repairs (circled).

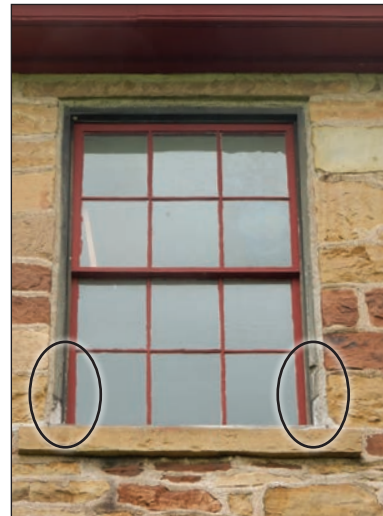
**Figure 107:** Window 207, second floor. Dutchman repairs (circled).

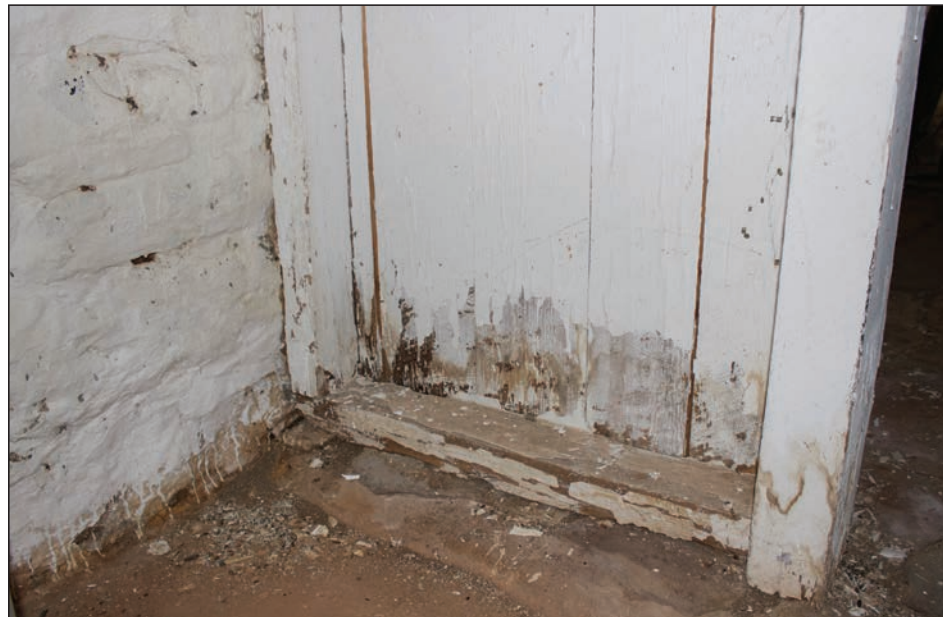
The interior partition walls are in good condition without any major deficiencies. The basement partition wall is made of wood planks. Some rising damp and water damage can be seen on the base of the wall at the south end. The interior partition walls on the first and second floor are constructed of wood with lath and plaster. Their condition is excellent.

**Figure 116:** Rising damp on the basement partition wall.

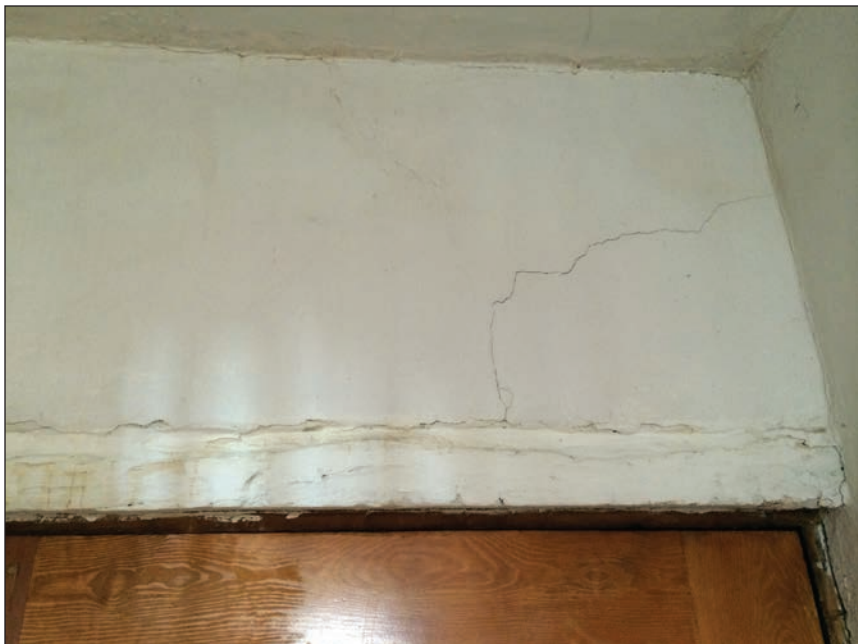
Figure 122: Plaster cracking around rear entrance door 101B.

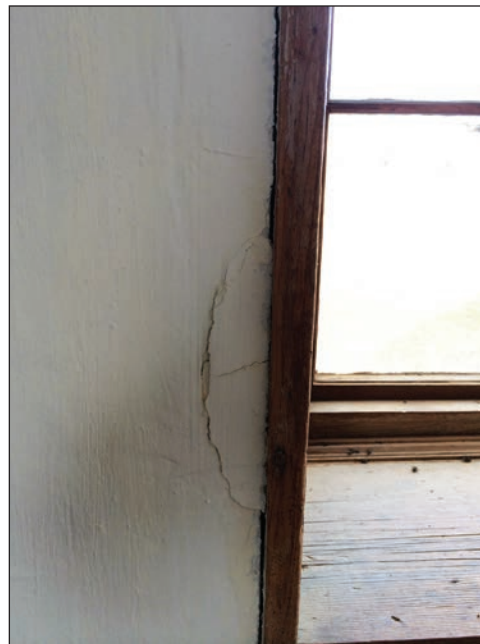
Figure 123: Plaster delaminating around first floor window.
