# Hatteras Light Station Oil House

## Historic Structure Report

Cape Hatteras National Seashore  
Hatteras Light Station  
Oil House  
**Historic Structure Report**

December 2017

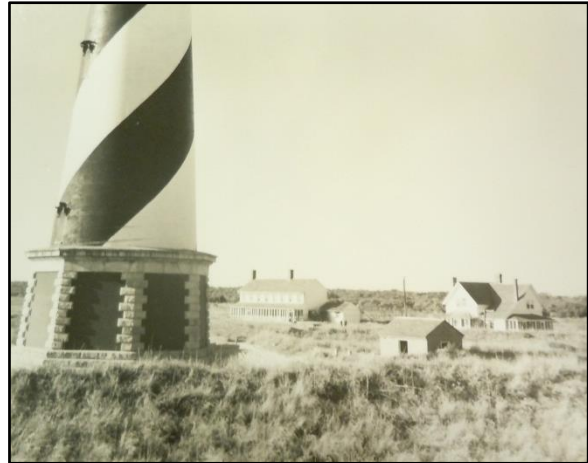
**Figure 14.** The oil house in December 1952; the south and east elevation windows have been removed from their openings. Photo: Cape Hatteras National Seashore Archives.

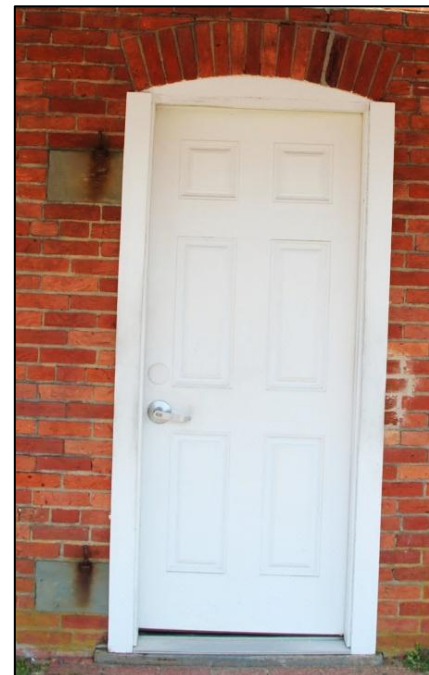
**Figure 63, right.** The replacement exterior door is new but is not character defining. Photo: HPTC, 05/12/16.

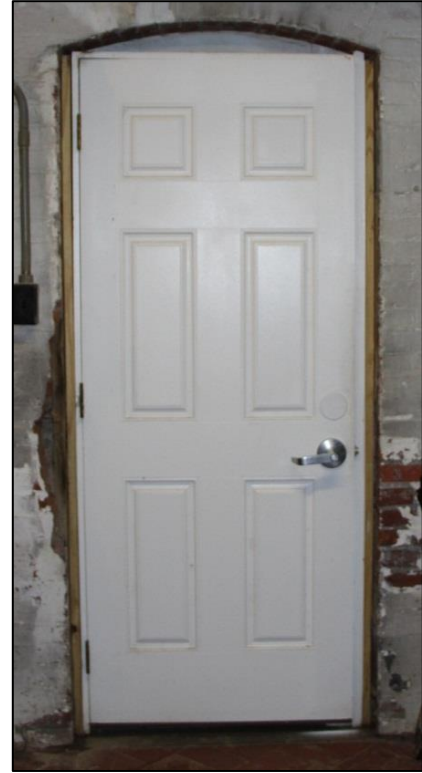
**Figure 70.** The new exterior door has not been trimmed out on the interior. Photo: HPTC, 05/12/16.

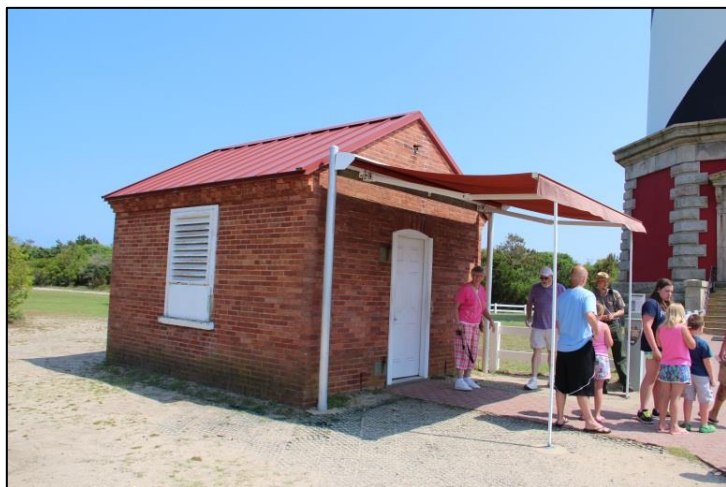
**Figure 75.** The Oil House retains its character-defining shape and mass. The modern awning, replacement door, and plywood window infill are not character-defining features. Photo: HPTC, 05/12/16.

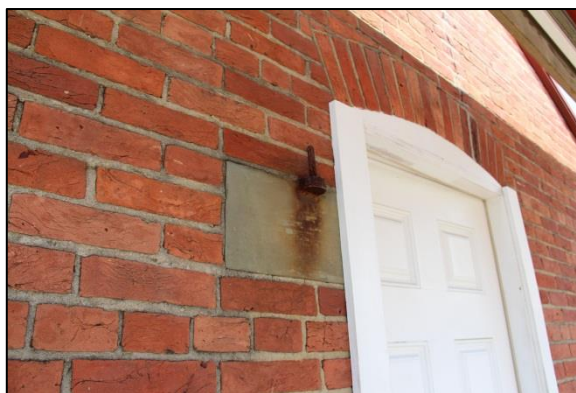
**Figure 77.** A pair of slate blocks with metal pintles have been retained at the door opening, however the original metal door has been replaced with one that does not match the original in any way. Photo: HPTC, 05/12/16.

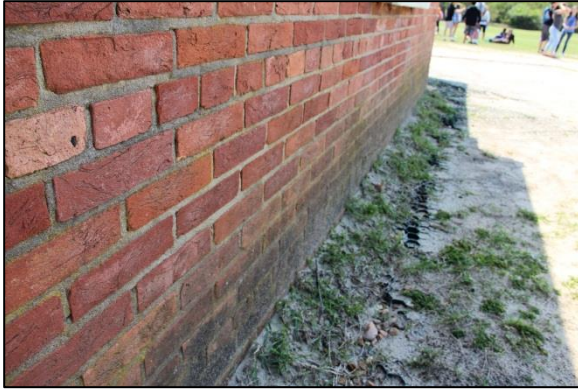
**Figure 84.** Biological growth present at the base of the exterior wall due to splashback from water draining from the roof. Note the presence of Portland cement-based mortar (not original). Photo: HPTC, 05/12/16.

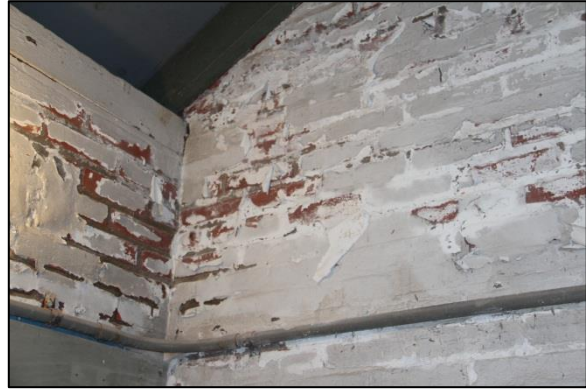
**Figure 85.** The paint on the interior of the walls is peeling and degraded. Note the presence of Portland cement-based mortar (not original). Photo: HPTC, 05/12/16.

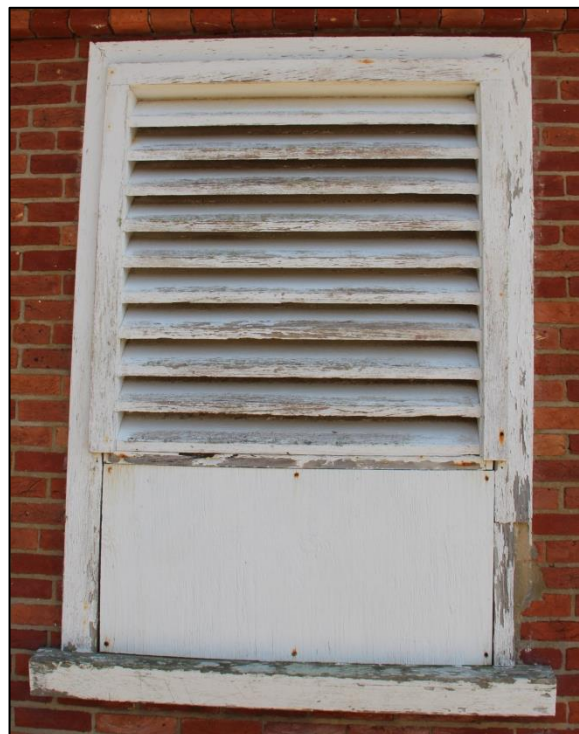
**Figure 86, right.** An example of one of the deteriorating and non-character-defining window openings. Photo: HPTC, 05/12/16.
