**Martin Luther King Jr. Birth Home**  
**501 Auburn Avenue, NE**

# **Historic Structure Report Amendment**

**September 2019**

**Martin Luther King Jr. Birth Home**  
**501 Auburn Avenue, NE**  
**Martin Luther King, Jr. National Historical Park**  
**Atlanta, Georgia**

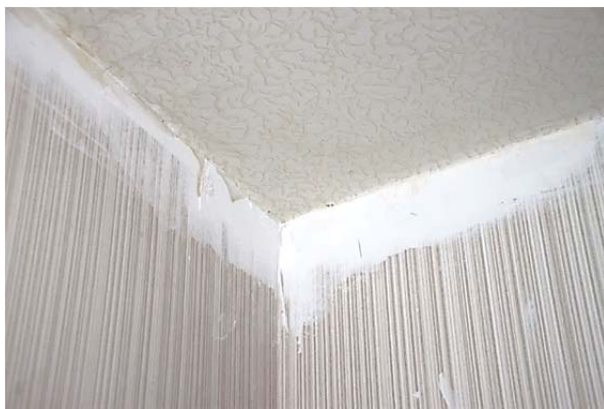
**FIGURE 157.** Joint compound repair at structural repairs.

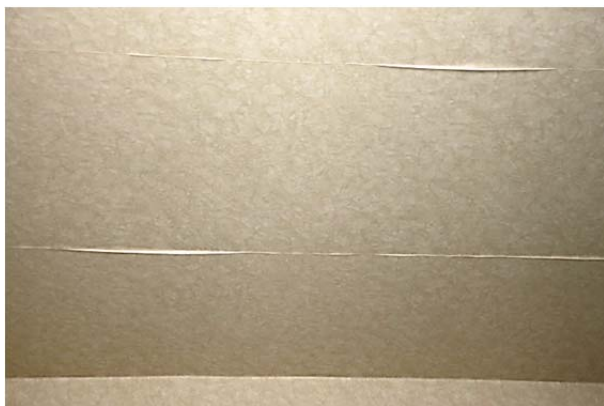
**FIGURE 158.** Typical delamination of ceiling paper.

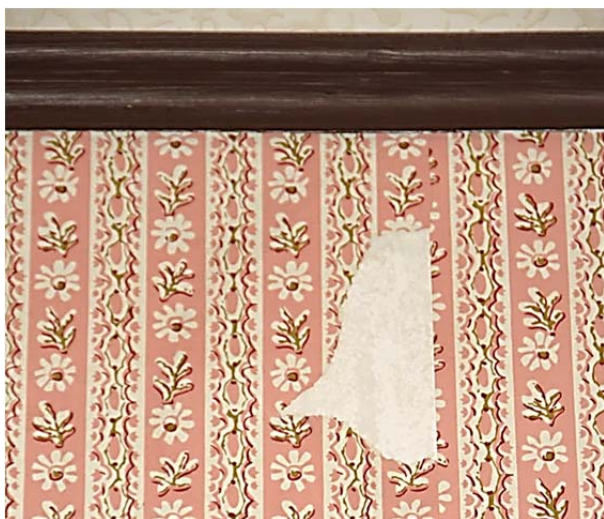
**FIGURE 159.** Wallpaper damage at Christine's room.

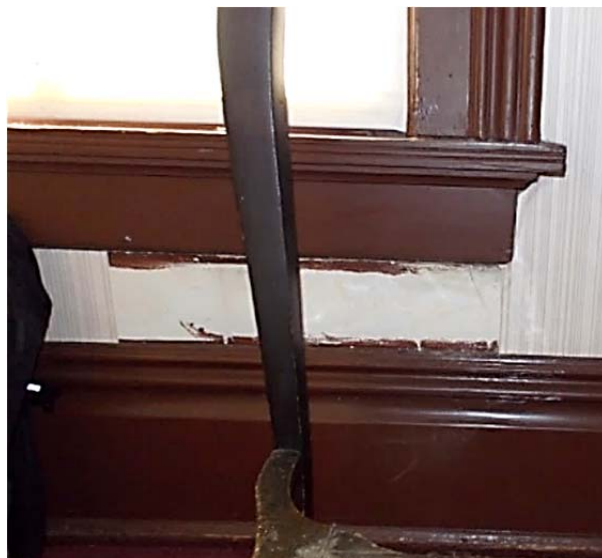
**FIGURE 160.** Deterioration of plaster below window.

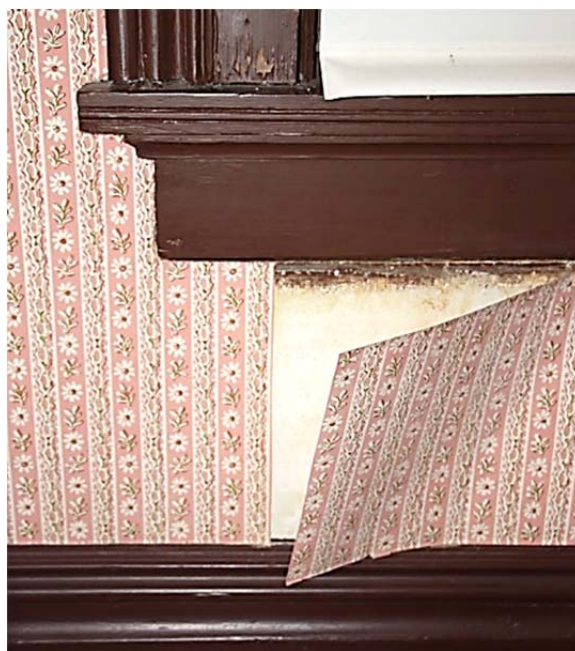
**FIGURE 161.** Delamination of wallpaper below window.

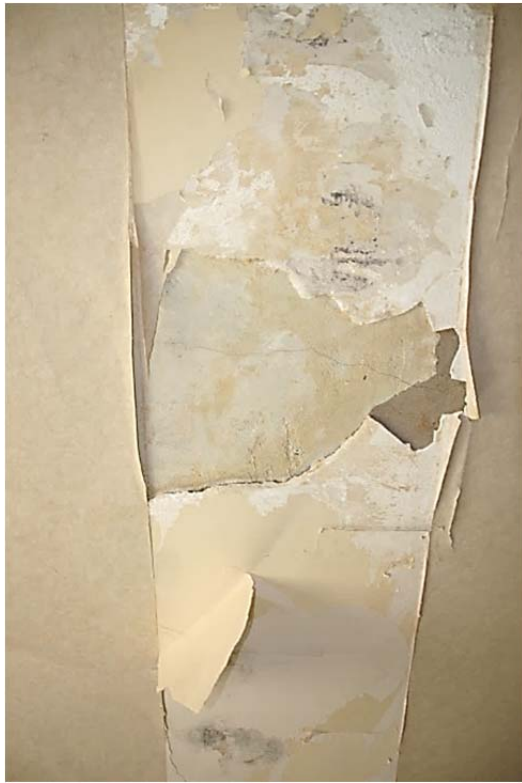
**FIGURE 162.** Moisture damage to the ceiling paper and plaster ceiling of birth room.

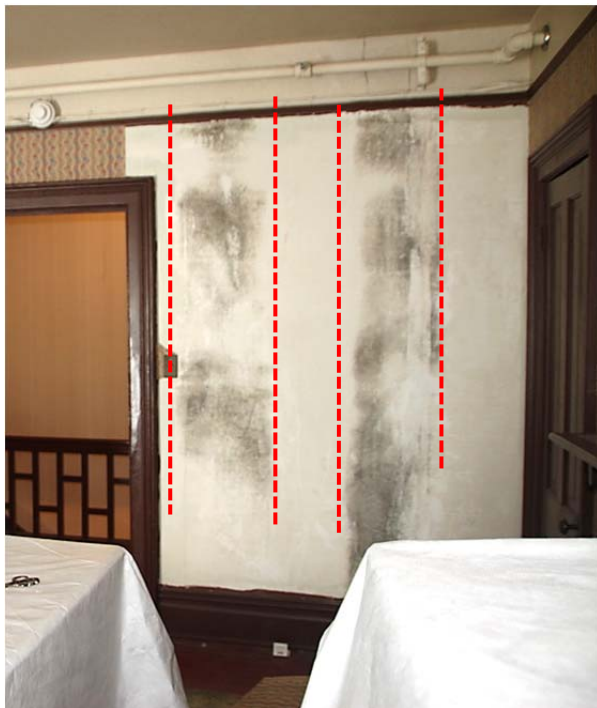
- Wallpaper was observed to be delaminating due to mold and mildew growth behind the wallpaper where supply air ducts were located (Figure 163 and Figure 164). This condition was severe in the birth room, where wallpaper peeled away from the wall. The location of the mold and mildew appears to follow the cold surface of the duct for the full height of the wall.

**FIGURE 163.** Mold and mildew following paths of two in-wall HVAC ducts in the birth room.

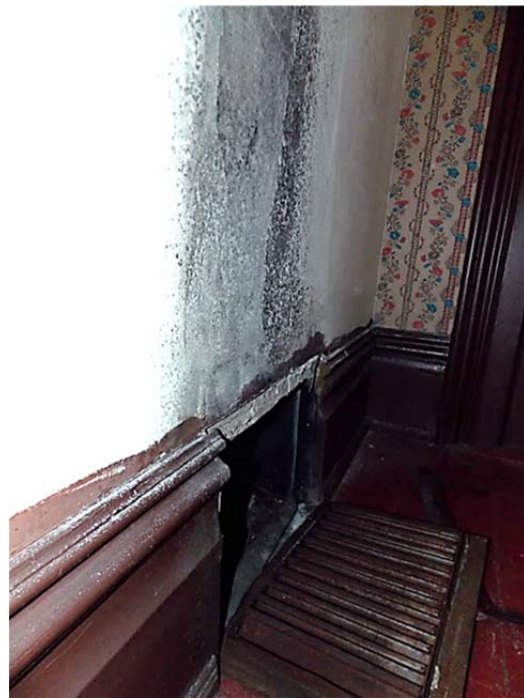
**FIGURE 164.** Mold / mildew following paths of two in-wall ducts at birth room.

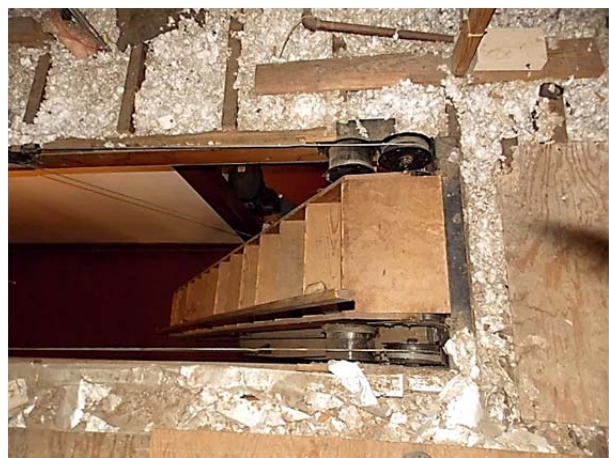
**FIGURE 168.** Attic access ladder. Previous seal over the access door has deteriorated.

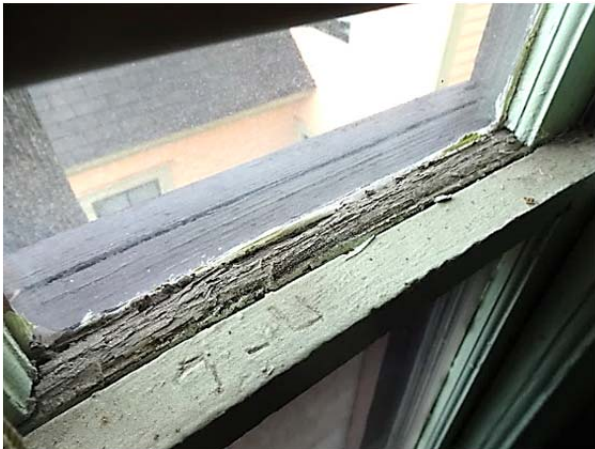
**FIGURE 169.** Top surface of meeting rails between sash. Note that the upper sash rail has degraded paint and extensive weathering of the wood.

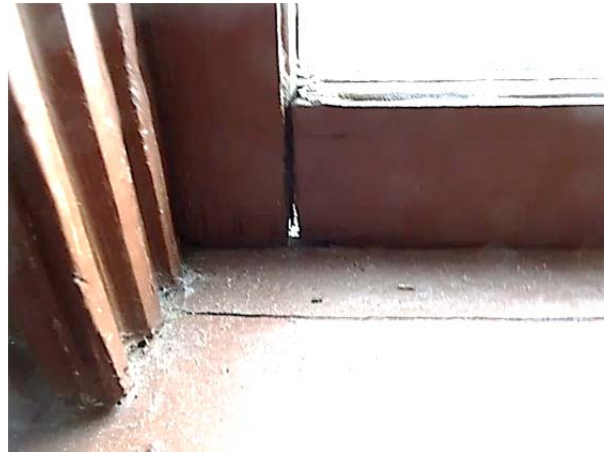
- A few windows had open joints in the bottom rail of the lower sash (Figure 170). Joints separated by as much as 1/4-inch wide were visible from the interior.
- At a few windows, the interior wood stop, and exterior glazing putty were missing (Figure 171). The edge of the glass and gaps between the glass and the wood sash were evident.
- At many windows, the exterior glazing putty was cracked, dry, and loose. Pieces of deteriorated putty have fallen off, exposing the glazing channel of the wood sash or the muntin to the weather (Figure 172). When paint applied to wood and putty surfaces degrades, both materials deteriorate more rapidly. Failure to adequately maintain paint on windows and trim is apparent, both inside and outside.

**FIGURE 170.** A second-floor window sash on the north elevation with an open joint. Note daylight visible at the joint.

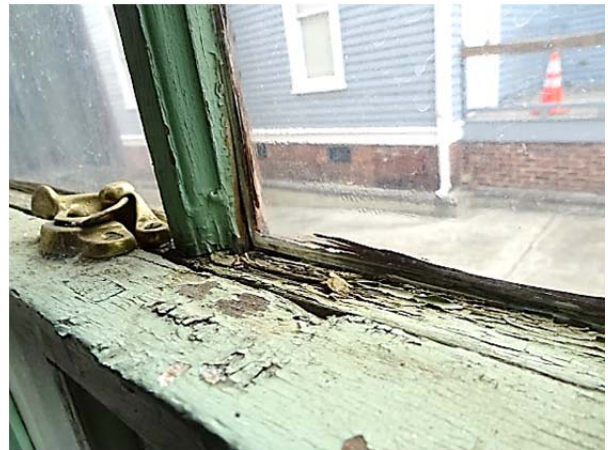
**FIGURE 171.** The sash where the wood stop and exterior glazing putty were missing.

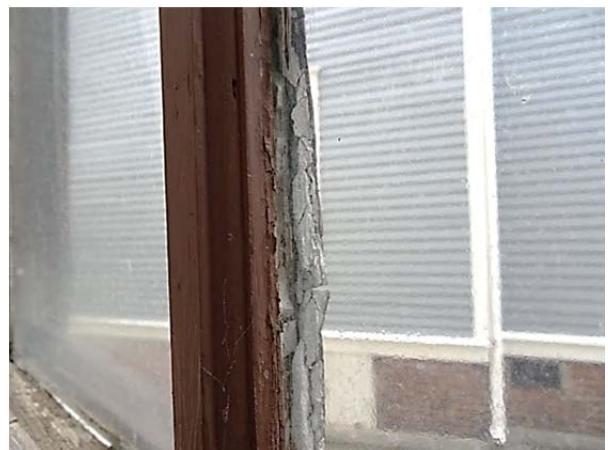
**FIGURE 172.** Exterior glazing putty that is cracking and deteriorating. The paint coating appeared to be keeping the putty in place.

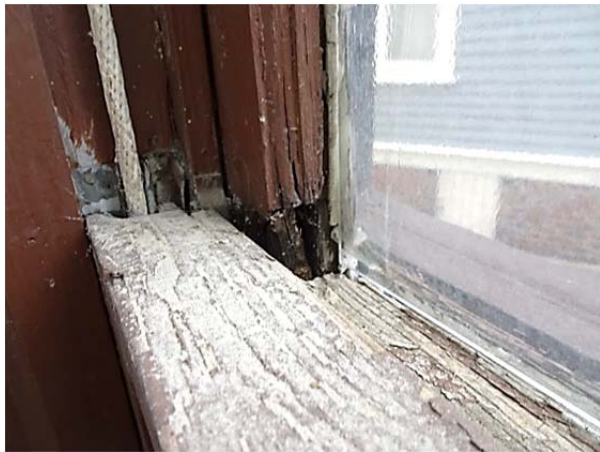
- Deteriorated wood was observed at the meeting rail of the upper sash at a first-floor window on the east elevation. The remaining portion of the meeting rail had separated and dropped from the sash and mullions above (Figure 173).
- A broken parting strip was observed at the bathroom window on the second floor (Figure 174). The wood parting strip was cracked and was no longer plumb.
- One window unit appeared to be inoperable because of a screw placed in the joint between the sash and the frame (Figure 175).

**FIGURE 173.** Note, the meeting rail of the upper sash has deteriorated and dropped.

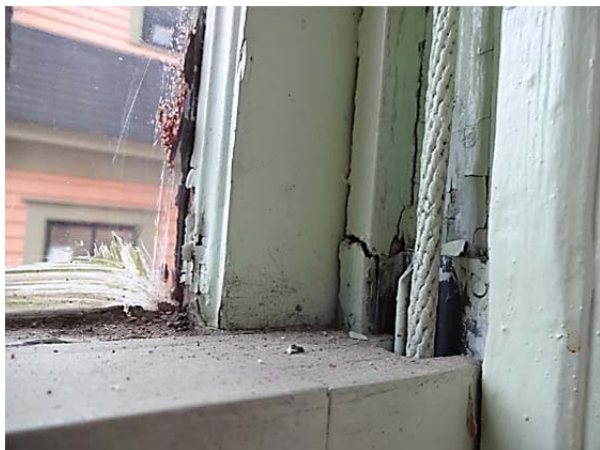
**FIGURE 174.** Damaged parting strip above lower window sash.

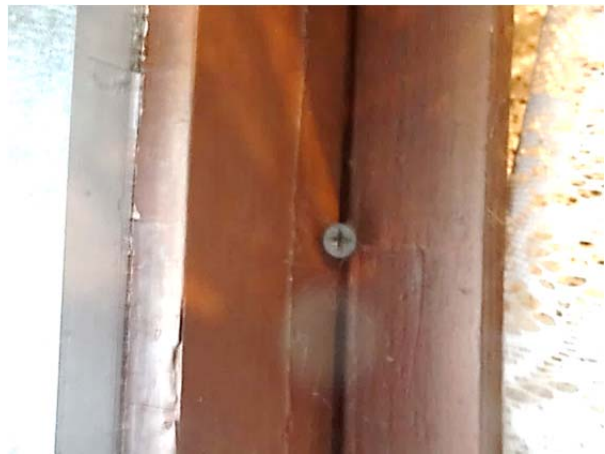
**FIGURE 175.** Screw installed at the joint between the sash and frame at one location.

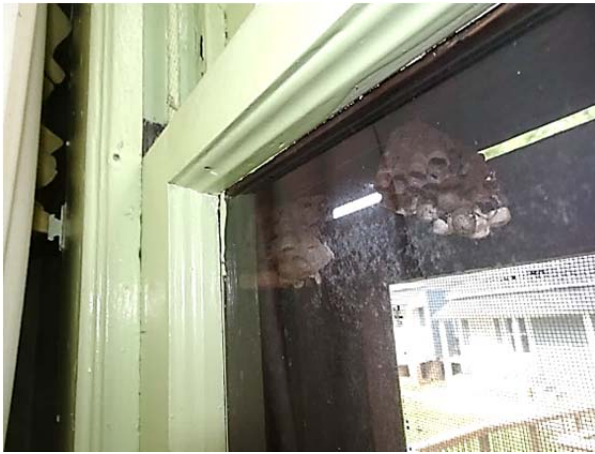
- Alligatoring, cracking, and peeling paint were observed on both the interior and exterior surfaces of windows. At interior locations, the area of peeling paint was small and localized. At the exterior, large flakes of peeling paint were observed. Degrading is most pronounced at the top surface of the bottom sash rail (Figure 176). At areas of peeling paint, the underlying wood was exposed to view.
- Mud dauber nests were observed in the space between the window sash and the exterior screen at the first-floor bathroom window (Figure 177). The screen was loose with gaps between the framing and the window opening which allow the insects to get behind the screen.

**FIGURE 177.** Mud dauber nests between the window sash and screen.

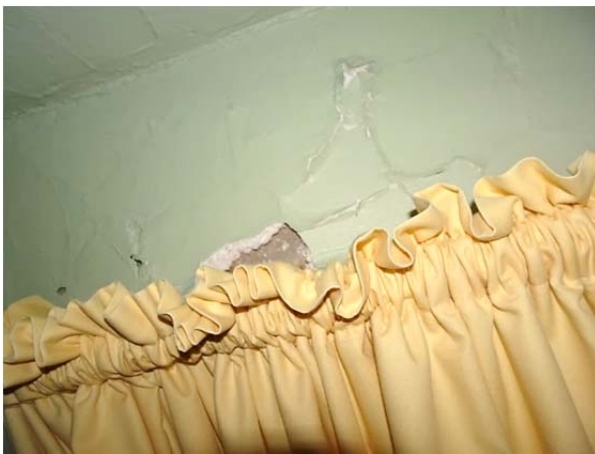
**FIGURE 178.** Deteriorated plaster and moisture staining above the window unit.

- Moisture staining and evidence of water infiltration were observed on the plaster above the first-floor bathroom window (Figure 178). The staining and delamination are signs of moisture infiltration from above.
- One window opening on the west elevation has a hole in the exterior window screen (Figure 179). The hole is approximately 1 inch in diameter.
- A previous dutchman repair was made to the stool of a window on the second floor on the east side (Figure 180). The dutchman joint extends across the full width of the stool and is open.

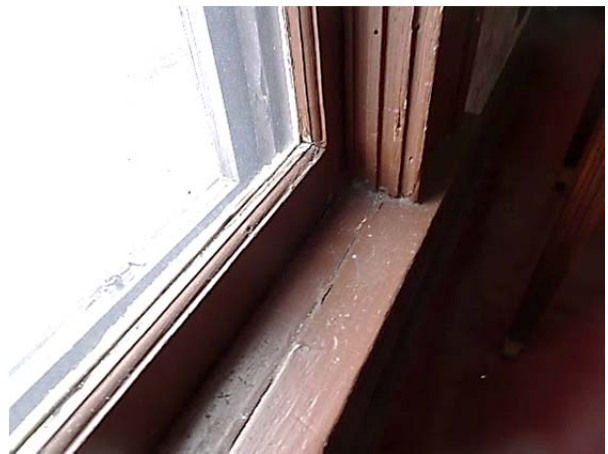
**FIGURE 180.** Previous dutchman repair to this window stool has open joint.

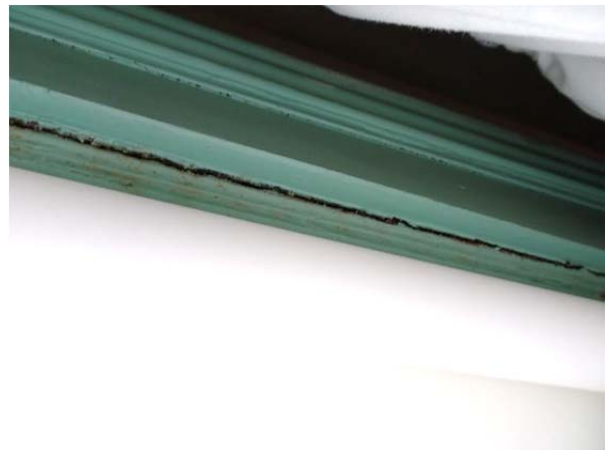
**FIGURE 181.** Open joint between the window casing and jamb framing.

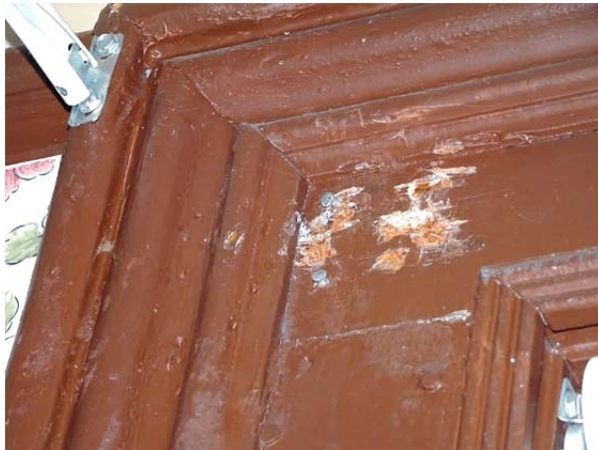
- Damaged wood was observed at window casing where curtain rods had previously been installed (Figure 182). The damage consisted of holes and small divots in the wood.
- Damage, including small chips and divots, was observed at the wood sash stop between the casing and jamb at one first floor window (Figure 183). The damage was most likely related to physical impacts.

**FIGURE 182.** Wood casing where a curtain rod had been previously removed.

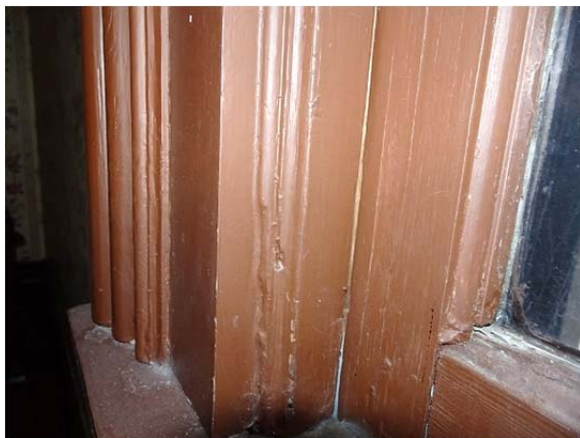
**FIGURE 183.** Jamb with bead molding at first-floor window. Note damage including chips and divots at bead molding.

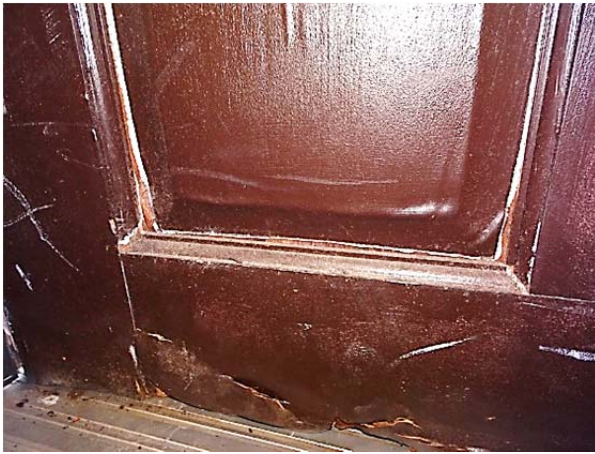
**FIGURE 184.** Severe damage at the bottom of the rear door on the first floor.

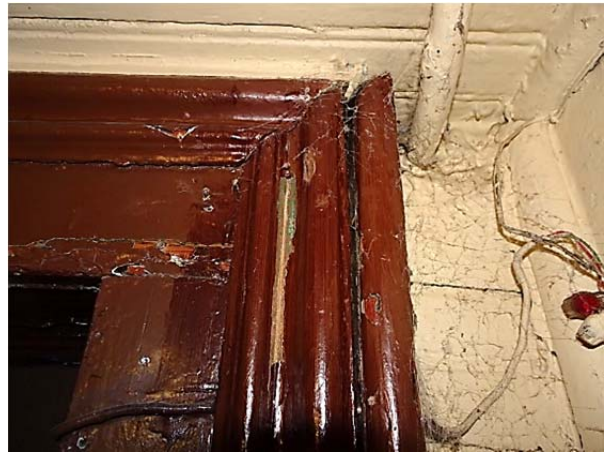
**FIGURE 187.** Displaced trim at second-floor exterior door.

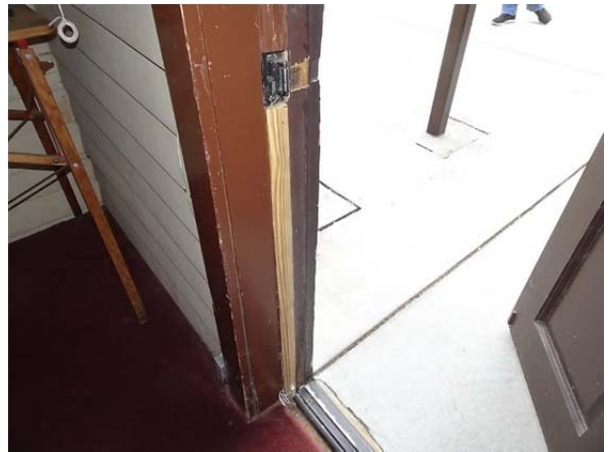
**FIGURE 188.** Unpainted dutchman repair to exterior door jamb, first floor rear hall.

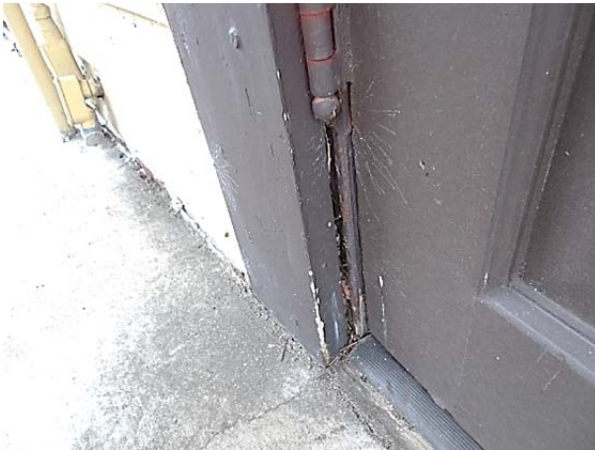
**FIGURE 186.** Open joint between the door casing and door jamb.

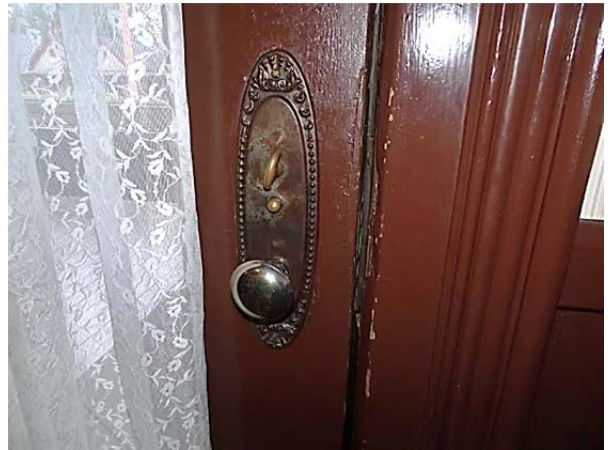
- The finish on the front door hardware was tarnished and worn (Figure 189).
- Peeling paint was observed on door casing and doors, especially at the rear of the Birth Home (Figure 190). The deterioration consisted of small chips or abrasions on wood surfaces. Typically, an underlying paint coating was visible; however, at some locations bare wood was visible.

**FIGURE 189.** Door knob and escutcheon plate on the front door. Note the original finish has been worn away at some places.

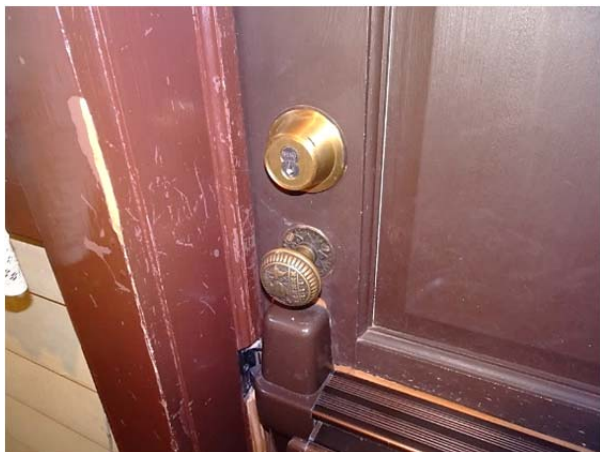
**FIGURE 190.** Peeling paint on rear door casing.

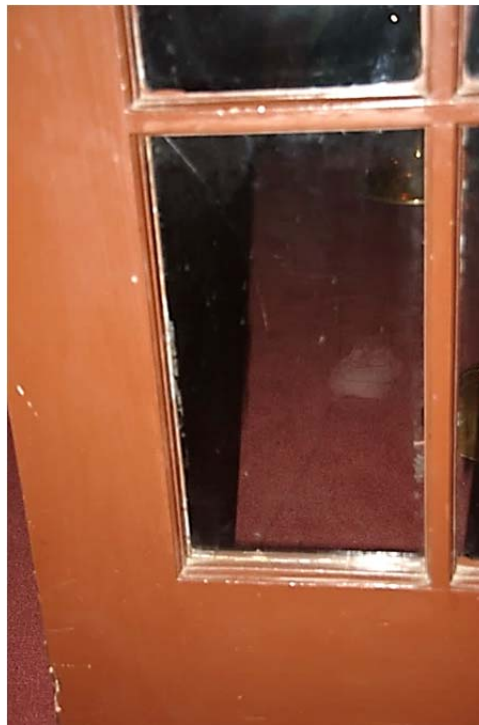
- On the first floor, the original upper hinge of the unique door between the hall and the back porch is displaced (Figure 191). The hinge leaf is not set fully into the mortised jamb, probably because the screws for the new hinge did not have sufficient solid wood for a snug installation as a result of the screw holes from the original hinge.
- One glass pane in the French doors at the entrance hall is cracked (Figure 192).

**FIGURE 192.** Cracked glass light at French door.

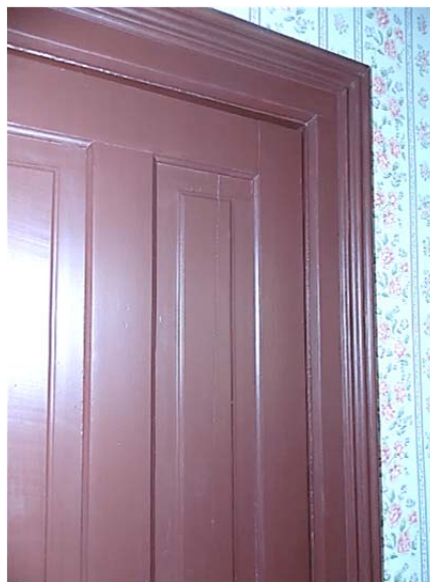
- One wood panel of the closet door in the upstairs front bedroom is split vertically (Figure 193).

**FIGURE 193.** Crack in closet door panel.

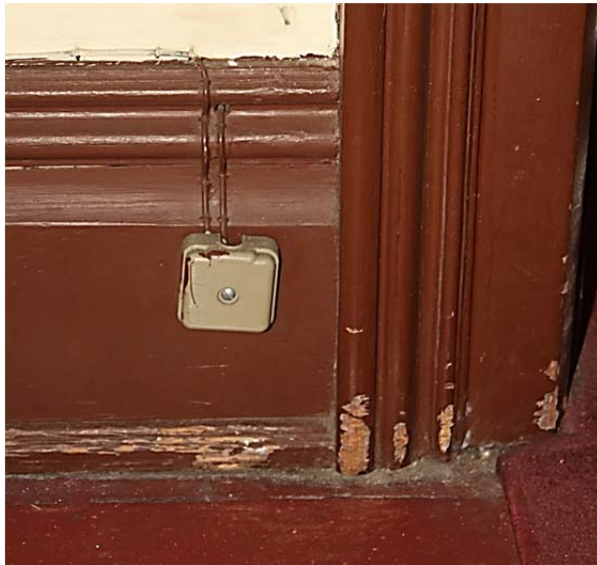
**FIGURE 194.** General wear at wood casing and base.

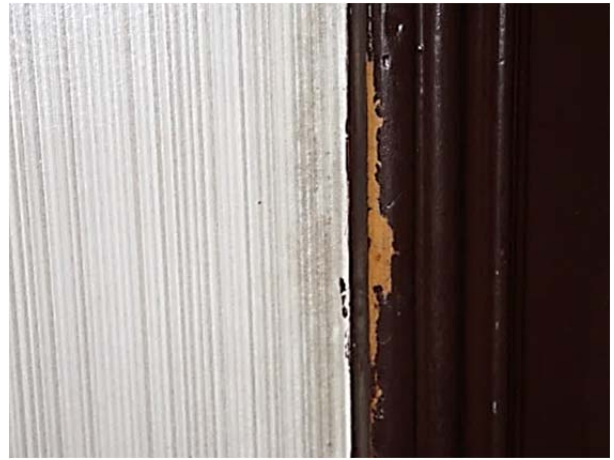
**FIGURE 195.** General wear at a door casing.

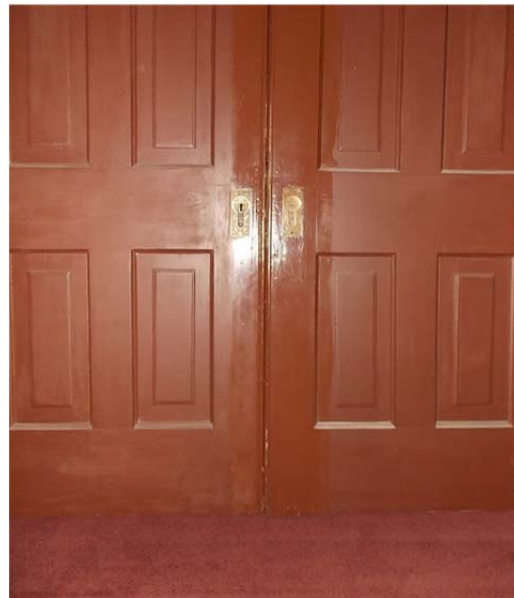
**FIGURE 197.** Paired pocket doors observed to have been painted in the closed position. Note the difference in the sheen of the paint where the two doors meet.

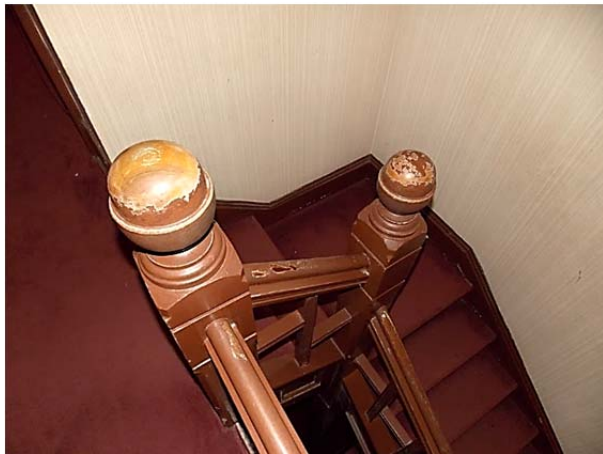
**FIGURE 198.** Worn finish on newel posts.

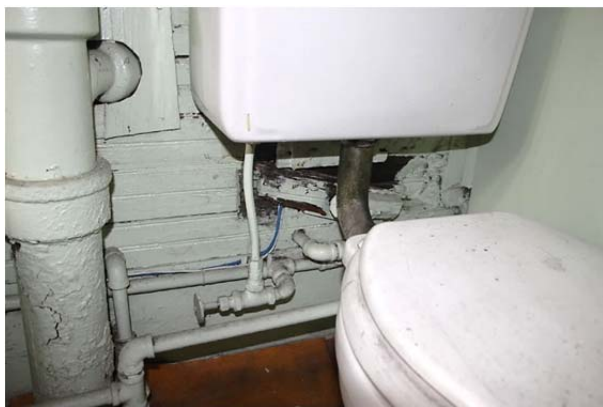
**FIGURE 199.** Damaged wainscot panel behind the toilet.

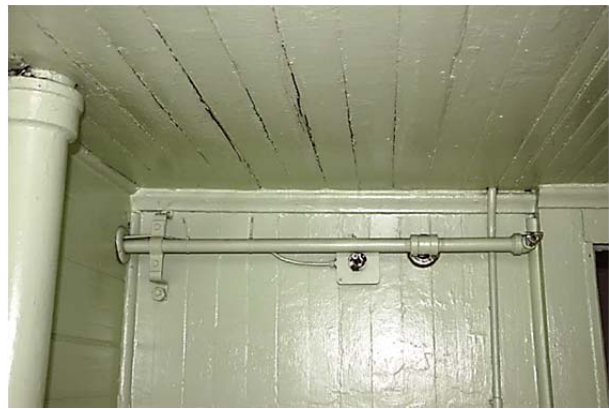
**FIGURE 200.** Deteriorated ceiling boards in the bathroom.

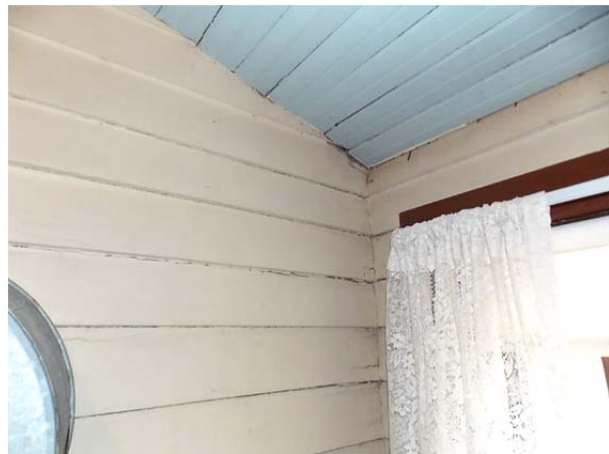
**FIGURE 201.** Deteriorated wood siding inside the back porch.

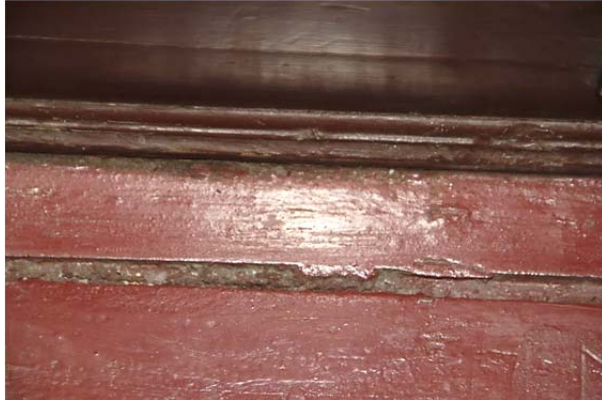
**FIGURE 202.** Aged separation at wood flooring.

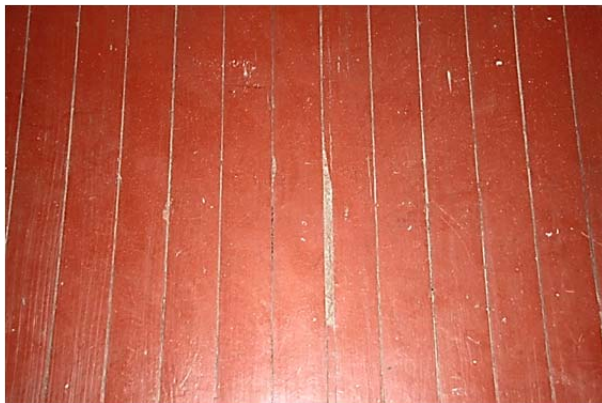
**FIGURE 203.** Typical wear on wood flooring.

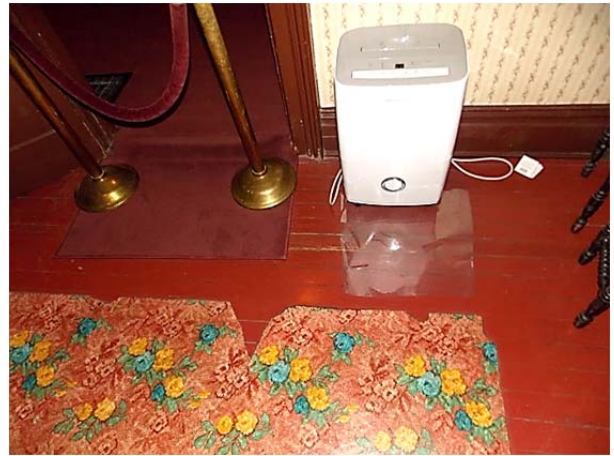
**FIGURE 204.** Deteriorated edges of vinyl floor cloth.

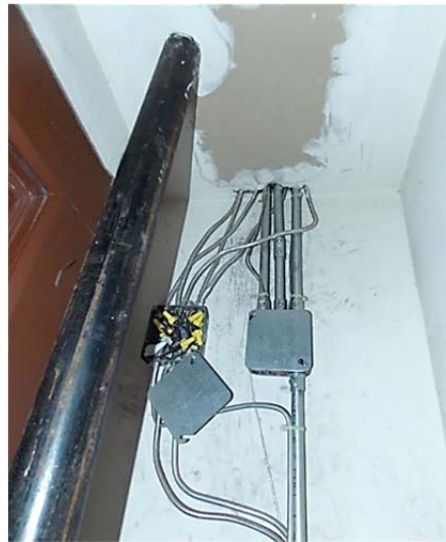
**FIGURE 215.** Open junction box and conduit penetrations at closet.
