HFR-23

## INTRODUCTION

# Transcriptions from South Wall

Building #5

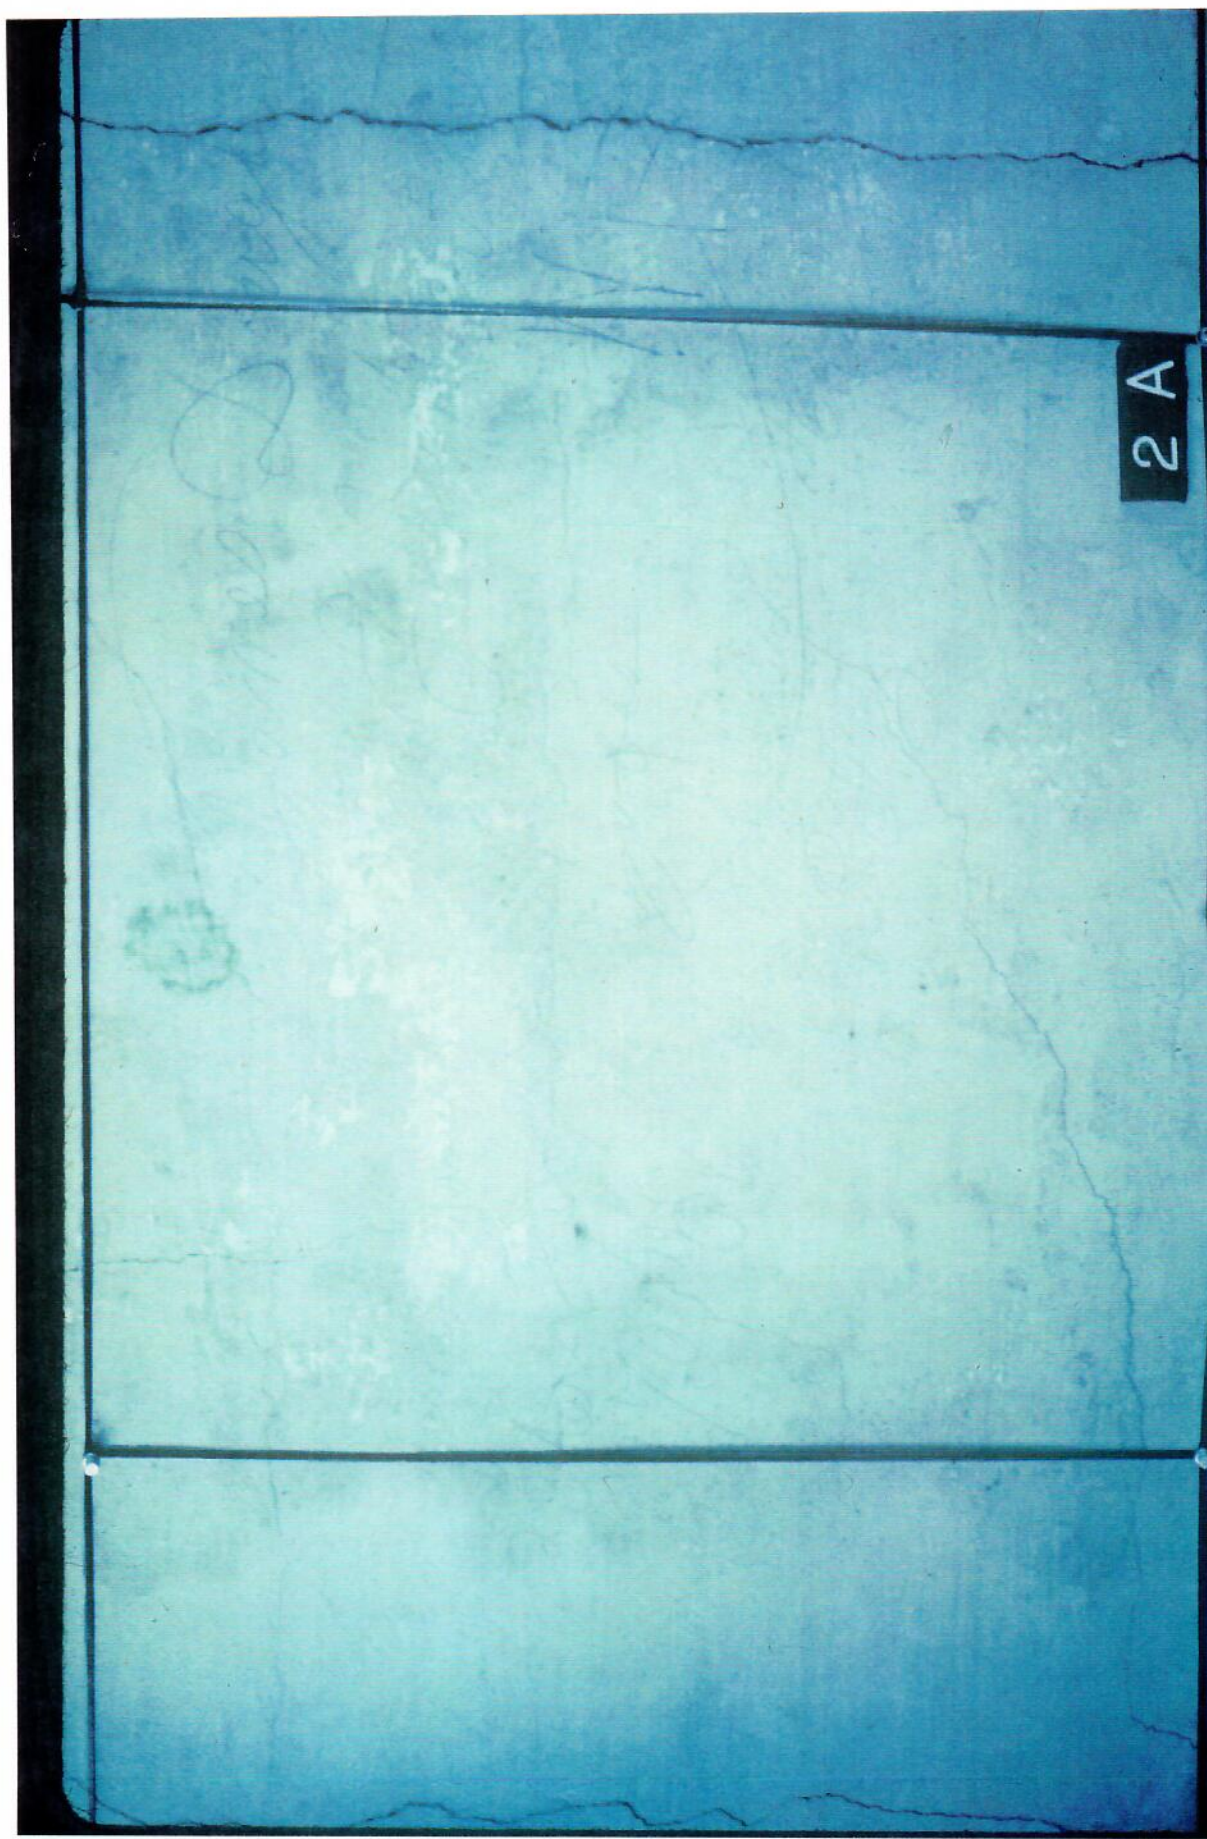
Photograph of block 2A taken with ultra violet film

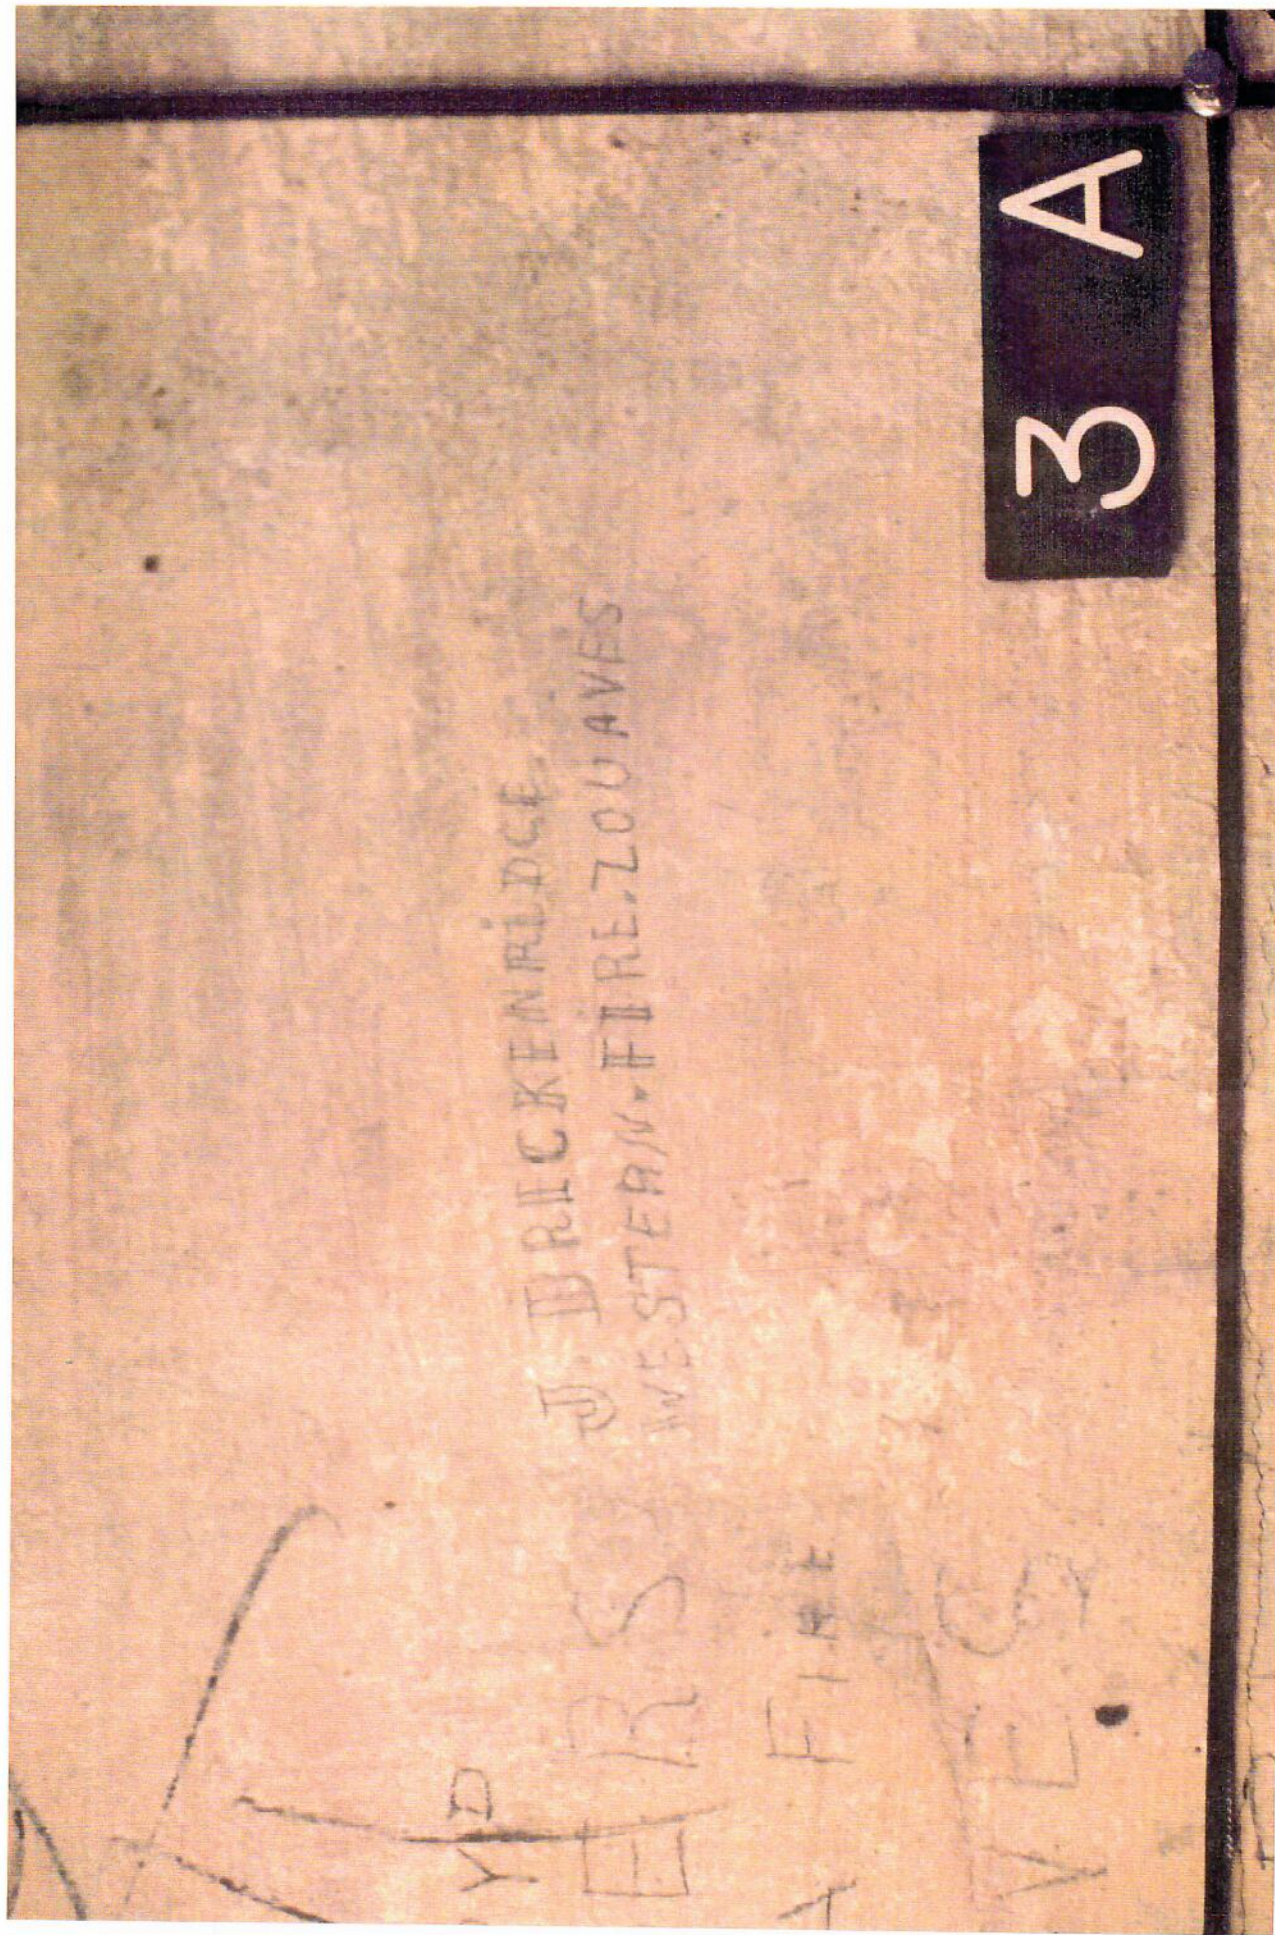
Detail from block 3A, South Wall, 3rd floor.

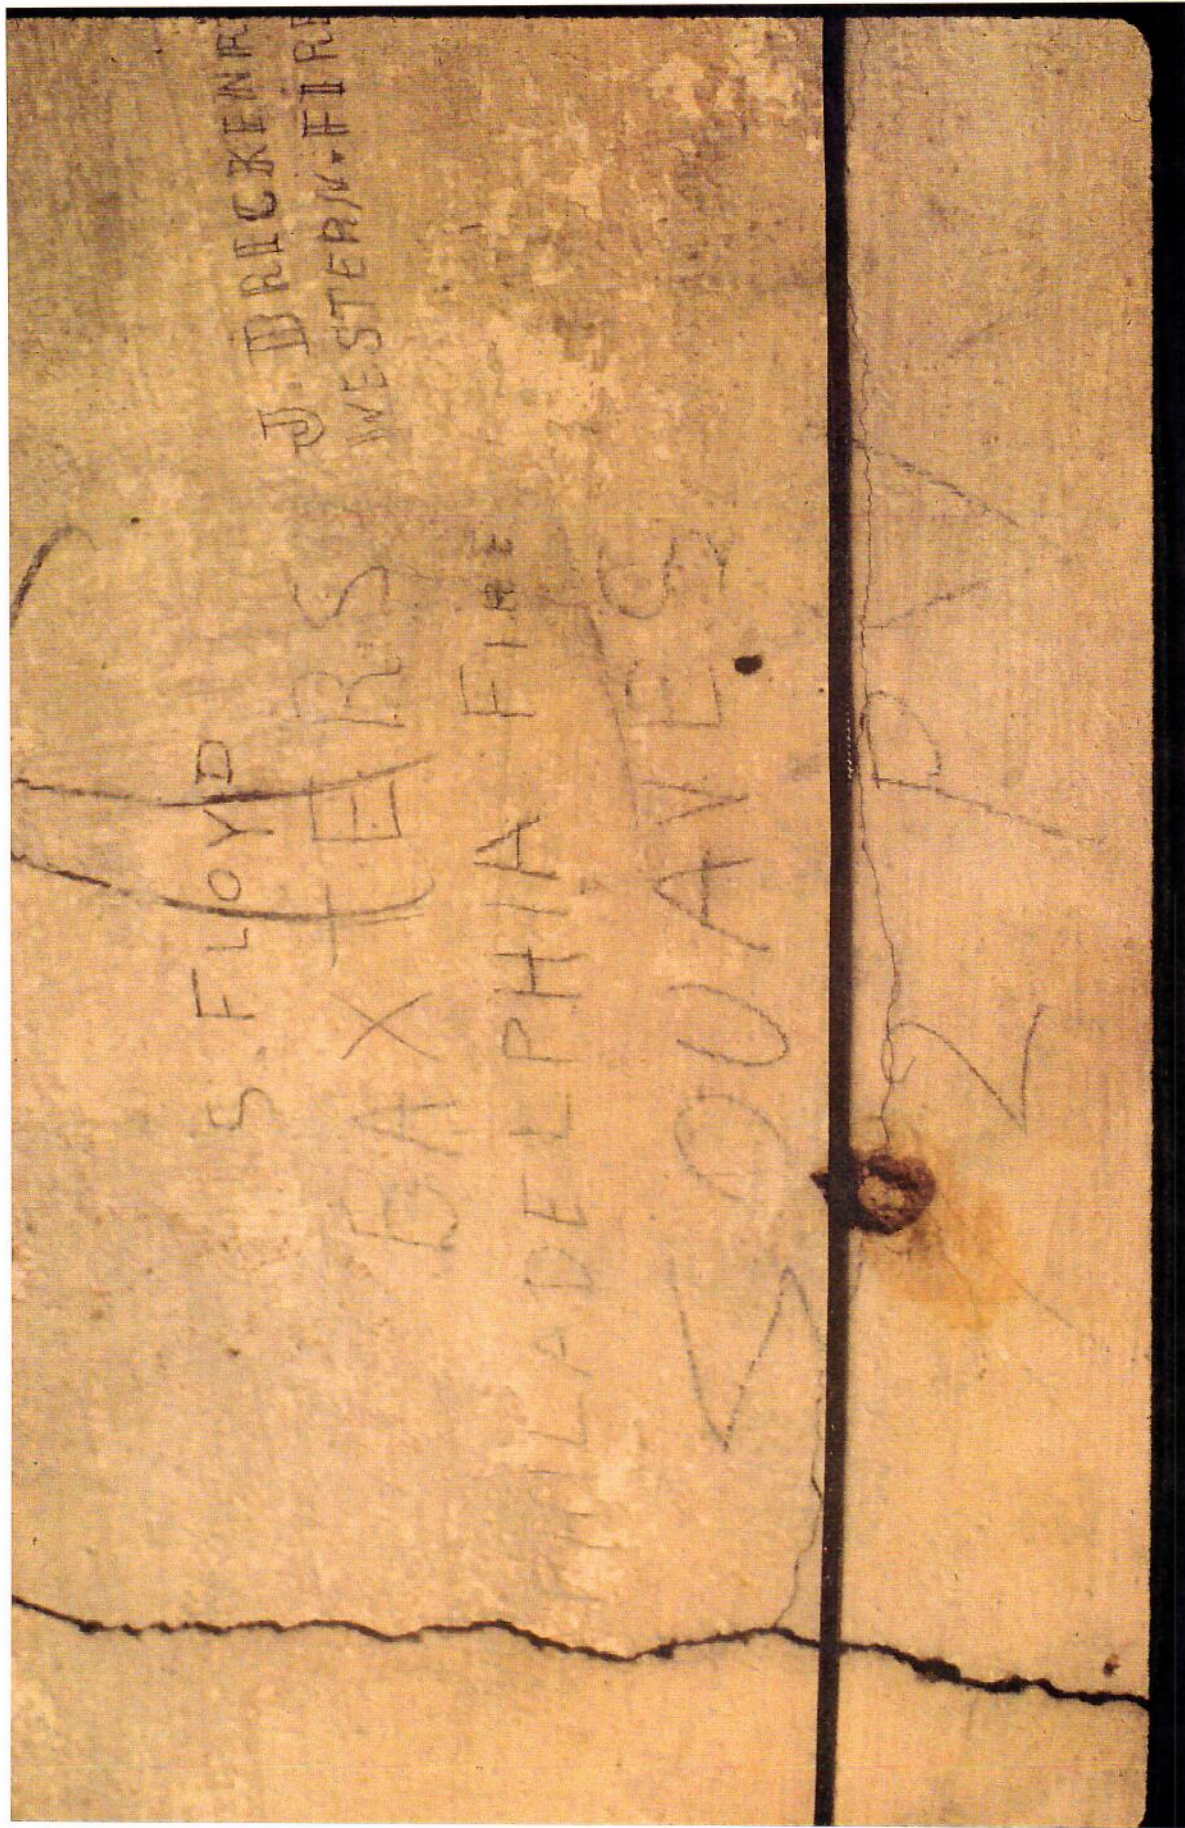
Detail from block 3A, South Wall, 3rd floor

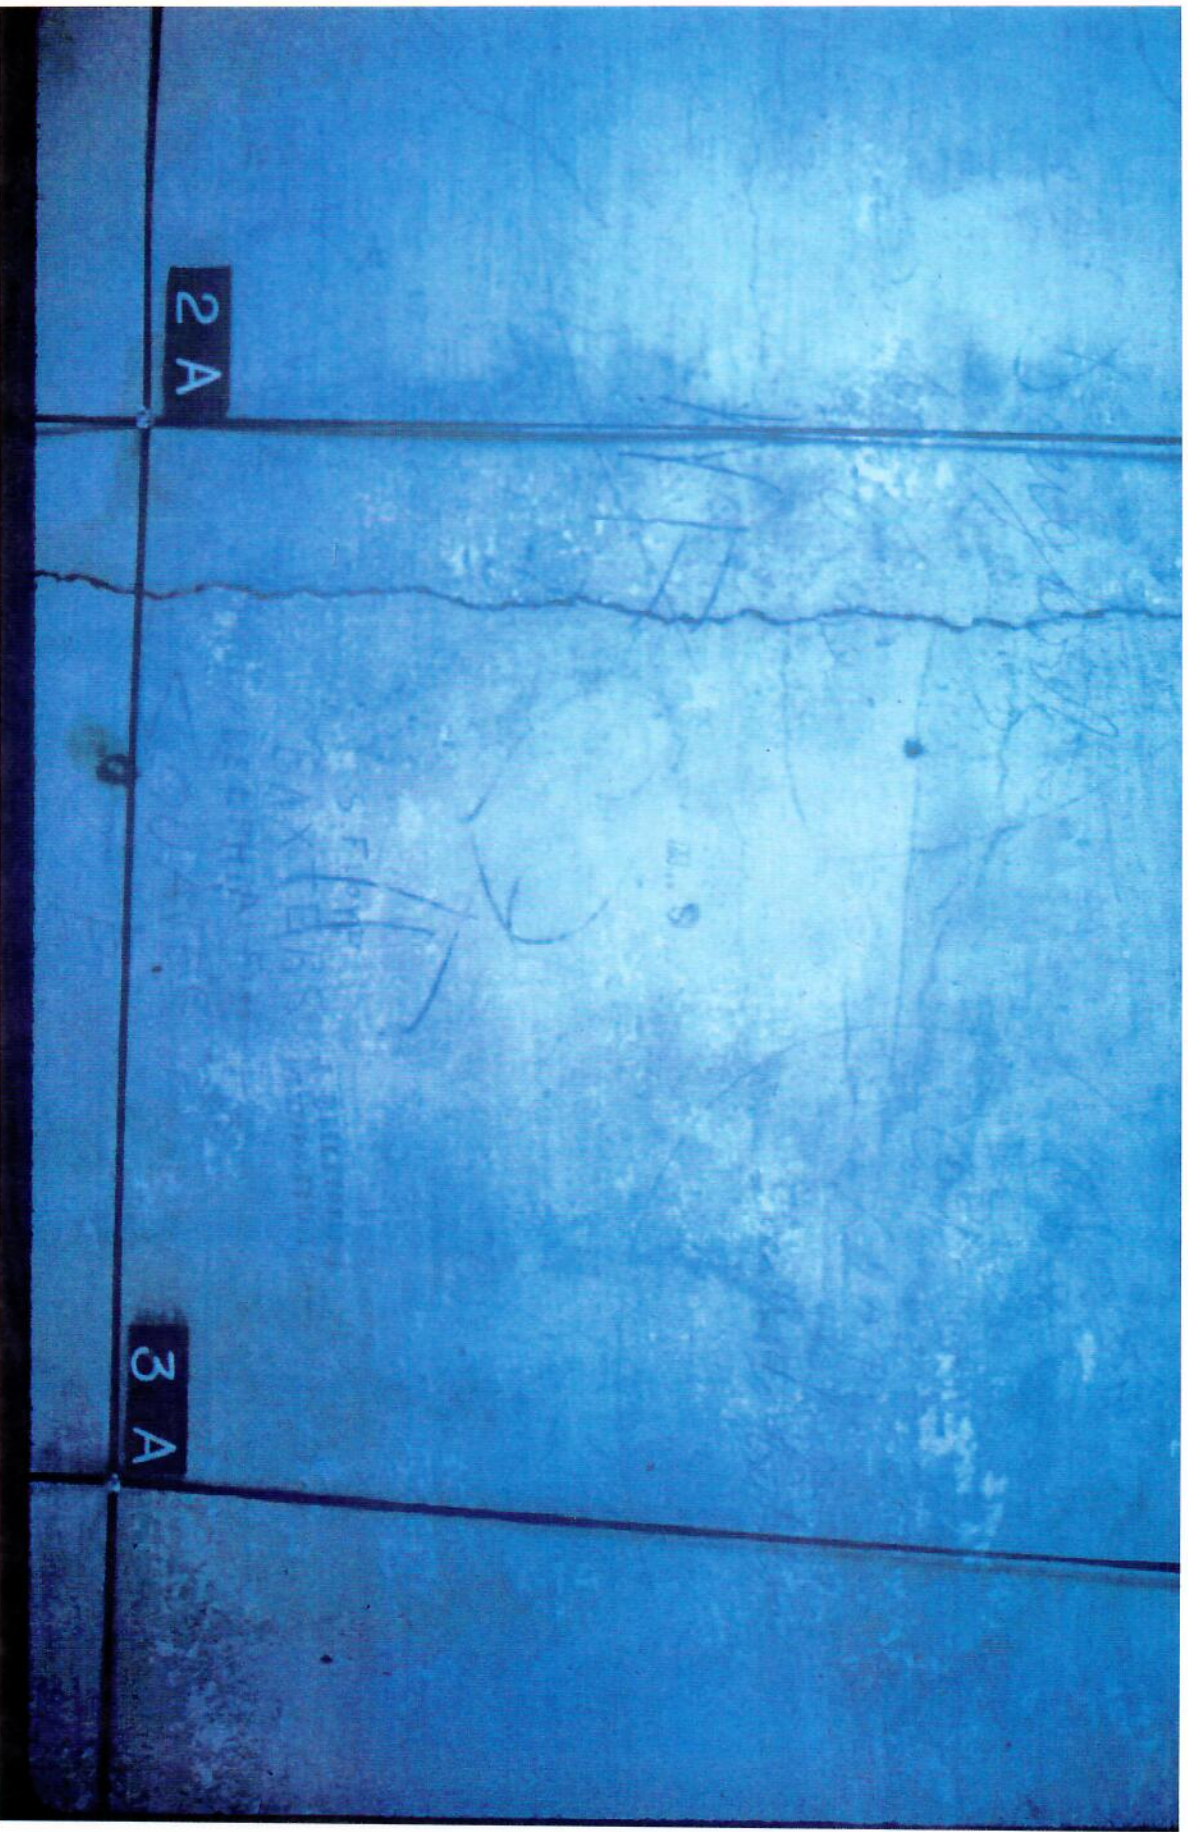
Photograph of block 3A taken with ultra violet film

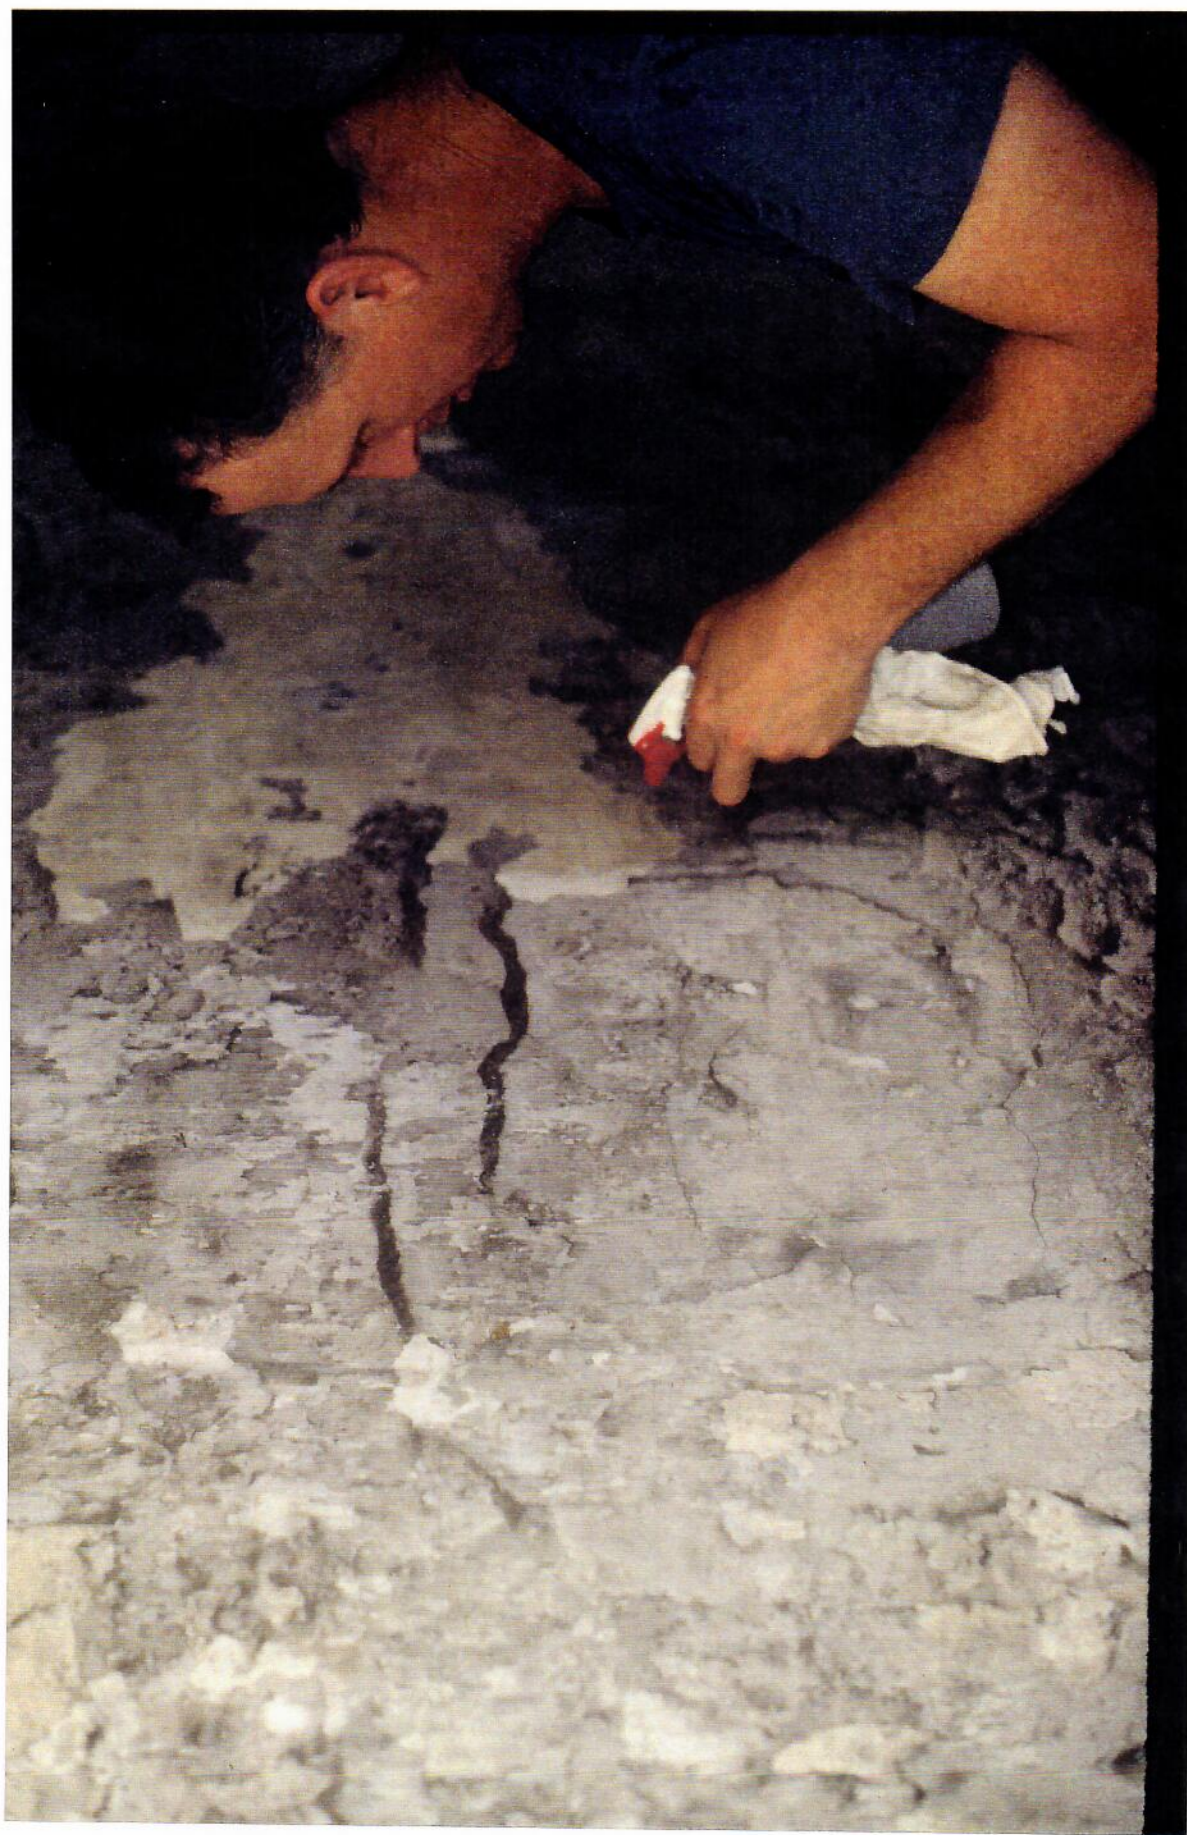
Detail of sample block on South Wall, S.E. room, 2nd floor. Graffiti bearing plaster being misted with distilled water to reveal obscure inscriptions

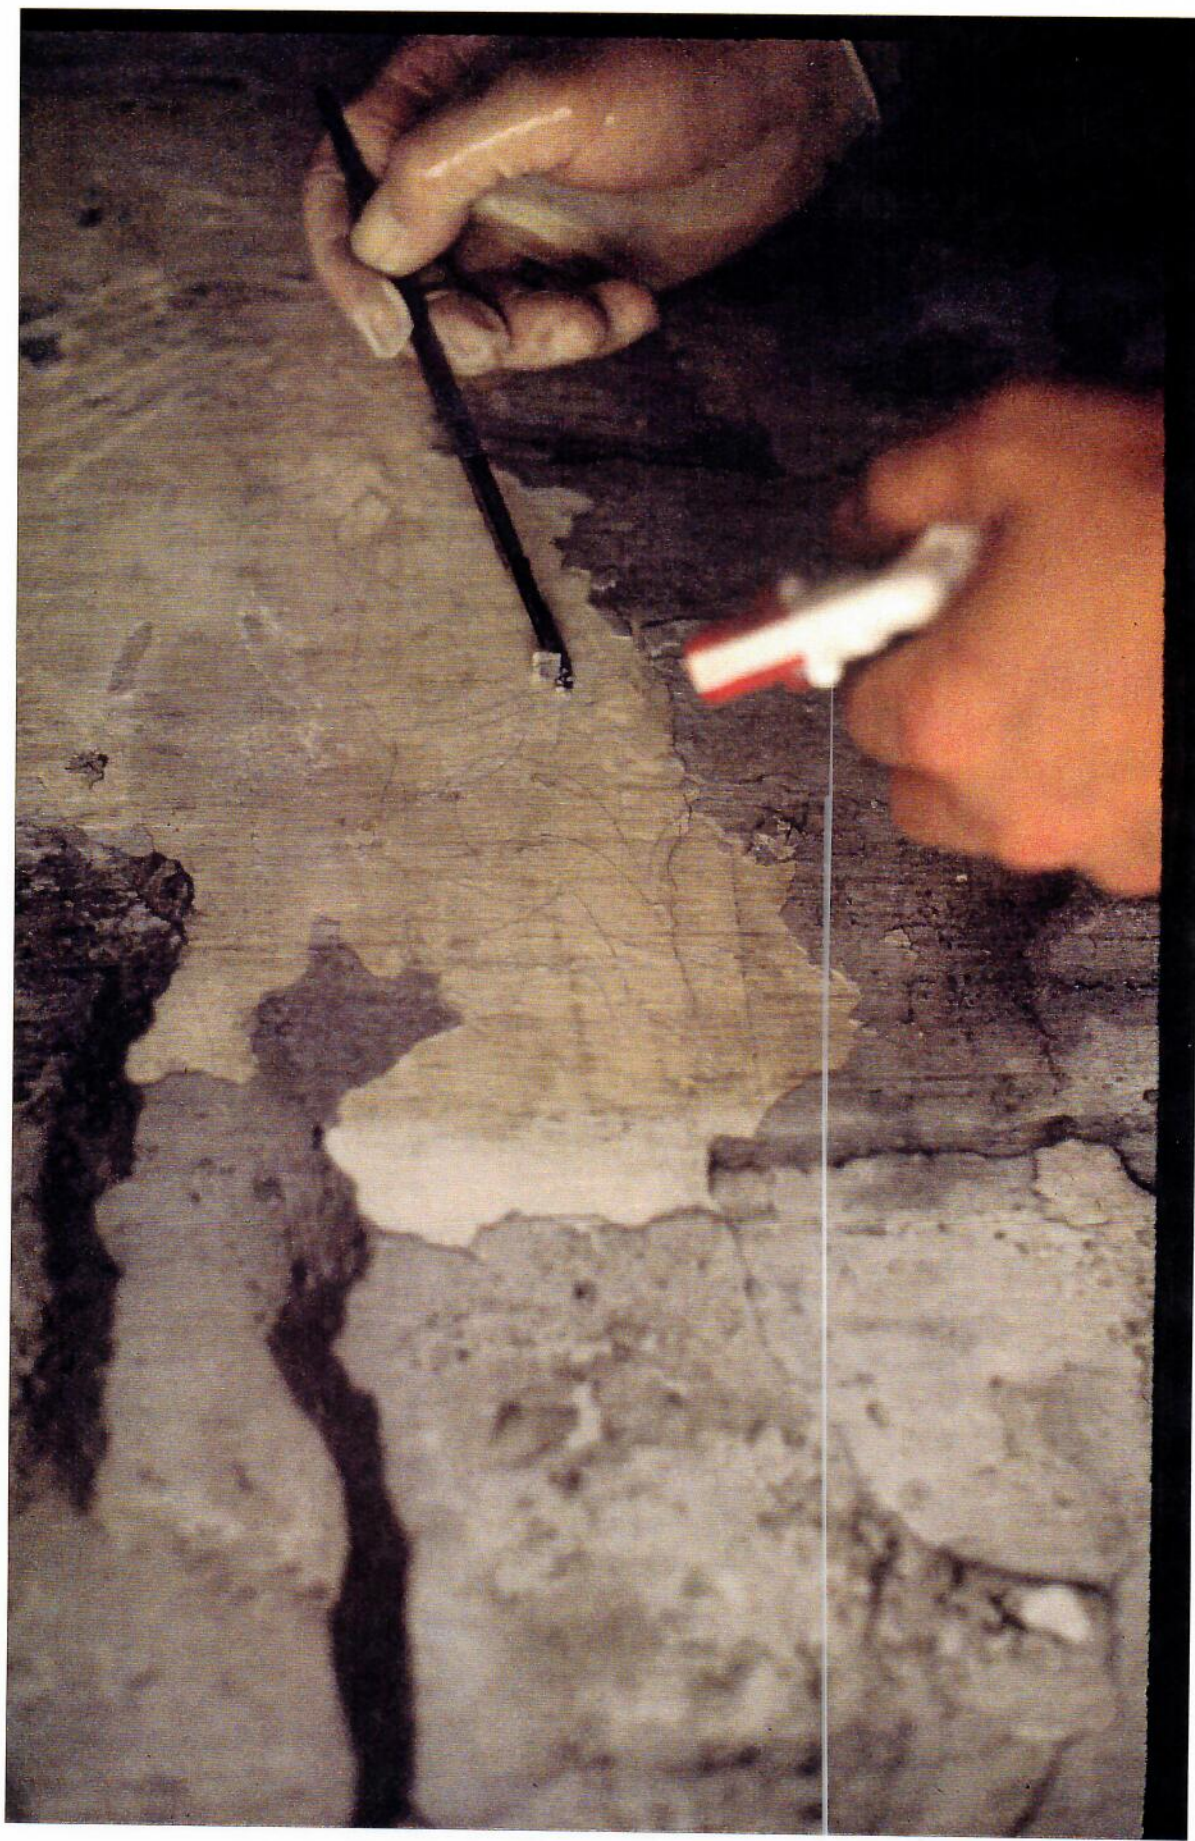
Detail of sample block on South Wall, S.E. room, 2nd floor. White wash coating which covers equestrian figure being mechanically removed.

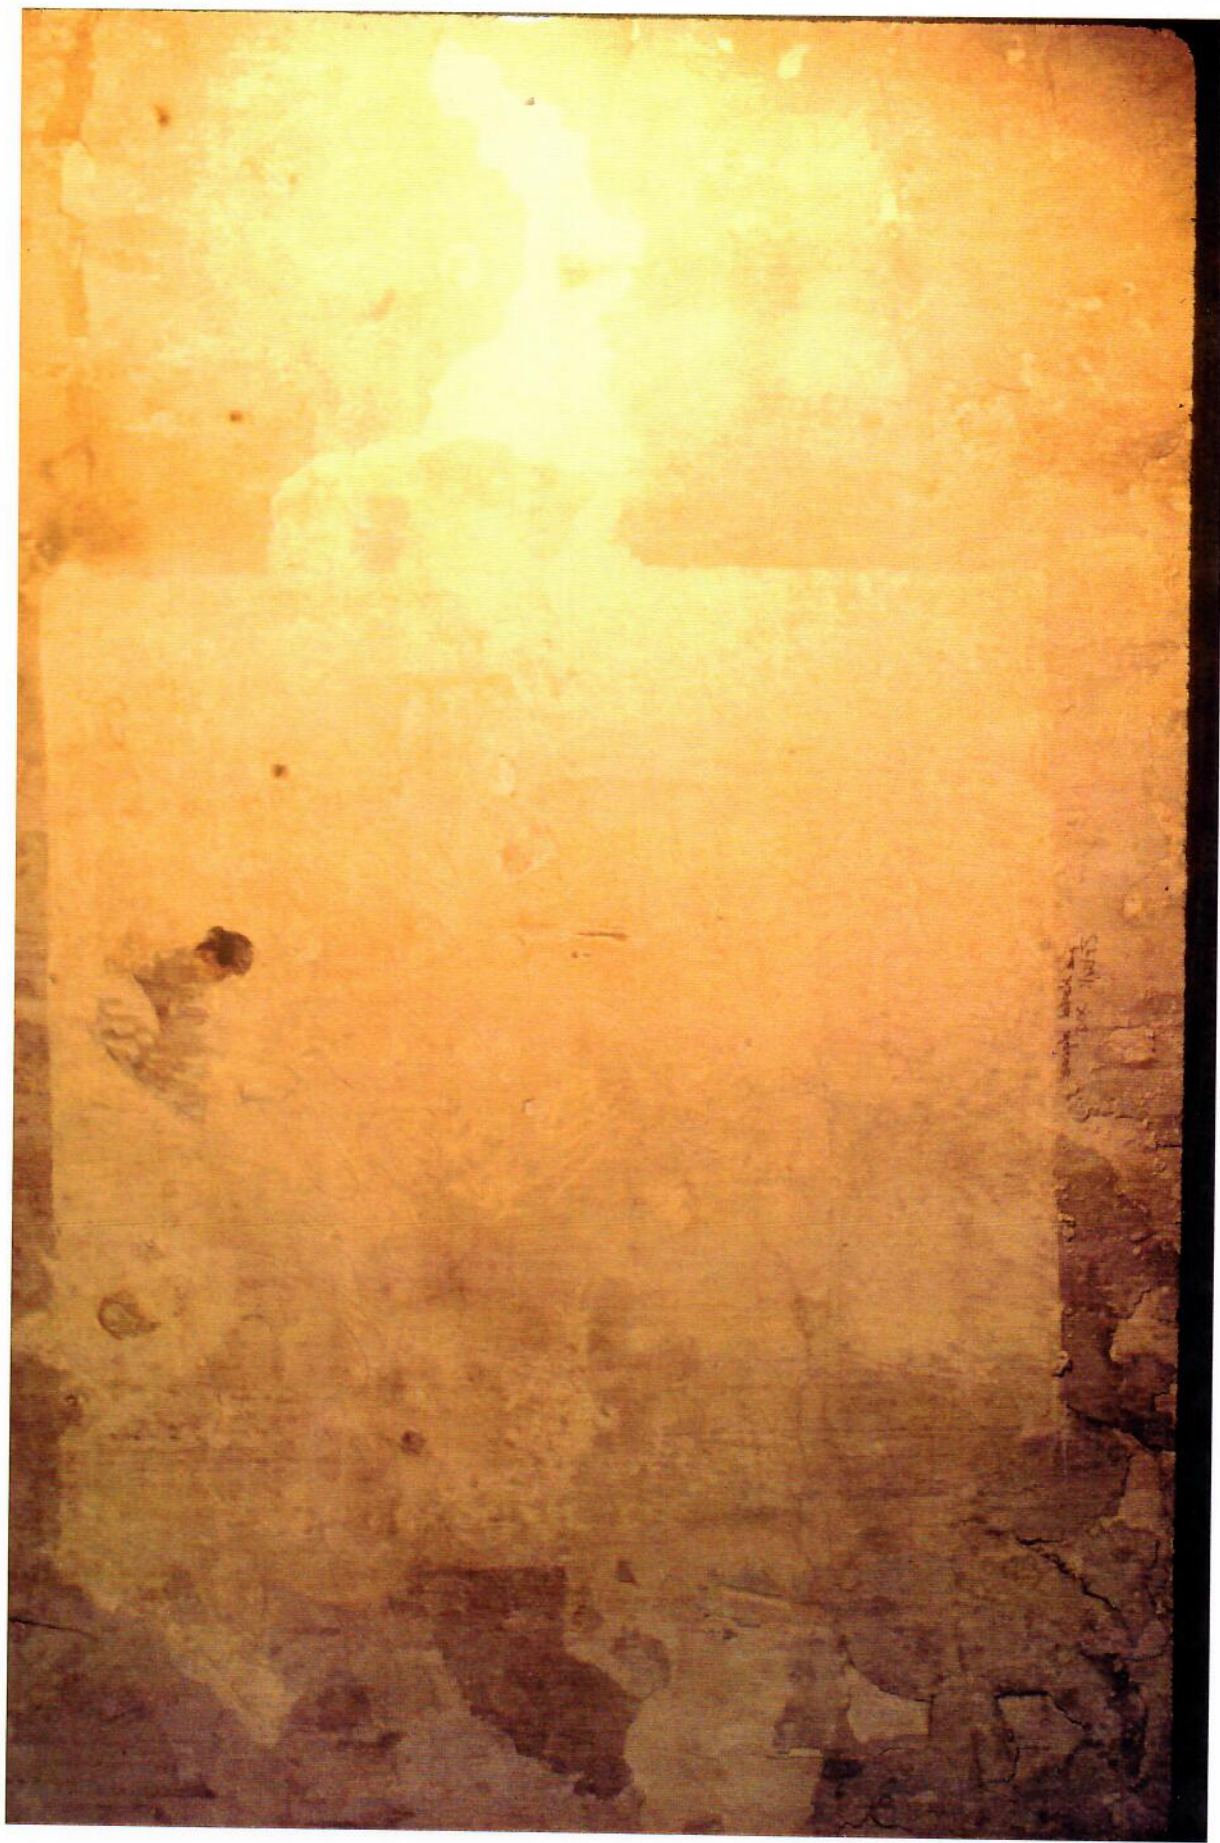
Sample block on North Wall, S.E. room, 2nd floor. Faint inscription reads "Geo. Washington"

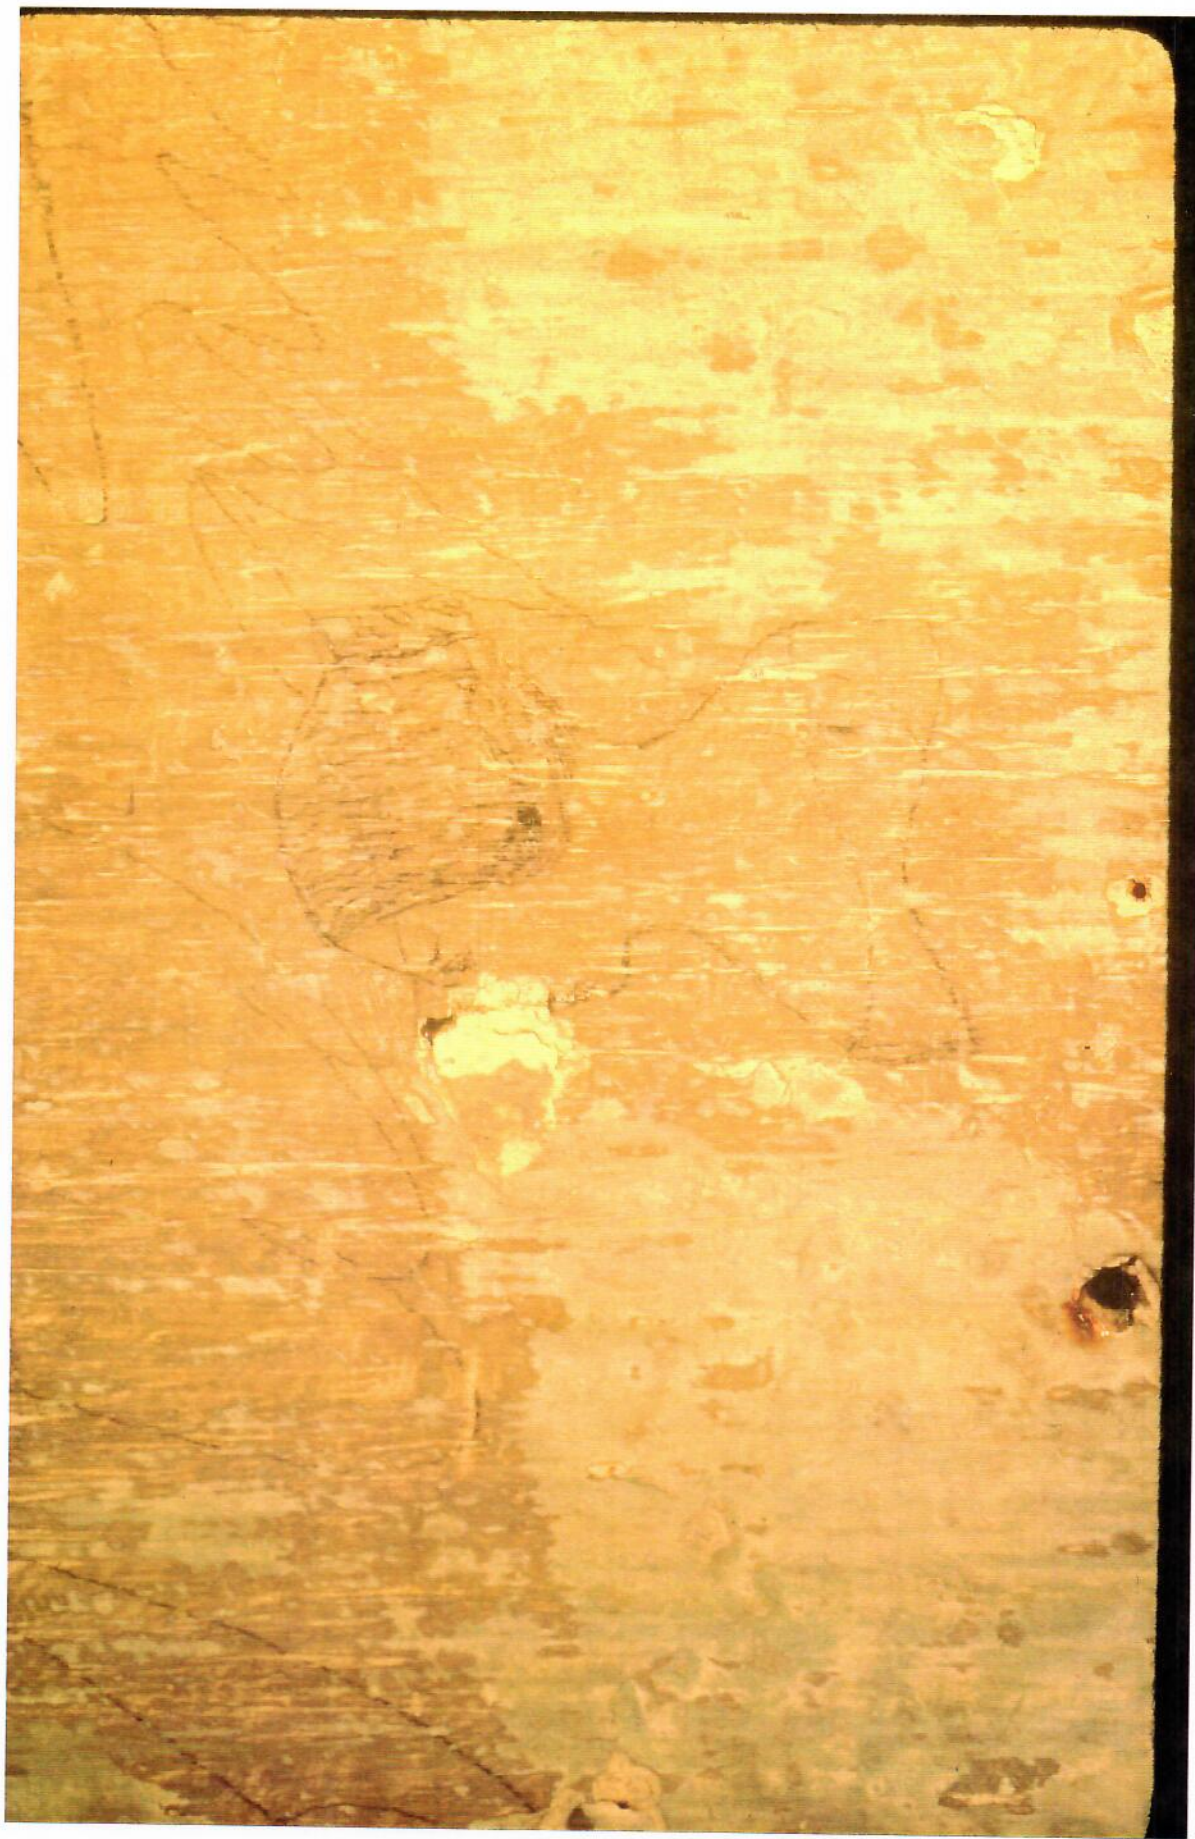
Detail from North Wall, N.E. room, 2nd floor. Female portrait, appears to be executed in pen and ink.

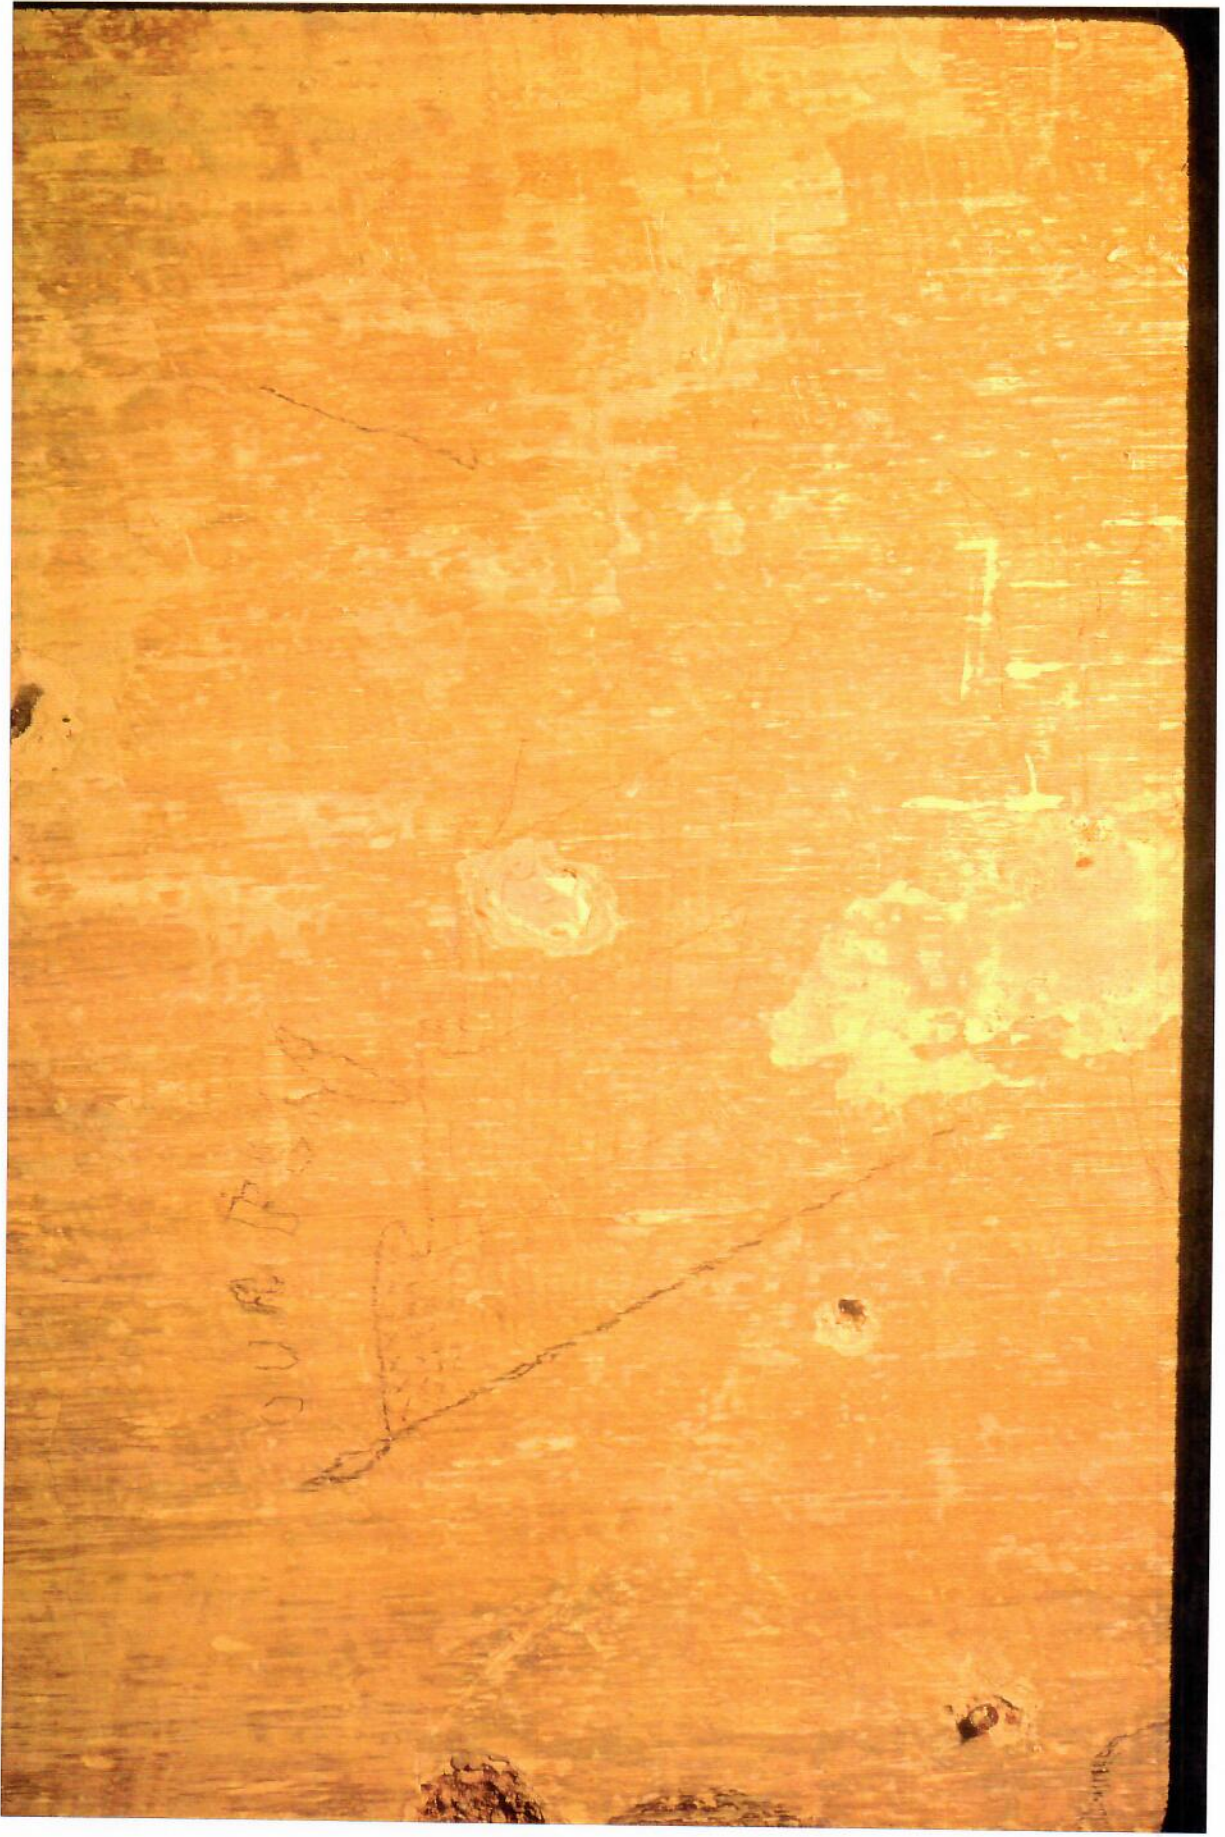
Detail from North Wall, S.E. room, 2nd floor. Image of American flag with inscription above reads "Our Flag"

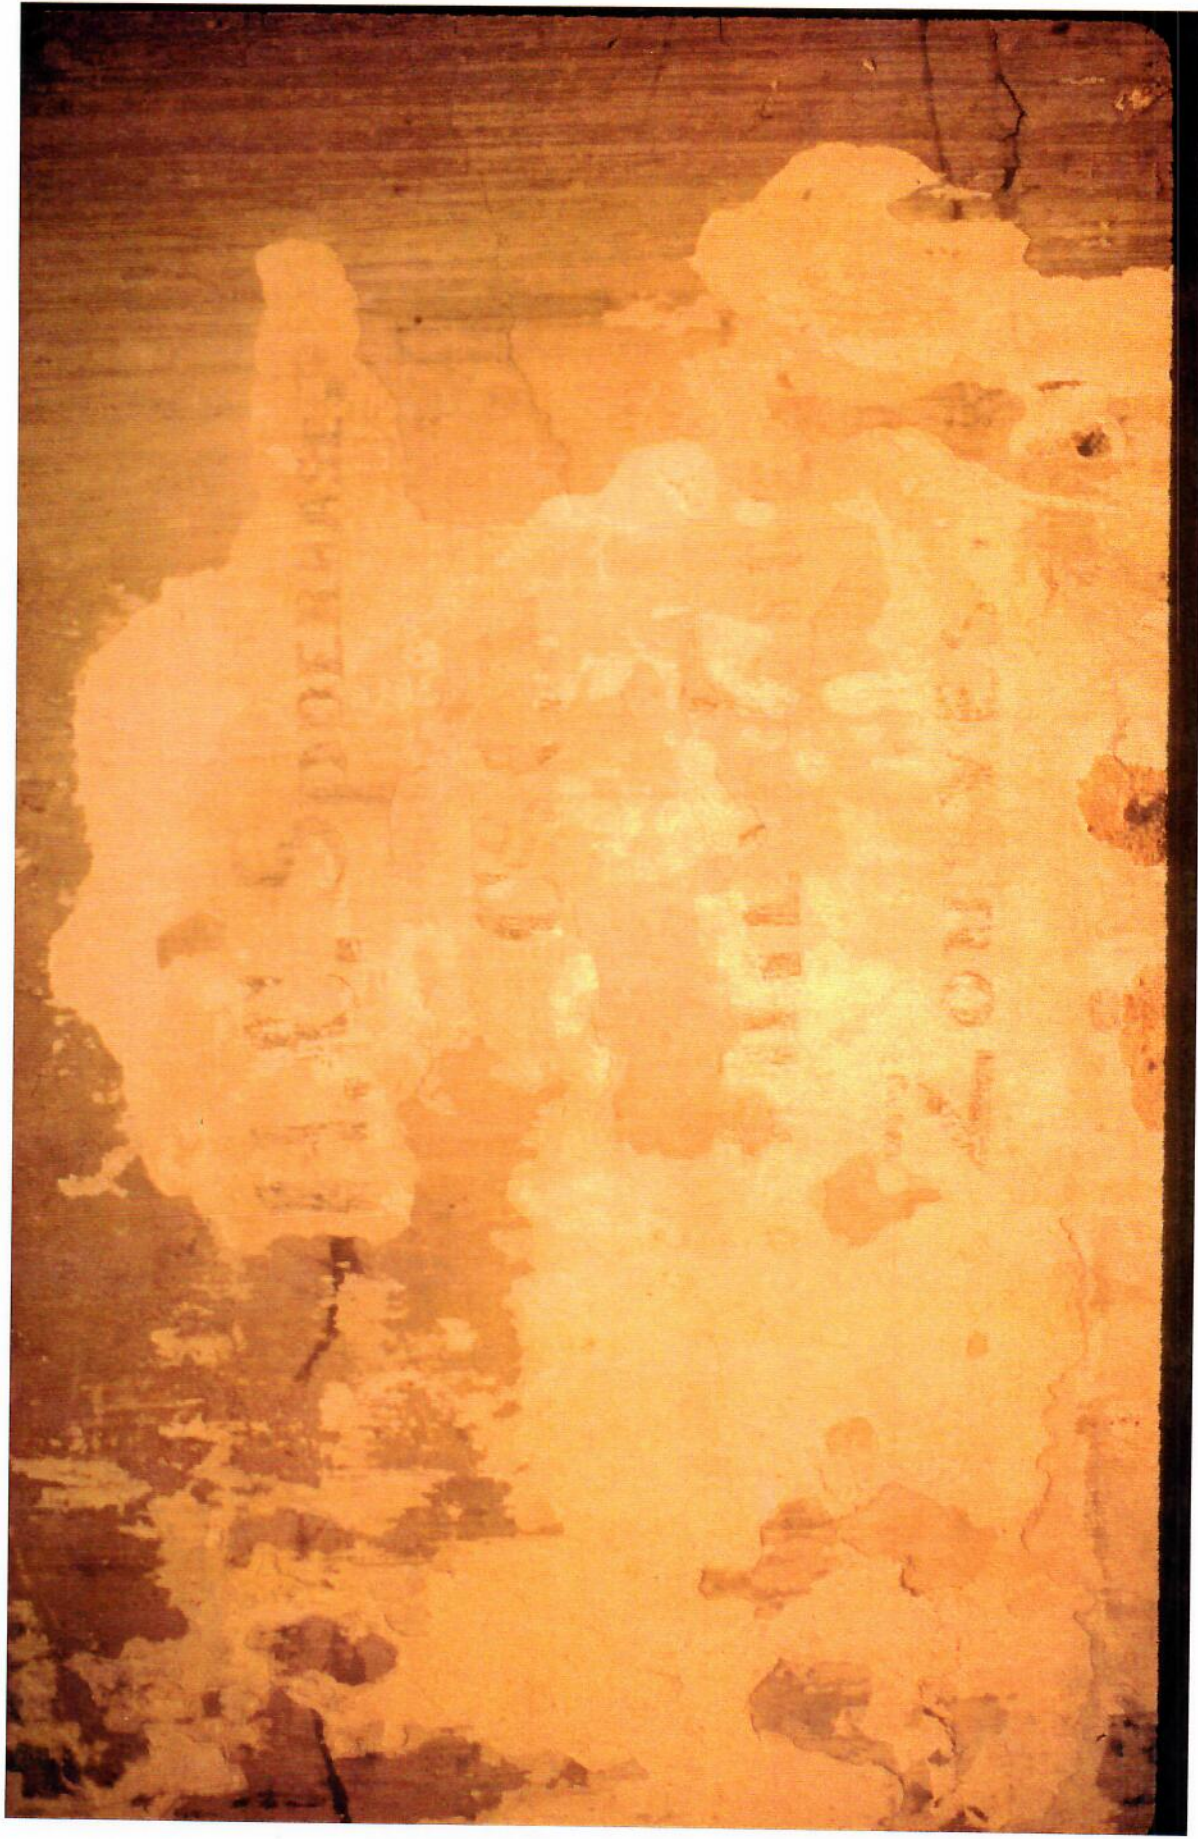
Detail from West Wall, S.E. room. Graffiti revealed as a result of natural separation between plaster and overlying layers of paint.
