HFR-23

## INTRODUCTION

# Transcriptions from South Wall

Building #5

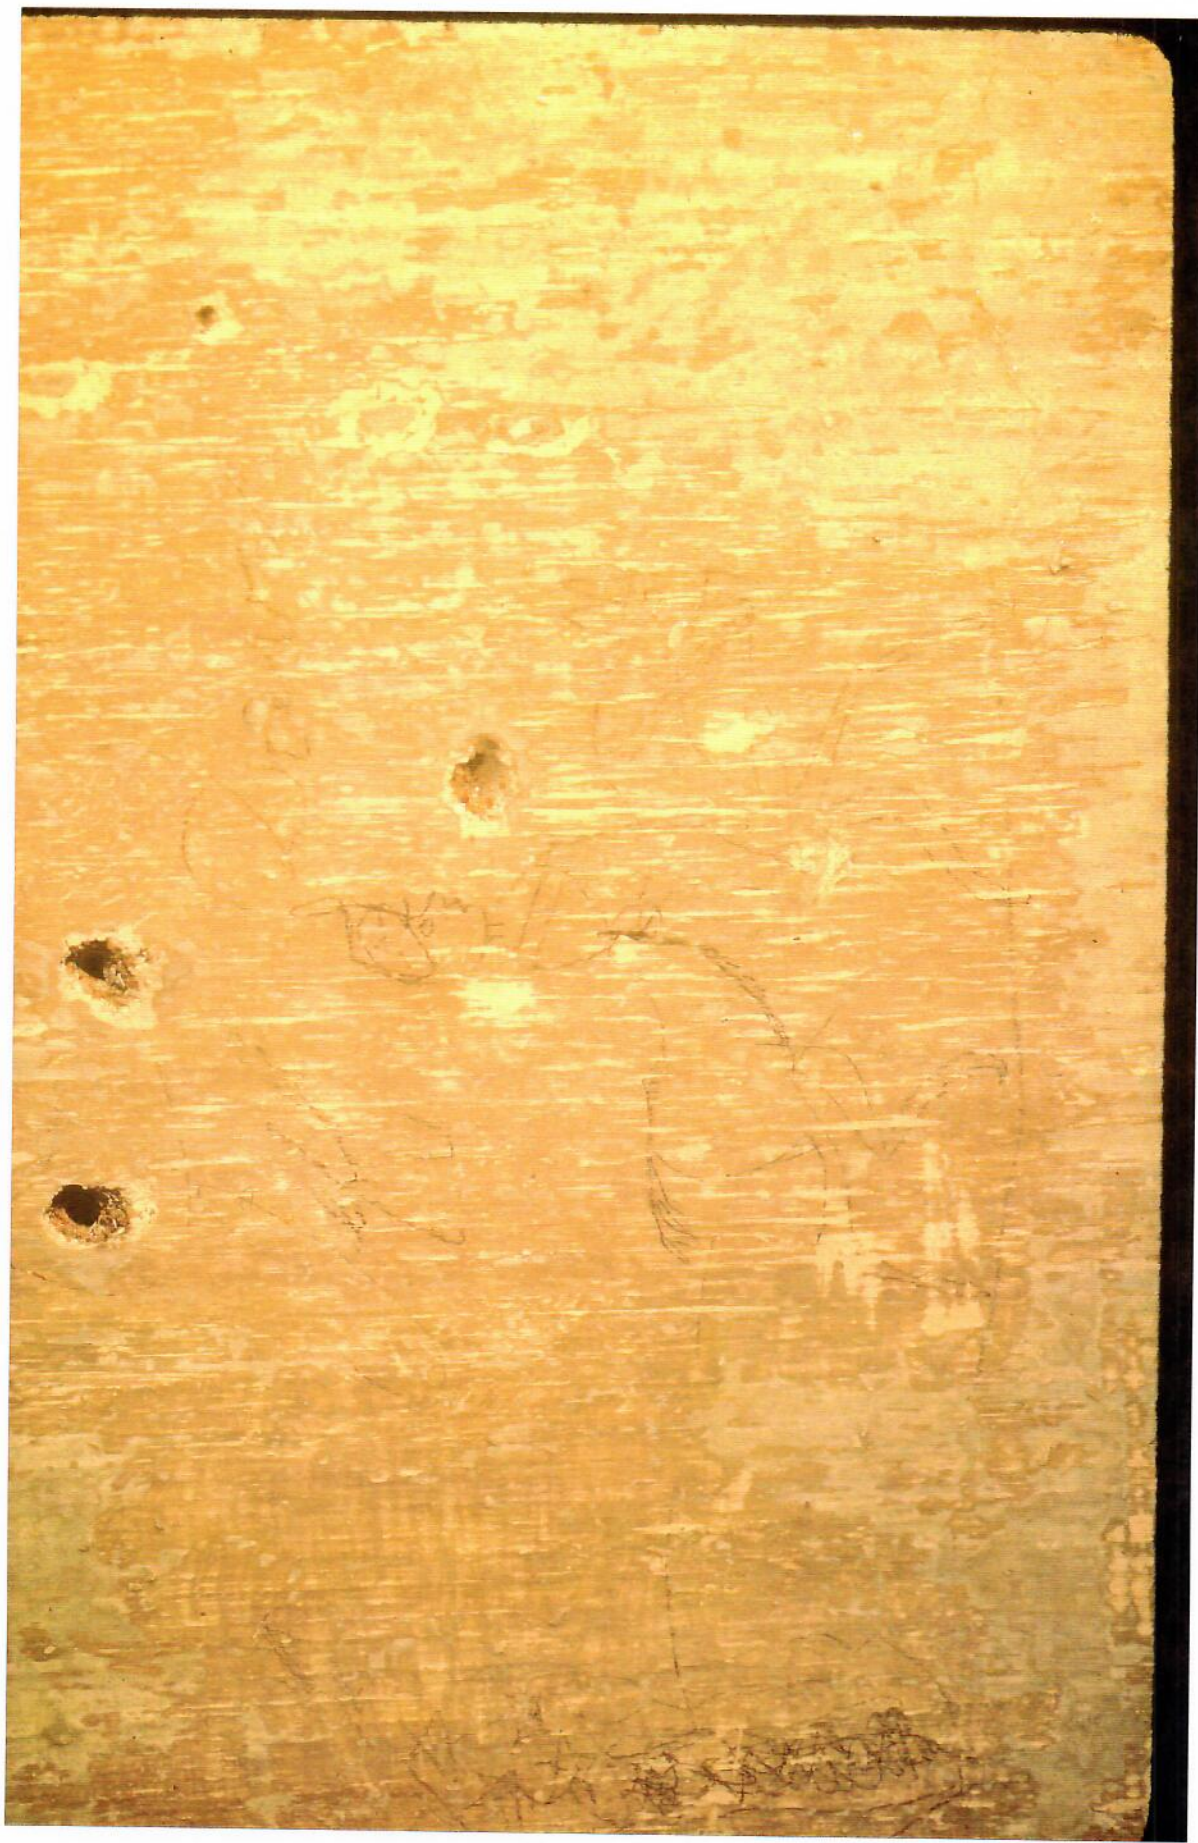
Detail of sample block on South Wall, S.E. room, 2nd floor. Drawing of equestrian figure with cinched waist, "Jeff Davis" inscribed above.

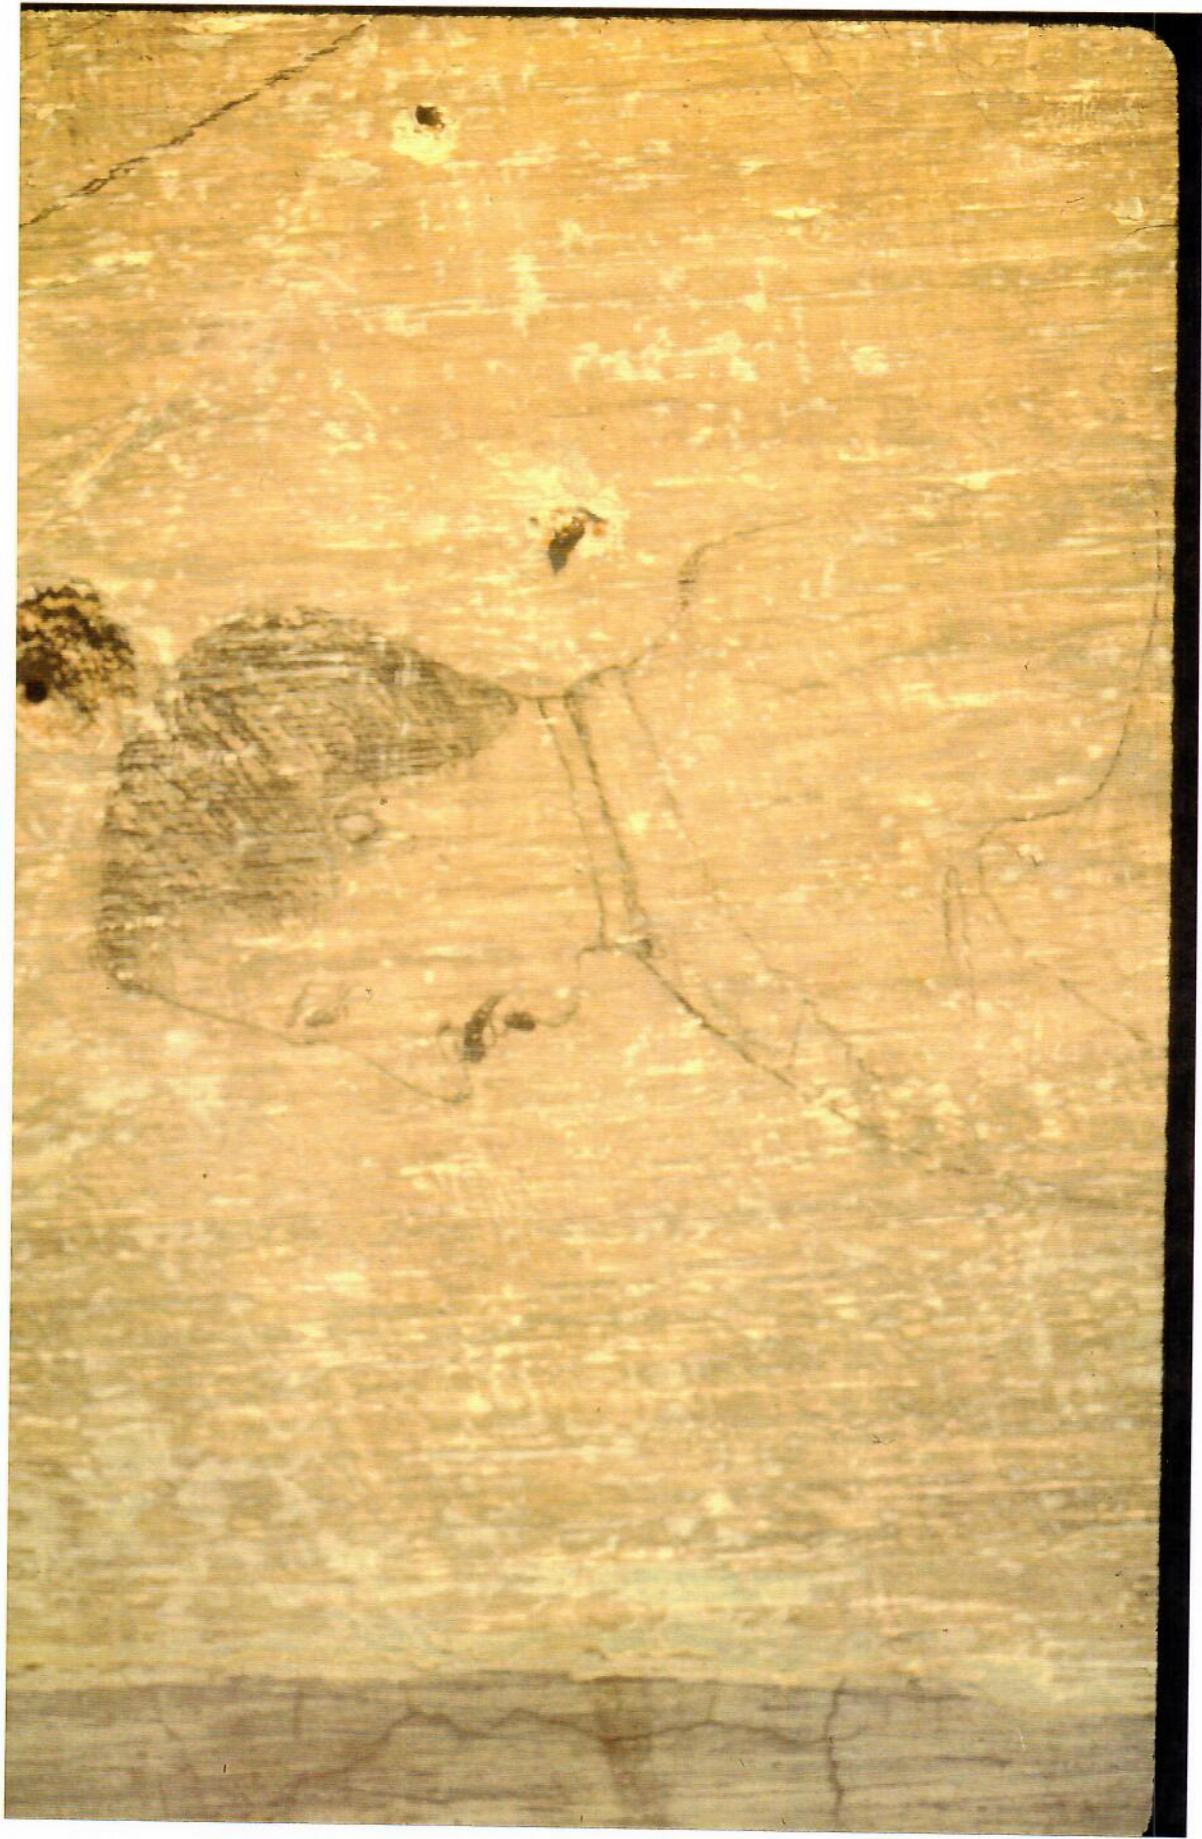
Detail from sample block, North Wall, N.E. room, 2nd floor.
