# Jetty Workers' House #2 Historic Structure Report

Cape Lookout National Seashore  
Harker's Island, North Carolina

February 2012

2012  
Historic Structure Report  
Jetty Workers' House #2  
Cape Lookout National Seashore

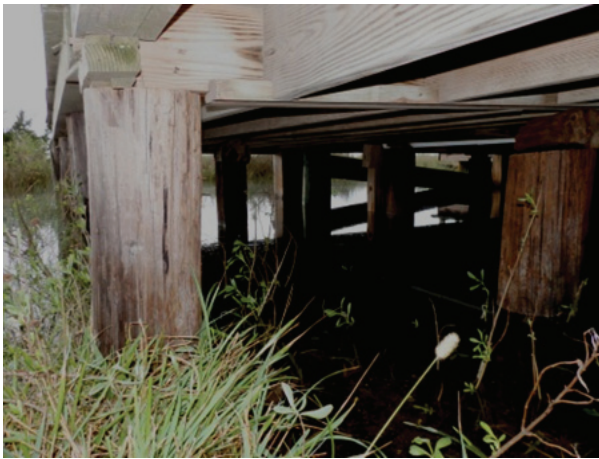
Figure 7. View of pilings from southeast corner of house.

**Foundation:** The building is set on a combination of round and square wood pilings that raise the house about two feet above grade under the original structure but as low as six inches in parts of the rear additions. The majority of the wood pilings under the original building, including the front porch, are square or rectangular, but those under the south and east porches and additions are generally round, about 12" in diameter, similar to the utility poles used for pilings in some of the other historic structures in the park. A few of the pilings are deteriorated and need replacement.

A number of the foundation piles are in poor condition and must be replaced. Placement should replicate the historic arrangement of piers, except where framing conditions necessitate additional support.

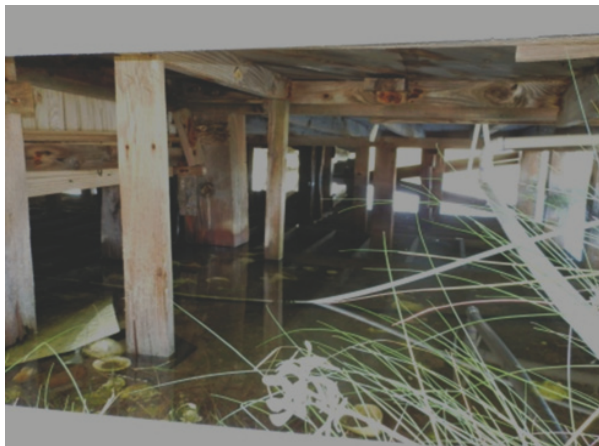
Figure 8. View of pilings at rear of house.

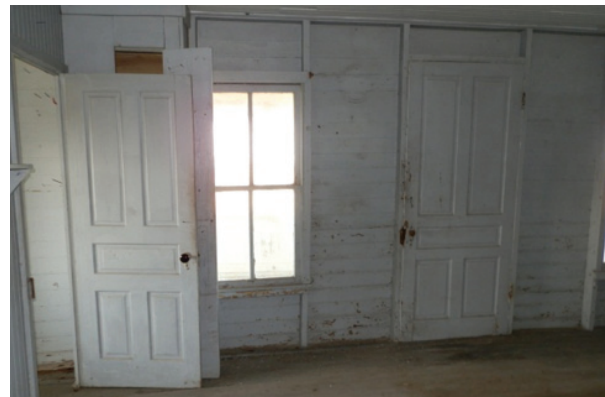
Figure 9. View of framing at north side of Room 101 in the original building. Note the lack of proper headers at the openings.

In some cases, sizing and spacing of historic framing members do not meet modern code requirements, but the historic framing can be augmented without total replacement. Spans can be reduced by additional beams run perpendicular to the joists at mid-span of the original joists.

Improvements to the connection of the wall framing to the perimeter sills will be possible, but augmentation of the wall framing is not recommended since virtually all of the wall framing is an exposed, character-defining feature of the interior.

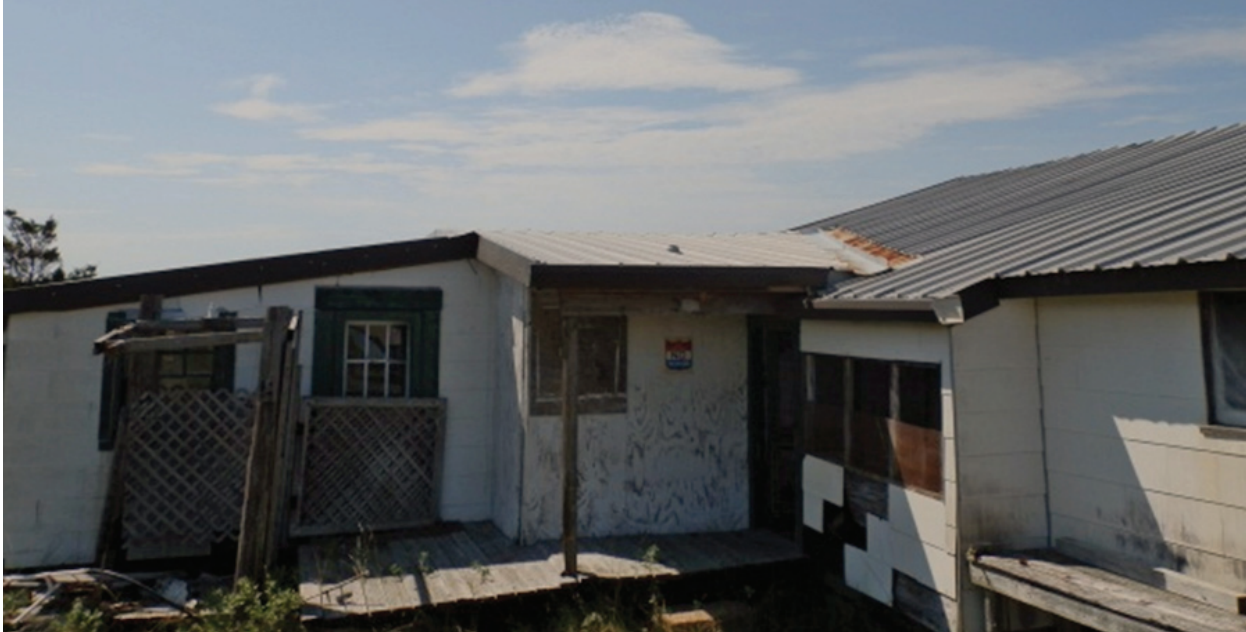
Figure 26. View of junction of added roofs and the rear shed of the original roof, now covered with modern metal roof covering.

as rolled asphalt roofing, the latter apparently used only on the additions. Modern K-style gutters are installed on portions of the rear roof sheds but they are not in good condition. Although the metal roof compromises the building's historic character, it is relatively new and in excellent condition, except perhaps where the roofs of the additions connect to the rear shed of the main roof.

When the modern rear shed of the roof is removed, the roof line of the historic roof can be determined. If there are more than two layers of asphalt shingles, that would be an indication that

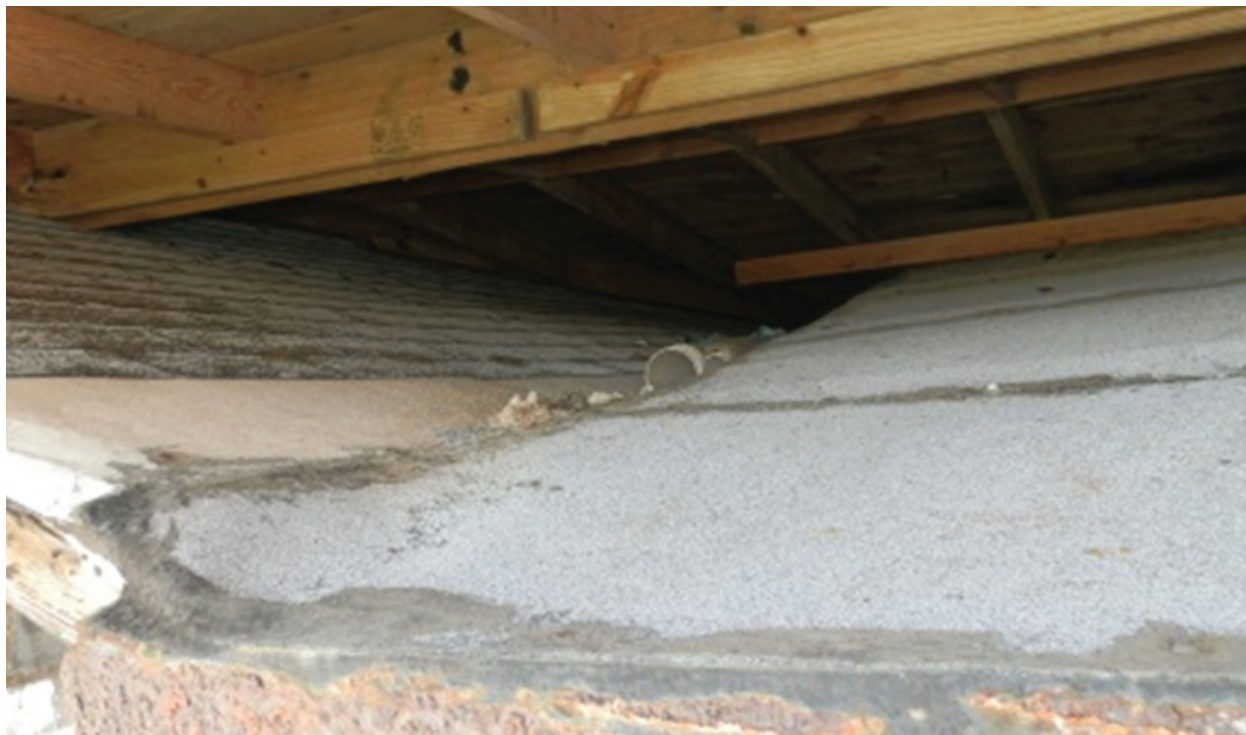
Figure 27. View of early asphalt shingles and rolled asphalt roofing present prior to construction of a new roof structure over the rear additions in the late twentieth century.

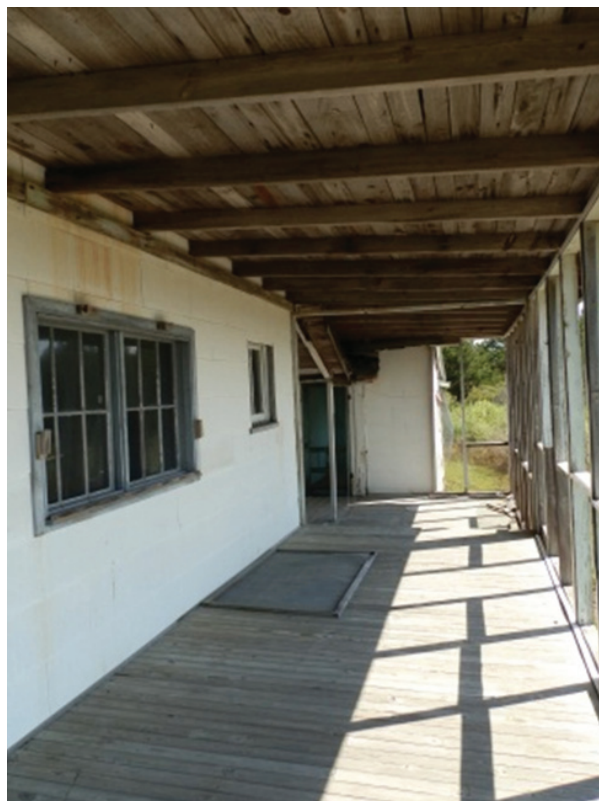
Figure 34. View south on added west porch.

The late-twentieth century alterations and additions to the porches are in poor condition. The west porch and the open deck on the east side of the rear additions should be removed completely. The original configuration of the back porch has not been precisely identified but should be ap-

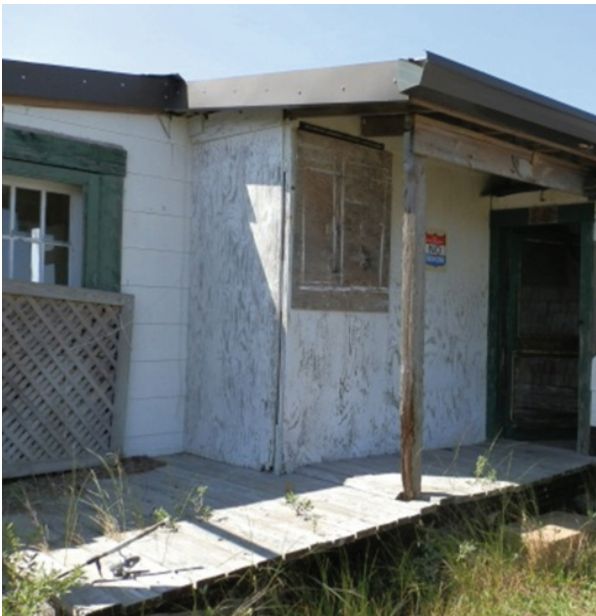
Figure 35. View of modern deck on east side of rear addition.

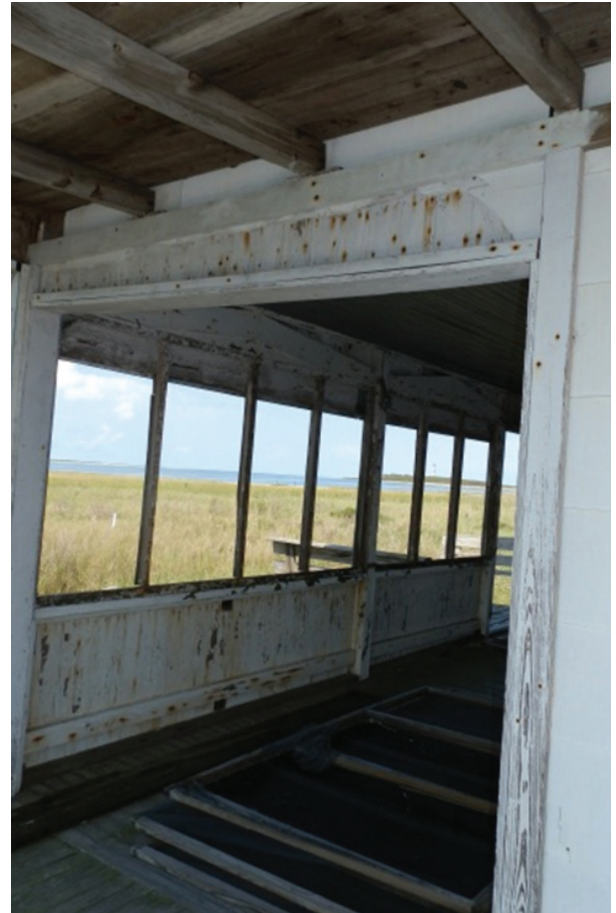
Figure 38. View at west end of front porch.

The missing knee wall at the western end of the front porch should be reconstructed to match the original walls on the north and east end of the porch. Knee walls should also be reconstructed on the back porch, with accommodation to allow access to the two rooms and half bath added around 1940. Both porches should be screened.
