project evaluation program  
restoration of buildings 12 and 12A

# HARPERS FERRY

NATIONAL HISTORICAL PARK / MARYLAND - WEST VIRGINIA

PROJECT EVALUATION PROGRAM  
RESTORATION OF BUILDINGS 12 AND 12A  
HARPERS FERRY NATIONAL HISTORICAL PARK

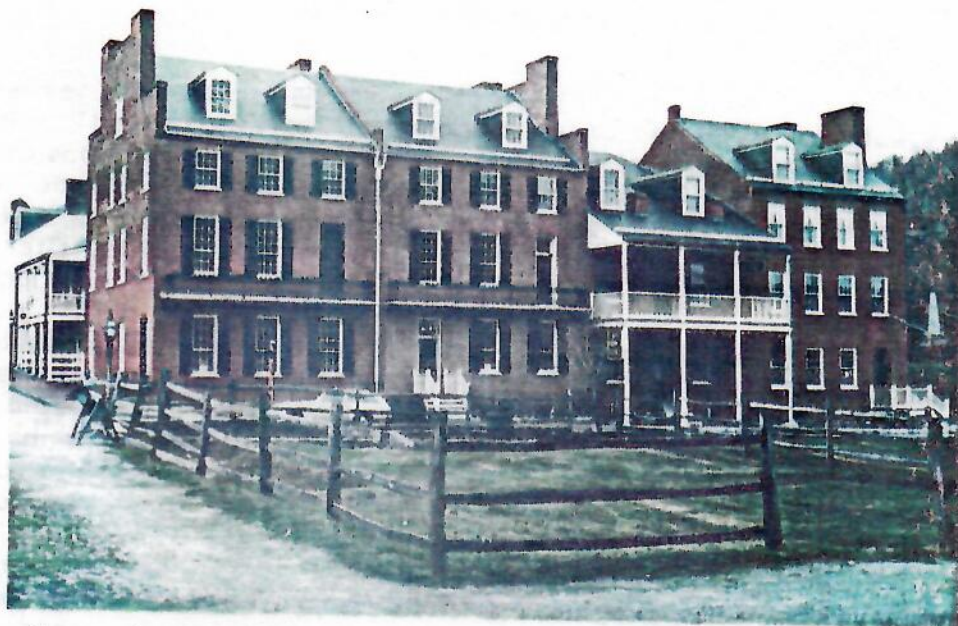
Harper's Ferry National Historical Park, buildings 12, 11, 10, and 9 (left to right). Photo taken in April 1983.

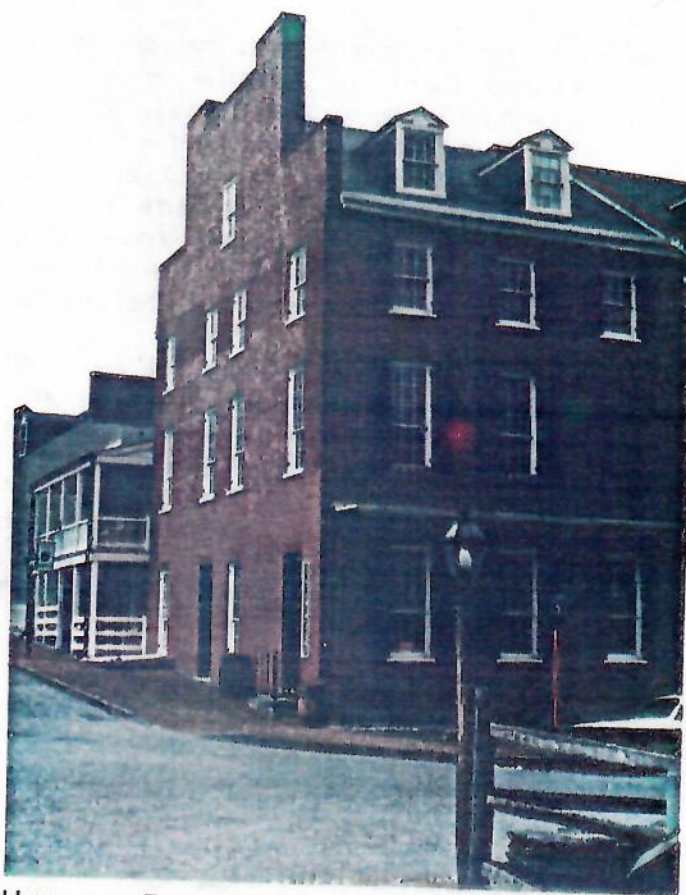
Harpers Ferry National Historical Park, building 12, with building 12A behind and adjoining building 12. Photo taken in April 1983.
