REPORT FOR:

RE: FORT HAYS BLOCK HOUSE  
HAYS, KANSAS

CFS No. 18-1042

DATE : MAY 17, 2018

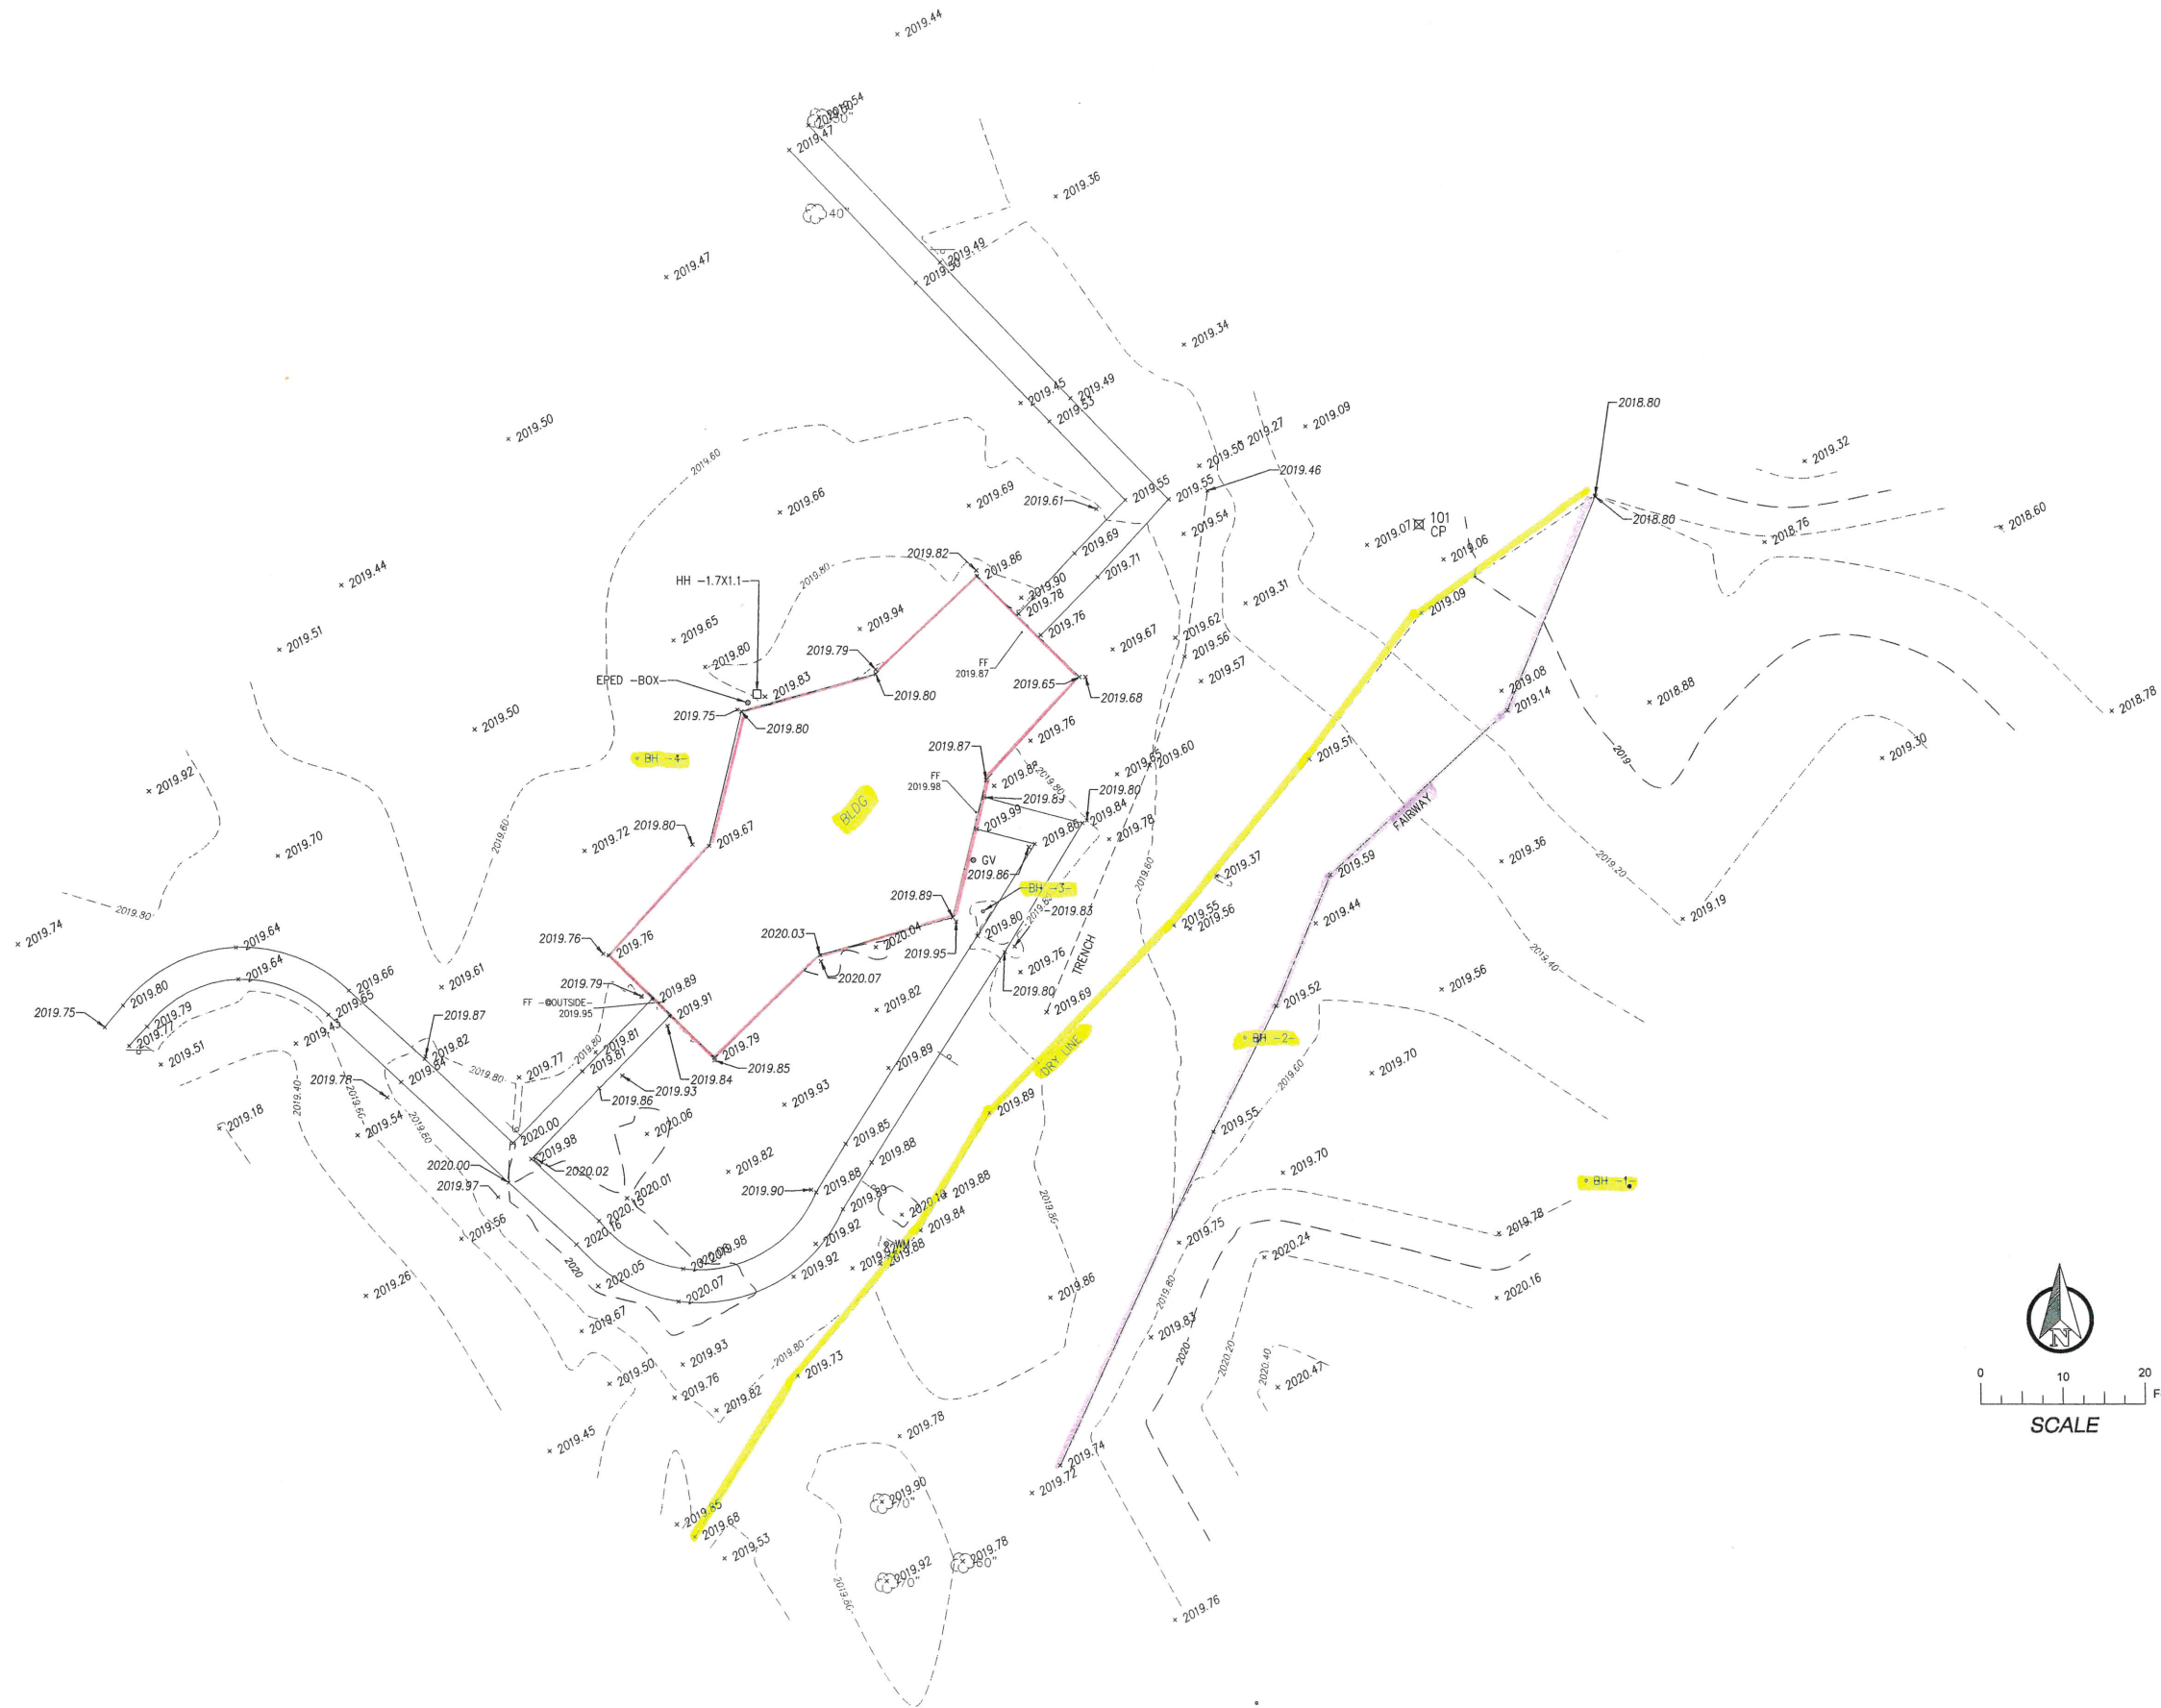
**FORT HAYES BLOCK HOUSE  
SITE ASSESSMENT SURVEY**

There is an adjacent golf course to the east of the Block House. It is approximately 40 feet to the edge of the fairway and 20 feet to the "dry line". The dry line is defined as the line where the vegetation stops showing signs of being irrigated (see enclosed survey).

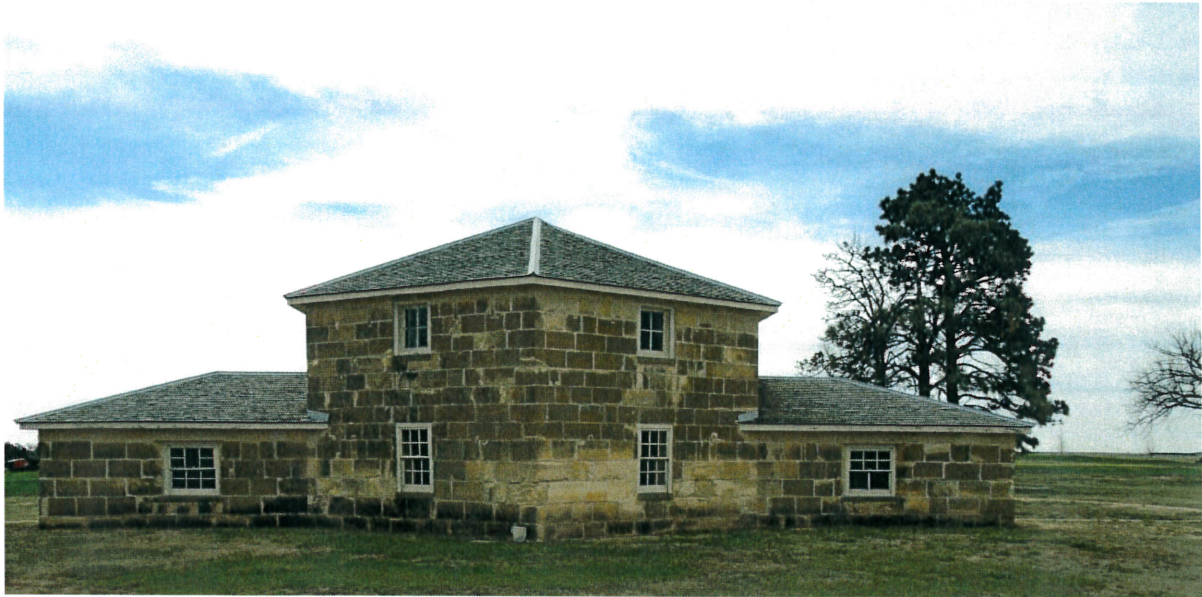
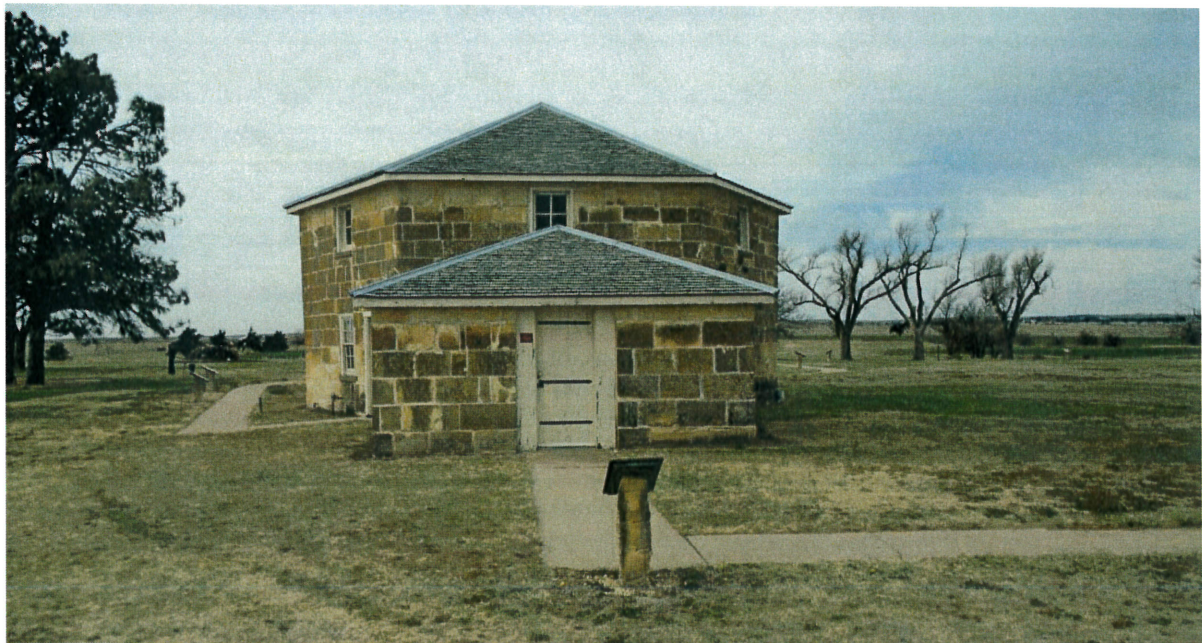
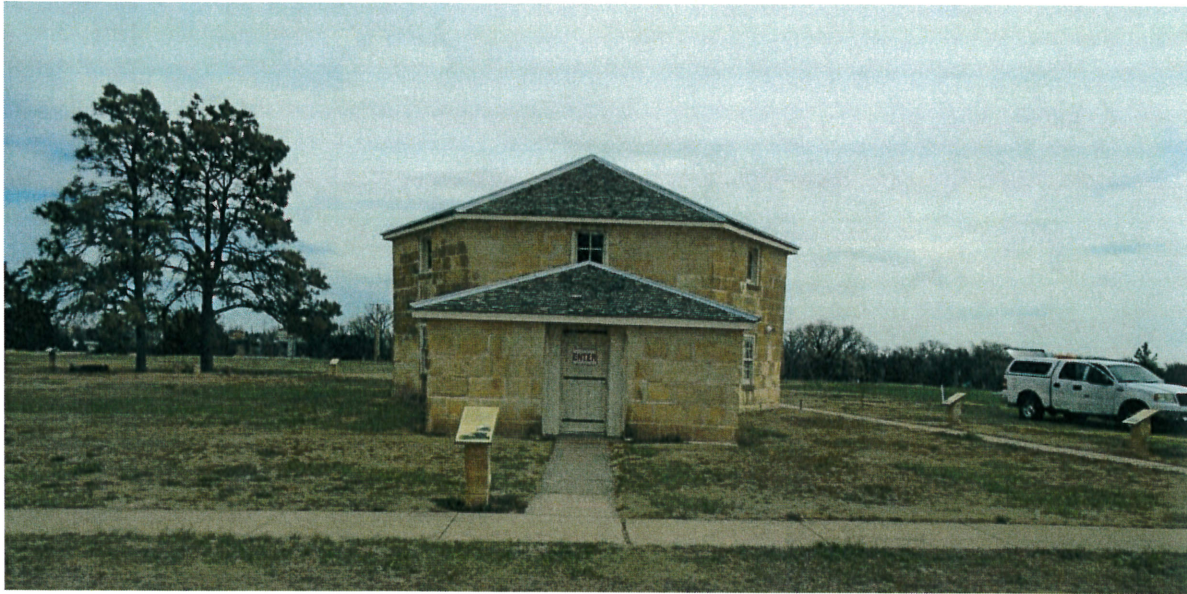
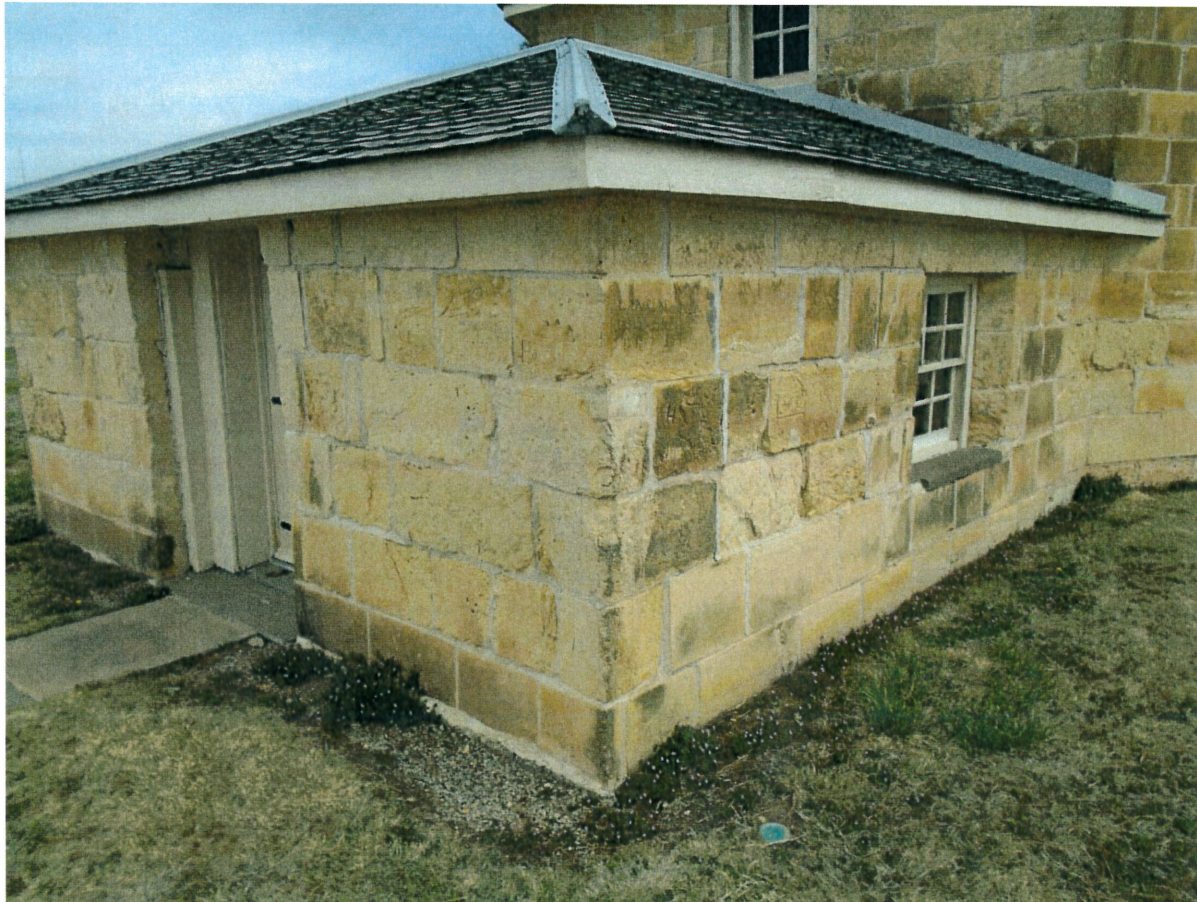
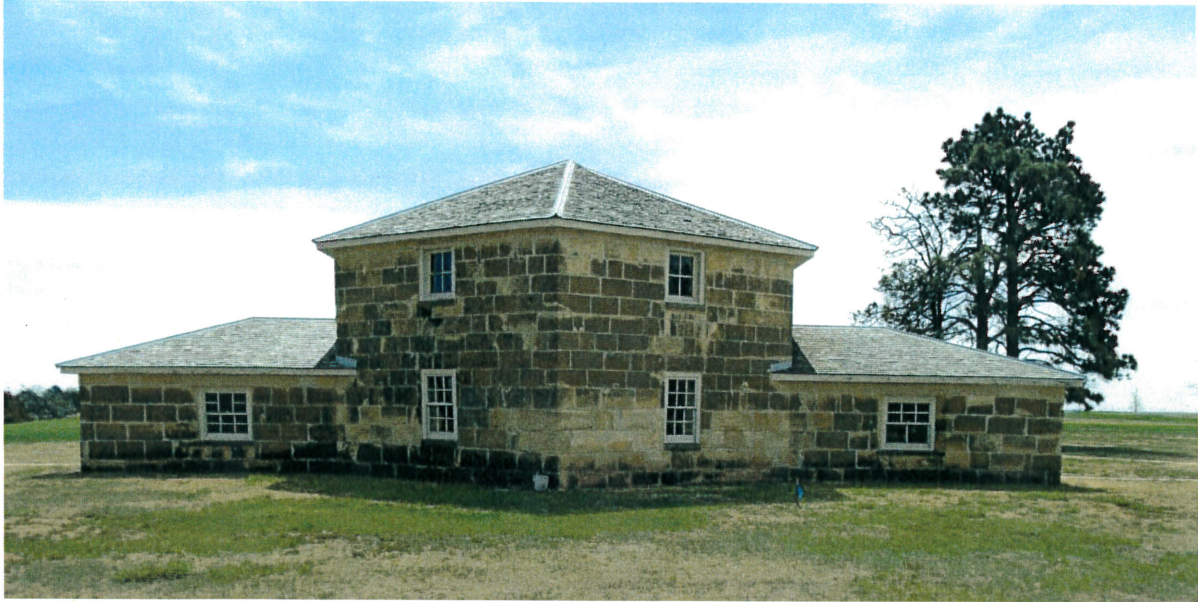
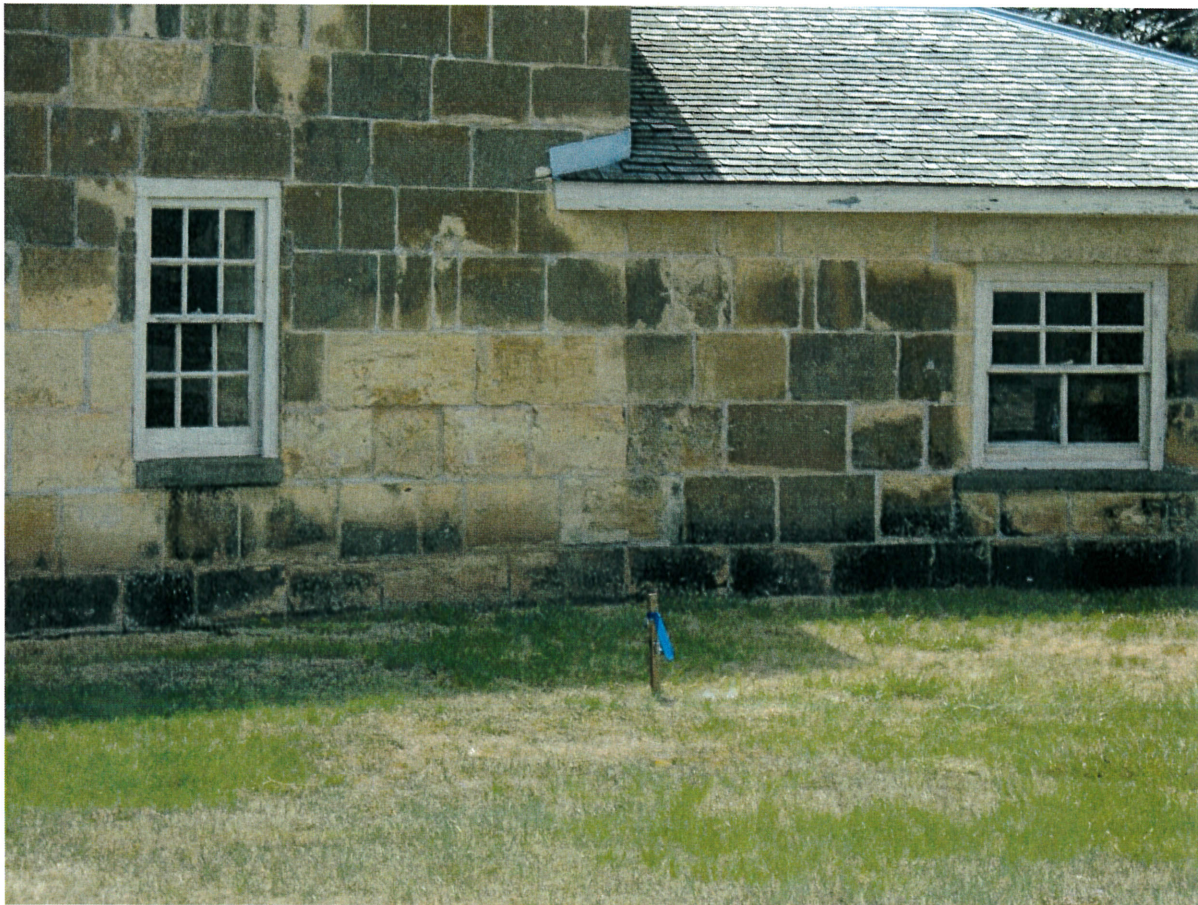
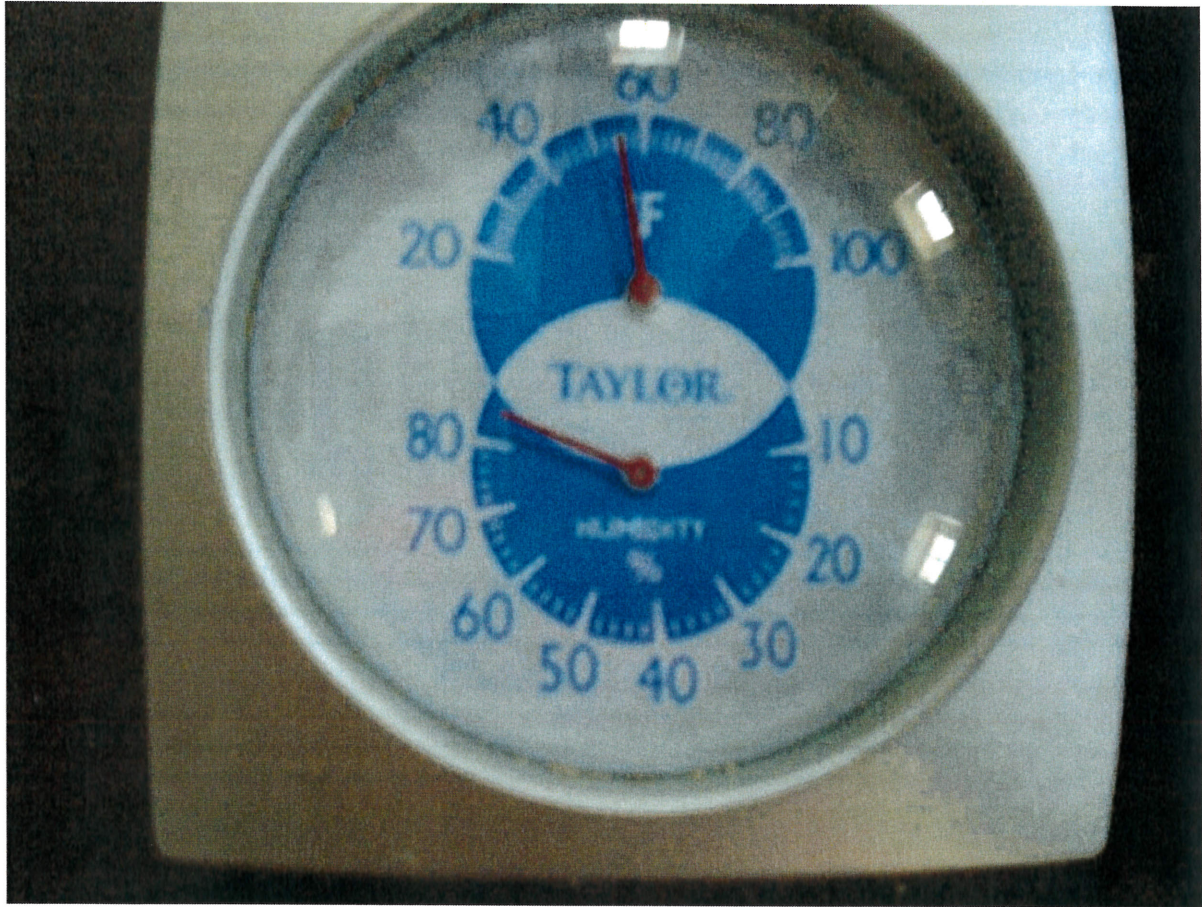
## **Appendix C: Site Photographs**

Over the years, some deterioration of the limestone blocks themselves has occurred. Some tuck pointing of the mortar joints has been instituted and the interior walls have been painted (see enclosed photos).

We speculate that 150 years ago when this stone was quarried using horse drawn wagons, the stone was taken near the surface where the material itself of lower quality and prone to deterioration. 150 years of exposure to the weather and the elements are taking its toll on the stones themselves and over time you will get some natural degradation.

1. Only use lime based mortar for tucking point the masonry walls. Do not paint the stone.
2. Encapsulate the crawl space area with 20 mil vapor barrier and install a dehumidifier set at 55% humidity.
