FINAL PROJECT REPORT

1. Project title/name: St. Mary's Art Center Building and Site Assessment project
2. NPS grant number(s) **NV-17-10001**
3. National Register property name/address (If applicable): **55 North R Street, Virginia City, NV 89440.**

## **Condition Assessment and Repair Recommendations**

for the  
**St. Mary's Art Center**  
**Virginia City, Nevada**

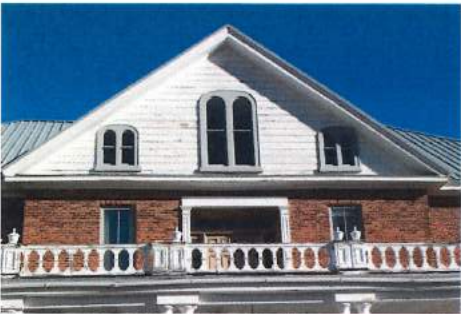
Photo 1- Roof and West Gable

The building has a standing seam metal hip roof with (4) gables on each elevation and two brick chimneys. The metal roof appears to be in good condition. The east, west and north gables are in generally good condition and only need re-painting. The south gable is deteriorated and needs to be reconstructed. The chimneys are relatively tall and unbraced and their condition could not be observed. Some bricks have fallen from the chimneys.

Remove loose paint and repaint existing gables on the east, west and north elevations. Reconstruct existing south gable with wood to match size and color of existing.

The chimneys should be repaired by replacing missing bricks and repointing all brick joints.

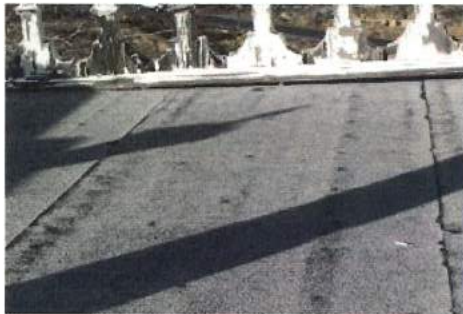
Photo 4 - Existing 3rd Floor Porch Finish

The third floor porch currently has a worn and insufficient waterproof membrane. It is placed over the finish decking layer directly over the existing 1x deck boards. This is seen as the finish ceiling of the second floor porch below. The third floor porch has little slope for positive drainage. The framing members of the third floor porch are significant and visible. The columns are round and tapered. The beams at the

Remove the existing finish surface and underlayment (if any) and leave the existing 1x boards in place. Provide new plywood substrate and walkable waterproof membrane surface. At each front column remove 2" from the top to provide a 2" positive slope across the entire length of the deck. Replace the existing 3- 2x beam with new 6x12 beams. The existing 4x floor joists and 1x boards are to remain. Remove and replace the existing metal gutter and downspouts with new galvanized metal

gutter and downspout. Paint entire 3rd floor porch framing members to match existing.

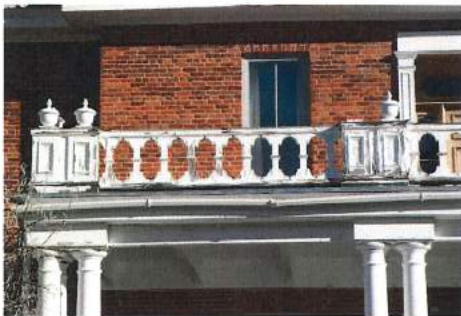
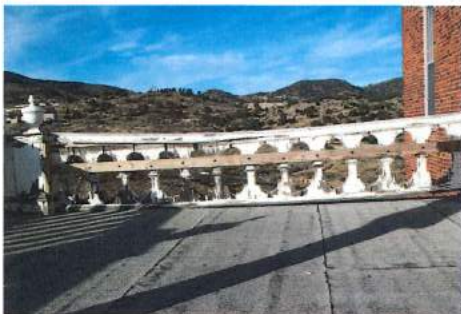
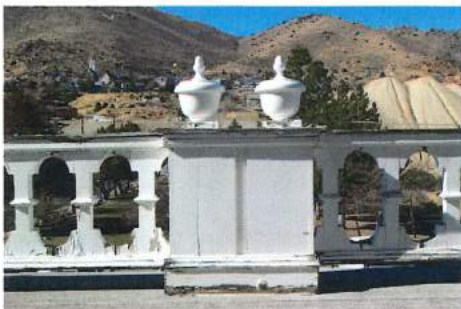
The third floor porch railing is a significant feature of the building and adds a lot of historic character to the front elevation. The railing appears to be original and deteriorated. The railing

is of wood construction and 29" high with several ornamentations. The side railings are in poorer condition than the front. The third floor porch railing is inboard of the columns and beams framing the deck.

for the reconstructed railing to the framing members. The new waterproof membrane should not be negatively impacted by this reconstruction effort. Provide a new cable railing, 42" high, at 24" inboard of the reconstructed wood railing to meet current code requirements on the three sides. A new cable rail system would require blocking at the end framing bays of the 2nd floor porch ceiling, showing a visible modification to the existing linear lines of the 4x members. Blocking for the reconstructed and new cable rail may be necessary along the front due to the offset of rail posts to framing below.

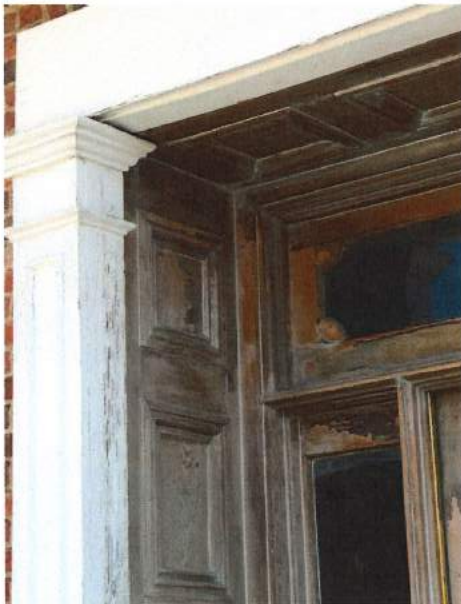
Photo 11 - Existing 3rd Floor Porch Door Corner Detail

The third floor porch door's current finish condition is deteriorating. Stain is worn. There is hardly no difference in elevation between the door step and existing deck finish.

Sand all wood on door and trim and finish to match the original. A slight taper is needed at the door step to account for the minimal dimension between the deck and the existing door threshold. Adjacent to the door step on either side the new slope can continue to the exterior brick wall.

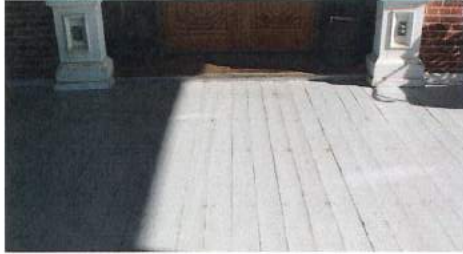
Photo 13 - Second Floor Porch Floor Boards

The 2nd Floor Porch has 1x wood boards over a subfloor of 1 x 4 boards. 4 x 12 beams, spaced about 4 feet on center, support the subfloor and porch. Ponding has occurred toward the center of the porch and may be created a problem in the ceiling of the space below. There exists a 1/16"-1/8" gap between boards, allowing any moisture that accumulates on the surface to permeate below.

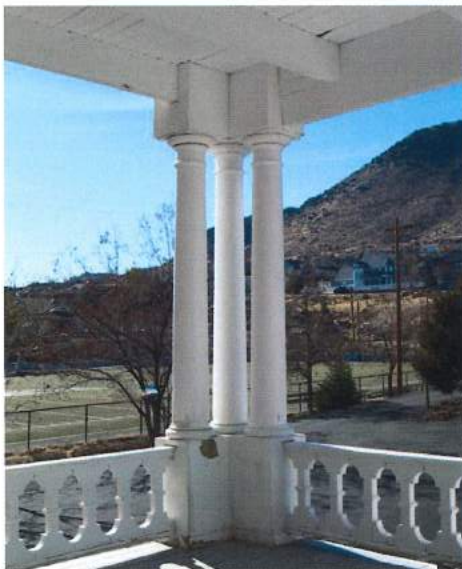
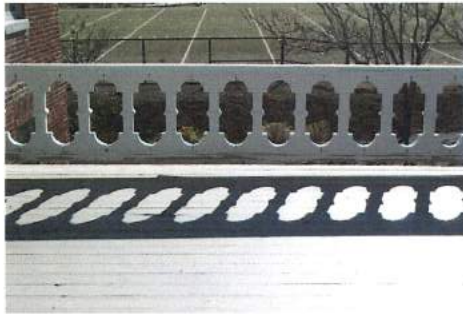
The second floor porch railing is a significant feature of the building and adds a lot of historic character to the front elevation. The railing appears to have been reconstructed with plywood and picks up original detailing and proportions. The railing is of wood construction and 29" high with several ornamentations, but no intermediate base supports, varying from the original railing on the third floor porch. The column bases also appear to be reconstructed with plywood.

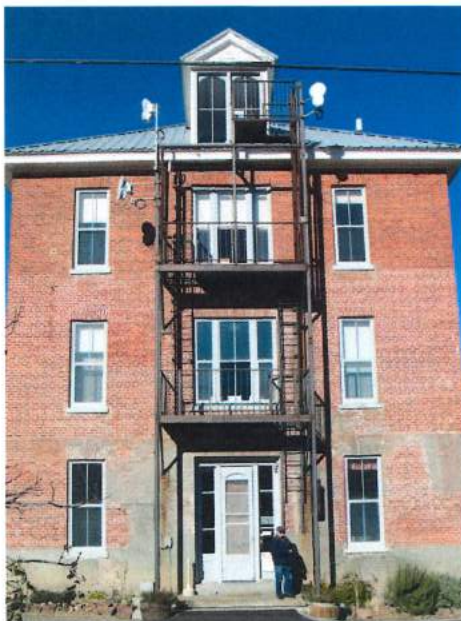
Photo 16 - South Elevation with Steel Stairs

| Observations | Recommendations | Plans | Local/GC |
|---|---|---|---|
| <p>The South Elevation has an existing steel frame stair/ladder system as an existing exit route. The top landing is not adequately connected to the building and will need immediate connection. Window openings provide access to the steel landings on the third and second floors with steel chain ladders provided on the interior to help occupants down to the steel landing elevations from the window sills. This is an inaccessible exit route. From the second floor landing occupants must use a ladder to get to grade. The building currently provides no accessible path of travel to the second, third and fourth floors.</p> | <p>Remove the existing fire escape and provide a new accessible system, likely on the north side (see Accessibility section) that allows access from grade to the fourth floor. A new annex may be needed with a grade-level vestibule and may be an opportunity to provide more space for desired programming.</p> | <p>Yes-<br/>Deferred</p> | <p>GC</p> |

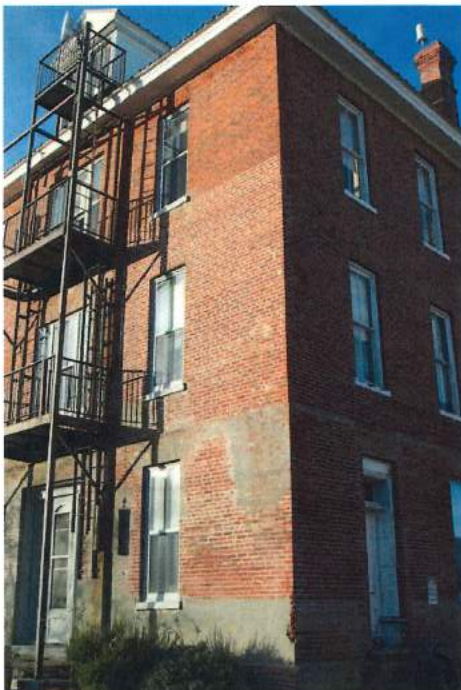
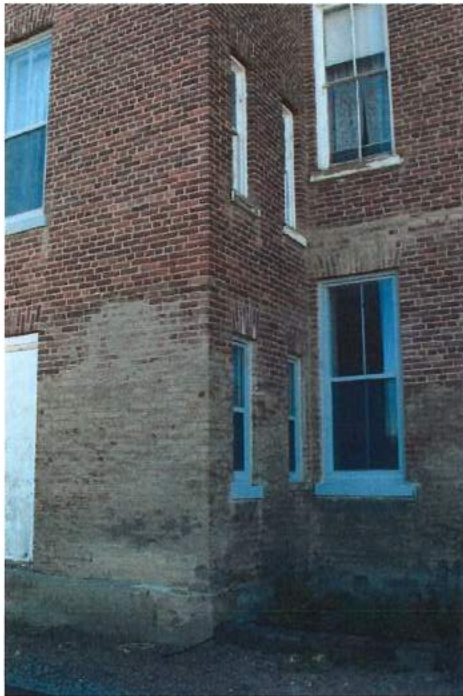
Photo 17 - Southeast corner showing parge coat on first story brick

Photo 18 - East elevation showing parge coat on first story brick

Work has been done to offset the effects of water infiltration on the first story brick facade to varying degrees on all four sides. This parge coating (or stucco plaster on the brick) now covers the historic brick.

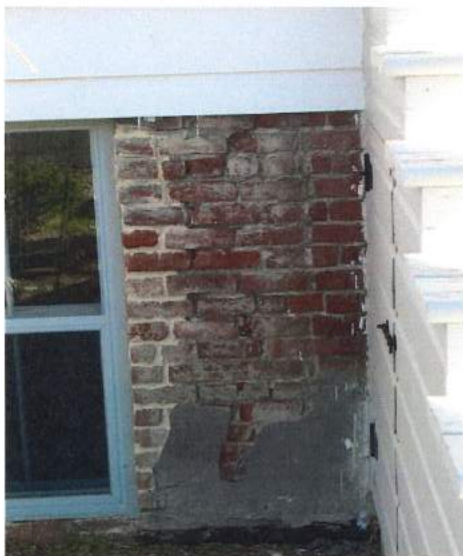
Photo 19 - West Elevation, north of main stairs

| Observations | Recommendations | Plans | Local/GC |
|---|---|---|---|
| There is some brick deterioration on the building. The above photo shows a crack in the brick possibly due to settlement. | Repoint and replace bricks as necessary. | No | Local or GC |

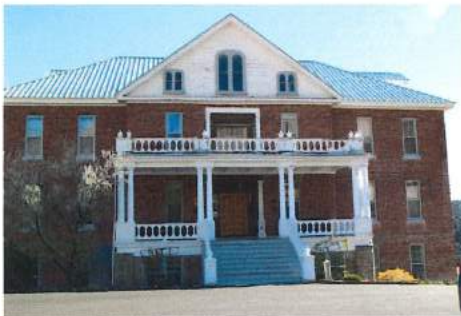
Photo 20 - Main Stairs on West (front) Elevation

The exterior wood stairs at the West (front) elevation remain in fair condition. The double 2x6 boards are placed inconsistently tread-to-tread with varying gap widths between the two boards.

Repair and repaint the existing stairs on rail.

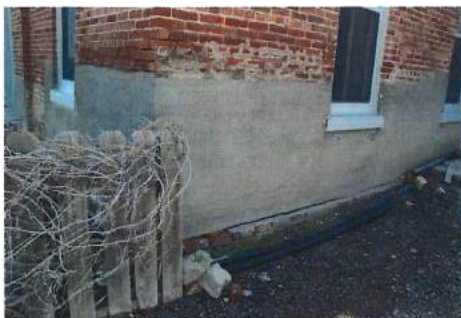
Photo 21 - Northwest Exterior Corner of building showing brick foundation and cement plaster applied to the surface of the brick which is counterproductive as it seals in the moisture.

The existing foundation appears to be brick foundation

Repoint existing foundation as necessary.

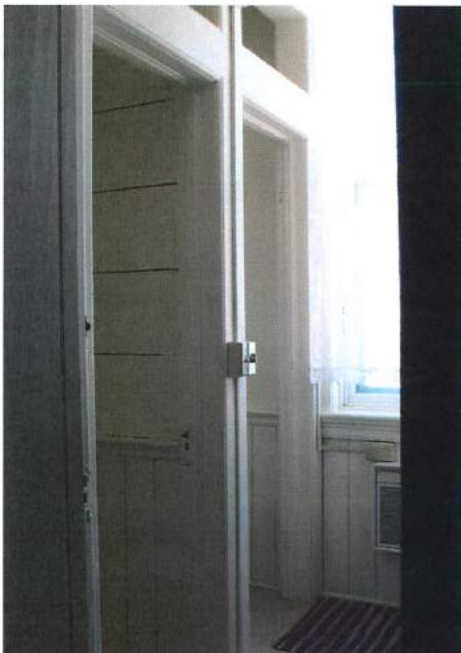
Photo 26 - Toilet Room showing separate water closet stalls.

Toilet rooms are located off each intermediate landing of the main stair between the first and third floors on the east side of the building. Each restroom has at least one existing water closet, lavatory and shower stall. The toilet rooms are in poor condition and need improving. One water closet is leaning backward on its pedestal.

Replace all existing plumbing fixtures.  
Rework toilet rooms as necessary.

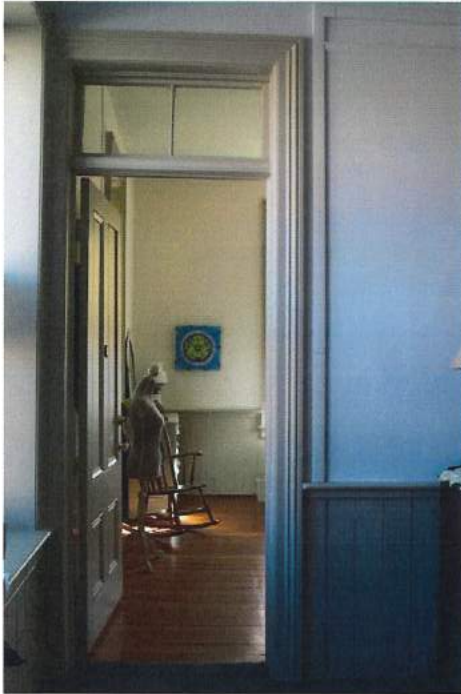
Photo 29 - 2nd Floor Hallway showing chair rail and high rail looking into a bedroom

The majority of the interior walls are finished with plaster, despite their construction. The corridor, some bedrooms, a few of the larger community spaces have walls with a chair rail and some wood paneling. Some bedrooms have wall paper finish, likely over plaster. The corridor walls have a high picture rail with a molding at the ceiling line. Many rooms have surface-mounted conduit on the plaster walls. Some rooms that do not have the wood paneling below the chair rail have a 1x6 or 1x8 base board (4th floor).

Repair Wall finishes, rail trim pieces, base boards, moldings as necessary. Size, texture, paint color to match existing in kind.
