# DANFORTH MEMORIAL LIBRARY | PRESERVATION PLAN

SEPTEMBER, 2018

## I. EXECUTIVE SUMMARY

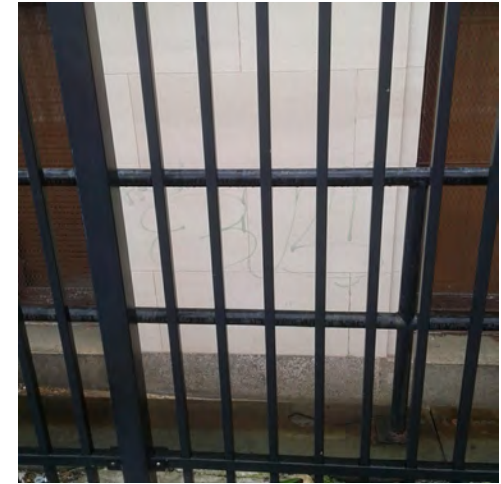
P63: Graffiti on the E elevation.

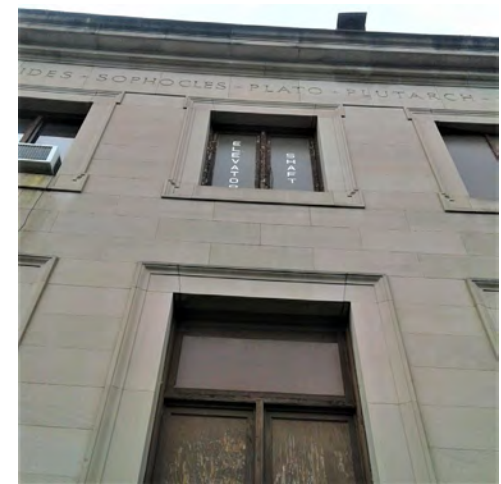
P66: Windows boarded at elevator, E elevation.

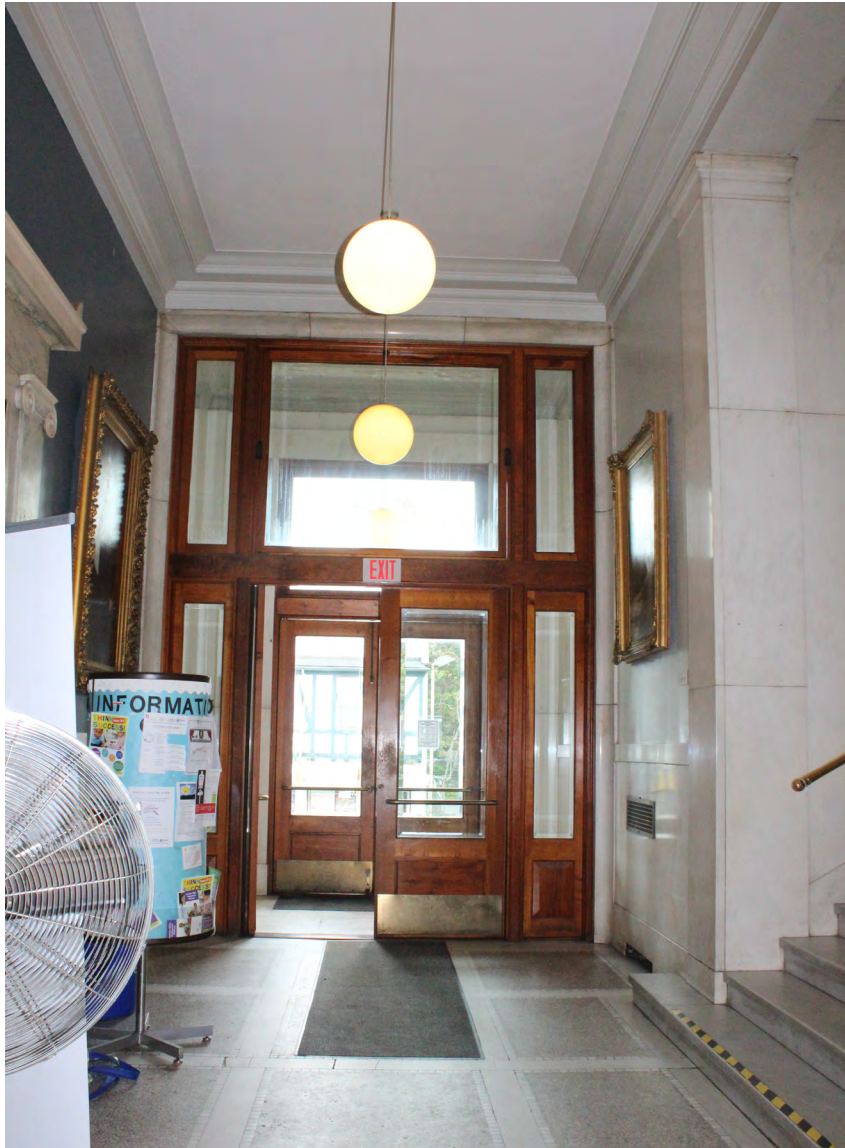
Photo 1: The wood and glass entry doors, sidelights and transom date to 2007. They are in good condition

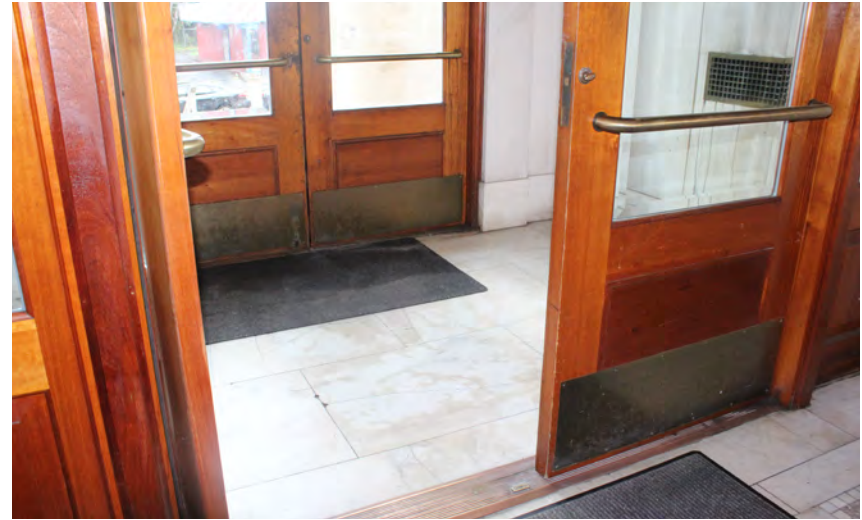
Photo 2: The original marble flooring remains. It has some cracking but generally is in good condition

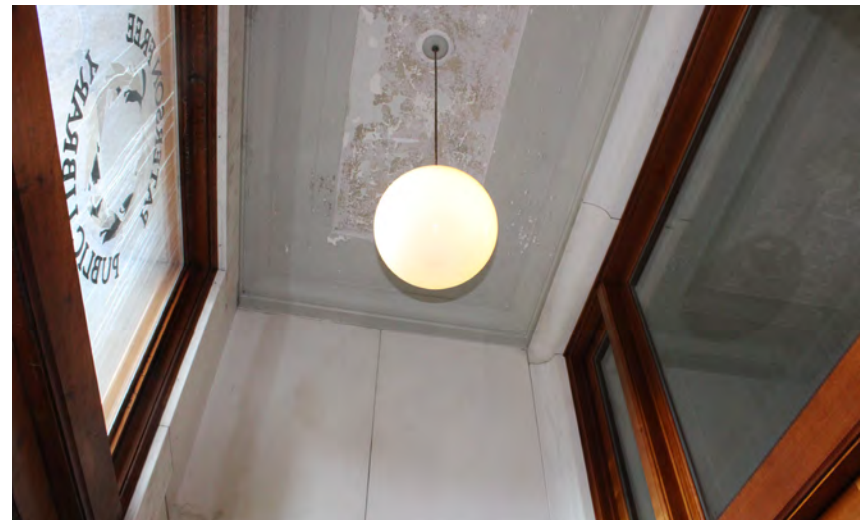
Photo 3: The original marble walls and plaster ceiling remain. The marble is in good condition. The plaster ceiling needs to be repainted. The fixture is reminiscent of the original and should remain

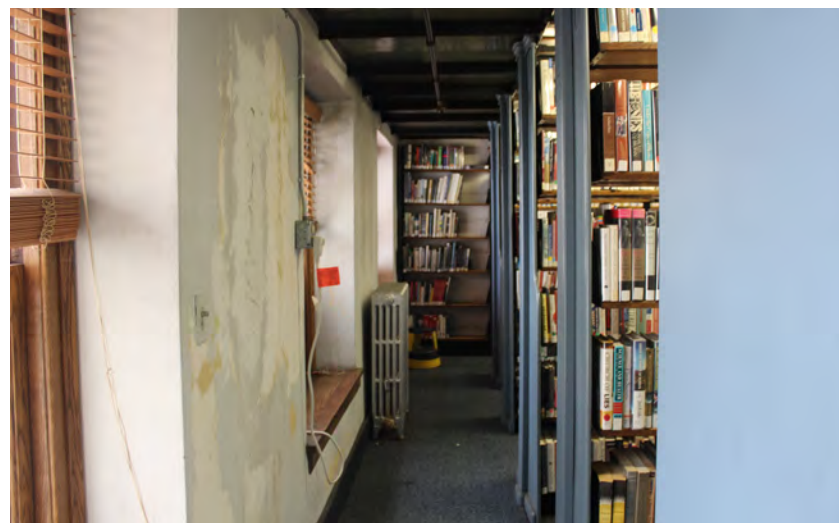
Photo 24: The exterior walls have significant water staining, especially at the windows. The brick needs to be repointed

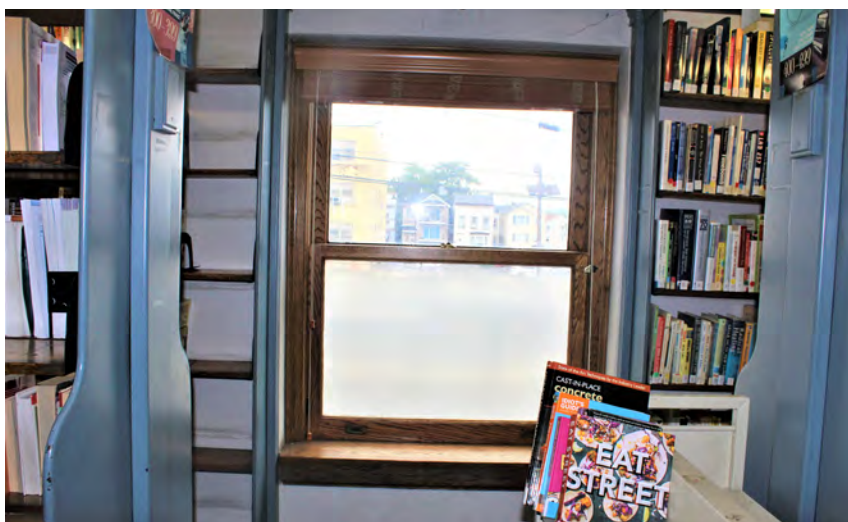
Photo 25: Many of the wood windows on this level have clouded

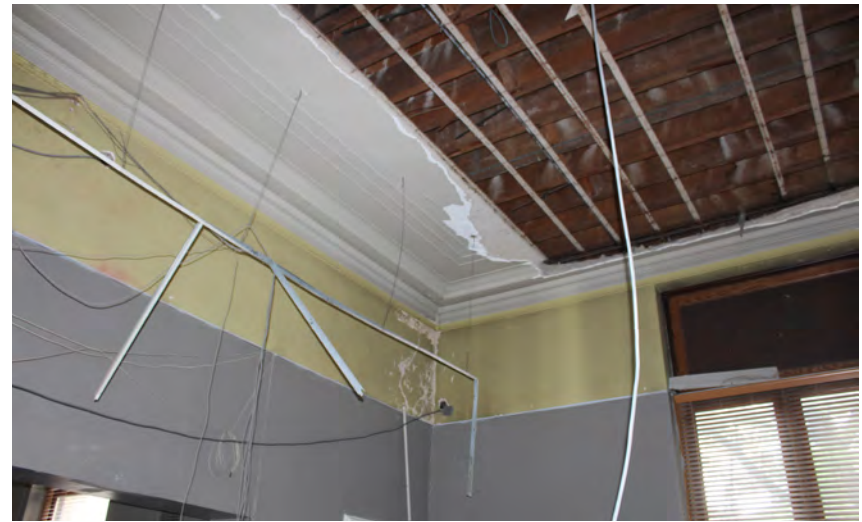
Photo 38: The suspended ceiling was hung from the plaster rather than the floor joists. After 40 years, the weight of it caused the ceiling to fall

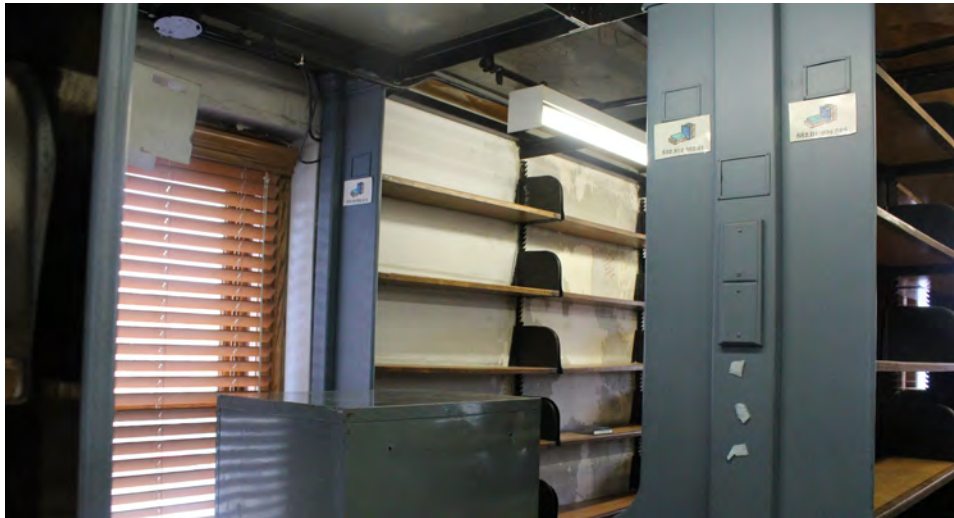
Photo 55: There is also water damage on the east wall

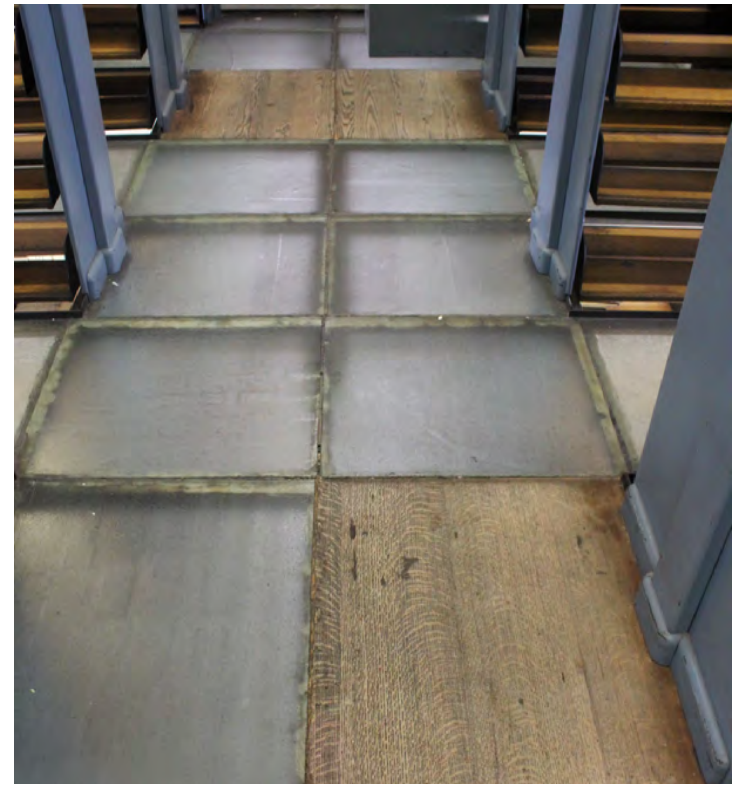
Photo 56: Several of the glass panels are missing

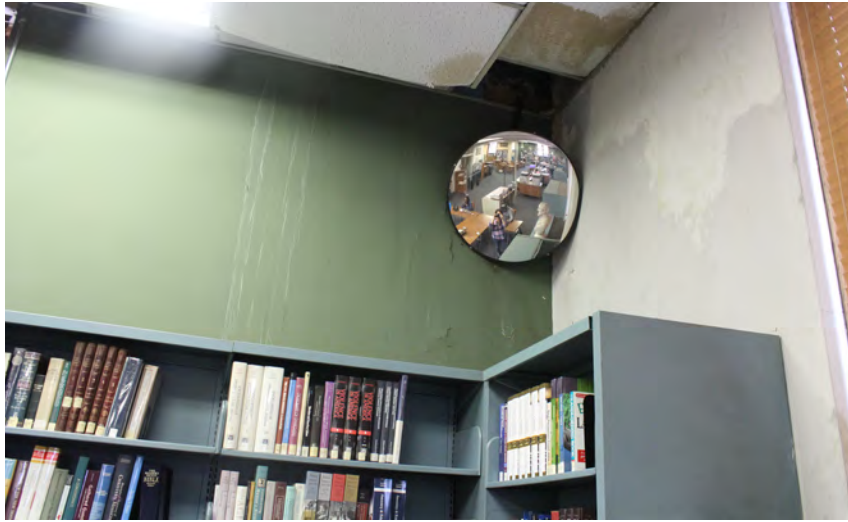
Photo 65: Water damage in the SW corner

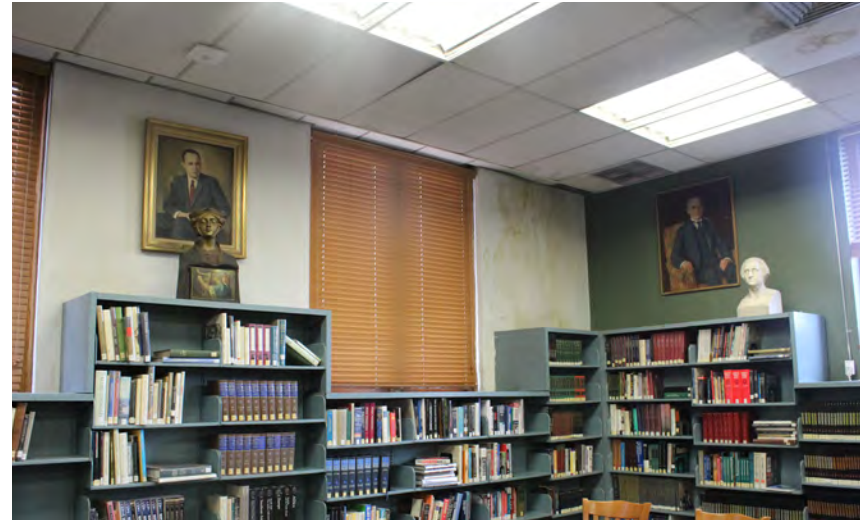
Photo 66: Water damage in the SW corner and along the west wall

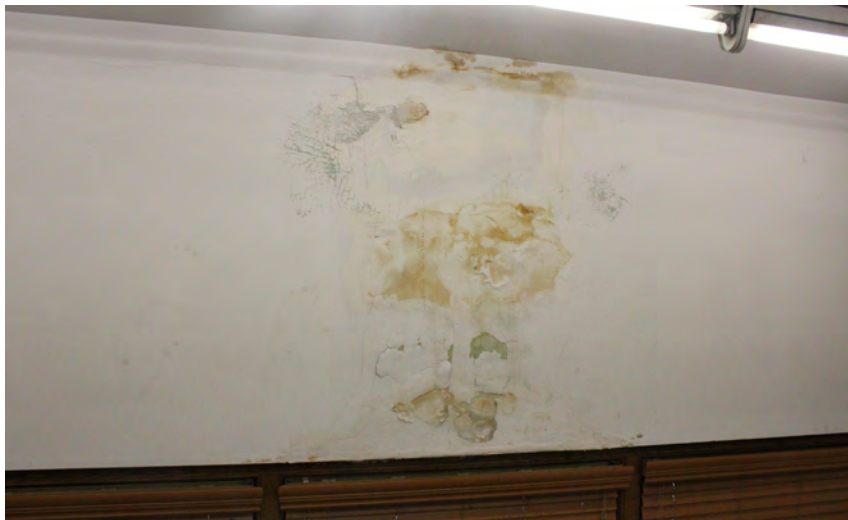
Photo 67: Water damage visible from the mezzanine on the south wall

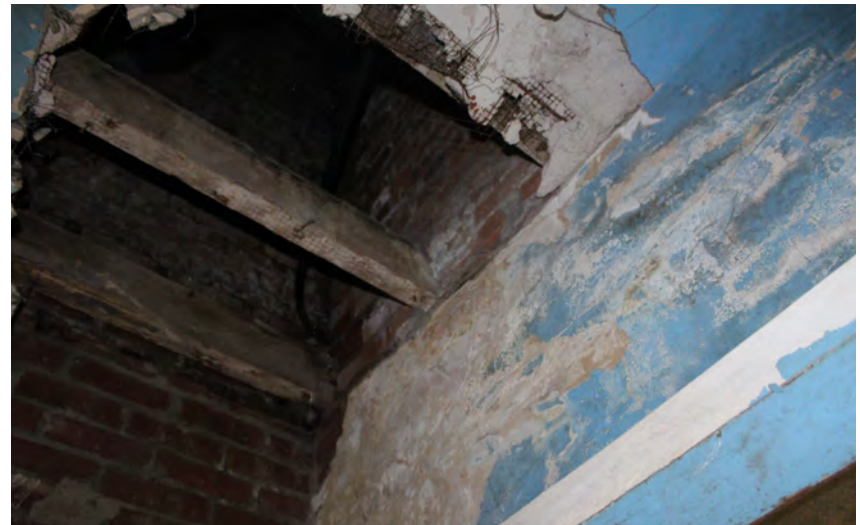
*Photo 81: A leak caused damage, loss of plaster and heavy mold*

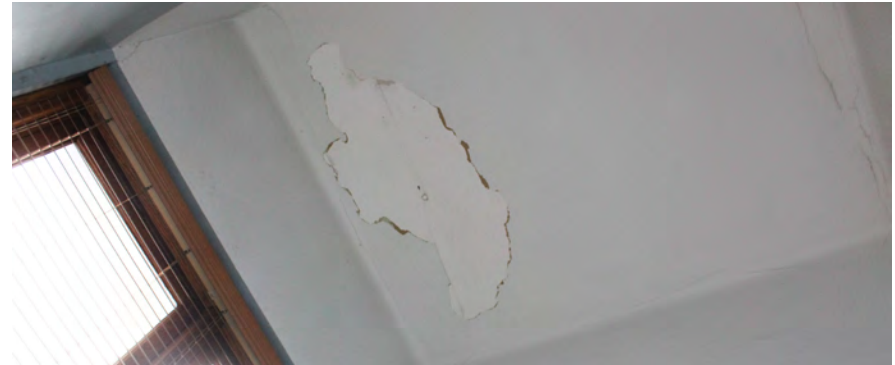
Photo 86: Water damage in the bathroom ceiling

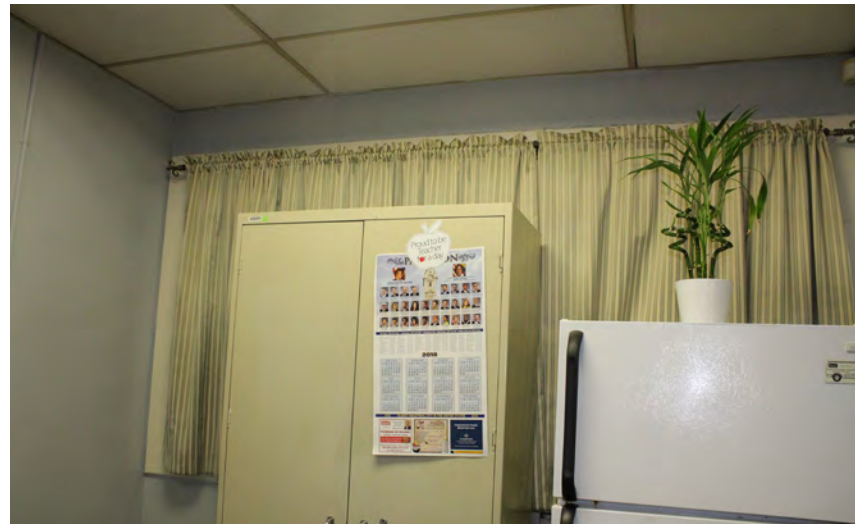
Photo 90: The internal business window is no longer used and should be removed in the long term

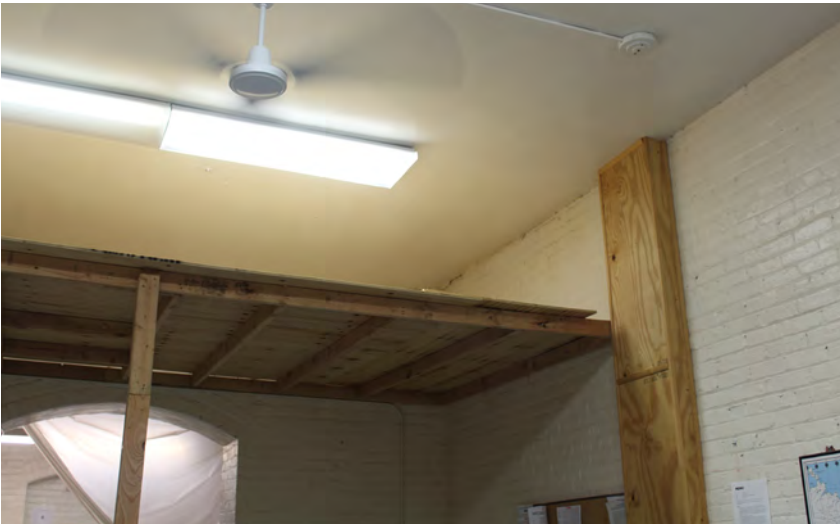
Photo 109: A crack in 007 caused maintenance to build this scaffolding for protection

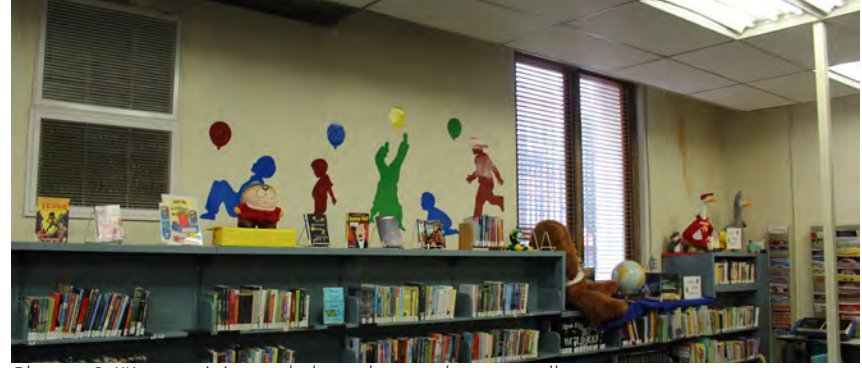
Photo 118: Water staining and plaster loss on the west wall

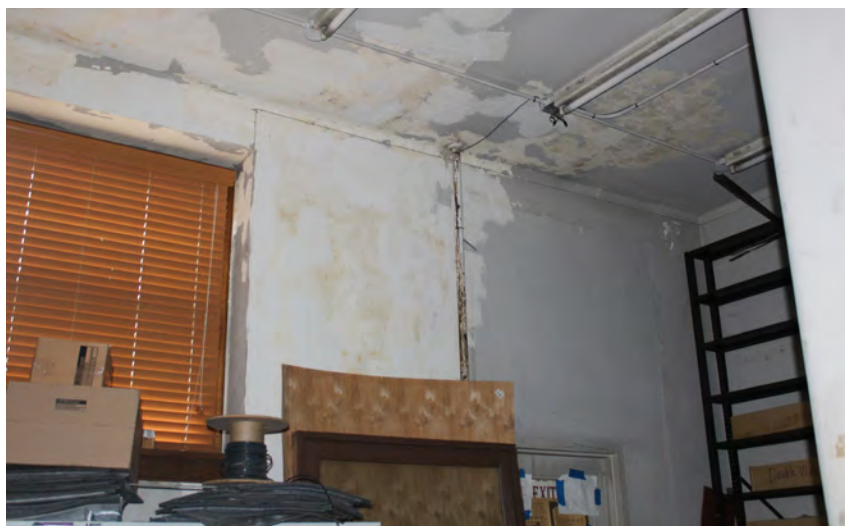
*Photo 123: Additional water staining*

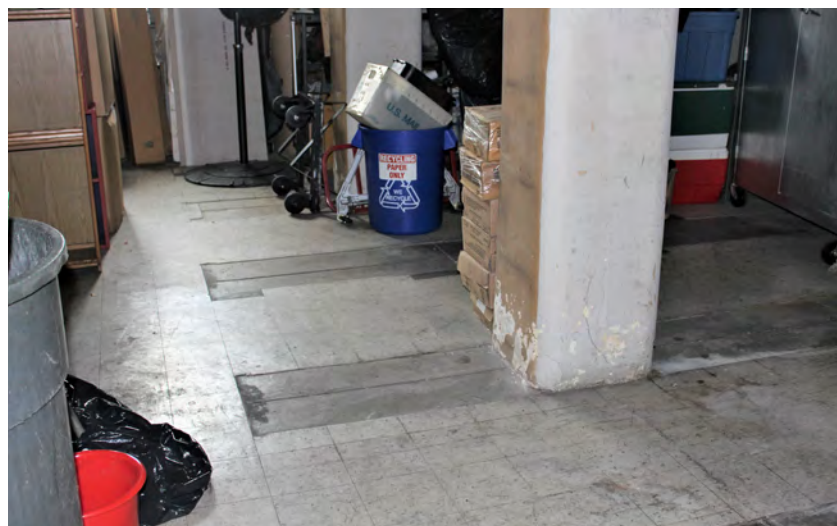
*Photo 124: The floor needs to be replaced*

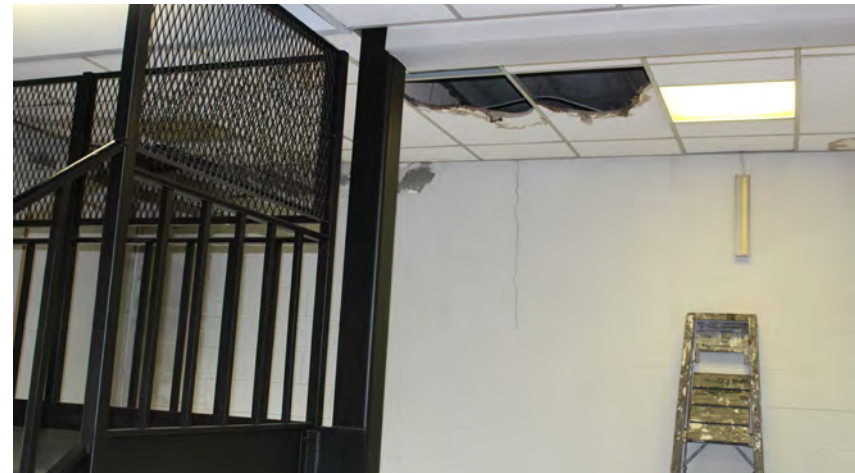
Photo 128: The tower is in poor condition with significant water damage

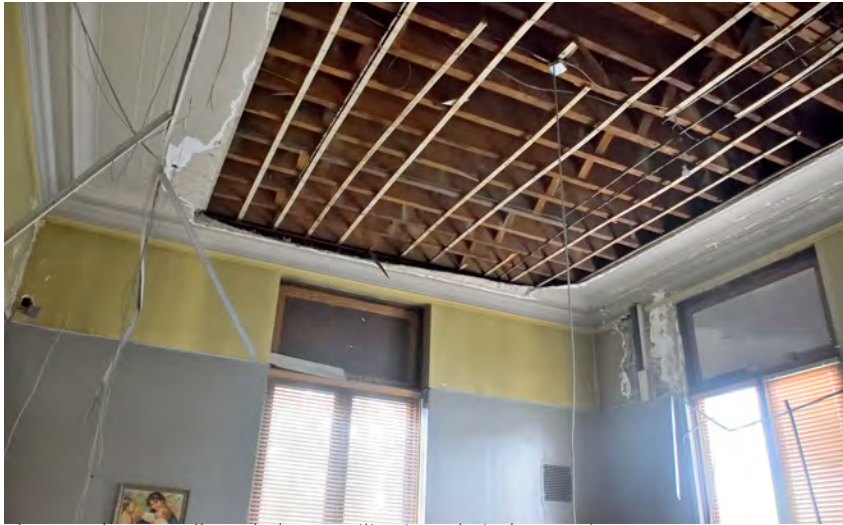
*Photograph #1 – Collapsed Plaster Ceiling in Technical Processing Room*

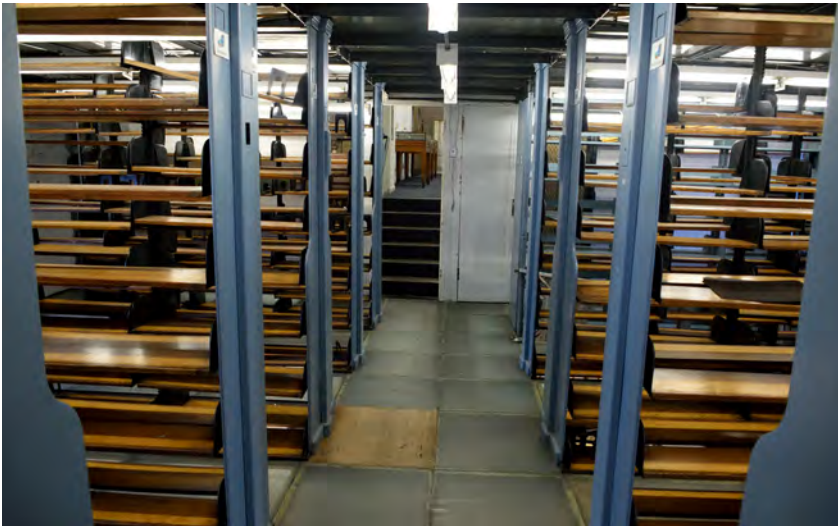
*Photograph #5 – Cracked Glass Floor Pane and Plywood Panel*

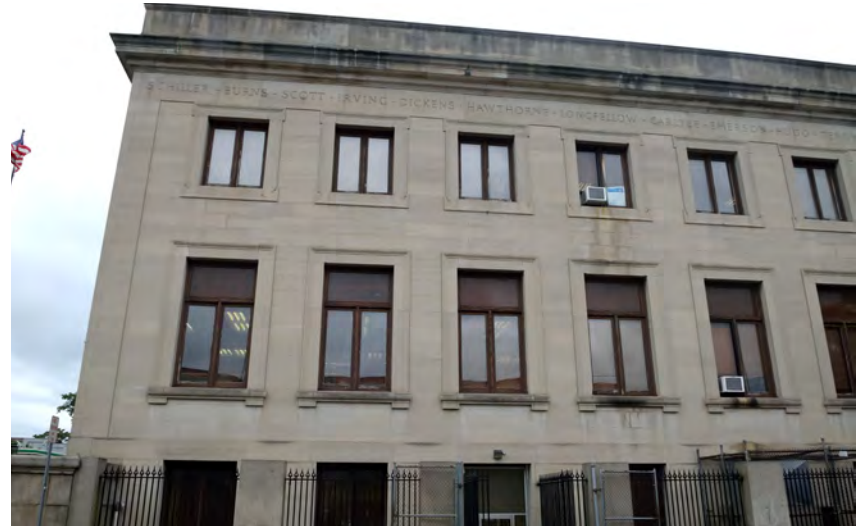
*Photograph #6 – Limestone Cladding Typical Condition*

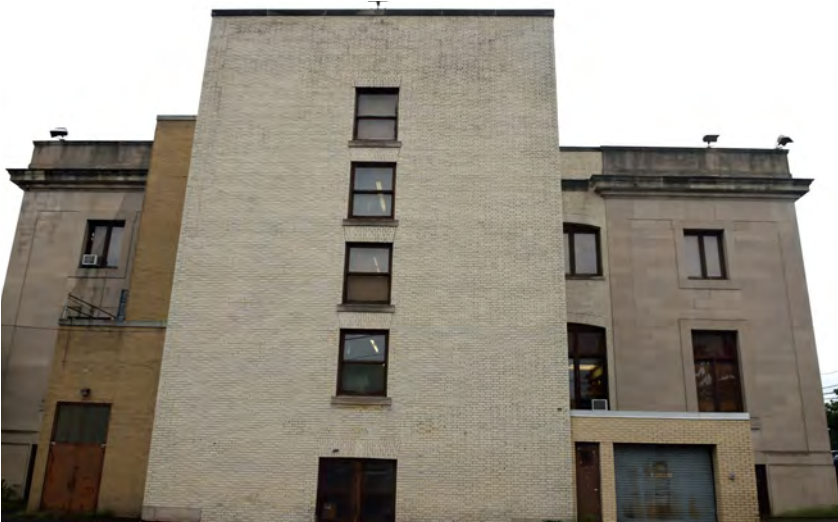
*Photograph #7 – Brick Cladding Typical Condition*

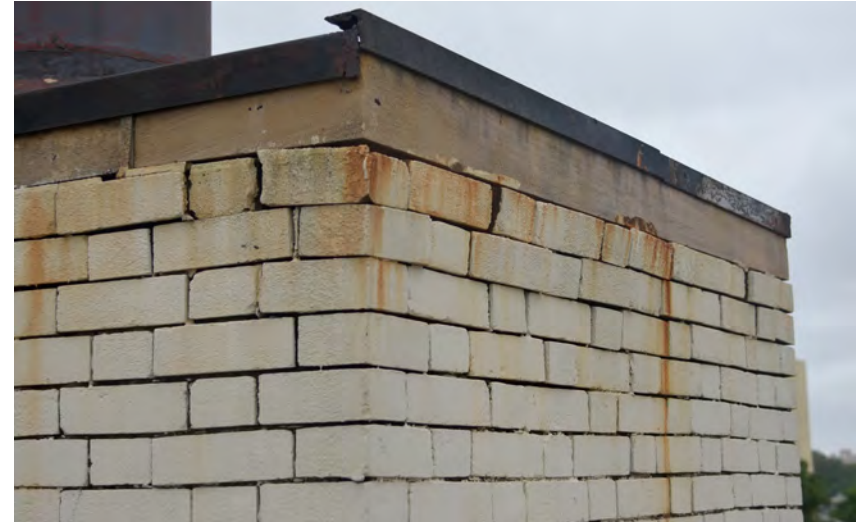
*Photograph #8 – Loose Bricks and Limestone Coping*
