# **Big Four Depot** Master Plan Options

for the City of Galion, Ohio

**JULY 20, 2018**

Big Four Depot | 127 North Washington St., Galion, Ohio 44833

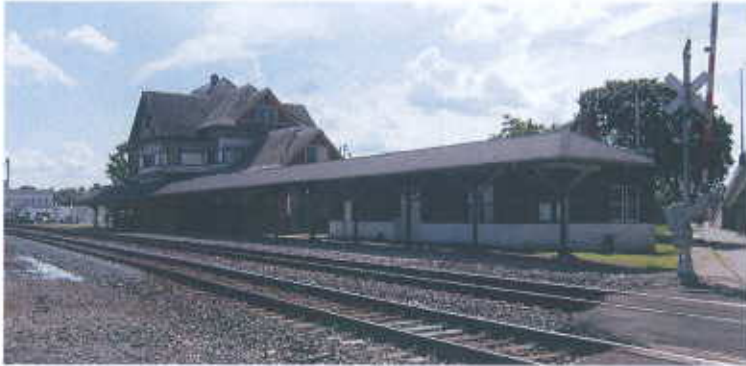
**1.** Overall site looking to the southwest. The canopy is in the front and the depot building is the rear.

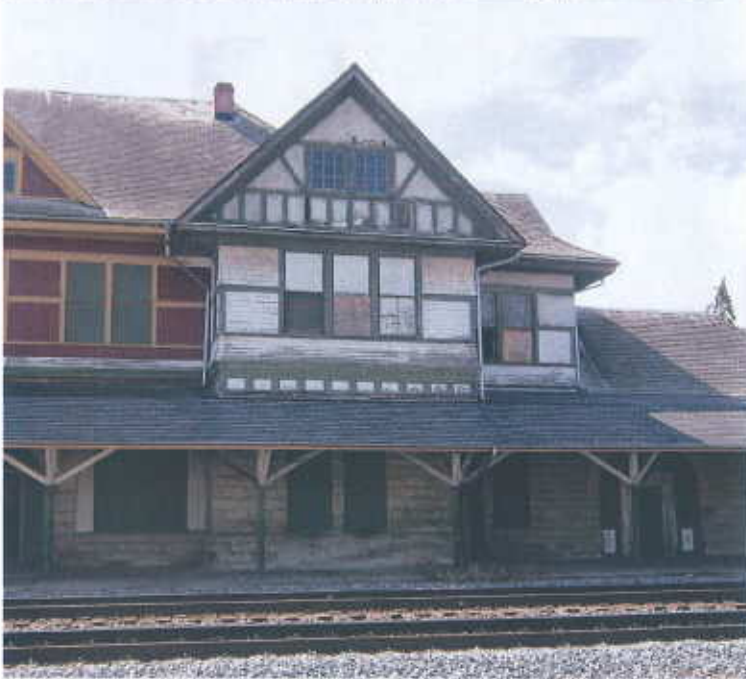
**2.** Partial east elevation, north half.

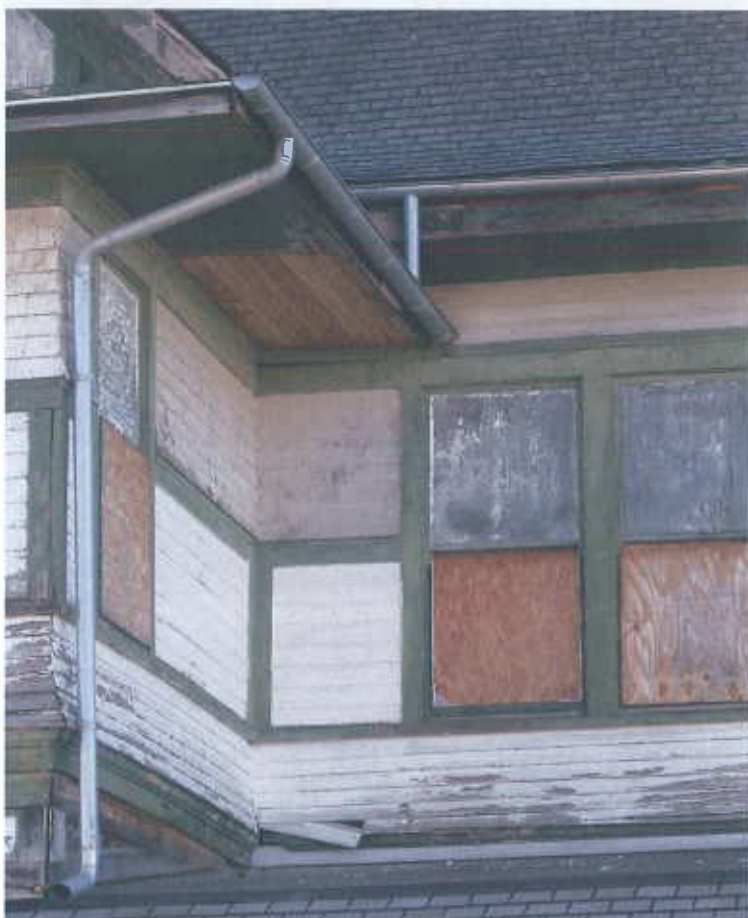
**9.** Detail, east elevation. Boarded windows, damaged siding, peeling paint, round metal downspouts, half round metal gutters.

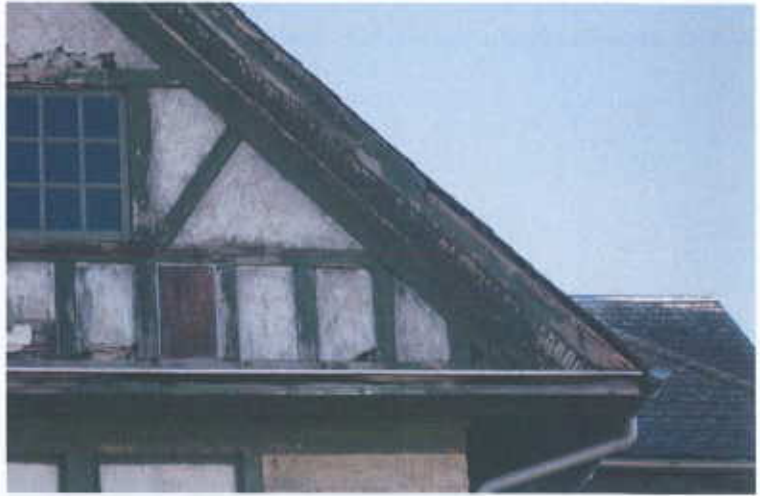
**11.** Detail, east elevation. Boarded windows, peeling paint.

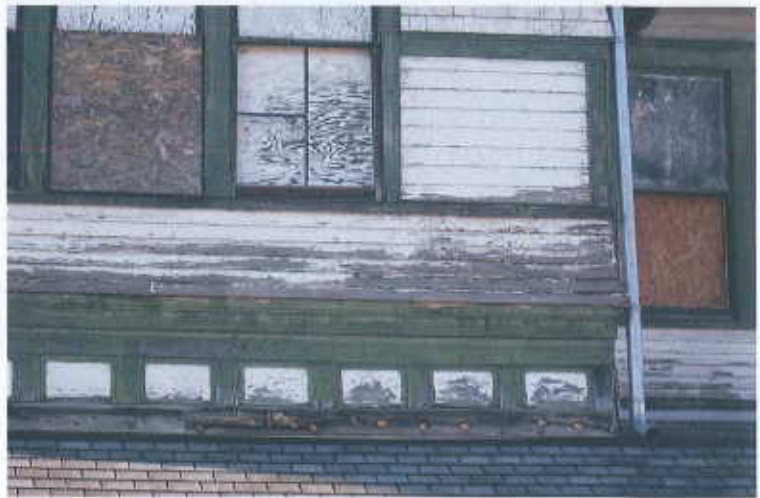
**12.** Detail, east elevation. Deteriorated stucco and peeling paint.

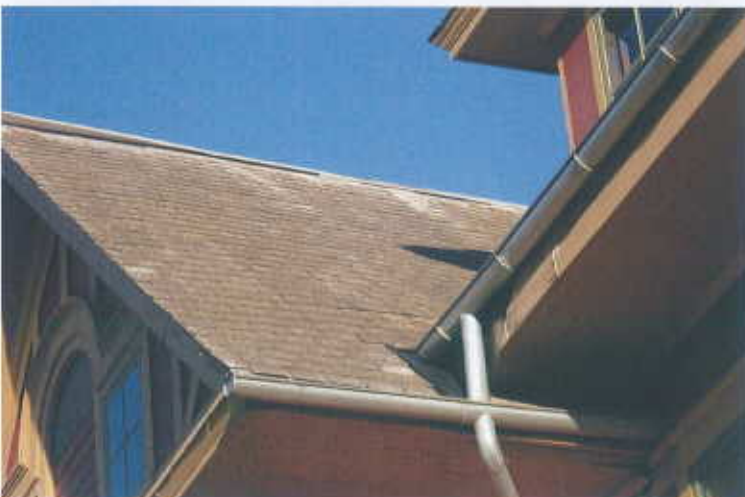
**15.** Detail, west elevation. Missing shingles at uplifted ridge cap.

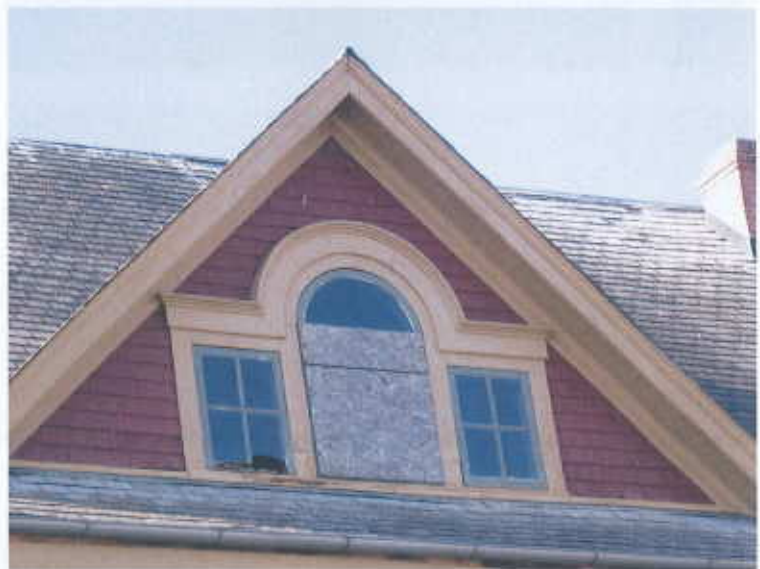
18. Detail, west elevation. Rotted storm window sash and different siding styles.

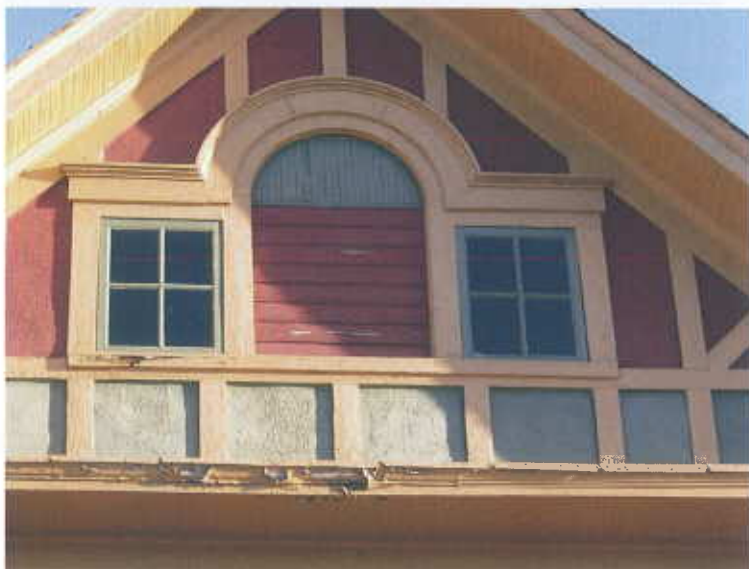
**20.** Detail, west elevation. Boarded windows, peeling paint.

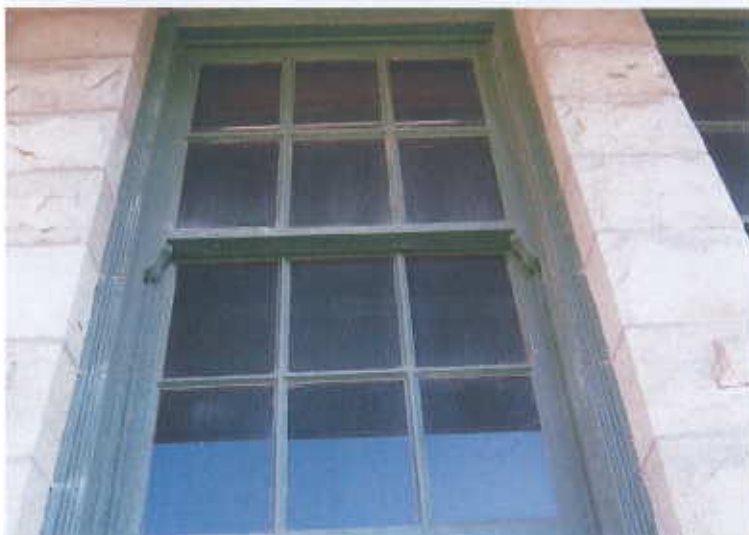
**21.** Detail, west elevation. Saw cuts at the window frame as a result of preparing masonry joints for repointing.

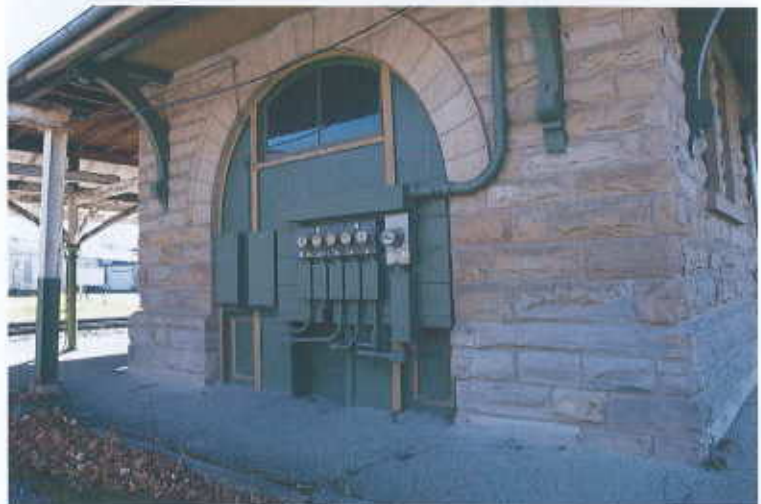
**24.** Detail, gas service at northwest corner of the main part of the depot.

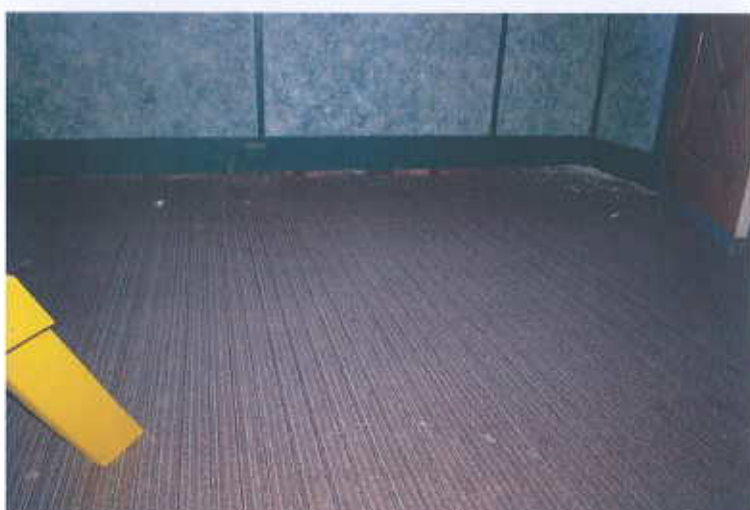
**115.** Room 102, sagging floor in northwest corner, bricks exposed at floor line.

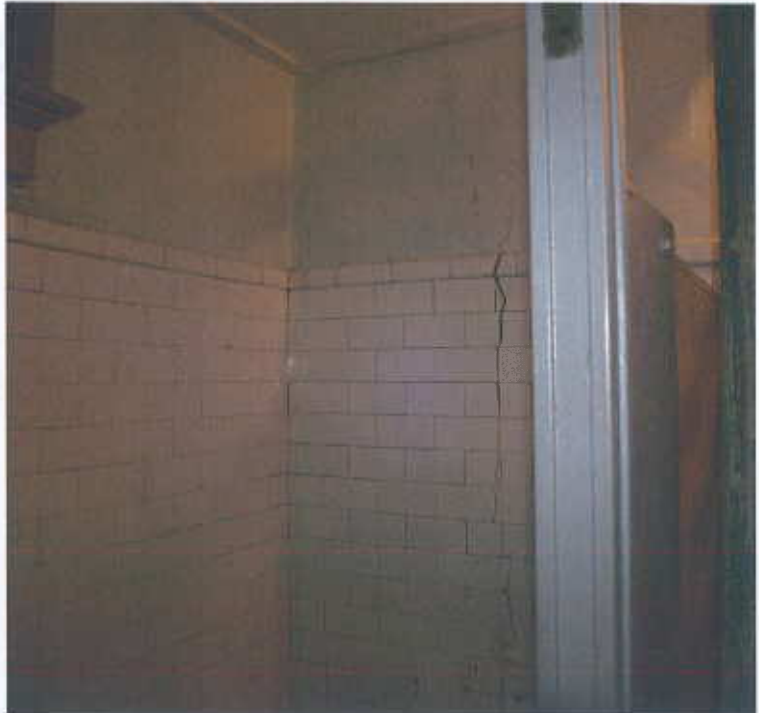
**123.** Room 105, cracked historic tile wainscoting.

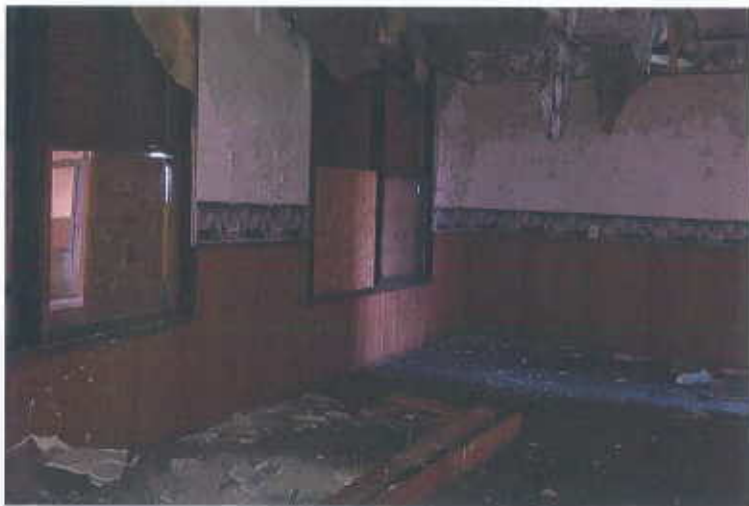
**219.** Room 212, ceiling, walls, and flooring in poor condition.

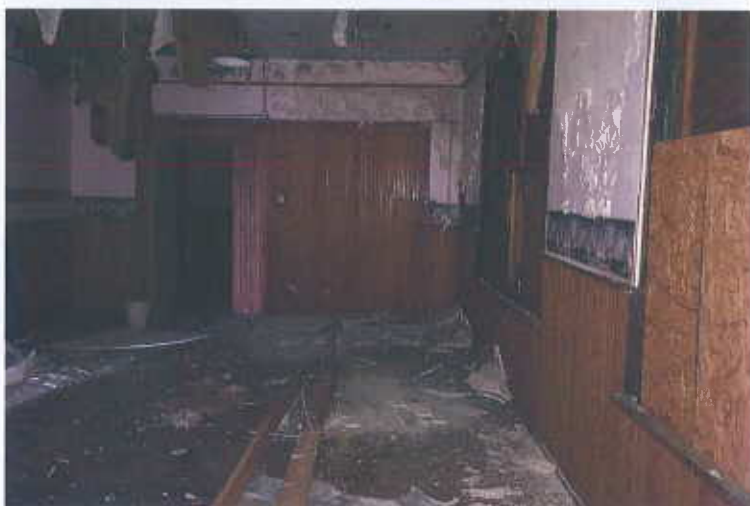
**220.** Room 212, ceiling, walls, and flooring in poor condition.

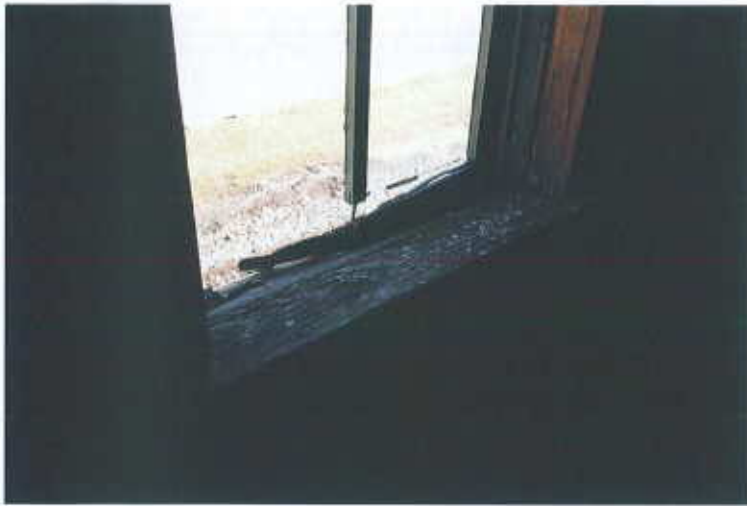
**301.** Attic, deteriorated wood window and sill.

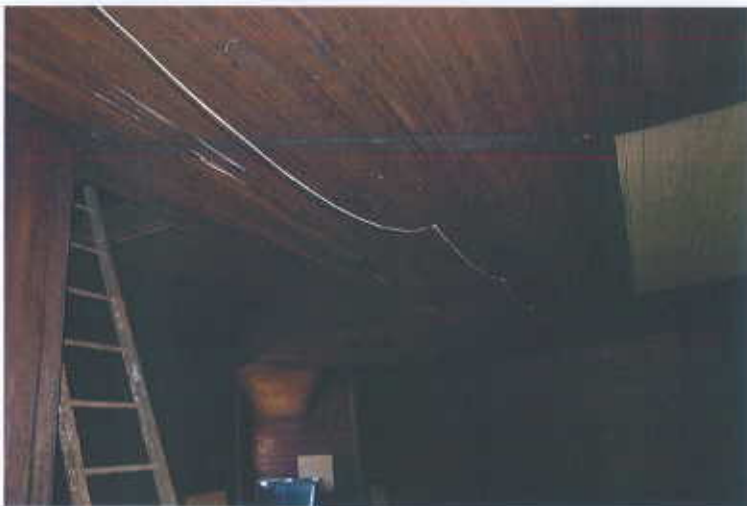
**302.** Attic, beadboard ceiling with some damage and alterations.

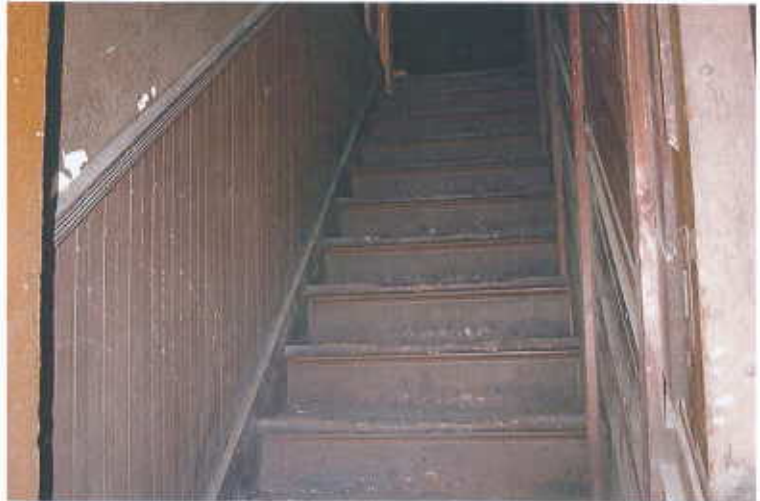
**305.** Attic, stair railing is missing.

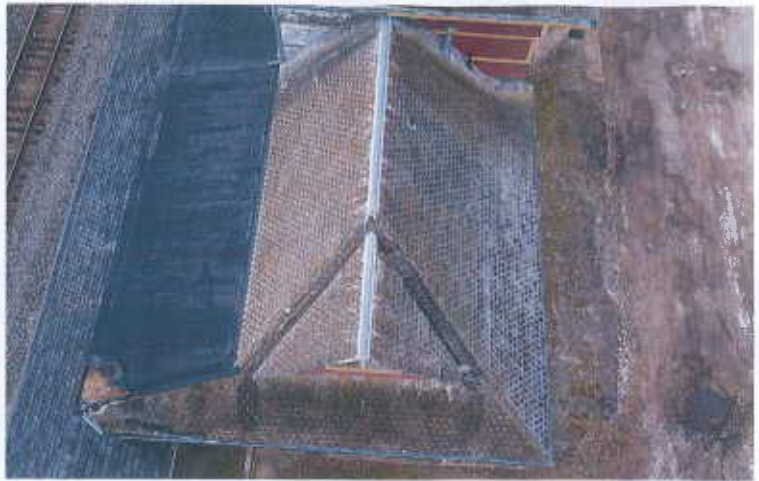
**01a.** The replacement membrane roofing has come unfastened at a corner, exposing wood board underneath (bottom left); the field of the transite roof is covered in green and brown deposits, likely biological growth.

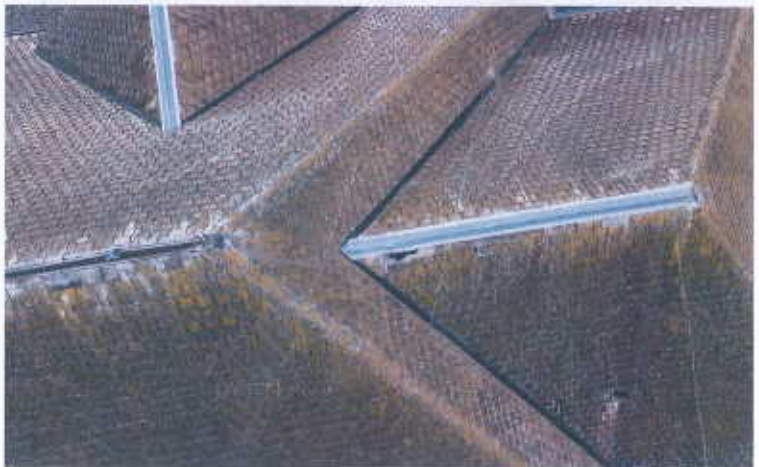
**01b.** A section of ridge flashing is missing (left); there is a hole in the roof by the ridge (middle).
