# Dayton Station Rehabilitation Study

Dayton, Oregon

August 31, 2018

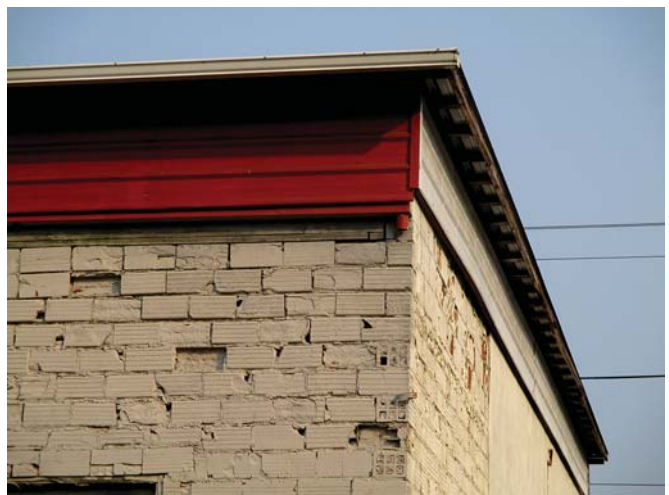
*The metal sidewalls and metal roof structure at the SE corner*

Starting from the top of the structure, the metal roof has done a serviceable job in keeping the elements out of the building, but appears to be approaching its usable lifespan. To address, another layer of metal roofing material could replace the existing, though the roof presents a great opportunity to perform some restorative work, discussed later in this report.

It is strongly recommended to remove the metal roof and side walls, to return back the modernist profile of the office and garage. At this time, a new low-sloped roof surface is to be installed, with plywood sheathing attached in a manner that provides a structural diaphragm. Additional strengthening of the wood roof support members could be incorporated in a unobtrusive manner, as that framework will likely remain visible from below.

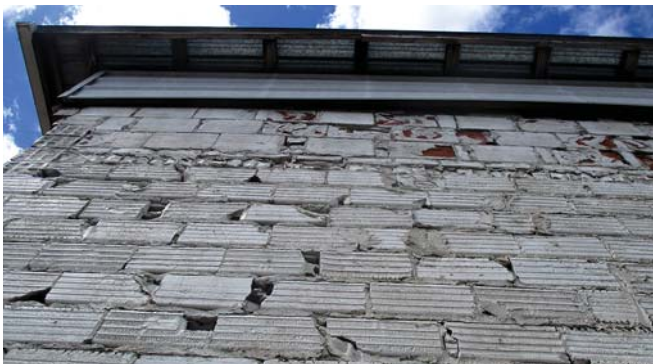
*The poor condition of the pre-1940 addition's exterior walls*

The hollow clay tile walls show occasional cracks evident of building movement, either as a condition of its age and normal settling, or as a result of the seismic events experienced over the years. The most conspicuous location of wear and tear is at all three walls of the rear addition to the garage. These walls never received a parge coating, and its direct exposure to the elements is partly the reason for its poor condition. A number of the masonry units display cracks, missing sections, and even face spalls. The mortar hasn't been repointed for decades, if ever. Water infiltration into the units, and in towards the interior, exacerbate the damage. The vertical joint between the new and original masonry units shows open gaps, and will need to be addressed in a more permanent manner.

The masonry exterior walls are to be repaired as required, with missing details such as the projecting brick coursing and wall signs returned. Various treatments of the pre-1940 addition are shown in the three design concepts, ranging from retaining and patching, to demolition and reconstruction. Reconstruction should provide a wall surface similar to the main garage, and incorporate a parge coated finish.

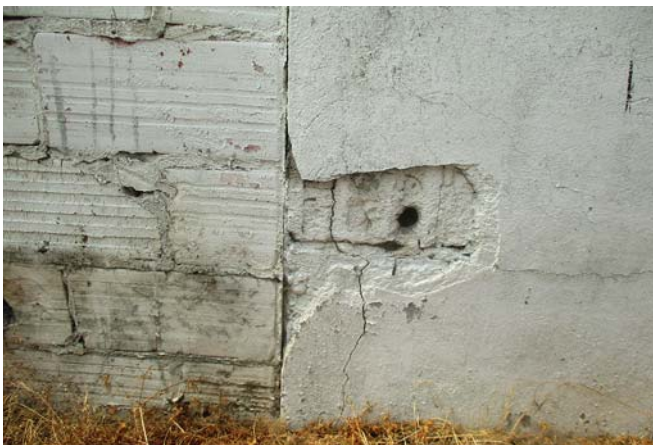
*The joint between the addition and the garage, with its parge coating*

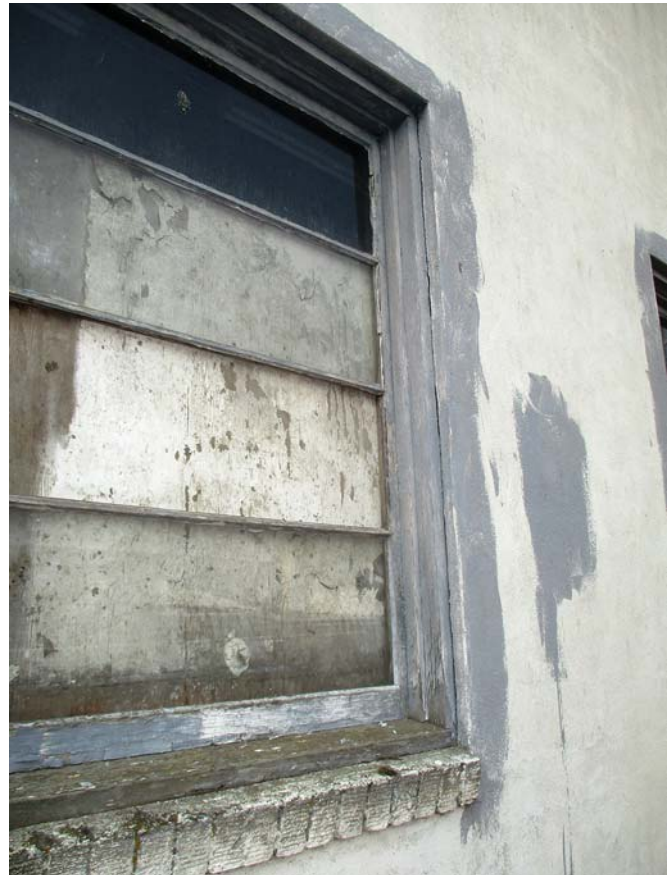
*One of the east windows of the garage*

The original wood windows show weather damage at the very least, and at the worst severe breakage with missing elements. Some window locations were boarded up, making unknown the window condition, or if they even exist. Certain windows could be repaired and refurbished. Other might need to be fully replaced, with matching configurations using in-kind materials.

Regarding the windows, all those that are in repairable condition should be repaired. New windows are to match the original in configuration and materials. Various treatments of the garage doors are shown in the three design concepts, from partial retention to full replacement. The current doors are somewhat difficult to operate, and are definitely not weather tight or a barrier to pests and vermin.

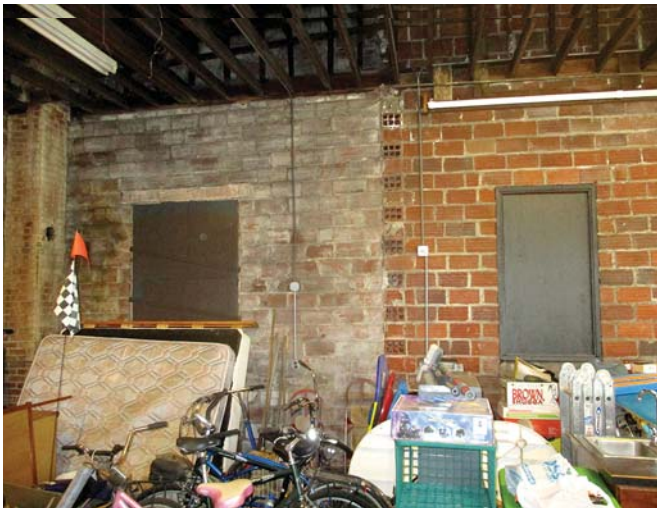
*The pre-1940s addition (left) and the original garage wall (right)*

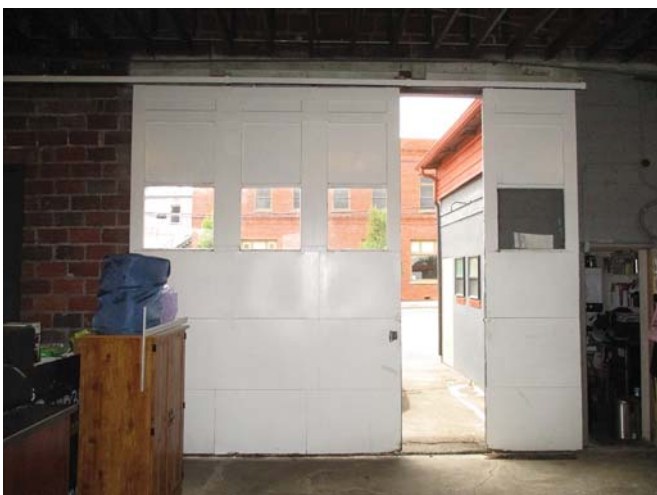
*The west garage door*

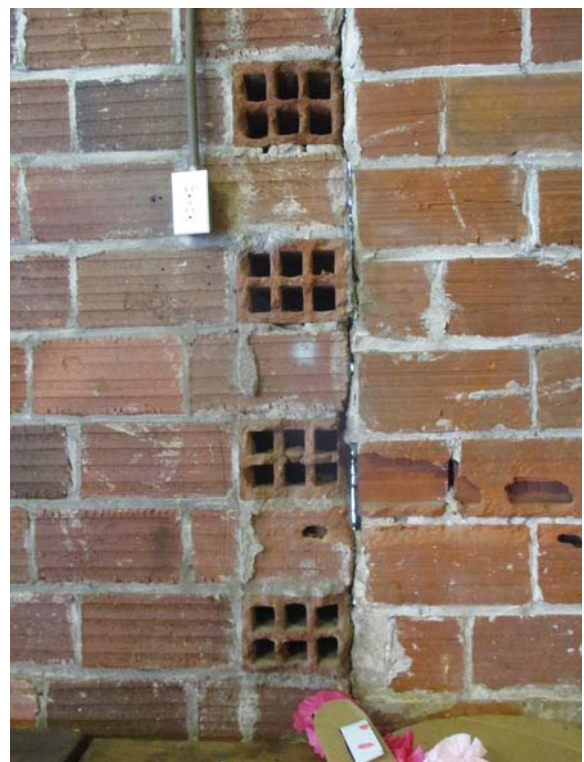
*The cut south wall of the garage, and the joint with the addition*
