## **Jefferson Court Apartments**

**205 Jefferson Avenue**

## **Historic Structure and Exterior Building Assessment**

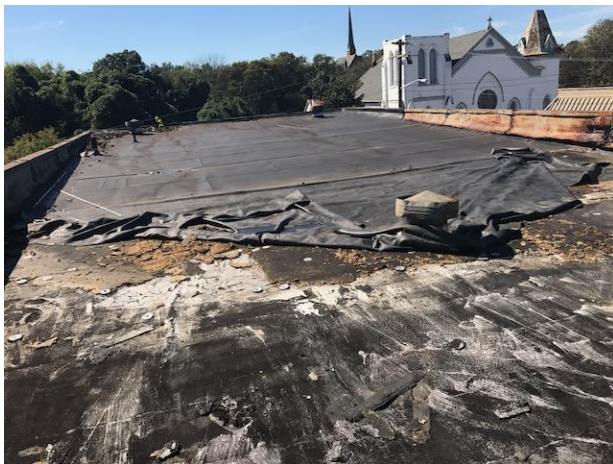
*Figure 5 Partial install of new membrane*

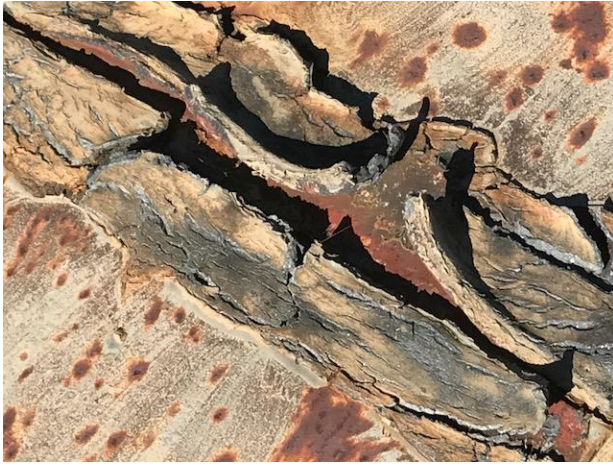
*Figure 6 Sealant failure at metal flashing*

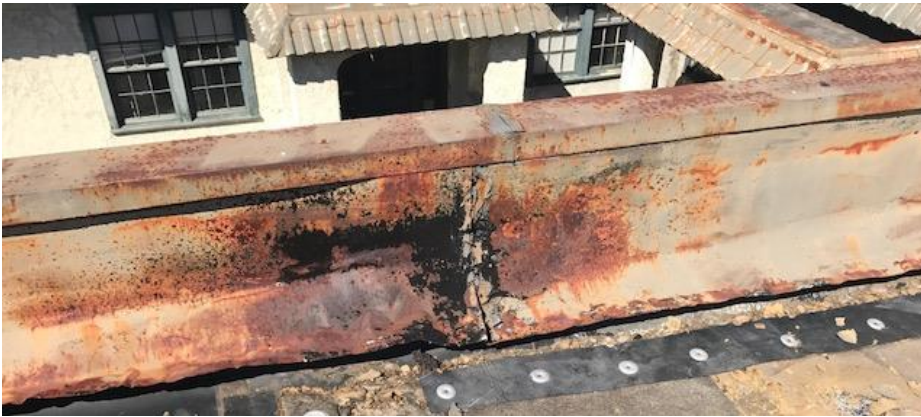
*Figure 7 Parapet wall and cap rust*

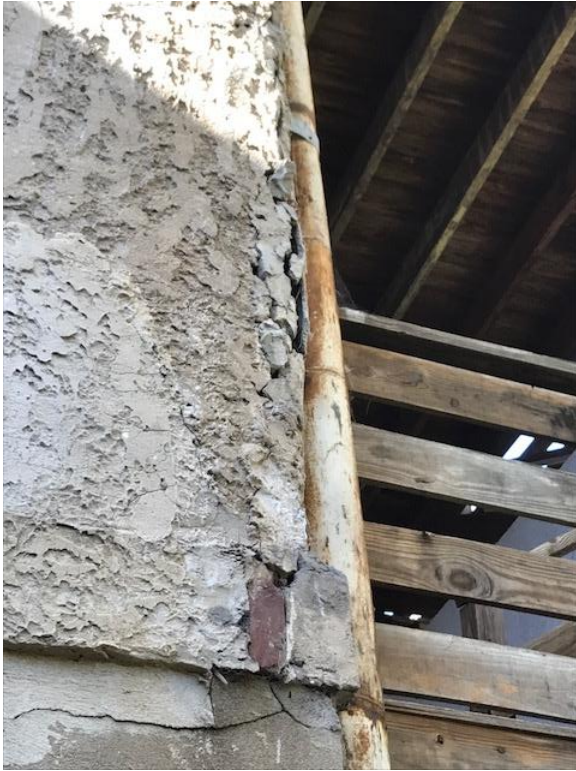
*Figure 8 Water damage to stucco corner*

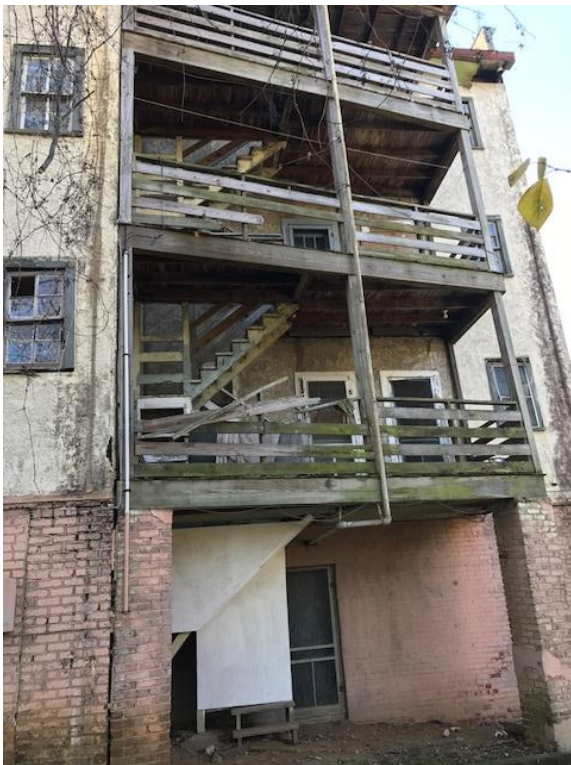
*Figure 9 Rear porch with mildew and broken rails*

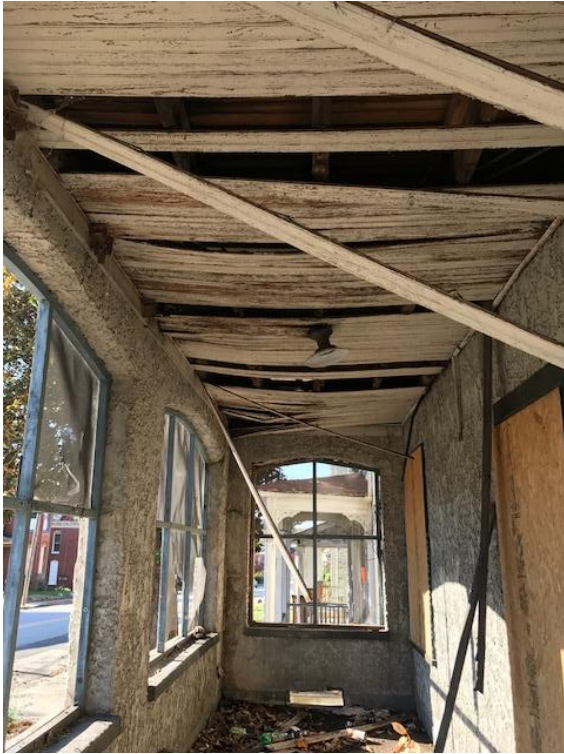
*Figure 10 Balcony ceilings failing from water infiltration*

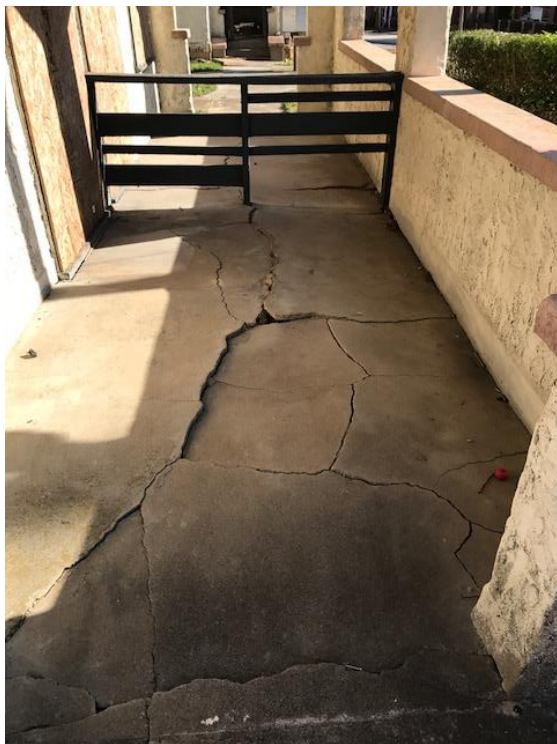
*Figure 11 Balcony foundation failing from improper drainage*

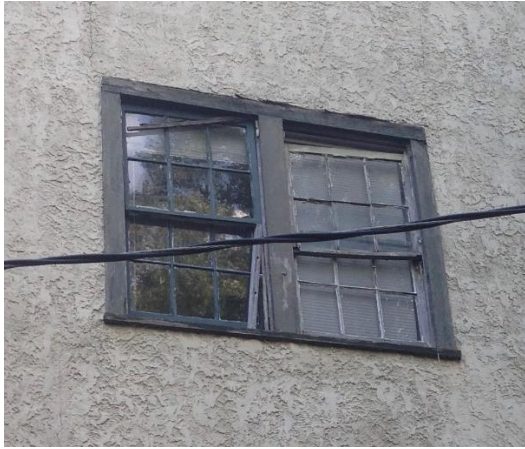
*Figure 12 Double hung window in disrepair*

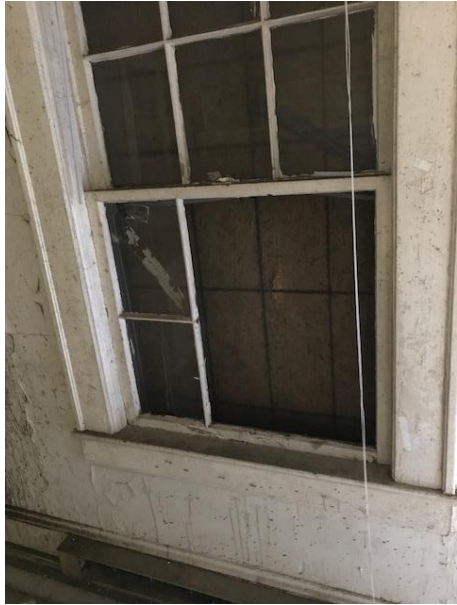
Photo 1 See A2 “Right Courtyard”

These are extreme examples of the damage, but show a sampling of the disrepair listed below. Most doors and windows are rebuildable/repairable.

1. All windows and doors will need priming and painting. Proper prep should be taken prior to this. Windows need re-puttying. Doors have wood glazing bars to hold in the glass panes. Some are missing or broken and will need to be replicated.
2. The window and door schedule may not show all items necessary for repair and replacement where access was not available or where windows and doors were boarded up. Therefore, the scope of the project would include all necessary repairs or replacement of parts to make the windows and doors fully operable with no rotted or damaged material to sash, door, muntins, trim, jambs, sills, and any other parts required for full functionality.
3. Although there are some remaining screens most are damaged, new replacement screens would be needed for all windows.
4. Replace all glass where missing or broken.

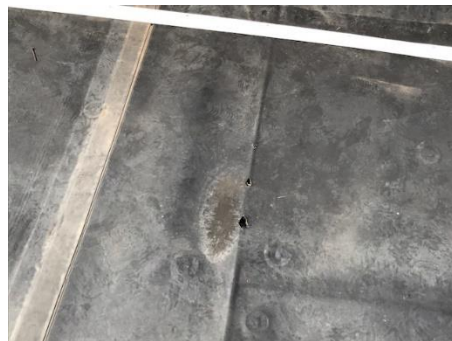
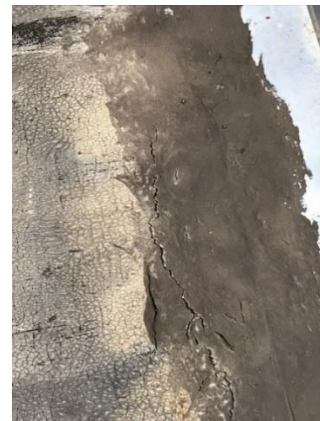
Item 49

| | Description |
|---|---|
| <b>49</b> | Holes and separation of transition from old roof to newer |

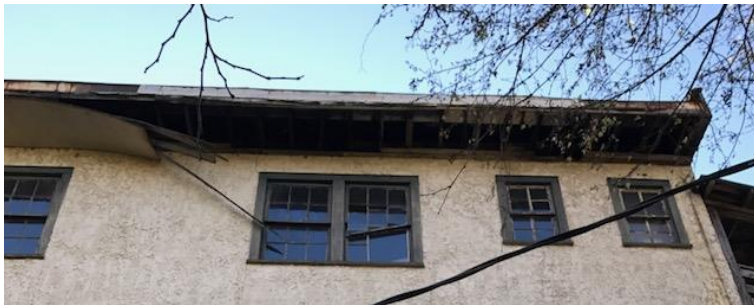
Photo 5

The soffits are deteriorating at certain location due to the improper drainage of the roof. The tongue and groove soffit material are missing or rotting away. The fascia along parts of the roof are also rotting and exhibit wear from not being properly coated. See architectural drawings **A6** and **A8** for photos below.

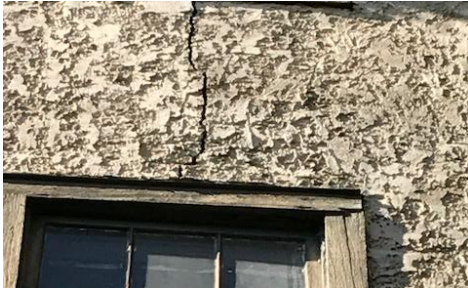
Photo 8

Both foundation and exterior walls has numerous areas on all sides of the building where cracks, holes, missing building materials, exposed structural framing, etc. can be observed. These conditions have caused the building to deteriorate further and compromise the overall structure. First floor porch floors along the front units have cracked and heaved as well as numerous cracks and improper repairs can be observed at the steps leading into the common entry doors. Bulges along the foundation wall and the building's corner, open seams in the stucco exposing the skeletal structure underneath are apparent. There are missing brick along the foundation band, lack of mortar along the rear foundation wall, stucco sections that have fallen away exposing the brick along both the foundation and piers supporting the rear porches. Improper "patching" is evident along the band where caulking has been used to close gaps, but is now cracking and allowing water to infiltrate. Exterior walls have stress cracks especially around window casings, running down toward the foundation. All such deficient areas are located on Architectural Drawing Elevations A1 through A6 and are keyed.

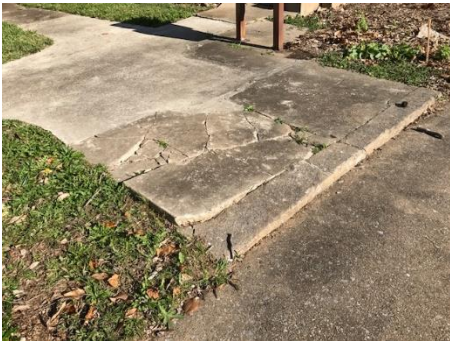
Note: The sidewalks leading to both the building's entry doors and individual units' entry porches have cracked and heaved due to the lack of maintenance over the years. This is a tripping hazard at the very least.

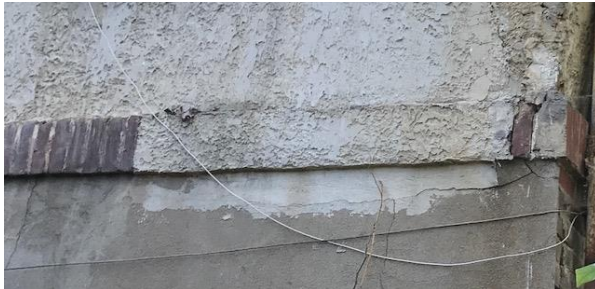
Photo 12

The decorative belt course at the foundation is in various states of disrepair. As noted in the foundation section of this report, bricks are missing at different intervals exposing the sill beams of the building. Mortar is missing as well as the stucco finish, which was removed at some point and the brick painted. There is one area where the stucco is still covering the belt course.

*Belt course showing stucco and exposed brick*

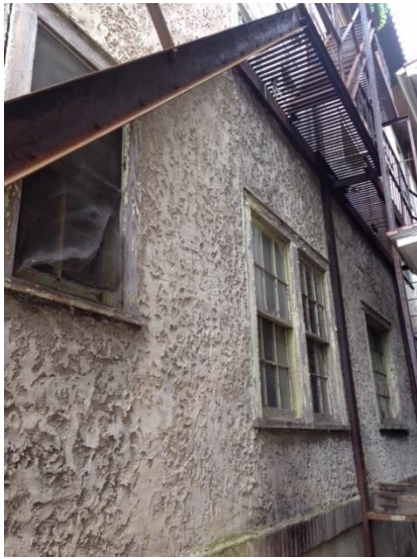
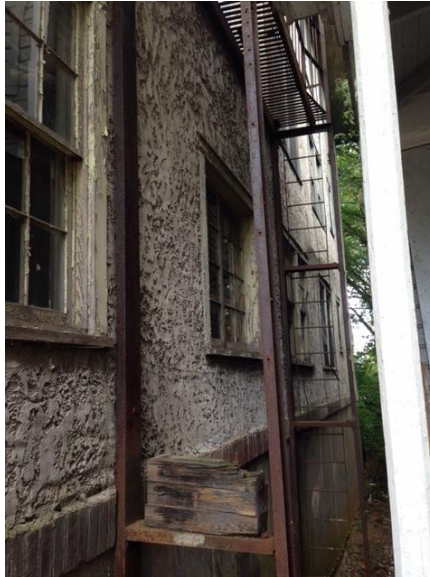
The fire escape located on the right side of the building. It is constructed of metal and anchored to the building to serve the units along this side. Its condition is poor with rust dominating most of the surface and the anchors have detached from the building at certain intervals and the support system is corroding. Walking on the fire escape currently is unsafe. The photos on the proceeding page

Fire escape and supports below
