## SQUIRE POPE CARRIAGE HOUSE PRESERVATION PLAN

PREPARED FOR:  
THE TOWN OF BLUFFTON  
20 BRIDGE STREET  
BLUFFTON, SC 29910

PREPARED BY:  
MEADORS, INC.  
PO BOX 21758  
CHARLESTON, S.C. 29413

DATE: 09.30.2019

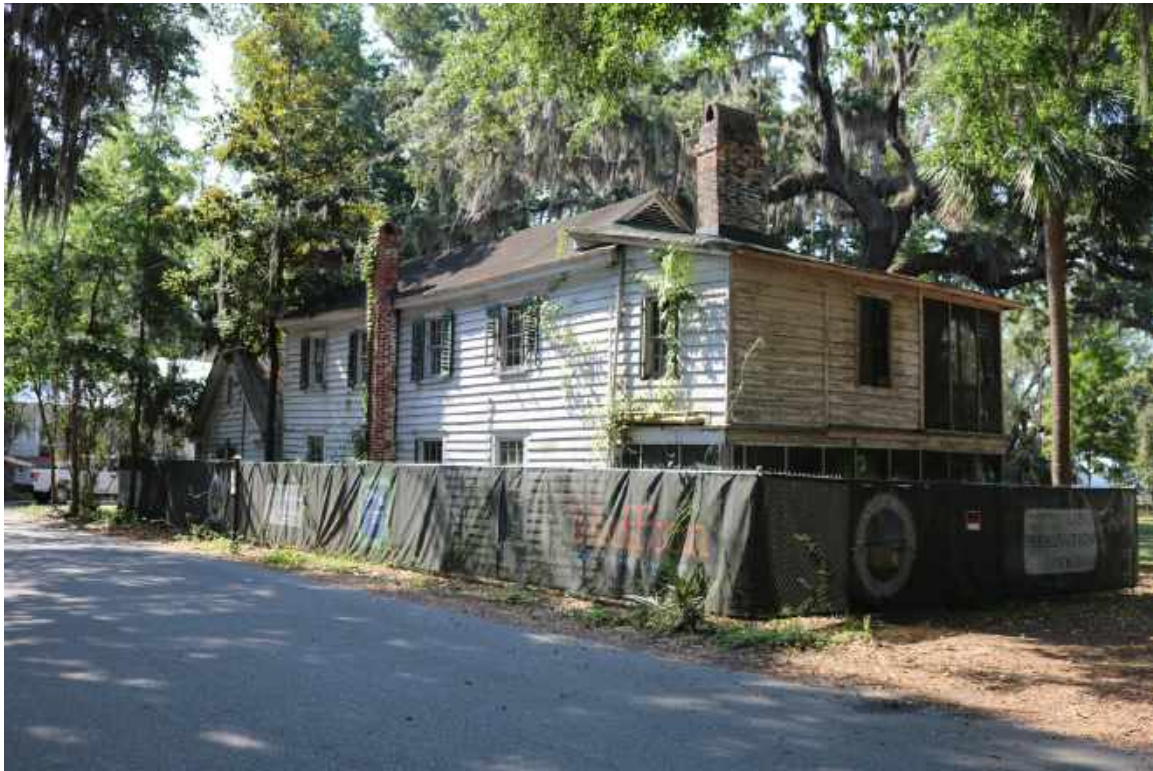
The exterior envelope of the Squire Pope Carriage House is significantly deteriorated with numerous visible areas of damage and structural settlement. A visual analysis of the exterior of the structure indicates extensive settlement of the structure at the west façade of the structure and at the hyphen connecting the two independent buildings.

**Figure 43:** Squire Pope Carriage House, Northwest Corner: Overview of existing exterior conditions.

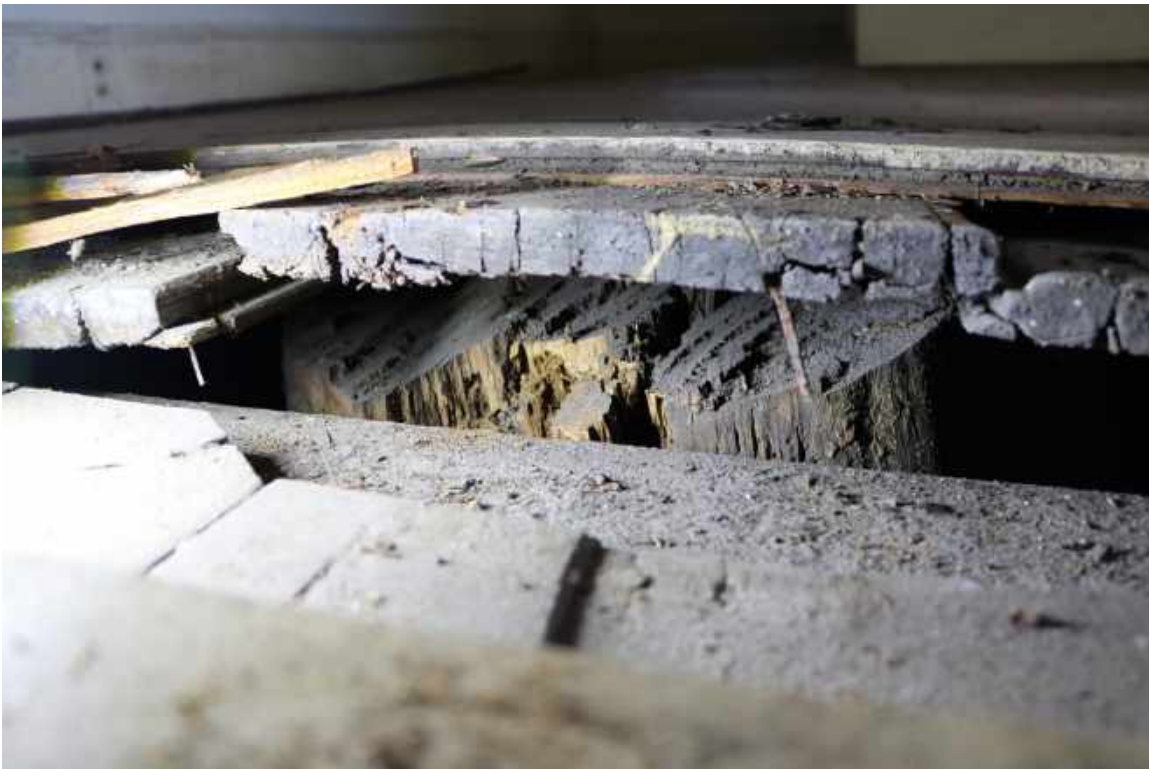
**Figure 44:** Room 101, Foundation: Detail of tree stump found between the floor joists when the flooring was selectively removed.

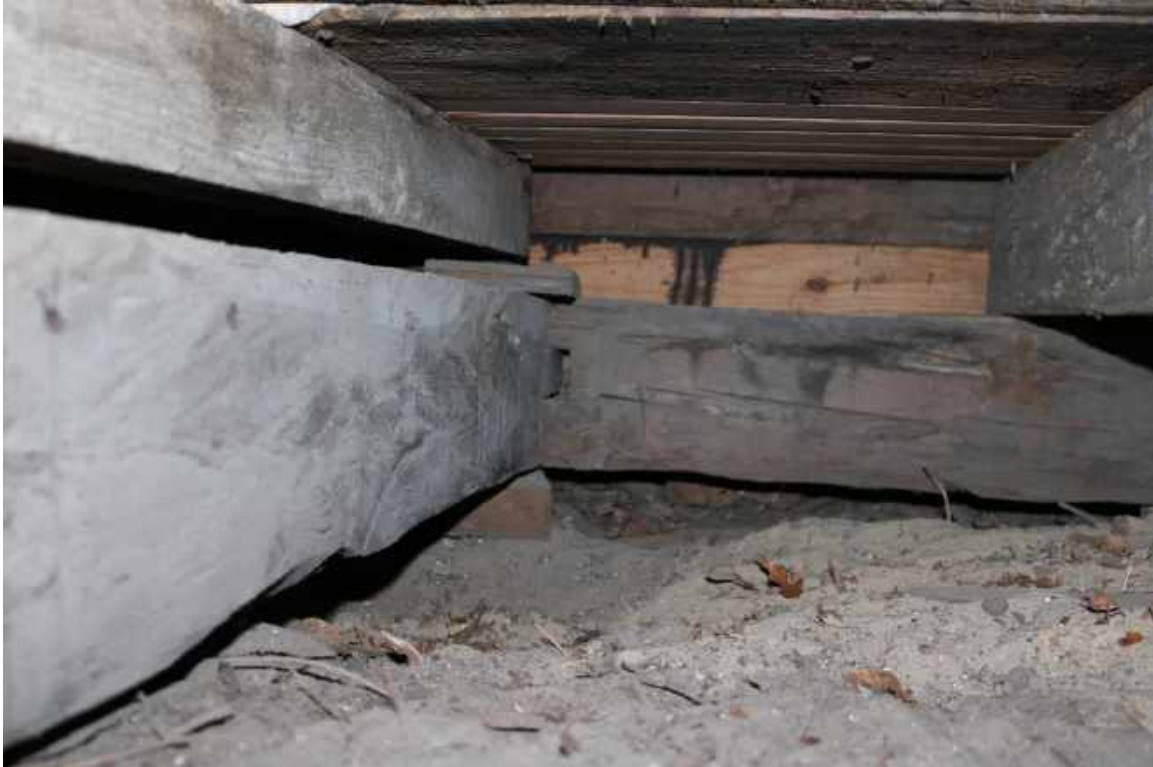
**Figure 45:** Crawlspace Beneath Room 103, Looking South: Detail of the intermediate eastern perimeter sill (at left) mortised into the south perimeter sill. The sill at left is believed to be the original eastern sill for the smaller structure. Note adze marks on both historic sills. An floor joist is installed above the intermediate perimeter sill.

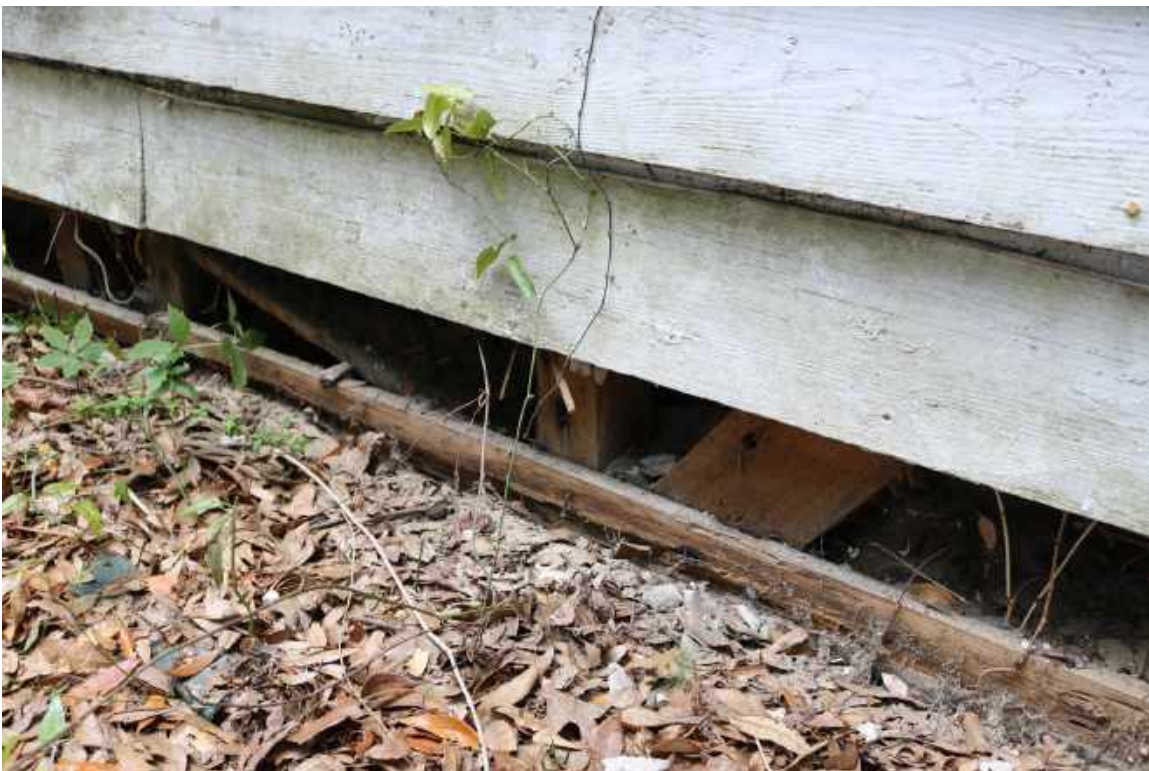
**Figure 48:** North Elevation of Two-Story Building: Detail of corner brace intersecting the deteriorated north perimeter sill.

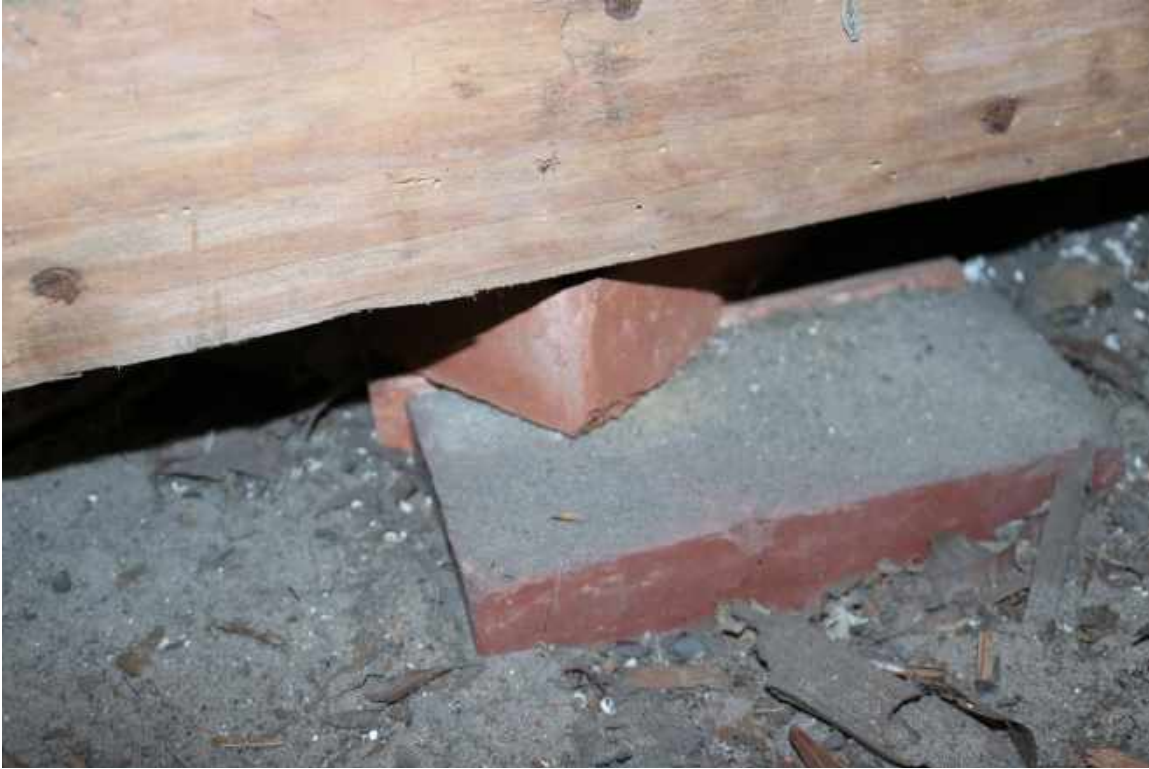
**Figure 49:** Crawlspace beneath Room 103: Detail of dry stacked modern masonry installed below floor joist.

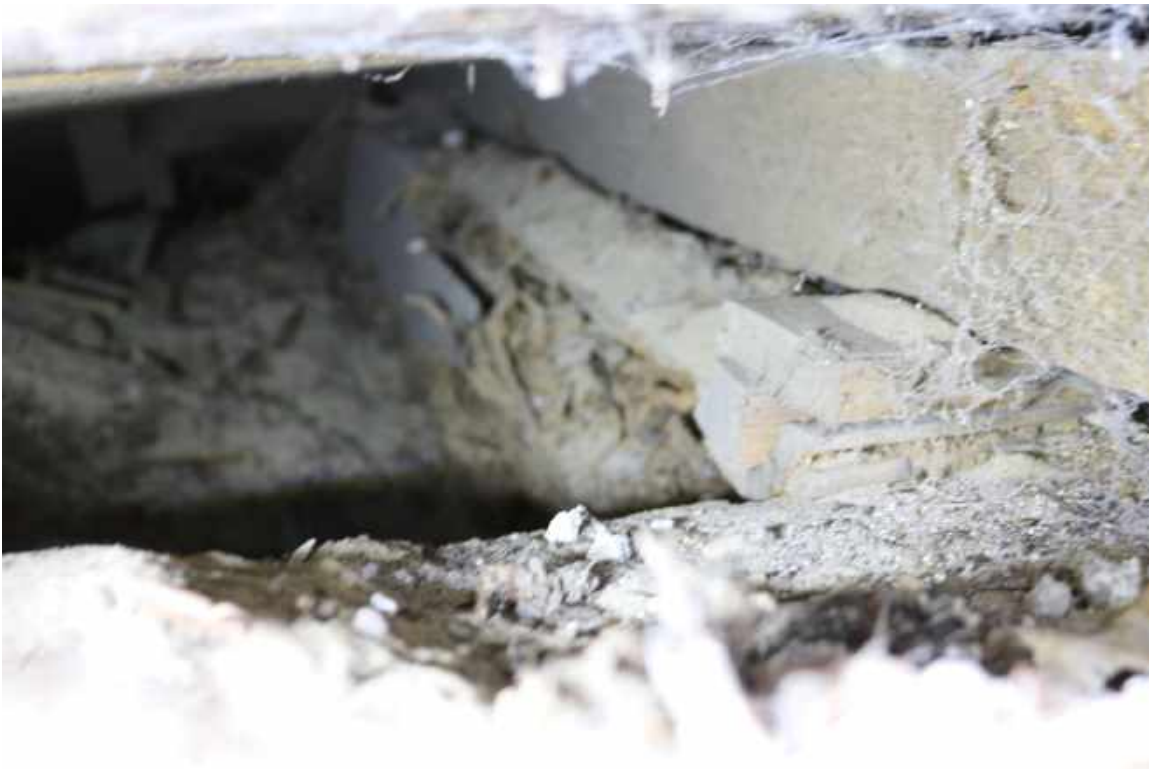
**Figure 50:** Crawlspace Beneath Room 101, Northwest Corner: Detail of deteriorated western perimeter sill. The settlement in this area is due to the failure of this structural member.

It is expected that the buried or inaccessible perimeter sills are in a similar condition and will require extensive repairs or full replacement. The west perimeter sill exposed directly below the west bay window is completely deteriorated. The complete failure of this member has likely caused extensive settlement in this area.

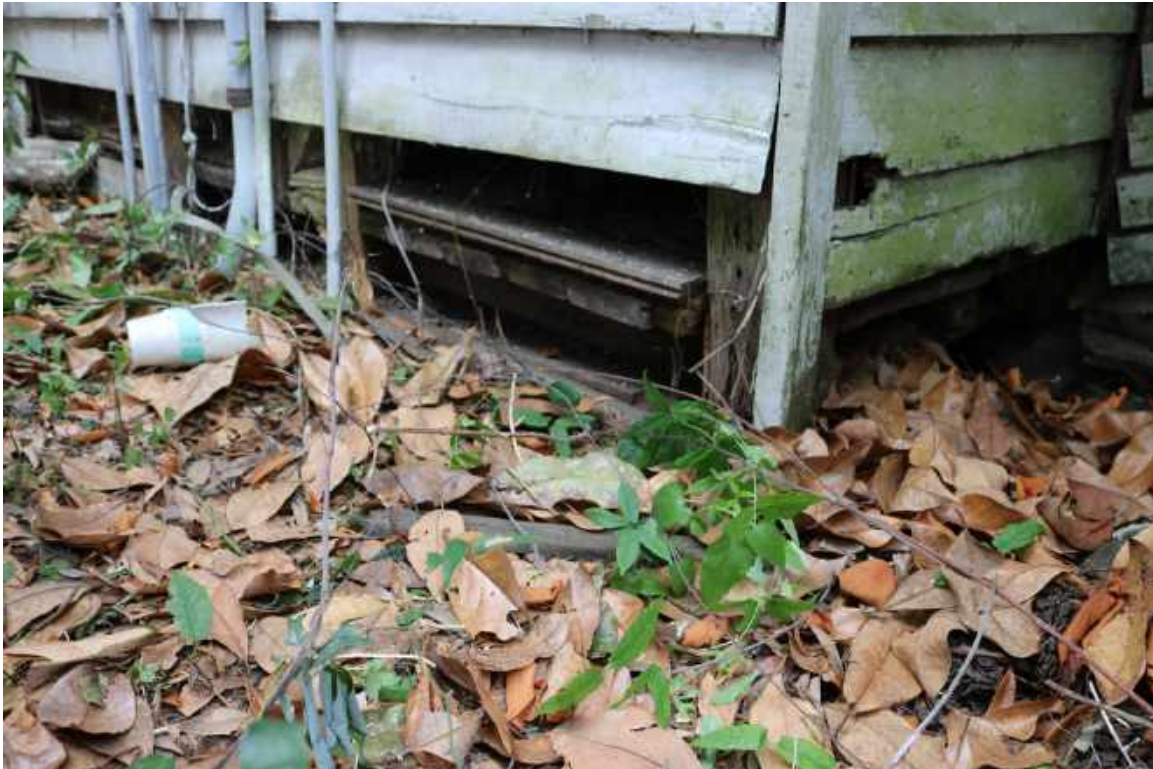
**Figure 51:** Northeast Corner of One-Story Building, Northwest Corner: The corner post has completely deteriorated. The perimeter sill is covered by soil.

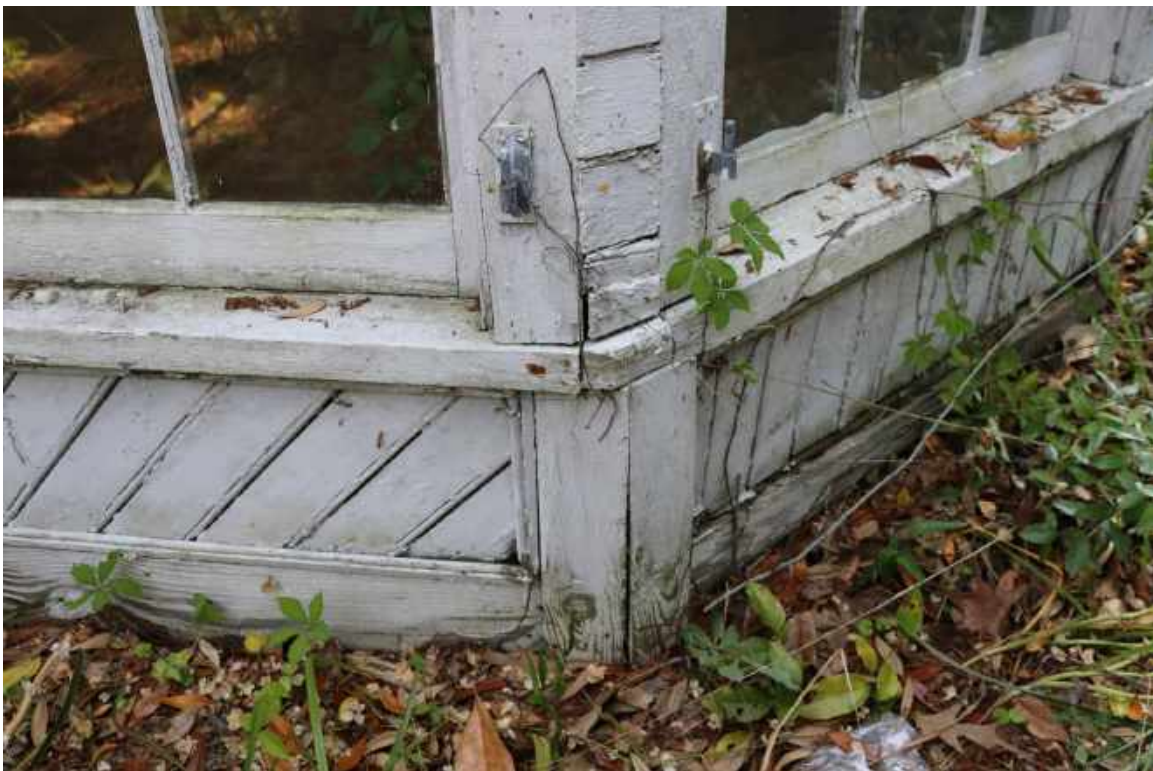
**Figure 52:** South Elevation of One-Story Building: Detail of the foundation of the bay window. The decorative paneling is extensively deteriorated.

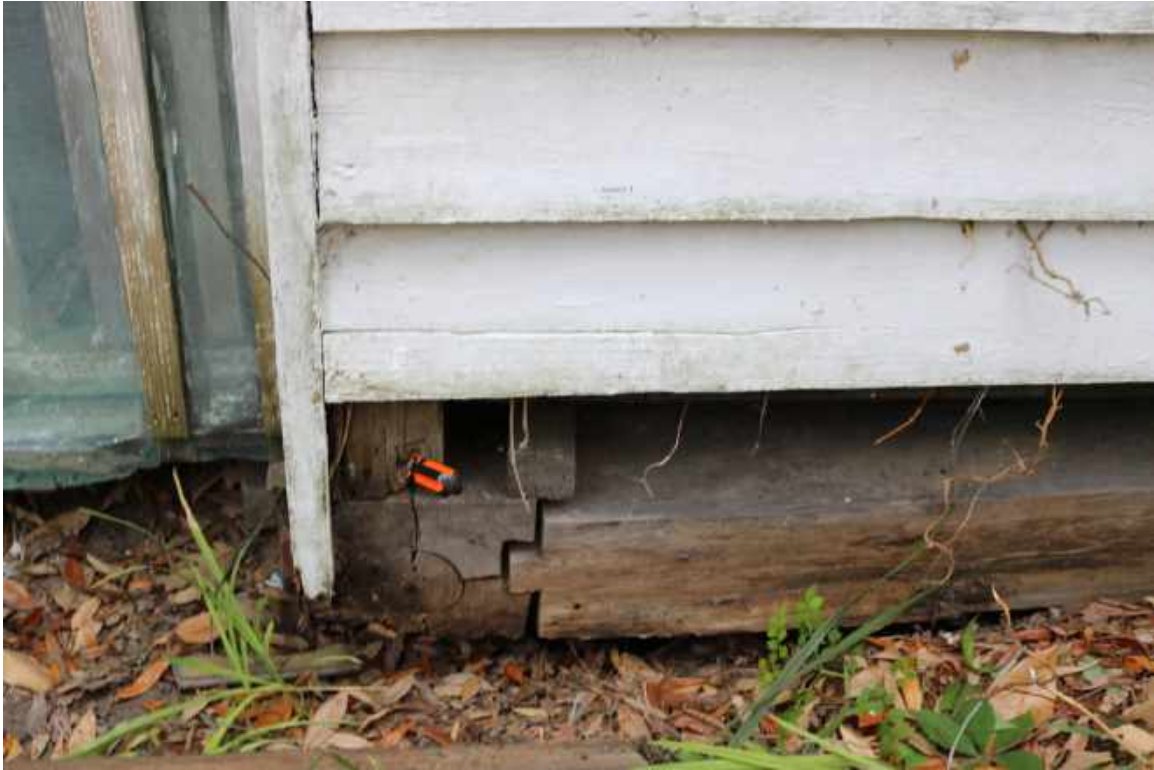
**Figure 53:** South Elevation of One-Story Building, Southwest Corner: Detail of exposed perimeter sill resting at grade. The bottom of each sill is deteriorated.

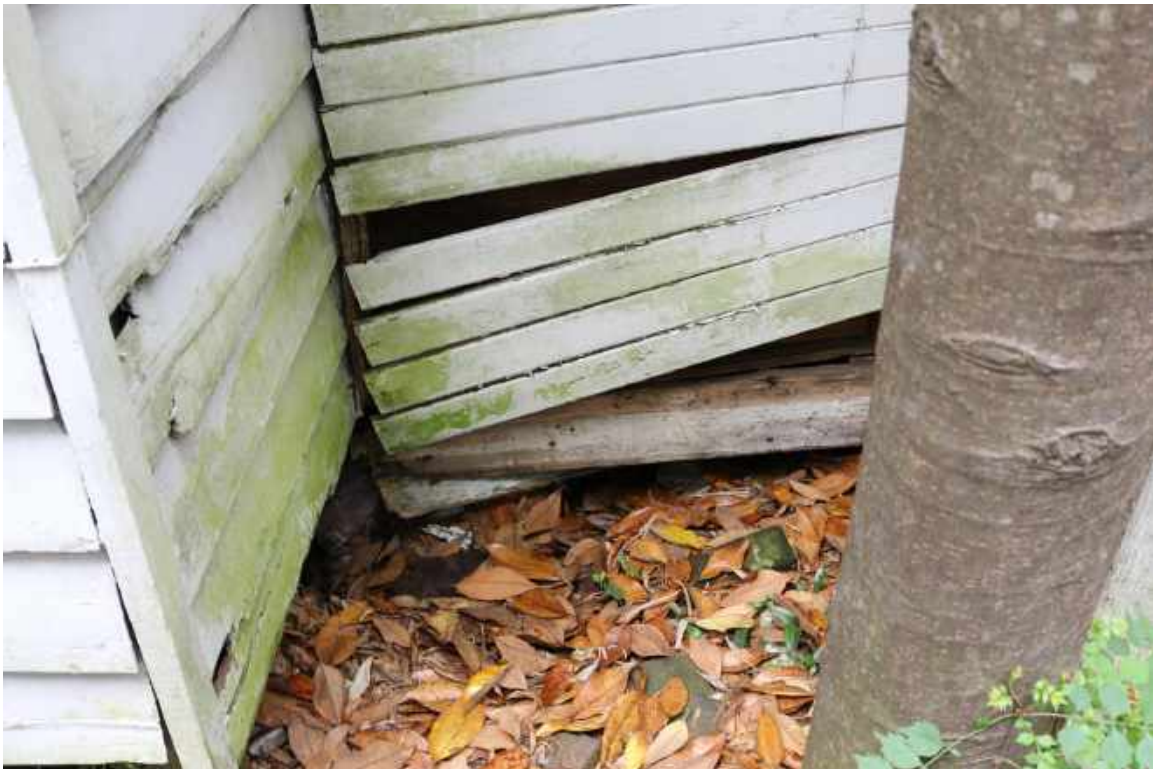
The hyphen foundation has completely failed and requires reconstruction. A small concrete pad is placed on the north side of the hyphen and was likely installed to support a water heater or similar equipment. The hyphen has settled on the north and south ends as the structures on either side have independently moved.

**Figure 54:** North Elevation, Hyphen: The foundation of the hyphen has failed.

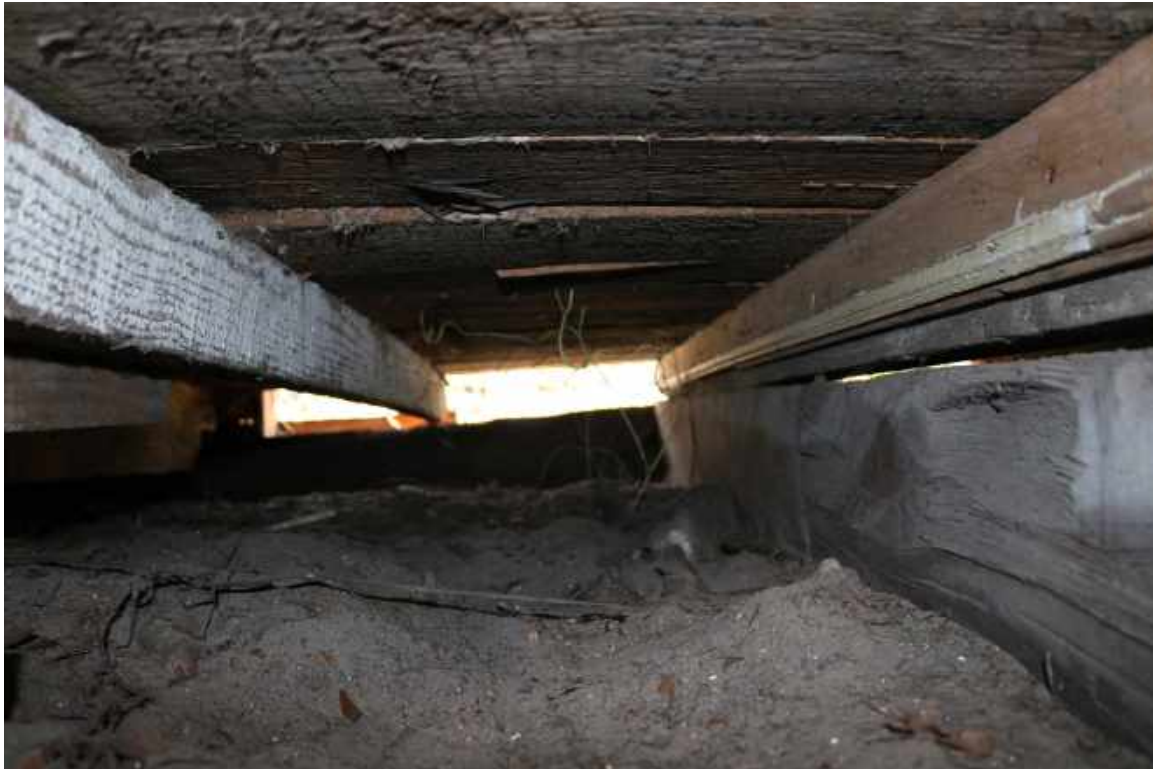
**Figure 55:** Crawlspace Below Room 103, Looking North: Detail of Floor Joists. The intermediate perimeter sill is located at right. An additional floor joist has been installed directly over the sill after the building was enlarged.

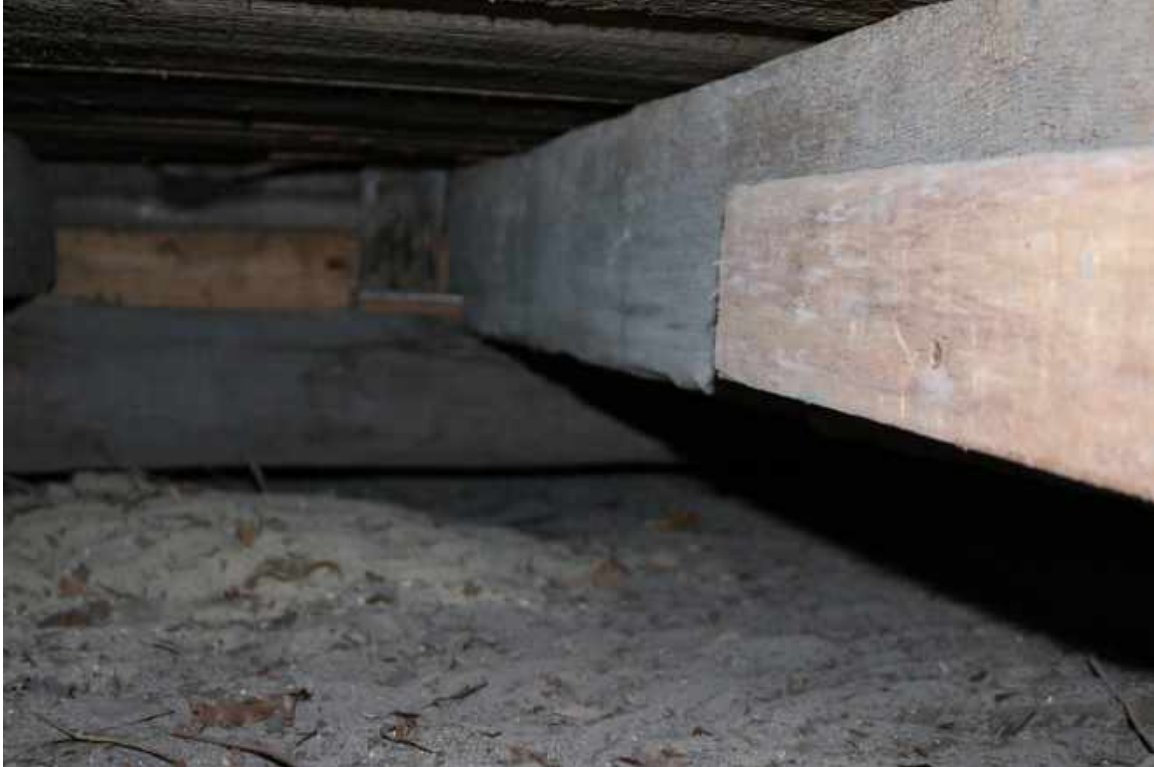
**Figure 56:** Crawlspace Below Room 103, Looking South: Detail of Floor Joist. The joist appears to be in fair condition.

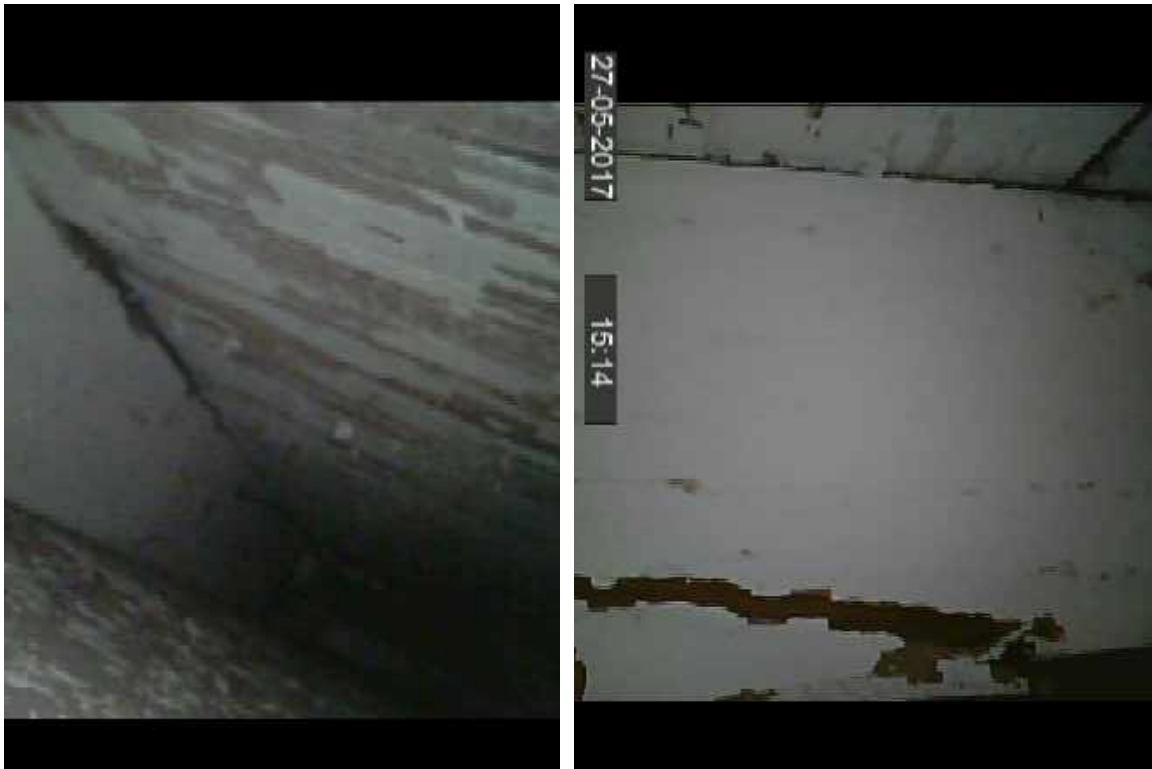
**Figure 58:** Second Floor Joists Below Room 202: One joist was cracked due to settlement. The joists are hidden due to ceiling paneling in Room 101. The floor joists are whitewashed, indicating they were likely exposed on the first-floor.

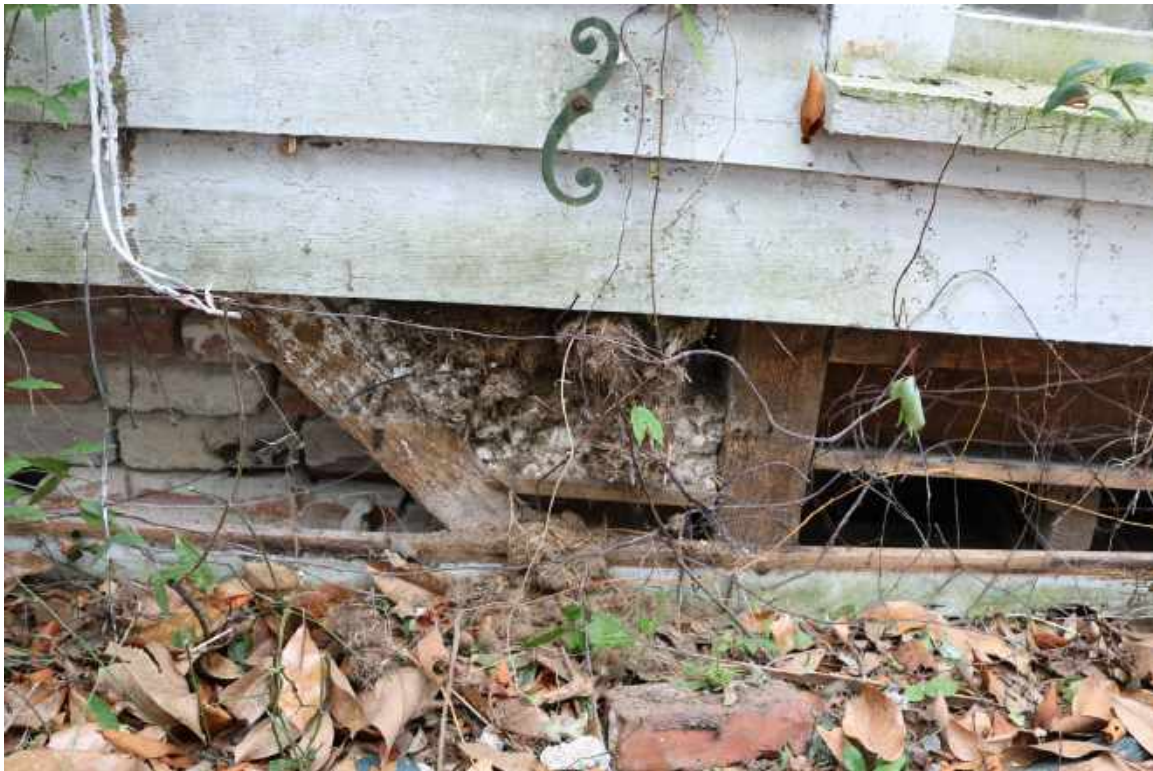
**Figure 59:** North Elevation of Two-Story Building: Deteriorated corner post at the northeast corner. The internal diagonal chimney is present behind the post.

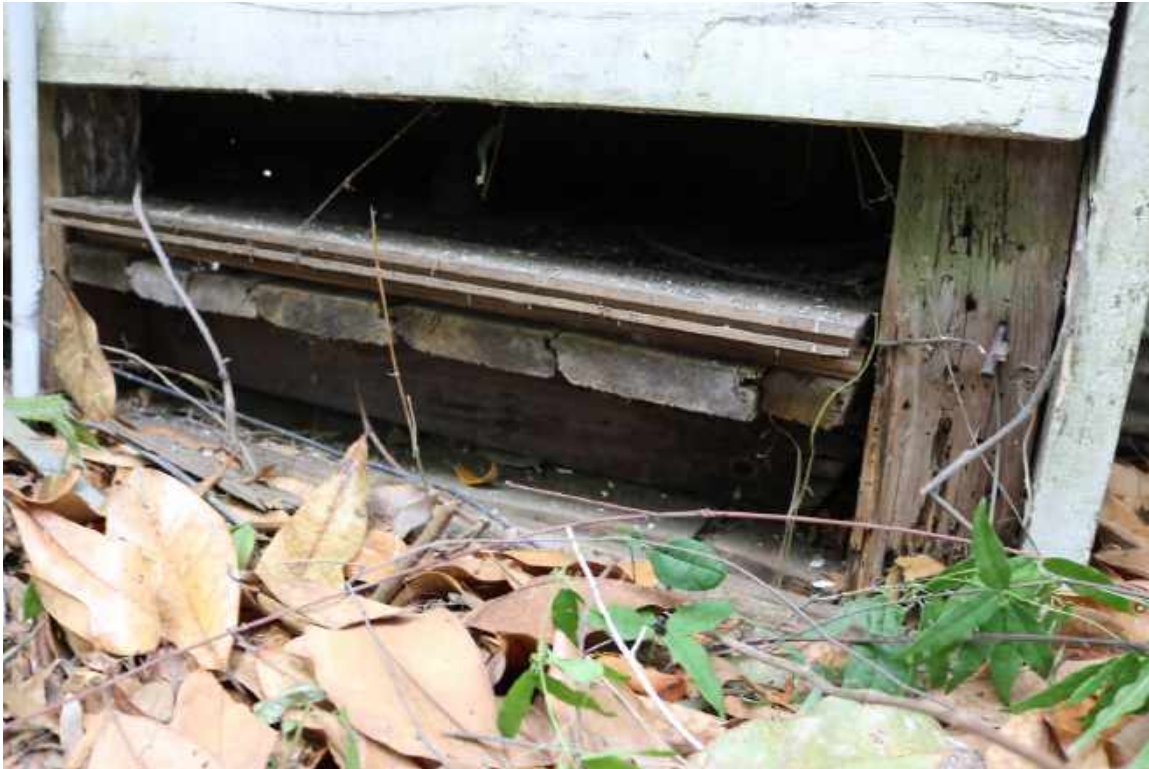
**Figure 60:** North Elevation, One-Story Building: Detail of floor joists and flooring at this location. Deterioration is evident where the members are in direct contact with the ground.

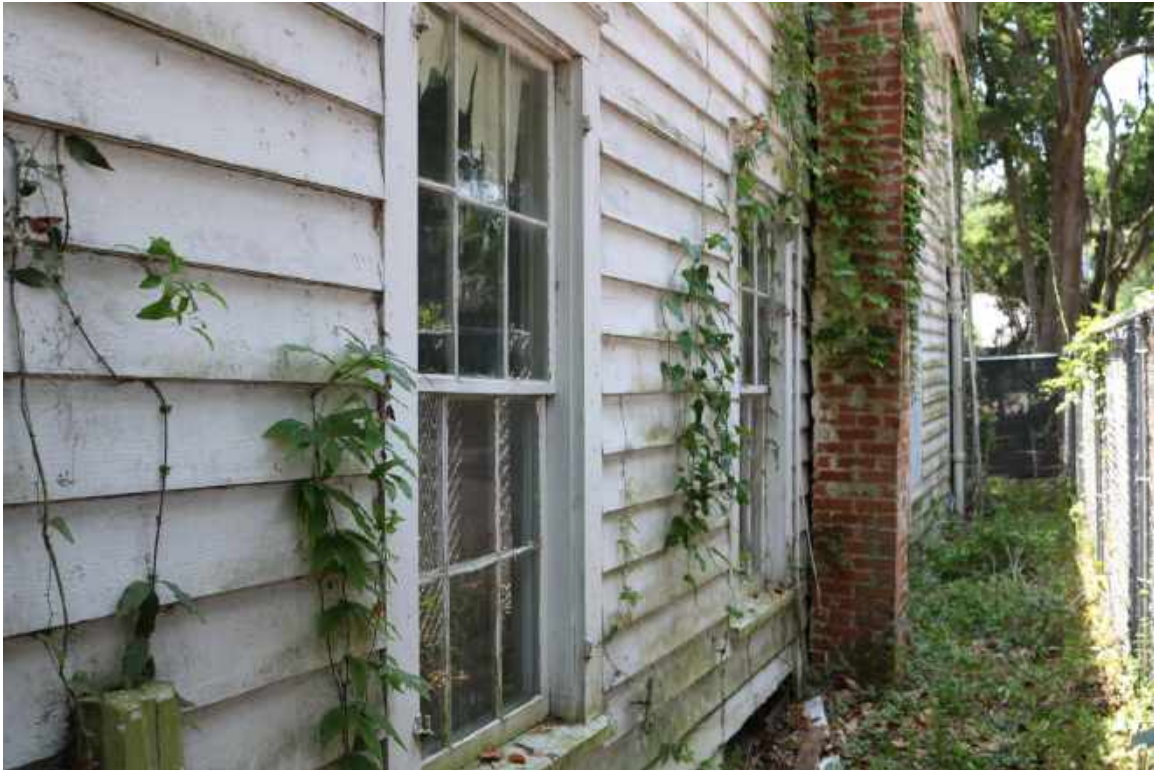
**Figure 64:** North Elevation of Two-Story Building: Detail of window conditions on this elevation. The original shutters are missing. Biogrowth is prevalent.

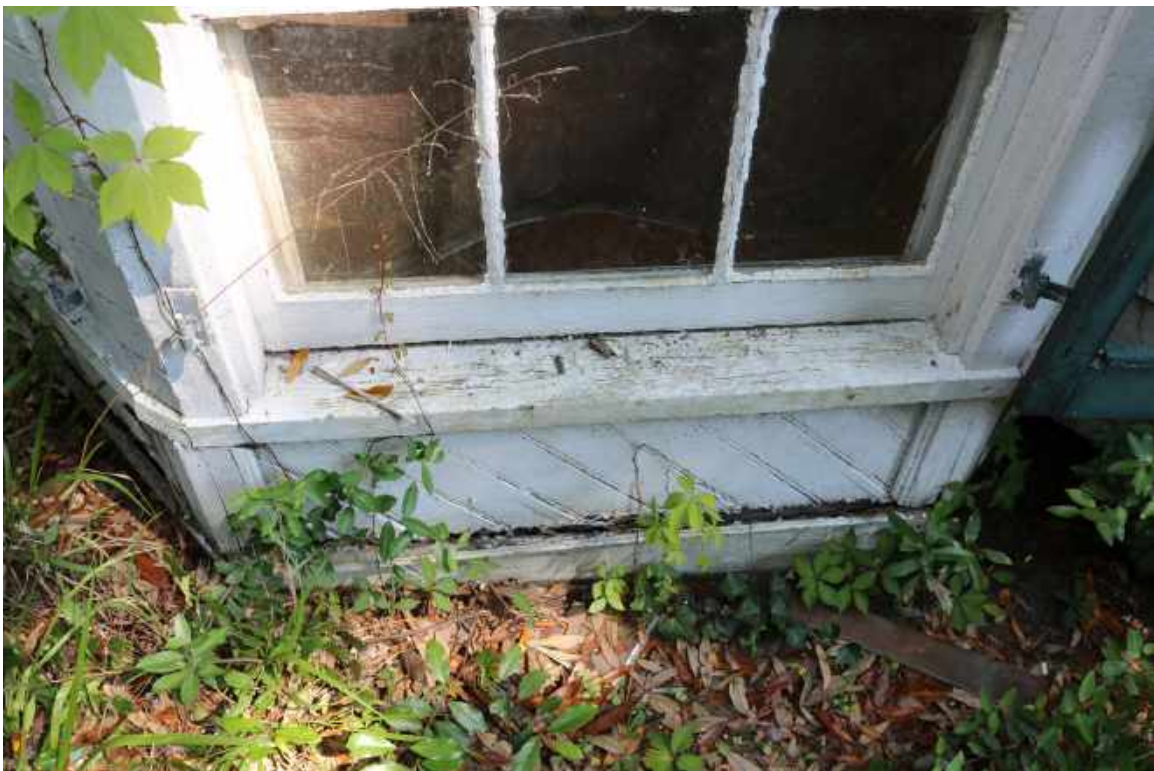
**Figure 67:** South Elevation of One-Story Building: Detail of window and trim deterioration within the south bay window.

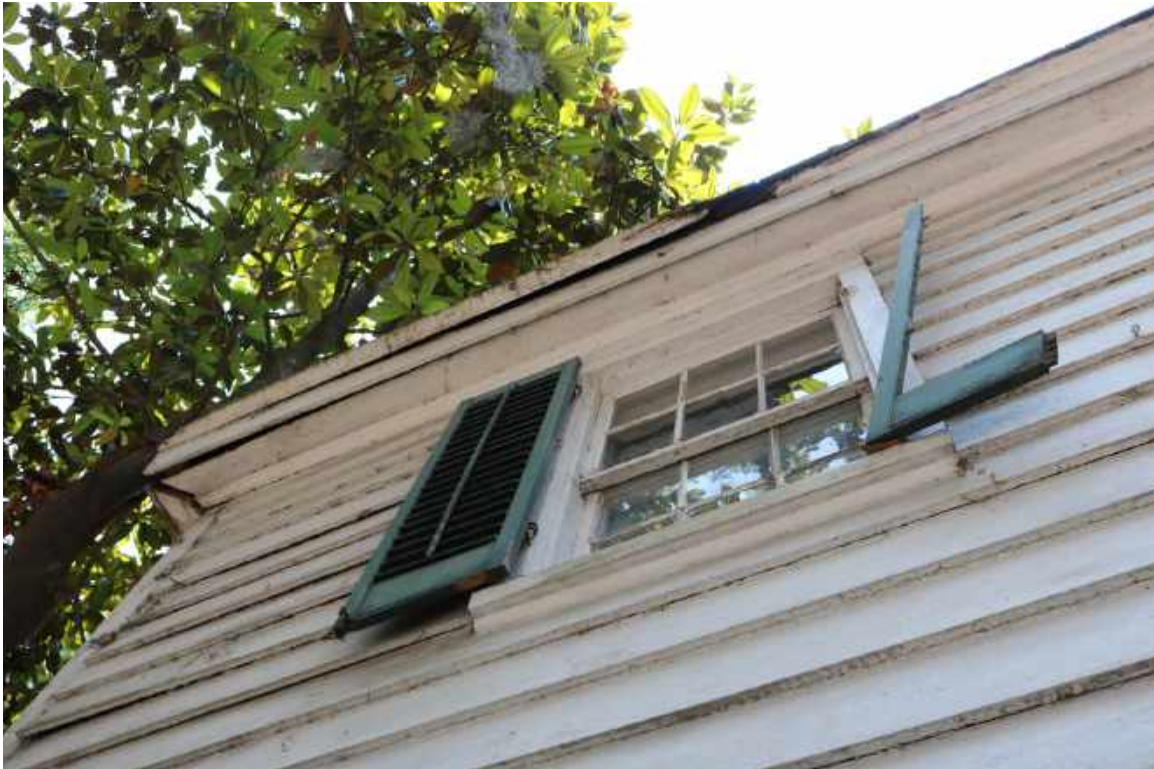
**Figure 68:** North Elevation of Two-Story Building: Detail of dislodged siding to the left of the window. Note the deterioration within the soffit.

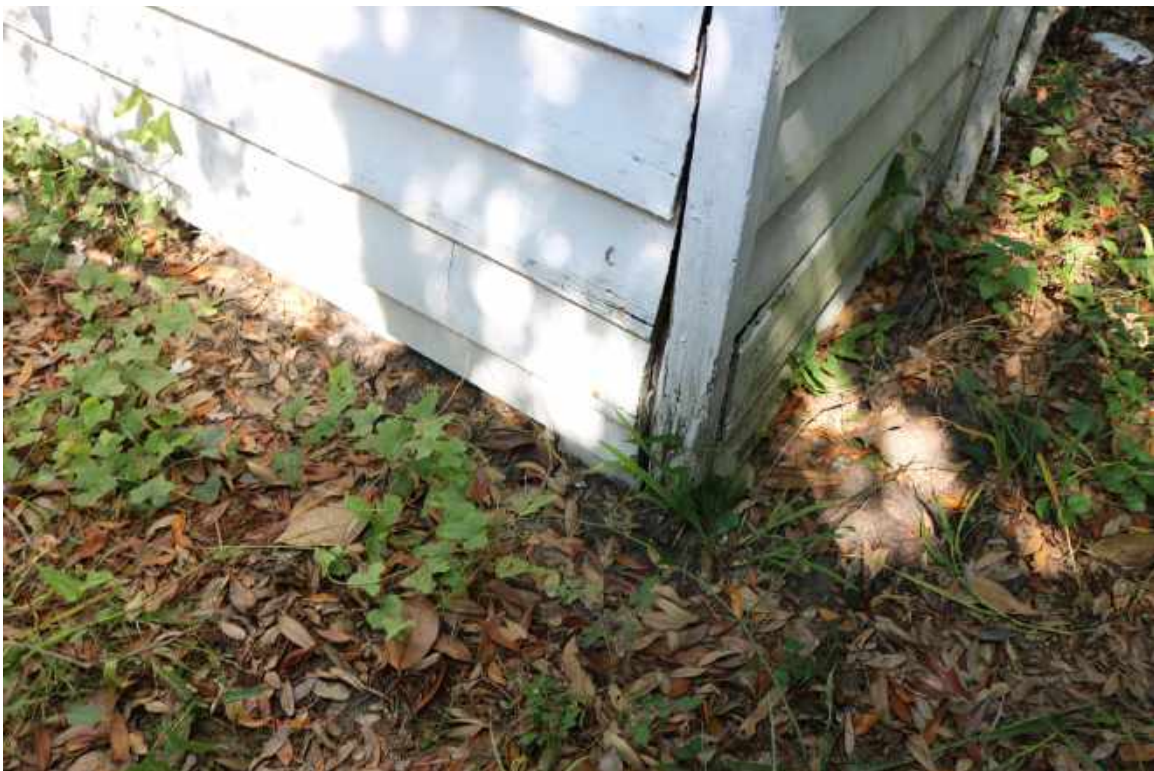
**Figure 69:** South Elevation of One-Story Building: Detail of siding failure due to corrosion of the steel fasteners.

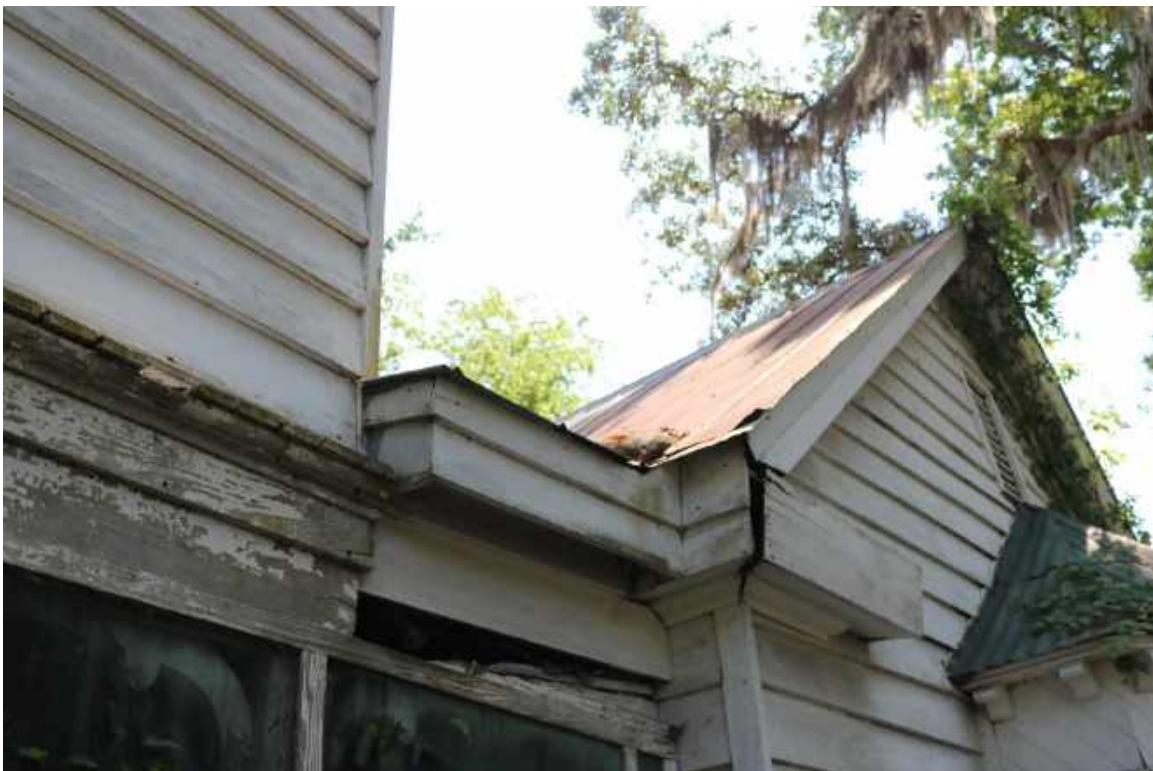
**Figure 70:** South Elevation of Hyphen: Detail of dislodged fascia trim on the gable eyebrows.

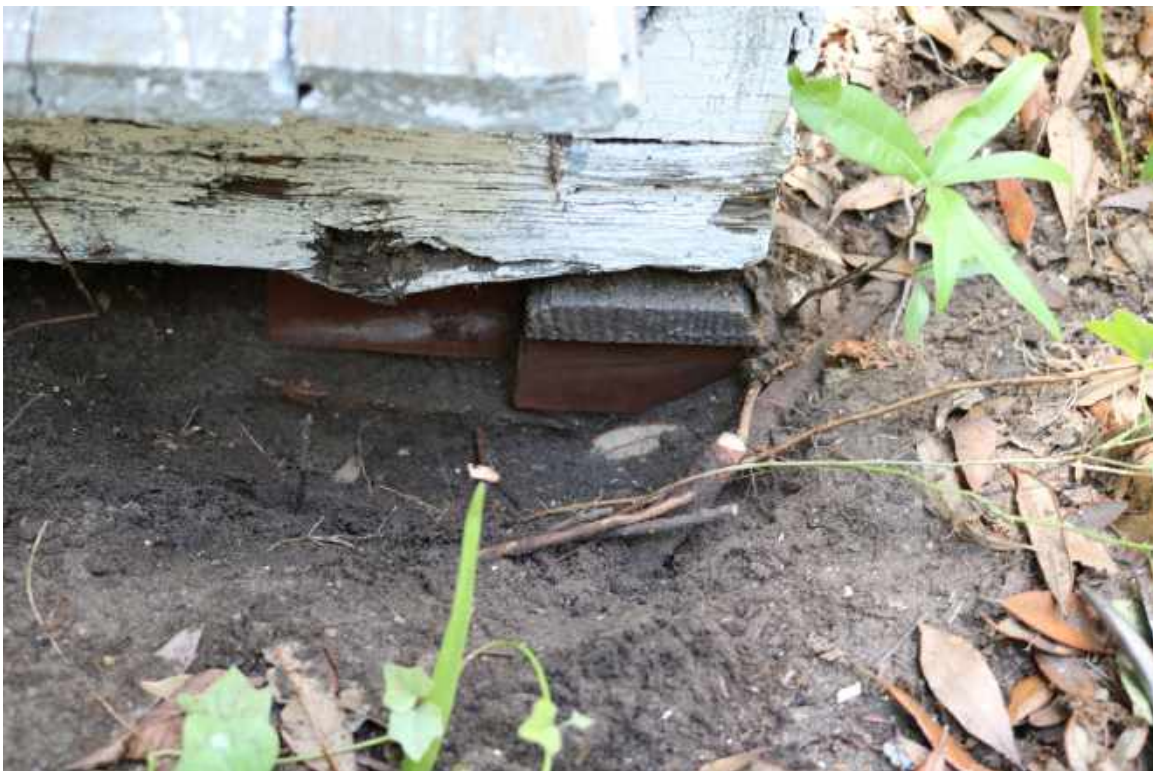
The porch foundation has collapsed, and the framing is sitting on the ground. Excavation below several columns indicates the porch originally rested on two to three courses of brick. Much of the decking on the first floor is deteriorated at the ends and several areas have been previously repaired in front of the south door. Previous repairs to the decking at the front entrance have now collapsed due to settlement of the floor.

**Figure 73:** Southwest Corner of Porch: The porch foundation has also settled into the surrounding soil. The ends of the decking boards are deteriorated throughout the first-floor.

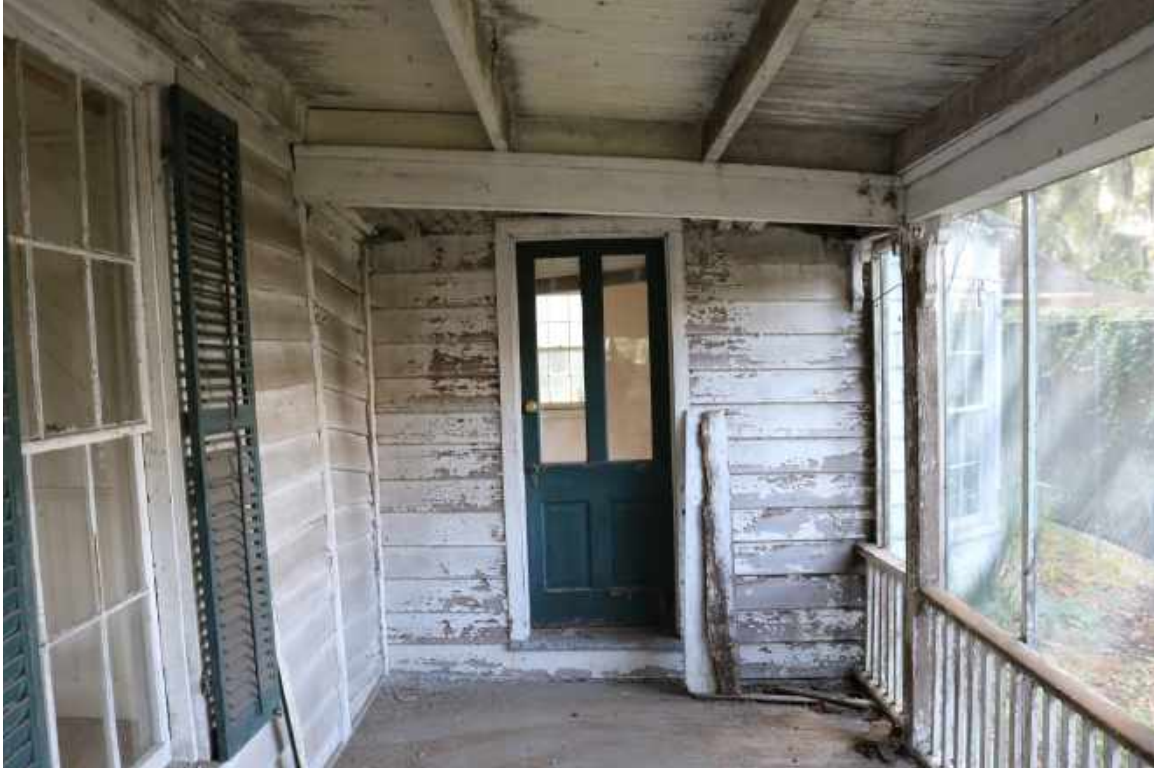
**Figure 74:** South Elevation, Hyphen Porch: Detail of complete failure of the porch structural elements at the hyphen where it intersects the smaller building.

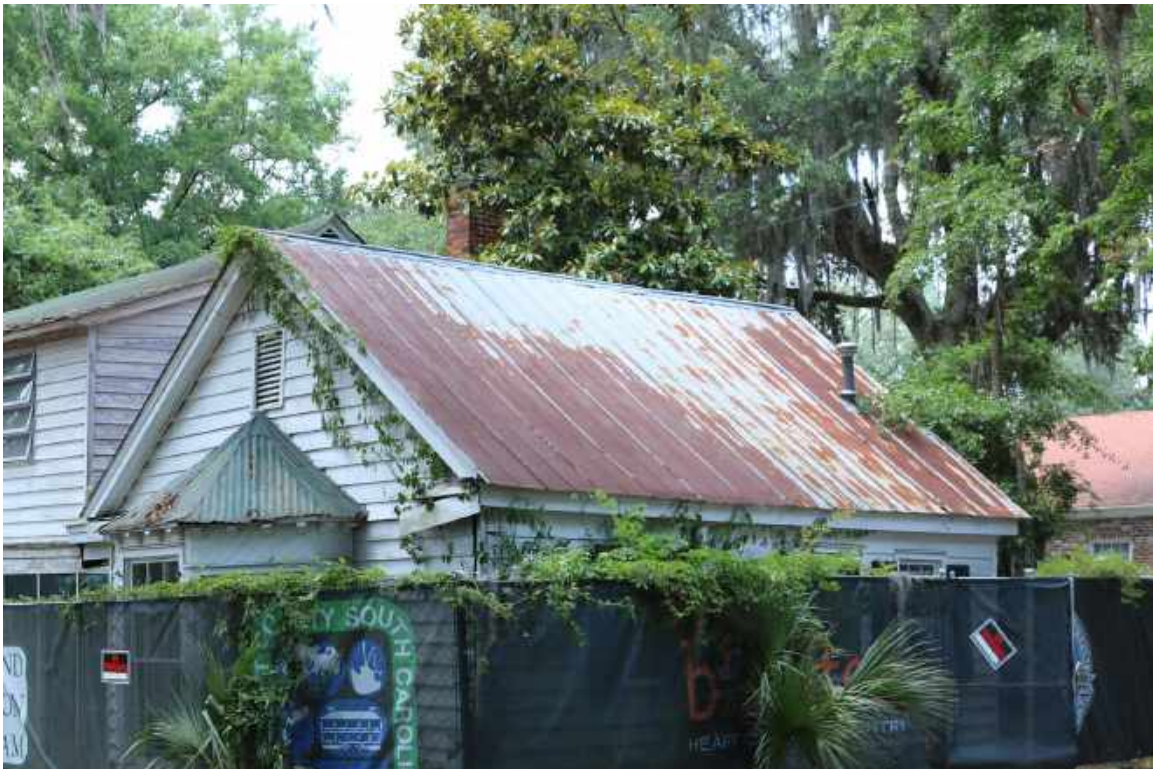
**Figure 83:** One-Story Building Roof: The roof is a modern 5V steel roof. This roof was likely installed in the 1990s. The coating has failed and the metal roofing panels are actively corroding.

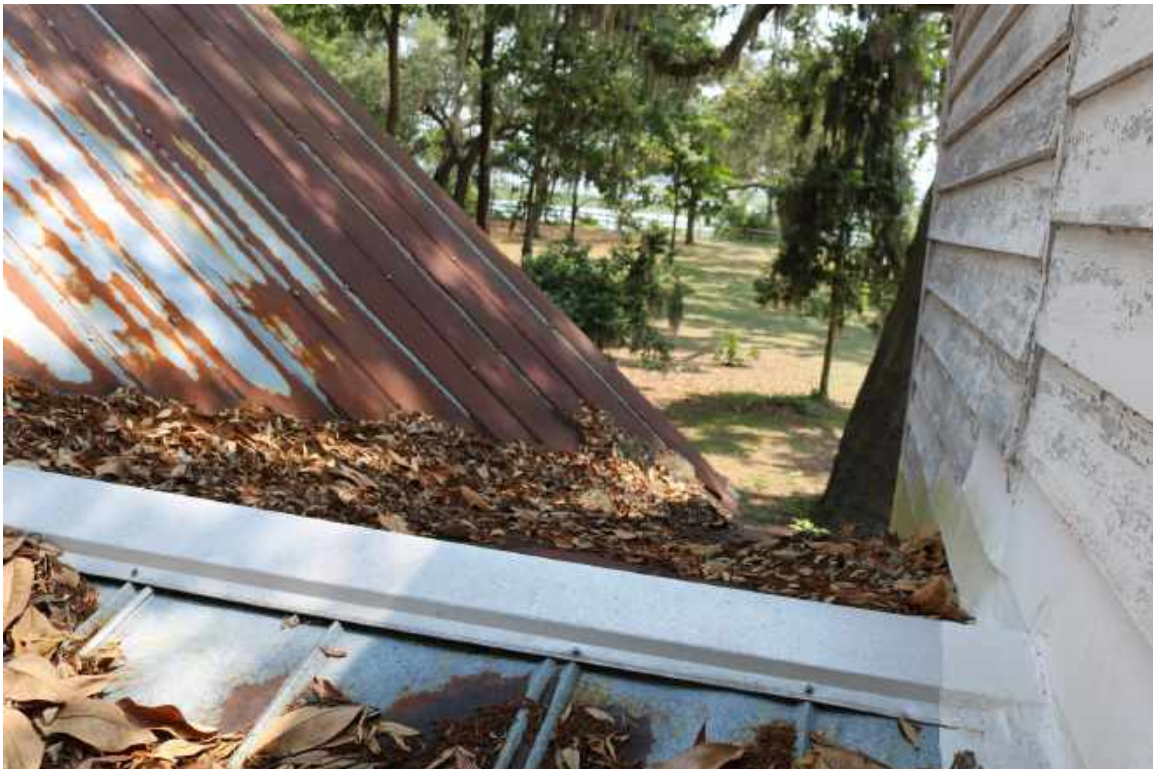
A small gable roof connects the two structures over the hyphen. The hyphen roof is covered with a modern 5V roof. The metal panels are heavily corroded and organic debris has accumulated on this roof. Several layers of metal roofing were observed within this area. Counterflashing was not observed between the metal roof and the exterior clapboards on the second floor. A modern membrane system has been applied to the adjacent west clapboards, likely to flash this area.

**Figure 84:** Hyphen Roof: Detail of the 5V roof over the hyphen. Leaf debris are present on this roof.
