## SQUIRE POPE CARRIAGE HOUSE PRESERVATION PLAN

PREPARED FOR:  
THE TOWN OF BLUFFTON  
20 BRIDGE STREET  
BLUFFTON, SC 29910

PREPARED BY:  
MEADORS, INC.  
PO BOX 21758  
CHARLESTON, S.C. 29413

DATE: 09.30.2019

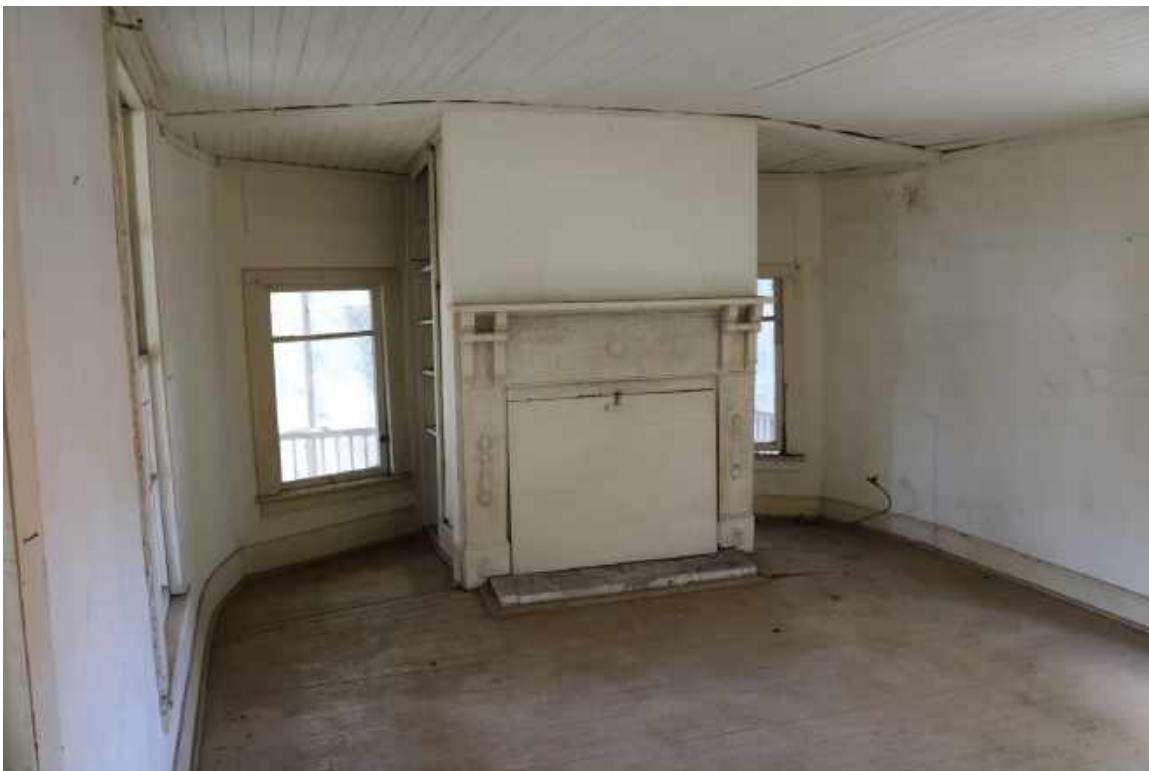
**Figure 85:** Room 101, Looking West: There is extensive settlement on either side of the masonry chimney. The ceiling visible bows downward on either side.

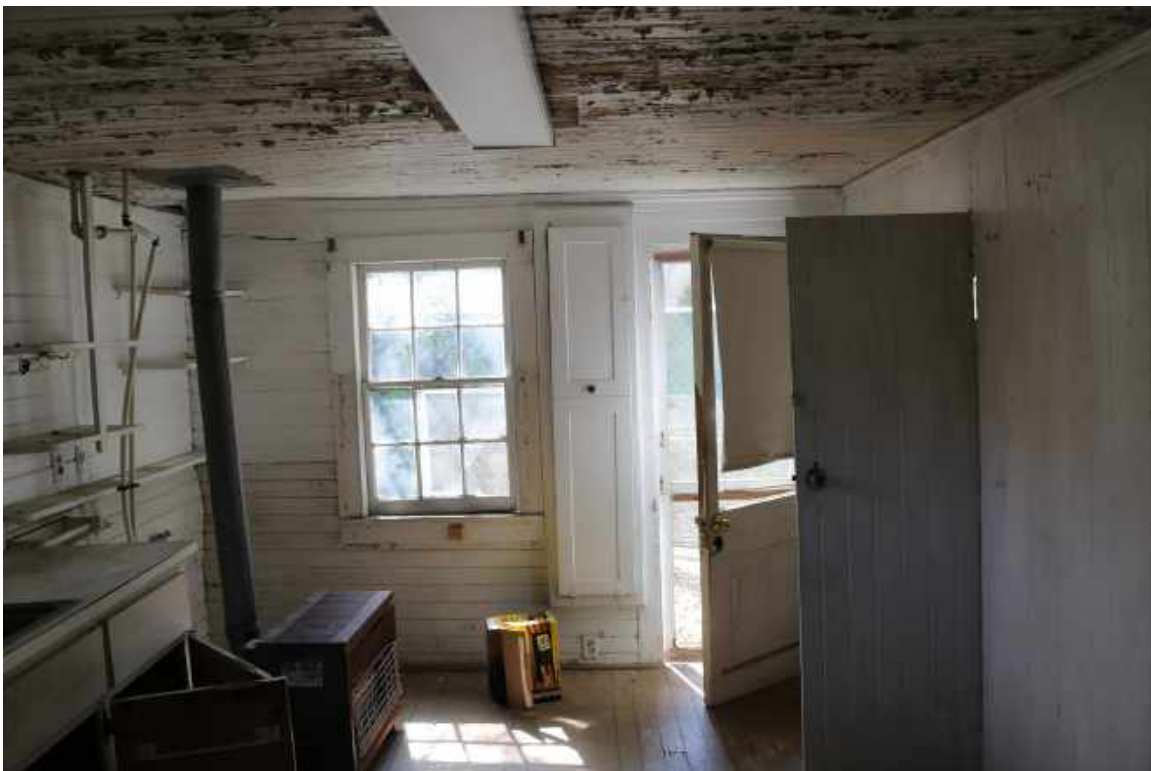
**Figure 92:** Room 105 (Kitchen) Looking East: There is extensive paint failure within this room.

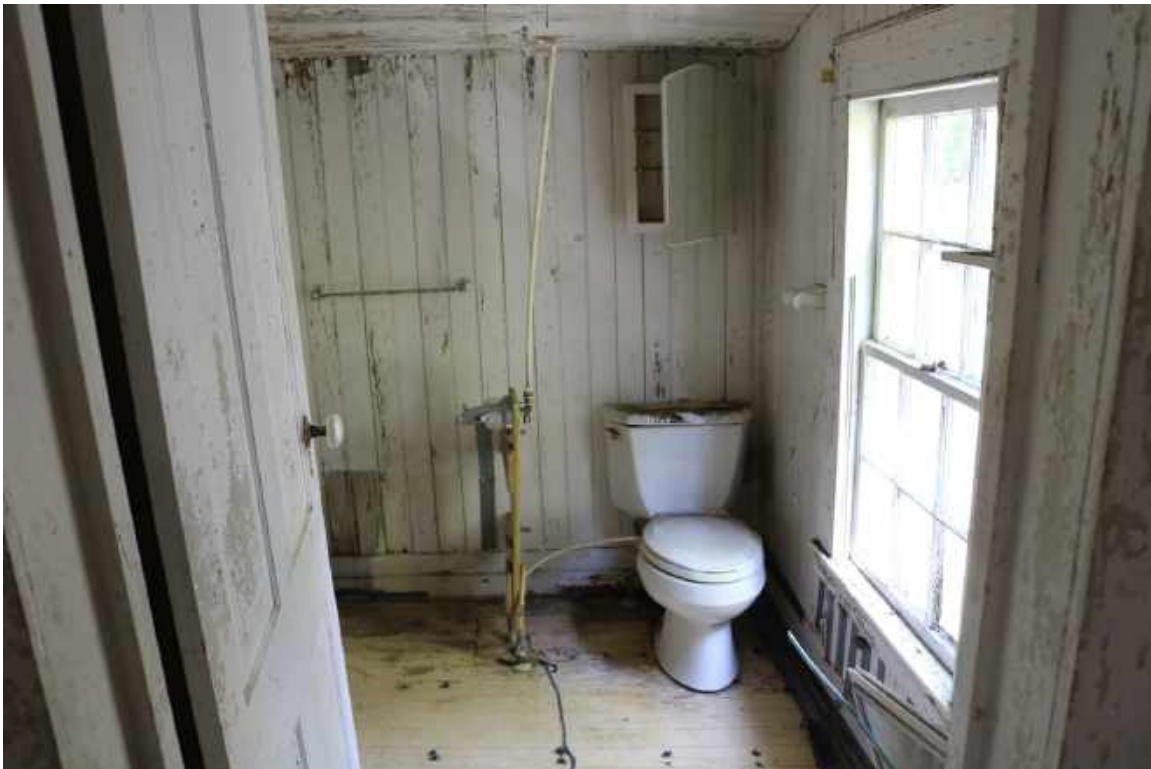
**Figure 95:** Room 201, Looking West: The room has been infilled on the roof of the first floor porch. Due to settlement in the foundation, this room is structurally unstable.

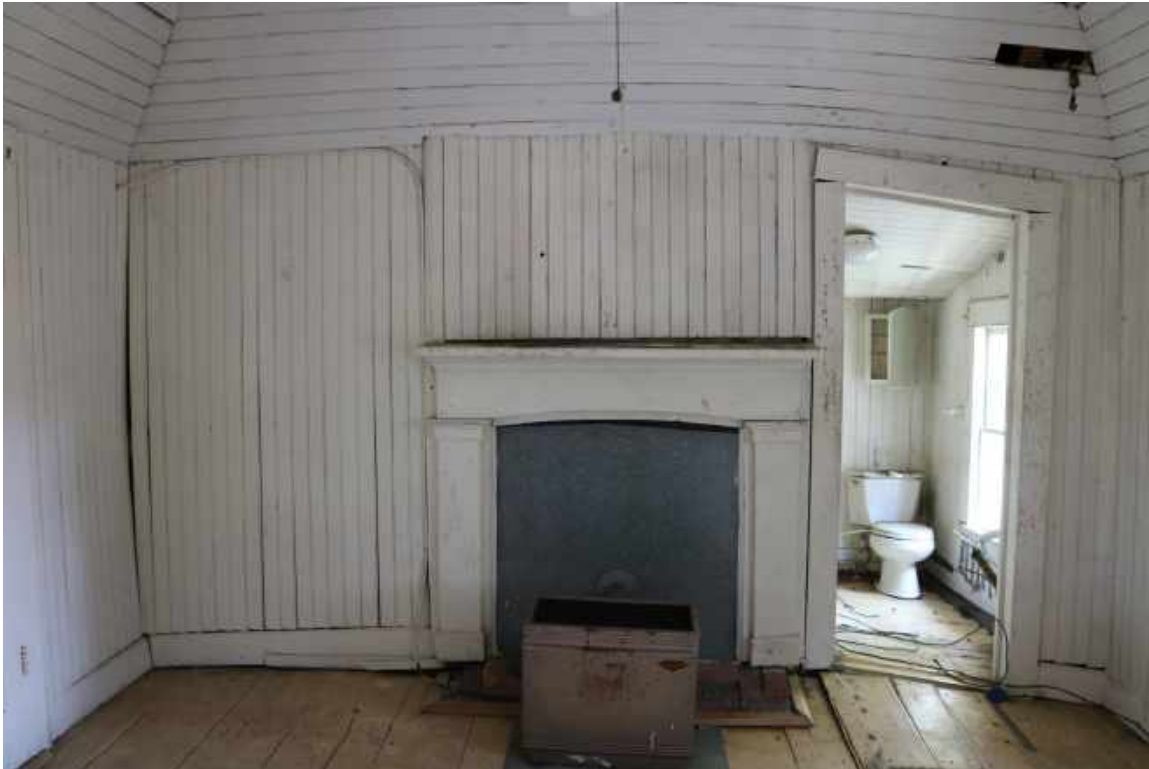
**Figure 96:** Room 202, Looking West: Note settlement at the northwest corner. The mantle located within this room appears to be the oldest within the structure and is a typical antebellum style.

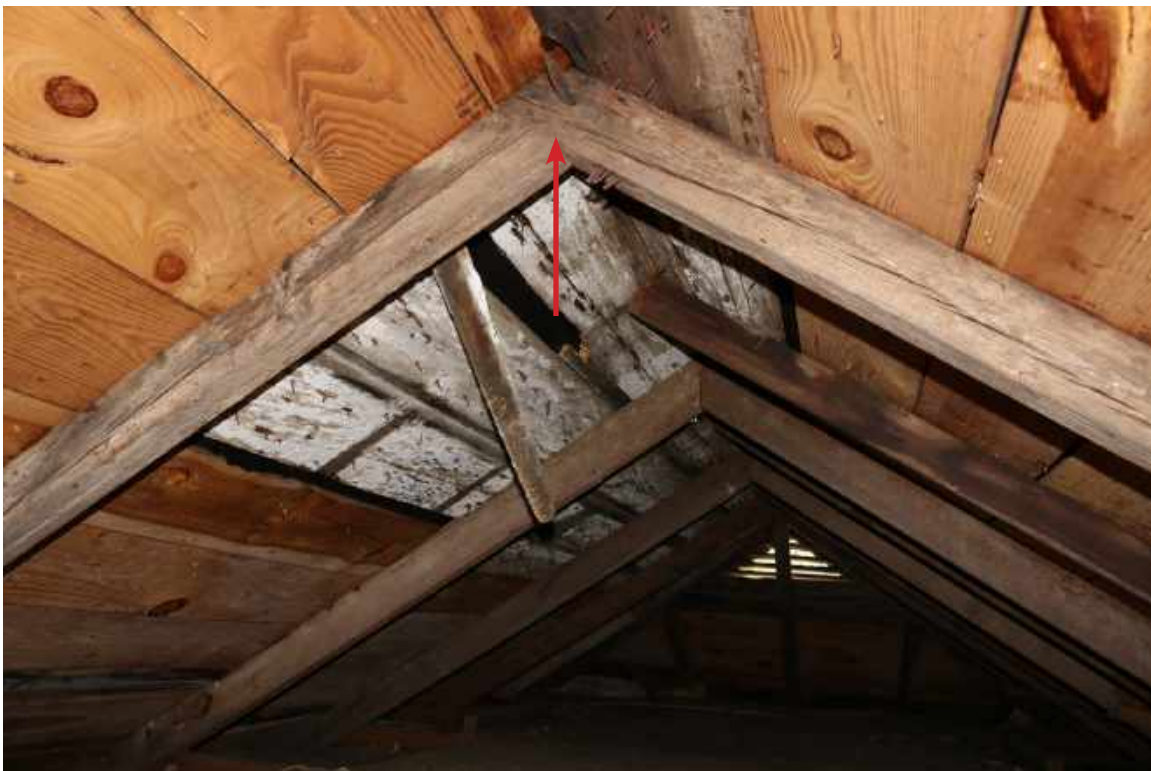
**Figure 110:** Attic of Two-Story Building: Detail of transition between pegged (arrow) and toenailed rafters (behind). Reclaimed floorboards have been used as decking at this location. The reclaimed material is deteriorated.

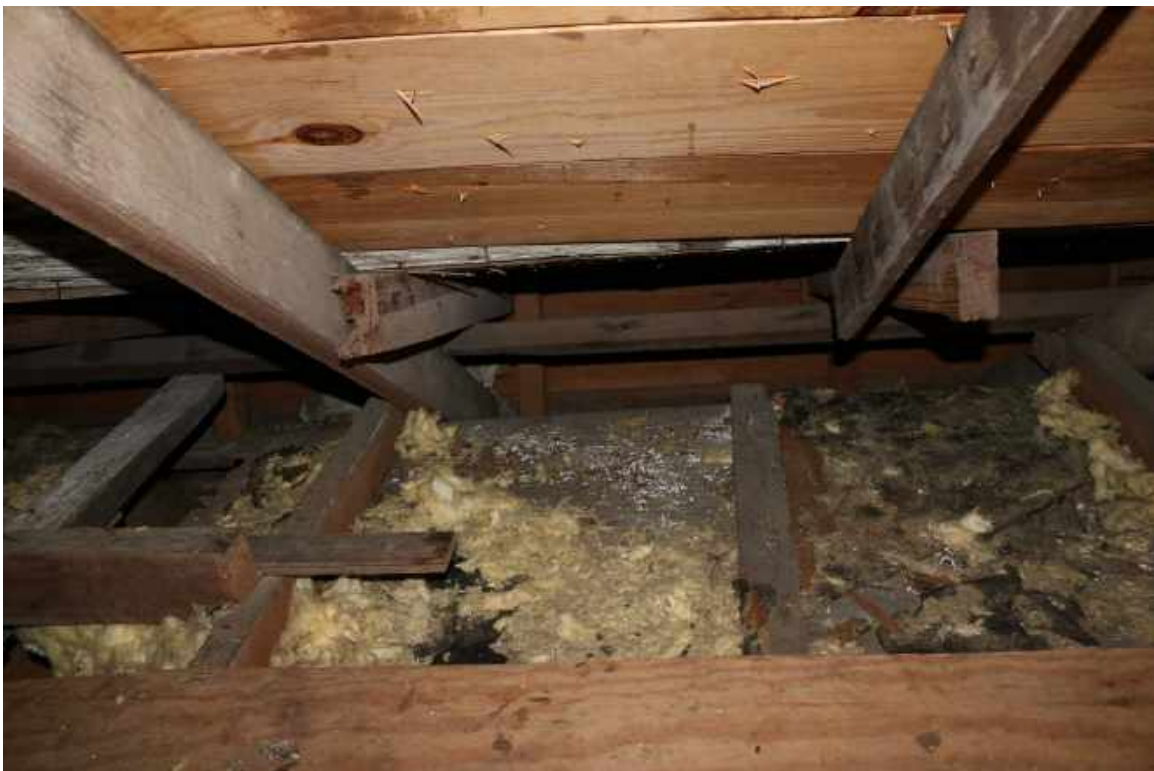
**Figure 112:** Attic of Two-Story Building, Looking South: The rafter tails from the porch framing rest adjacent to the historic roof framing. The porch framing is modern and the rafter ends are deteriorated at select locations.

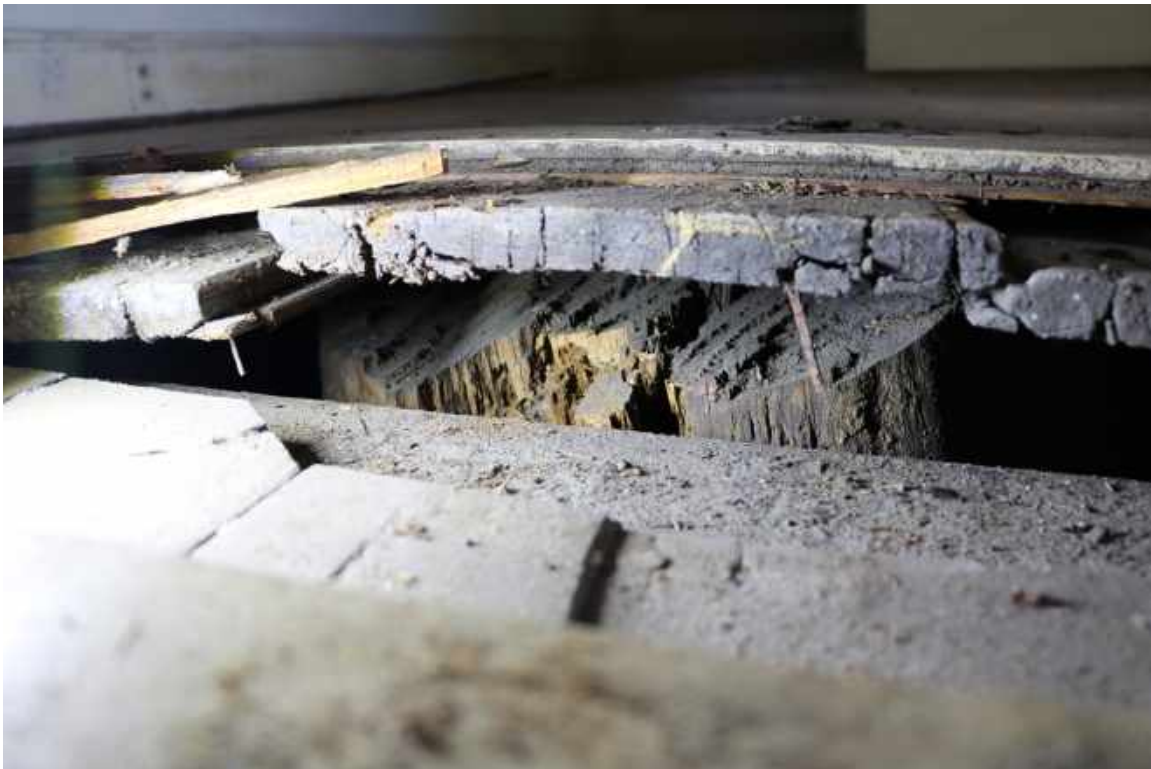
**Figure 118:** First Floor, Room 101: A deteriorated tree stump was found between two joists at this location.

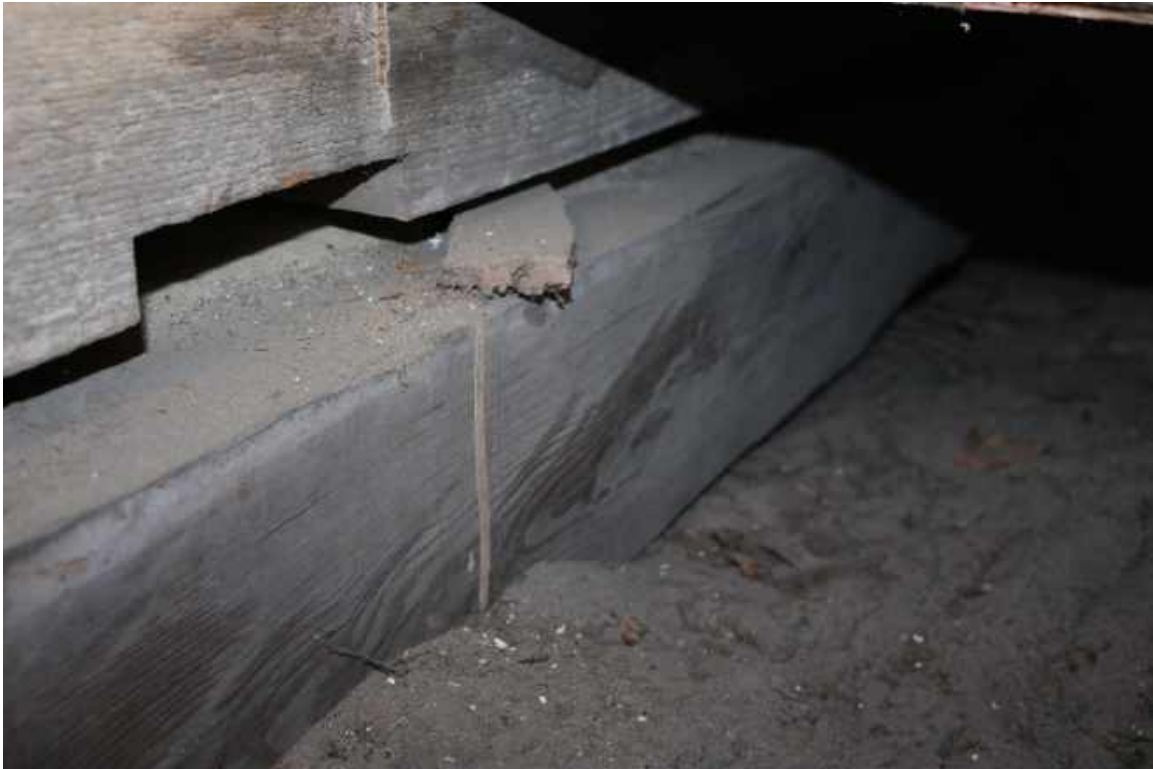
**Figure 139:** Foundation System - Detail of settlement of foundation members.

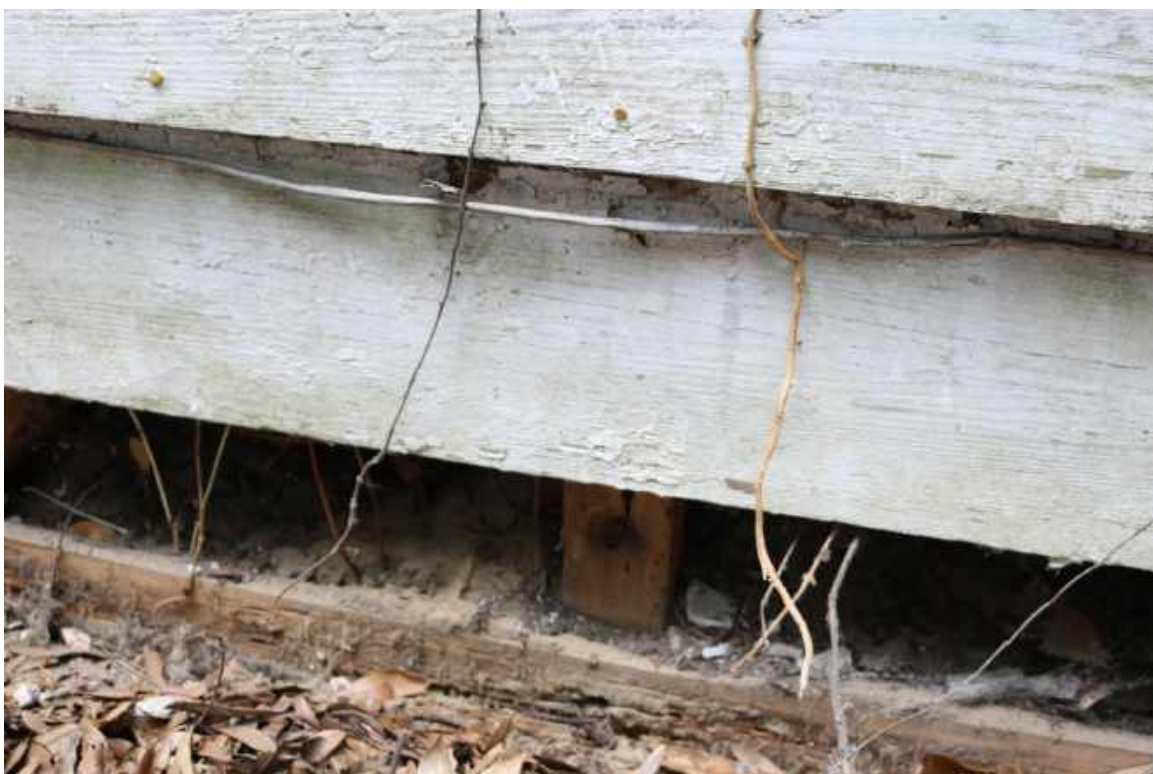
**Figure 140:** North Elevation: Detail of buried perimeter sill with a vertical framing member exposed.

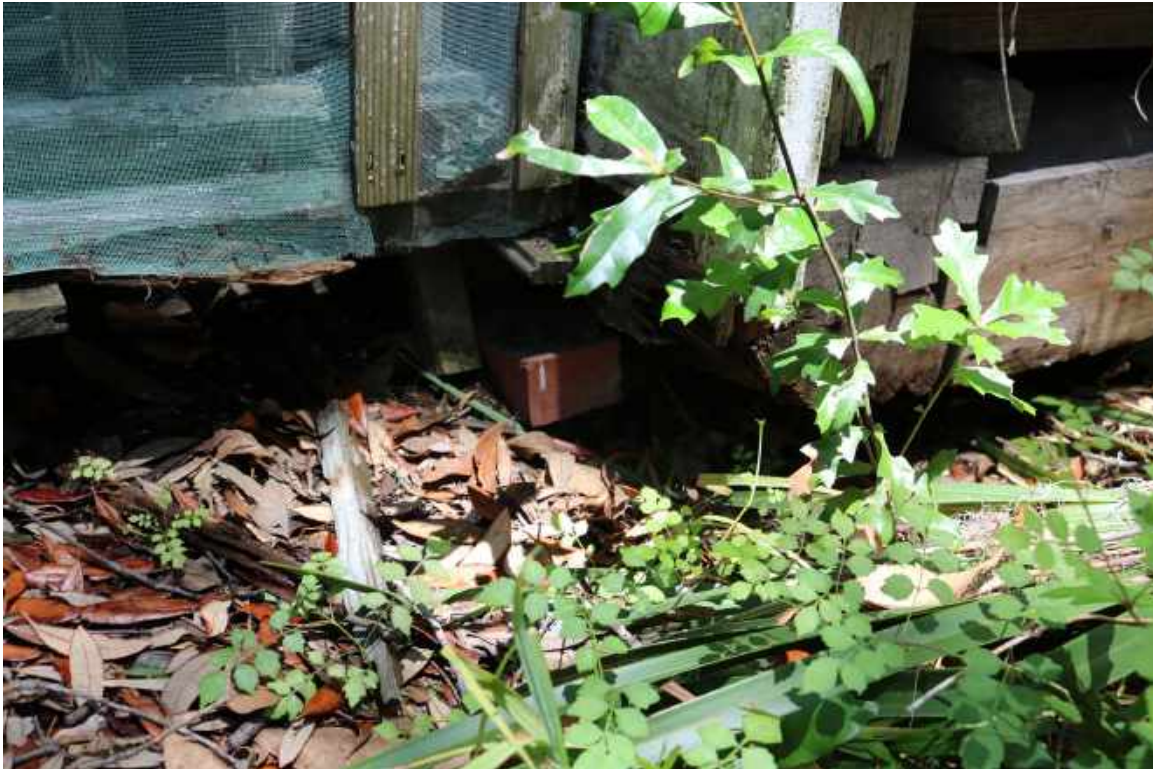
**Figure 141:** South Elevation: Masonry rubble located beneath the exposed perimeter sill.

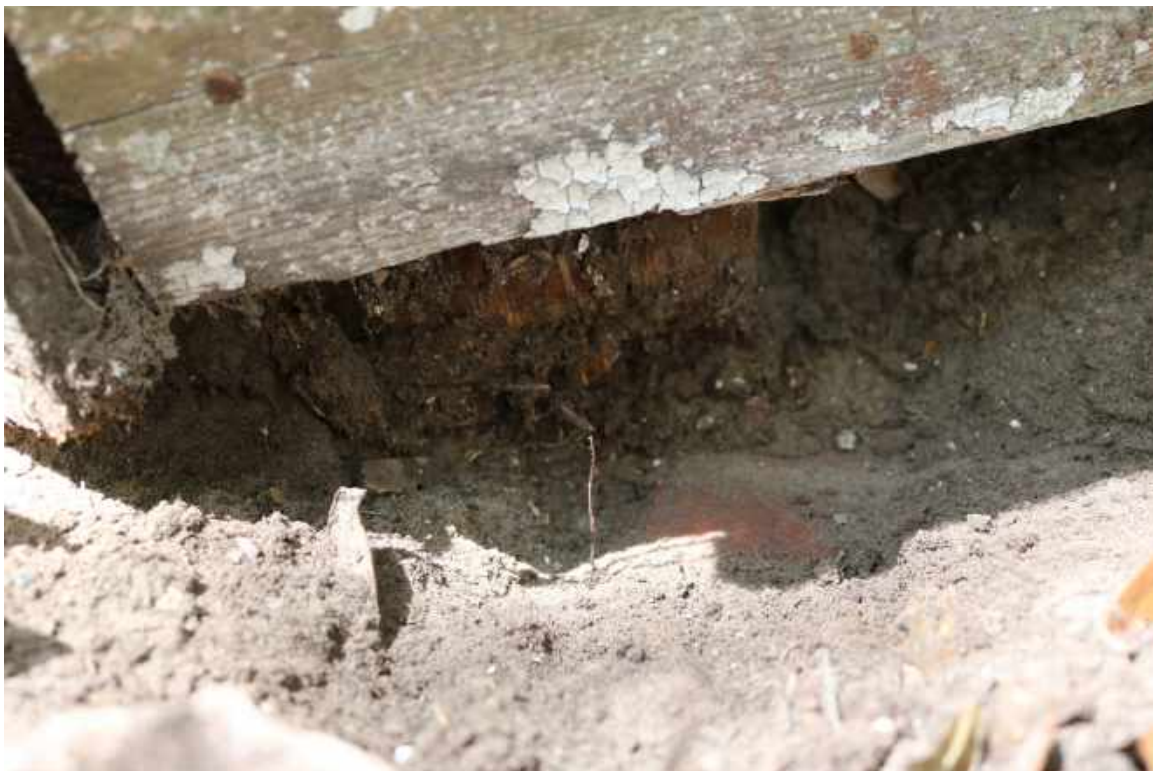
**Figure 142:** South Elevation, One-Story Kitchen Building - Detail of the deteriorated lower end of a vertical framing member.
