# HUTCHINSON HOUSE

## Existing Conditions and Recommendations

AUGUST 23, 2019  
FINAL REPORT

Simons Young + associates  
4SE Structural Engineers  
Hillary King, Preservation Consultant

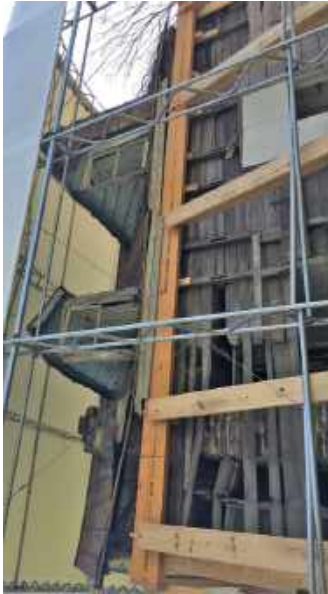
23 North elevation showing chimneys, chimneys are on raised joists at side wall

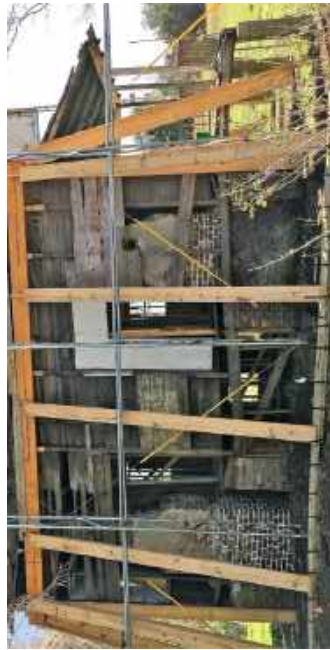
25 North elevation showing all piers and end joists for piers at rear portion of side wall. Photographs on this wall document wall structure, with the actual exterior wall to the north. See northeast elevation photo 8 for brick piers that indicate rear porch or endosed rooms along north

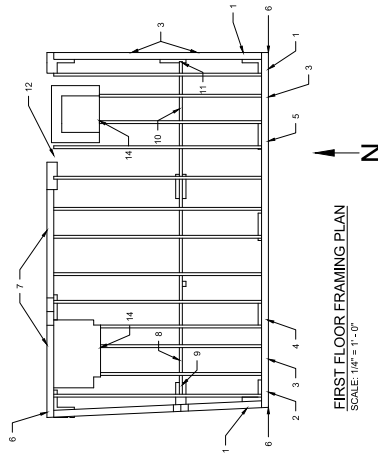
#### Notes on First Floor Framing

- 1) Sills are 7 x 6 on south and east side, 6 x 6 on west side, all full length of house.
- 2) Sills bearing on original foundation.
- 3) Sill is missing on one corner of the pier, causing the crack in the misaligned pier.

Most piers are deteriorated at their north and south ends where they bear on the sills. This deterioration is only evident on the north end of the pier. Under the hearth they appear to be in generally good condition.

The sills on the east, south (except where noted), and west sides are in generally good condition.

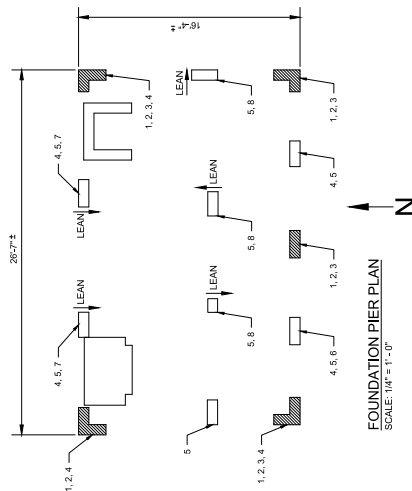
#### Notes on Pier/Foundation Plan

- 1) Original pier.
- 2) Original pier with some poor pointing.
- 3) Brick base at top of pier, needs repair.
- 4) Brick base at top of pier, needs repair.
- 5) Later pier, poorly built.
- 6) Later pier, base inside building line.
- 7) Later pier, base inside building line.
- 8) Later pier, base inside building line.

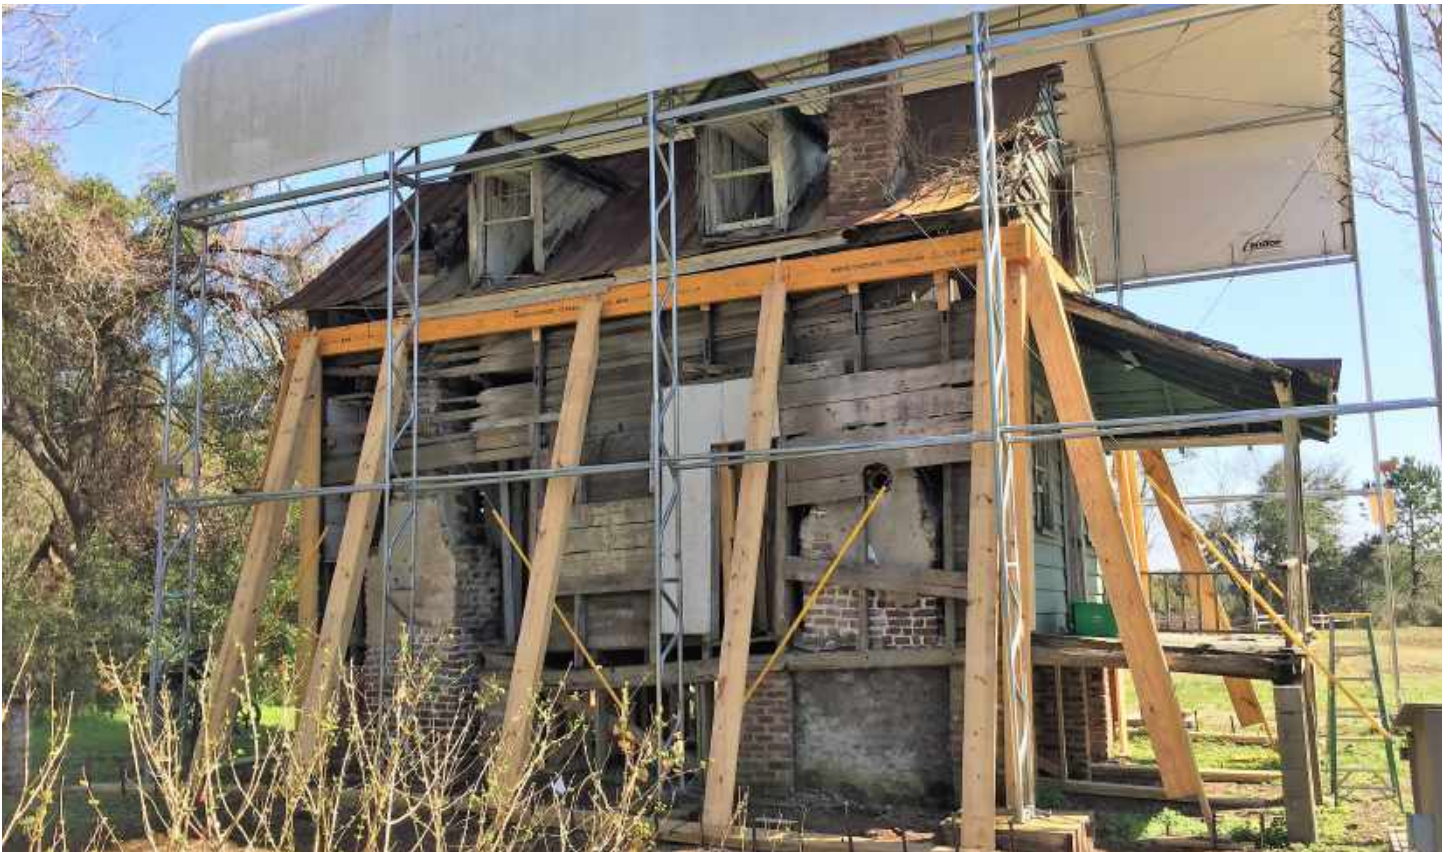
The north elevation of the building has no siding, allowing an easy viewing of the framing. Pinned and tenon joinery connects the second floor joists to the balloon framed studs. The first floor has some joists that are hand hewn, and other joists that are not. Many of the joists have end rot where they have been exposed to weather. The large sill on the north elevation has broken due to severe deterioration.

EXPOSED FRAMING FROM NORTHWEST
