# HICKORY HILL ENGINEERING REPORT

December 19, 2018

# Hickory Hill Residence

## Structural Analysis Report

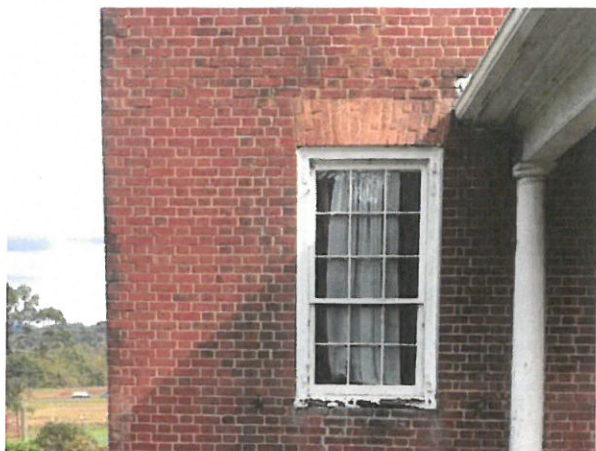
On the Front Left (SW) Corner of the Left Wing, there are cracks below the front and rear First Floor windows for Room 105 (see attached floor plans and Photo Pg.1) that have been roughly patched and are likely related to the rotted wood window sills allowing moisture penetration into the brick below the sill. There is also a peculiar separation of the built in cabinetry (also referred to as the Press), from the plaster on the rear wall. The separation tapers from narrow at the floor to approximately 1” wide at the top of the wall. This would typically indicate an outward tilting of the end wall, however there is no corresponding cracking in the exterior brick, and no interior crack showing behind the plaster, or in the same location on the second floor wall above. There is also some separation of the cabinet cornice trim at the ceiling level, so there may have been some movement in the cabinetry over the years. The floor structure under the cabinets may have settled slightly from age allowing the separation, but there was no access to the crawl space below to allow inspection of the first floor framing. The suggested repair is to patch in the gap with matching plaster. Plaster repairs should be made in compliance with the Department of Interiors Preservation Brief #21 – “Repairing Historic Flat Plaster”.

Left Front – Crack Below Rotted Window Sill

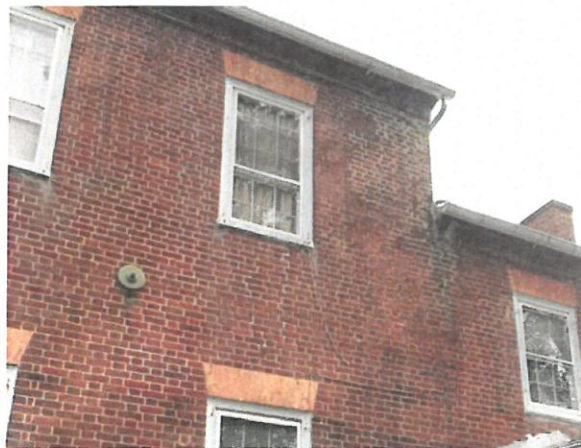
Cracking in the upper right front corner of the Main Building where it steps down to the Right Wing is likely to be related to water damage to joints caused by gutter and flashing leaks or overflows. Previous joint repairs also extended down to just below the gutter for the step down wing. The unique brick cornice joints were also repaired and appear to be structurally sound and stable. There is no crack showing on the interior in Room 202, but there could be possible cracking concealed behind the built in cabinetry on the end wall. These issues do not appear to be connected to the cable tie that runs from front to rear through the second floor framing of both wings. Repointing is

Right Front Upper Level – Previous Repointing Work

recommended for long term stabilization and aesthetic improvement.

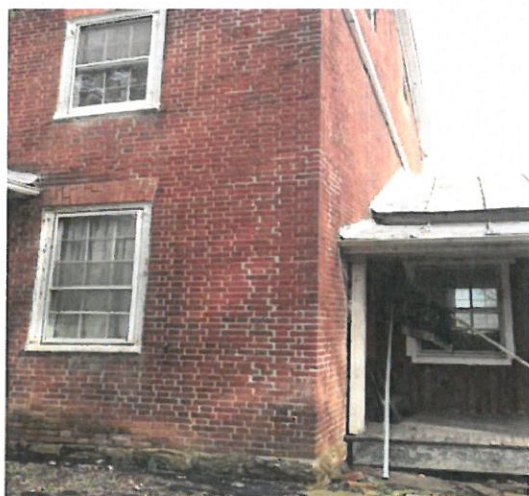
Cracking in the front right corner of the Right Wing and above and below windows of Rooms 101 and 201 has been repointed and appears to be stable. The joints from roof to ground show a slight horizontal movement in the front, and the end pointing was likely to be incidental cracking. Minor settlement in the end wall may be the cause, however corresponding cracking above and below the windows on the rear elevation are probably related to whatever movement has occurred in this portion of the building. Other possible explanations might be related to the reported earthquake in the late 1800s, or even from the added construction stress of the wood frame Kitchen addition. There are no through cracks showing on either floor, but there are cracks above the front window and the attic stair door that indicate some movement over the years. There is a peculiar separation between the right end wall built in cabinets and the plaster on both floors, with a gap in the plaster that tapers from nothing at the first floor to about 1 ½" at the ceiling, and continues on the second floor in a similar manor. This is also very similar to Room 205 at the opposite end of the house. The cornice molding at the first floor ceiling has not separated, but the cornice molding at the ceiling on the second floor cabinet has moved the same amount as the wall gap.

Right Front Kitchen End – Previous Repointing From Foundation to Roof

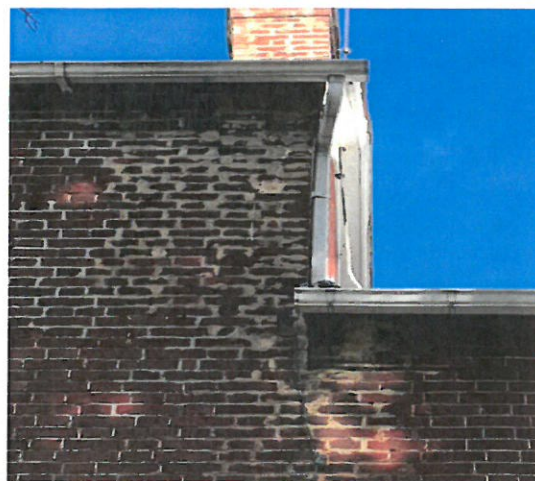
Close up of Previous Repointing

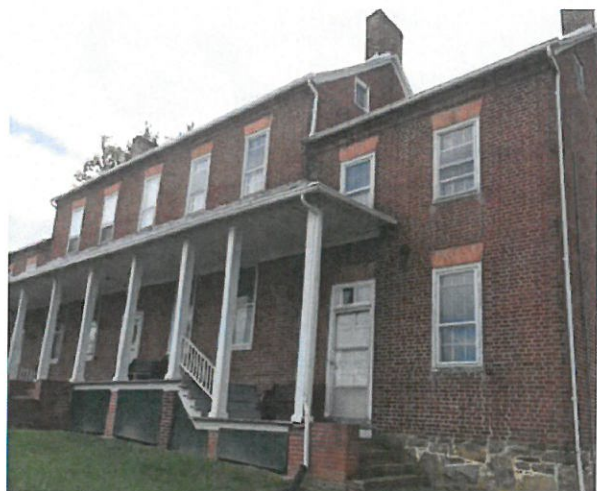
Left Rear – Cracking Below Window and Foundation Repointing

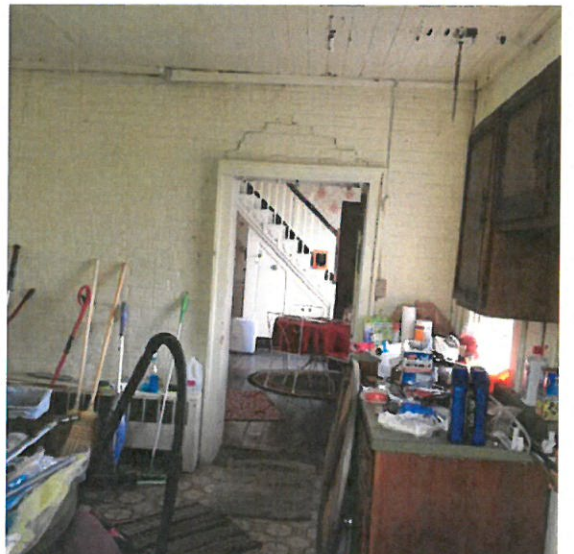
Interior Wall – Showing Cracking in Door Lintel

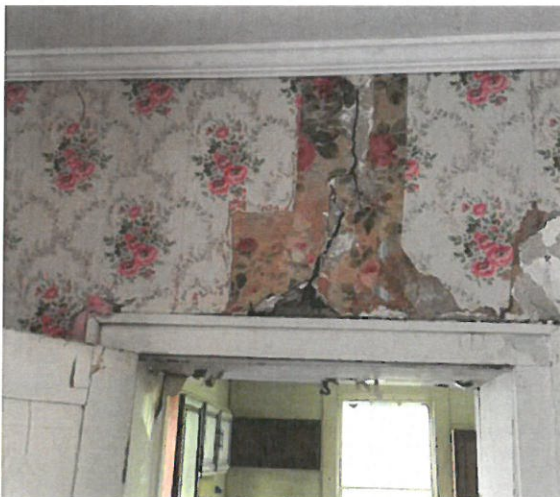
Dining 101 – Crack in Brick Lintel

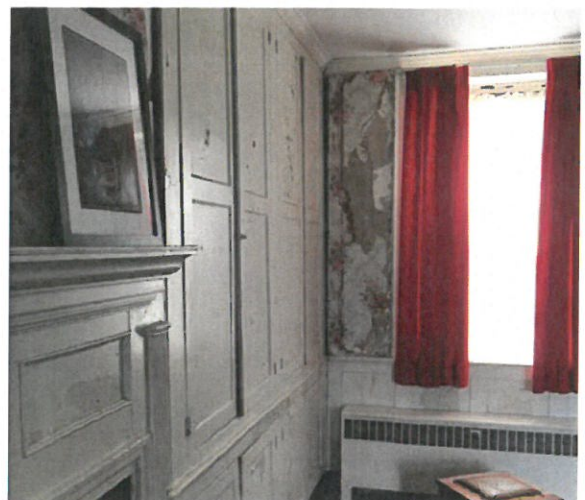
Dining 101 - Front Wall Separation  
Between Plaster and Cabinet

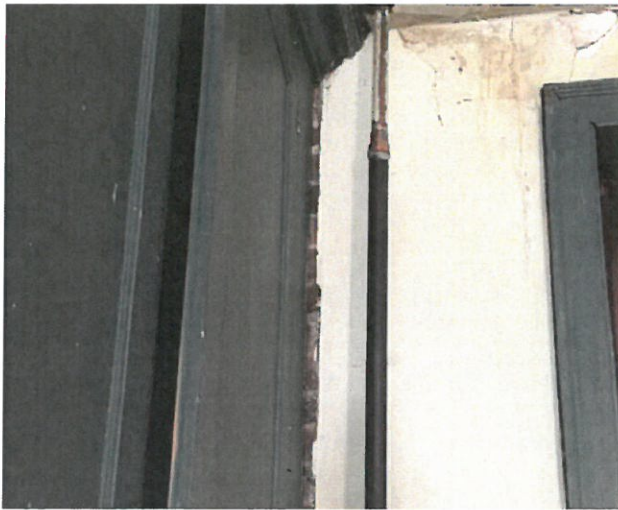
Room 105 – Separation of Press Cabinet and Plaster

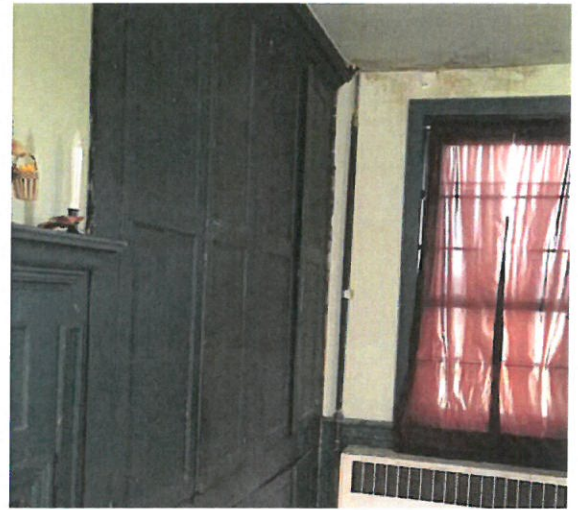
Room 105 – Rear Corner with Cabinet and Plaster Gap

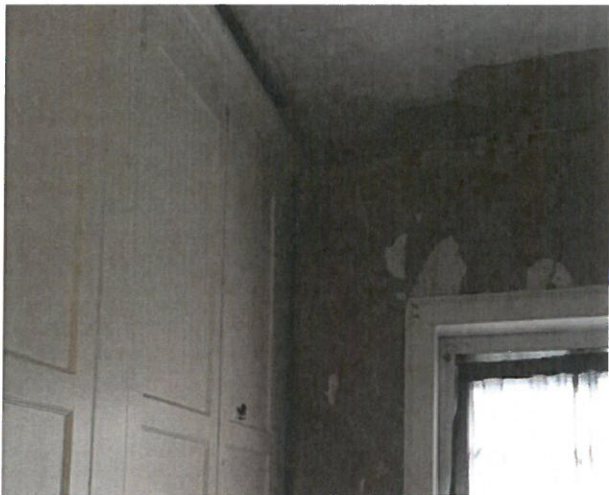
Room 201 – Separation Between Cabinet and Plaster at Front Wall and Ceiling Gap

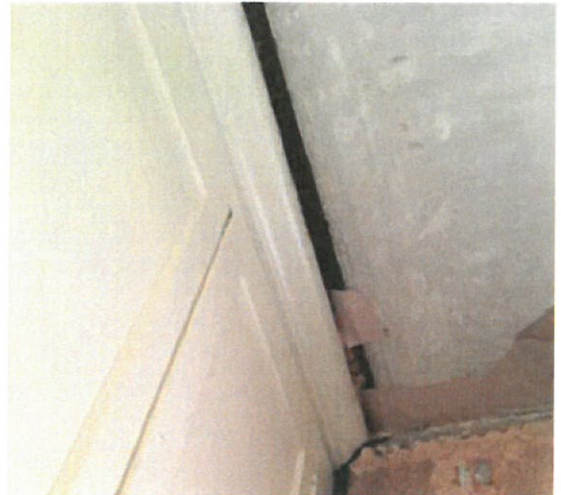
Room 201 – Separation Between Cabinetry and Ceiling

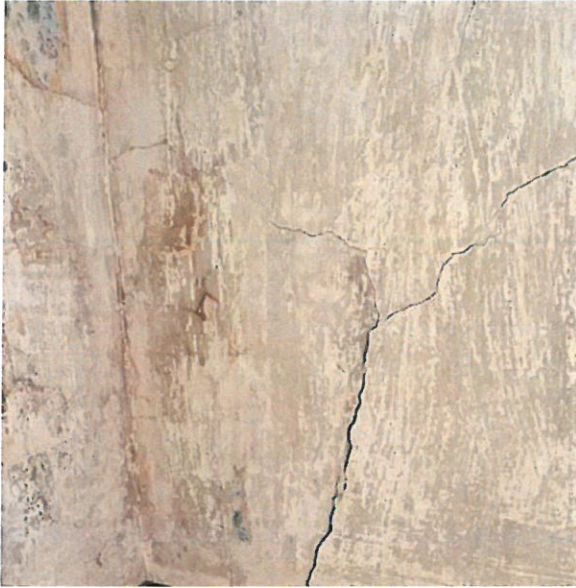
Bedroom 201 – Hairline Cracking in Plaster

Any exterior cracks which have telegraphed to the interior should also be repointed, which will require removal of damaged plaster and plaster repair to match the original. The Department of Interior Preservation Brief #21 – Repairing Historic Flat Plaster Walls and Ceilings is an excellent guide for historic plaster repairs. It is recommended that the plaster repairs be held off until exterior repointing is complete, and moisture readings in the brick walls indicate that new plaster will properly cure and bond. Hairline cracks can be repaired with joint tape and plaster skim coating.

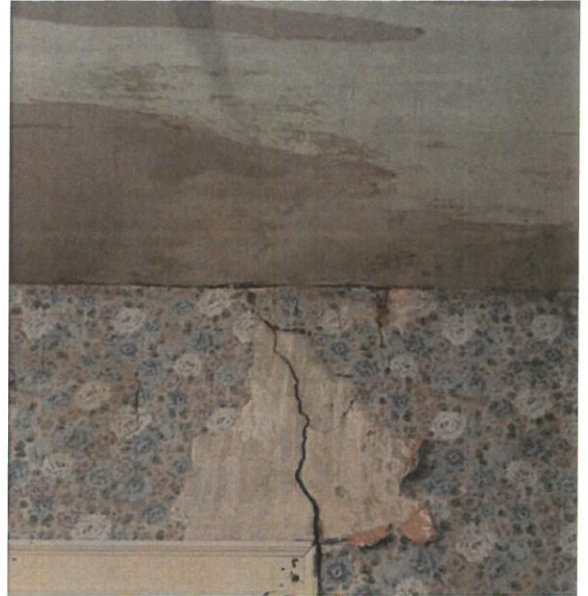
Bedroom 201 – Structural Crack above Front Window

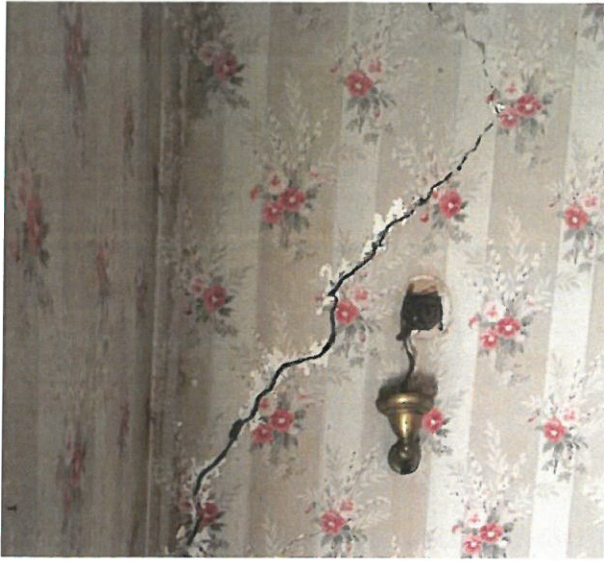
The vertical cracking in Room 204 in the Front Left End Wall of the Main Building is only evident on the interior of the Second Floor. It does not appear to be a through crack to the exterior. It seems unlikely, but it could have some connection to the joint deterioration below the lower gutter where the Main Building steps down to the Left Wing. The left end wall of the main portion of the house is approximately 12 feet from the cable ties which run from front to back. These ties probably helped prevent the crack from migrating to the lower floor. Repointing of the brick and possibly adding a vapor permeable water repellent (not waterproof) coating would help prevent further cracking from moisture infiltration and freeze-thaw stresses.

Bedroom 204 Mail Wing – Showing Structural Crack in End Wall

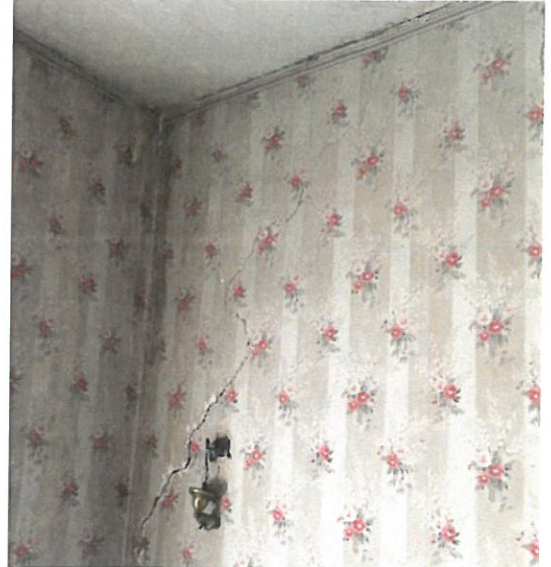
Bedroom 204 – Showing Full Front of End Wall Crack

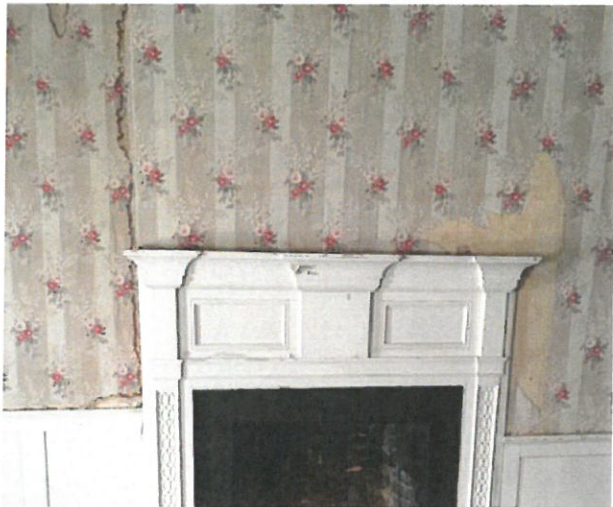
Bedroom 204 – Showing Crack Beside Cabinetry Tie Turnbuckle

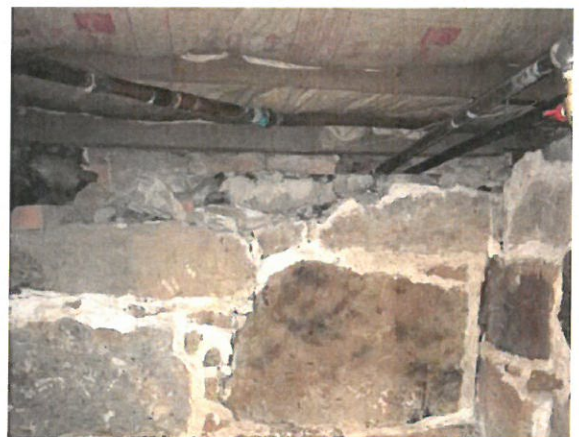
Basement Room 1 – Right Front Corner  
with Minor Cracking
