L-1417

MEMORANDUM for the Custodian, Bandelier National Monument.

The following is a report on the findings of an intensive survey of conditions on the boundary of the Otowi Section of the Monument. The survey was carried on on August 29 and 30. The headings at the beginning of each statement have reference to specific locations indicated on the attached map.

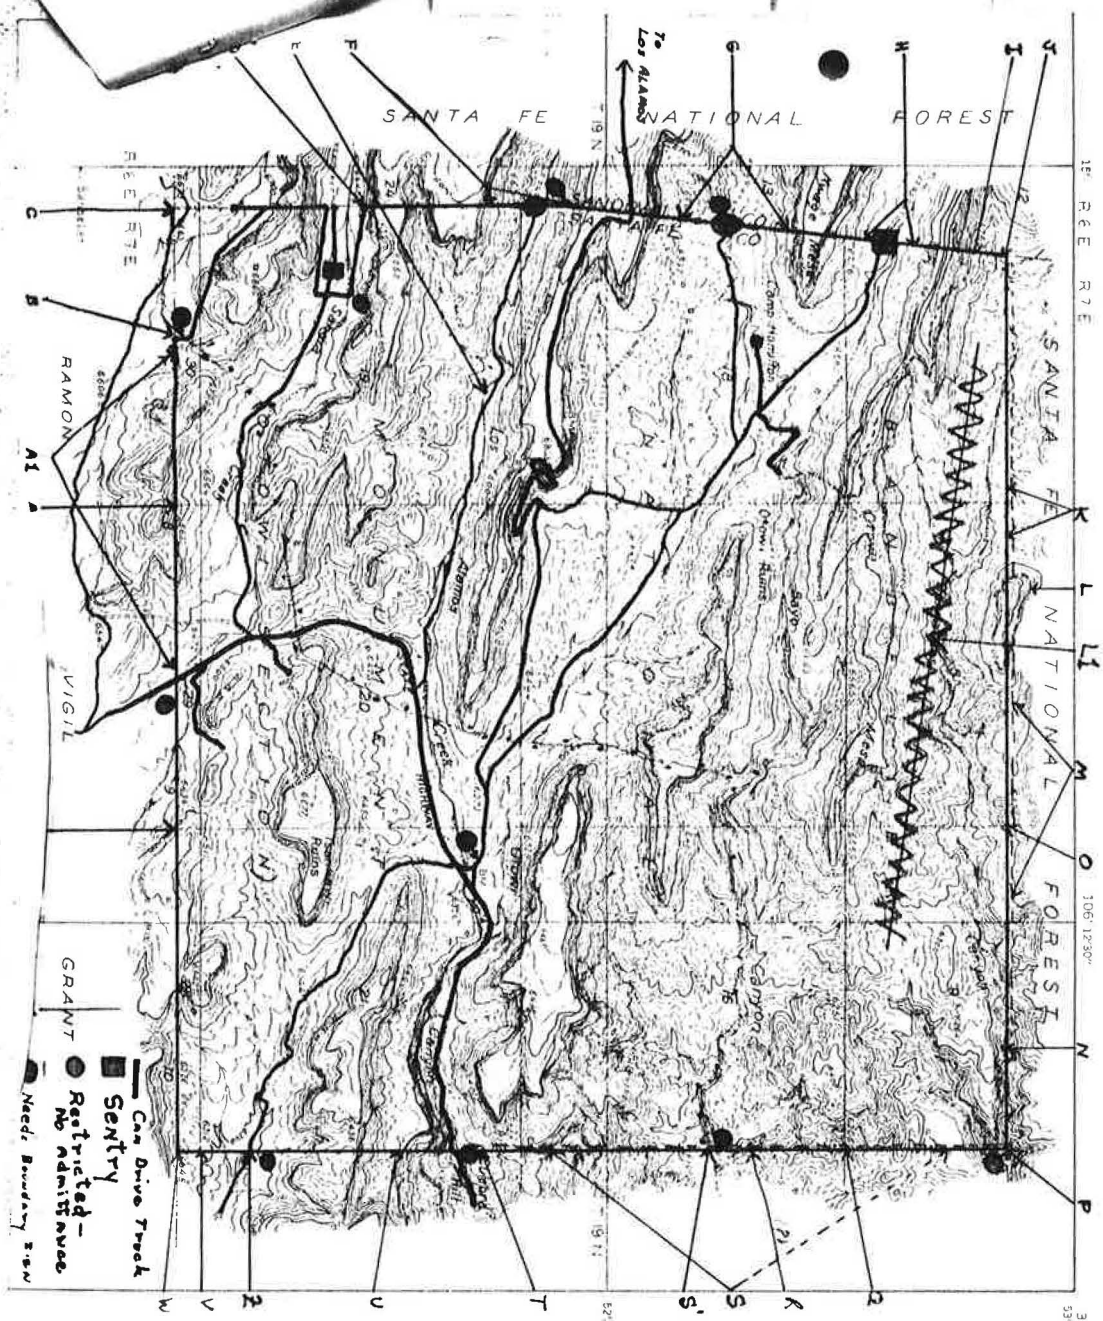
B. Gate was purposely taken down. Gate restored during patrol. Livestock had passed through this gate previous to the last rain.

G. Fence in good shape. All this stretch restricted area but no sentry stationed here. Gate permits entrance to Los Alamos. Gate locked with padlock. Horses have passed through the gate recently.

H. Fence altogether down this area. Believed to be one of main places where livestock gain admittance to the monument area.

K. Fence cut several places this area. Fence temporarily repaired during patrol.

M. Fence between these two points has been cut in several places. It is believed it was cut to remove livestock from the Monument. Temporary repair of these places was made during patrol. Large openings have been made under the fence in several places by severe erosion.

S. Fence, this area, needs considerable re-stapling. Some wires hanging and would permit entrance to livestock attempting to find an opening in the fence.

T. Fence completely down this area for about 100 yards next to the road. By driving up the little side road by the present Bendelier Monument sign you can drive right to the fence.

Z. Gate found open here. Closed during patrol.

Al. This stretch of fence could stand some tightening up and a few washes have made deep passages under the fence.

Sl. ~~XXXXXXXXXXXXXXXXXXXXXXXXXXXXXXXXXXXXXXXXXXXXXXXXXXXXXXXXXXXX~~  
A jeep had been driven up this dry creek bed. Gate was left open. I saw no evidence of livestock having passed through.
