Final Report  
F-C3726

PRESERVATION OF HISTORICAL MASONRY STRUCTURES

March 14, 1974

National Park Service  
Philadelphia, Pennsylvania

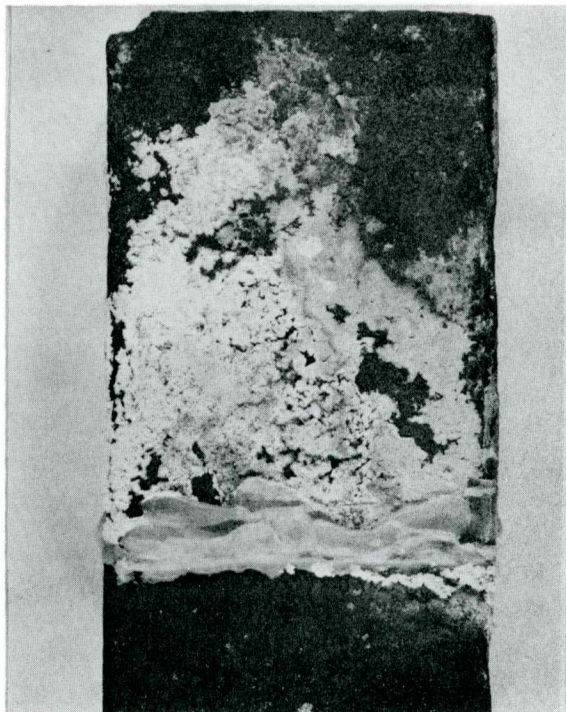
Figure 1. Sodium Sulfate Efflorescence on Brick Coated with Hydrozo Clear. The Crystals Formed on the Outer Surface of the Coating.

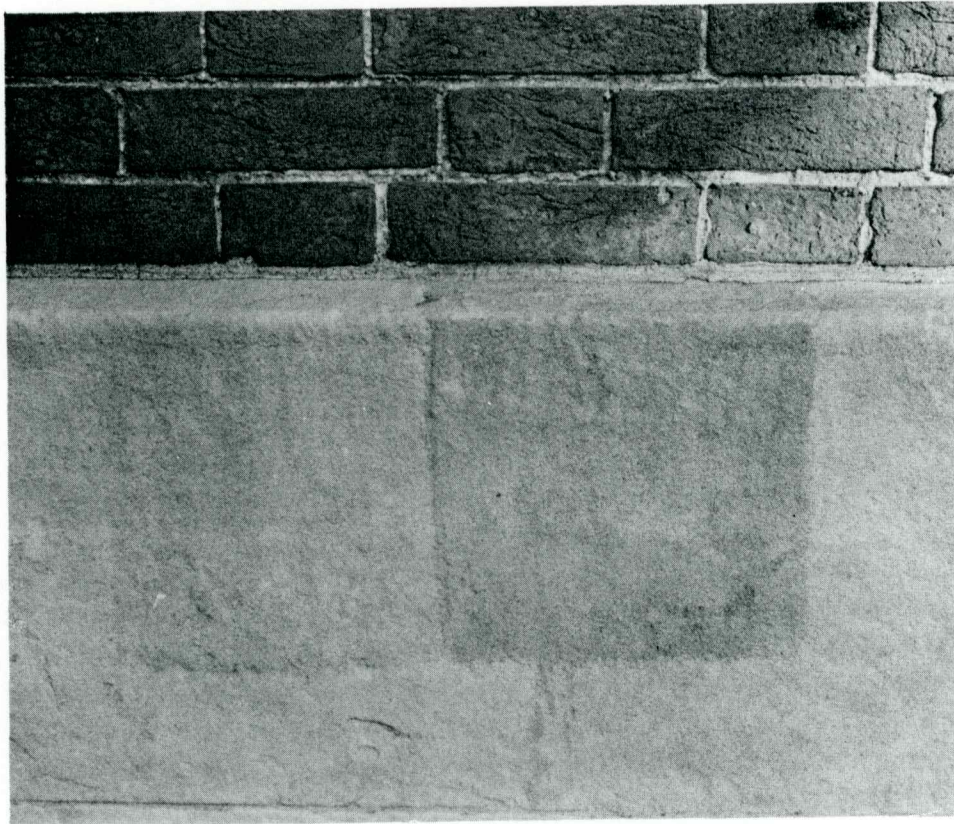
This material, an elastomer, is applied as a clear coating. This type preservative had been applied to a small area on the south side of the First Bank three years ago and at this time appears dark and absorbs water at a faster rate than untreated marble (see Figure 2).

Figure 2. Marble Coated with Chlorinated Rubber Three Years ago.

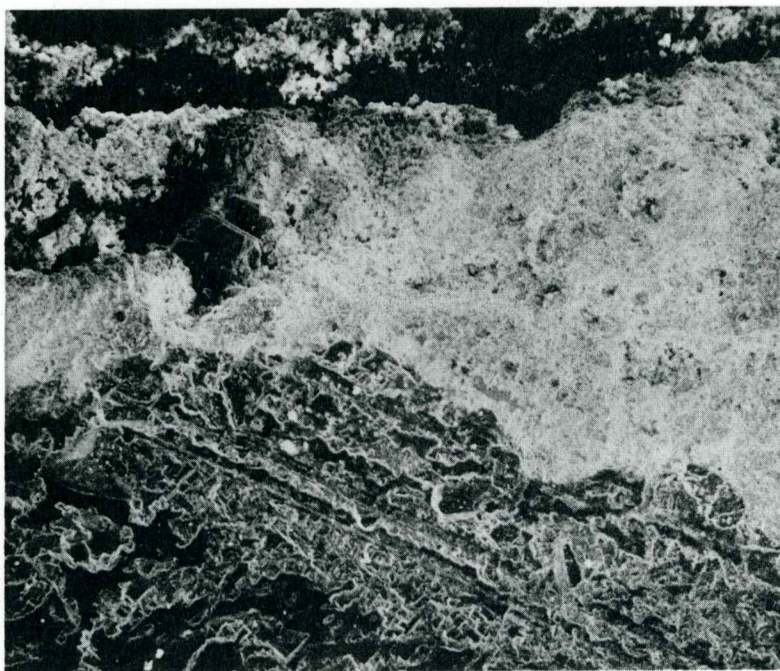
Samples of marble from the First Bank were treated by this method for possible use on the capitals. These methods were used : One was the submersion of the sample in the hot solution containing urea, the second coated with barium hydroxide solution and glycerine and kept moist with repeated applications for 30 days and the third submerged in the barium hydroxide solution for 30 days. Process one and two did not penetrate more than 0.1 to 0.2 mm below the surface

while the third method penetrated up to 1.6 mm deep (Figure 3). Soft calcium carbonate powder filled into a cracked piece of marble and treated for 30 days bonded the pieces together quite well indicating that good adhesion to the stone is possible.

Figure 3. Barium Hydroxide Treatment Showing Depth of Penetration after 30 days Submersion. The White Material is Barium Carbonate (50X).

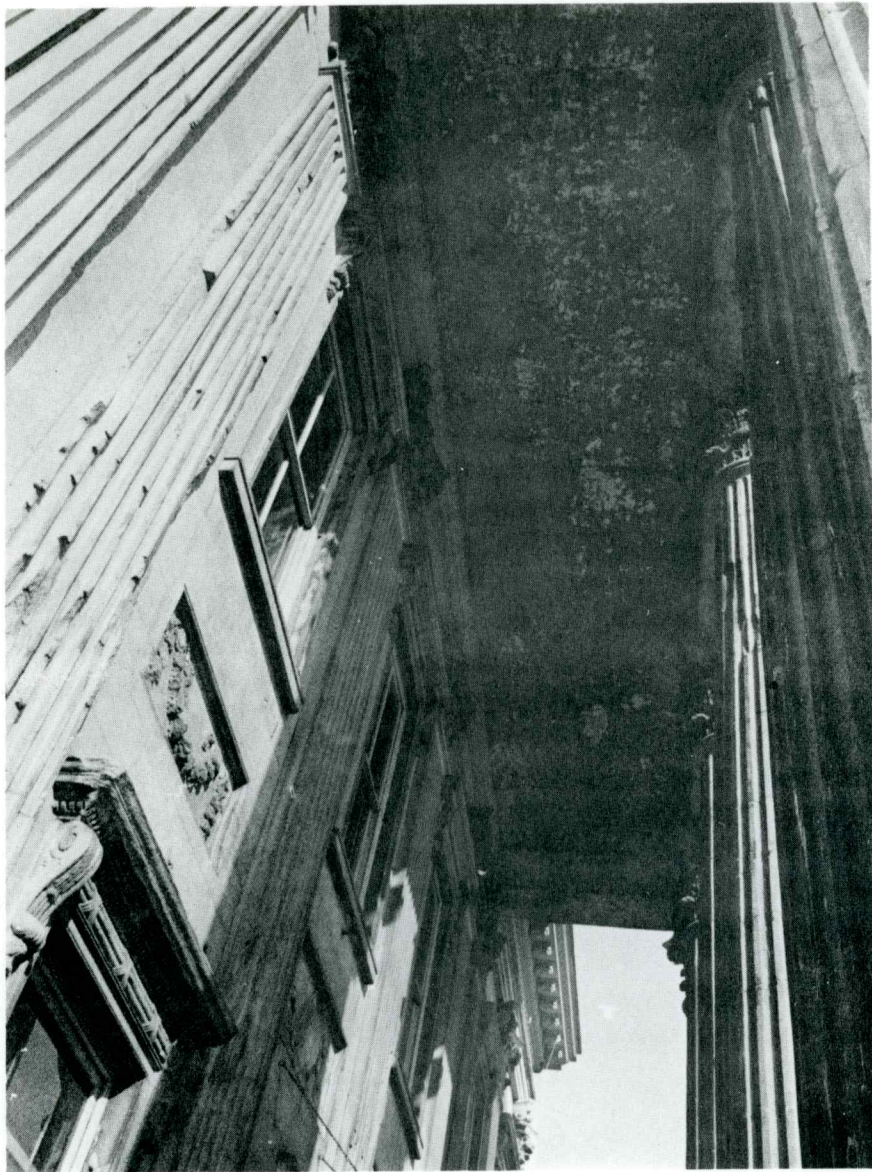
Figure 4. Dirt Incrusted Ceiling of the Portico on  
The First Bank of the United States.

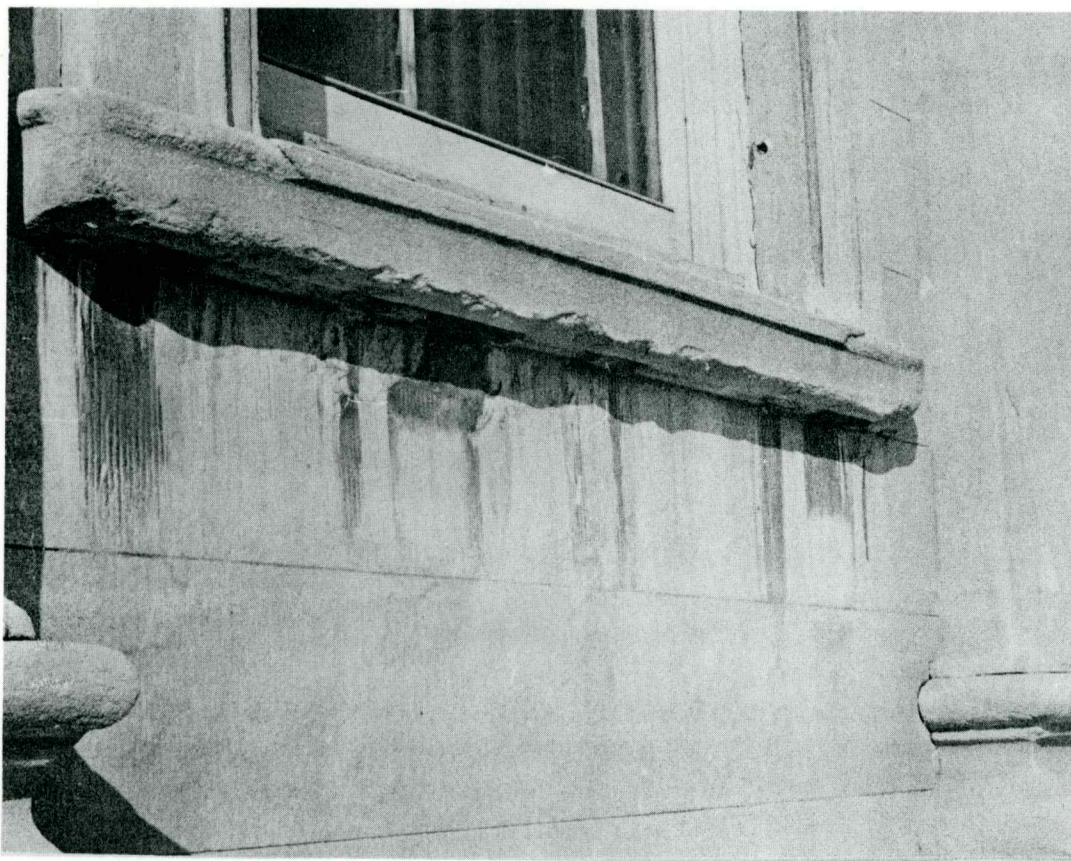
Figure 5. Stains under the South Front Window of The First Bank

Stains in the marble such as those under the front window at the southern end of the First Bank (Figure 5) should be removed. There are numerous materials for removing iron and copper stains. but some of these may add soluble salts to the stone. Ten percent aqueous solutions of formic or sulfamic acid can be used. Stanbolov (28,29) mentions various materials such as an aqueous solution containing sodium hydroxide, a non-ionic detergent and sodium borogluconate, an aqueous solution of the sodium salt of ethylenediamine tetraacetic acid and a potassium binoxalate paste.

Stains should be removed before overall washing to remove materials deposited in the process.

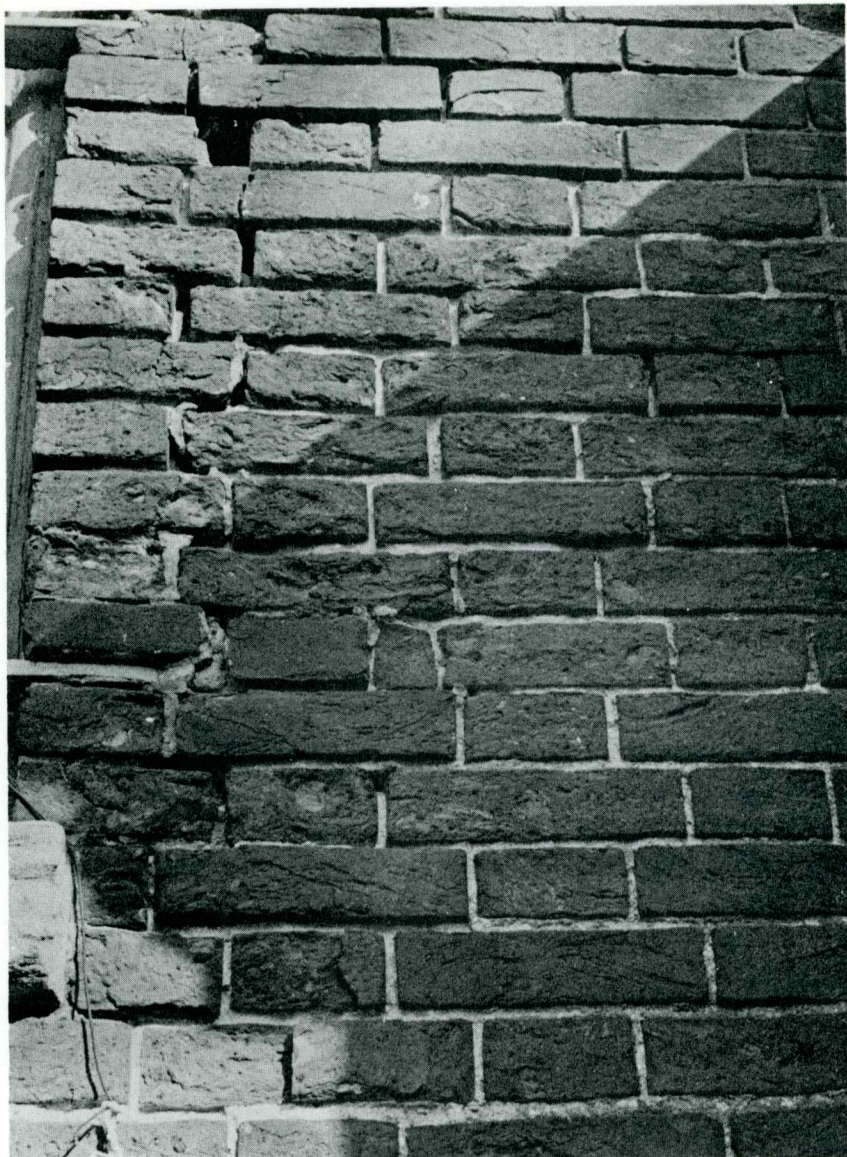
Figure 6. South Wall Brick of The First Bank Showing Loss of Mortar, Breakage and Excess Wear.

1. Work should start with the replacement of badly damaged bricks and all necessary repointing and repairs to the brick walls. An example of the problem is shown in (Figure 6). Work on the windows such as glazing and painting should be done at about the same time along with cleaning and caulking of all joints requiring flexible sealants. Also the repairing of stonework and the replacement of some small sections can be done at this time.

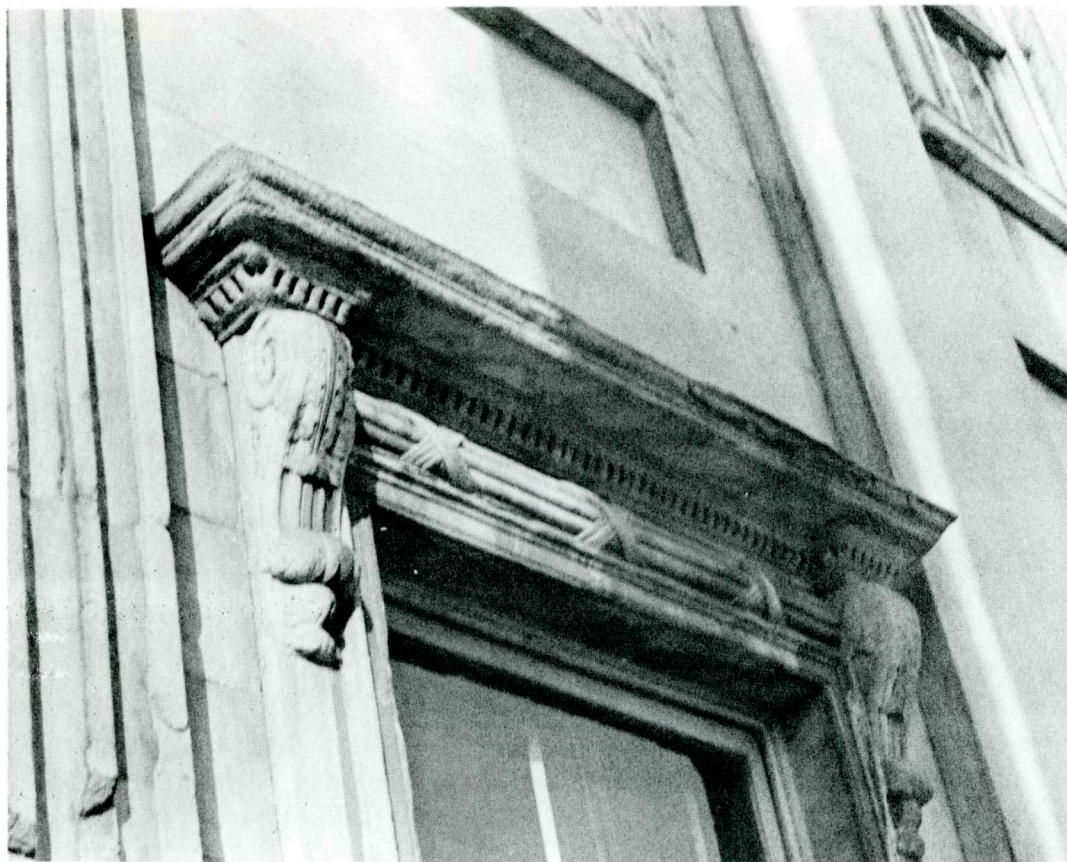
Figure 7. Stonework over a Window of The First Bank Needing Consolidation.

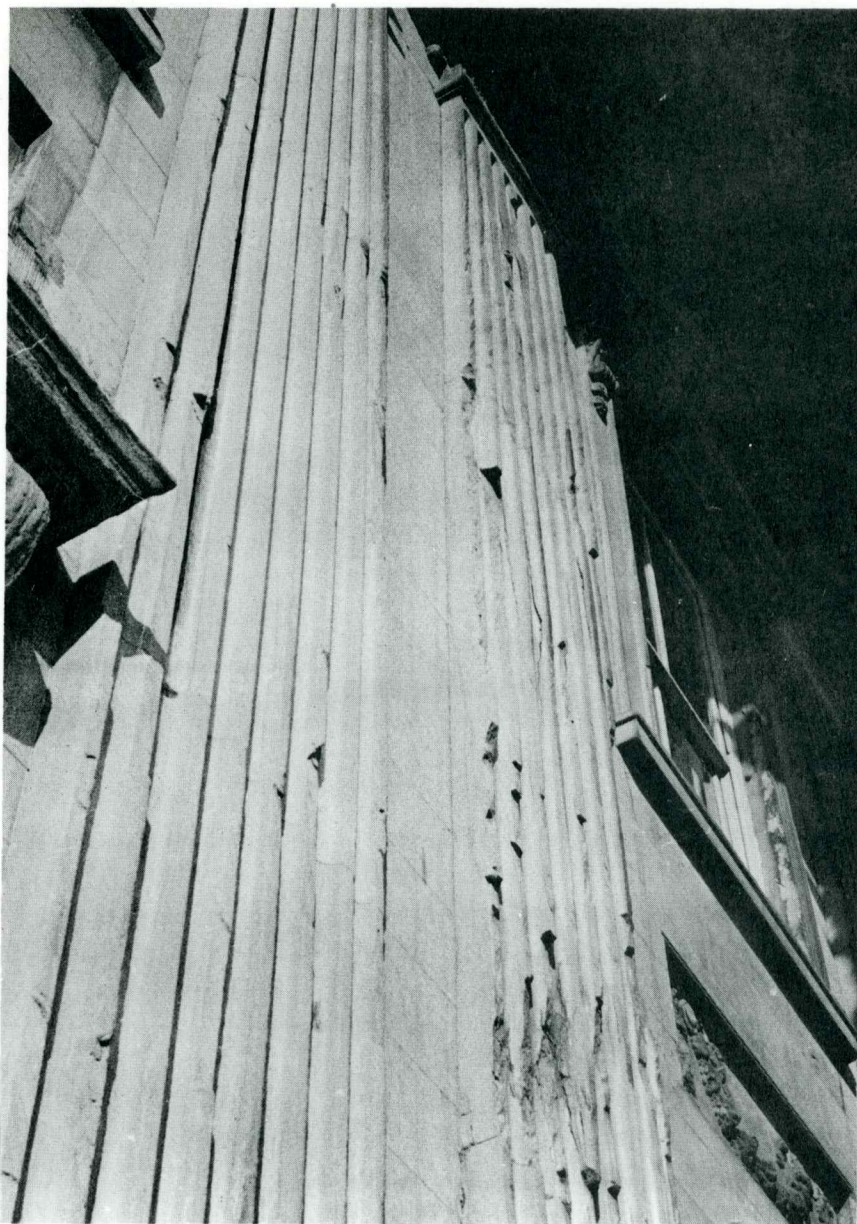
A major problem exists with the stone fluting on the front of the building. This problem as shown in Figure 8 is partially due to the direction of the bedding planes. Repairs would probably be as costly as replacement, and if neither is to be done, loose pieces should be removed and all sharp edges toned down.

**Figure 8.** Stone Flutings on the Front of The First Bank Showing Excessive Exfoliation Along Bedding Planes.

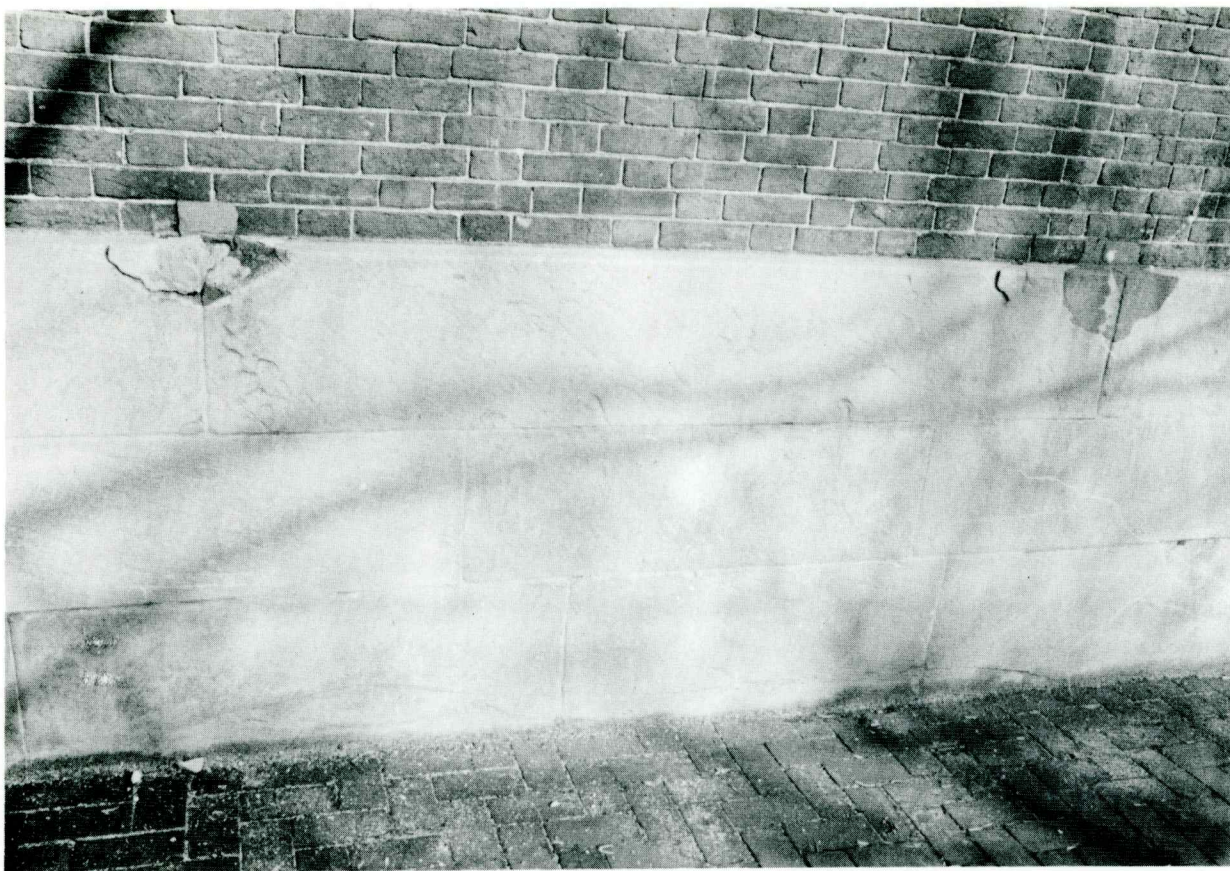
Figure 9. Stonework Along South Wall Showing Breakage from Expansion of Rust on Buried Beams.

Along the south wall (Figure 9) broken out sections of marble should be cut out square for replacement of stone blocks. Failure has occurred at these locations due to the expansion of the rust on the underlying steel (Figure 10). It will be necessary to work these steel beams free so that they can be cleaned and painted. There should be a space left behind the new blocks to fill in with a flexible waterproofing material to protect the metal and allow room for expansion.

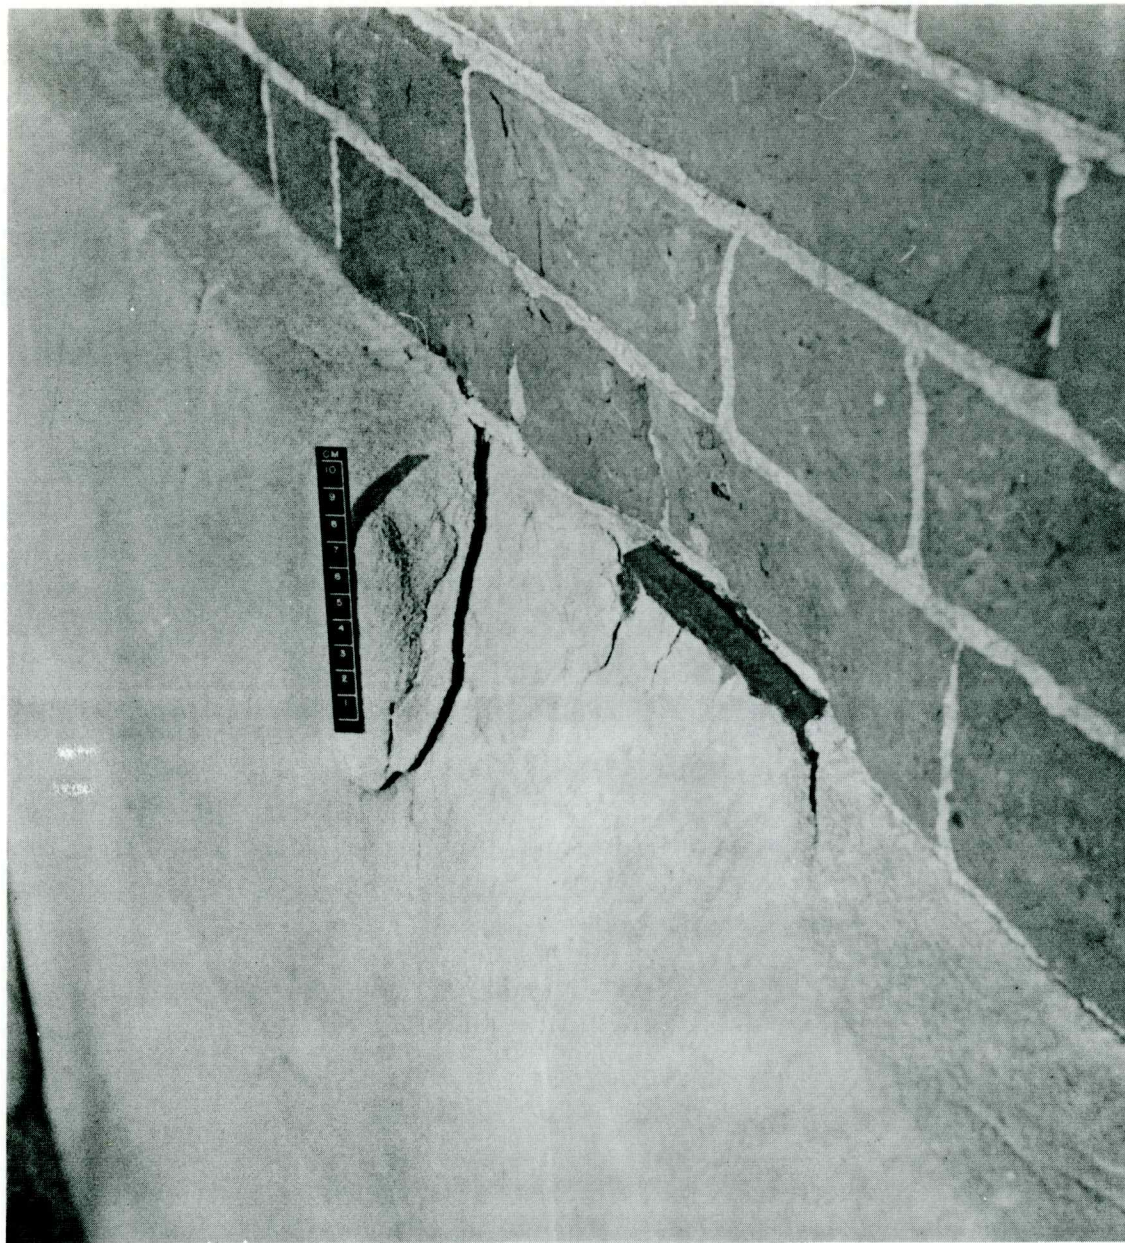
Figure 10. A Close View of the Rusted Steel that has Broken off Pieces of Marble.

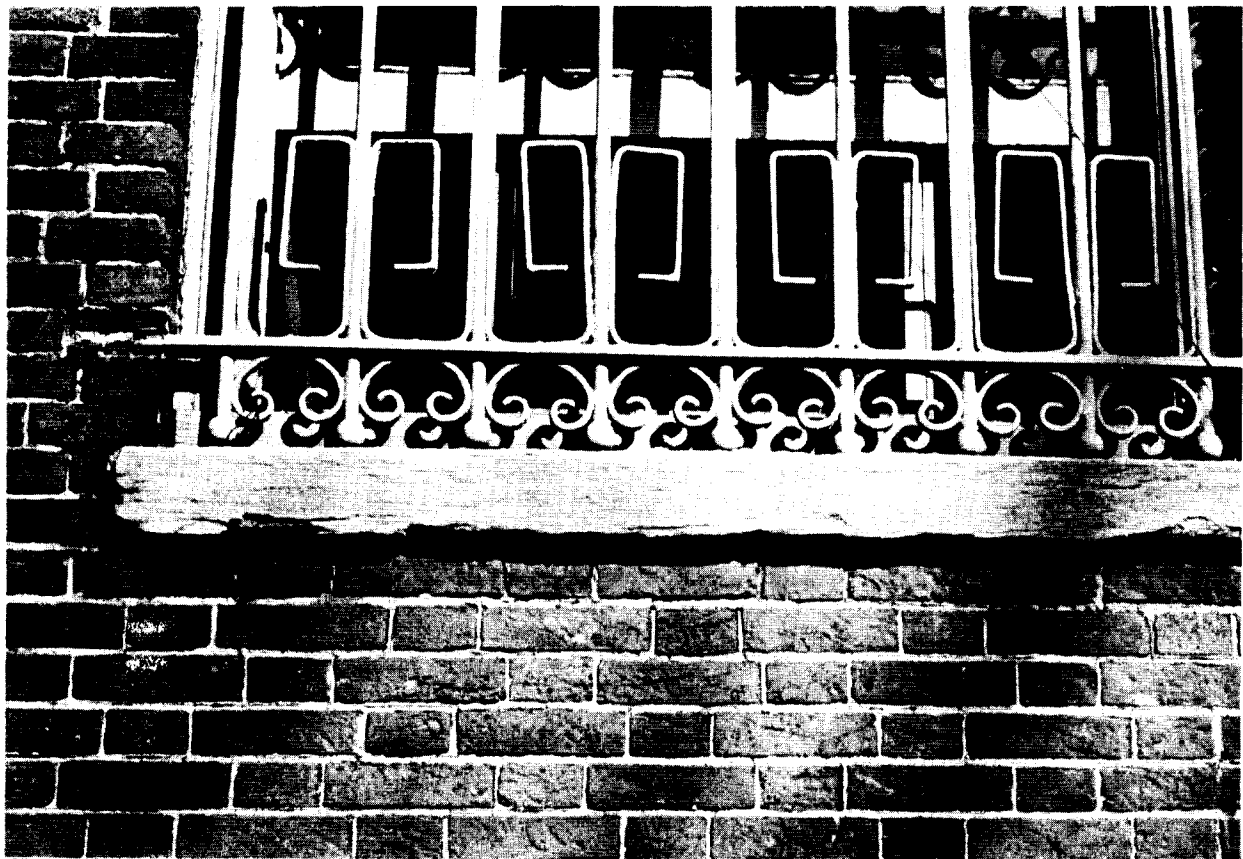
Figure 11. Window Sill on Southern side of Building Showing Deterioration of Marble.

Deteriorating marble above the front windows and door and window sills (Figure 11) should be treated with a polymeric material that will consolidate the stone. This should be first tried on the second floor window with an acrylic monomer after it is first tested

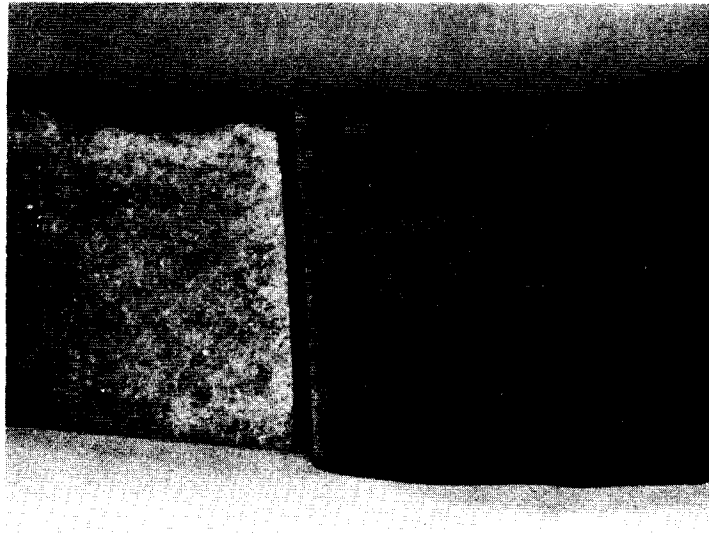
Figure 12. Marble from The First Bank Cleaned and Treated Deeply with Epoxy on Right Sample. The Darker Appearance is Due to Reduced Reflection of Light.

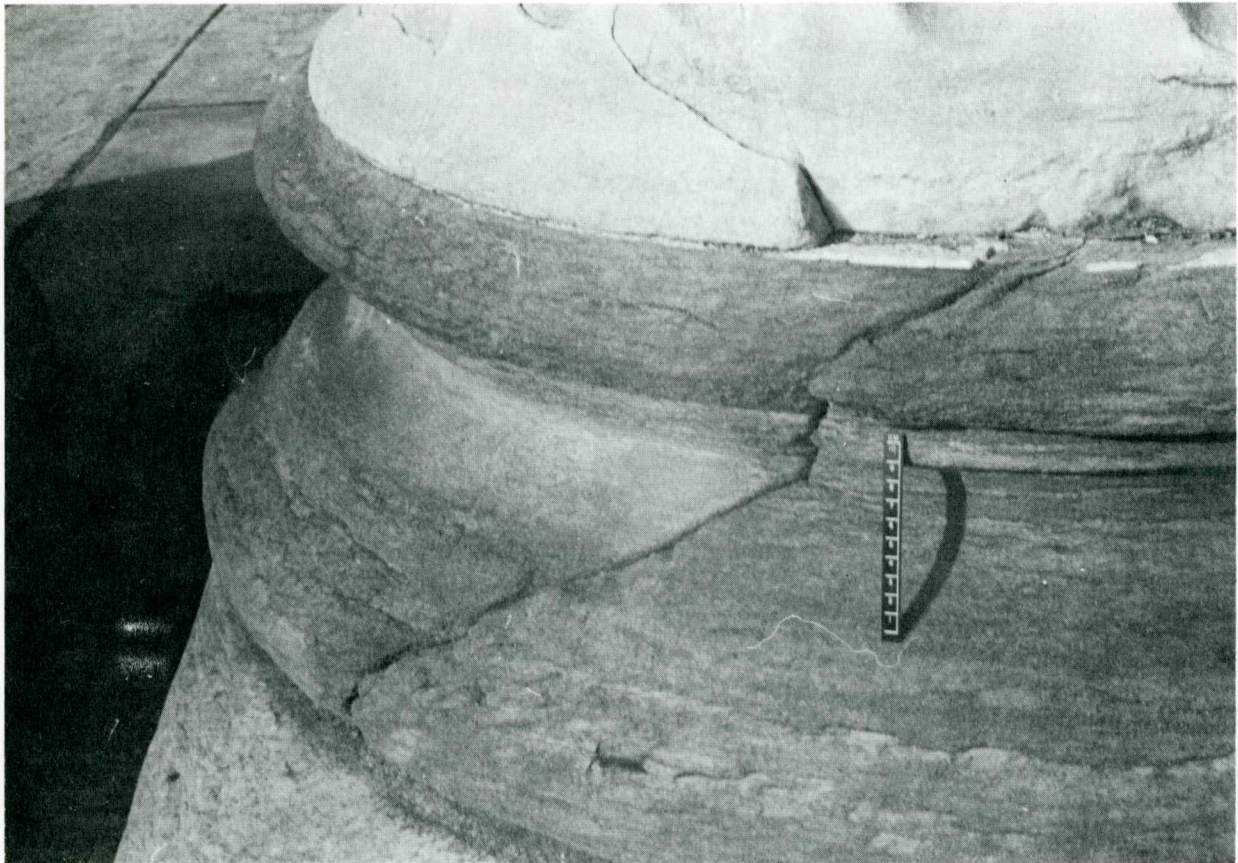
Another area requiring consolidation is the column bases. The base of the second column is very absorbent and as shown in Figure 13 still remains wet from rain the day before. Column bases three and four also show this to a lesser extent. The deep cracks must be sealed and it would be desirable to slightly smooth down the stone before adding the preservative.

Figure 13. Column Base (Second from Southern End) Showing a Deep Crack. Note that the Stone is Still Wet from Rain the Day before the Photograph was taken.
