# Emergency Stabilization Plan

## Dome Fire

Mojave National Preserve, California

September 2020

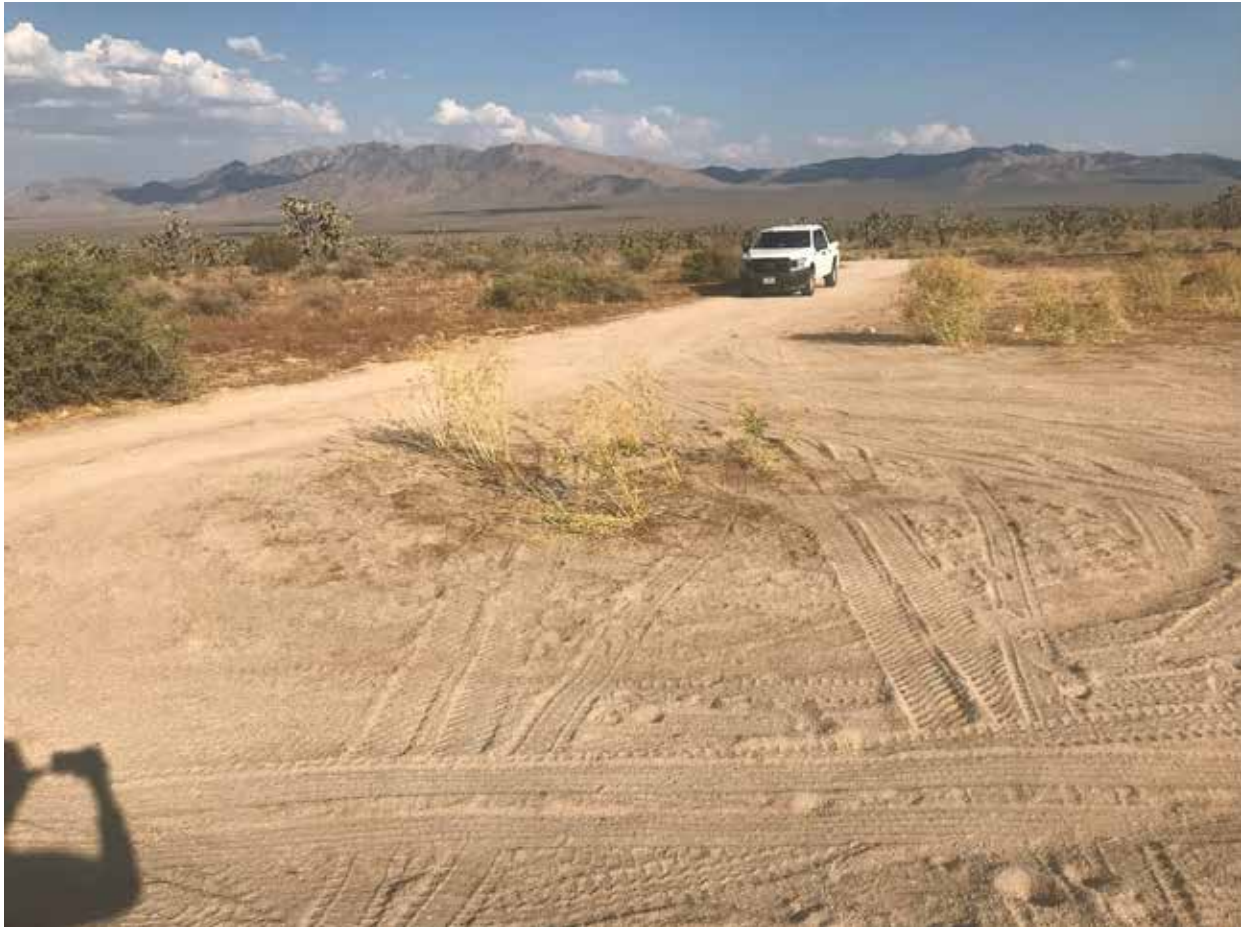
**Figure 1. Perennial pepperweed in seed with multiple vehicle tracks going through it at the Morningstar Mine Road pullout.**

Fertilized patches of invasive annual grasses may have the ability to persist and prevent natural succession of native vegetation. In order to reduce the seed output and viability of red brome and cheatgrass in retardant drop zones, we recommend IPMT staff apply herbicide in retardant drop zones to the interspaces between native perennial vegetation after invasive grasses have germinated but before native annuals have emerged (January-February).

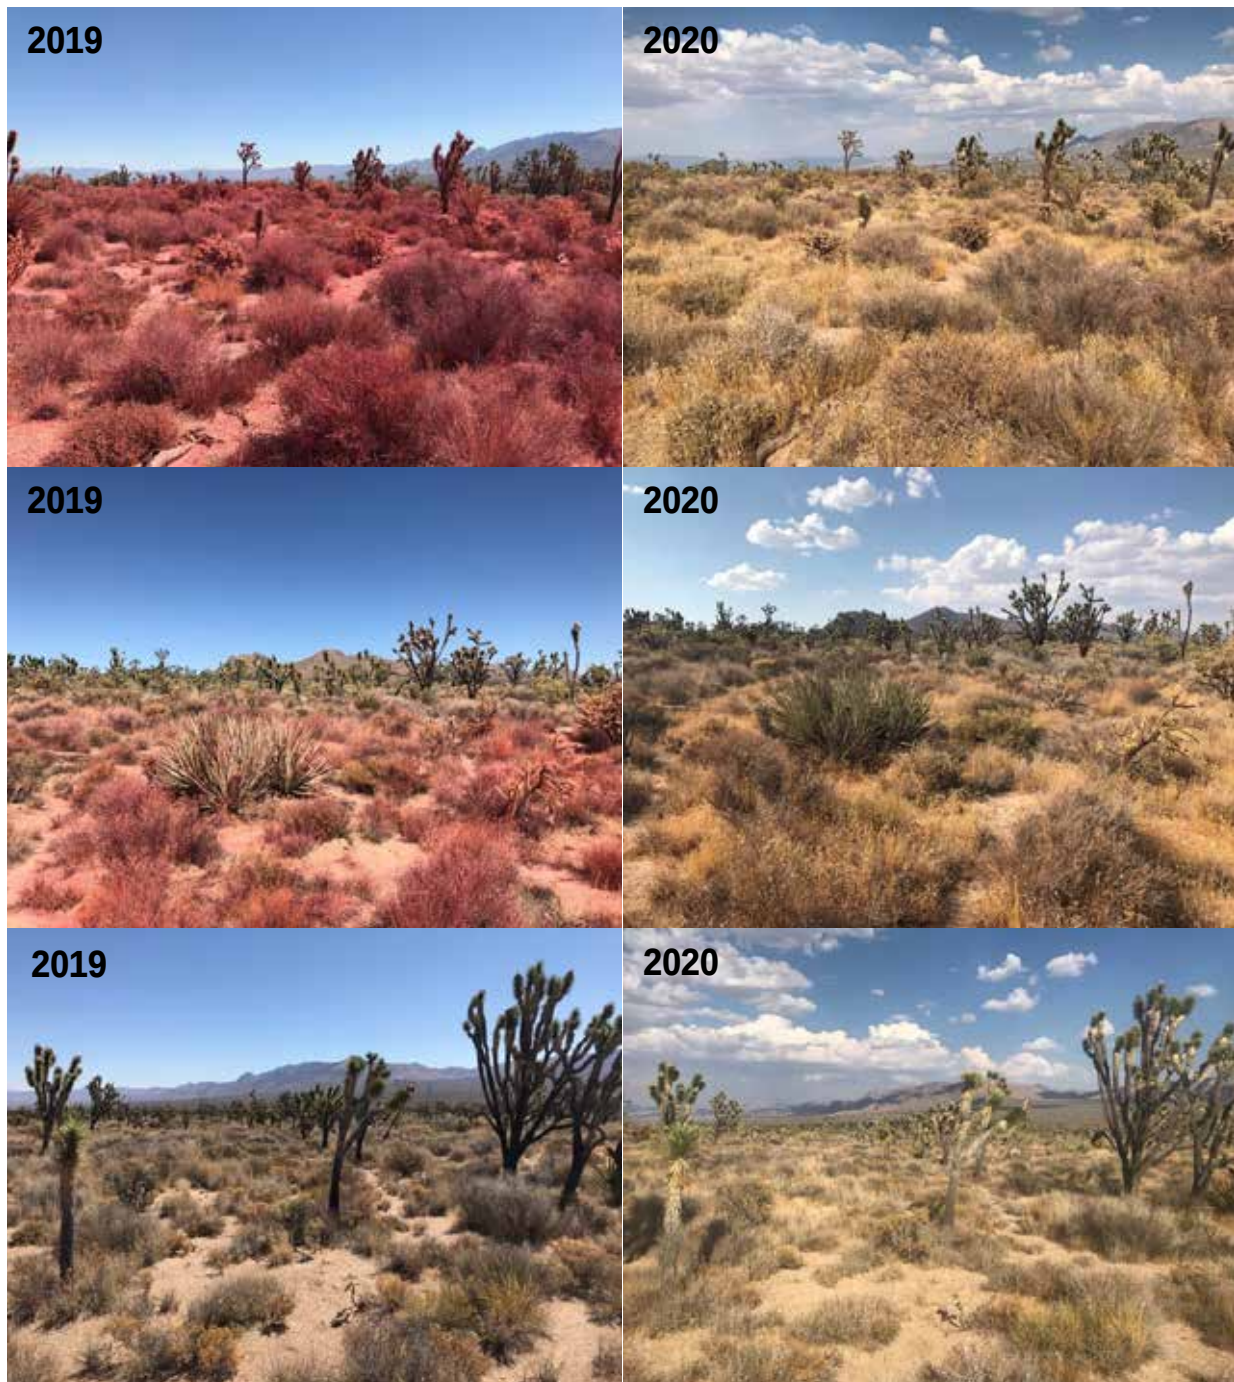
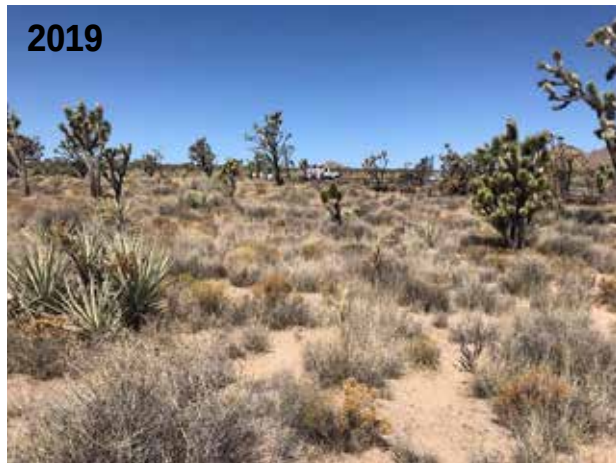
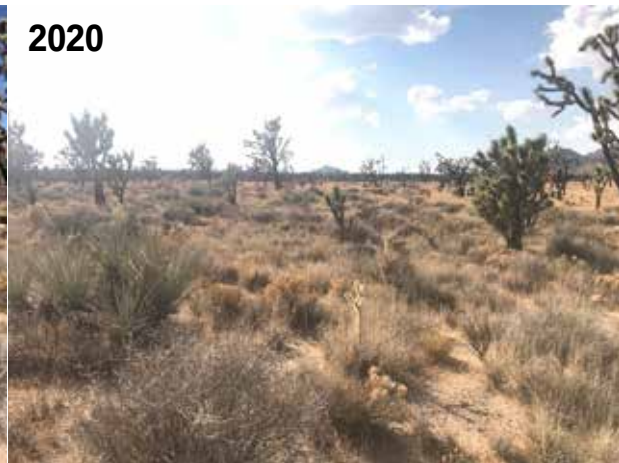
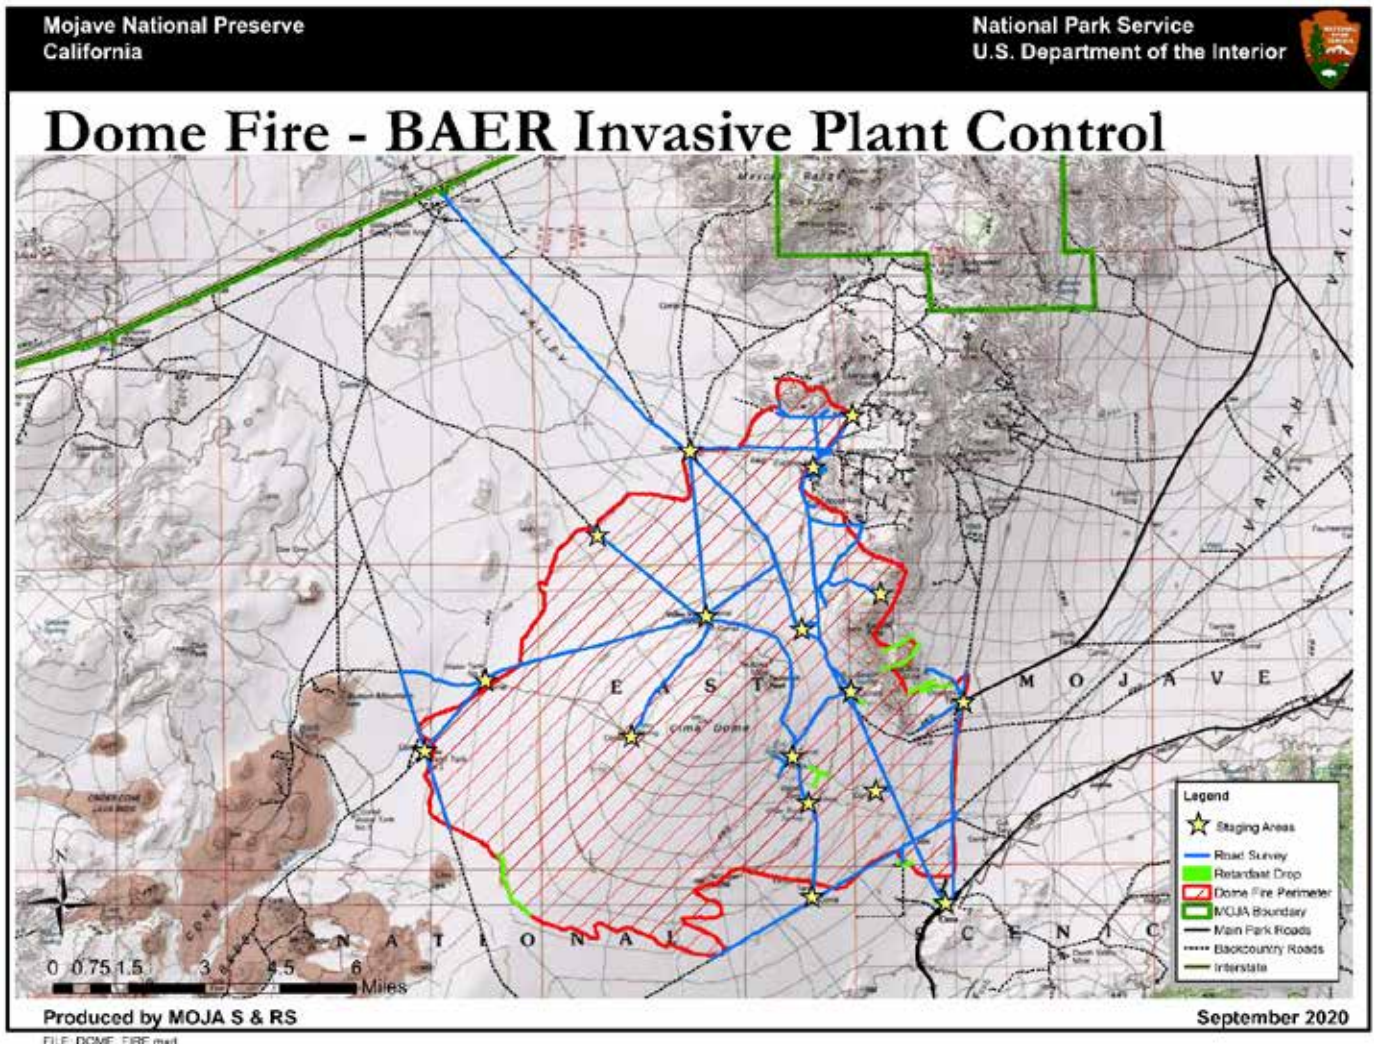
2019 Star Fire, a significant increase in invasive annual grasses was observed within retardant drop zones compared to the surrounding area (Figure 2).

**Figure 2. Photopoint Retakes from 2019 Star Fire. Top two sets of photos are within the retardant drop zones and the bottom sets of photos are from an unburnt area adjacent to the fire. Red brome (gold-colored grass) has proliferated in the retardant drop areas.**

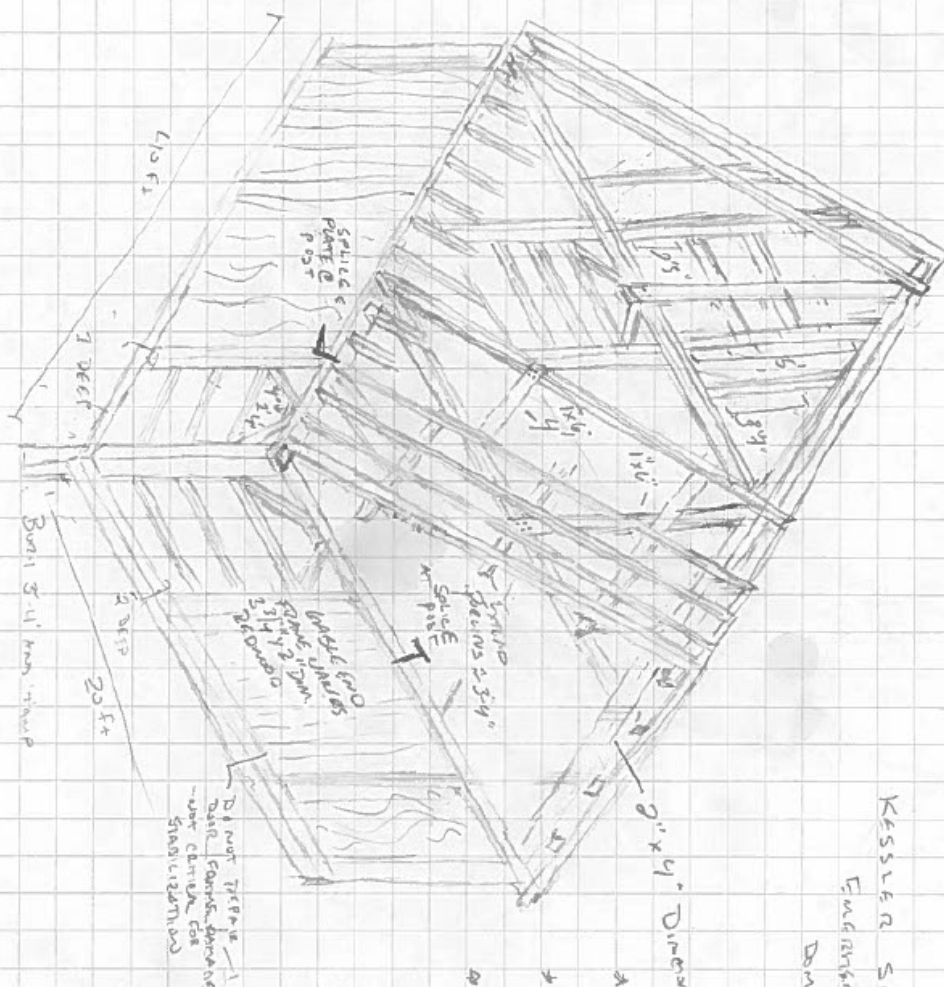
# KESSLER STAIRS HAY BARN FOUNDATION STABILIZATION DOME FIRE MORA

The Kessler Hay barn should be stabilized as soon as possible to prevent additional resource damage and prevent injury to persons/livestock. Stabilization will be completed by an NPS historic preservation crew, with guidance from an NPS historical architect. Work includes replacing several feet of mud sills and a corner post and repairing/replacing roof components.

- ALL FRAMING NOMINAL
- FIRE WOODS NOTED
- 2x6x8 ROOF BRACES
- 10 DOUBLES
- 2x6x8 SQUARE BRACES

- 2x4 BRACE 12'x3' CORNERPOSTS PANELS
- TOP PLATES: 1"x8' NOMINAL
- RAFTERS: 12' 8"x6" NOMINAL
- WEST WALL FRAME NOMINAL: 2"x4'x8'
- SOUTH WALL FRAME NOMINAL: 2"x3 1/2"x8'
- POSTS: 2x12x8x8' 5"x3 1/2"x8' 12x12
- MUD SILL: 2x12x8x8'
- SOUTH WALL - 2x6x8
- WEST WALL - 1x6x8
- BRACES: 2"x3 1/2"x8' 12x12x8'
- STRUTS: 1"x6" NOMINAL
- JOISTS: 2x12x8' 2x6x8' 8"
- ONLY WOOD TO BE REPLACED BY NOMINAL 2"x4"

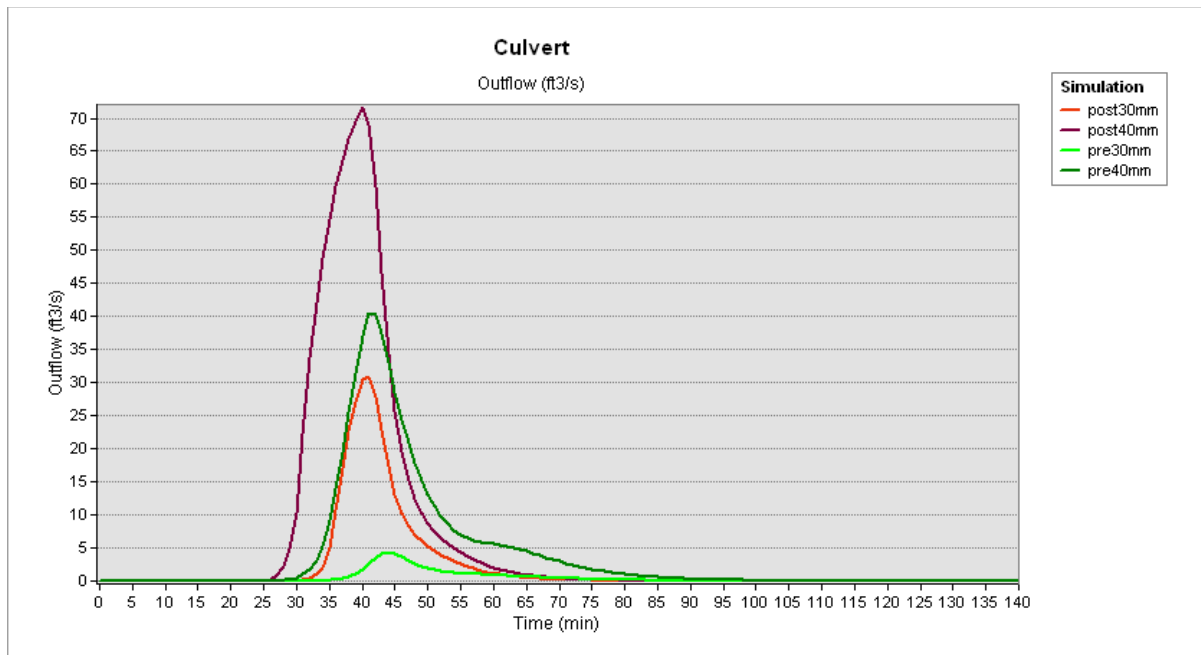
Table 2 and Figure 2 show the relative change in peak flow rates due to the Dome fire. The anticipated increase in runoff in response to the 10 year 1 hour storm is fairly large at a 7 fold increase. However, the anticipated change in runoff for the 25 year 1 hour storm is much less (at double the flow). Considering the similarity in response for the post-fire 10 year storm event (30mm) and the pre-fire 25 year storm event (40mm), it can be hypothesized that the sort of flow that had a 1/20 some chance of happening prior to the fire, now has closer to a 1 out of 10 chance of occurring due to the Dome fire.

**Figure 2.** Hydrographs showing the outflows at the box culvert on Cima road near Kessler springs in pre and post-fire landscape conditions resulting from the design storms in Table 1.

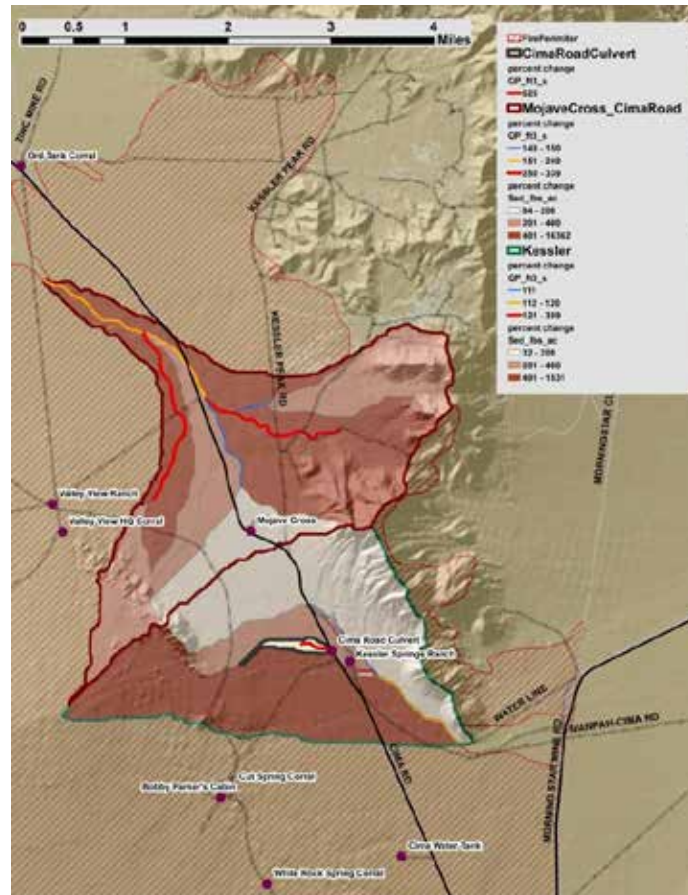
Figure 3. Shows the Cima Road culvert location and drainage areas for the dominant washes flowing NW and SE from the Dome Fire area. Percent change in runoff behavior for sediment discharge from hillslopes and peak flow rates for wash segments is displayed for the Kessler and Mojave Cross drainage areas and the expected peak flow rates at the culvert.

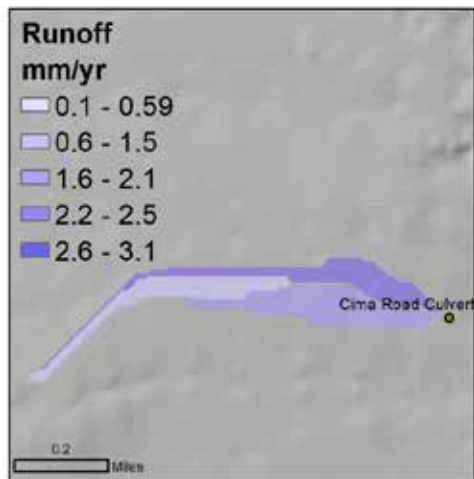
Table 1 shows predicted runoff and peak runoff rates for the Cima road culvert. The watershed is small and in not burned conditions, the model only expects runoff to be generated at the 5 year and above return period storms and peak runoff in not burned conditions is rounded to zero for all storms. Only the 25 year storm event (4% probability of occurring in one year) under burned conditions is expected to generate a small but detectable peak runoff rate that can be easily managed by the culvert.

Figure 3. Shows predicted annual post-fire hillslope runoff for the small Cima Road culvert watershed.

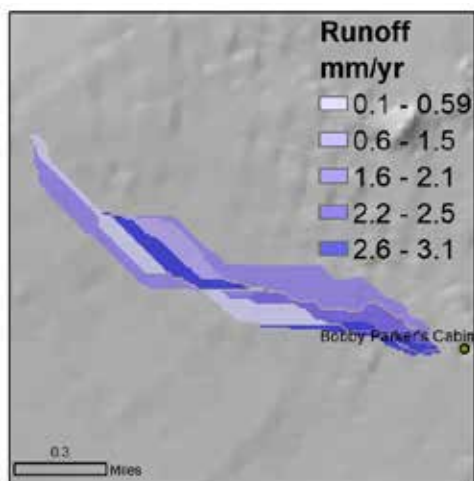
Table 2 shows predicted runoff, peak runoff rates and erosion for the watershed above the Bobby Parker cabin. The watershed is small and in not burned conditions, the model only predicts peak runoff and erosion to be detectable during a 25 year storm. For burned conditions, peak runoff and erosion is above zero for the 5, 10 and 25 year storms.

Figure 4. Shows predicted annual hillslope runoff for the small Bobby Parker Cabin watershed.

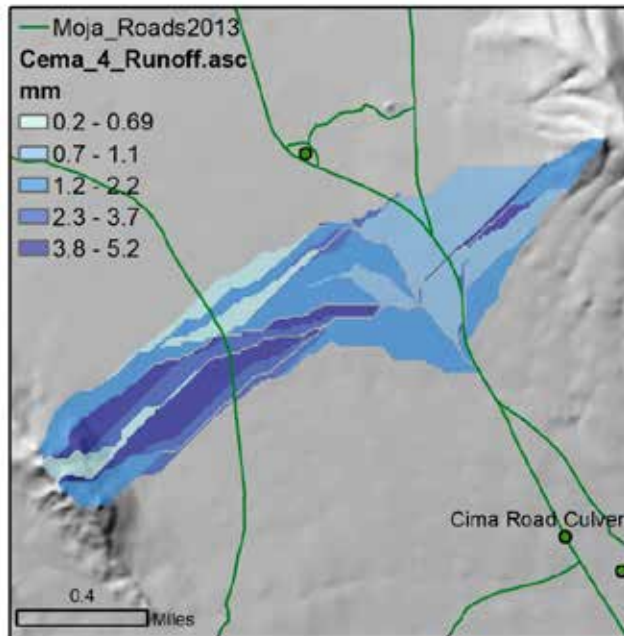
Table 3 shows predicted runoff, peak runoff rates and erosion for the watershed draining over the Cima road to the north of the culvert. The watershed is small (387 acres) and in not burned conditions, the model only predicts peak runoff to be detectable during the 10 and 25 year storm events. For burned conditions, peak runoff and erosion is above zero for the 2 year storm and higher. This road crossing needs to be cleared periodically during normal conditions indicating the not burned predictions maybe low. The road will most likely require clean out more frequently after the fire.

Figure 5. Shows predicted annual hillslope runoff for the watershed draining over the Cima road to the north of the culvert.

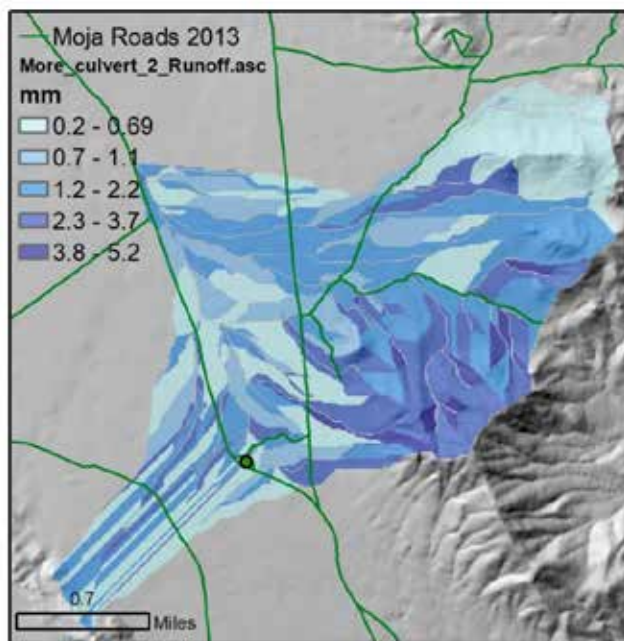
Table 4 shows predicted runoff, peak runoff rates and erosion for the watershed draining over the Cima road to the north of the Mojave cross. The watershed is 2,500 acres and in not burned conditions, the model only predicts peak runoff to be detectable during the 10 and 25 year storm events. For burned conditions, peak runoff and erosion is above zero for the 2 year storm and higher. The road will most likely require more frequent clean out post-fire. This wash is predicted to have more runoff and erosion for 5 year and higher return period storms than the smaller wash to the north of Cima road.

Figure 6. Shows predicted annual hillslope runoff for the 2,500 acre watershed draining over the Cima road to the north of the Mojave Cross memorial.
