## **Woodbury Fire**

### **BURNED AREA REHABILITATION PLAN**

**UNIT:** Tonto National Monument (National Park Service)

**DATE:** July 17, 2019

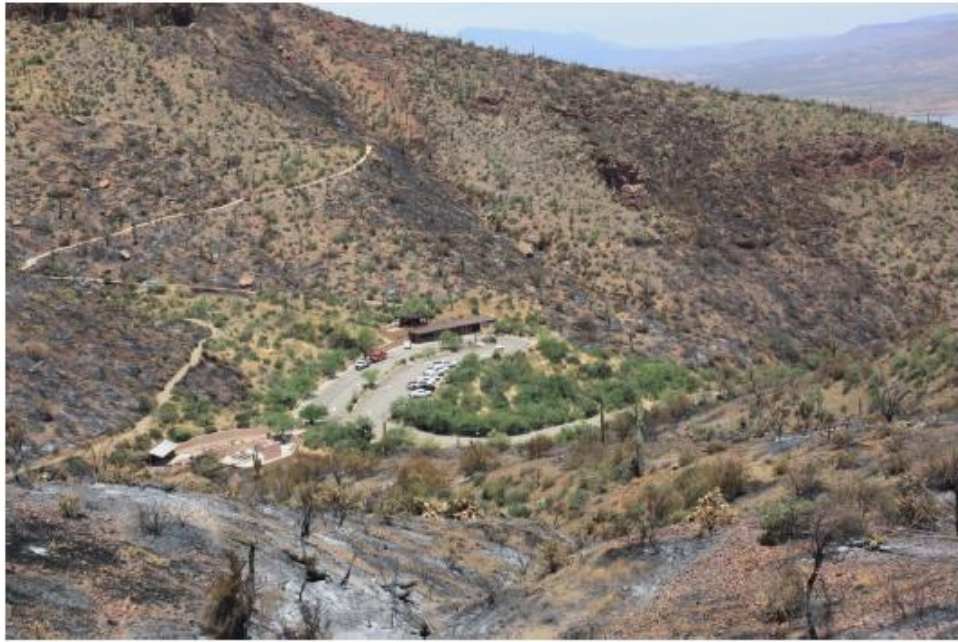
- **Lower Cliff Dwelling trail:** Rock fall, debris and hazard trees and Saguaro Cactus could potentially impact safety. We recommend closure of this trail, during this monsoon season, and placement of hazard signs when the trail does reopen. We also recommend a baseline assessment of scorch height and instability (leaning/exposed roots) for individual saguaros that could fall or roll onto the trail. Hazard tree/cactus removal may be warranted depending on this assessment and observations of deterioration following winds and precipitation events during the summer monsoon. We recommend minimizing staff access and requiring full PPE until the assessments are complete and the slope is deemed safe.

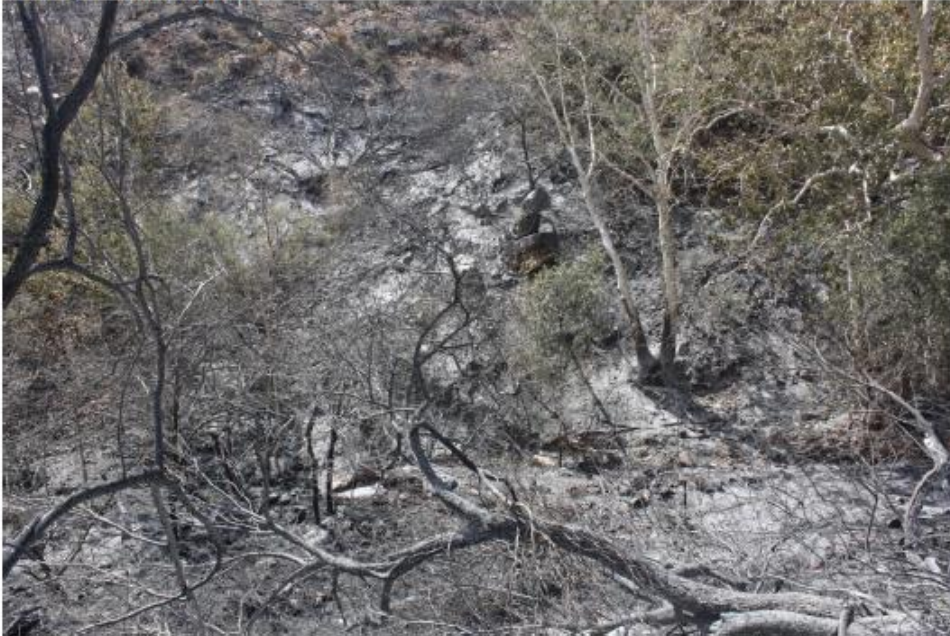
- ***Upper Cliff Dwelling Trail:*** This trail winds through the creek bottom and is susceptible to significant changes from flooding, erosion, debris and hazard trees. Recommend closure of this trail, placement of hazard signs when the trail does reopen, and potentially a complete reroute out of the creek. Conduct a hazard tree assessment with focus on the mature Arizona Sycamore trees. Hazard tree removal may be warranted depending on this assessment and observations of deterioration following winds and precipitation events during the summer monsoon. We recommend minimizing staff access and requiring full PPE until the assessments are complete and the slope and drainage are deemed safe.

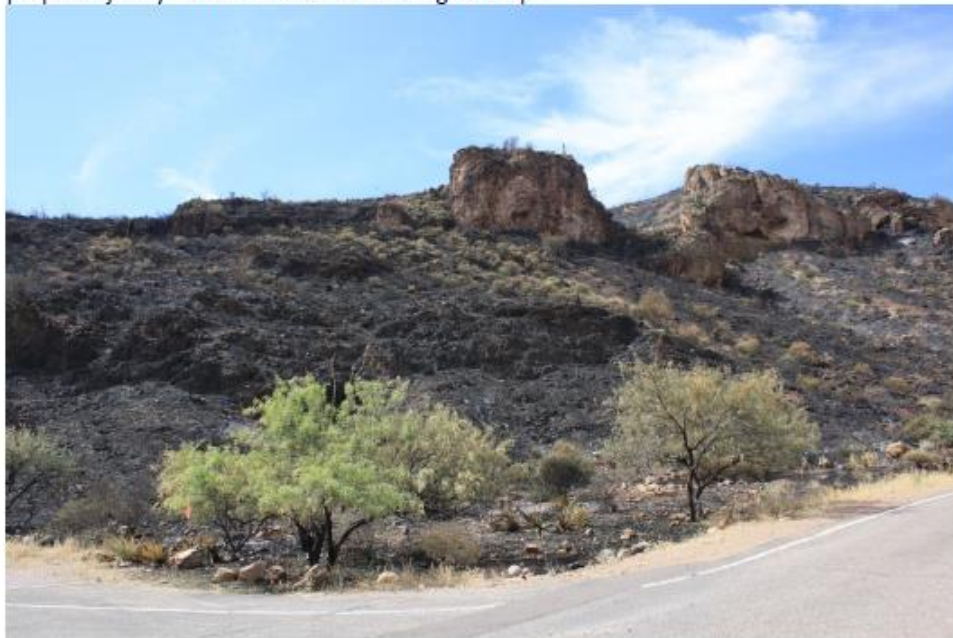
- **Entrance Road Side slope:** Located between the picnic area and the culvert crossing, on the east side the road passes the toe of a hill with steep slopes. The entire slope is burned and the shoulder is narrow. Dry ravel of slope material was observed on the road. Recommend placement of Concrete Jersey Barriers as a rock fall containment barrier to shield motor vehicles and protect the roadway and buried utilities. Jersey barriers should extend from culvert up canyon to the road crossing (where the double 8' culverts are located). Consider seeding/mulching operations on the segment above the proposed jersey barriers to assist in securing the slope.

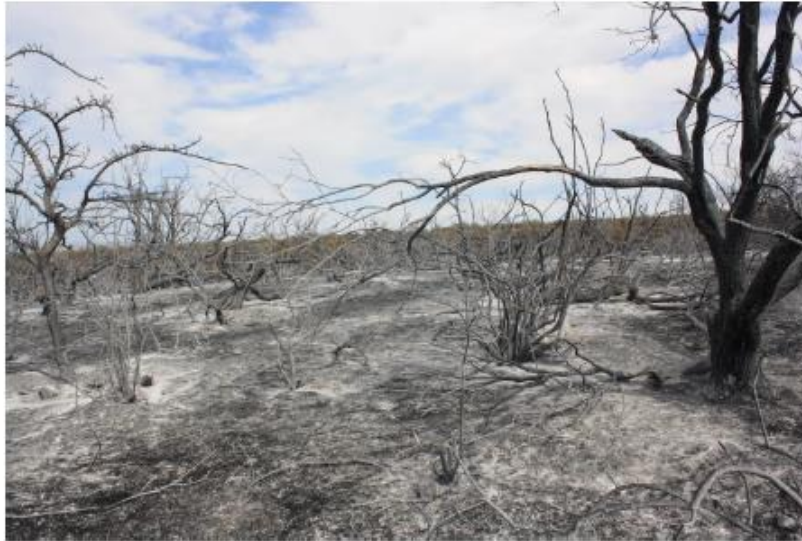
- **Cave Canyon Creek Floodplain:** The risk of flash flooding is elevated. Recommend developing a flash flood evacuation plan and monitoring weather radar for storm-cells in the watershed.

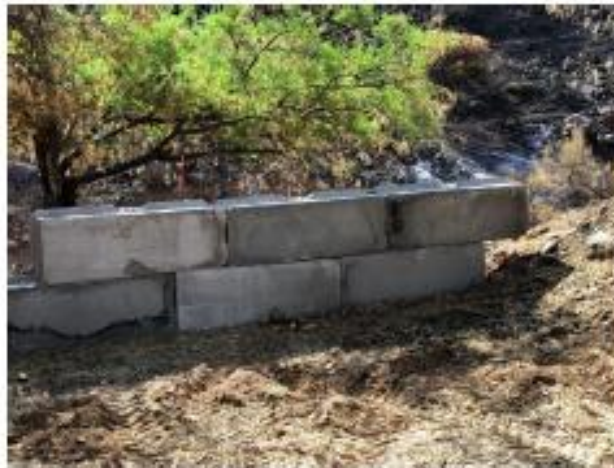
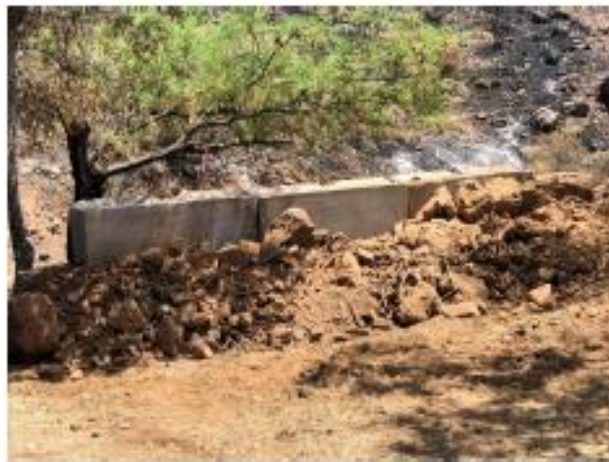
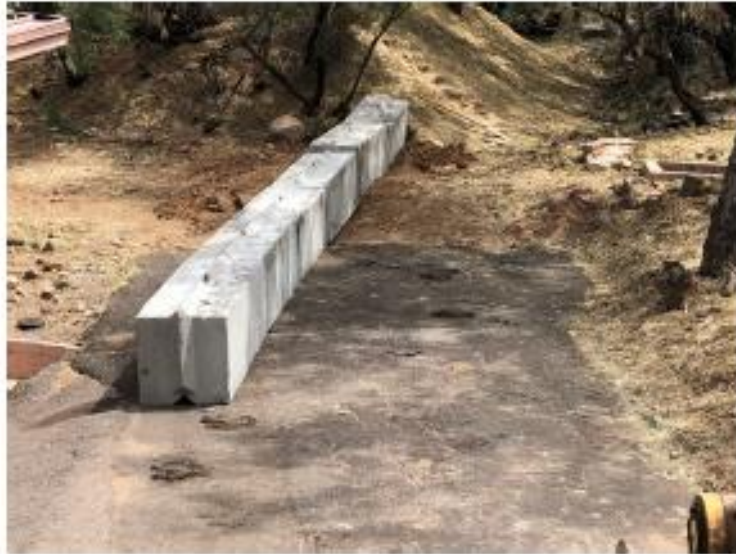
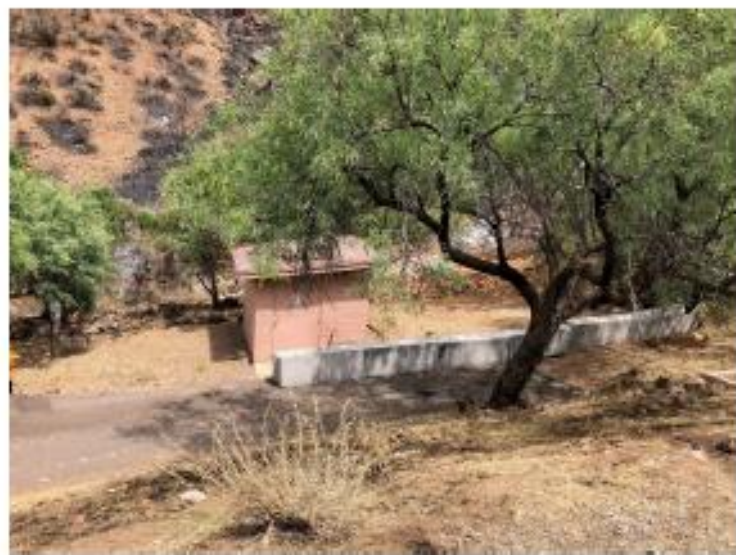
**Groundwater well house and partially buried storage tank area (Cinda - Lead):** Located adjacent to Cave Canyon Creek. Storage tank is well armored with large boulders. The well house is downstream of the storage tank and would be impacted by elevated flood flows. Armoring of the well house area on the west, south, and east sides with Concrete Jersey Barriers is complete.

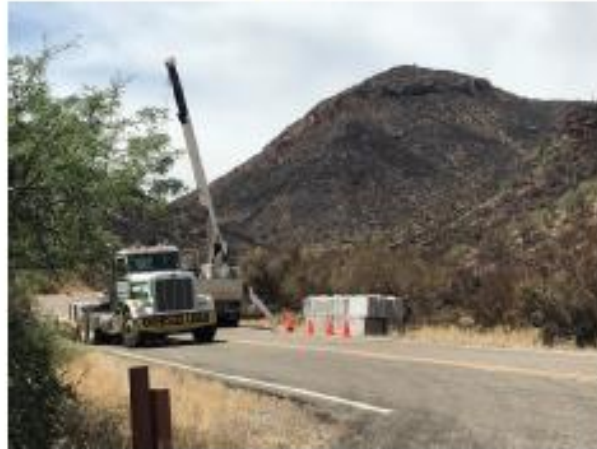
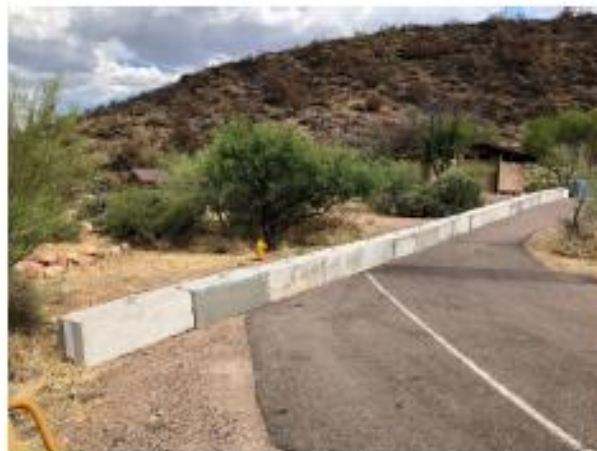
**Protect Admin/Maintenance Complex from overland sheetwash and flooding (Cinda - Lead):** Located at the northend of the picnic area, several drainages flow directly towards the admin/Maintenance Complex. Armoring of the area above from the comfort station west towards the entrance road will hopefully divert water away from this area during heavy rains. Concrete Jersey Barriers have been installed. Barriers will be moved after monsoons.

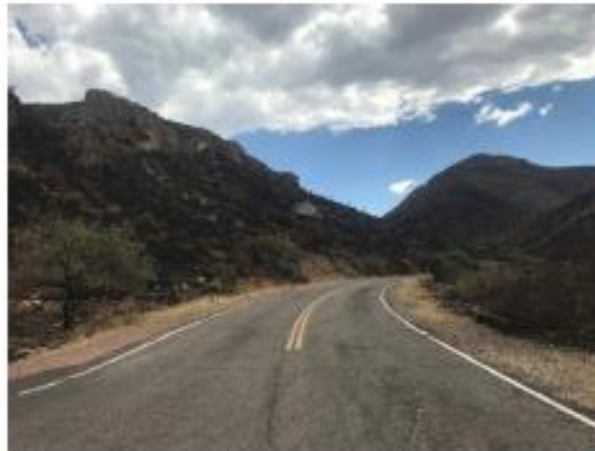
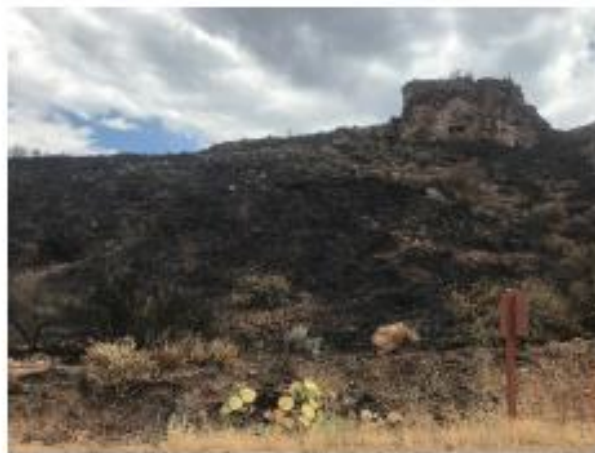
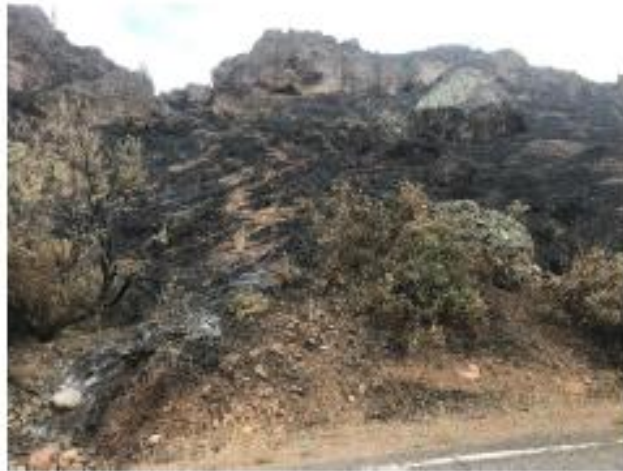
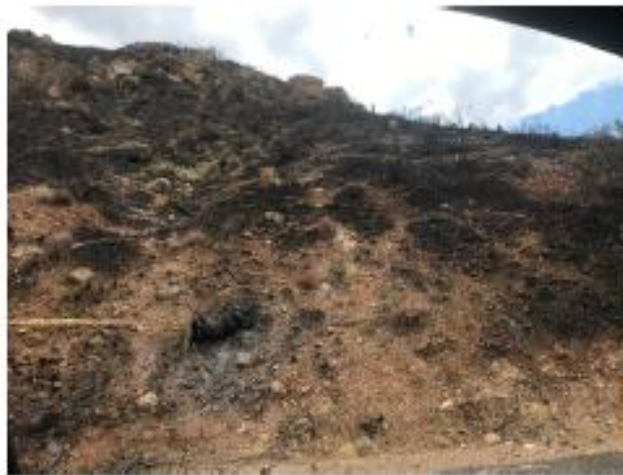
**Entrance Road Side Slope (Cinda - Lead):** Located between the picnic area and the culvert crossing, on the east side the road passes the toe of a hill with steep slopes. The entire slope is burned and the shoulder is narrow. Recommend placement of Concrete Jersey Barriers as a rock fall containment barrier to shield motor vehicles and protect the roadway and buried utilities. Jersey barriers should extend from culvert up canyon to the road crossing (where the double 8' culverts are located). Daily maintenance and clean up of the road may be required until the slope is stabilized.

Evaluate impacts to road after the monsoons begin. If significant debris begins to cover the entrance road, consider purchasing the 500' of barriers and placing them along the roadway. Also, a geohazard assessment is needed by a geomorphologist along this slope. Large rocks and boulders are now exposed on the steep hillslope with no vegetation anchoring the slope (*Duane working with IMR to identify a specialist*).

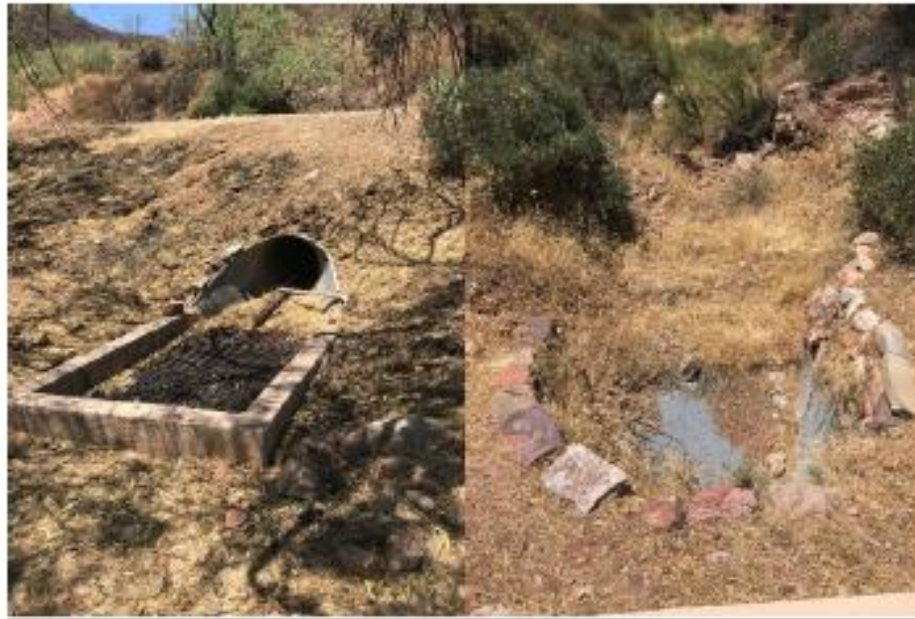
**Culvert cleaning (Cinda - Lead):** Fire related flood flows are normally elevated and typically move ash, soil/rock and floatable woody debris. Culverts are usually not designed to accommodate fire effects. Two locations will need culvert cleaning of creek bed load throughout the summer monsoon season and potentially for one year. One is the large 2 culvert crossing of the main park access road to the visitor center and the other is a small culvert near the groundwater well pump house.

Assess status of culverts along the entrance road and Lower Cliff Dwelling Trail. Complete as much removal of debris with park maintenance staff before the monsoons. Develop a long-term plan and recommendations for a trail crew to remove larger rocks and boulders located within the culverts. Crews will be needed after the monsoon to clean out additional debris deposited. Work with Tonto Basin Fire, the USFS or ADOT on evaluating and flushing the VC parking lot culvert.

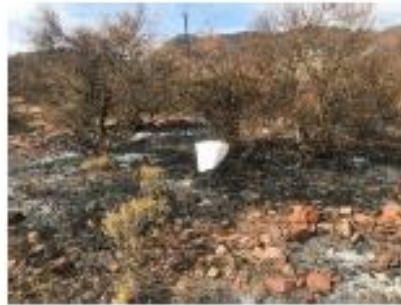
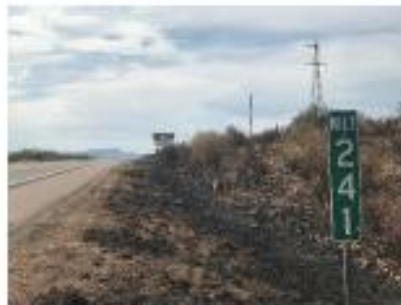
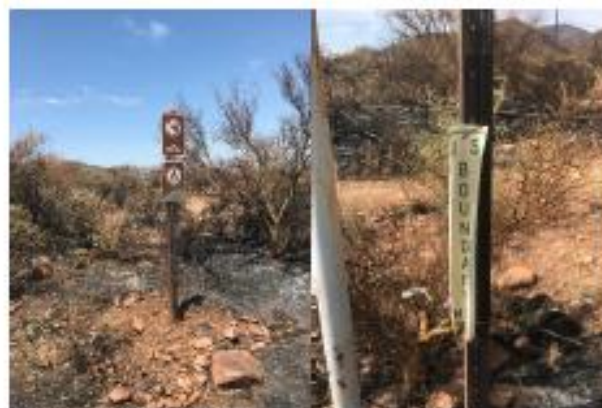
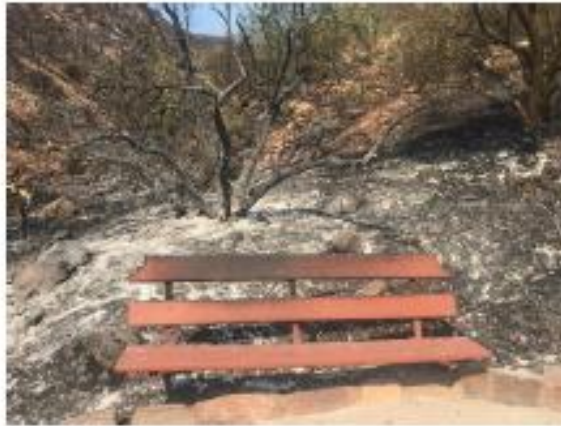
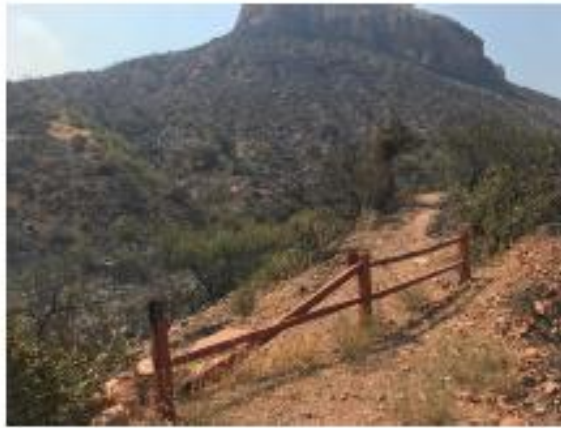
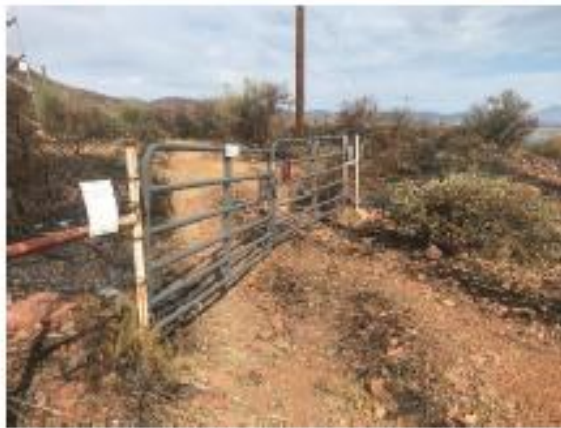
**Signs, Benches, Fences (Cinda – Lead):** Placement of new hazard signs at the trailheads, along the entrance road, and picnic areas is needed. A disclosure of entering a recently burned area is warranted as abatement of all risks is not possible. Typically, after 1 or 2 years these can be removed as site conditions stabilize and vegetative groundcover is once again established. Park signs and benches burned by the fire will be replaced along the entrance road, Hwy 188 corridor, and LCD trails before opening the park.

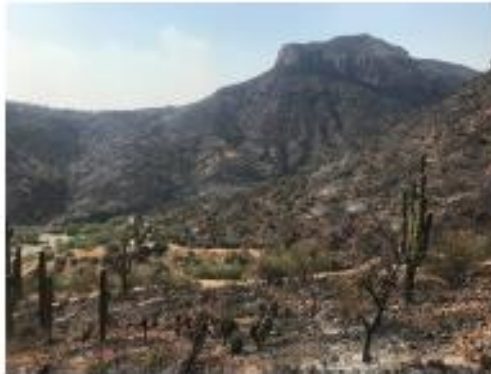
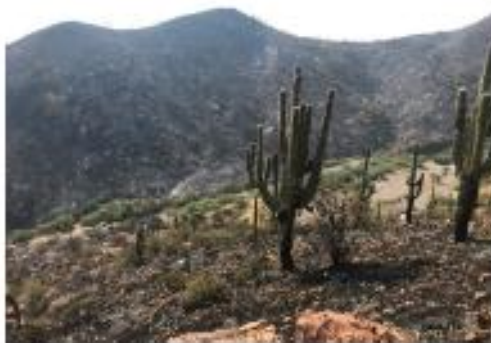
**Lower Cliff Dwelling Trail (Brett - Lead):** Rock fall, debris and hazard trees and saguaro/barrel cactus could potentially impact employee and visitor safety. There is a need to conduct an assessment of scorch height and instability (leaning/exposed roots) for individual saguaros and hazard trees that could fall and impact the trail. Hazard tree/cactus removal may be warranted depending on this assessment and observations of deterioration following winds and precipitation events during the summer monsoon.

Ecologists and saguaro experts will evaluate impacts to cactus and trees along the LCD trail. Hazard vegetation should be marked and then recorded for removal. Fire weakened/killed trees and cactus along the LCD trail corridor will be removed by a Wildland Fire Module or similar module including assistance from an Arborist/Master Faller overseeing the project. Schedule Andy Hubbard and Don Swann for a field consultation regarding hazardous saguaros (*Brett*). Once BAER funding is approved, the module will conduct work prior to opening the LCD trail to visitors.

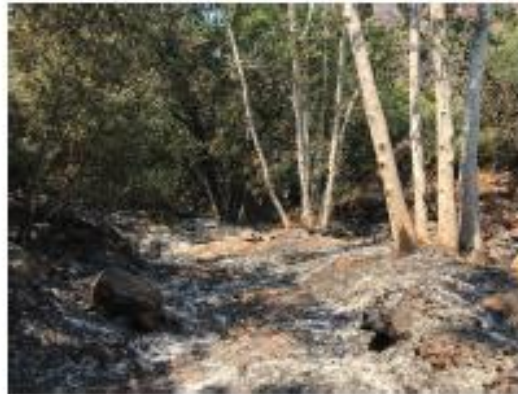
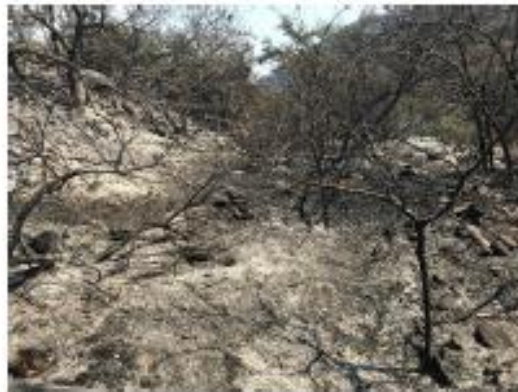
**Upper Cliff Dwelling Trail (Brett – Lead):** This trail winds through the creek bottom and is susceptible to significant changes from flooding, erosion, debris and hazard trees. Conduct a hazard tree assessment with focus on the mature Arizona Sycamore and Black Walnut trees. Hazard tree removal may be necessary depending on this assessment and observations of deterioration following winds and precipitation events during the summer monsoon.

Fire weakened/killed trees and cactus along the UCD trail corridor and riparian area will be removed by a Wildland Fire Module or similar module including assistance from an Arborist/Master Faller overseeing the project. Schedule Andy Hubbard and Don Swann for a field consultation regarding hazardous saguaros and an arborist for assessment of the riparian area. Once BAER funding is approved, the module will conduct work prior to opening the UCD trail to visitors. Some dead vegetation within the riparian corridor may be removed by park staff with reciprocal saws so that it doesn't plug up downstream culverts.

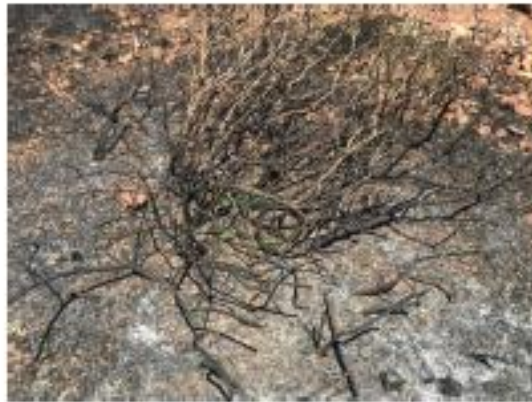
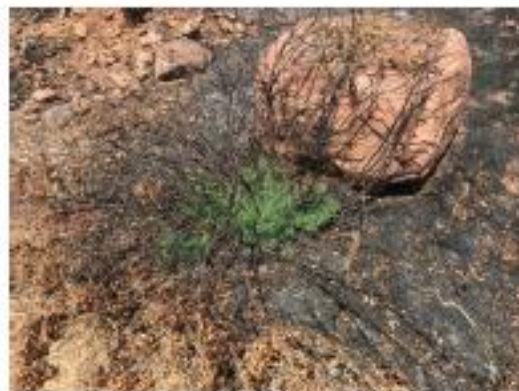
**(Cinda/Brett/SODN – Co-Leads):** The first phase of this project involves removing dead brush and trees that are not sprouting regrowth up to 12' from the road edge. Brush and trees with new regrowth will have dead/burned parts removed. Brush will be placed in nearby creeks as checkdams or hauled off to the barrow pit. This corridor is from the entrance gate to the visitor center parking lot. Saw work can be done by fire modules or outside trail crews. Jute matting, waddles, and reseedling should occur where needed.

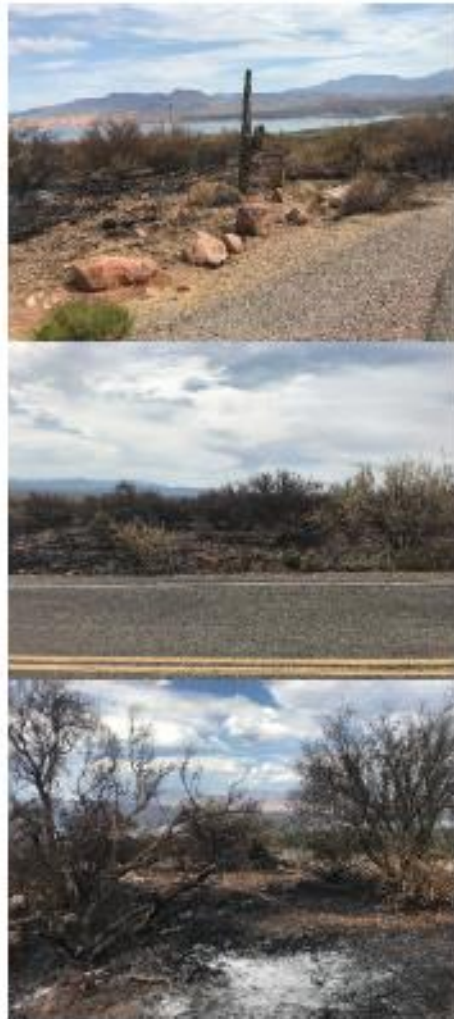
(Cinda/Brett/SODN – Co-Leads): The second phase of this project involves removing dead brush and trees that are not sprouting regrowth up to 150' from the road edge. Brush and trees with new regrowth will have dead/burned parts removed. Brush will be placed in nearby creeks as checkdams or hauled off to the barrow pit. This corridor is from the entrance gate to the visitor center parking lot. This work can be done by fire modules or trail crews with support from TONT staff. Jute matting, waddles, and reseedling should occur where needed.

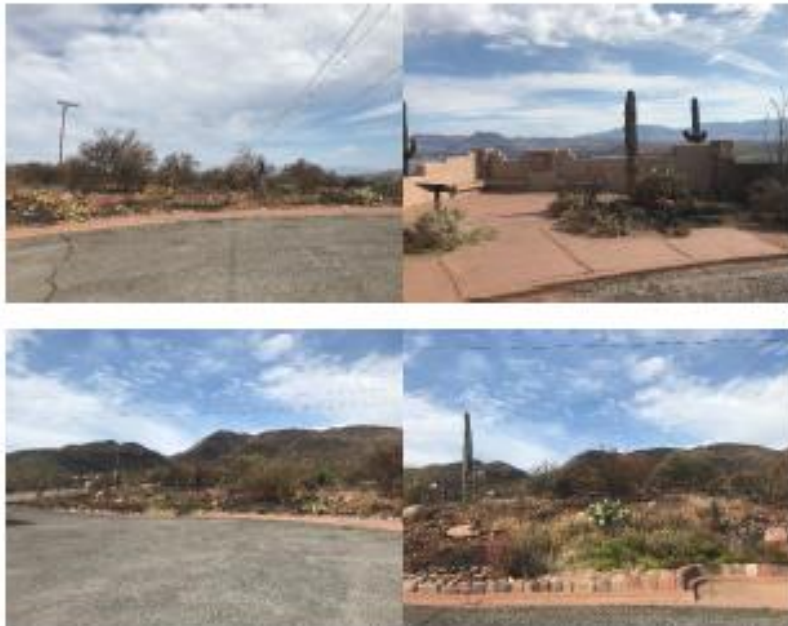
**(Cinda/Brett – Co-Leads):** This project involves removing dead brush and trees that are not sprouting regrowth from the turnaround road edge to the fenceline. Brush and trees with new regrowth will have dead/burned parts removed. Brush will be hauled off to the barrow pit. This work can be done by TONT staff. Reseeding should occur where needed. An area to build a park entrance sign should be cleared and prepared as part of this project. Future funding will be procured to build the iconic park sign.

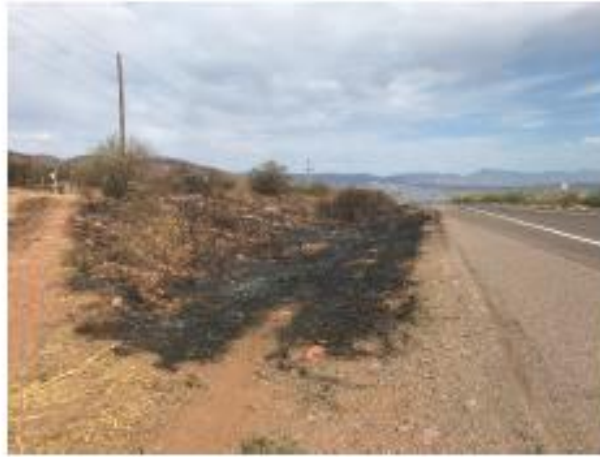
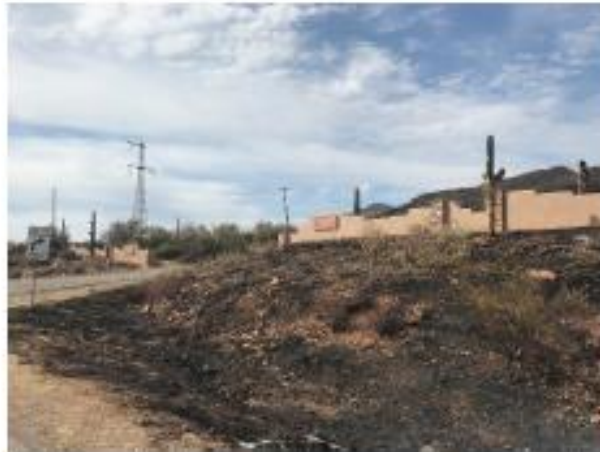
**(Cinda/Brett/SODN – Co-Leads):** This project involves removing dead brush and trees that are not sprouting regrowth from the 188 road edge to the fenceline. Brush and trees with new regrowth will have dead/burned parts removed. Brush will be hauled off to the barrow pit. This work can be done by fire modules or trail crews with support from TONT staff. Jute matting, waddles, and reseedling should occur where needed. This work will be done in conjunction with ADOT as well.

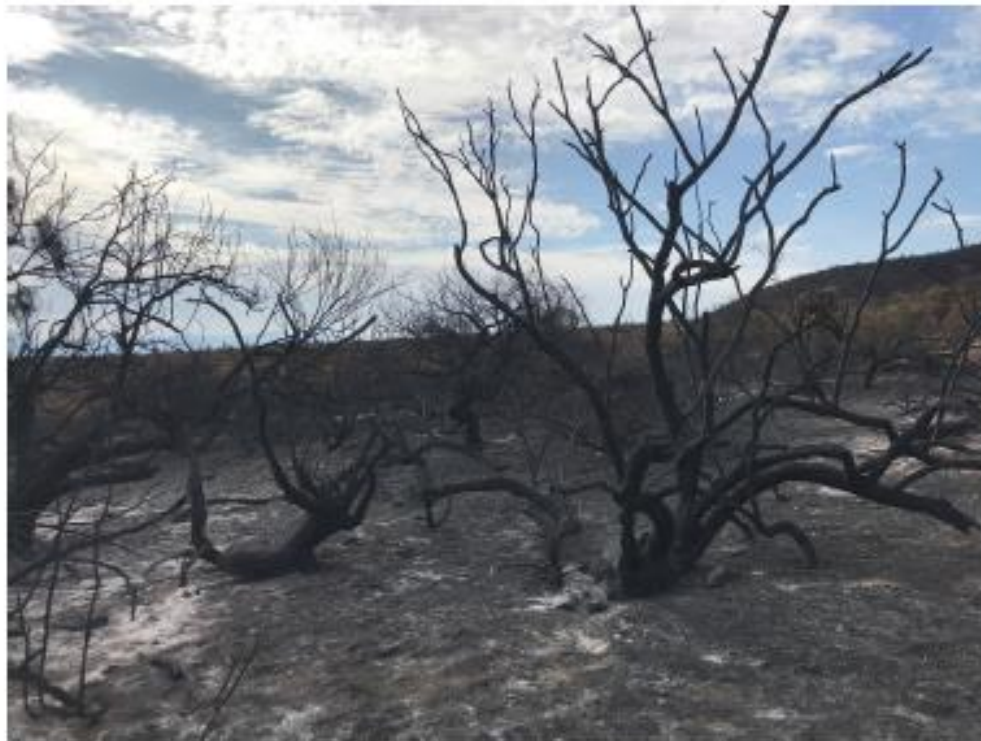
**(Brett/SODN – Co-Leads):** Develop a restoration plan in conjunction with SODN. Assessments of the Hidden Ridge site will be needed after the summer rains. The site will be re-recorded and mapped.
