# Preservation/Restoration of Moton Field

Tuskegee Airmen  
National Historic Site  
Tuskegee, Alabama

*Historic Structure Report*  
Bath & Locker House

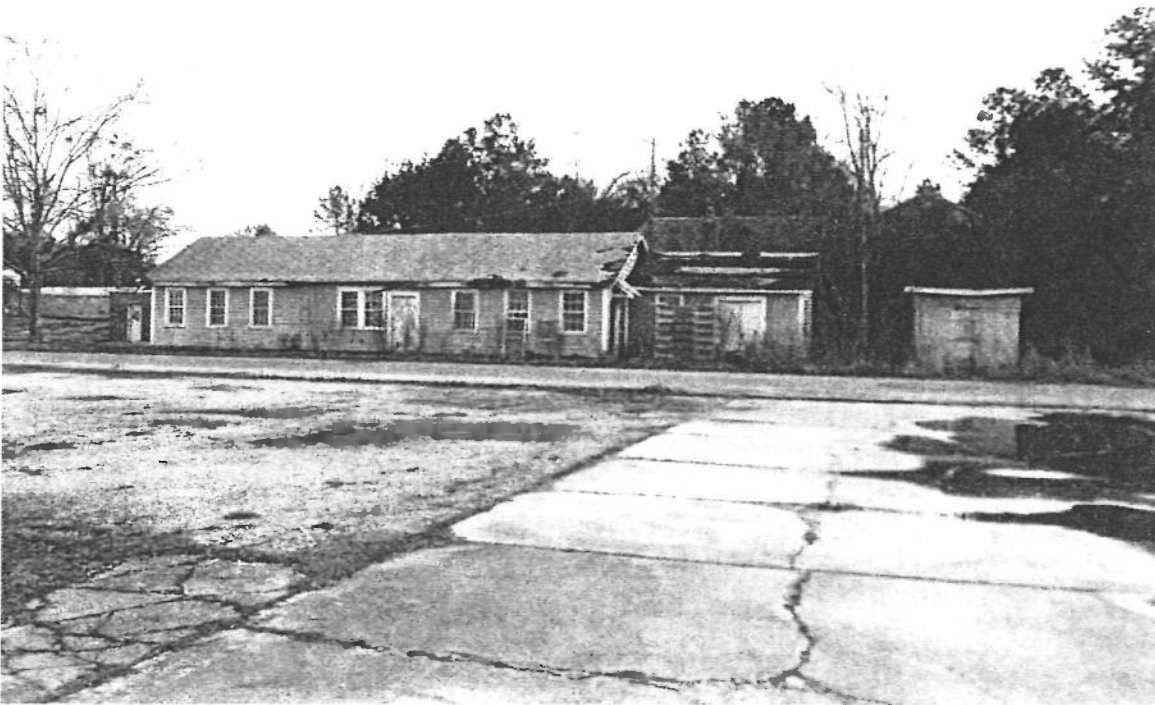
**Figure 6:** North facade in 1997 prior to stabilization. National Park Service, SERO, Atlanta, Georgia.

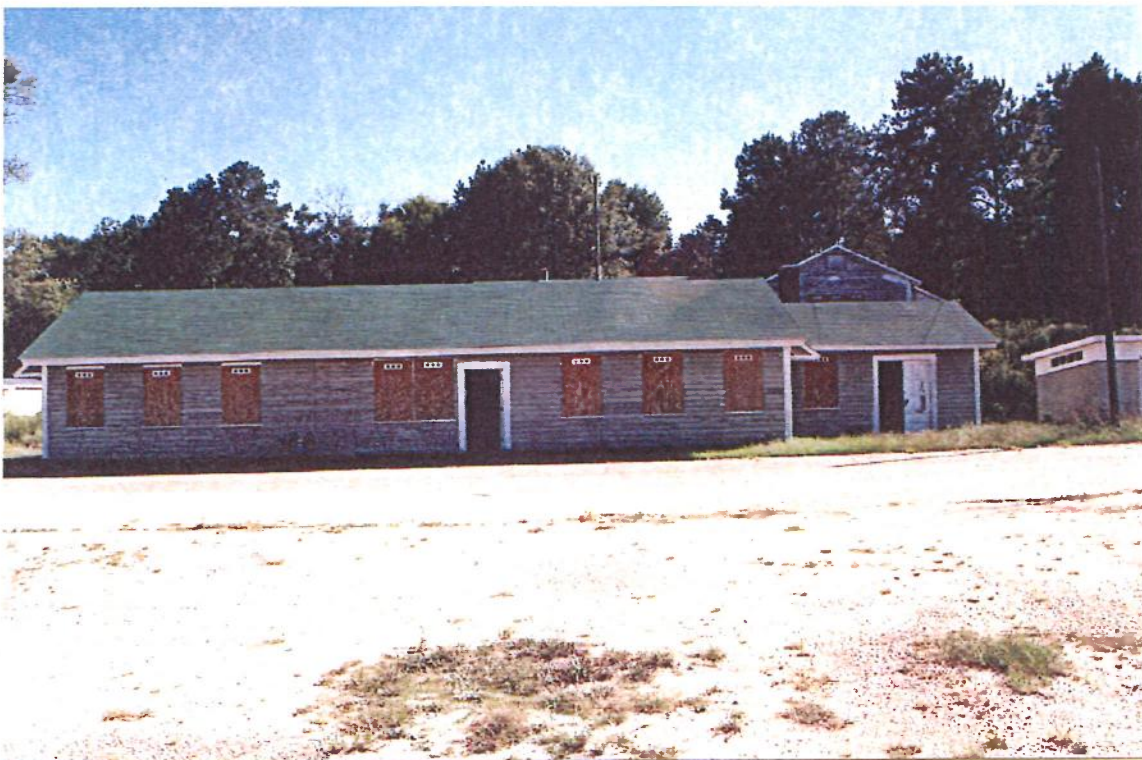
**Figure 8:** Existing north front facade.

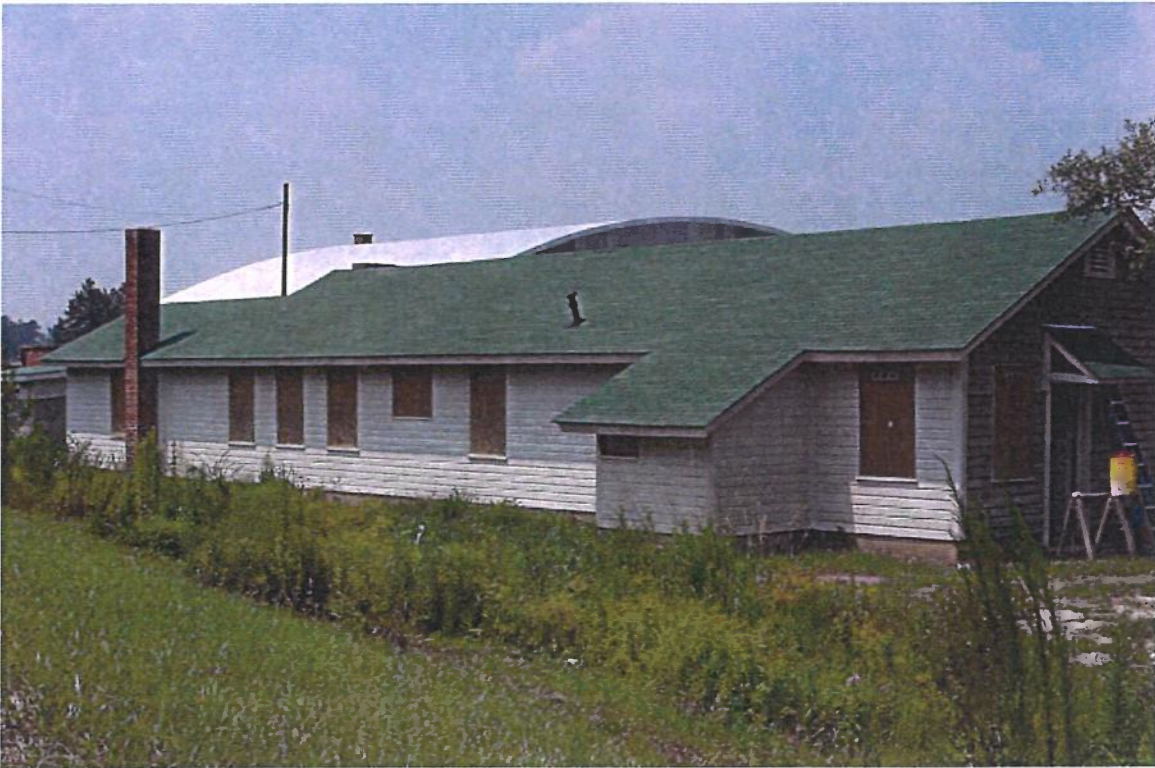
**Figure 9:** Existing south rear facade.

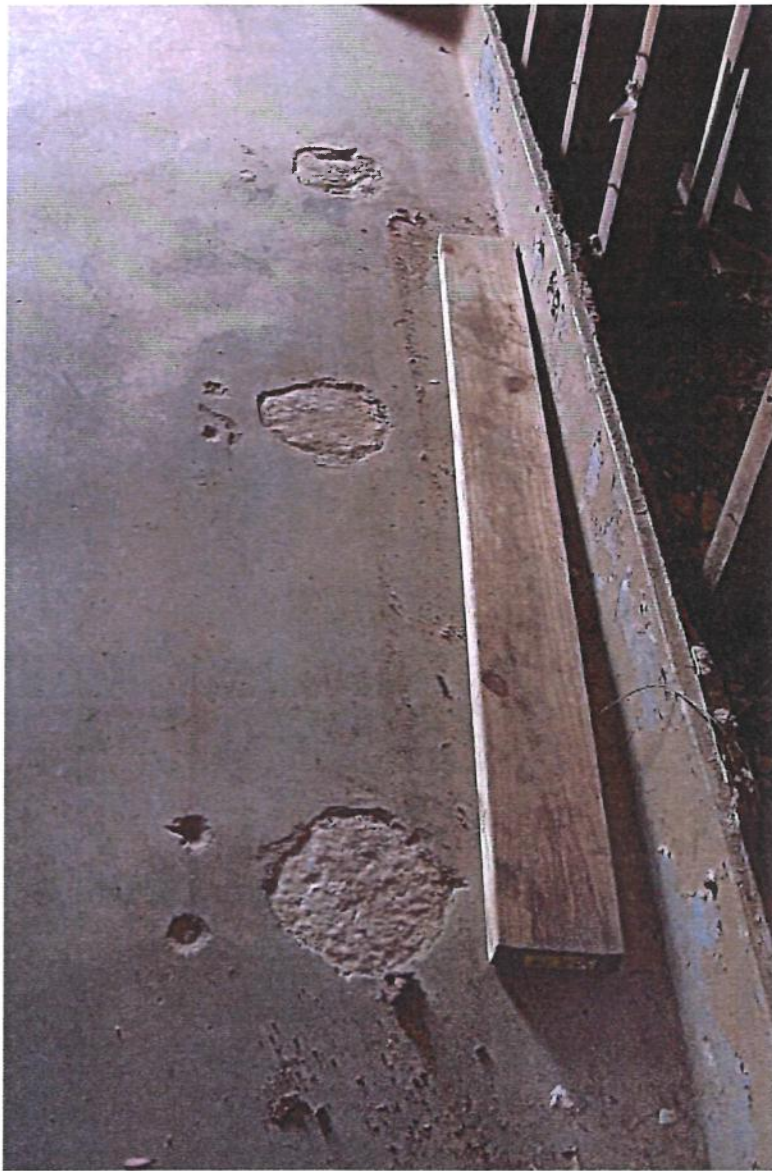
Figure 10: Former location of toilets in men's toilet room.

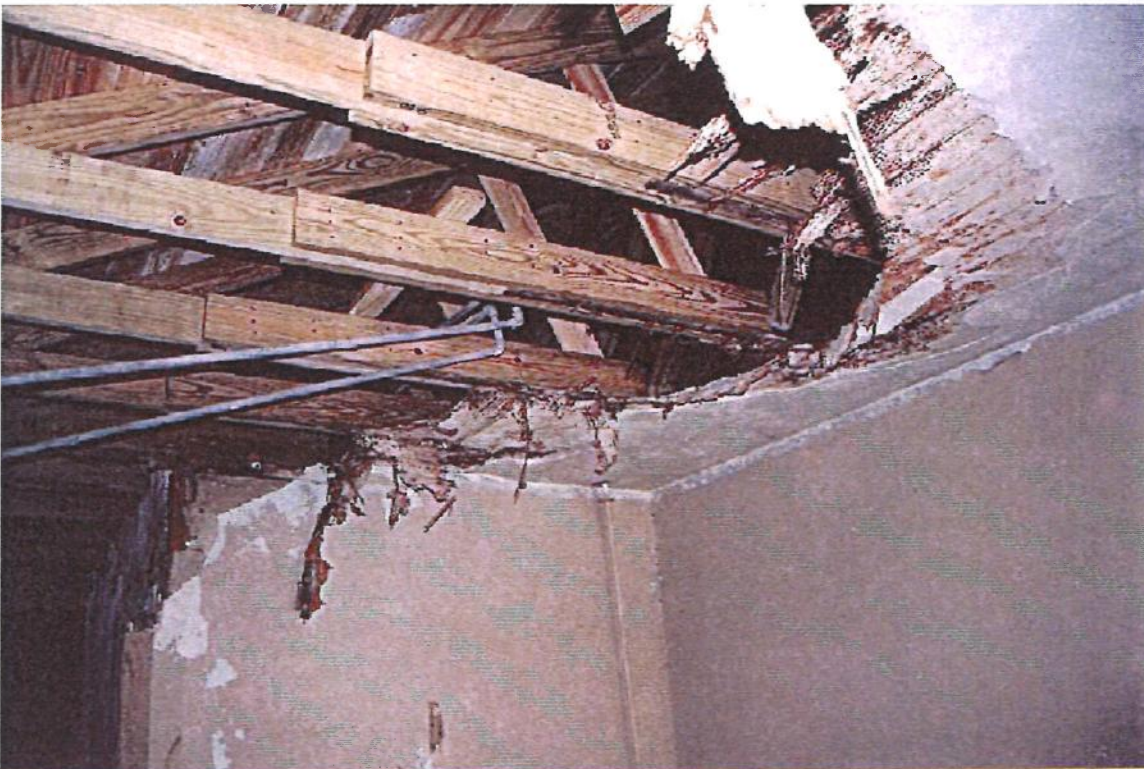
**Figure 12:** Deteriorated condition of plaster ceiling in the first aid room.

All interior walls and ceilings were originally painted plaster. Much of the plaster has been lost over time due to the deterioration of the building. In general, the further away from the south wall, the better the condition of the plaster. A room by room description of interior finishes follows.

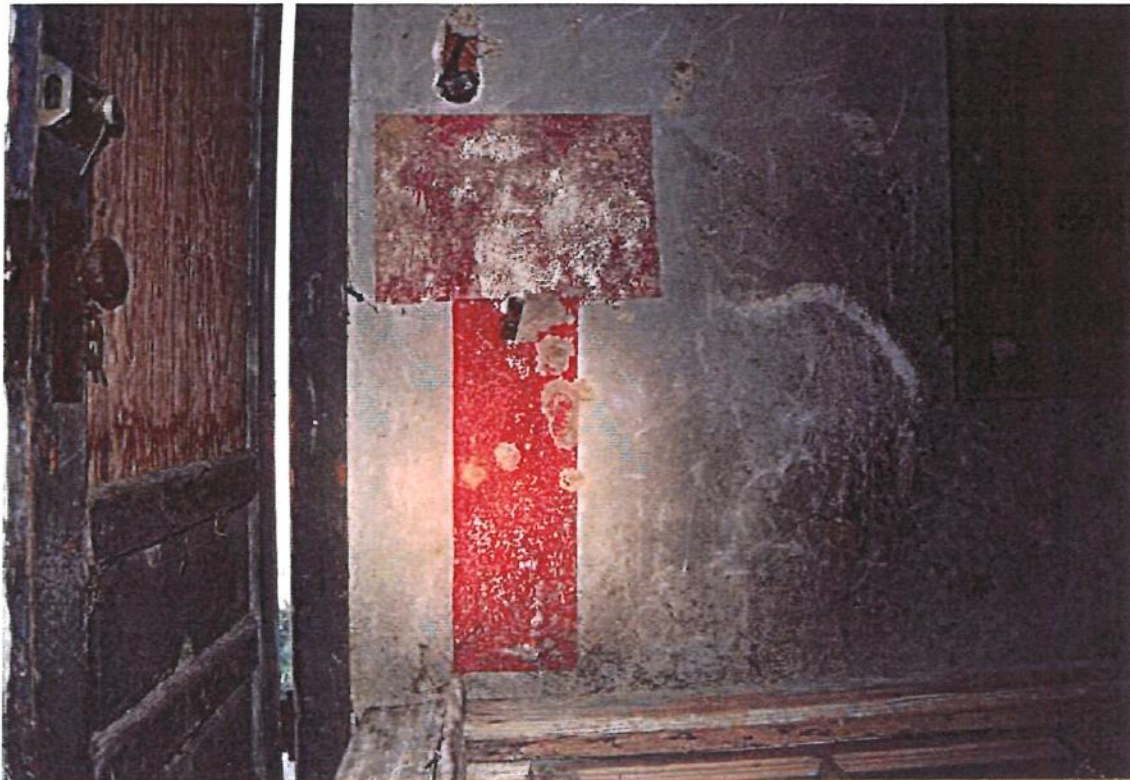
**Figure 13:** Evidence of fire safety system on the north interior wall of the heater room.

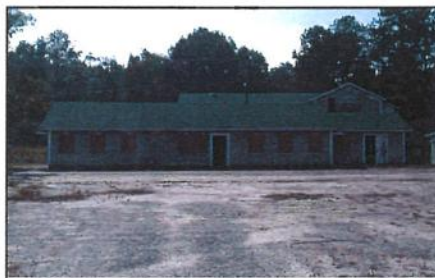
| <b>Deficiency:</b> | Loose and warping siding has been replaced. Loose and peeling paint has been corrected |

| <b>Recommendation:</b> | Repaint to match original color scheme. |

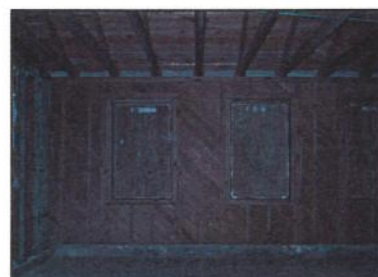
| <b>Deficiency:</b> | Collapsed portions have been replaced. |

| <b>Recommendation:</b> | Utilize as restored. |

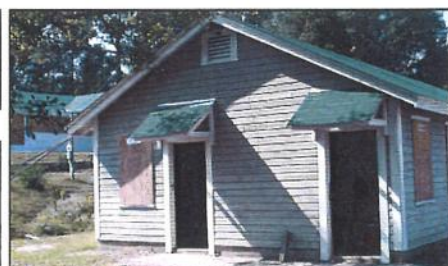
| <b>Deficiency:</b> | Missing boards and deteriorated trim have been replaced during stabilization. Loose and peeling paint has been corrected. |

| <b>Recommendation:</b> | Repaint to match original color scheme. |

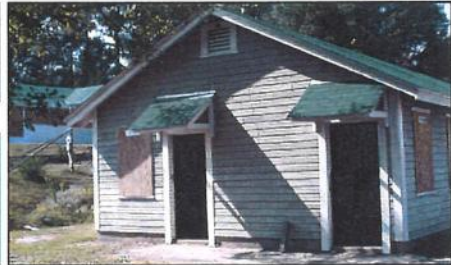
| <b>Deficiency:</b> Missing and deteriorated elements have been replaced during stabilization. |

**Materials:** \$2,922.00 **Labor:** \$228.00 **Quantity:** Total = \$3,150.00

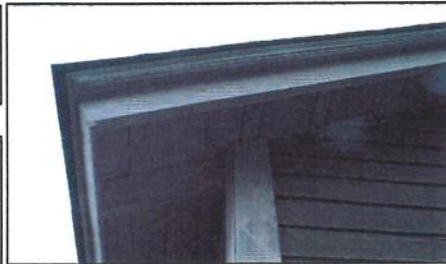
**Deficiency:** Missing boards and deteriorated trim have been replaced during stabilization. Loose and peeling paint has been corrected.

**Recommendation:** Repaint to match original color scheme.

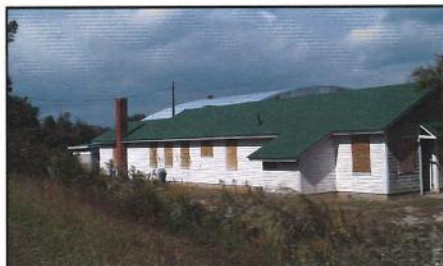
The current roof covering is green three tab asphalt shingles. The shingles were replaced during recent stabilization work and do not accurately reflect the historic roof covering.

**Recommendation:** Remove modern roofing material and replace with replicated roofing material to match original construction.

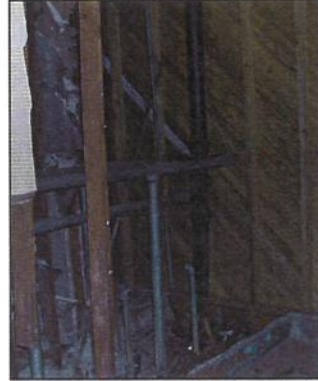
The south exterior wall was largely reconstructed in the recent stabilization work. Only a portion of the original frame work on this facade remains at the southwest corner of the building. Interior wall studs closest to the south wall are either deteriorated or missing. The east wall of the heater room has one replacement stud as well as a new pressure-treated plate that runs the entire length of the wall. In the southeast corner of the men's locker room what remains of the original frame wall is severely deteriorated. Water damage has destroyed the plate along the east wall to the point that some thirty-six inches of the plate no longer exist. Two wall studs on this wall closest to the southeast corner have been removed and the next wall stud does not meet the plate because of damage. On the east wall of the men's toilet, what remains of the plaster is helping to support the frame wall. The plate has been recently cut away at the south end and at least three wall studs are missing from this end.

**Recommendation:** Install missing studs to receive new wall surface.

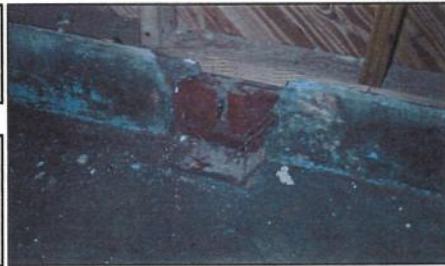
The original concrete slab on grade floors remain intact throughout the building. Concrete curbs around the perimeter of each room were constructed of brick with concrete applied over the surface. The floors and curbs are generally in sound condition but are cracked and broken in some areas.

**Recommendation:** Repair broken curb with in-kind concrete material.

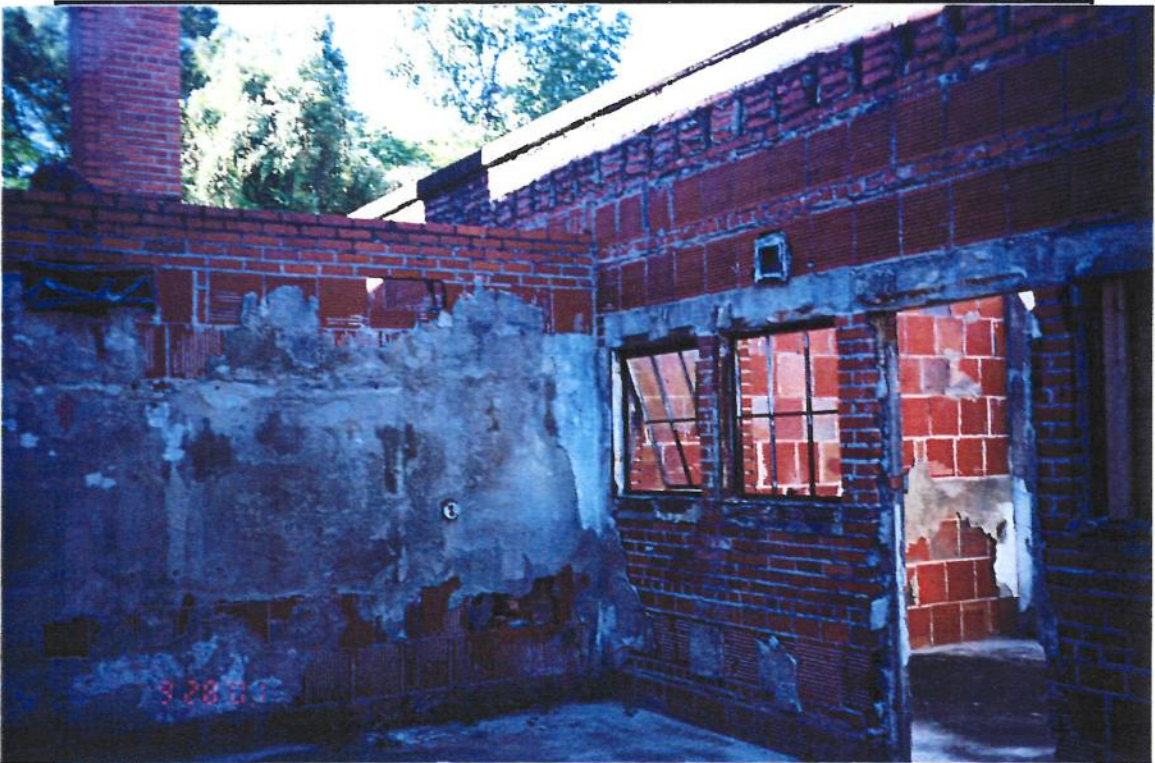
**Photo 10. Hangar No. 1, Interior – Parge coat mortar observed on structural clay tile and masonry surfaces.**

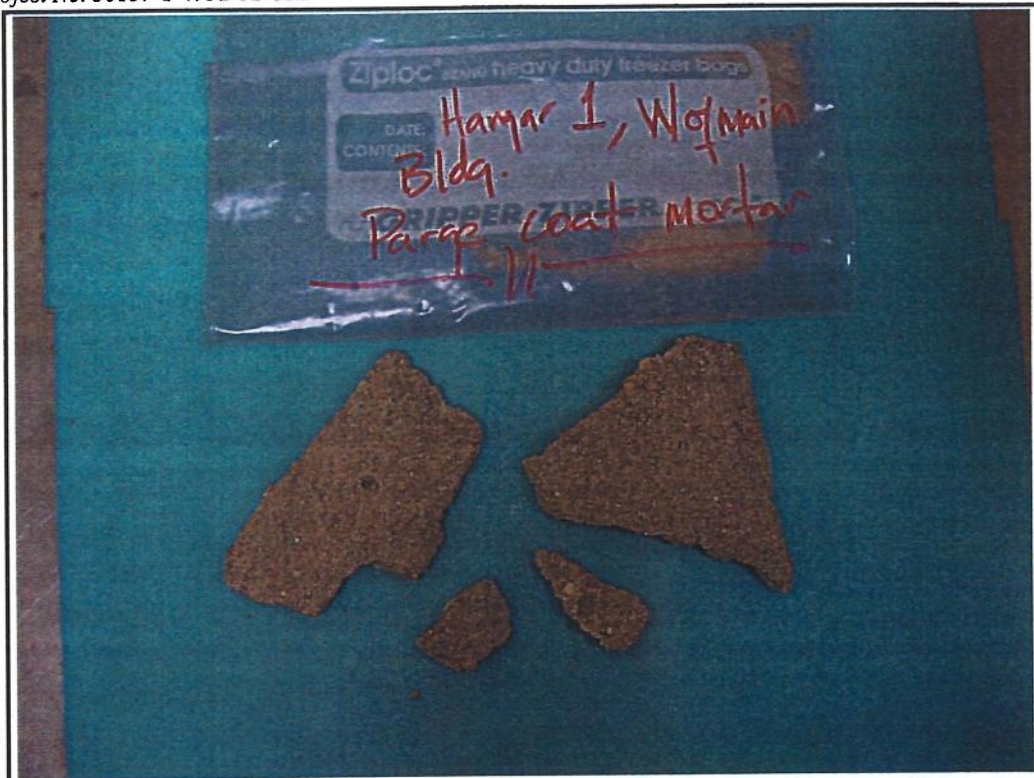
Photo 11. Hangar No. 1, Interior – Parge coat mortar observed. Note sand particles on surface poorly bonded to mortar.

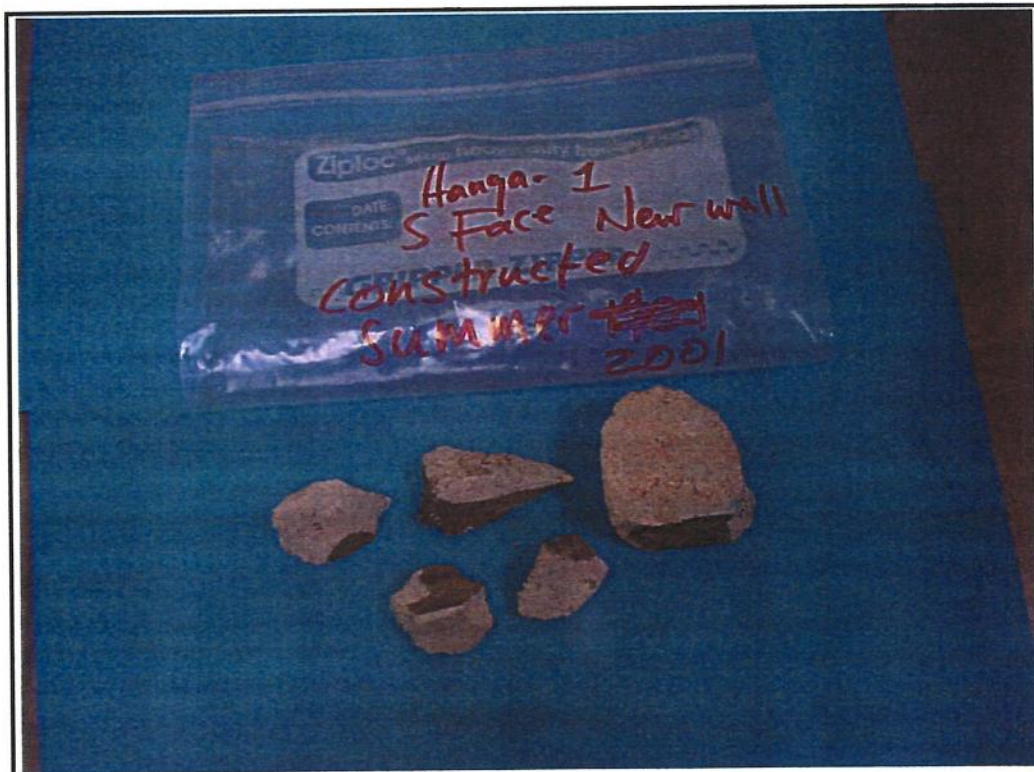
Photo 12. Hangar No. 1, Exterior South Face – Mortar samples taken from new construction. Note white mortar color (A) and brown smear coat (B) on tooled joint surface.

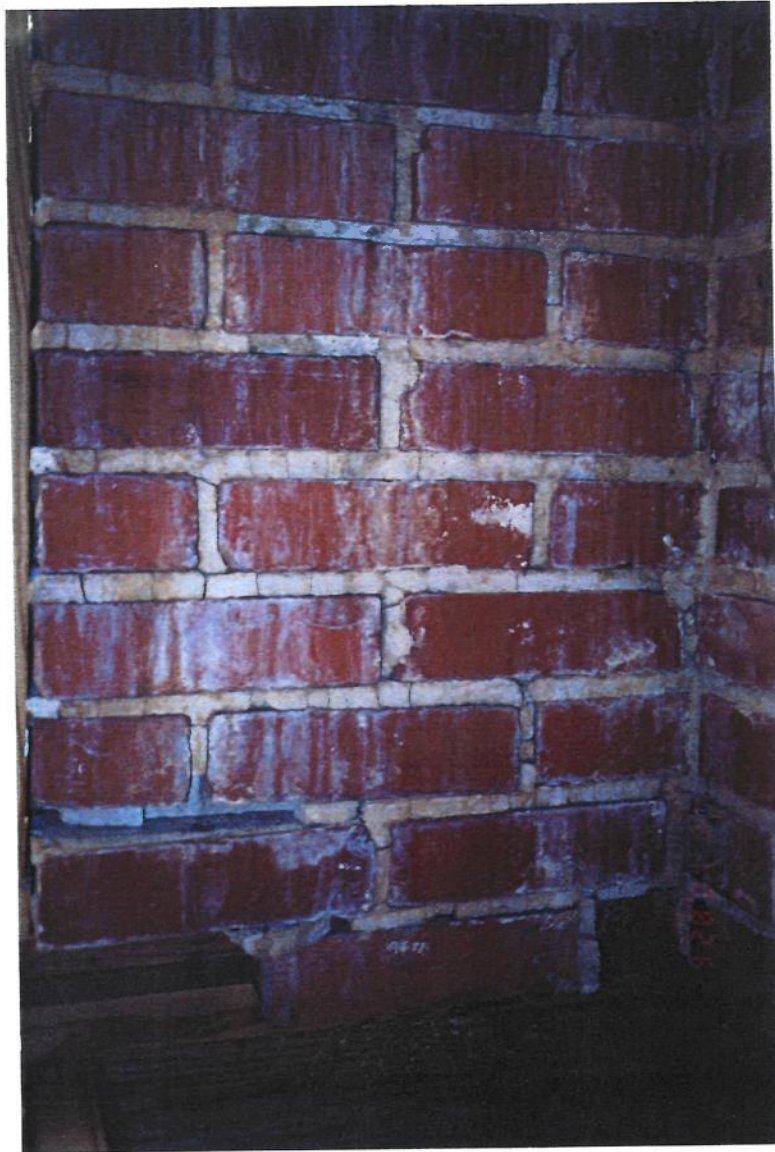
**Photo 15. Fire Protection Shed – Interior face beside door. Note cracked mortar.**

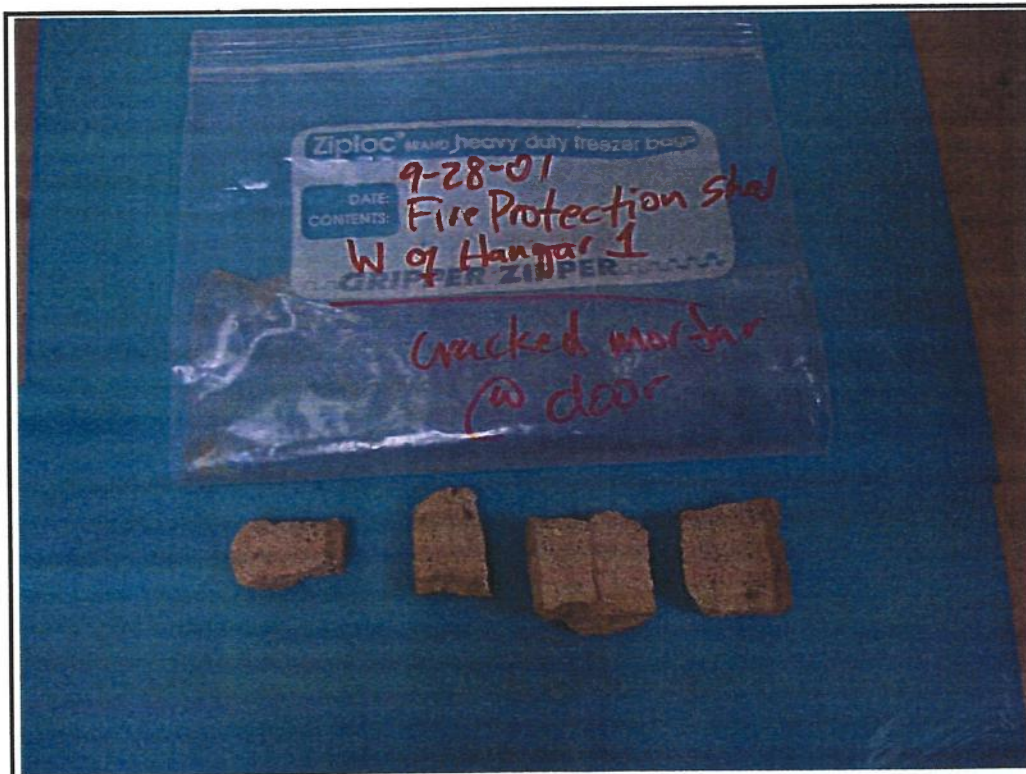
Photo 17. Fire Protection Shed – Interior cracked mortar at door. Note mortar discoloration at surface (extending approximately  $\frac{1}{4}$  inch from surface).
