# Preservation/Restoration of Moton Field

## Phase II

Tuskegee Airmen  
National Historic Site  
Tuskegee, Alabama

*Historic Structure Report*  
Dope Storage Shed

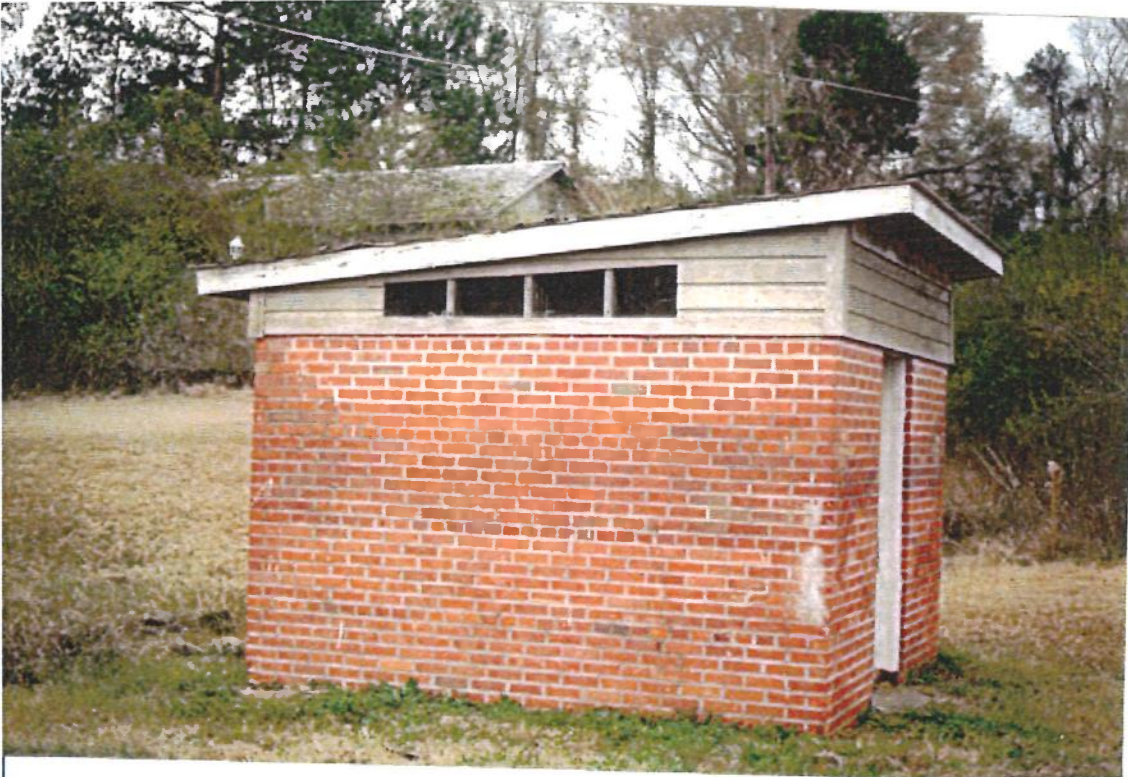
**Figure 4:** East elevation of structure prior to reconstruction of the wood siding and roof. Pond & Company.

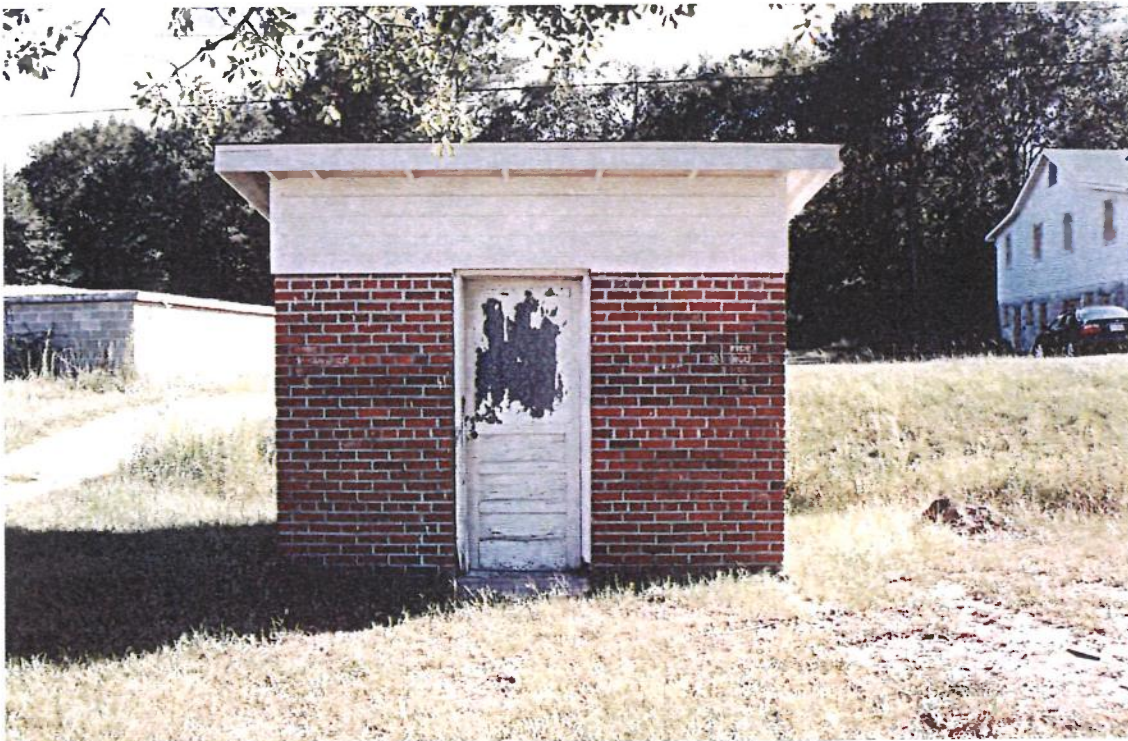
**Figure 5:** North elevation after reconstruction of wood siding and roof structure.

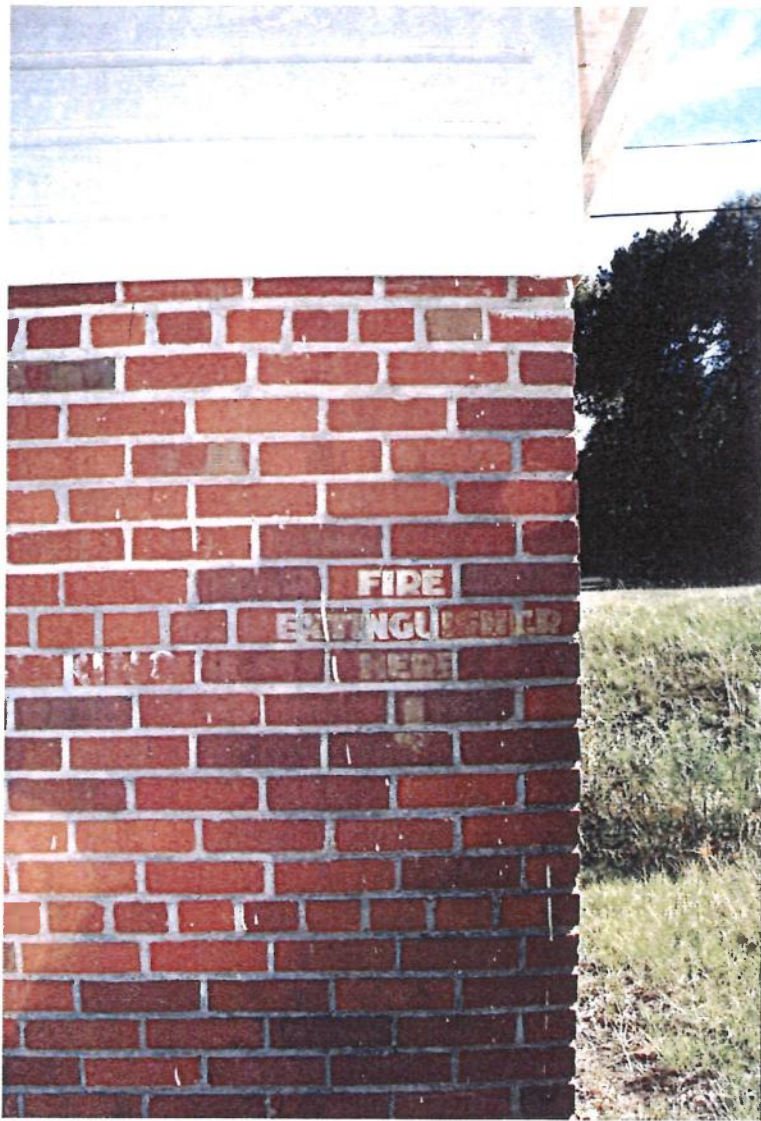
Figure 7: Fire safety indicator on north elevation.

- Clean masonry walls with the gentlest method possible in heavily soiled areas; do not remove historic stenciled fire safety indicators on the north facade.
- Repoint mortar joints where there is evidence of deteriorated mortar with mortar of a similar strength, composition, color, and texture to the historic mortar (see Conclusions in the *Mortar Analysis* in *Appendix D* for recommended compatible mortar); tool joints to match existing.
- Install fire safety fixtures to original location on north (front) facade.

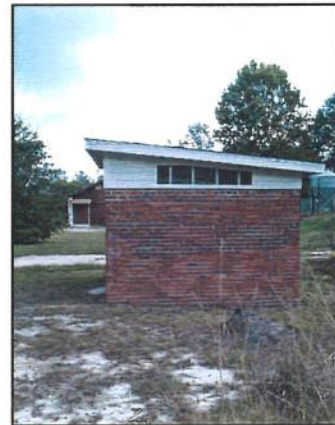
**Brick****Feature Description:** Brick wall**Feature Notes:****Feature Condition:** Fair**Total Inventory:** 283 S.F.**Historic Rating:** H**Priority:** Minor**Deficiency:** Wall is discolored and weathered

**Recommendation:** Clean masonry to remove discoloration without harming existing masonry.  
Re-point mortar joints where evidence of deterioration.

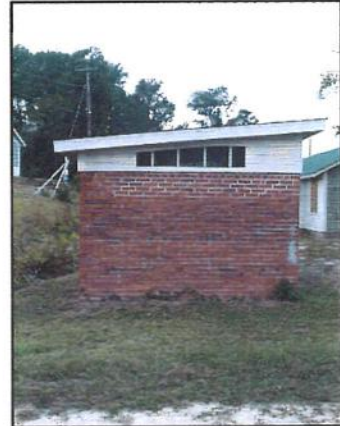
**Deficiency:** Section of roof had collapsed  
Frieze boards have been replaced during stabilization.  
Only four openings are required.

**Recommendation:** Reconstruct frieze to original  
4 opening configuration.

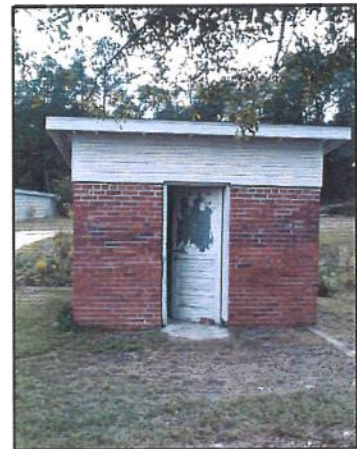
**Deficiency:** Wood fascia board was replaced  
during stabilization

**Recommendation:** Repaint to match original color  
scheme.

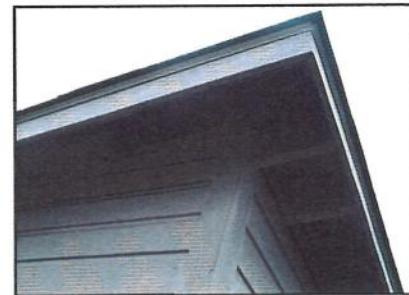
**EXTERIOR****4117****Exterior Eave/ Soffit****Wood****Feature Description:** 12" Wood roof eave**Feature Notes:****Feature Condition:** Good**Total Inventory:** 44 S.F.**Historic Rating:** H**Priority:** Minor**Deficiency:** Wood roof and eave system was replaced during stabilization**Recommendation:** Attach roof system to brick walls by tying frame into top row of bricks. Repaint to match original color scheme.

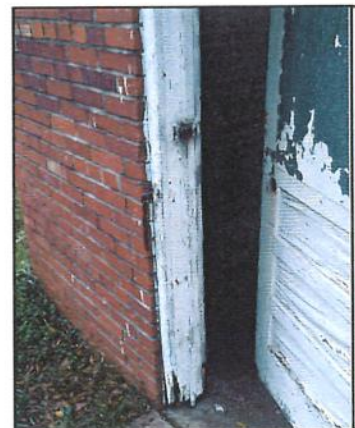
**Materials:** \$169.00 **Labor:** \$502.00 **Quantity:** **Total =** \$671.00**EXTERIOR****4151****Exterior Door Frame****Wood****Feature Description:** Wood door frame**Feature Notes:****Feature Condition:** Poor**Total Inventory:** 1**Historic Rating:** H**Priority:** Serious**Deficiency:** Door frame deteriorating**Recommendation:** Repair deteriorated areas of door frame. Reconstruct as necessary.

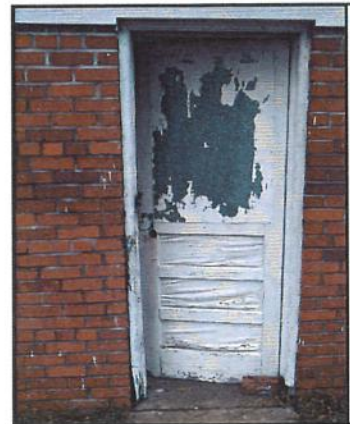
**Feature Condition:** Poor

**Deficiency:** Paint peeling, door hardware is missing, panels warped and buckled.

**Recommendation:** Restore and repair door items as required.

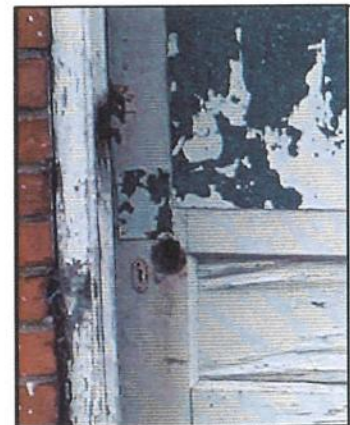
**Feature Condition:** Missing

**Deficiency:** Door hardware missing

**Recommendation:** Replicate hardware and install.

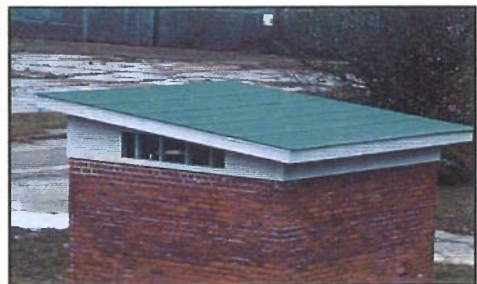
| <b>Feature Notes:</b> | Section of the roof had collapsed. The entire roof and structure has been replaced during stabilization. |

| <b>Recommendation:</b> | Replace modern roofing material with replicated shingles to match original construction. |

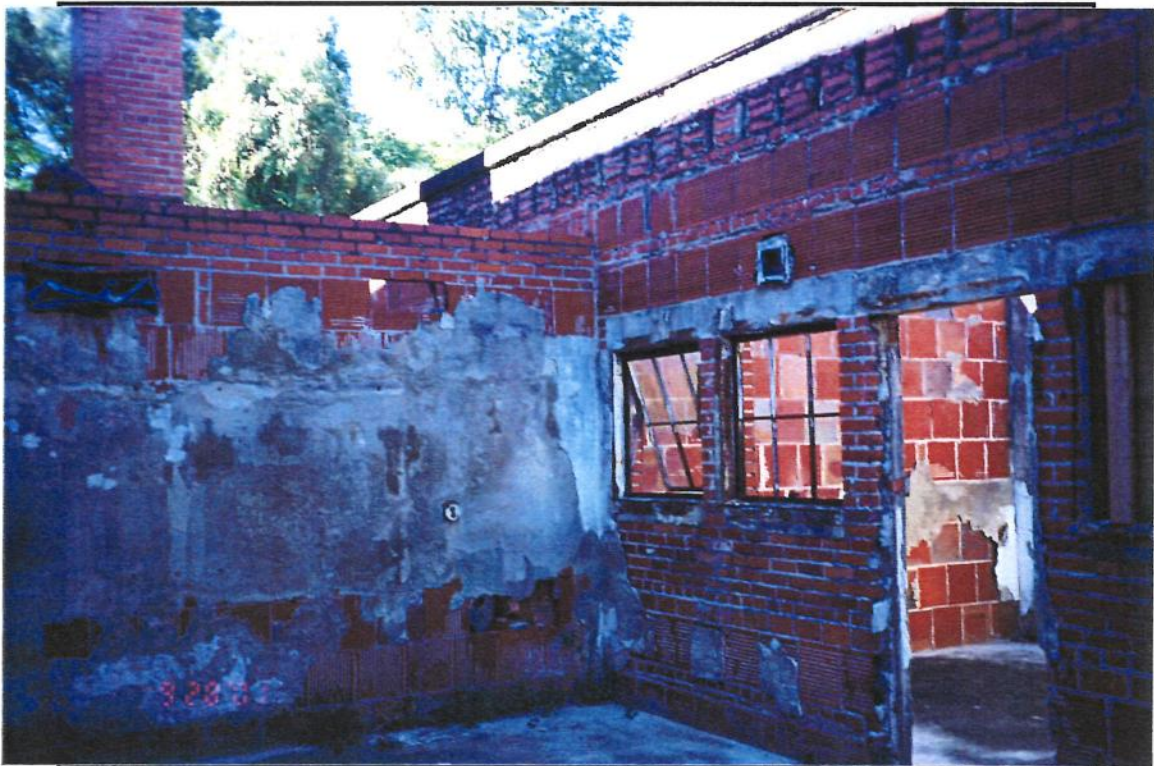
**Photo 10. Hangar No. 1, Interior – Parge coat mortar observed on structural clay tile and masonry surfaces.**

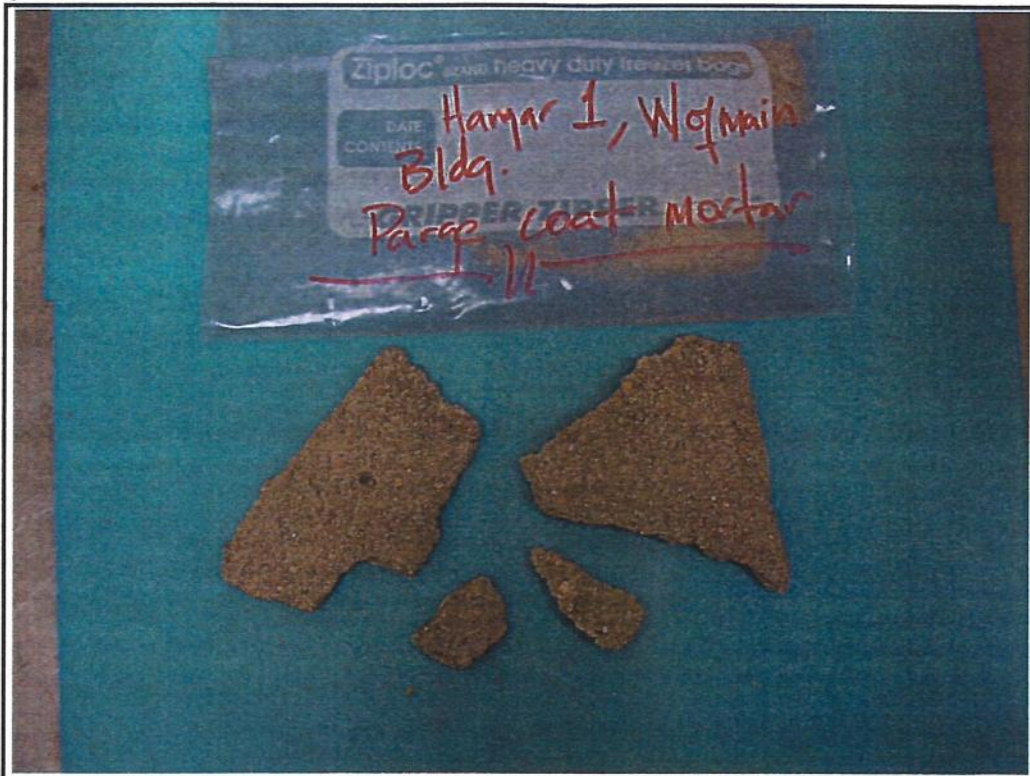
Photo 11. Hangar No. 1, Interior – Parge coat mortar observed. Note sand particles on surface poorly bonded to mortar.

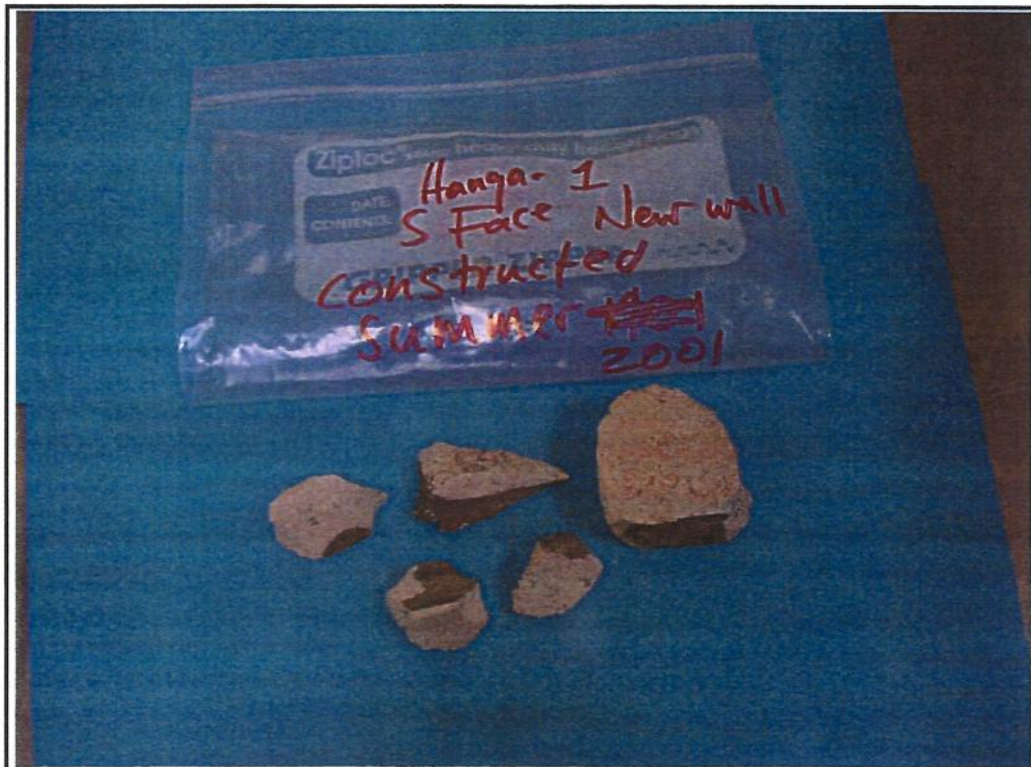
Photo 12. Hangar No. 1, Exterior South Face – Mortar samples taken from new construction. Note white mortar color (A) and brown smear coat (B) on tooled joint surface.

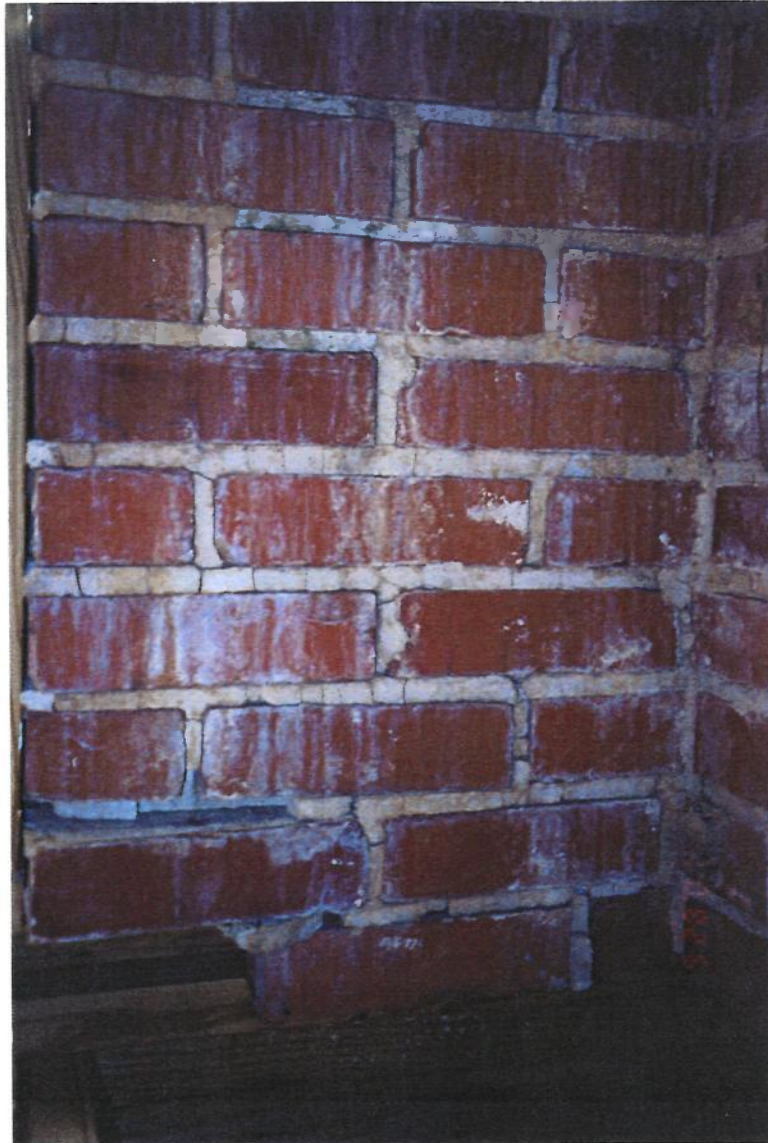
**Photo 15. Fire Protection Shed – Interior face beside door. Note cracked mortar.**

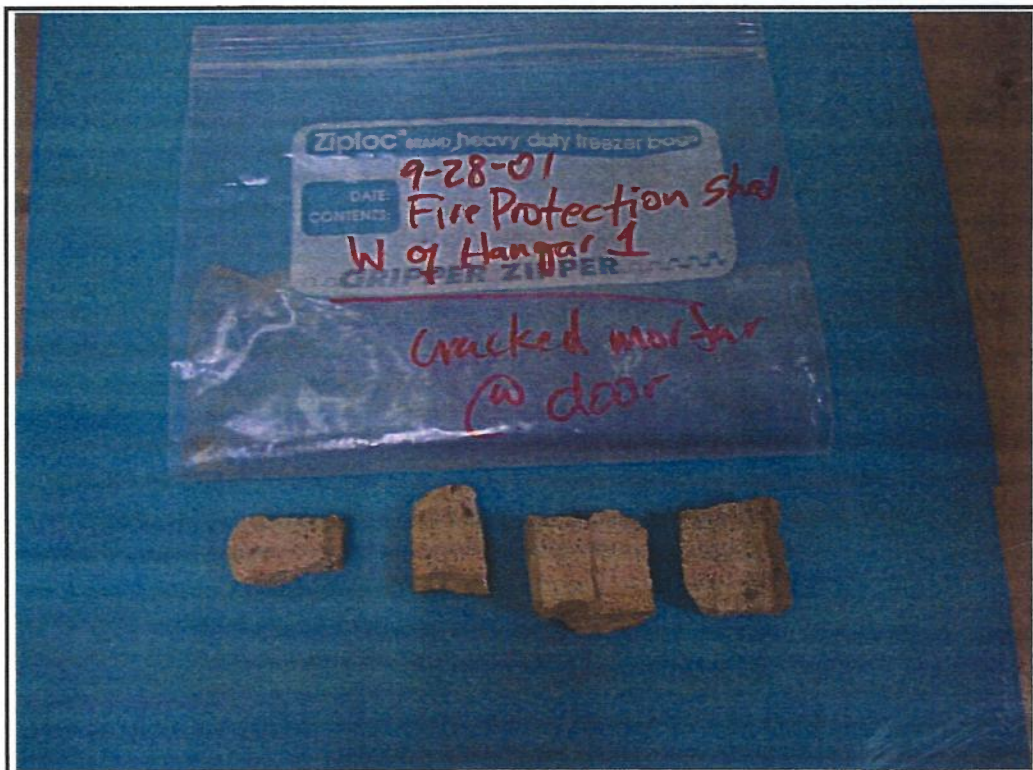
Photo 17. Fire Protection Shed – Interior cracked mortar at door. Note mortar discoloration at surface (extending approximately  $\frac{1}{4}$  inch from surface).
