# Preservation/Restoration of Moton Field

## Phase II

Tuskegee Airmen  
National Historic Site  
Tuskegee, Alabama

*Historic Structure Report*  
Entrance Gate

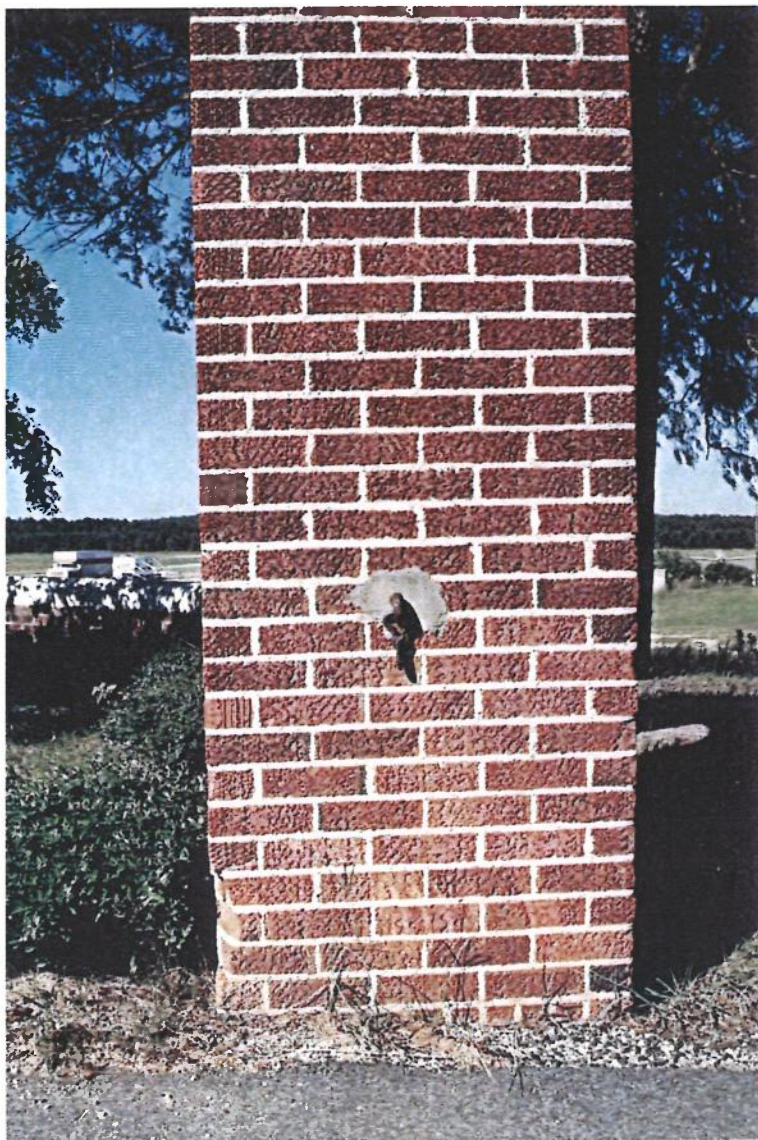
Figure 6: Evidence of the security chain on the south side of the North Wall.

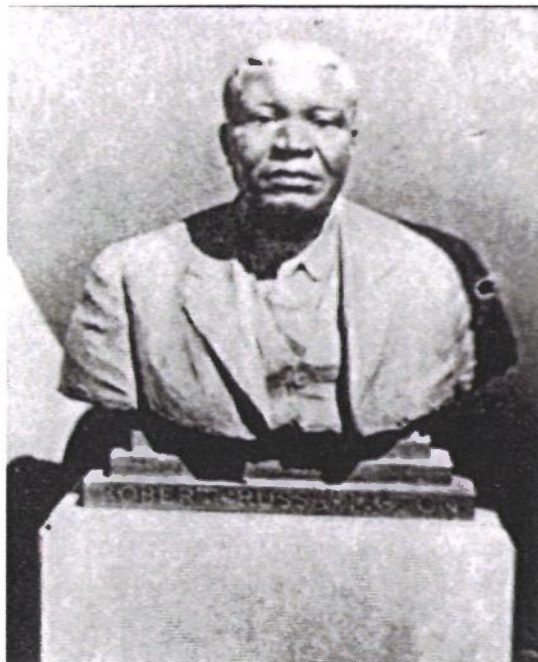
**Figure 8:** Bust of Robert Moton that was formerly located in the niche in the South Wall. AFHRA, Maxwell AFB.

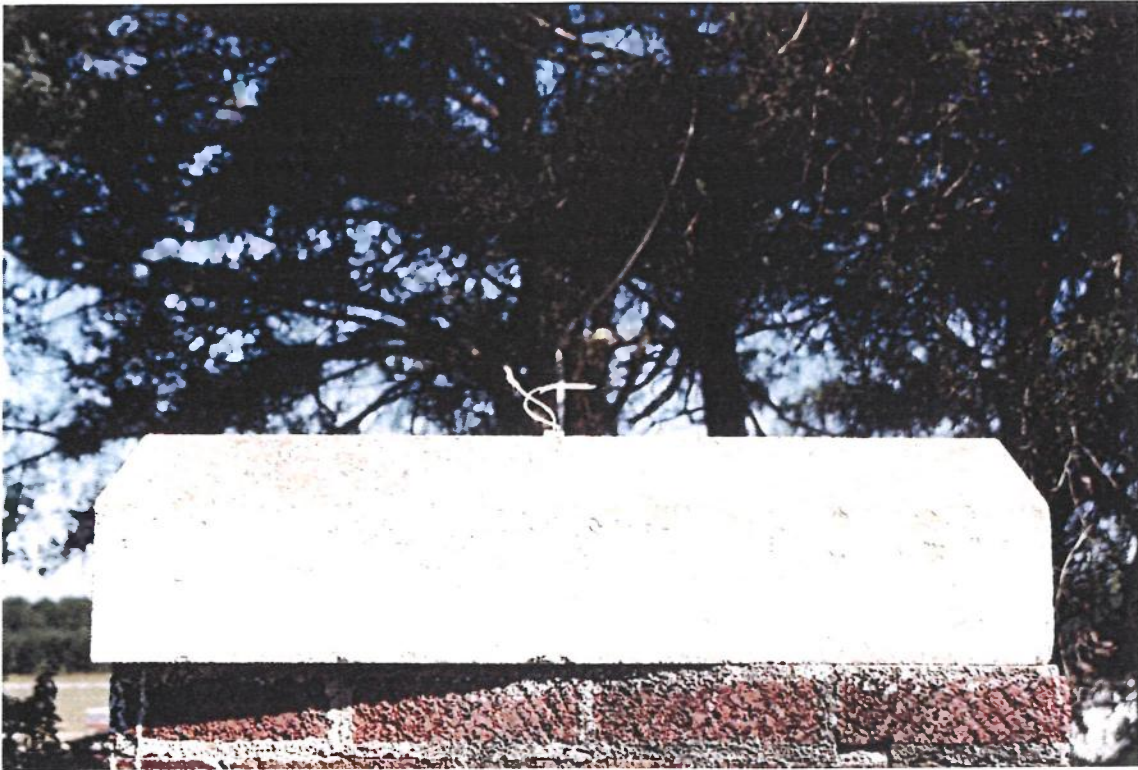
**Figure 9:** Existing lighting wiring on top of gate pier for lanterns.

- Repair structural deficiencies (stress fracture and separation of seat wall from wing wall) in North Wall.
- Clean gate hardware.
- Replicate missing light fixtures on gate piers based on physical evidence and historic photographs.

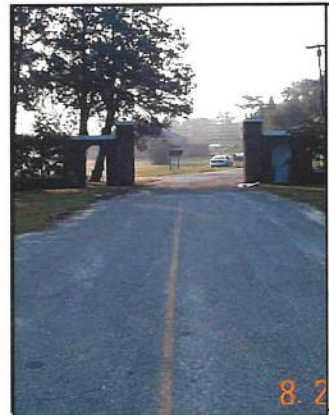
**Deficiency:** Minor discoloration on bricks  
Some deterioration of mortar.

**Recommendation:** Clean masonry to remove  
discoloration without harming existing brickwork.  
Repair and repoint mortar as necessary.

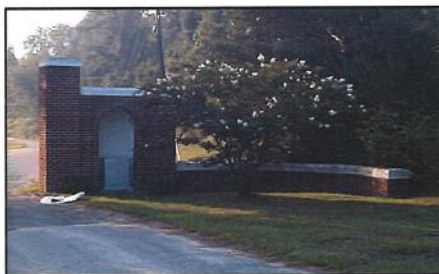
**Deficiency:** Missing sculpture for niche.

**Recommendation:** Repair and re-paint interior of niche. Replicate missing bust and install in niche. The replicated bust is not included in the estimate.

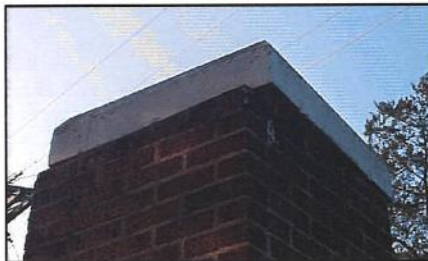
**Deficiency:** Pre-cast cap set askew

**Recommendation:** Re-align and secure as necessary.

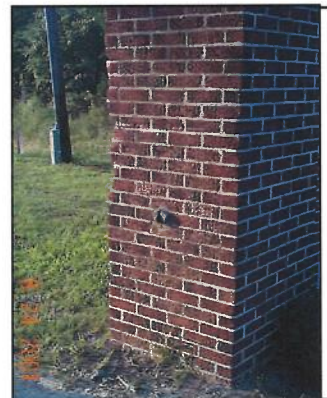
**Deficiency:** Deterioration of brick on col.

**Recommendation:** Replace damaged bricks and re-point deteriorated masonry mortar joints as needed.

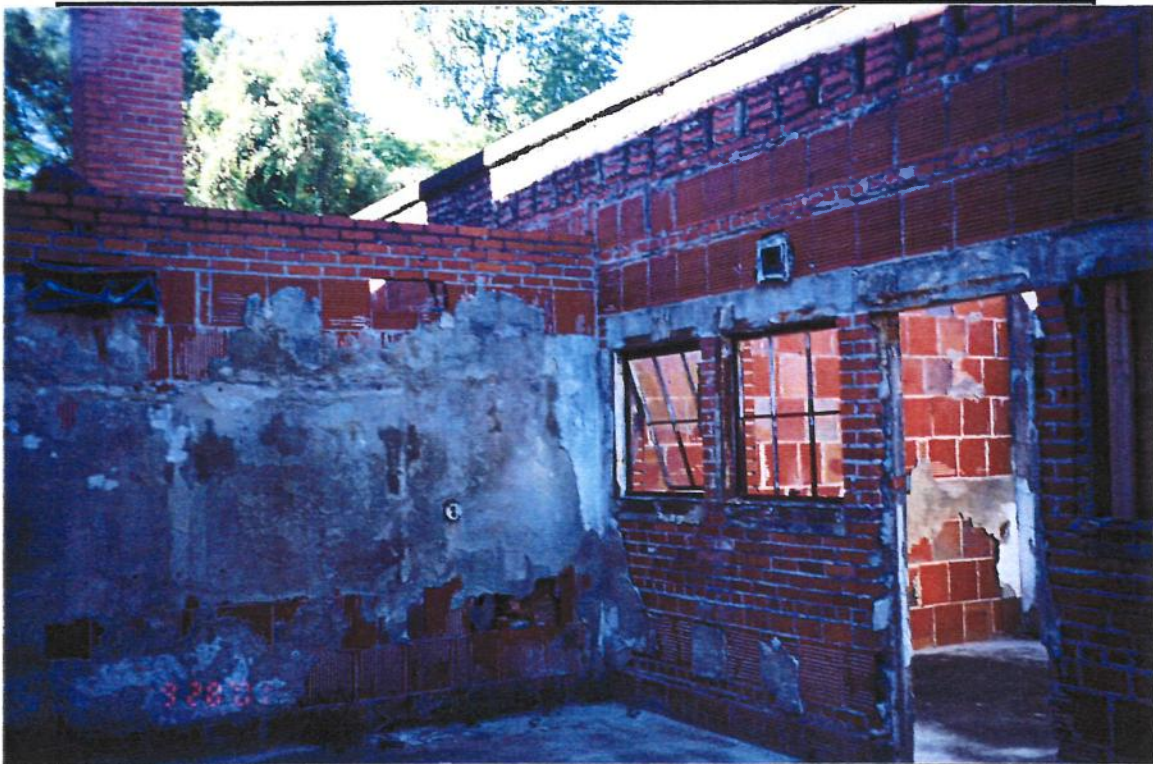
**Photo 10. Hangar No. 1, Interior – Parge coat mortar observed on structural clay tile and masonry surfaces.**

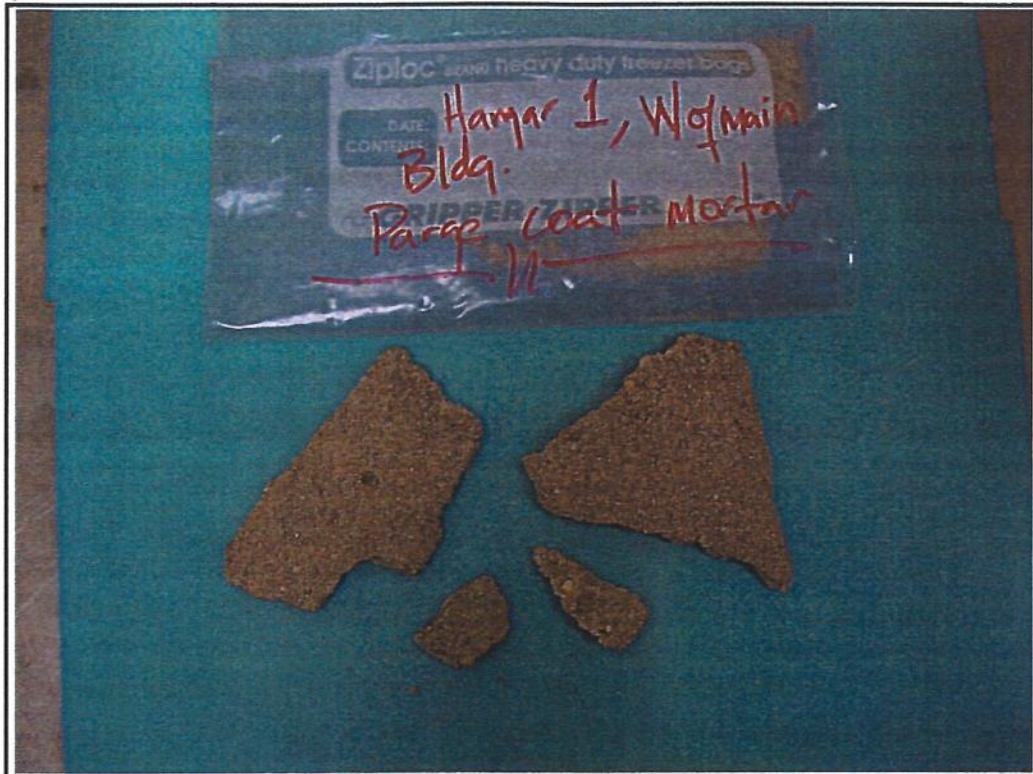
A visual survey of the Skyway Club was performed, but samples were not taken. The mortar observed at this structure was similar to the others and competent. Ms. Toole informed LAW that the block used for the Skyway Club was made with local materials and called "Tuskegee Block". The parge coat mortar taken from Hangar No. 1 was intact, but could be broken easily. The sand particles on the surface of the parge coat were exposed and poorly bonded (Photo 11).

Photo 11. Hangar No. 1, Interior – Parge coat mortar observed. Note sand particles on surface poorly bonded to mortar.

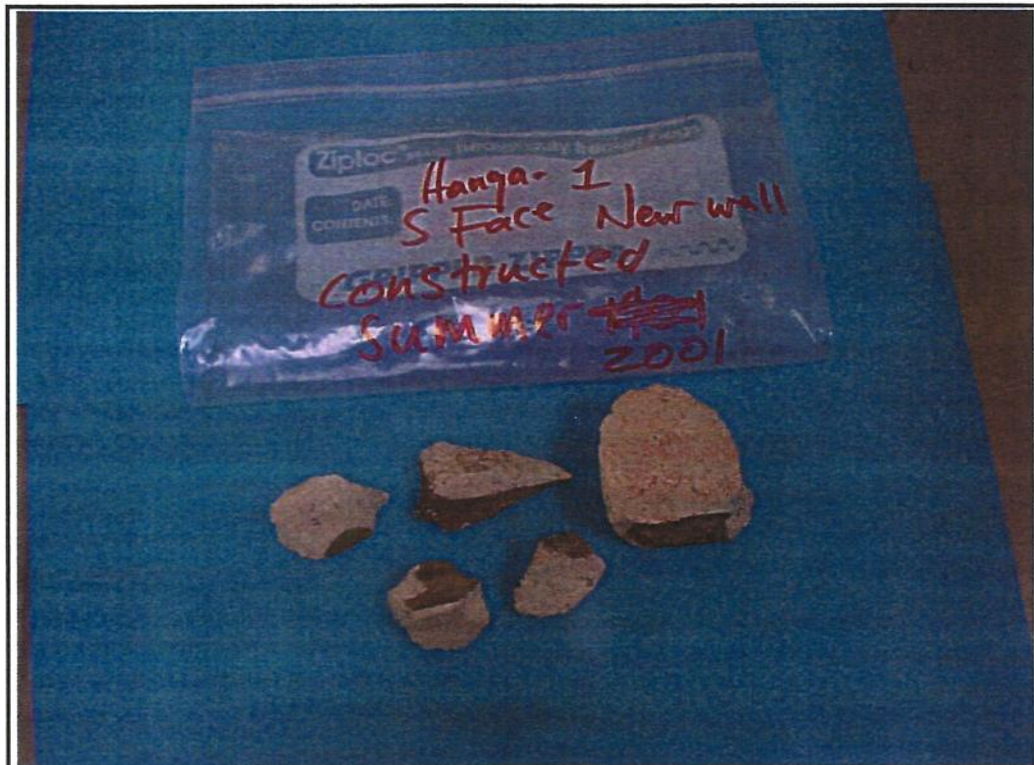
Photo 12. Hangar No. 1, Exterior South Face – Mortar samples taken from new construction. Note white mortar color (A) and brown smear coat (B) on tooled joint surface.

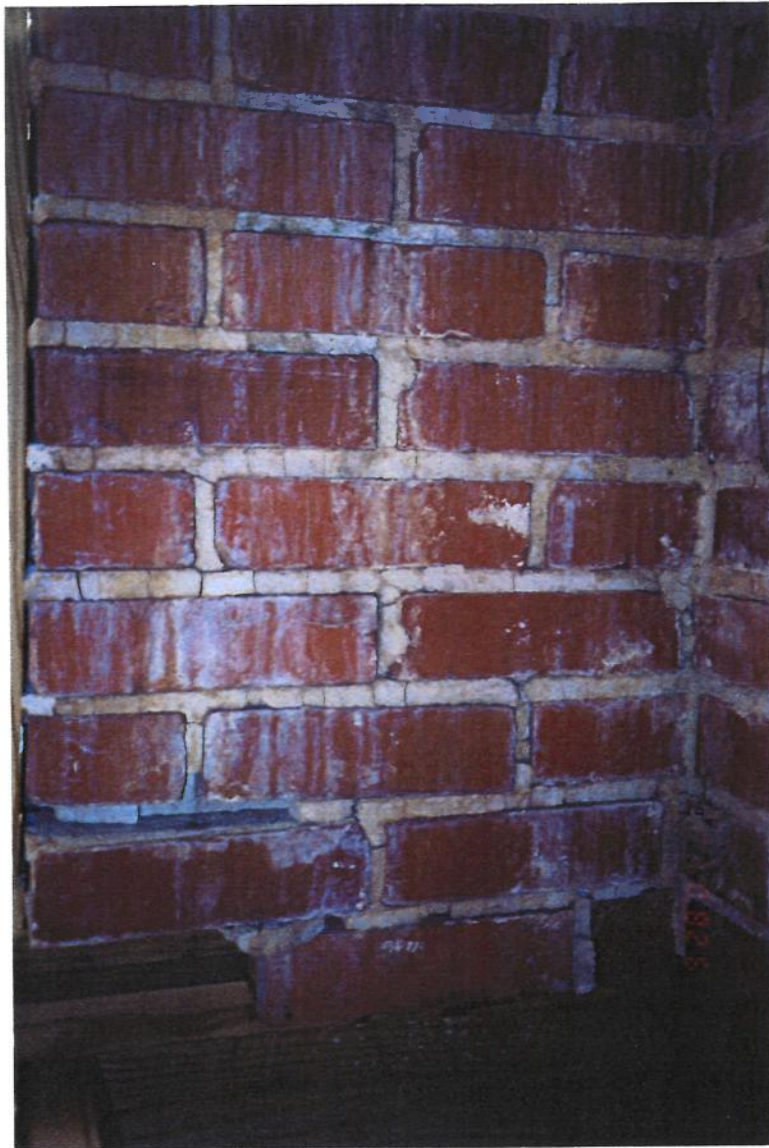
**Photo 15. Fire Protection Shed – Interior face beside door. Note cracked mortar.**

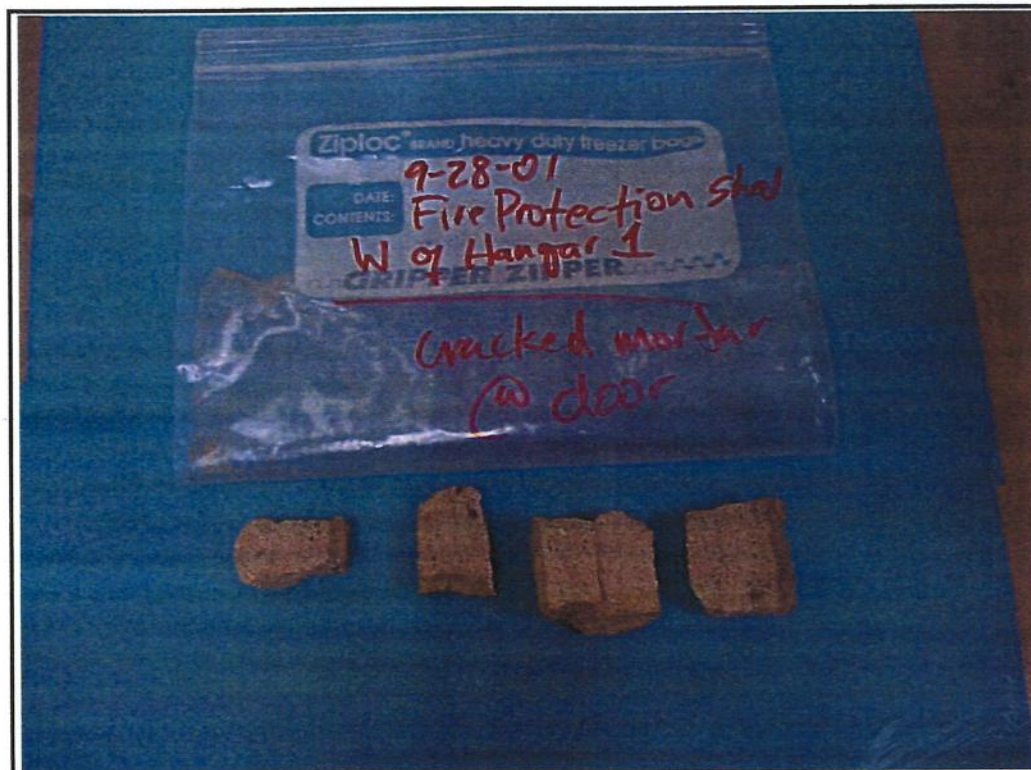
Photo 17. Fire Protection Shed – Interior cracked mortar at door. Note mortar discoloration at surface (extending approximately  $\frac{1}{4}$  inch from surface).
