# Preservation/Restoration of Moton Field

Tuskegee Airmen  
National Historic Site  
Tuskegee, Alabama

*Historic Structure Report*  
Fire Protection Shed

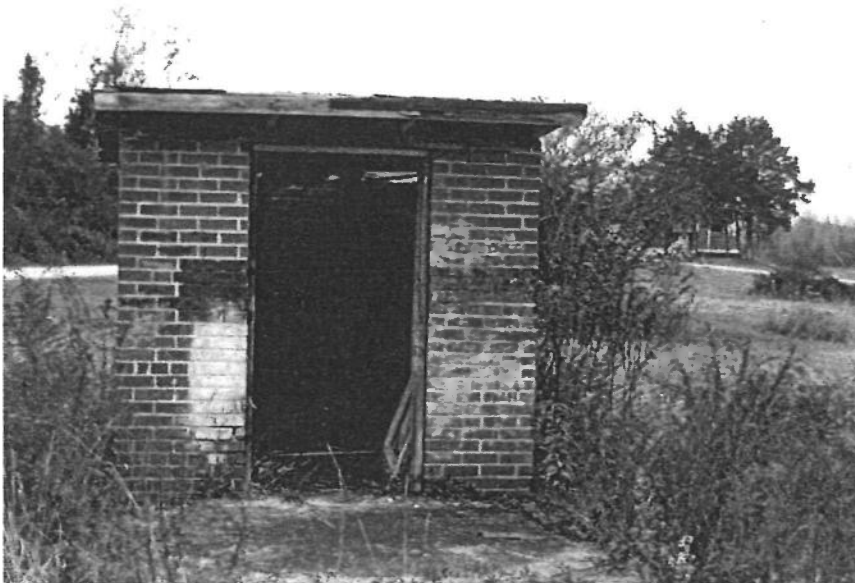
After flying operations at the field ceased in November 1945, Tuskegee Institute did not officially use the Fire Protection Shed and spent little money on maintaining all buildings at Moton Field after the war.<sup>32</sup> The Fire Protection Shed, like other buildings at Moton Field, deteriorated over time because of this lack of general maintenance. The Tuskegee Institute School of Veterinary Medicine began to use some of the buildings at Moton Field in the 1960s but the Fire Protection Shed was not among them.<sup>33</sup> (See *Figure 5*.)

**Figure 5:** Fire Protection Shed in 1997 prior to stabilization. National Park Service, SERO, Atlanta, Georgia.

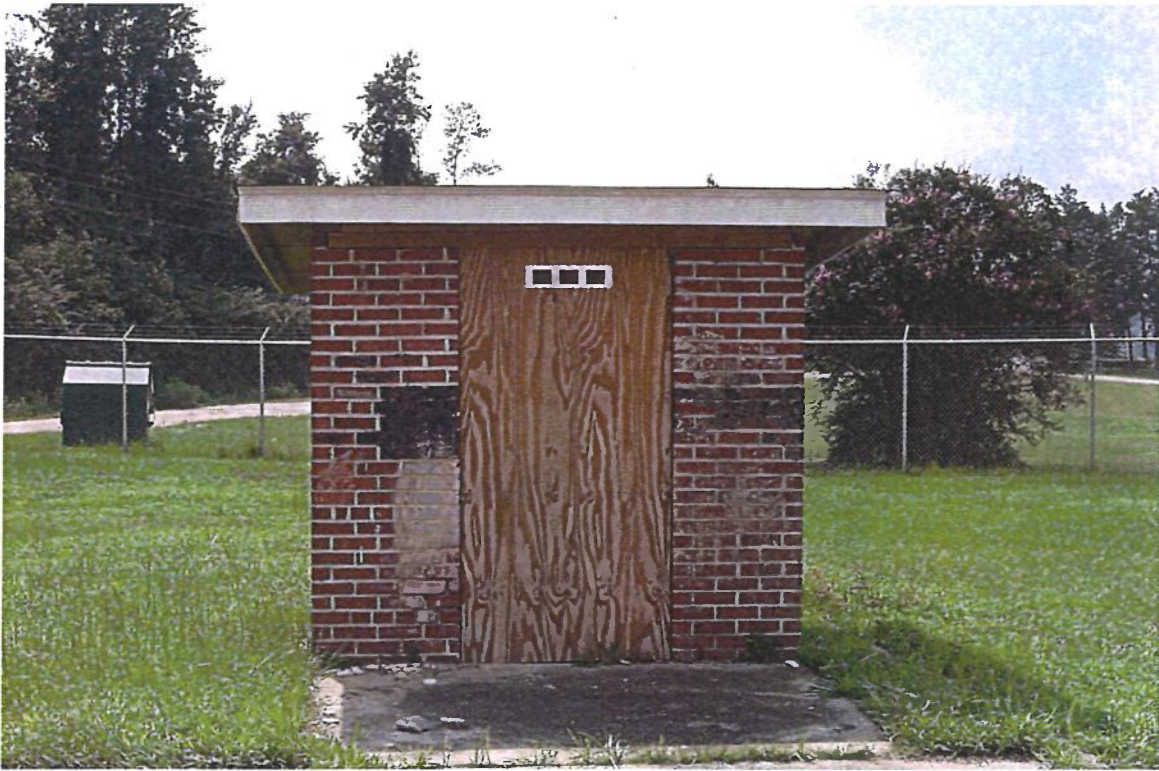
By the summer of 2001, the building no longer had a door or door frame and the shed roof was in poor condition. The recent stabilization effort has replaced the entire wood roof system largely with in-kind materials; this new roof has not been permanently attached to the brick structure. The fascia board has been primed but not painted. New rolled asphalt roofing has been installed as well. In addition, a temporary pressure treated door frame has been installed; a vented plywood sheet has been placed over the door opening to weatherproof and secure the building. (See *Figure 6*.)

**Figure 6:** East elevation of the Fire Protection Shed in the fall of 2001 after stabilization.

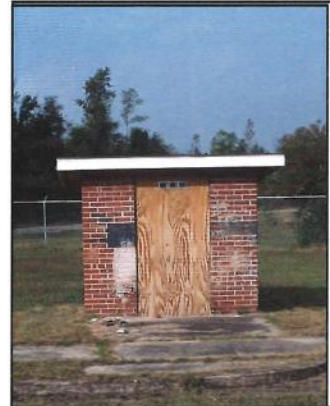
**Deficiency:** Some staining and discoloration

**Recommendation:** Clean masonry walls to remove staining and discoloration without damaging existing brick and mortar.

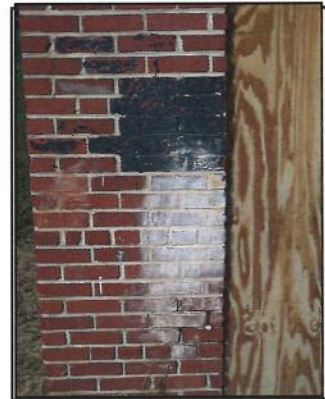
**Deficiency:** Mortar missing/ deteriorated in small area near entrance

**Recommendation:** Re-point mortar at missing and deteriorated areas.

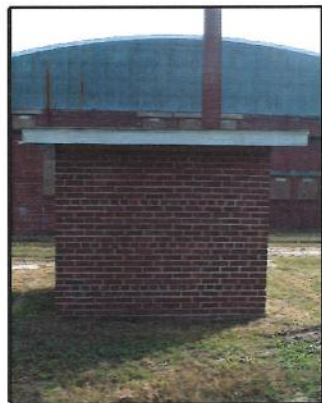
**Deficiency:** Fascia boards have been replaced during stabilization.

**Recommendation:** Restore original color scheme.

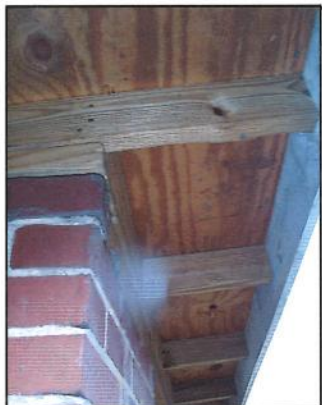
**Deficiency:** Entire roof structure was replaced during stabilization.

**Recommendation:** Repaint and restore original color scheme.

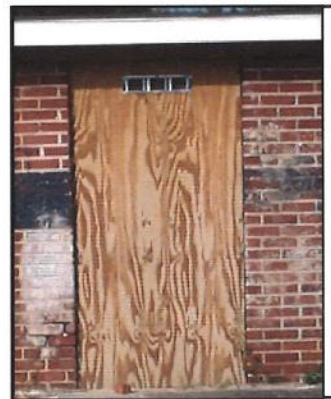
**Deficiency:** Door and frame are missing and plywood installed in opening during stabilization.

**Recommendation:** Remove vented plywood, re-create door and frame based on historical photographs and re-install.

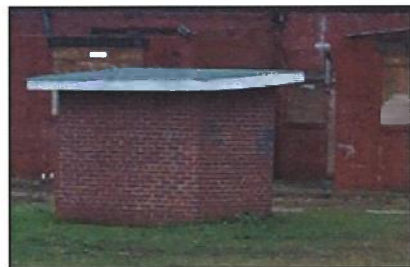
**Deficiency:** Asphalt roofing was replaced during stabilization.

**Recommendation:** Replace modern shingles with replicated shingles to match original installation.

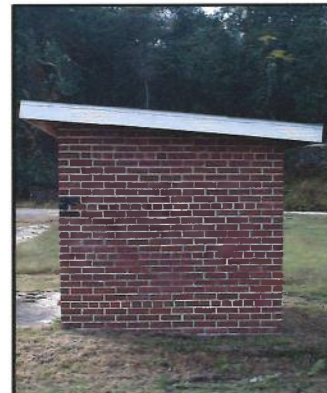
| <b>Deficiency:</b> | Roof structure was replaced during stabilization. |

| <b>Recommendation:</b> | Utilize restored structure as is. |

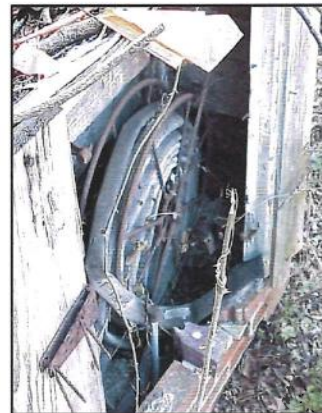
**Feature Notes:** At least one of the fire hose reels has been salvaged for replacement to its original position.

**Deficiency:** Deteriorating

**Recommendation:** Relocate salvaged unit to original location. Repair and reconstruct missing items/elements.

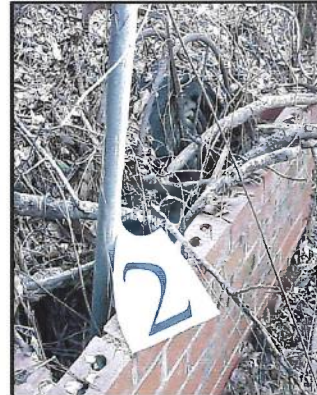
**Deficiency:** Missing

**Recommendation:** Reconstruct housing and base to match original structure. Use historic information for reconstruction.

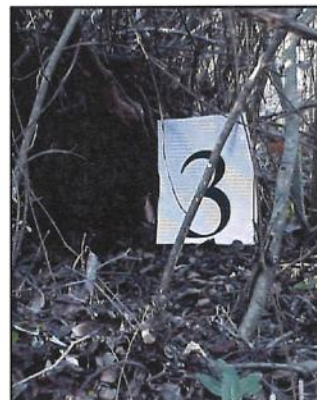
**Deficiency:** Completely missing

**Recommendation:** Reconstruct housing and base to match original structure. Use historic information for reconstruction.

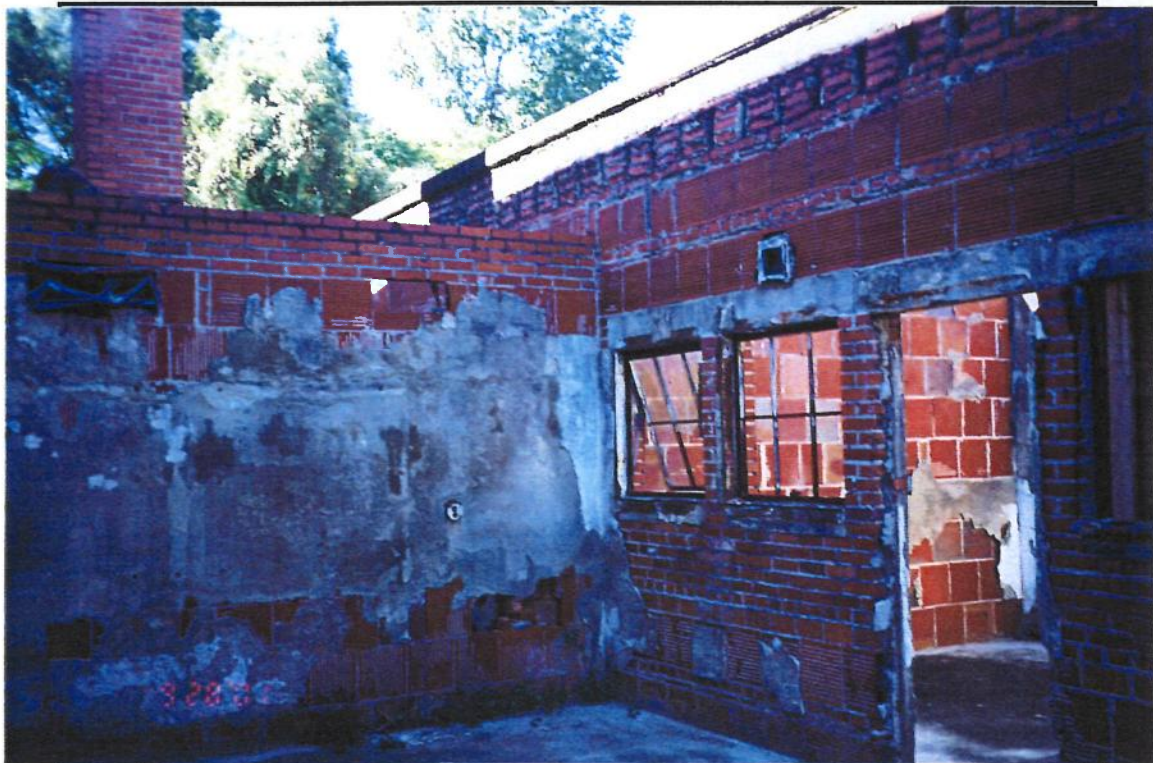
**Photo 10. Hangar No. 1, Interior – Parge coat mortar observed on structural clay tile and masonry surfaces.**

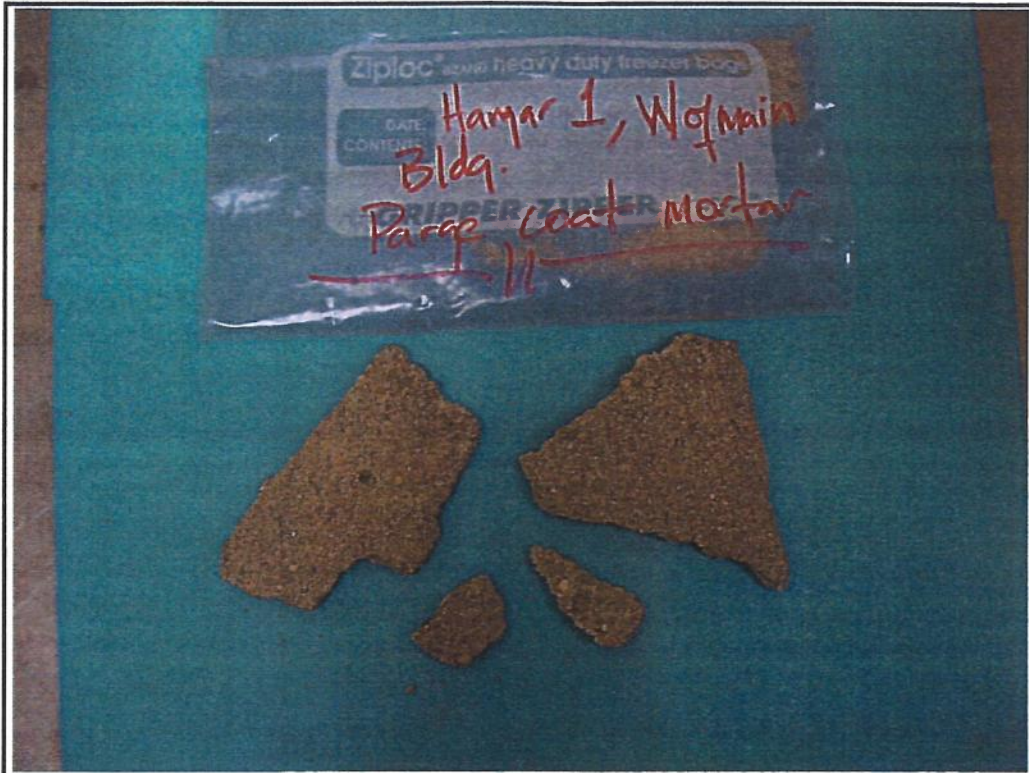
Photo 11. Hangar No. 1, Interior – Parge coat mortar observed. Note sand particles on surface poorly bonded to mortar.

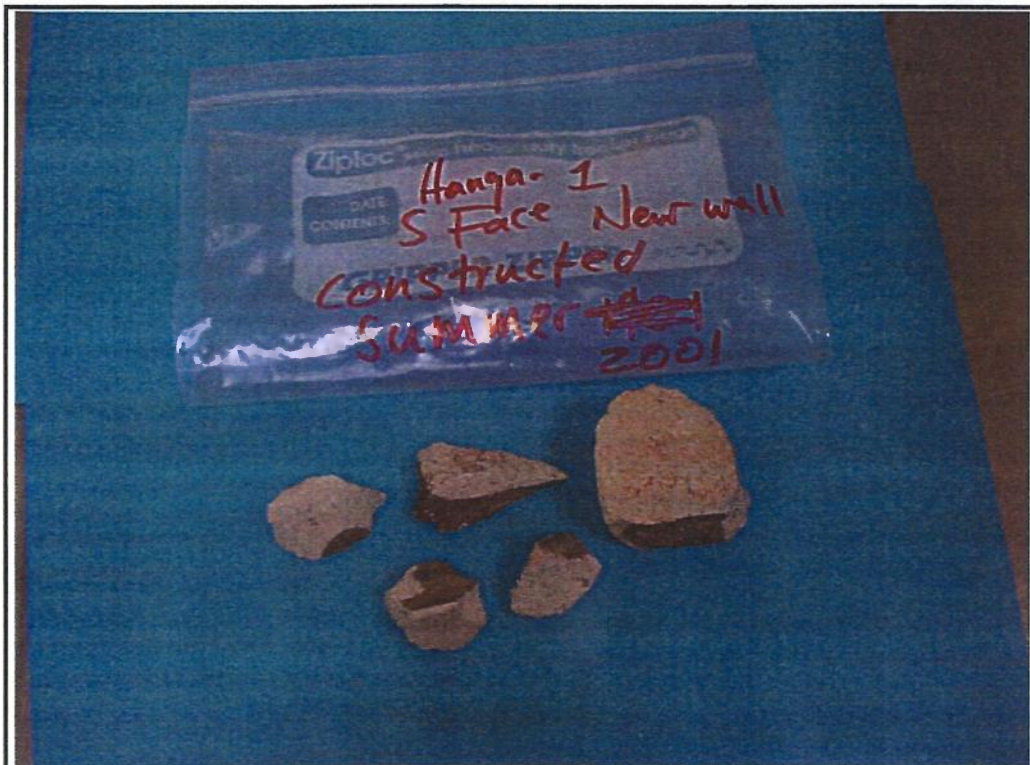
Photo 12. Hangar No. 1, Exterior South Face – Mortar samples taken from new construction. Note white mortar color (A) and brown smear coat (B) on tooled joint surface.

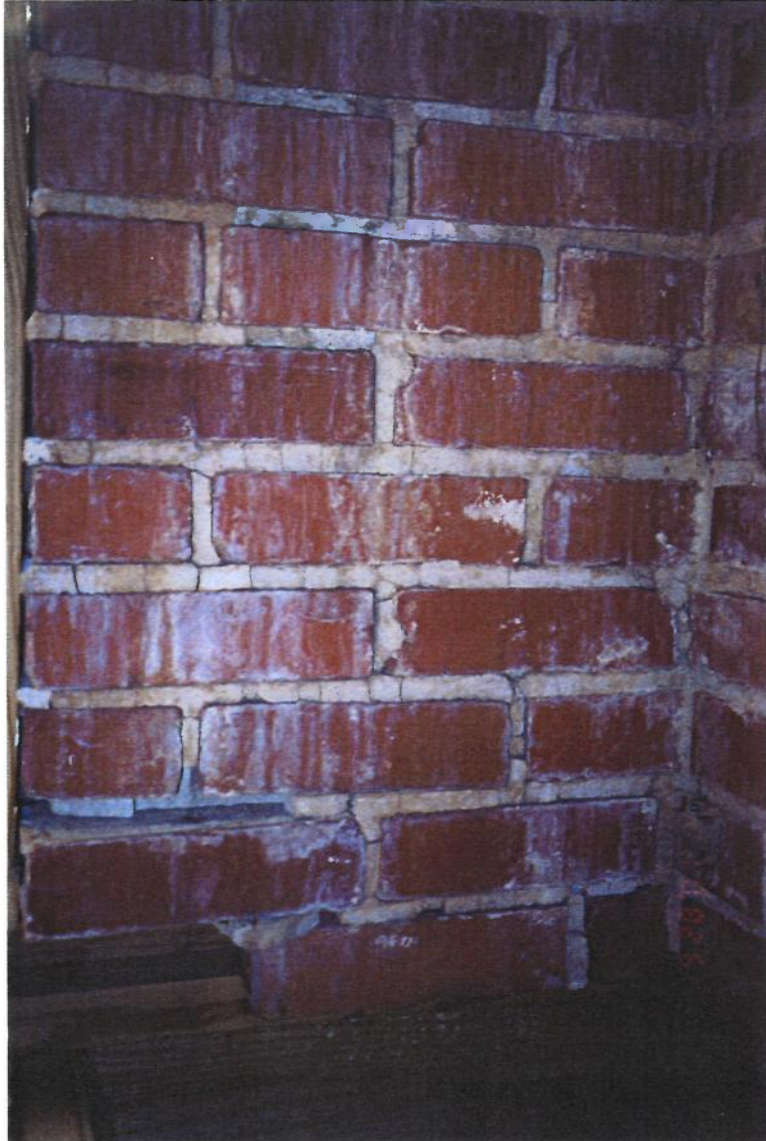
**Photo 15. Fire Protection Shed – Interior face beside door. Note cracked mortar.**

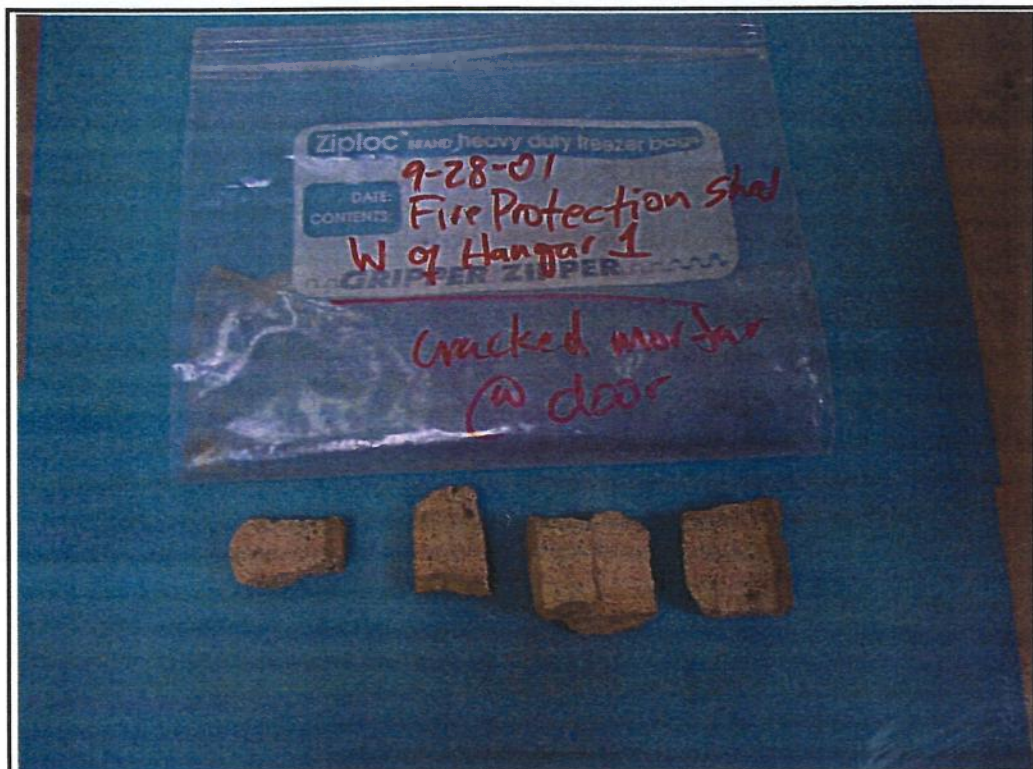
Photo 17. Fire Protection Shed – Interior cracked mortar at door. Note mortar discoloration at surface (extending approximately  $\frac{1}{4}$  inch from surface).
