# Preservation/Restoration of Moton Field

## Phase II

Tuskegee Airmen  
National Historic Site  
Tuskegee, Alabama

*Historic Structure Report*  
Oil Storage Shed

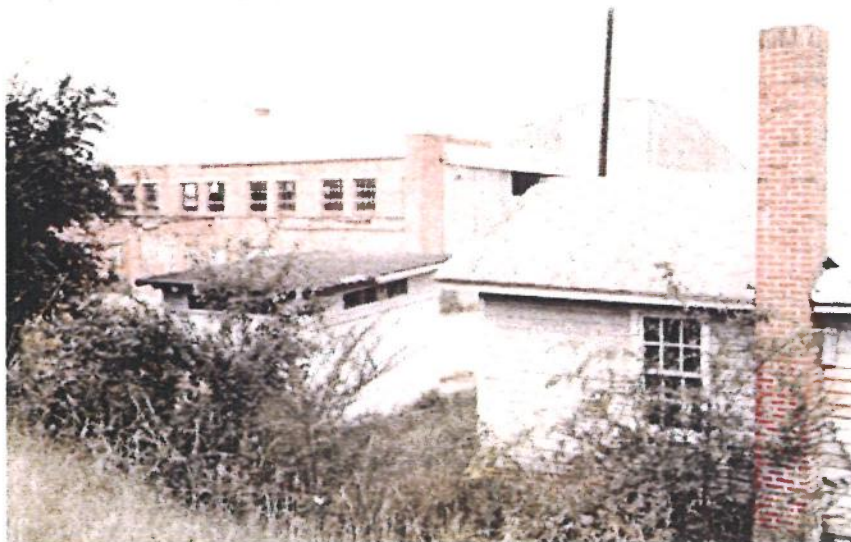
A photograph taken in the late 1970s or early 1980s documents the view of the shed from the southwest. While the asphalt roll roofing appears intact, the fascia on the west elevation was partially missing.<sup>31</sup> (See *Figure 4*.) By 1997, the wood frame portion of this building was in poor condition. (See *Figure 5*.) A majority of the novelty board siding was loose and deteriorating. The roof had a pronounced sag in the middle and the fascia board was in poor shape as well.<sup>32</sup>

**Figure 4:** Photograph taken by Booker Conley in the late 1970s-early 1980s showing damage to the fascia board on the east elevation. Booker Conley's Files, Physical Plant, Tuskegee University.

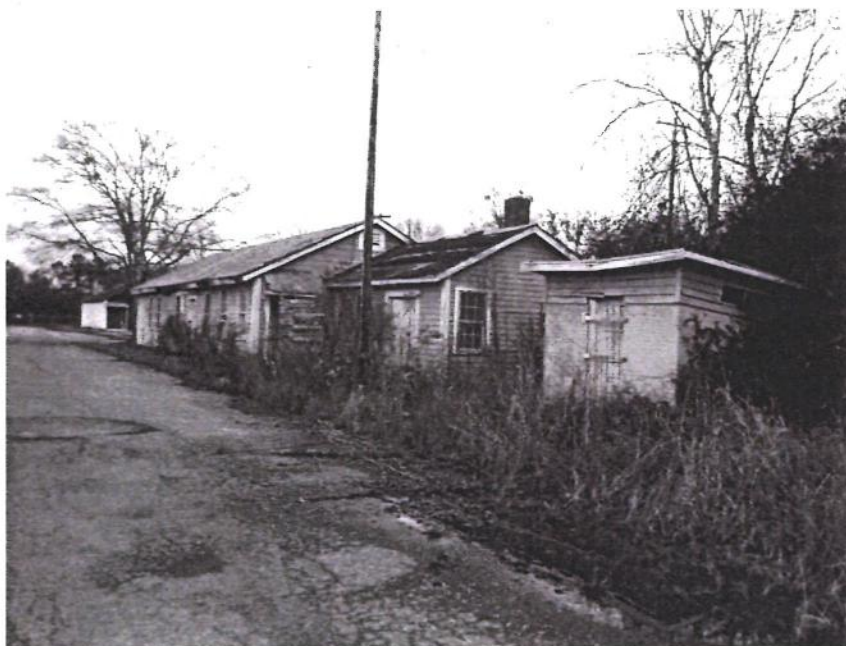
**Figure 5:** 1997 view from the west of the structure showing signs of roof deterioration. National Park Service, SERO, Atlanta, Georgia.

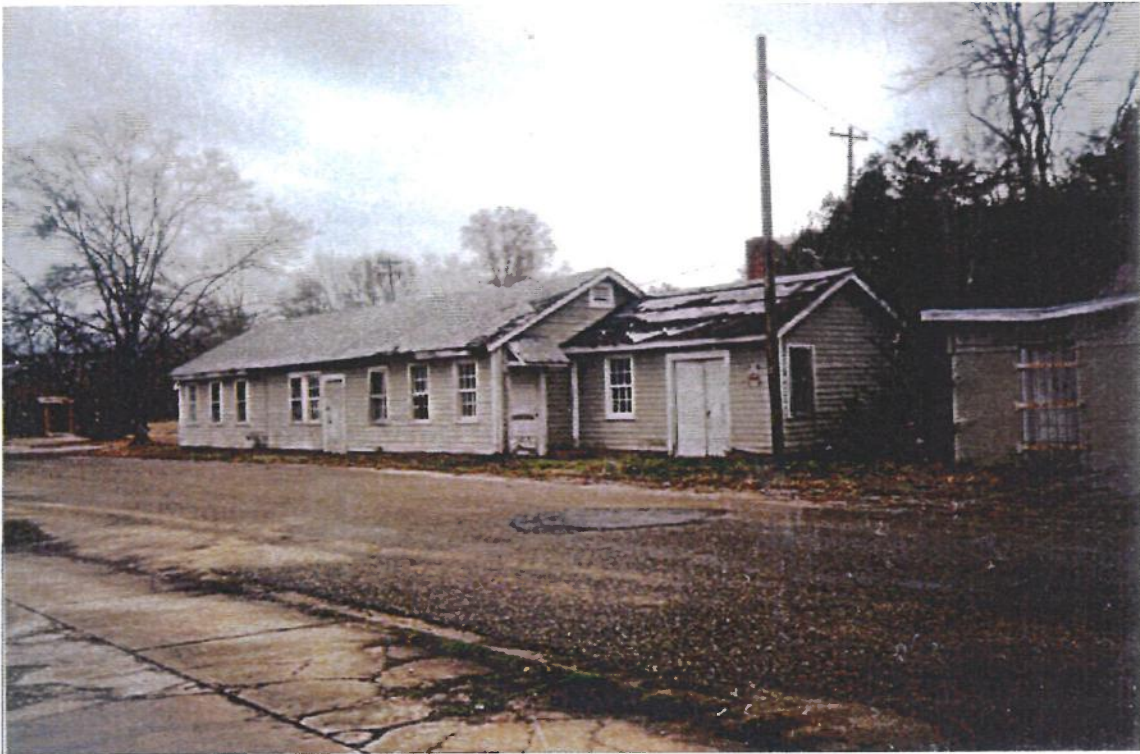
**Figure 7:** Oil Storage Shed prior to stabilization work. Pond & Company.

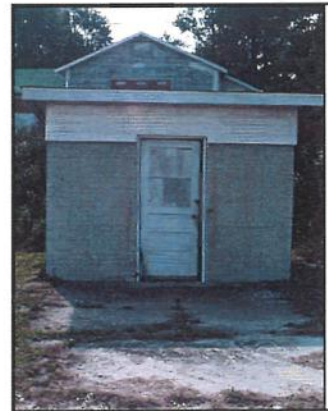
**Deficiency:** Recently painted during stabilization.

**Recommendation:** Re-paint to match original color scheme.  
Re-point brick as necessary.

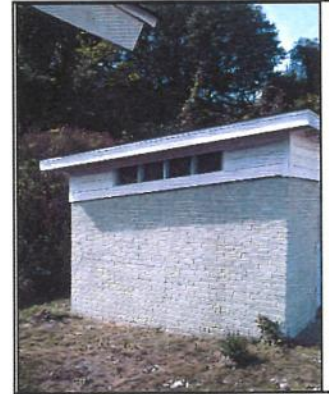
**EXTERIOR****4110****Exterior Wall Surface****Wood****Feature Description:** Frieze band above door**Feature Notes:****Feature Condition:** Fair**Total Inventory:** 88 S.F.**Historic Rating:** H**Priority:** Minor**Deficiency:** Verify number of openings provided during stabilization.**Recommendation:**

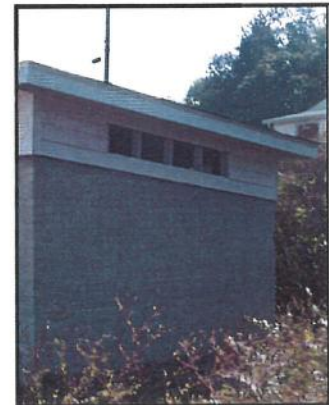
**Materials:** \$303.00 **Labor:** \$95.00 **Quantity:** **Total =** **\$398.00****EXTERIOR****4113****Exterior Wall Trim****Wood****Feature Description:** 6" Fascia board at roof**Feature Notes:** Fascia board was replaced and painted during stabilization.**Feature Condition:** Good**Total Inventory:** 52 L.F.**Historic Rating:** H**Priority:** Minor**Deficiency:****Recommendation:** Remove fascia at rear to leave rafter ends exposed per original construction.

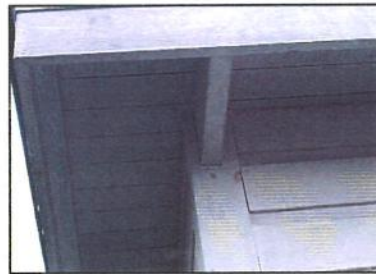
**EXTERIOR****4117****Exterior Eave/ Soffit****Wood****Feature Description:** Wood roof eave - approx. 12"**Feature Notes:** Entire roof and eave system replaced during stabilization.**Feature Condition:** Good**Total Inventory:** 52 S.F.**Historic Rating:** H**Priority:** Minor**Deficiency:****Recommendation:** Attach roof frame to wall by tying into top row of brick.  
Paint to match original color scheme.

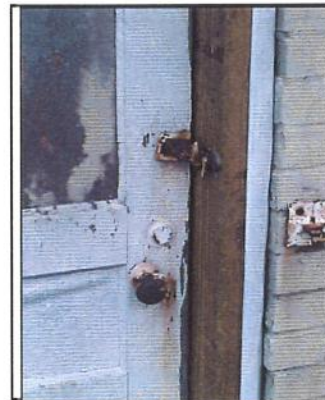
**Materials:** \$102.00 **Labor:** \$400.00 **Quantity:** **Total =** \$502.00**EXTERIOR****4151****Exterior Door Frame****Wood****Feature Description:** Wood door frame**Feature Notes:****Feature Condition:** Poor**Total Inventory:** 1**Historic Rating:** H**Priority:** Serious**Deficiency:** Minor deterioration at bottom, additional 2 by member attached at door latch.**Recommendation:** Replicate door frame and restore to original configuration.

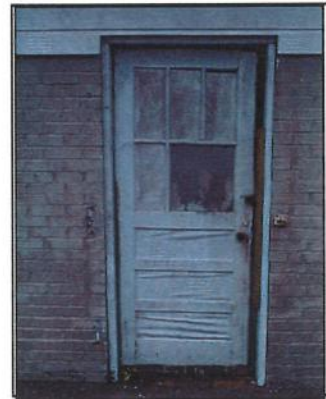
**Deficiency:** Missing panels, does not fit frame properly, and wood panels delaminating

**Recommendation:** Restore door to original configuration. Replace with replicated door based on historic photographs.

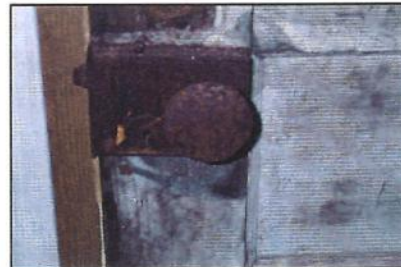
**Deficiency:** Rusting and missing strike.

**Recommendation:**  
Replicate and replace missing items as necessary.

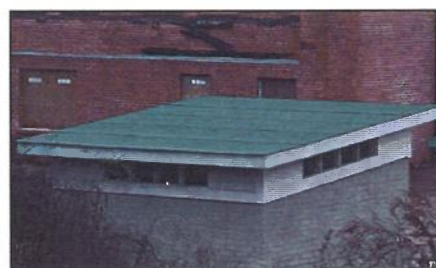
**Feature Notes:** Roof was replaced during stabilization.

**Recommendation:** Replace modern shingles with shingles that replicate original.

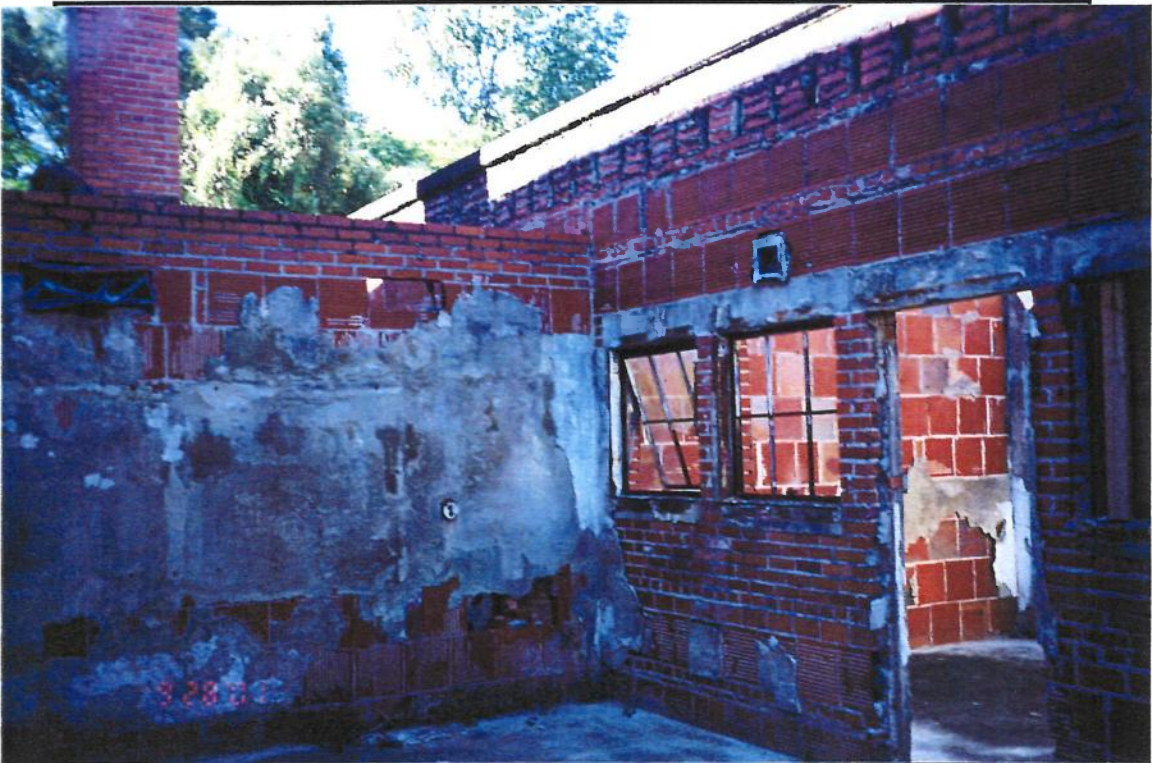
**Photo 10. Hangar No. 1, Interior – Parge coat mortar observed on structural clay tile and masonry surfaces.**

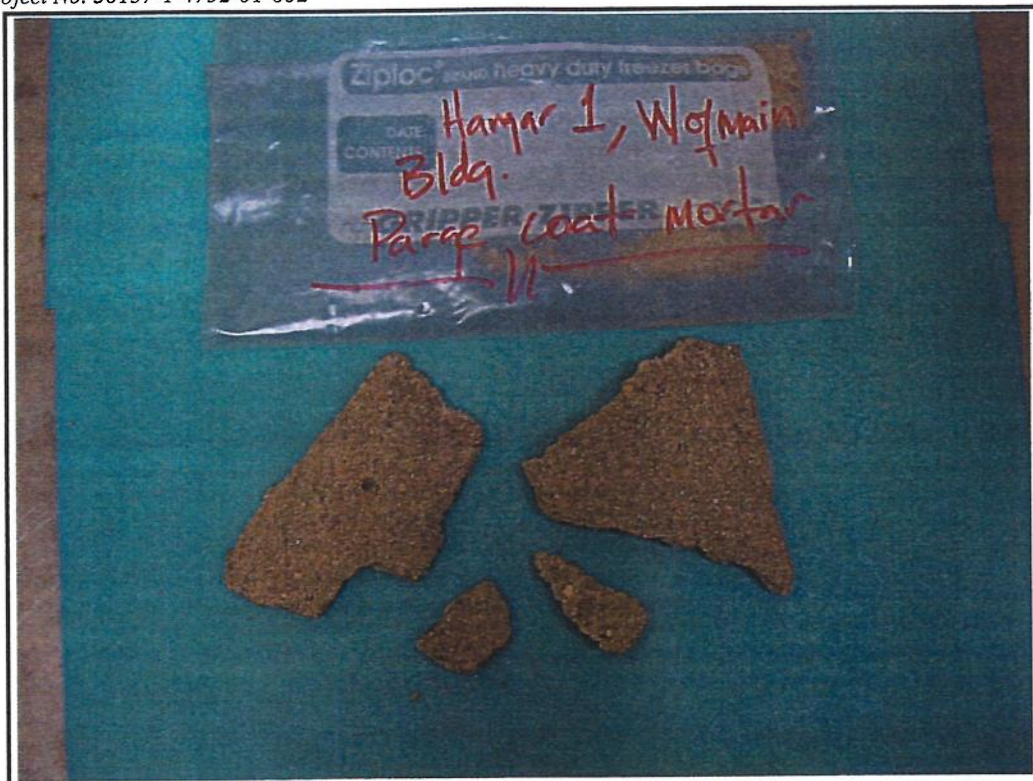
Photo 11. Hangar No. 1, Interior – Parge coat mortar observed. Note sand particles on surface poorly bonded to mortar.

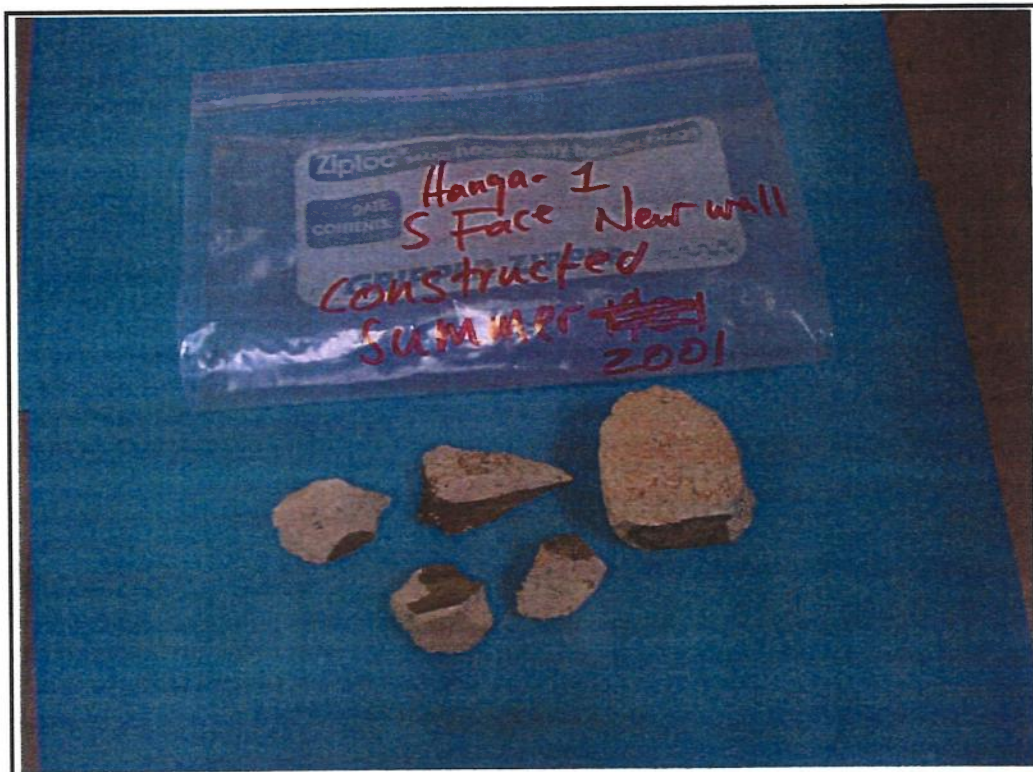
Photo 12. Hangar No. 1, Exterior South Face – Mortar samples taken from new construction. Note white mortar color (A) and brown smear coat (B) on tooled joint surface.

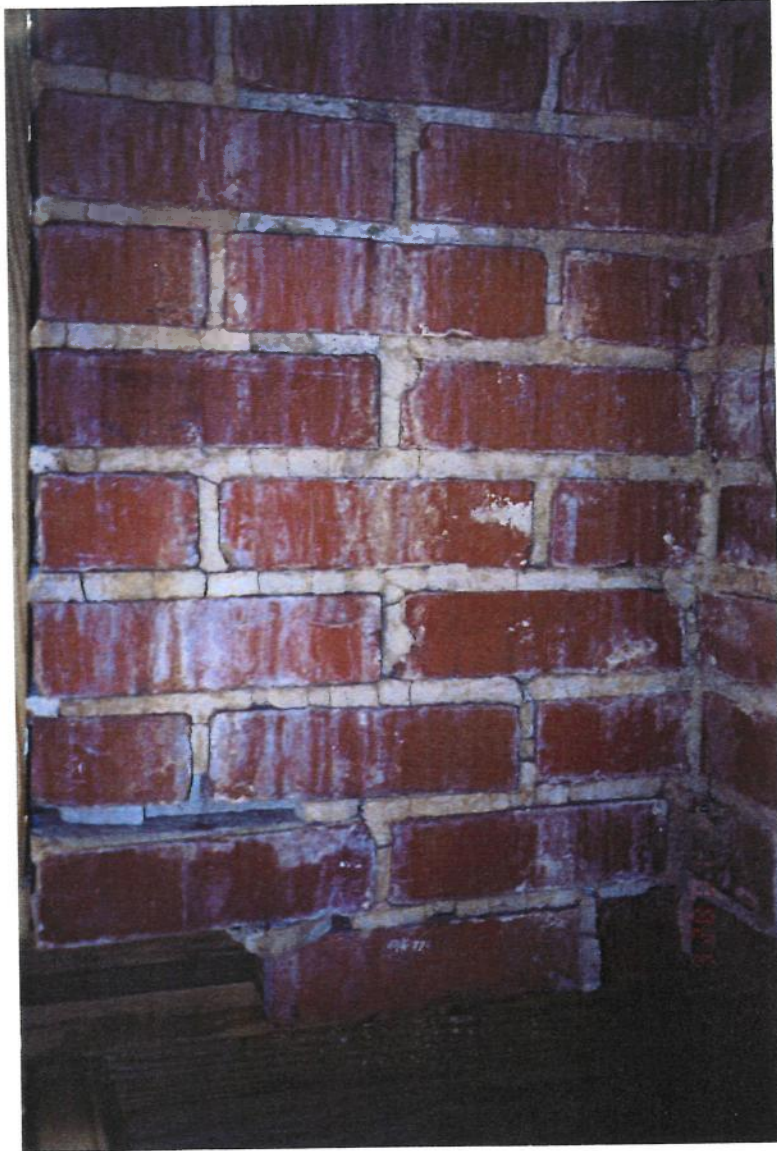
**Photo 15. Fire Protection Shed – Interior face beside door. Note cracked mortar.**

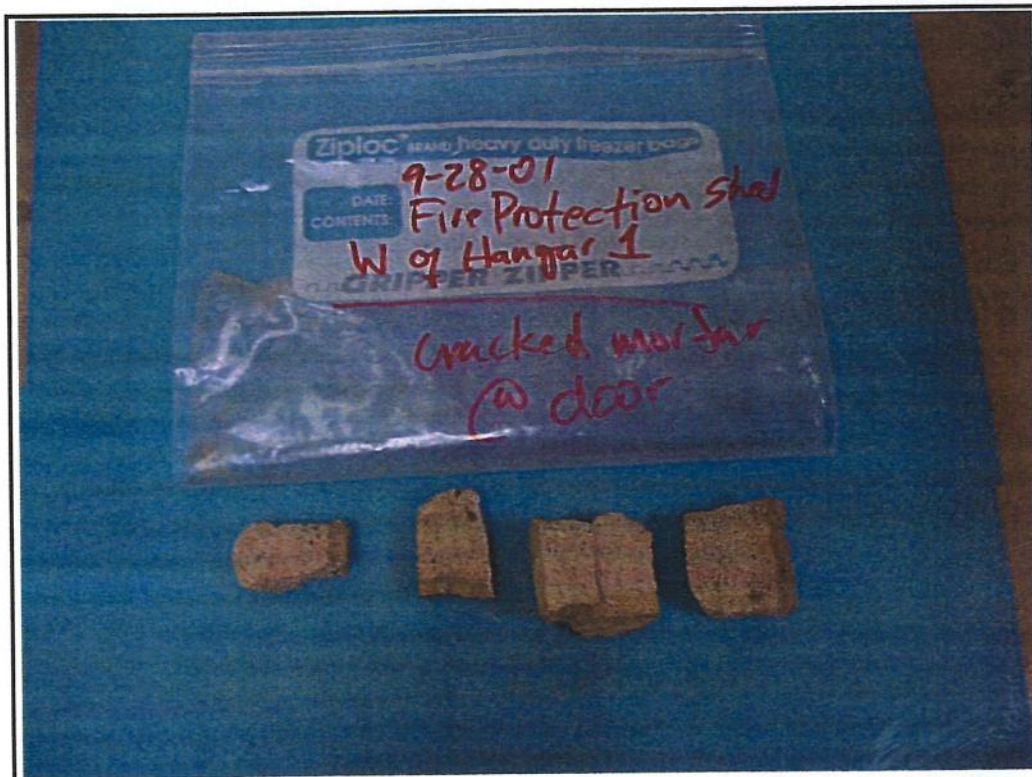
Photo 17. Fire Protection Shed – Interior cracked mortar at door. Note mortar discoloration at surface (extending approximately 1/4 inch from surface).
