# Preservation/Restoration of Moton Field

Tuskegee Airmen  
National Historic Site  
Tuskegee, Alabama

*Historic Structure Report*  
Warehouse/Vehicle Storage Building

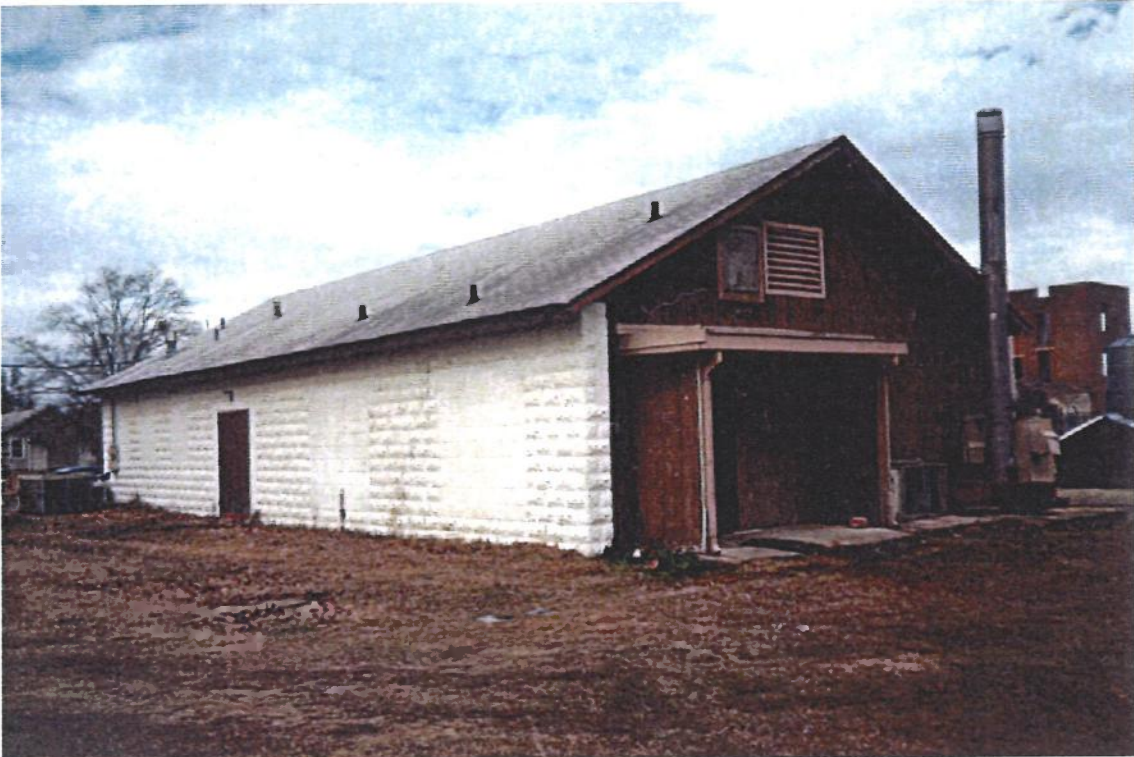
**Figure 6:** Looking northwest at the Warehouse/Vehicle Storage Building. Pond & Company.

The exterior of the building is in generally good condition, but the historic character of this building has been compromised by the complete replacement of the walls on the east and west facades and the infill of original window and door openings. (See *Figure 6*.)

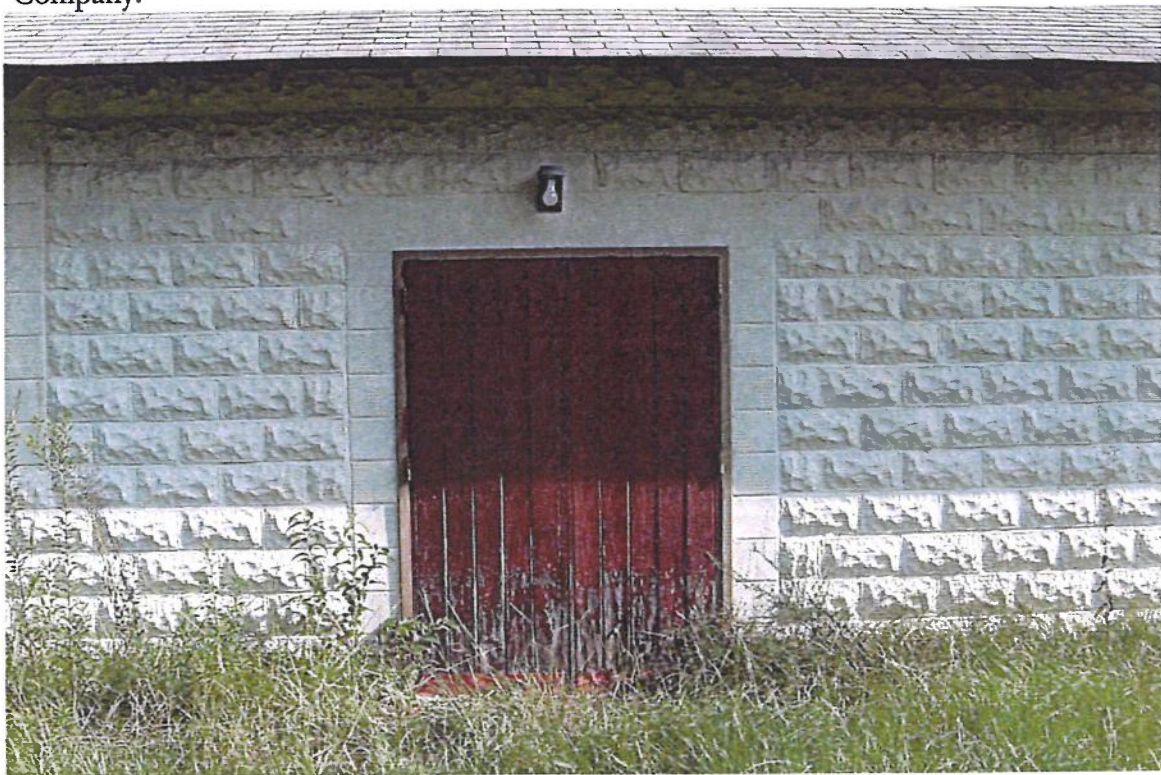
**Figure 7:** A door opening on the south façade created during the 1974 renovation. Smooth-faced replacement block matches original courses. The original window lintel remains.

- Remove nonhistoric door openings.
- Reconstruct historically accurate exterior doors and garage doors if documentation can be found to authenticate their design.

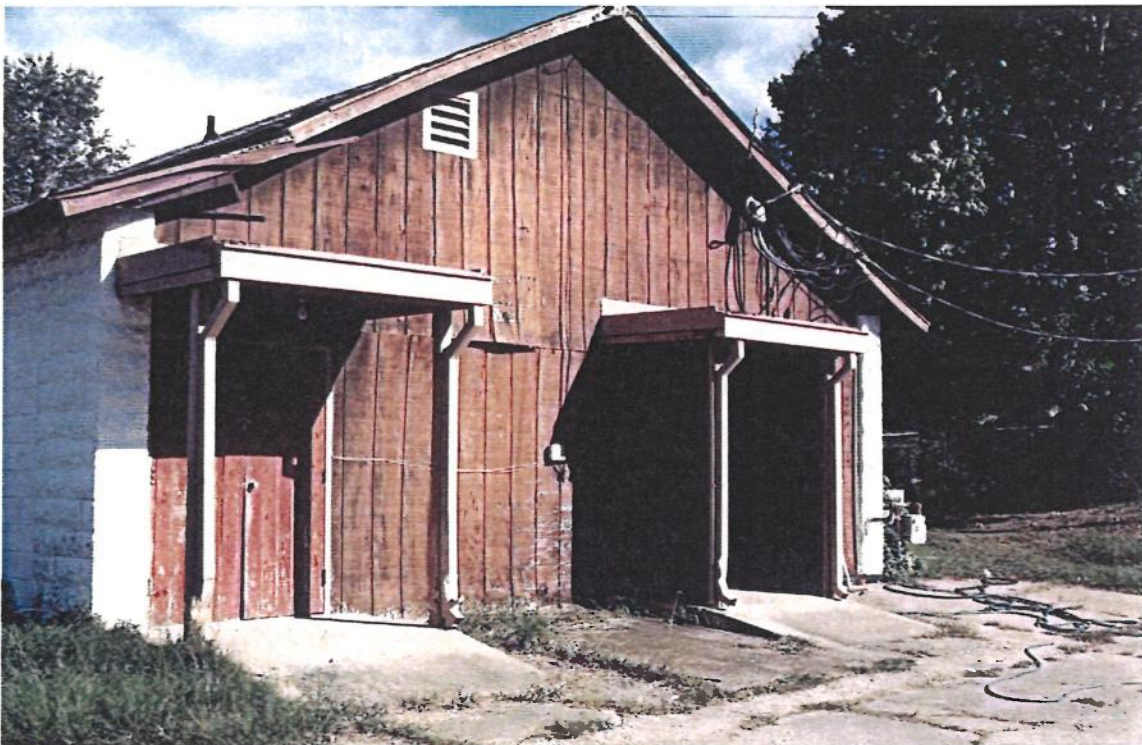
**Figure 8:** West facade as it looks today. Both the east and west facades were completely replaced as part of the 1974 renovation.

- Remove areas of 1970s frame construction; reconstruct cast concrete block and wood frame exterior walls, door openings, and vehicle entrances based on physical evidence, historic photographs, and 1970s architectural drawings.
- Remove canopies from west front and east rear facades; remove concrete ramps leading up to entrances being careful not to disturb historic concrete sidewalk underneath.
- Restore original color scheme to wood members if documentation can be found to authenticate colors.

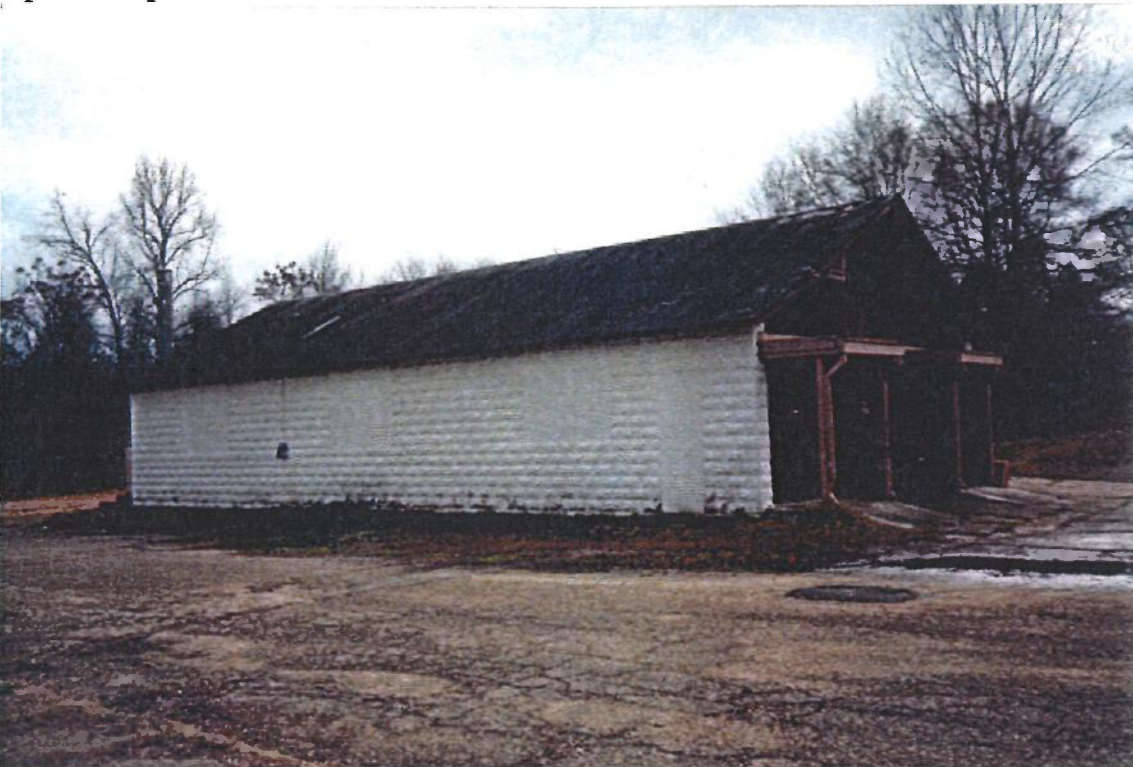
**Figure 9:** North facade of the Warehouse/Vehicle Storage Building as it looks today. Former window and door openings were infilled with smooth-faced block. Pond & Company.

- Clear all vegetation away from the building.
- Remove infilled concrete block from original door and window openings.
- Repoint joints as needed using a mortar similar in composition to the existing mortar (see Conclusions in the *Mortar Analysis* in *Appendix D* for recommended compatible mortar); tool joints to match existing.
- Remove exterior components of nonhistoric mechanical systems; replace exterior brick chimney stack on south wall.
- Remove entrance on south wall and restore to original window opening.
- Remove nonhistoric paint from the cast concrete block walls and re-paint based on information from the *Paint Analysis* (see Paint Recommendations in the *Paint Analysis* in *Appendix D*).

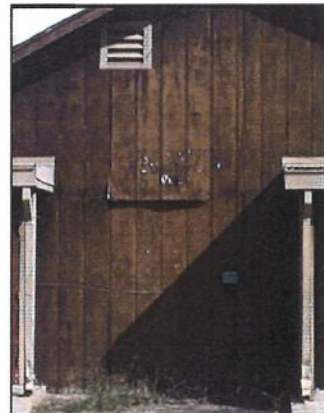
**EXTERIOR****4110****Exterior Wall Surface/ Cover****Wood****Feature Description:** Wood Siding**Feature Notes:** Generally good condition**Feature Condition:** Fair**Total Inventory:** 574 S.F.**Historic Rating:** N**Priority:** Historic**Deficiency:** Some splitting and separating of siding. Added in reuse of building.**Recommendation:** Remove later infill end panels and reconstruct as vehicle entrances.

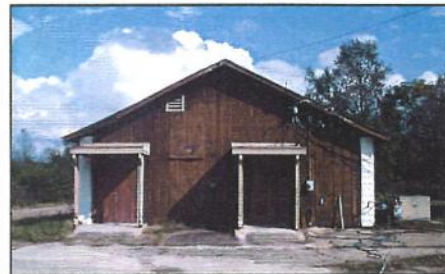
| <b>Feature Notes:</b> | Generally good condition |

| <b>Deficiency:</b> | Added in reuse of building. |

| <b>Recommendation:</b> | Remove later infill end panels and reconstruct as vehicle entrances. |

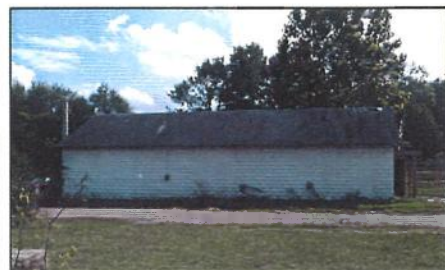
| <b>Feature Notes:</b> | Generally good condition. Some infill of original openings. |

| <b>Deficiency:</b> | Infill of original openings with block units. |

| <b>Recommendation:</b> | Remove infill concrete blocks from original window and door openings. Replicate original windows and doors and install. |

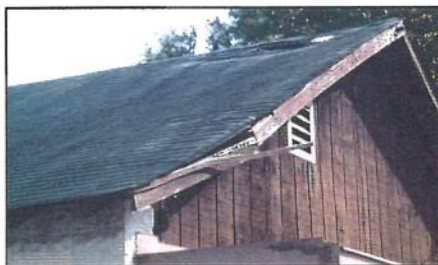
**Deficiency:** Damage to fascia on east elev.

**Recommendation:** Replace fascia to match original construction.

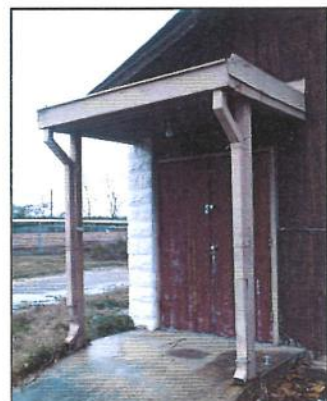
**Deficiency:** Added in reuse of building for veterinary school building.

**Recommendation:** Remove canopies.

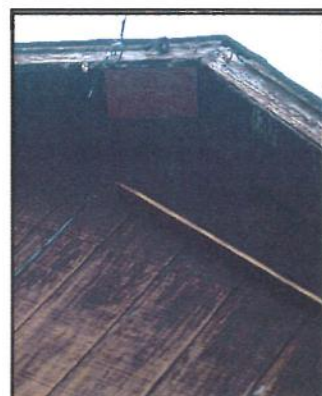
**Deficiency:** Some repair and paint chipping.

**Recommendation:** Repair eave per original construction.

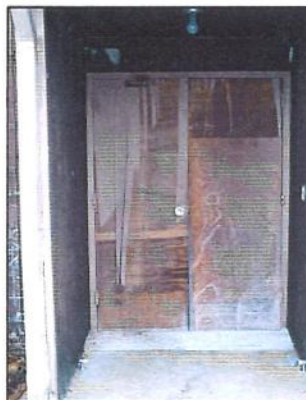
**Deficiency:** In generally poor condition.  
Added in reuse of building.

**Recommendation:** Remove entrances and restore to original vehicle entrance configuration.

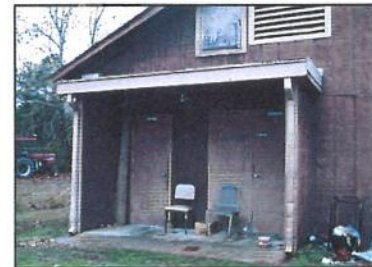
| <b>Deficiency:</b> | In generally poor condition. Added in reuse of building. |

| <b>Recommendation:</b> | Remove entrances and restore to original vehicle entrance configuration. |

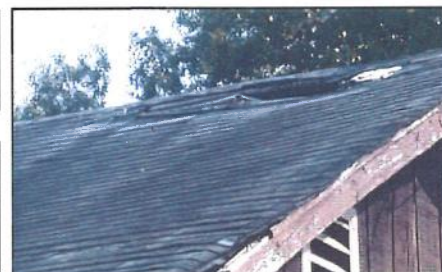
| <b>Deficiency:</b> | Some damage near eastern edge near roof peak. |

| <b>Recommendation:</b> | Remove roof, repair damaged area, and replace with 3 tab asphalt shingles to match original construction. |

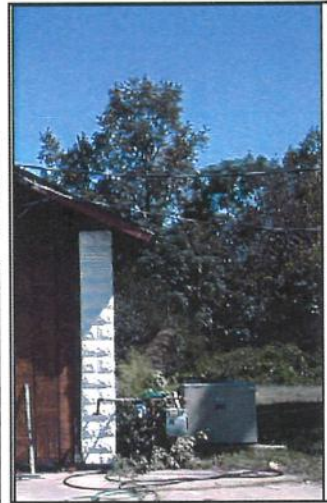
**FEATURE INVENTORY: MECHANICAL SYSTEMS****MECHANICAL****5864****Water Chiller****Feature Description:** Air cooled water chiller**Feature Notes:** Chiller is in fair condition, but nearing the end of its useful life.**Feature Condition:** Fair**Total Inventory:** 1**Historic Rating:** N**Priority:** Minor**Deficiency:** None**Recommendation:** Remove unit and associated connections.

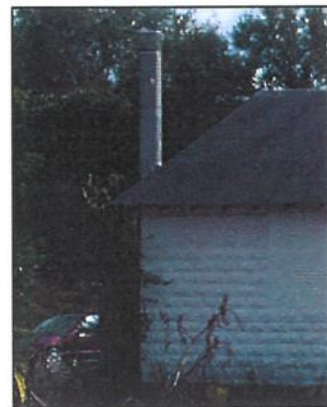
**EXTERIOR****4330****Chimney****Feature Description:** Chimney**Feature Notes:** Generally good condition. Not original construction.**Feature Condition:** Fair**Total Inventory:** 1**Historic Rating:** N**Priority:** Minor**Deficiency:****Recommendation:** Remove with removal of HVAC unit.

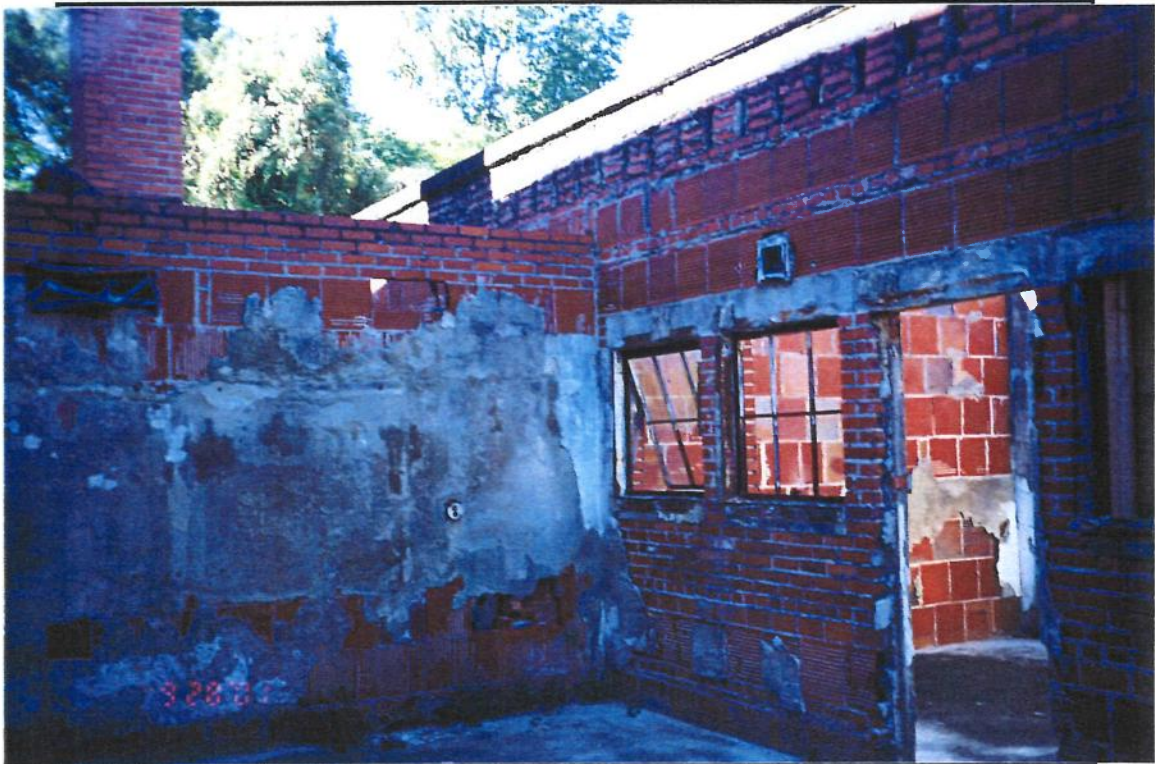
**Photo 10. Hangar No. 1, Interior – Parge coat mortar observed on structural clay tile and masonry surfaces.**

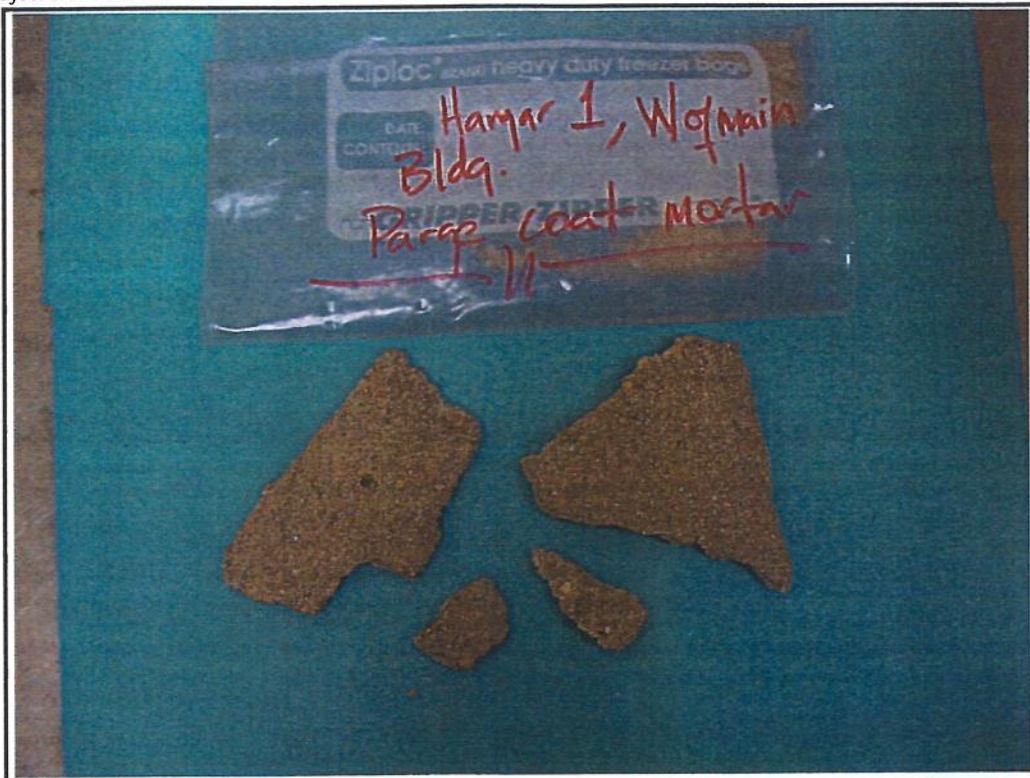
Photo 11. Hangar No. 1, Interior – Parge coat mortar observed. Note sand particles on surface poorly bonded to mortar.

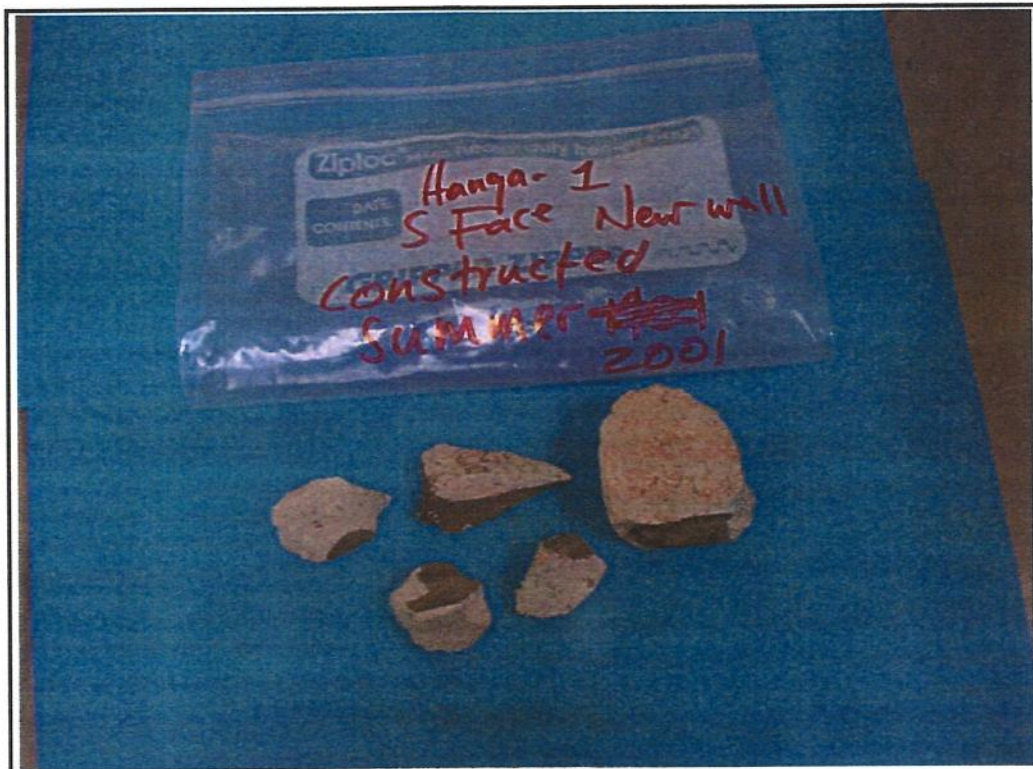
Photo 12. Hangar No. 1, Exterior South Face – Mortar samples taken from new construction. Note white mortar color (A) and brown smear coat (B) on tooled joint surface.

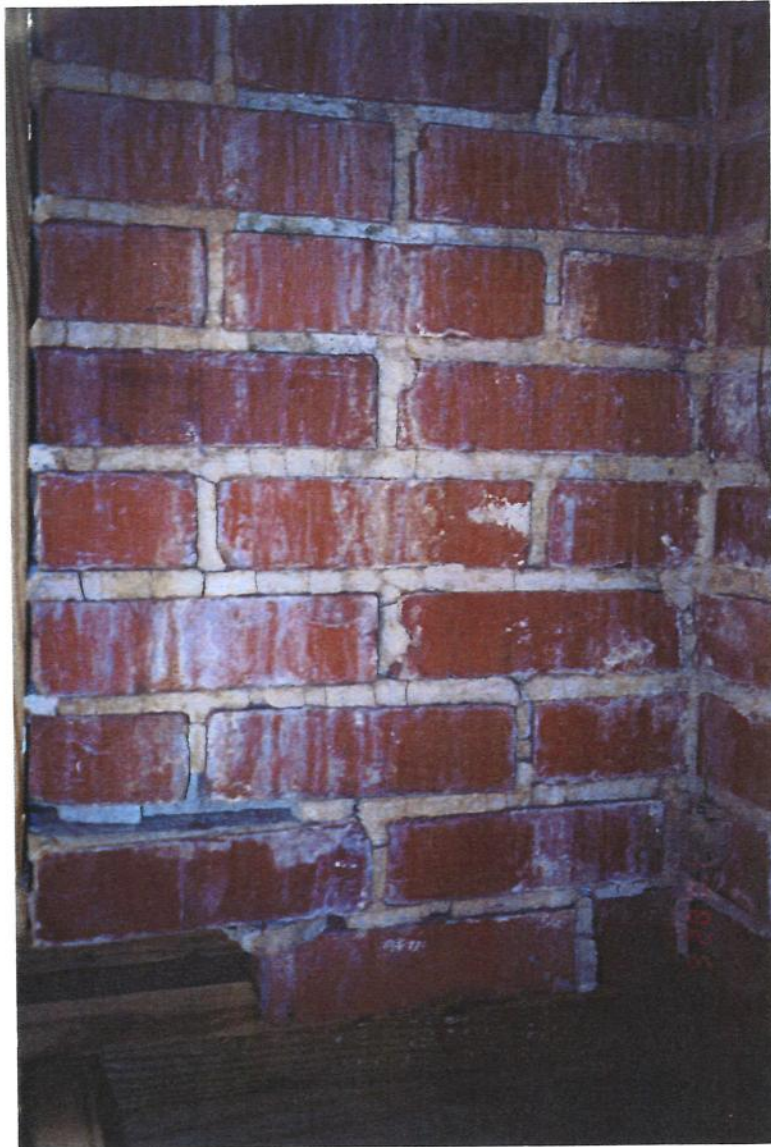
**Photo 15. Fire Protection Shed – Interior face beside door. Note cracked mortar.**

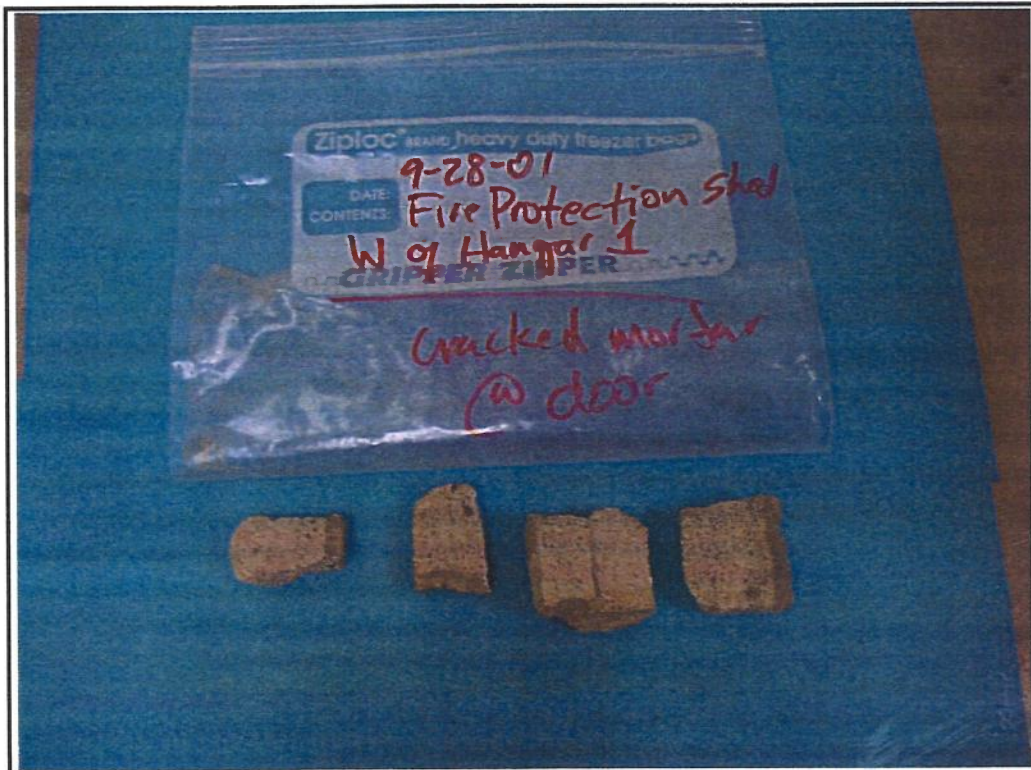
Photo 17. Fire Protection Shed – Interior cracked mortar at door. Note mortar discoloration at surface (extending approximately  $\frac{1}{4}$  inch from surface).
