# Stafford Slave Settlement

*Cumberland Island National Seashore, Georgia*

## Masonry Materials Analysis and Testing

January 2020

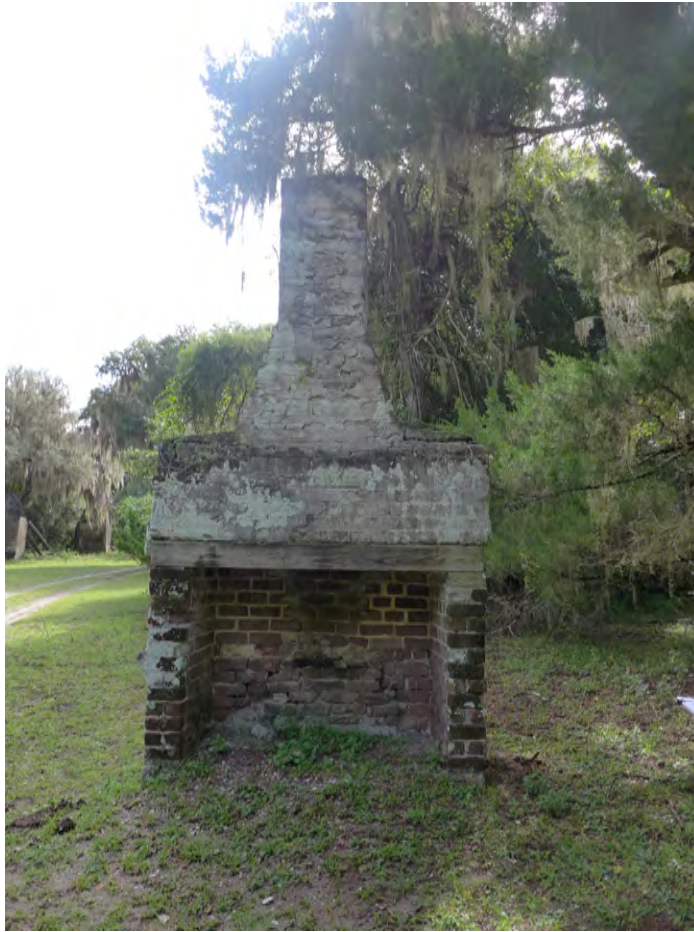
**Image 1.** Typical intact chimney with replaced wood lintel. Note the use of red brick for the hearth and firebox and the use of tabby brick elsewhere.

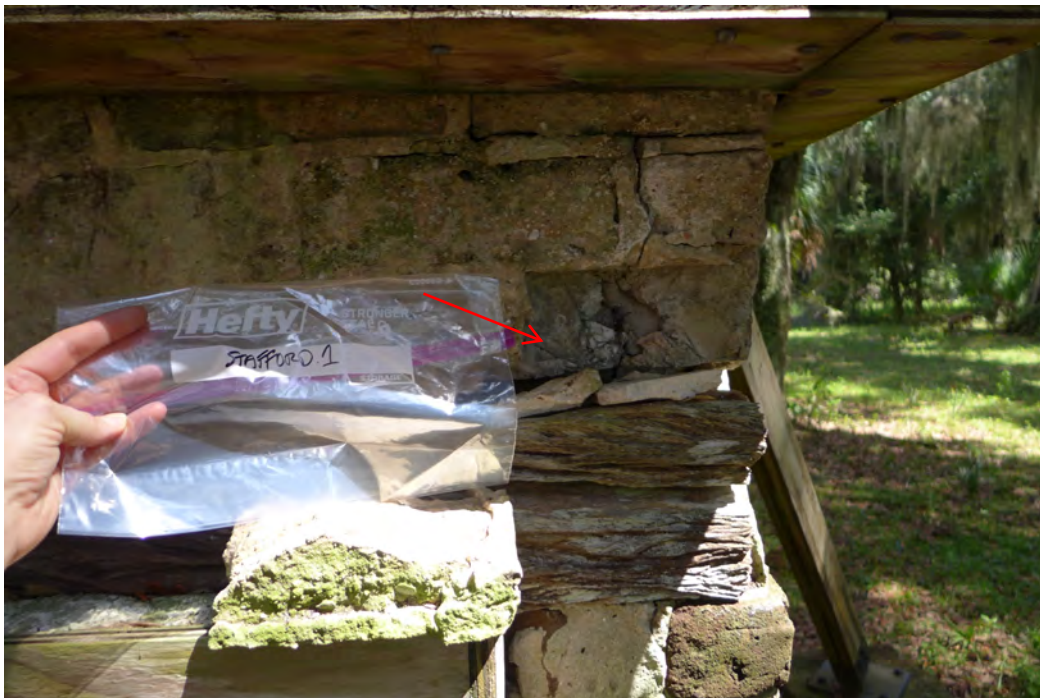
**Image 3.** Location of the sample Stafford. I.

The mortar analyzed for the current study was removed from the tabby brick masonry. More specifically, it was removed from the interior (protected) side of Chimney 18 above the lintel. (*Image 3*) The mortar is off-white in color (Munsell code approximately 10YR 8/1) and contains visible lime particles and incompletely burned shell fragments. It is relatively uniform in appearance. Although it was not analyzed as part of this study, the parging on the interior of the chimneys appears to be the same white-colored mortar material.

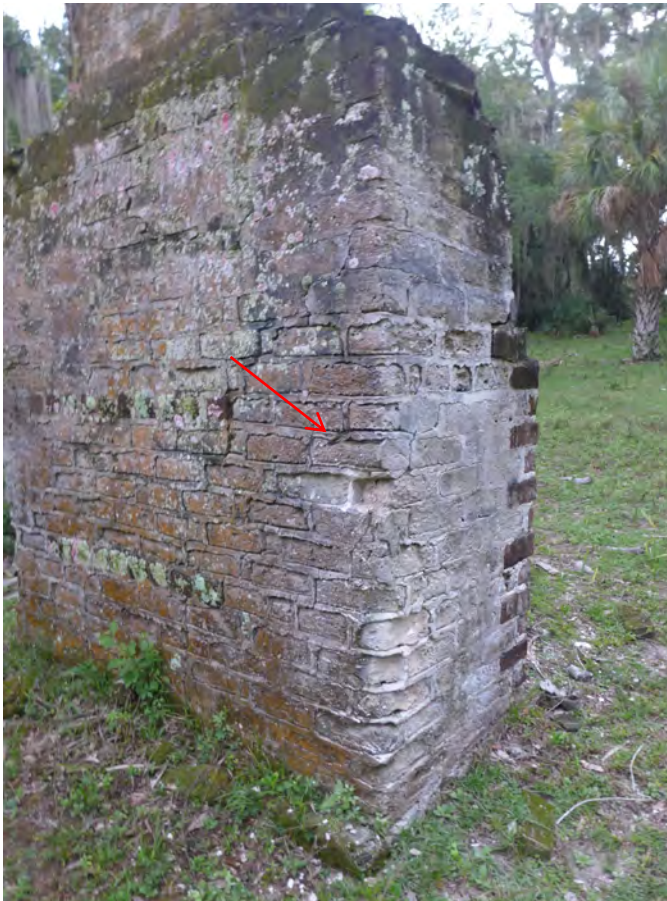
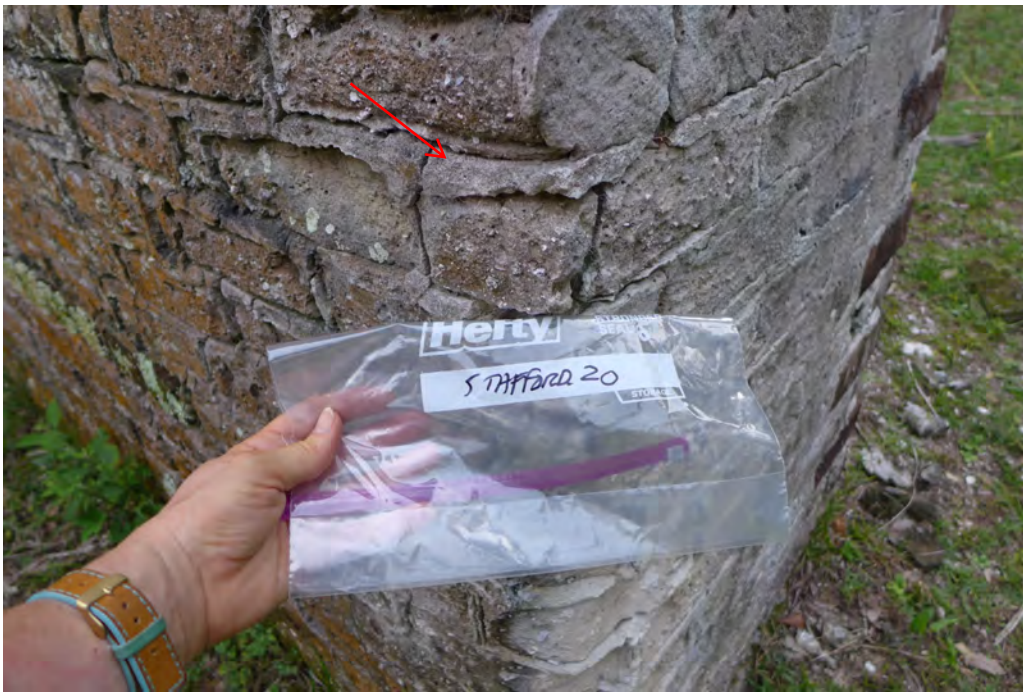
**Images 14 and 15.** Location of the sample Stafford.20.

| <b>Sample No.</b> | <b>Chimney No.</b> | <b>Material Type</b> | <b>Description</b> |
|---|---|---|---|
| Stafford.20 | 16 | Tabby brick | Removed from northwest corner of chimney, face only, “B” marked on back/interior of brick) mild erosion of brick face |

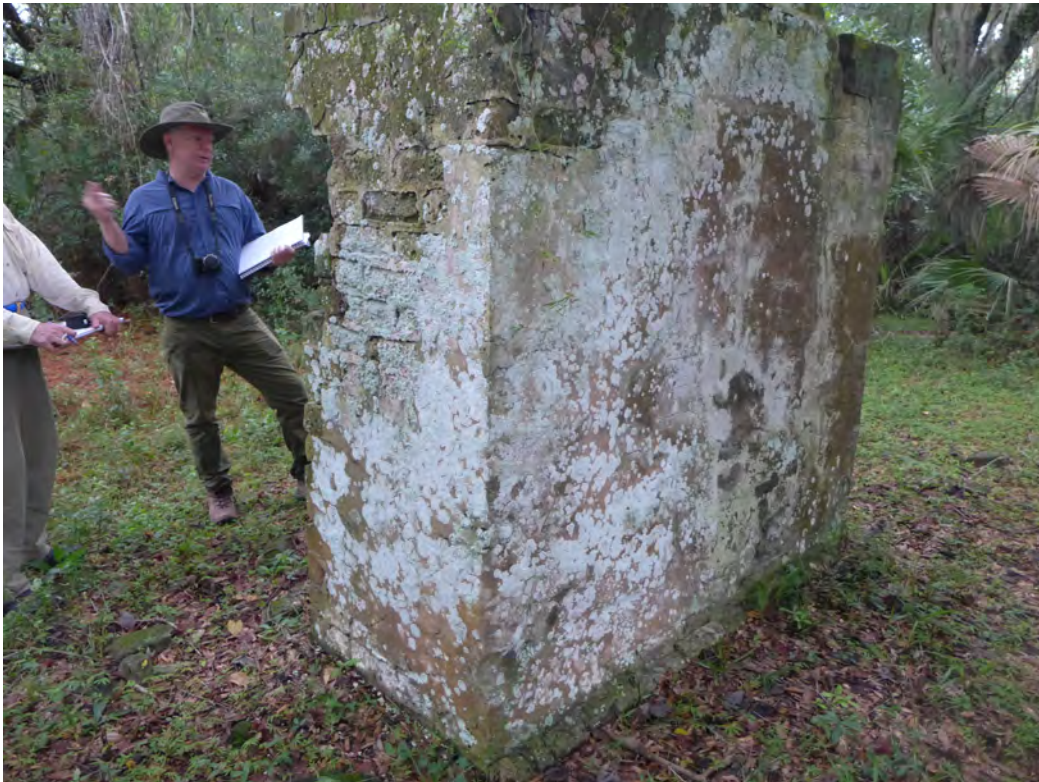
**Image 17.** The thin, brown-colored parging that is present on some of the chimneys (usually in partial form) is visible on this chimney.

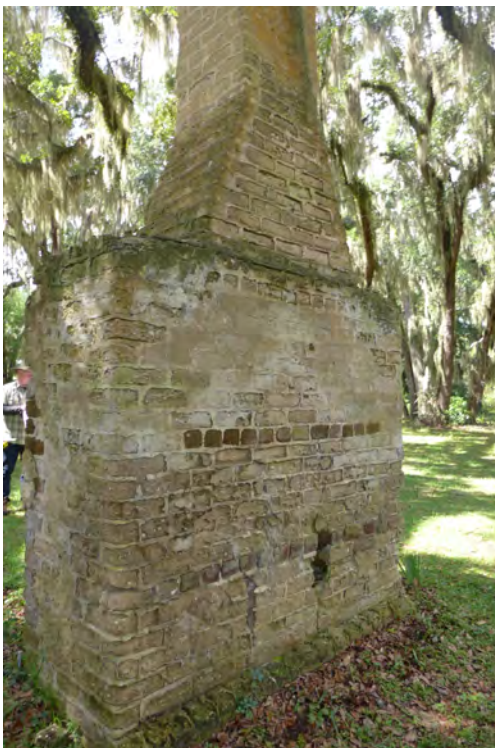
Although the conditions tend to be localized and somewhat random, some patterns of deterioration were observed. The most severe damage seems to be concentrated at the outside corners of the chimney bases, at the backs of the hearths, and in any location where a dense Portland cement re-pointing mortar or patching has been installed. In light of the information provided in the materials testing reports, this pattern makes sense. If cyclical wetting and drying of soluble salts is considered one of the primary causes of the severe tabby brick deterioration (namely erosion), then the pattern of eroded bricks at the bottom of the chimneys seems logical. The bricks at the bases of the chimneys are closer to the ground and the soluble salts are entering the brick masonry from the salt-laden ground moisture through rising damp and then hydrating or crystalizing (both of which cause damage to masonry). Damage from salts associated with rising damp tends to manifest themselves several inches or feet from the ground, depending on the type of salt and other environmental conditions, because this is the location where the salts are drying. The corners of the chimneys, which tend to exhibit some of the most extreme erosion, would tend to go through more frequent wetting and drying cycles than the rest of the chimneys, since they are exposed to air on two sides. The corners may also be more subjected to rain run-off from the “shoulders” of the chimneys, although this was not directly observed during the site visit.

**Image 18.** The exterior side of the hearth is typically in poor condition on most chimneys, as is visible in this photograph.

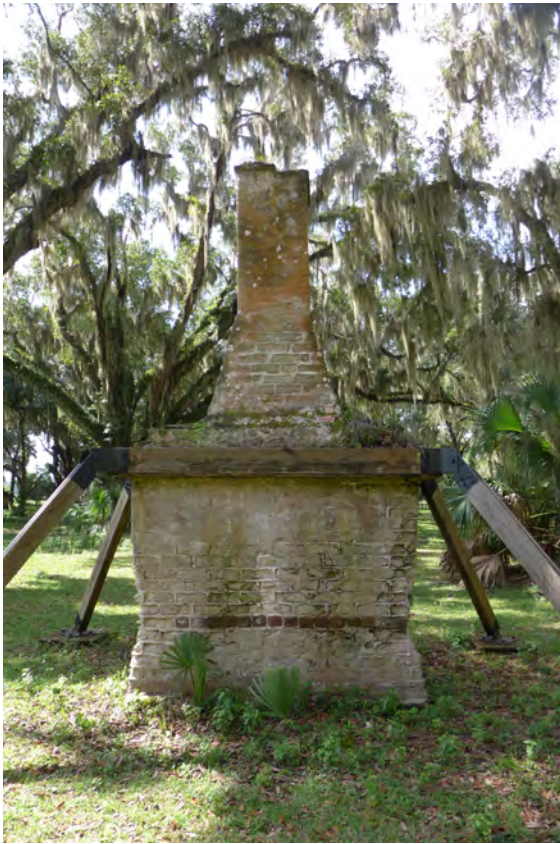
**Image 19.** This chimney clearly exhibits the typical deterioration pattern of eroded corners of the chimney base.

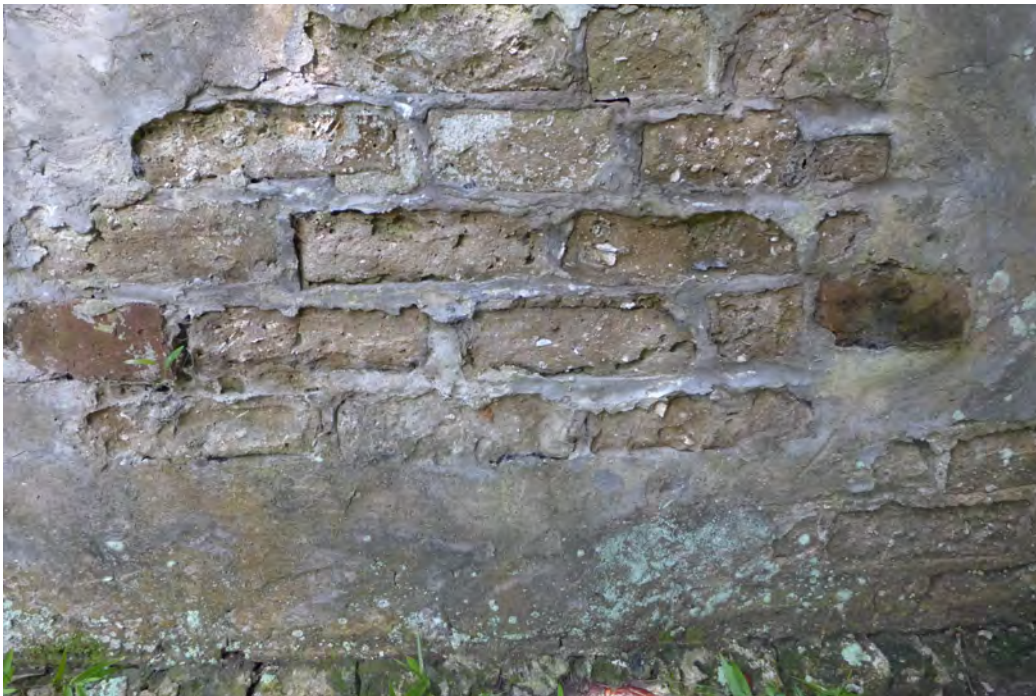
The presence of Portland cement patches and repointing, although not prevalent, is also causing damage to the tabby brick where it does exist. The dense, impervious Portland cement material redirects moisture through the adjacent highly porous tabby brick and historic mortar, exacerbating their deterioration. Portland cements can also contain salts such as sulfates, which could also be entering the adjacent tabby brick masonry and contributing to their deterioration.

**Image 20.** Portland cement repair materials have caused deterioration in adjacent tabby brick.

3. *Removal of Portland cement repair materials.* Existing Portland cement repair materials (parging, pointing) should be carefully removed and replaced with the recommended lime mortar above. The removal of the Portland cement materials will most likely damage the tabby and red clay brick masonry. However, the removal of this material is felt to be critical to the long-term preservation of the masonry and the long-term benefits of its removal are felt to outweigh any damage that might occur during the removal process.

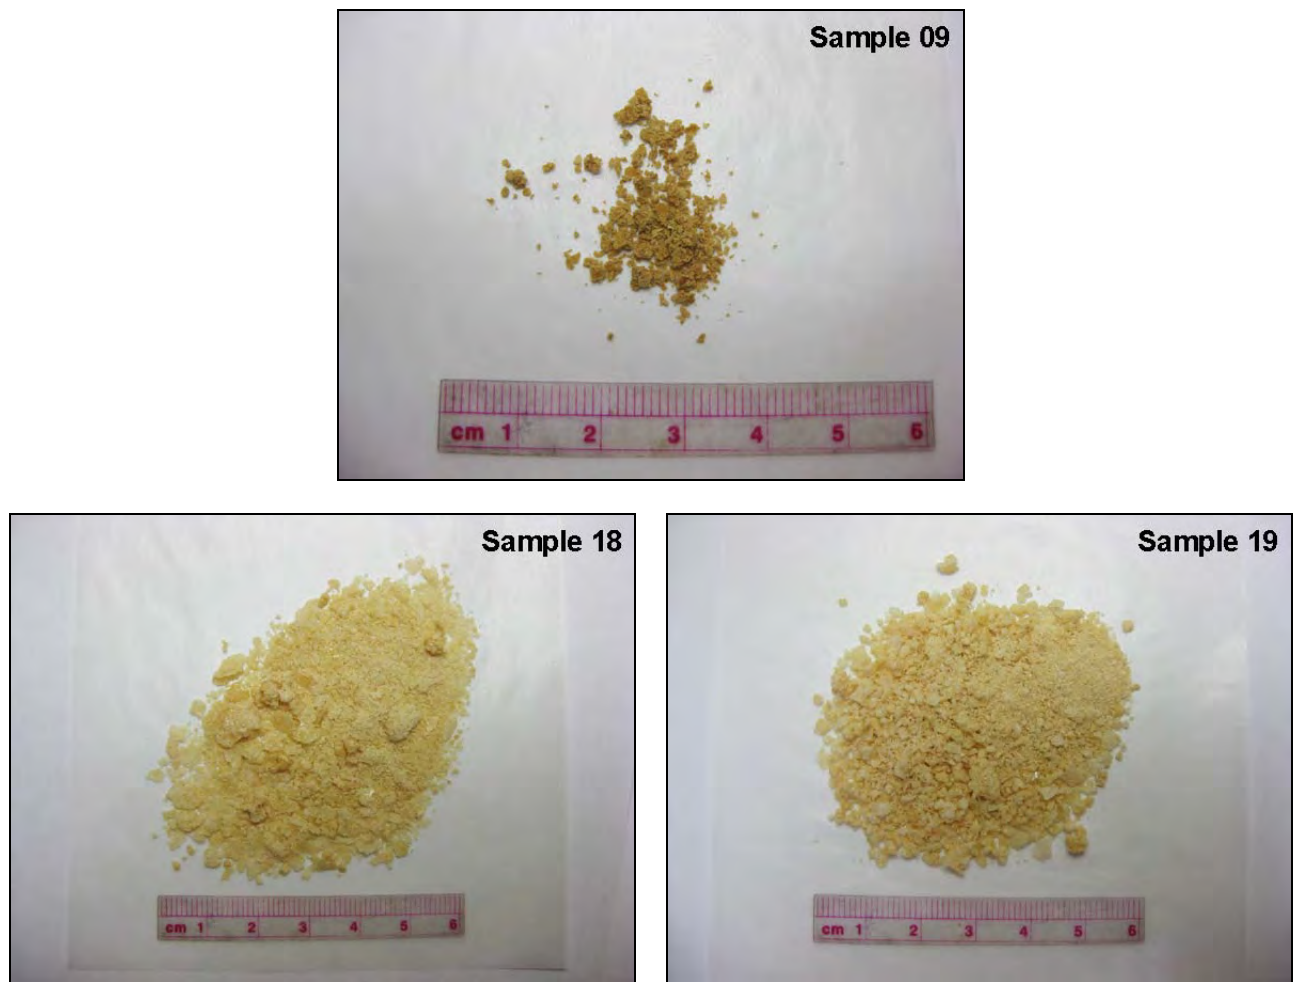
The variety of salts documented in the two damaged brick are certainly capable of causing progressive decay of the brick matrix through repeated wetting and drying cycles. The sulfates would tend to be the most destructive, but none of the salts are considered innocuous. This makes sense when one considers that some of the most pronounced damage observed on site was at the edges or sides of the chimney bases, where wetting and drying cycles would occur more frequently. Because there is no evidence for the presence of swelling clays in the brick matrix, nor are there other common environmental factors such as freeze-thaw cycling that

would damage the tabby brick, it is possible that soluble salts are one of the more significant causes of erosion in the tabby brick.

**Figure 3:** The salts extracted after evaporation are shown in these images. Much less salt was extracted for Sample 09.
