# Condition Assessment and Preservation Recommendations: **World War II Era Structures** Peleliu State, Republic of Palau

Stanley O. Graves, FAIA  
S. Patrick Sparks, PE, SECB

December 22, 2013

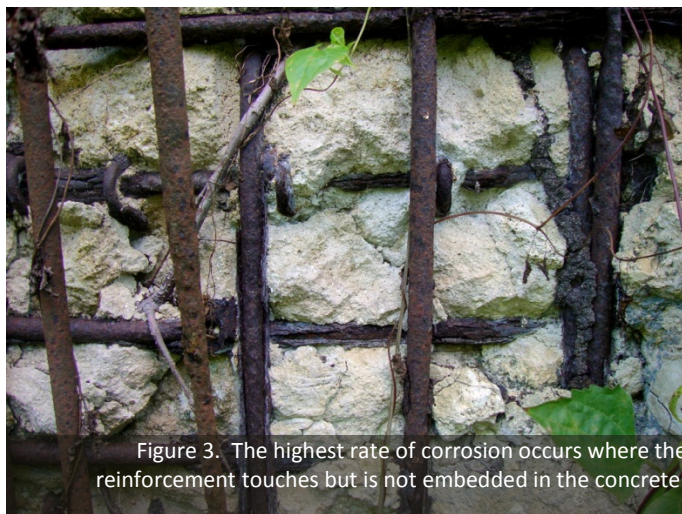
Figure 3. The highest rate of corrosion occurs where the reinforcement touches but is not embedded in the concrete.

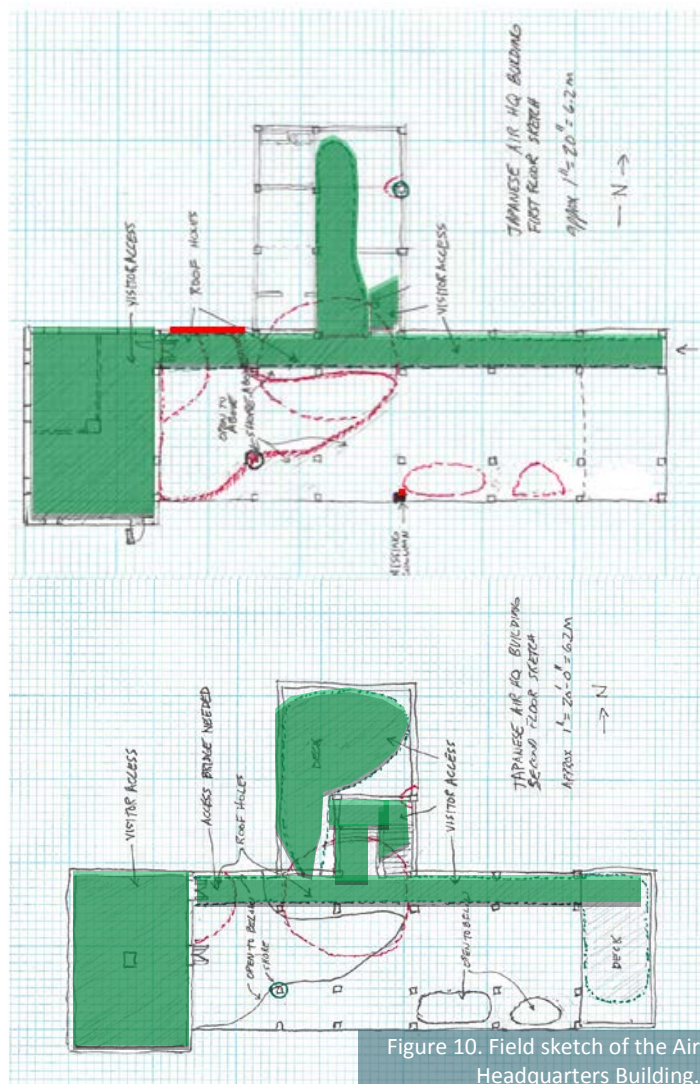
Figure 10. Field sketch of the Air Headquarters Building.

1. Loss or failure of columns has occurred at three locations. One exterior column on the south side has been removed at some time in the past, presumably as a result of severe battle damage. One column on the east wall of the north wing was likewise destroyed by artillery. Another column on the interior was badly damaged during the battle and has failed structurally at its base (Figure 12). In all cases the remaining structural frame as accommodated these losses and no significant distress is evident.
2. Cantilever slab areas occur where large portions of the roof and 2<sup>nd</sup> floor were destroyed, leaving some of the slab edges unsupported. An option for these is either to cut them back to the face of the nearest beams, or to provide vertical support at the edges with timber posts.

1. Install vertical shoring posts at the location of the missing column on the south side, under the beam on the north side, and along the unsupported 2<sup>nd</sup> floor slab edges (as indicated in Figure 10). Use 200 mm square timbers at the missing column, 150 mm square timber under the beam, and 100 mm square posts under the slab edges. Assure that the posts are installed snug tight so they will not fall out, and brace properly.
2. Remove loose pieces of concrete that pose an overhead falling-object hazard. Inspect regularly for changes in conditions.

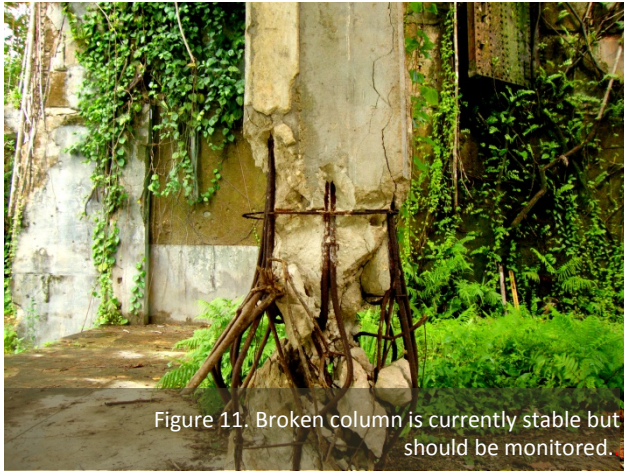
Figure 11. Broken column is currently stable but should be monitored.

As part of a long-term preservation strategy for the structure, we recommend permanent vertical shoring posts, improved confinement of the damaged columns, column splints as necessary, or a combination of both.

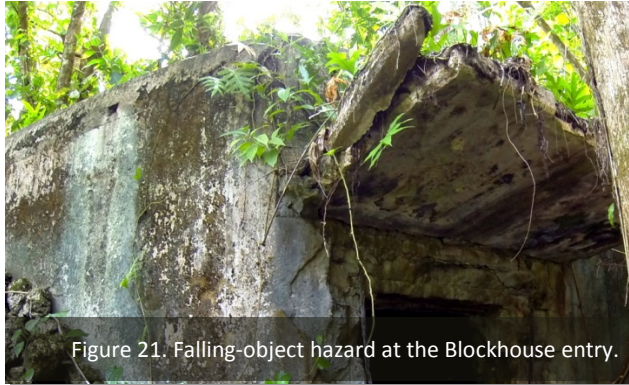
Figure 21. Falling-object hazard at the Blockhouse entry.

The Blockhouse is in good overall condition with only significant battle damage apparent at the entry doorway. The building is unique in that all of the steel firing port shutters survive and the one to the right of the door seems to have most of its components intact. Structurally, there is some deterioration of the bottom layer of reinforcement in the roof. However, as with the other fortified structures, there is not overall risk of collapse. The reinforcement should be cleaned and treated as described elsewhere.

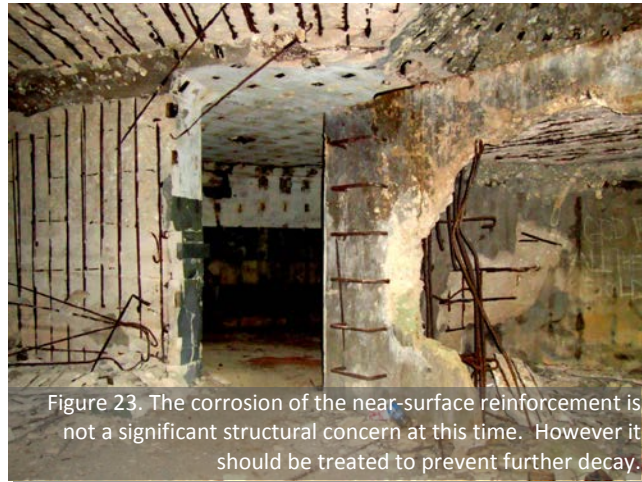
Figure 23. The corrosion of the near-surface reinforcement is not a significant structural concern at this time. However it should be treated to prevent further decay.

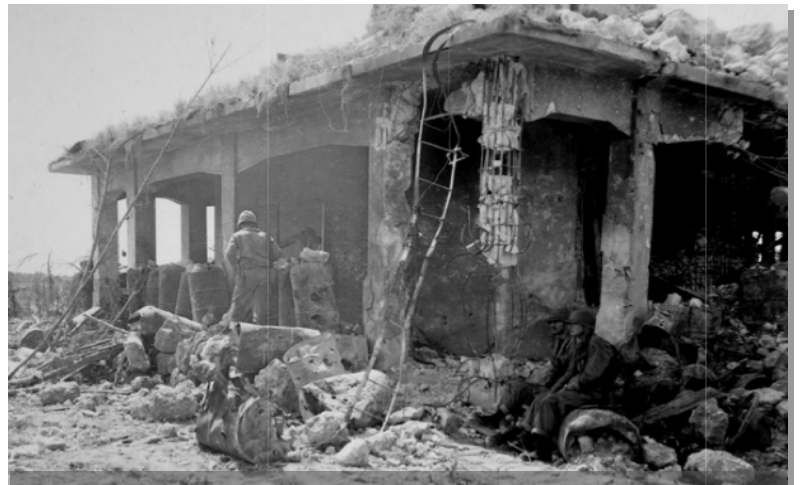
Figure 24. The Japanese Airfield Operations Center, with heavy damage to the west wall.

The west and south walls were heavily damaged from bombardment along with several of the verandah columns. In addition the west wall exhibits a zone of extraordinary corrosion and efflorescence. We obtained a sample of the efflorescence for testing (result to follow). Roots of a banyan tree penetrate the one-meter thick roof at this point, and water infiltration is severe. However, we expect that this extreme level of deterioration is caused by some other factor than simply moisture and carbonation. Other than this one area, there is very little significant corrosion damage on the building.

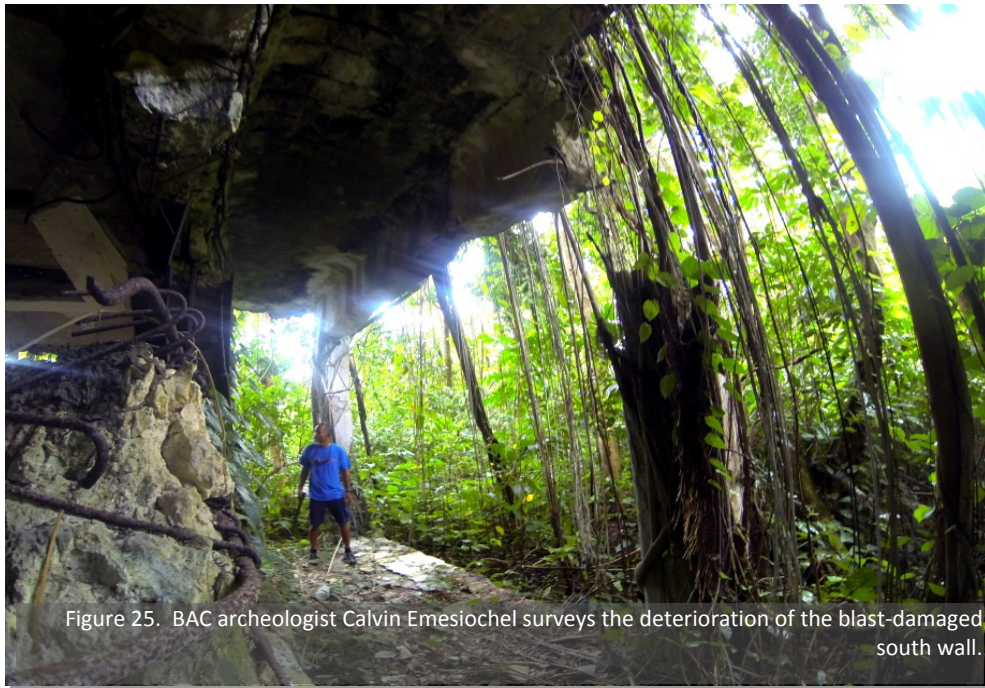
Figure 25. BAC archeologist Calvin Emesiochel surveys the deterioration of the blast-damaged south wall.

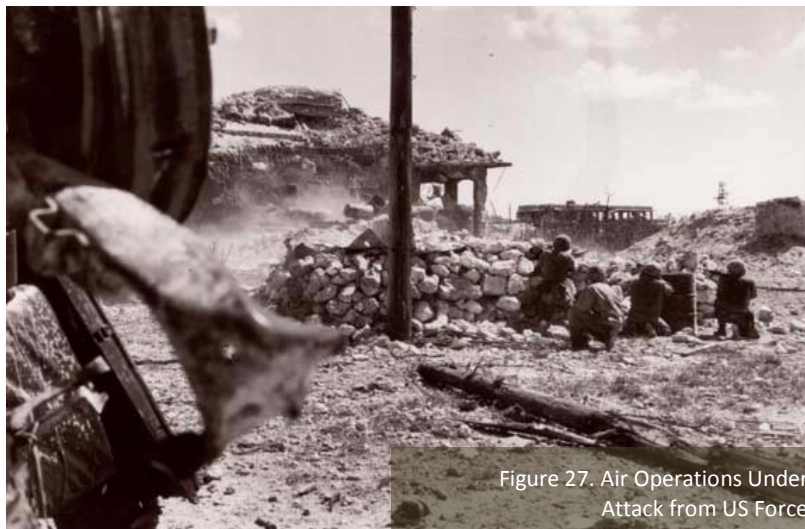
The portion of the veranda roof on the middle of the west side is structurally unsound due to the extreme deterioration in that localized area. Either shoring of the area indicated on the plan or removal of the deteriorated concrete is recommended. Also, remove the hanging concrete slab at the east side as highlighted on the plan.

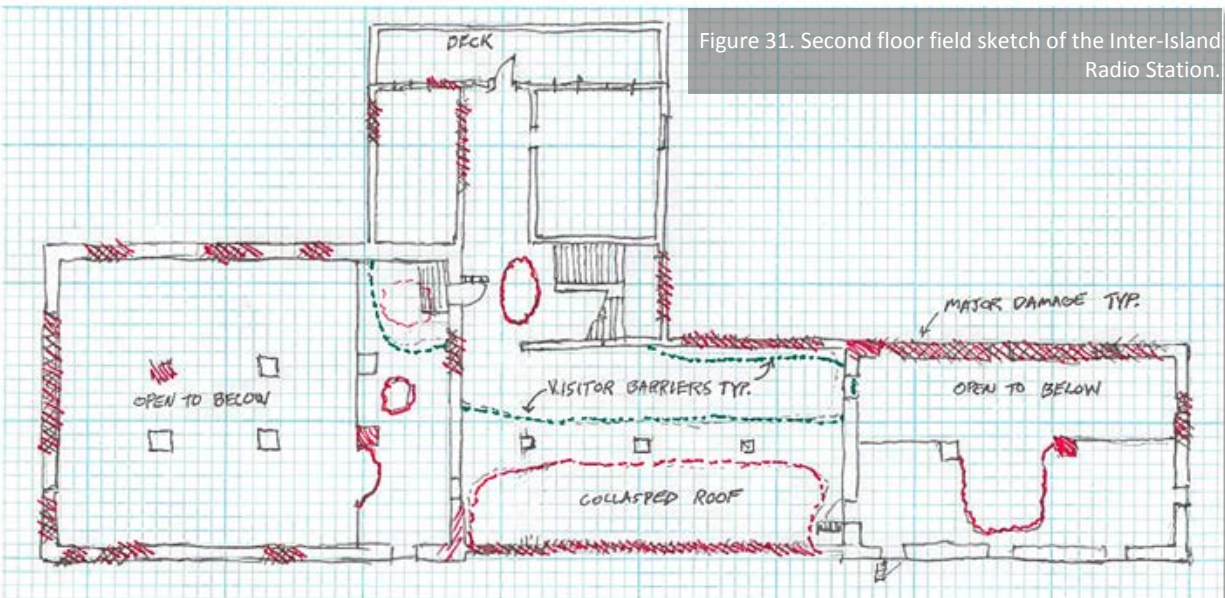
The building is in poor overall condition with extensive damage to south, west, and east ends. The central portion of second floor exhibits the only large areas of roof collapse we have encountered. Graffiti is abundant throughout, both historic to Marine occupation and recent. The building has much trash and debris. Overall most of the large damage areas are stable, but the building is still hazardous to enter.

There are a number of areas of severe damage, but most of them are generally stable. A large piece of roof slab is hanging from a few strands of rebar just above the second floor. This piece of slab should be cut down. Only an experienced contractor should do this work. Still, the building needs to be seen as a significant hazard and attractive nuisance with most areas cordoned off and posted with warning signs. The families that use the building should be specifically told not to enter the damaged areas.

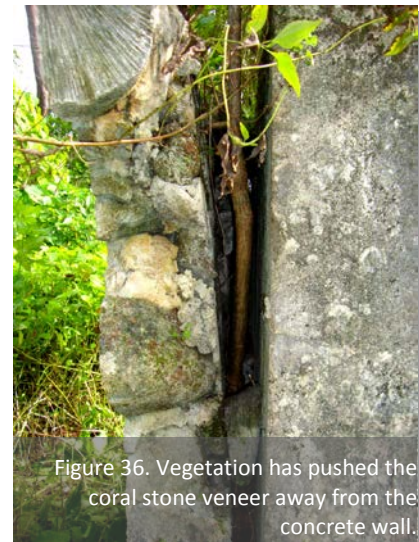
Figure 36. Vegetation has pushed the coral stone veneer away from the concrete wall.
