Re: Inspection and Repairs to  
Independence Hall Tower

REPAIRS TO  
INDEPENDENCE HALL TOWER  
S.S. OF CHESTNUT BET. 5<sup>th</sup> & 6<sup>th</sup> STS.  
NATIONAL PARK SERVICE

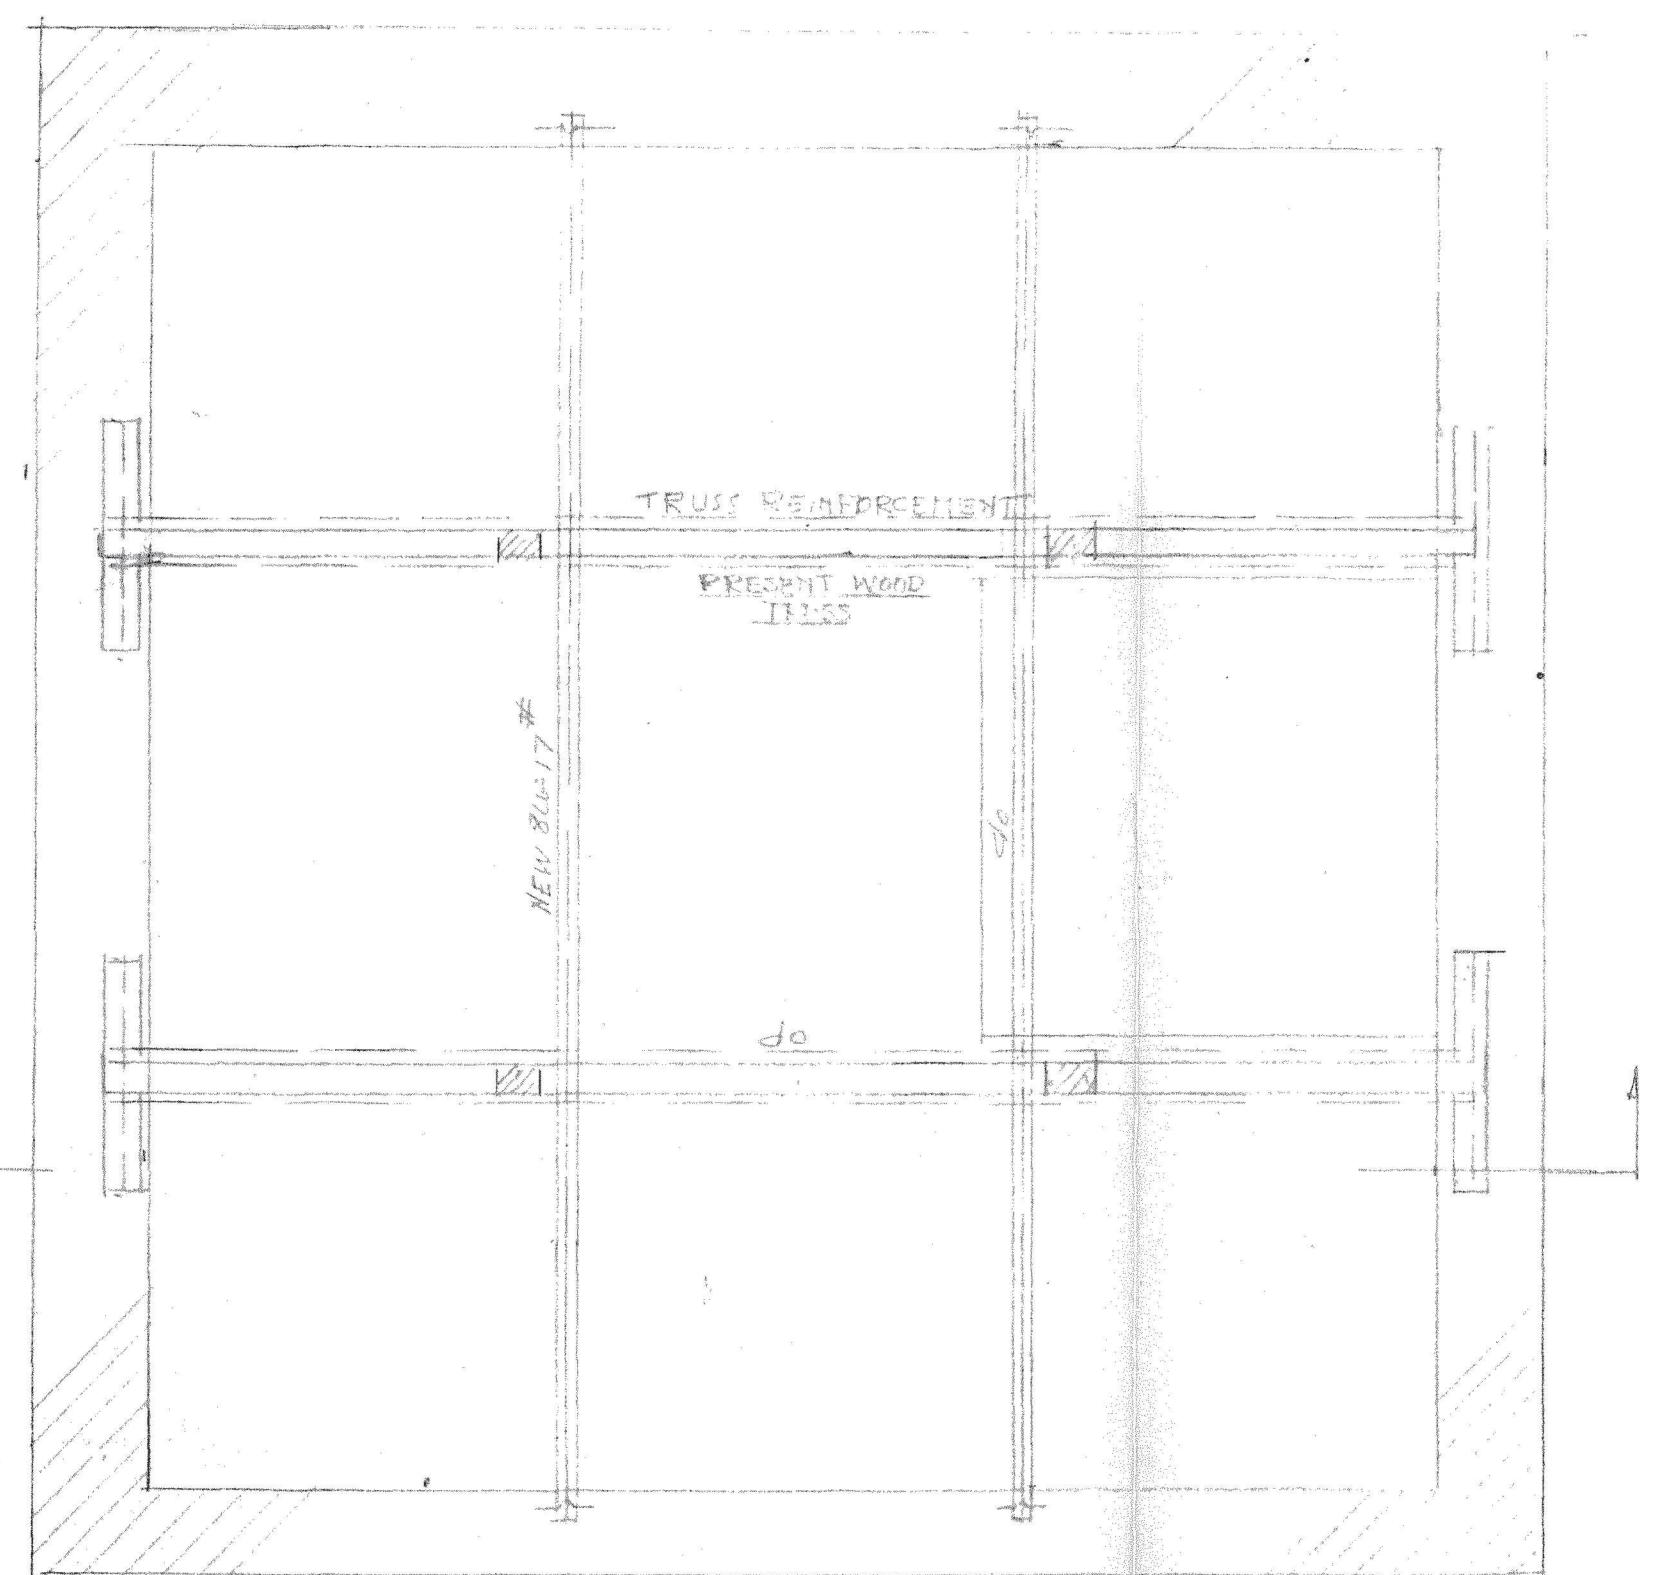
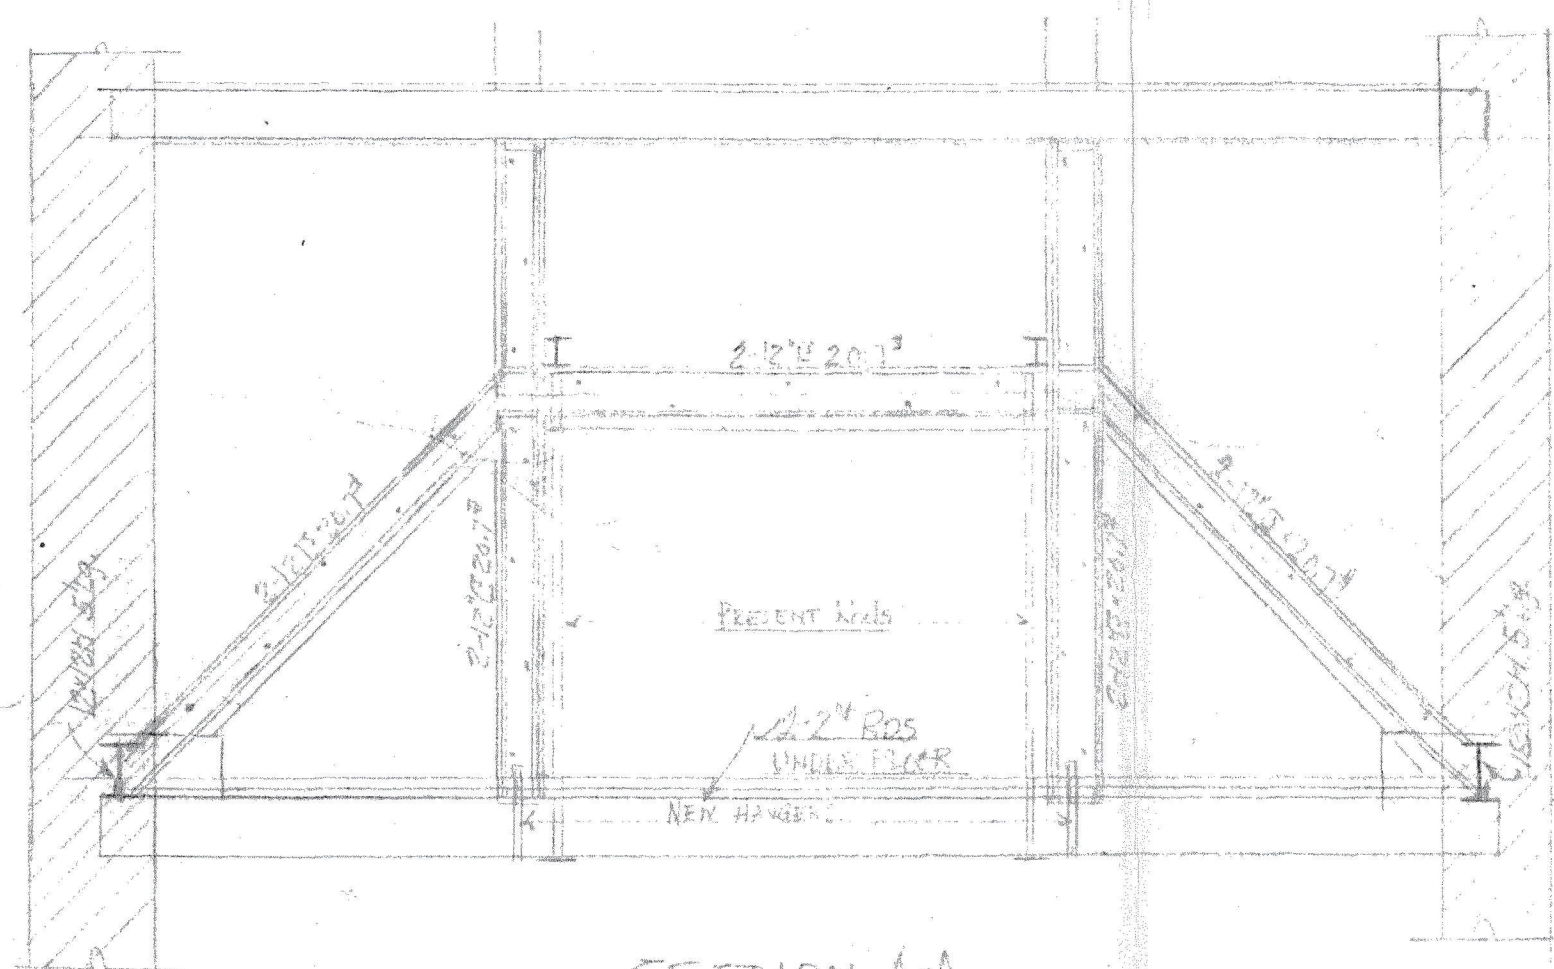
SKETCH NO. 1  
SCALE 1/4"=1'-0"

A clock mechanism is supported on the fourth level on the west side. I estimate this mechanism to weigh approximately 5 or 6 tons. Some of the main support columns are badly checked, and some of the trusses framing into these columns have sagged. In general, the wood supports seem in good condition.

1. No. 5 Level: The two interior trusses running east and west to be reinforced with two channels—one on each side with two tie rods under the floor serving as the bottom tie. This truss, with its two vertical posts, will be made to support the fifth, fourth, and third levels and carry the weight of the clock mechanism. A detail of this is shown in Sketch No. 1.

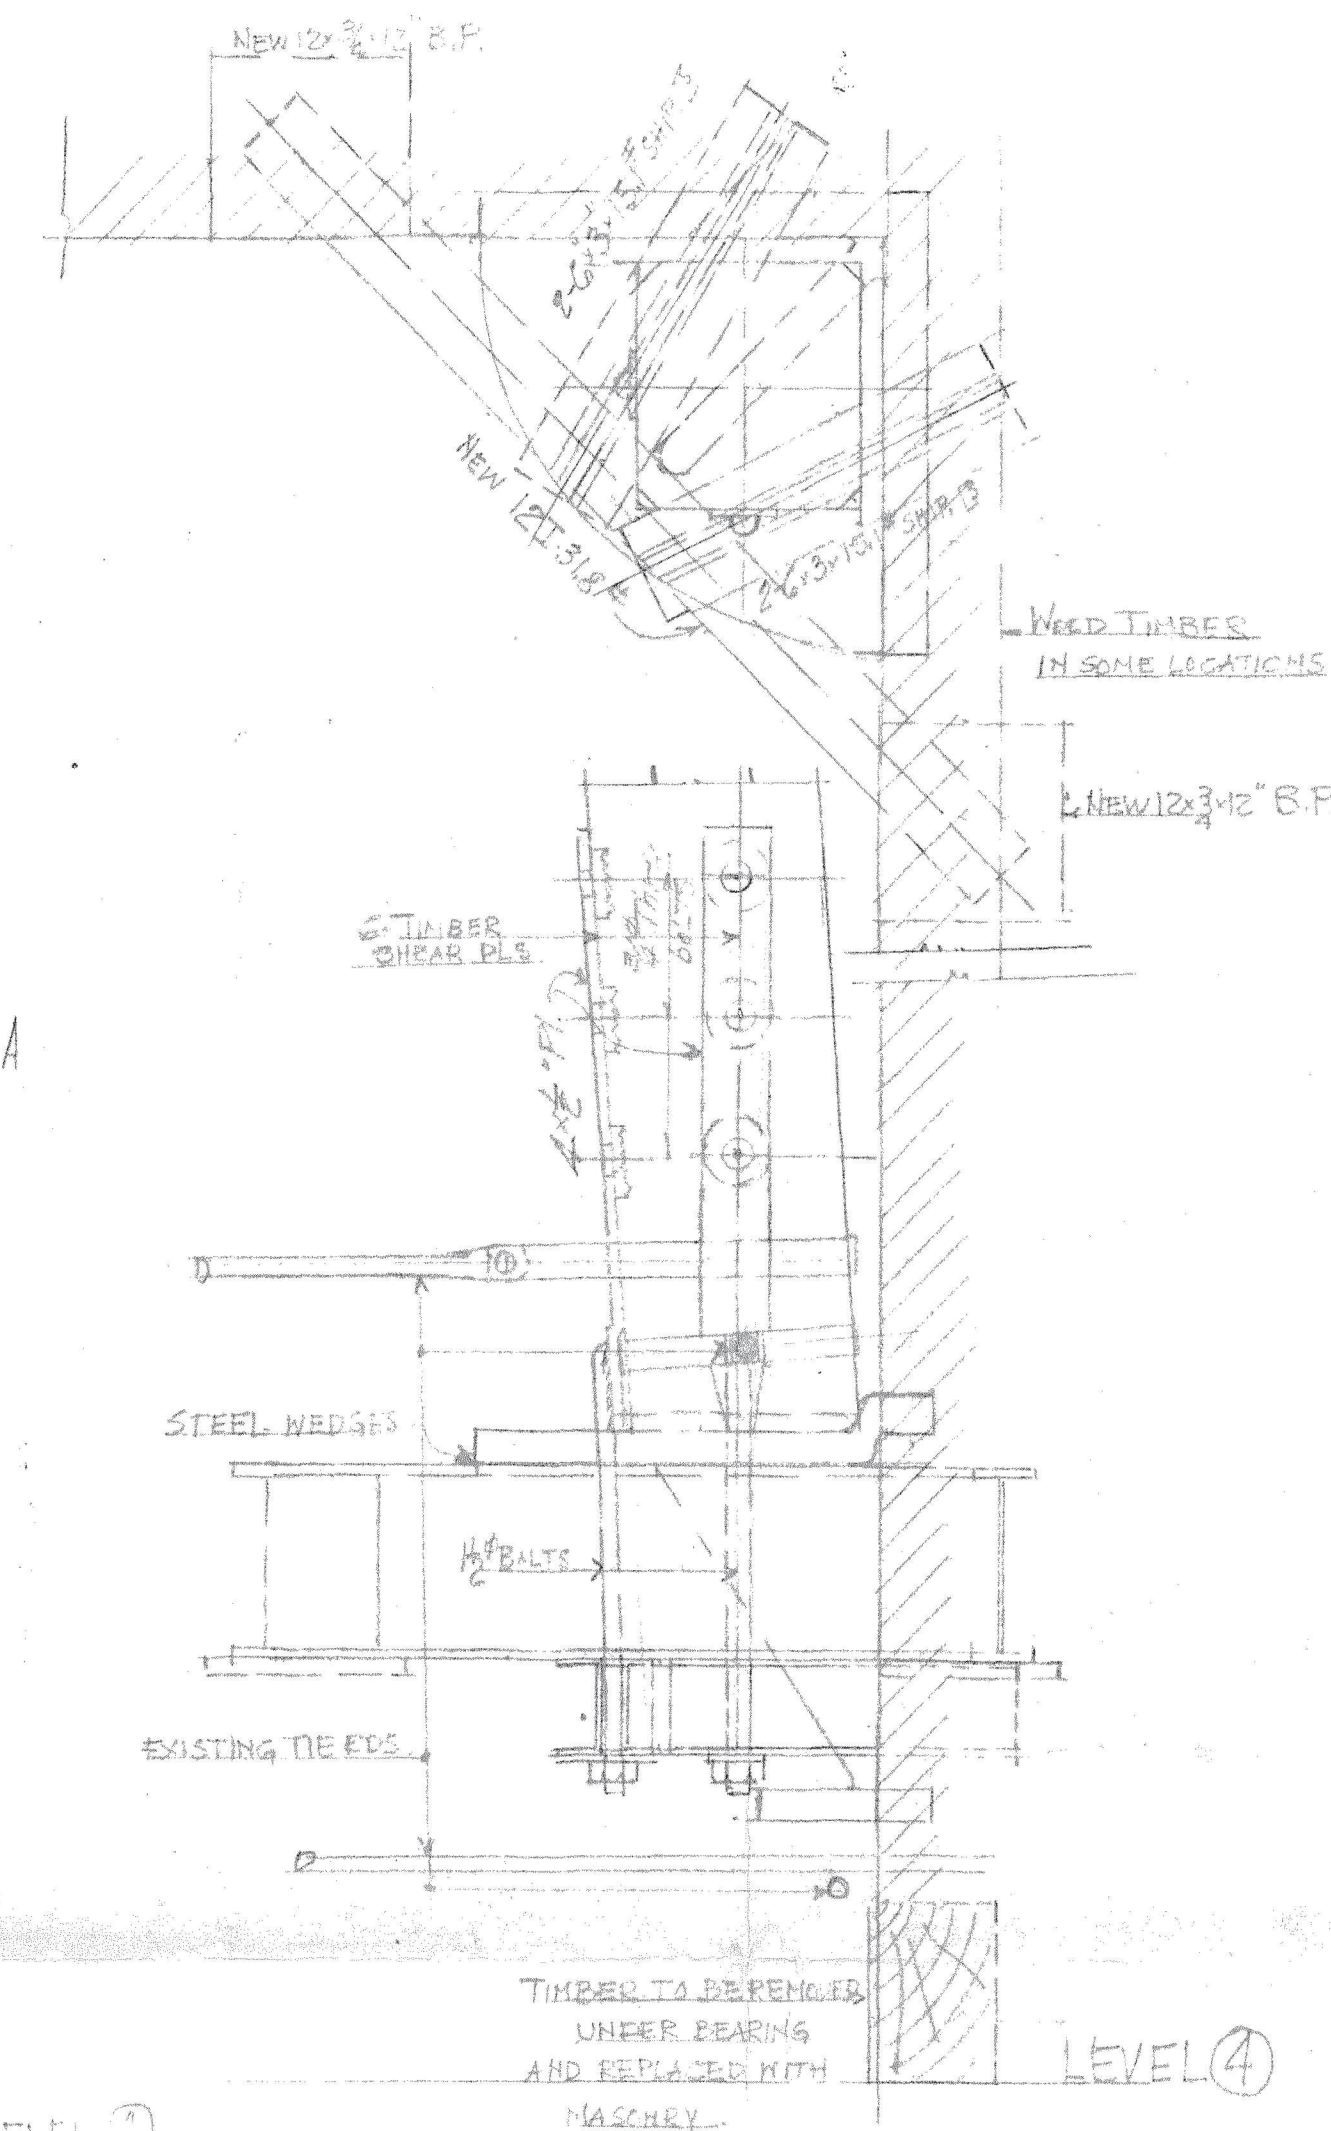
SKETCH NO. 2  
SCALE 1/2"=1'-0"

about 2' to another flange supported on the wall. These flanges, as far as I can see, are carried into the brickwork only about 3". There is considerable torque on these C.I. brackets; at least one has apparently moved out from its original position. I recommend that a steel "I" beam be placed diagonally across from wall to wall with a bearing of at least 10" to support the outer edge of the C.I. support, thus relieving the twisting action on the C.I. support. At the northeast corner, a timber now exists in the wall under this bearing. I would recommend this timber be removed from directly under the bearing. This can be done in three operations, cutting out the timber and rebuilding the brickwork. The same should be done if it occurs at other locations.

The bottom of the main tower supports is not fastened down at its bearing on the C.I. bracket. The only force holding the tower down against overturning is the weight of the frame tower, itself. According to my figures, this is inadequate to carry a 100 miles-per-hour wind load. The weight of the brickwork from the fourth to the third levels would add considerably to the dead load at each corner. I recommend that the weight of this brickwork be utilized to afford a sufficient factor of safety against overturning. This can be done by tying down the bottom of the four corner columns to its support, thus transferring the uplift to the brick walls. See Sketch No. 2.

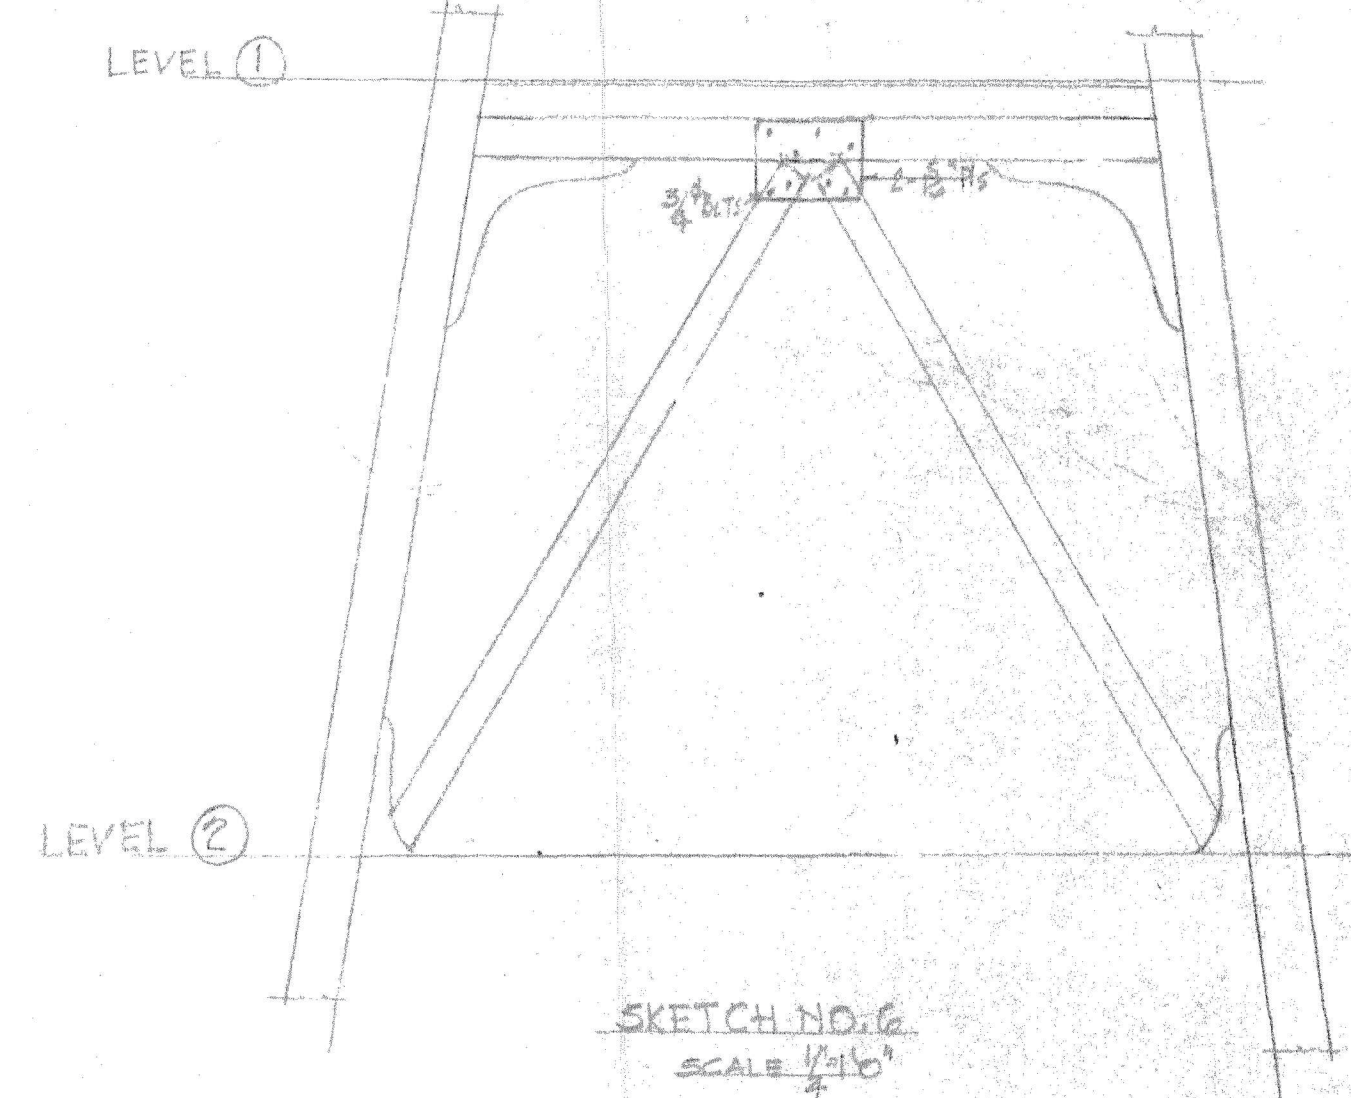
SKETCH NO. 6  
SCALE 1/2"=1'-0"

7. Several diagonals at the ceiling of the second level have badly twisted. I recommend that steel plates be

placed on each side with through bolts, as shown on Sketch No. 6.
