## **NORTH PROVIDENCE OLD TOWN HALL CONDITIONS ASSESSMENT REPORT**

2226 Mineral Spring Avenue, North Providence, RI

**May 1, 2020**

**BTGA No. 2004**

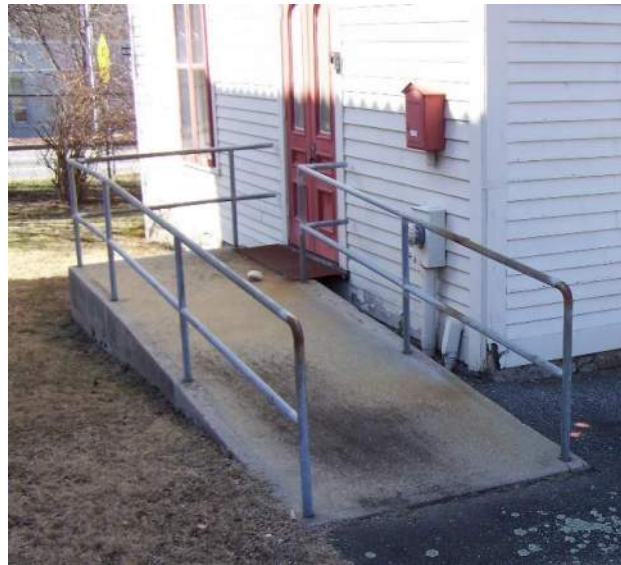
The landing outside the door does not meet the space requirements outside the arc of the door swing.

**Figure 3.3: Concrete ramp to south entrance.**

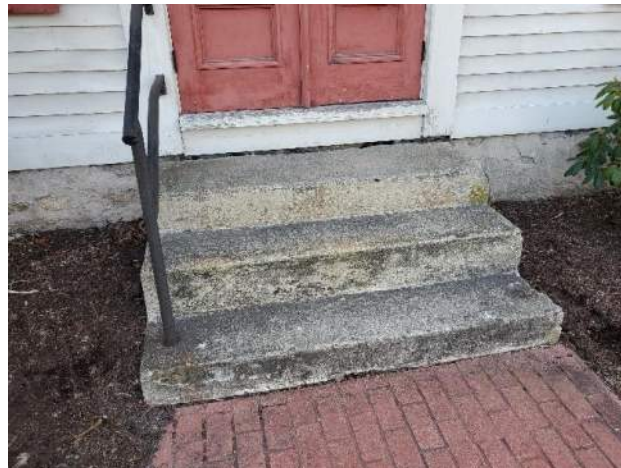
This does not meet building code requirements that risers be within 1/8" of consistent height or have a handrail on both sides. However, returning to an historic condition would remove even the one rail. Stairs in old photos show stone treads on masonry risers in approximately the same configuration as the rebuilt concrete version.

**Figure 3.4: Concrete steps to north entrance.**

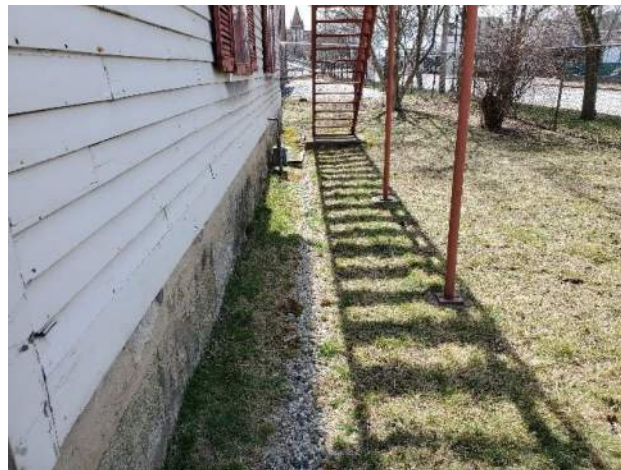
**Figure 3.5: Dripline along west wall.**

The building has no gutters which has contributed to a dripline on the west side of the building. Also see the Site Drainage portion of the report and Figures 3.5 – 3.9.

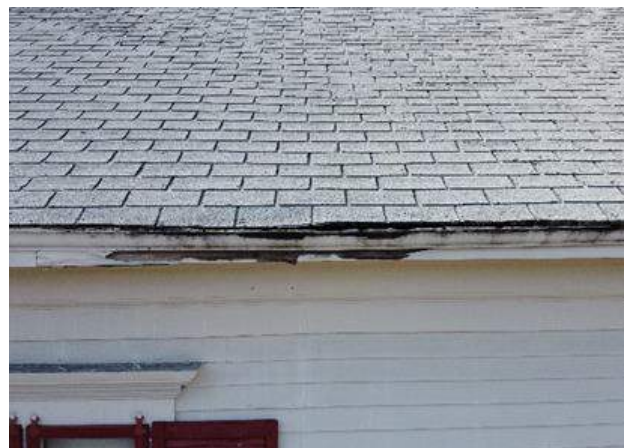
A spot near the middle of the roof edge on the east side of the building is greatly deteriorated. See figures 3.12 and 3.54.

Figure 3.12: Deteriorating roof edge.

Daylight is visible at the east roof edge. This is the most obvious deficiency from the outside; see figure 3.12.

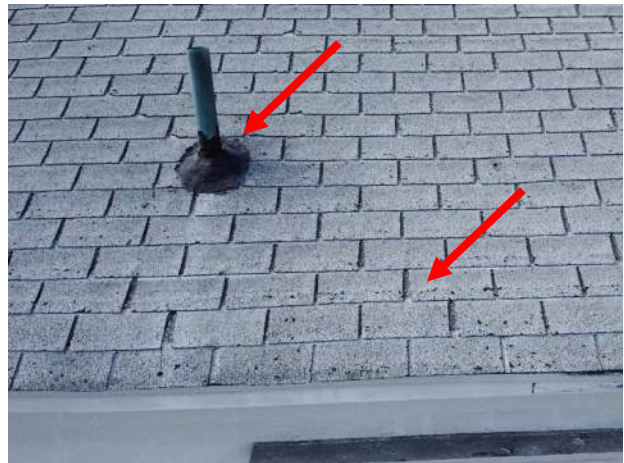
Discoloration and frayed edges indicate that the roof shingles have begun to fail. See Figure: 3.15 The roof ridge is straight and true indicating that the structure is sound. See figure 3.14

There are only 2 roof penetrations: the chimney and a plumbing vent near the east edge. Neither have proper flashing – the vent appears to only have black mastic as waterproofing while the chimney flashing, although present, is leaking copiously. There is no cricket.

Figure 3.15: Worn shingles and plumbing vent.

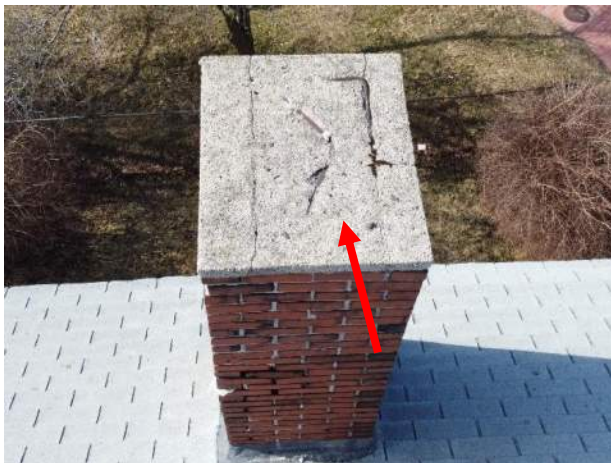
The cast concrete roof cap has worn enough that the rebar is visible. See figure: 3.16

Figure 3.16: Worn chimney cap.

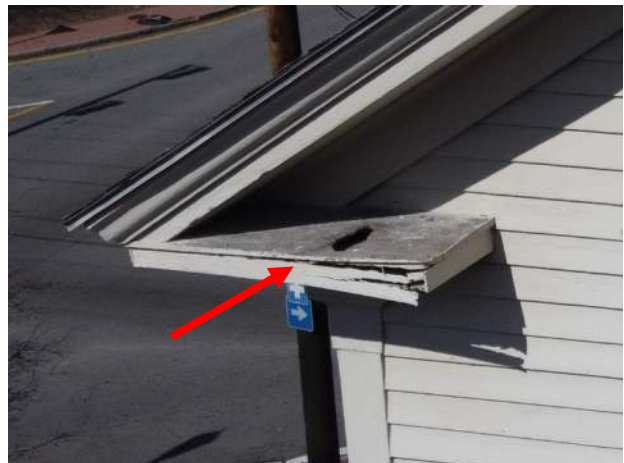
Figure 3.17: Hole in Cornice Return.

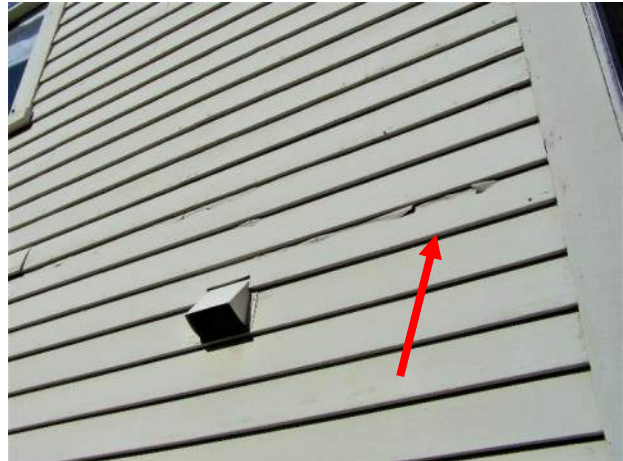
There are nail heads visible all around the building and in some cases are showing rust which is staining the siding.

Several siding boards have swollen creating a rough, unfinished appearance.

Figure 3.18: Siding.

The siding has a few areas that need to be replaced. Scrape and Paint it all, including louvers in the attic.

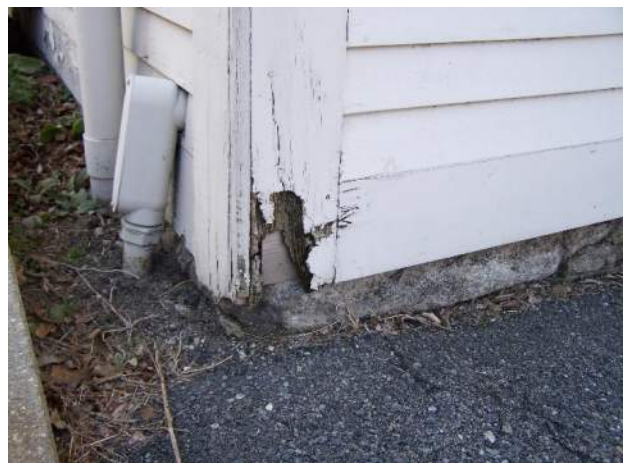
There are several pieces of trim that need to be replaced.

Figure 3.20: Trim.

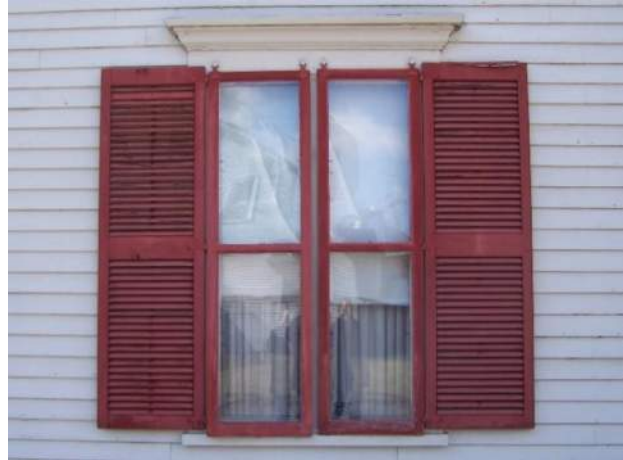
The paint visible on all wooden members of the windows: sashes, screens, shutters, storms, frames, trim, etc. both interior and exterior is past its useful life. Much of the wood is damaged from prolonged exposure to the weather.

The window drip caps are painted wood without metal head flashing and some of them have the joint at the siding sealed, which directs moisture back into the wall.

Evidence of water droplets on the top rail of this window is a sign that moisture has infiltrated the wall and found its way through the window head.

Interior stops are frequently loose and the stools, especially on south and west facing windows are damaged by moisture and UV exposure. Plaster damage around window openings is common.

Figure 3.21: Typical window.

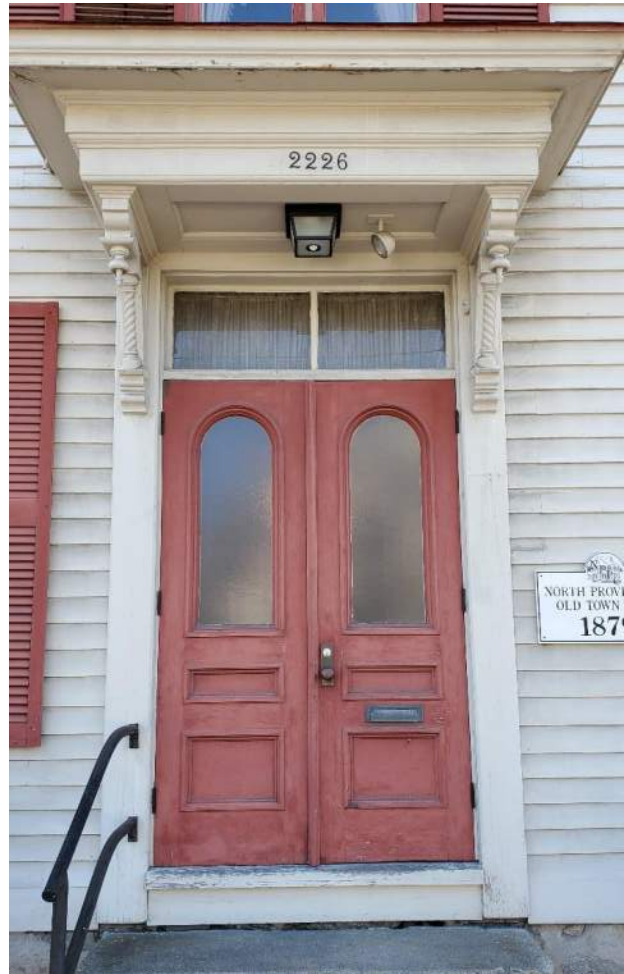
Door 1-1 is made up of two (2) 26" wide x 7' tall leaves. Cracks around the door perimeter allow visible light and therefore weather to enter. Bottom rail of the operable door is showing rot.

Figure 3.25: North, Front Door - Elevation.

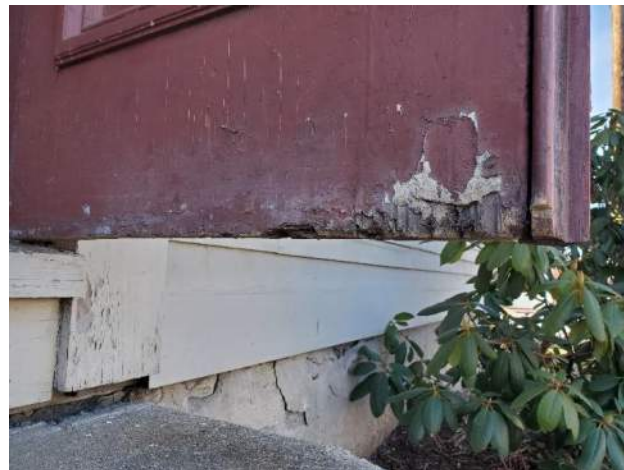
Figure 3.27: North, Front Door – Rot.

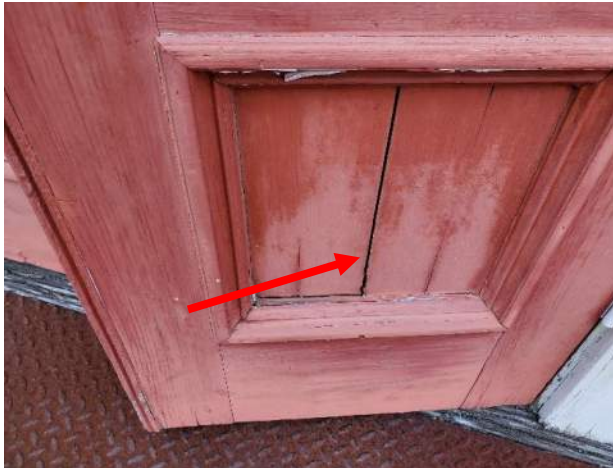
Door 1-2 is made up of two (2) 21 1/2" wide x 7' leaves. There is a 1/8" wide gap at the astragal where daylight can be seen. The bottom panel of each door leaf is broken with enough gap to allow light through. One of the panels is fixed, so the clear opening is less than 20" wide for this "accessible" door. The threshold is 1 3/4" tall and in VERY bad shape.

Figure 3.28: South, Back Door – Cracked panel.

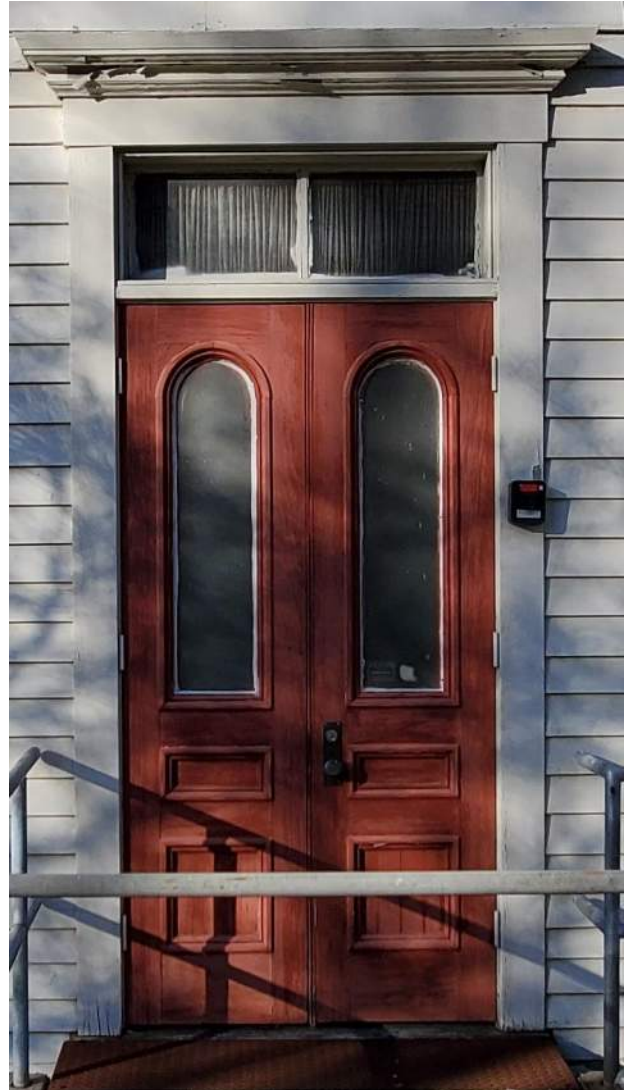
Figure 3.29: South, Back Door - Elevation.

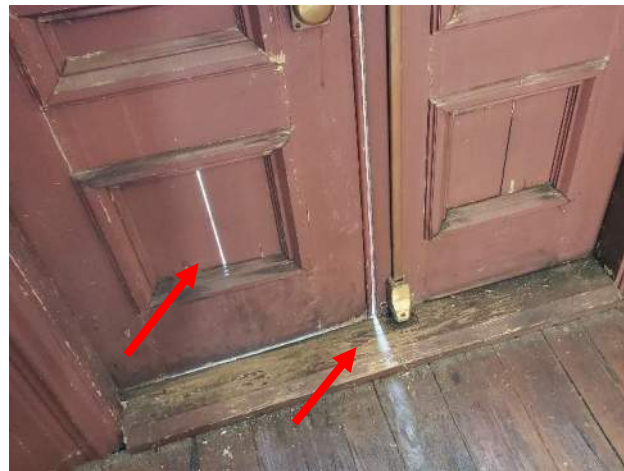
Figure 3.31: South, Back Door – Open joints.

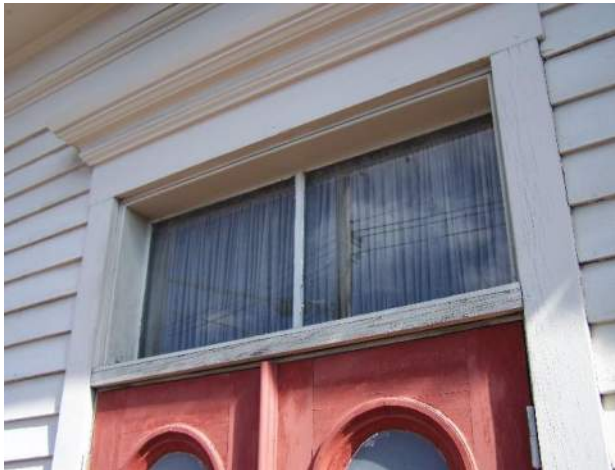
Door 2-1 is made up of two (2) 22 1/2" wide x 7' tall leaves. Cracks around the door perimeter allow light. These doors were added in the 1985 renovation.

Figure 3.32: Second Floor Egress Door - Transom.

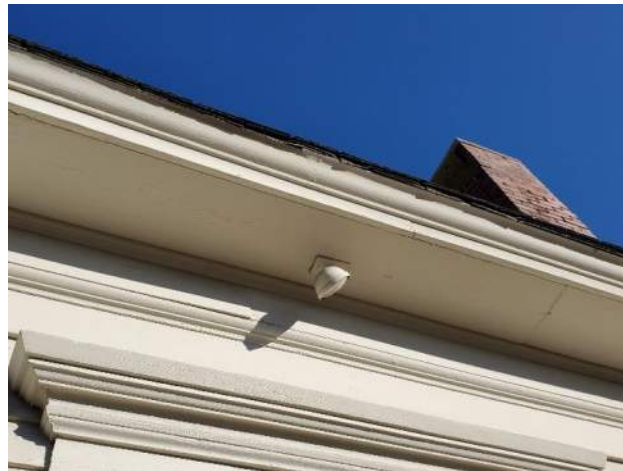
Figure 3.35: Egress Door - Light.

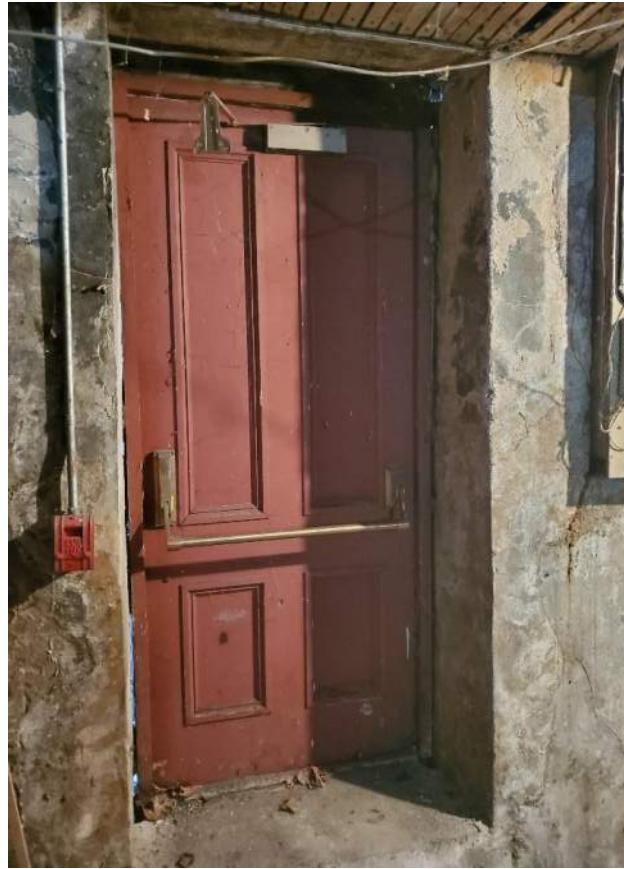
Door 0-1 is a single door in the basement that does not latch properly, has gaps around the frame allowing light through on all sides, and has no threshold. Hardware is damaged.

Figure 3.37: Basement door - elevation

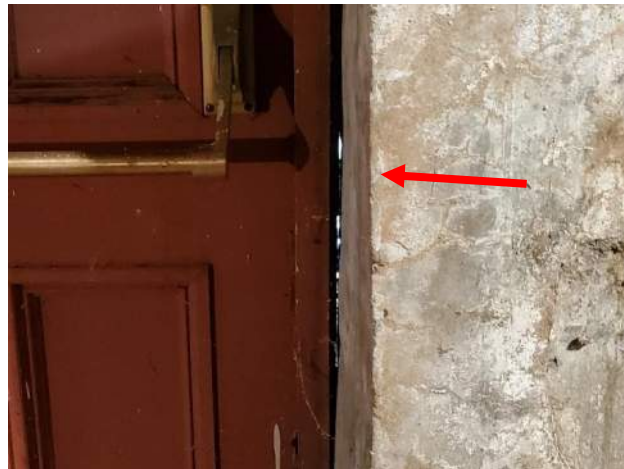
Figure 3.39: Basement Door - Daylight.

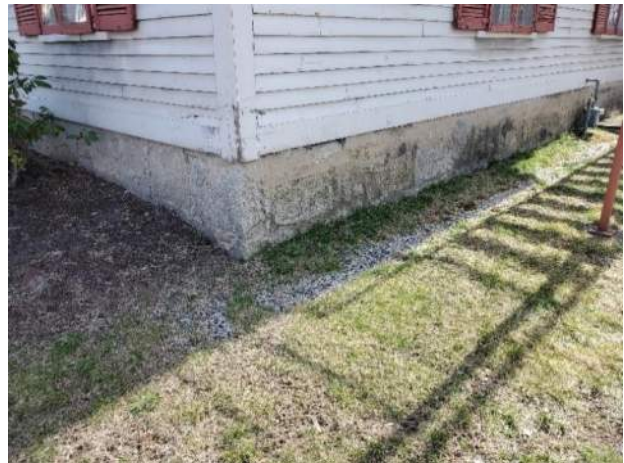
The rubble stone foundation received a parge coat at some point. That coating is beginning to fail with cracking, spalled sections, rising damp staining, and biological growth.

**Figure 3.40: Foundation.**

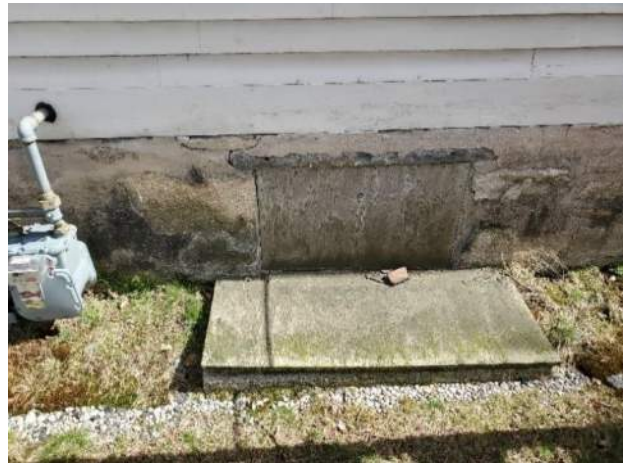
There is evidence of moisture intrusion in the basement around this opening. See figure 3.45.

**Figure 3.41: Coal Chute.**

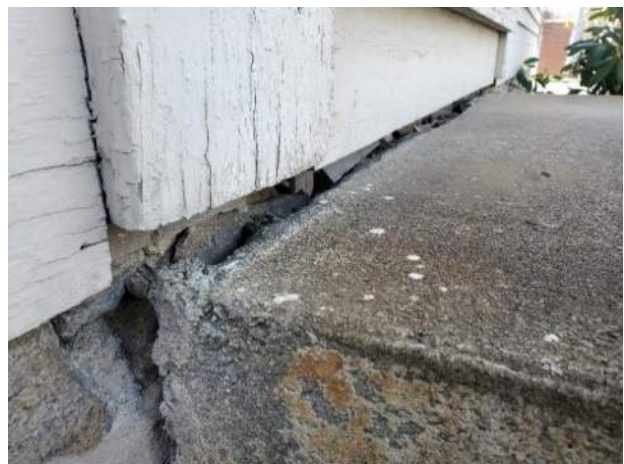
There are several open joints in the stone wall behind the front door stairs which allow water infiltration into the foundation.

**Figure 3.42: Gaps behind front stairs.**

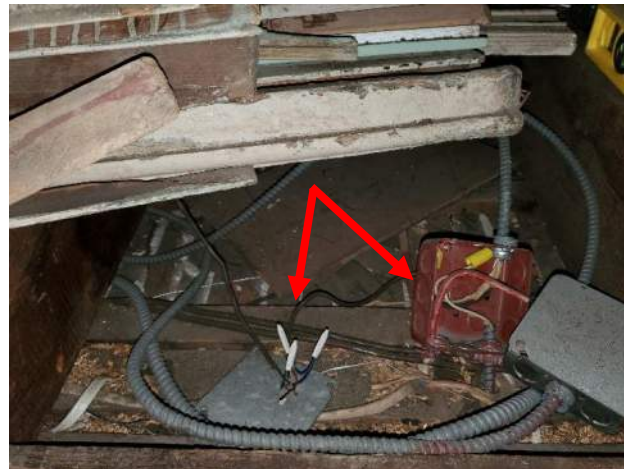
Figure 3.50: Exposed wire connections.

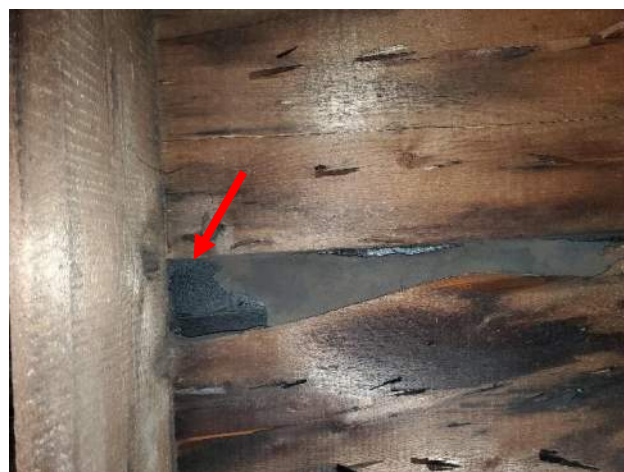
There are several places where the backside of the roof shingles is visible from inside the attic. In this photo you can see that there was a layer of roof felt in place, but over time it has become brittle and fallen away.

Figure 3.51: Visible backside of shingles.

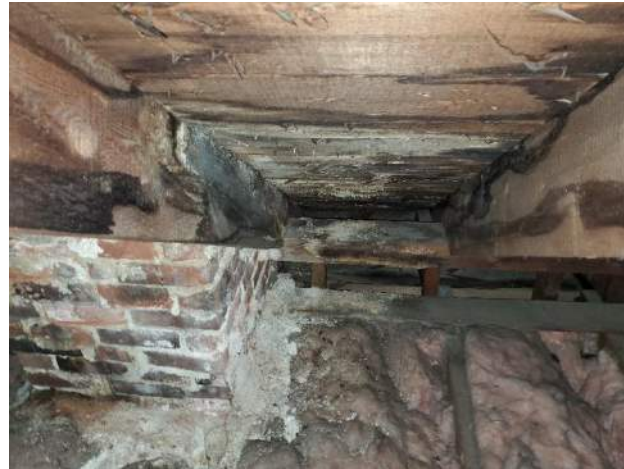
The chimney masonry is deteriorating. Based on the condition here and what's visible from the outside and in the basement, it may be that the masonry and mortar joints behind the plaster enclosures on the first and second floors are deteriorating as well.

Figure 3.52: Roof deck at chimney.

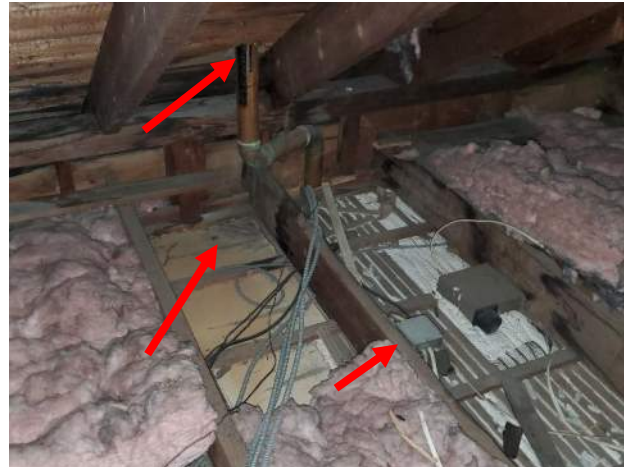
Also seen here is a heavy-gauge black insulated wire and two modern wires inserted into a junction box.

Figure 3.53: Plumbing vent.

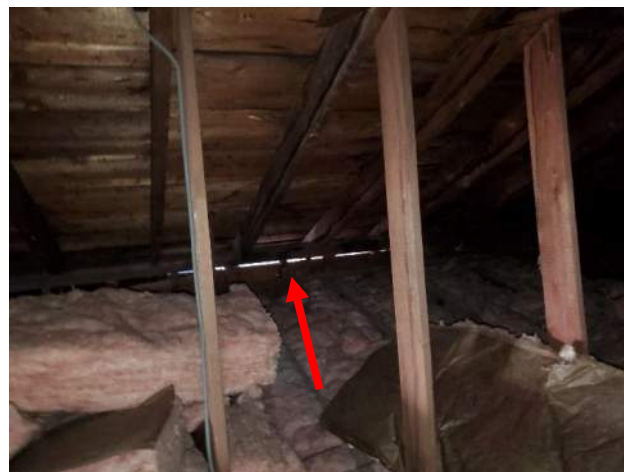
Figure 3.54: East roof edge.

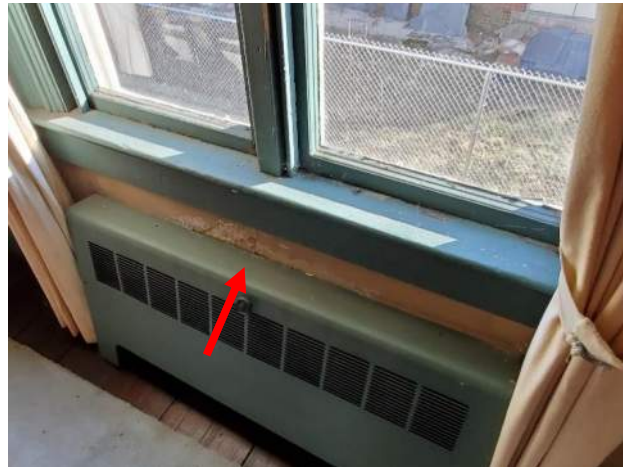
This is an example of the plaster damage frequently present between the windows and the heaters

**Figure 3.57: Moisture damage.**

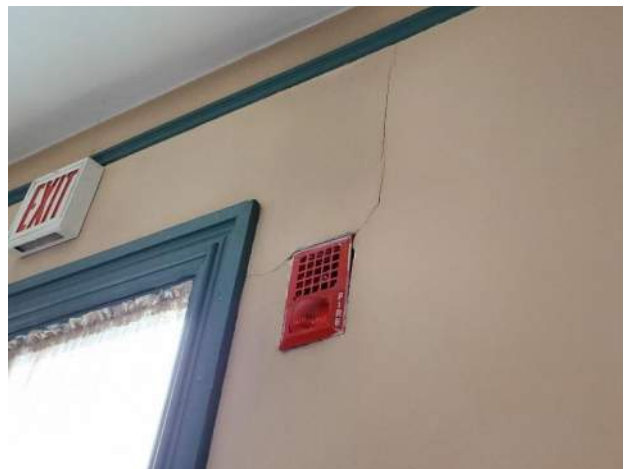
A crack that stems from the fire alarm to the door and ceiling.

**Figure 3.58: Plaster crack.**

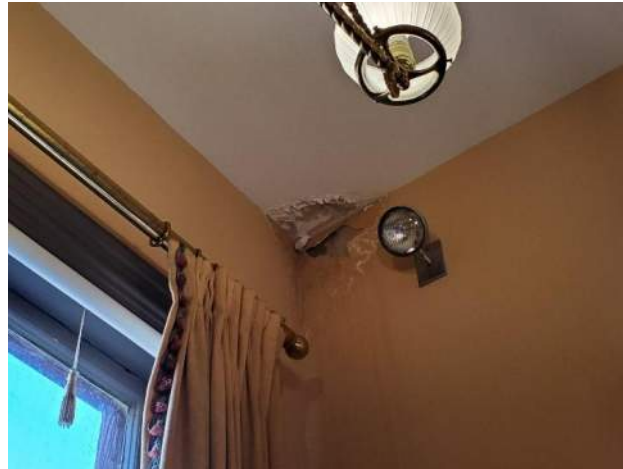
Leak damage apparent in the stairwell. This area is directly below the plumbing vent roof penetration. See figures 3.15 and 3.53.

Figure 3.59: Roof Leak.

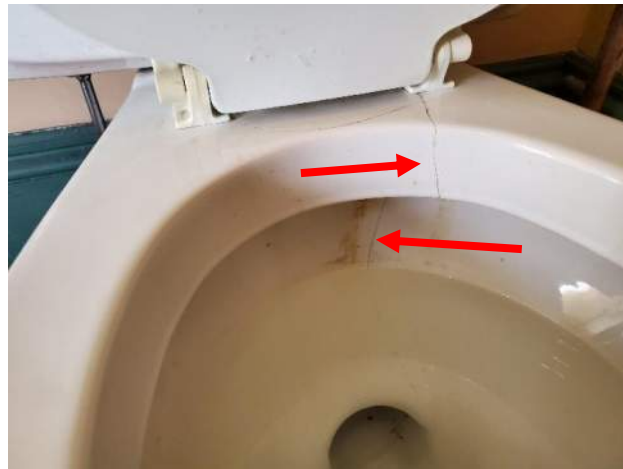
All plumbing fixtures in the building are operational except the toilet in the second-floor bathroom, which, even though it has water in it, shows evidence of past leaks and has a crack in the bowl.

Figure 3.60: Cracked toilet.

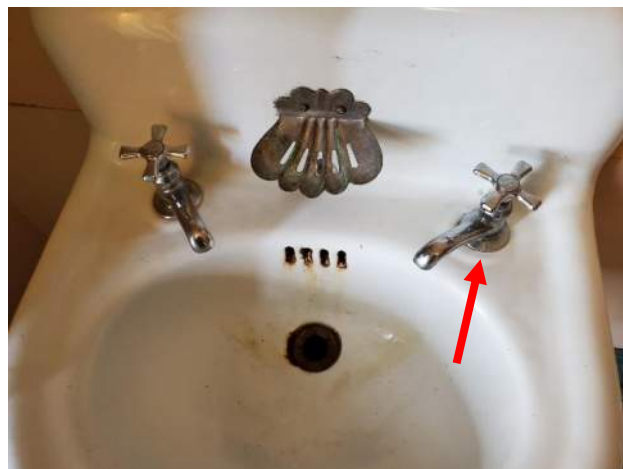
Although the sink in the second-floor bathroom is functional, the right faucet is loose in its setting, and both are difficult to operate.

Figure 3.61: Lavatory.

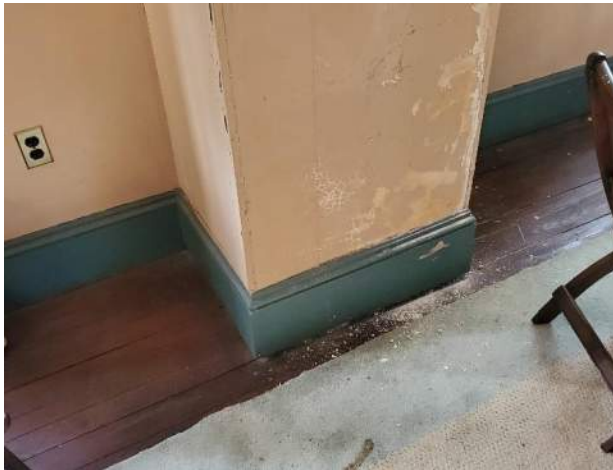
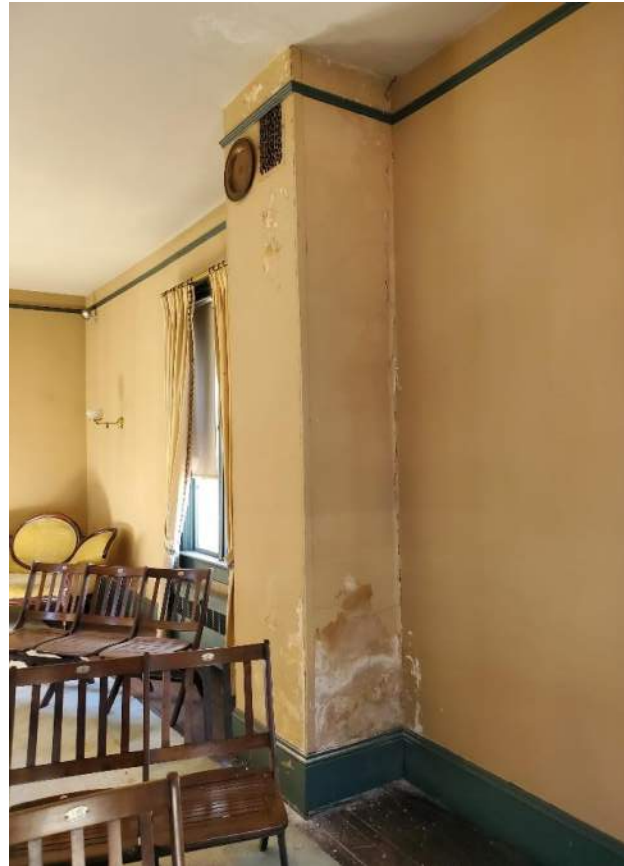
The embedded wood corner pieces on both outside corners, as well as the other two outside corners indicated on the plan to be cracking, have separated from the plaster distinctly.

**Figure 3.62: Chimney enclosure.**

**Figure 3.63: Chimney enclosure.**

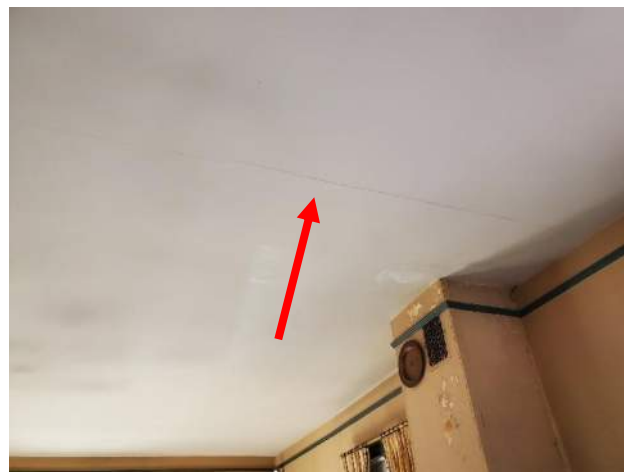
**Figure 3.64: Ceiling crack.**

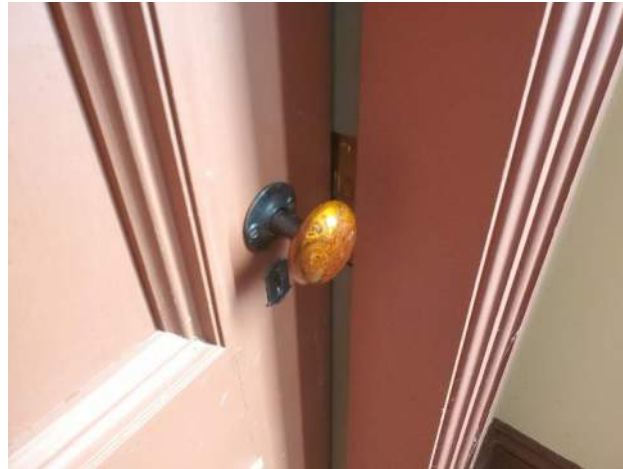
**Figure 3.66: Door 1-8 doesn't latch.**

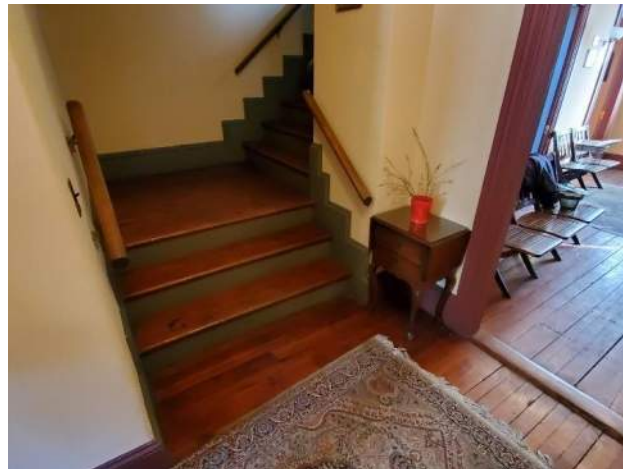
The interior stairs do not meet the standard code requirements for handrails, treads and risers in non-residential buildings and may require new or renewal of historic variances granted before 2003. Such permission should not be hard to achieve given the easy-to-navigate configuration.

**Figure 3.67: Interior stairs.**

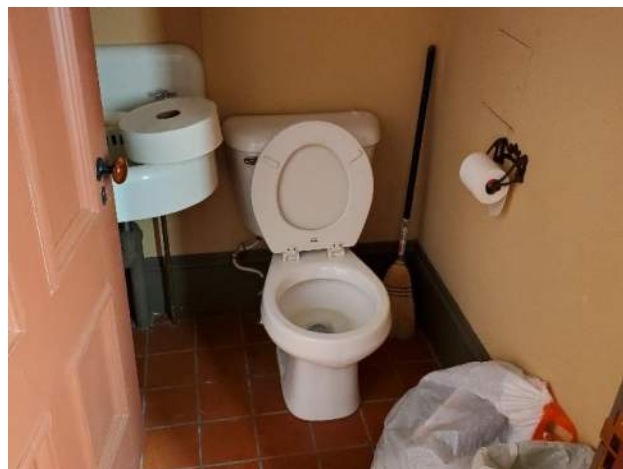
The toilet room contains a standard water closet and lavatory; both are operational. The room size does not meet the requirements to be made accessible.

**Figure 3.68: First floor toilet room.**

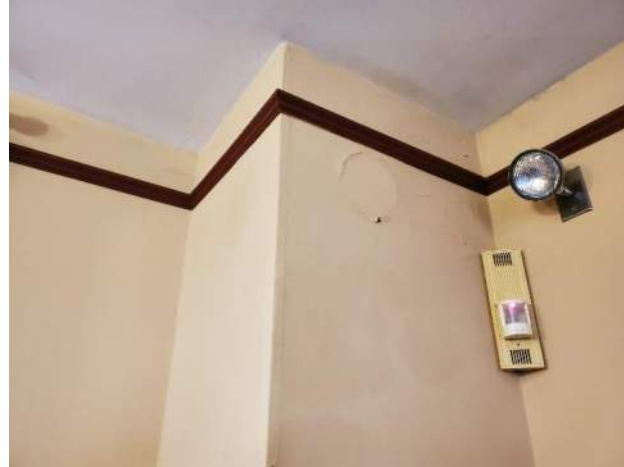
The plaster chimney enclosure is deteriorating. Based on the condition in the attic it becomes likely that the masonry behind the plaster enclosure is deteriorating as well.

Figure 3.73: Chimney Enclosure.

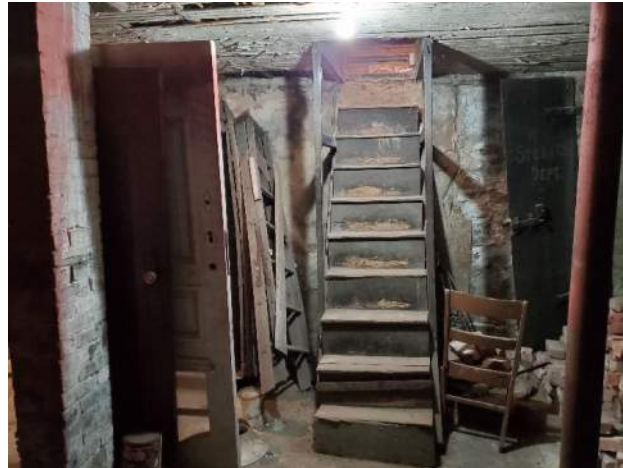
The existing stairs are rickety and unsound. They are configured more like a ship's ladder than a code-compliant stair.

Figure 3.77: Stairs.

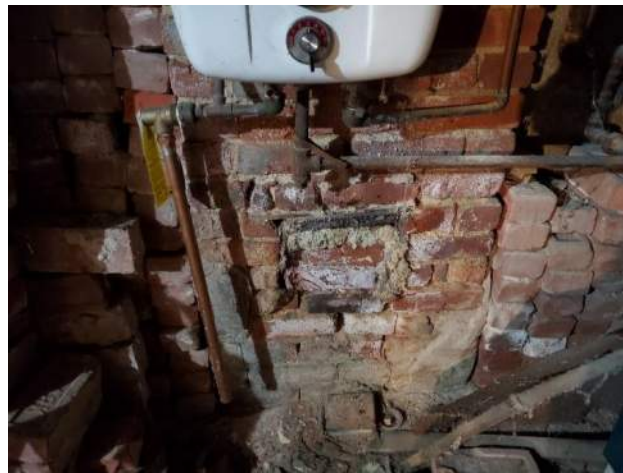
The brick masonry chimney in the basement has deteriorated greatly. Its current and continued use as a flue with gas appliances would indicate a requirement for a flue lining. No evidence of such a lining was found.

Figure 3.78: Basement - Chimney.

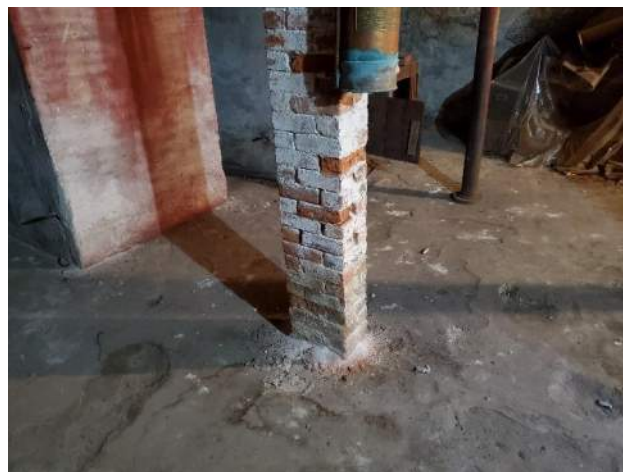
The brick masonry columns in the basement have mortar joints attacked by rising damp, but do not appear to have shifted.

Figure 3.79: Deteriorating brick column.

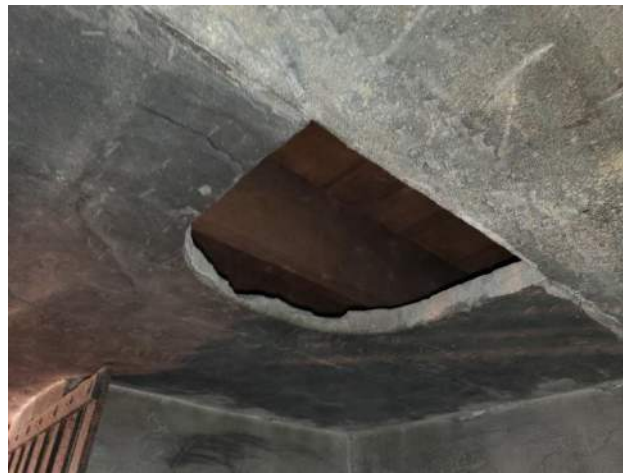
The cells have bluestone slabs for the ceiling. One of the cells has a large hole in the bluestone, but it's unclear how it was broken.

**Figure 3.81: Broken bluestone.**

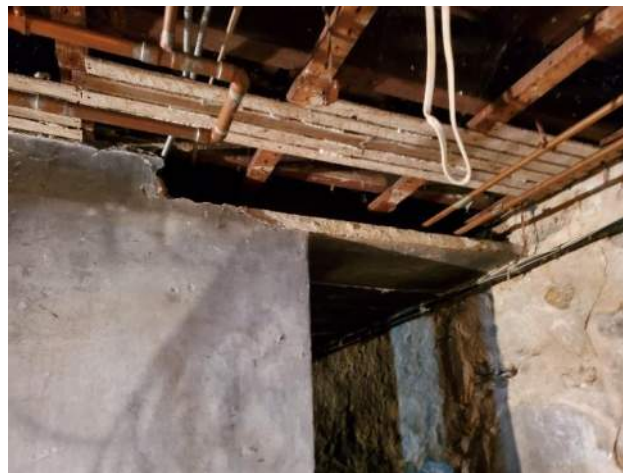
There are several places where the plaster enclosing the interstitial space over the cells has been broken open.

**Figure 3.82: Access over cells.**
