# CUMBERLAND TOWN HALL CONDITIONS ASSESSMENT

**45 BROAD STREET  
CUMBERLAND, RI 02864**

**ISSUED:**

18 June 2020

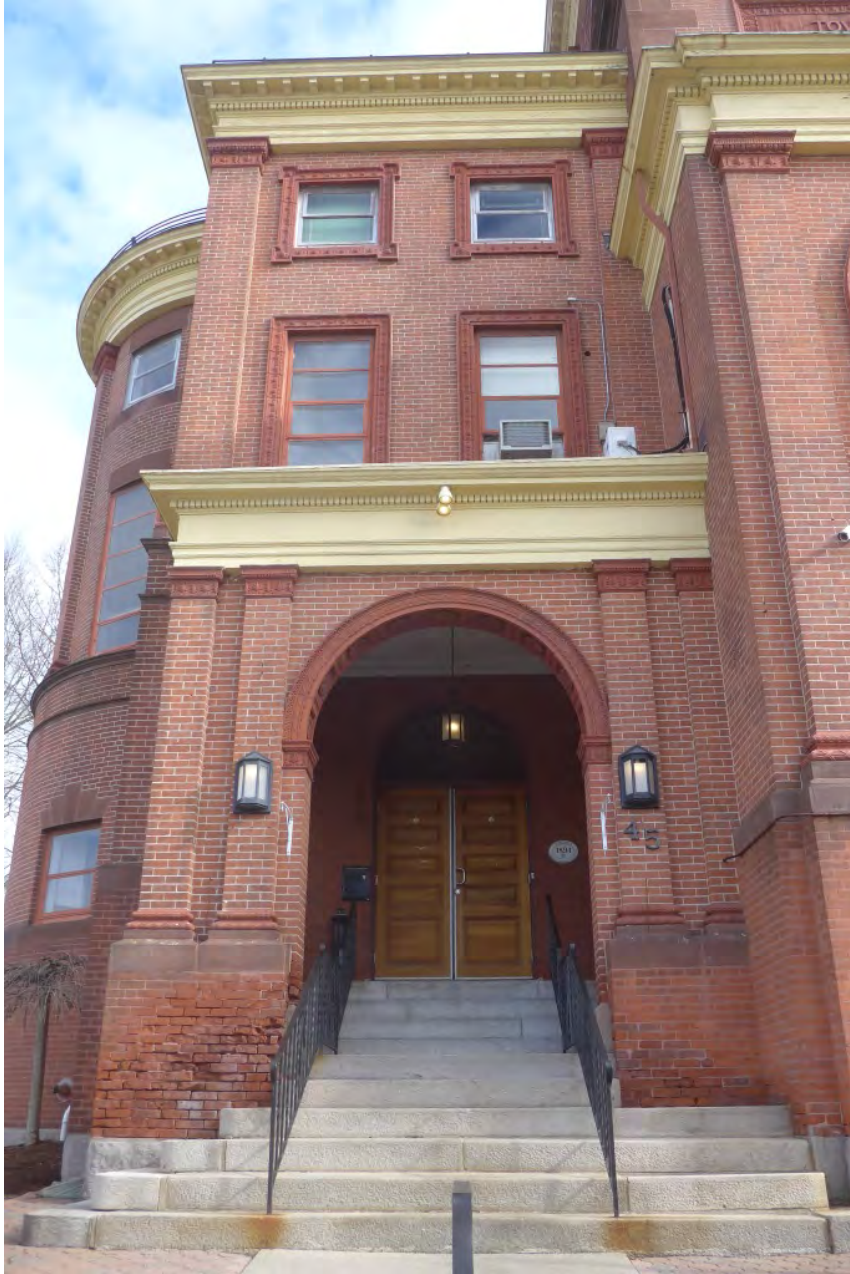
Cumberland Town Hall – Exterior - Masonry  
West Elevation – North Pavilion - Entrance - Overall  
Open Joints, Eroded Brickwork

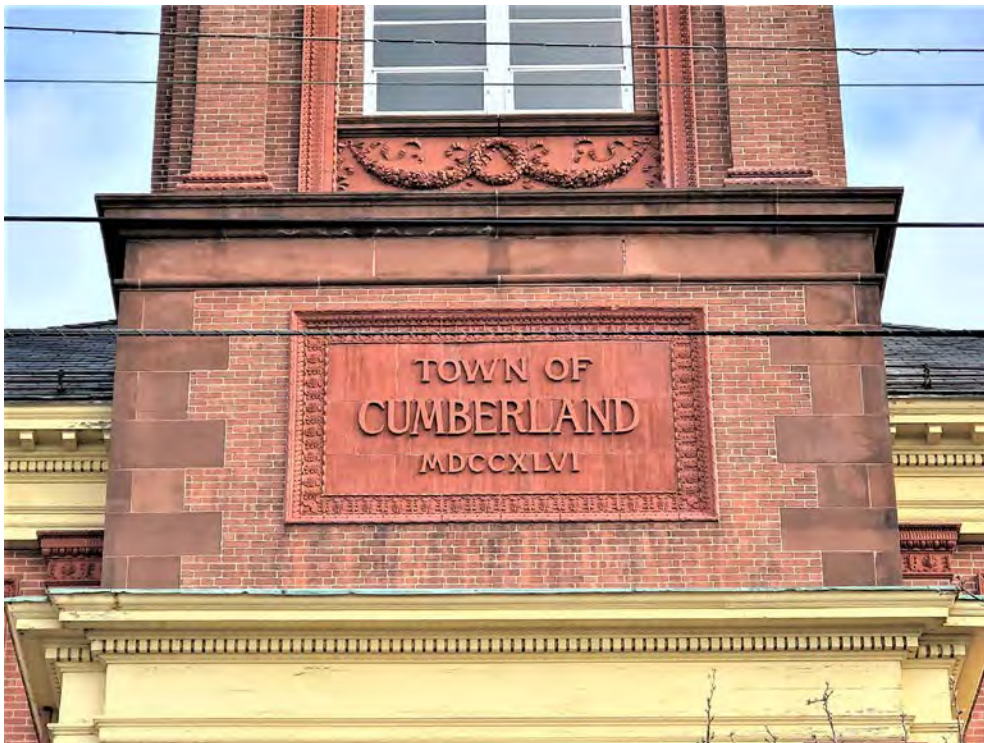
Cumberland Town Hall – Exterior – Masonry – Exterior Woodwork  
West Elevation – Central Pavilion - Tower  
Good Condition; Some Staining; Peeling Paint on Woodwork

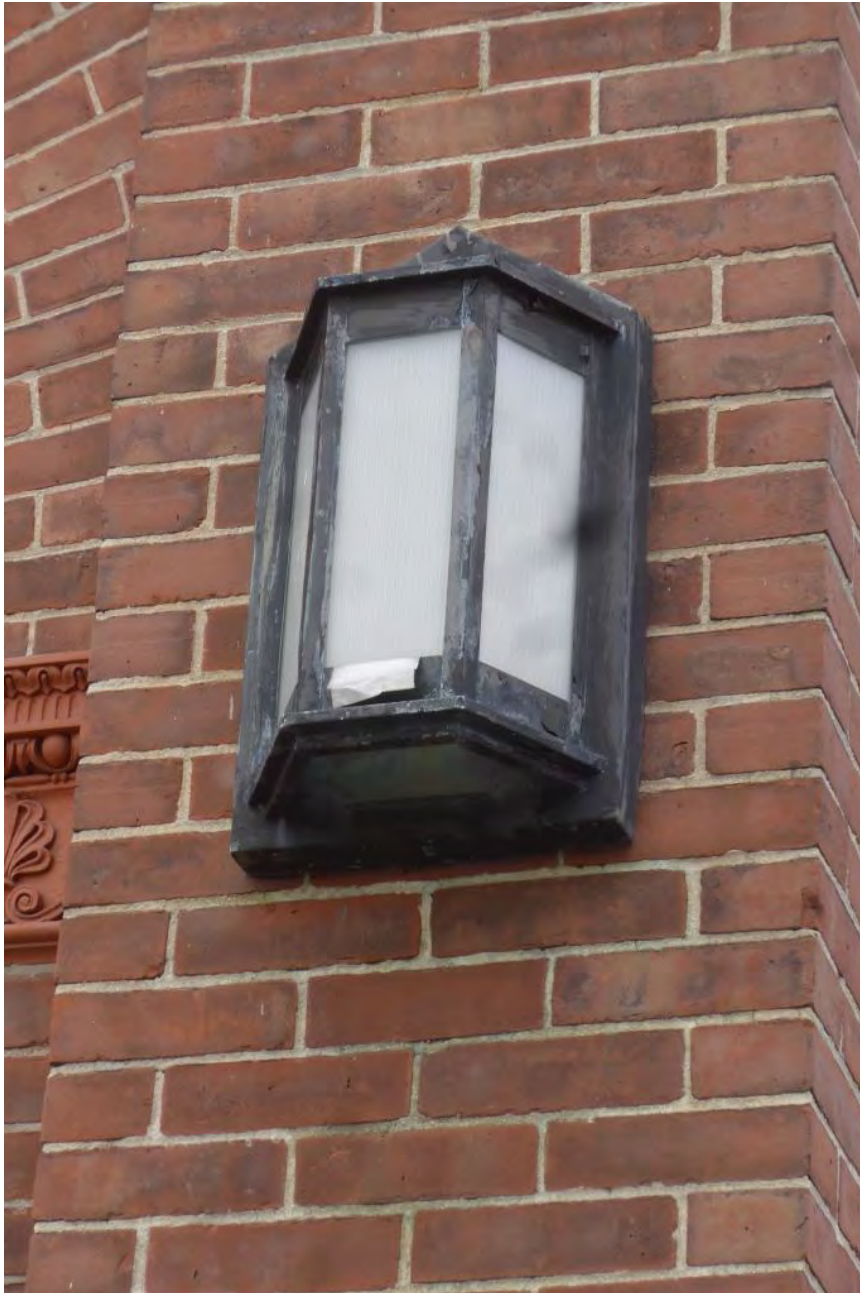
Cumberland Town Hall – Exterior – Historic Finishes and Building Elements  
West Elevation – at Main, West Entrance  
Historic Light Fixture  
In Fair Condition

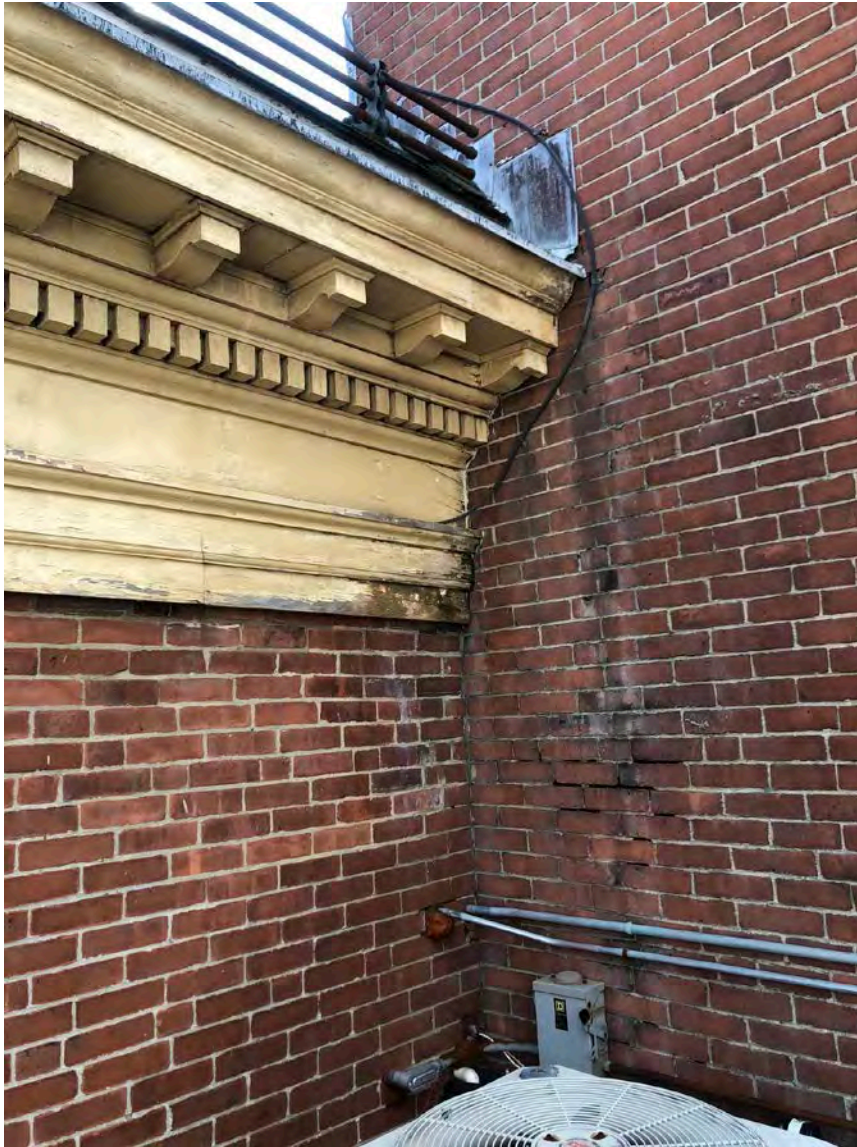
Cumberland Town Hall – Exterior - Masonry  
Inside Northeast Corner – Above Elevator Roof  
Open Joints, Eroded Brickwork, Staining, Worn and Peeling Paint – Due to Gutter Overflow

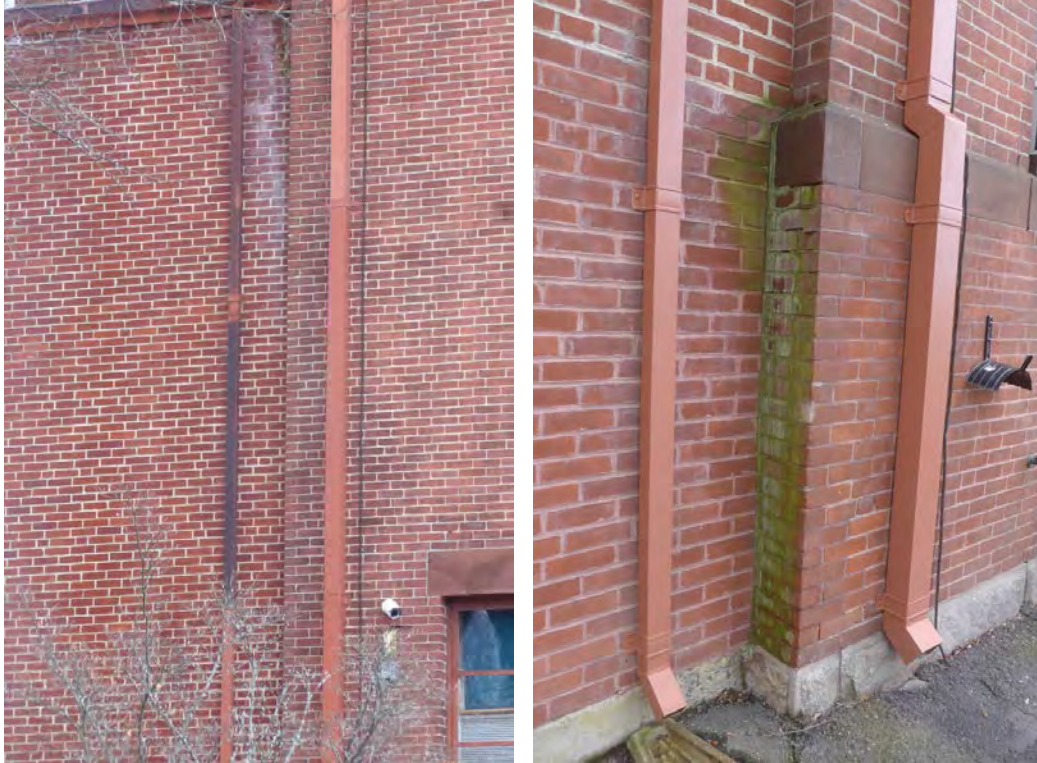
Cumberland Town Hall – Exterior - Masonry  
North Elevation – at Elevator Addition  
Efflorescence and Biological Staining

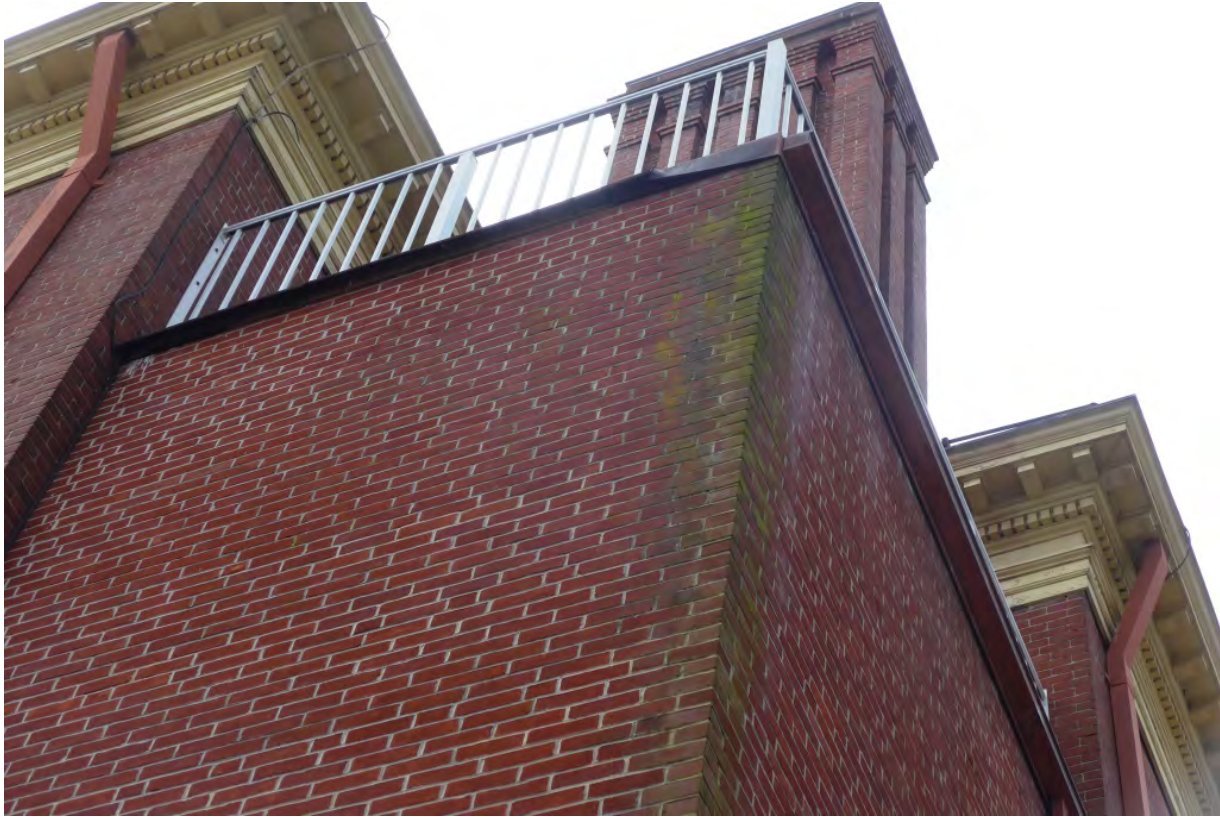
Cumberland Town Hall – Exterior - Masonry  
East Elevation at Northeast Corner  
Lifting Fascia at roof level

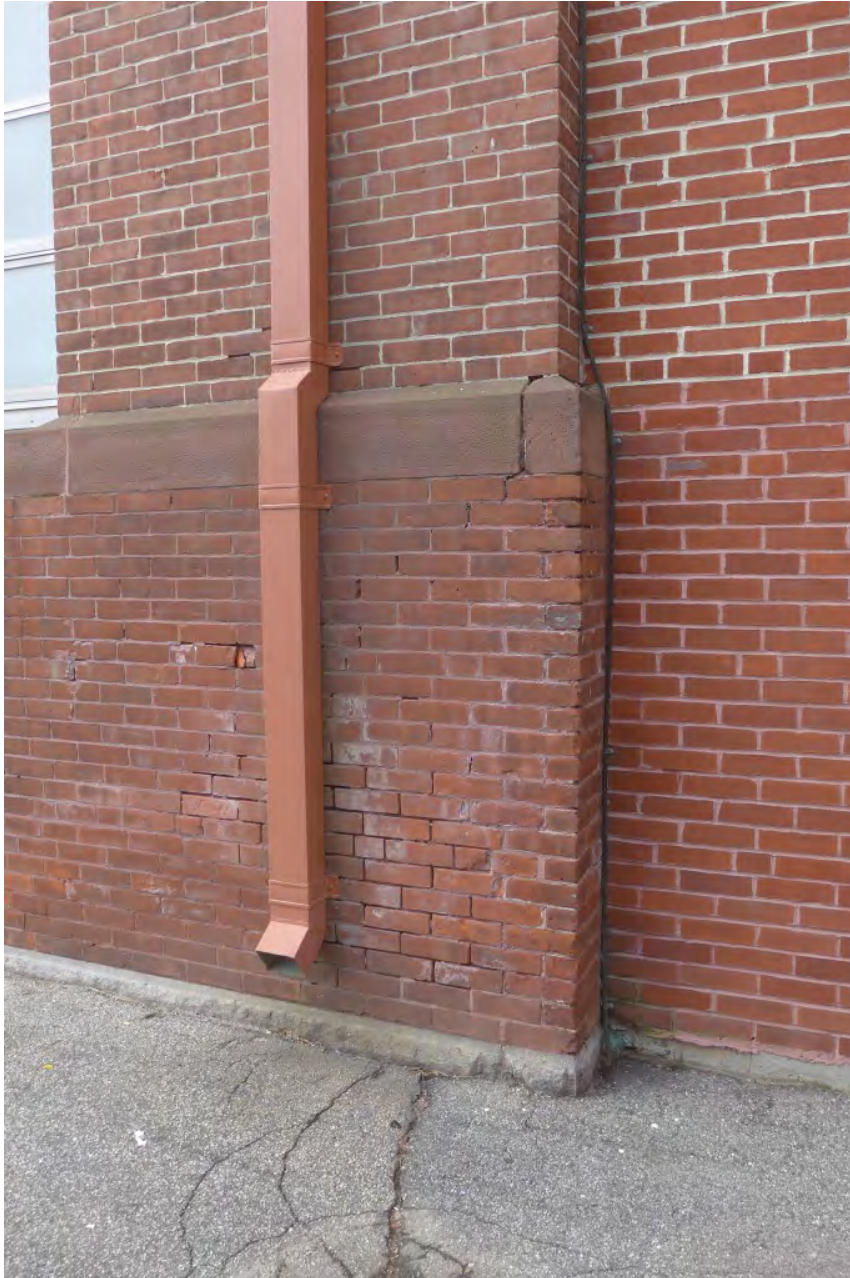
Cumberland Town Hall – Exterior - Masonry  
East Elevation – at Elevator Addition  
Open and Eroded Mortar Joints; Step Crack; Damaged Brickwork; Staining  
No Splashblock

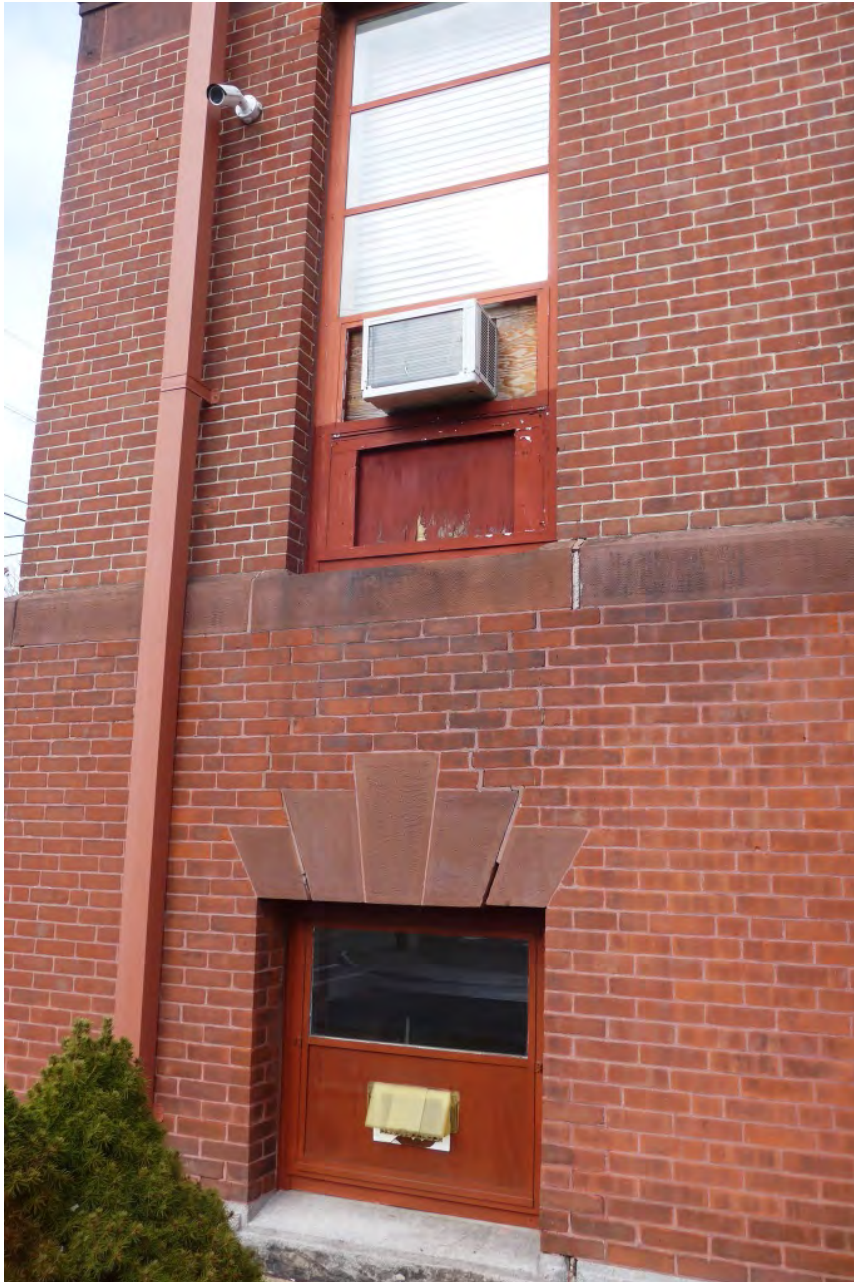
Cumberland Town Hall – Exterior - Masonry  
South Elevation – West Pavilion – West Bay - Basement Level/First Floor  
Open Joints, Staining

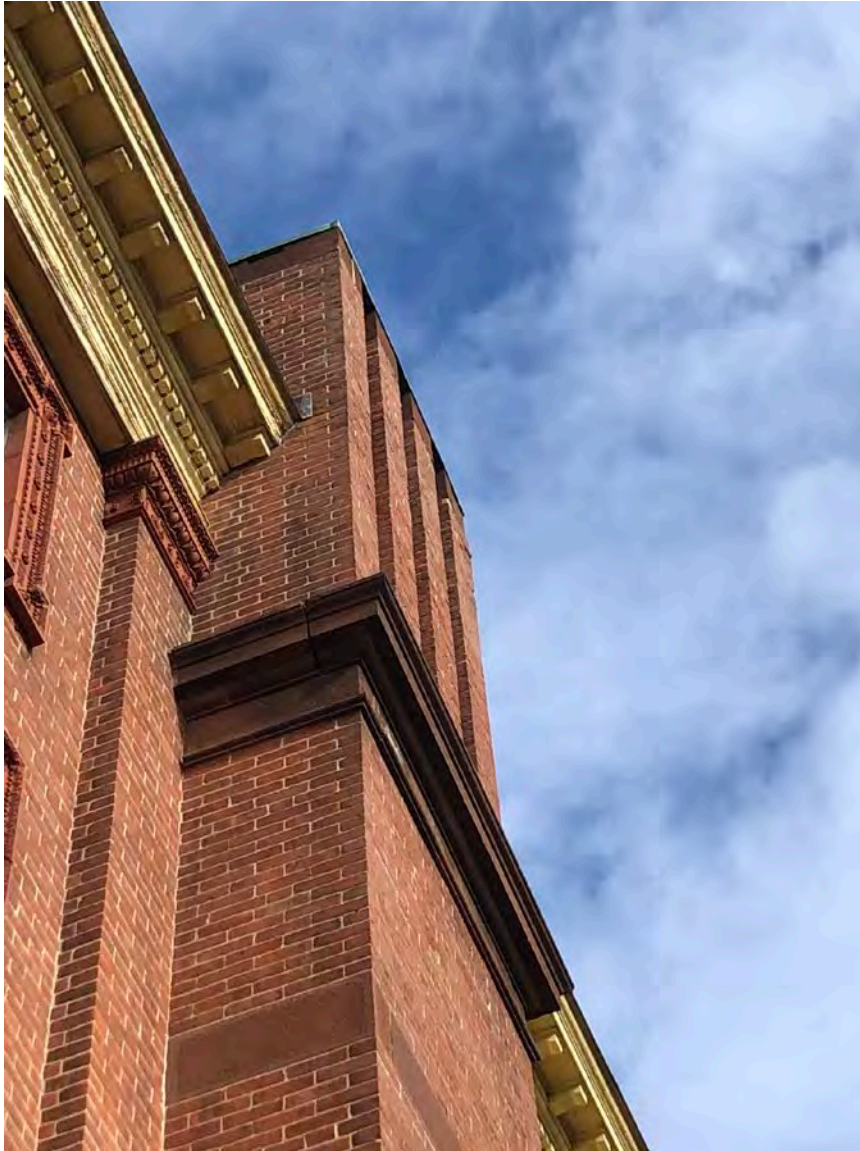
Cumberland Town Hall – Exterior - Masonry  
South Elevation – Chimney  
Top of Chimney has been Removed

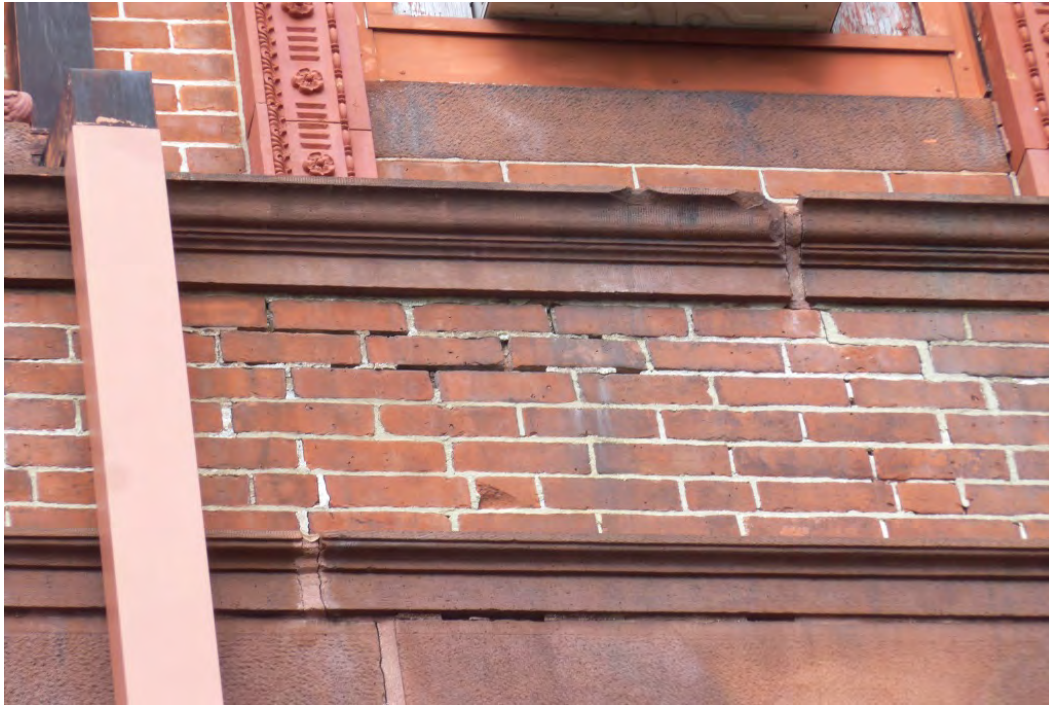
Cumberland Town Hall – Exterior - Masonry  
South Elevation – West Pavilion – West Bay - Second Floor  
Open Joints, Cracked and Missing Brownstone, Staining

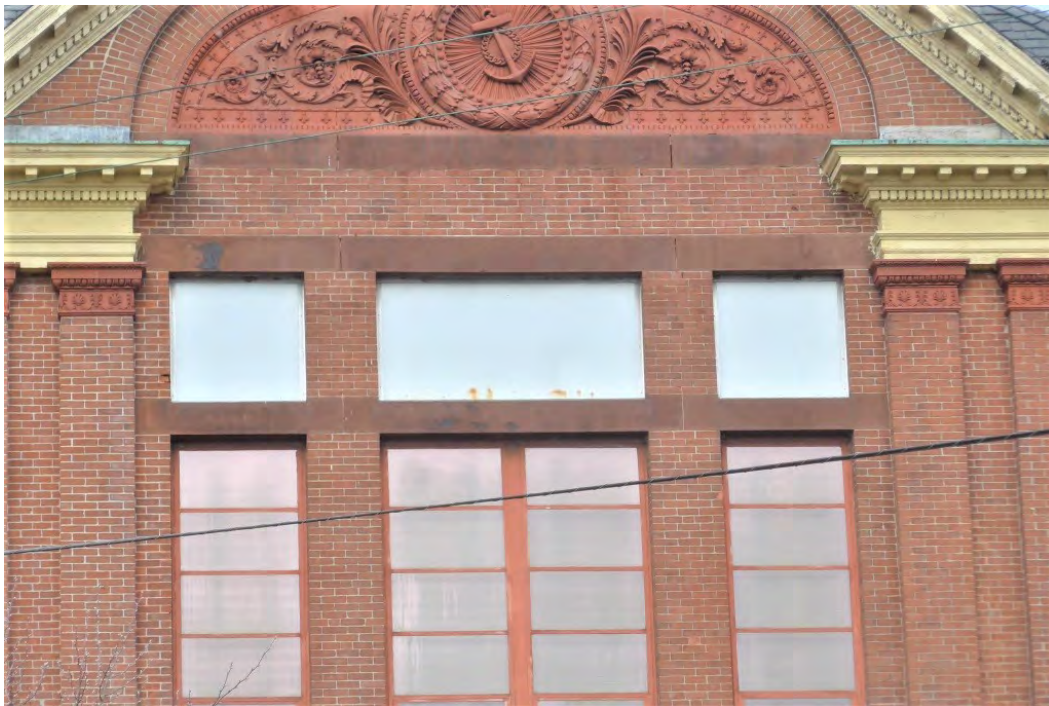
Cumberland Town Hall – Exterior - Masonry  
South Elevation – Central Pavilion  
Open Joints, Deteriorated/Missing Brickwork; Staining

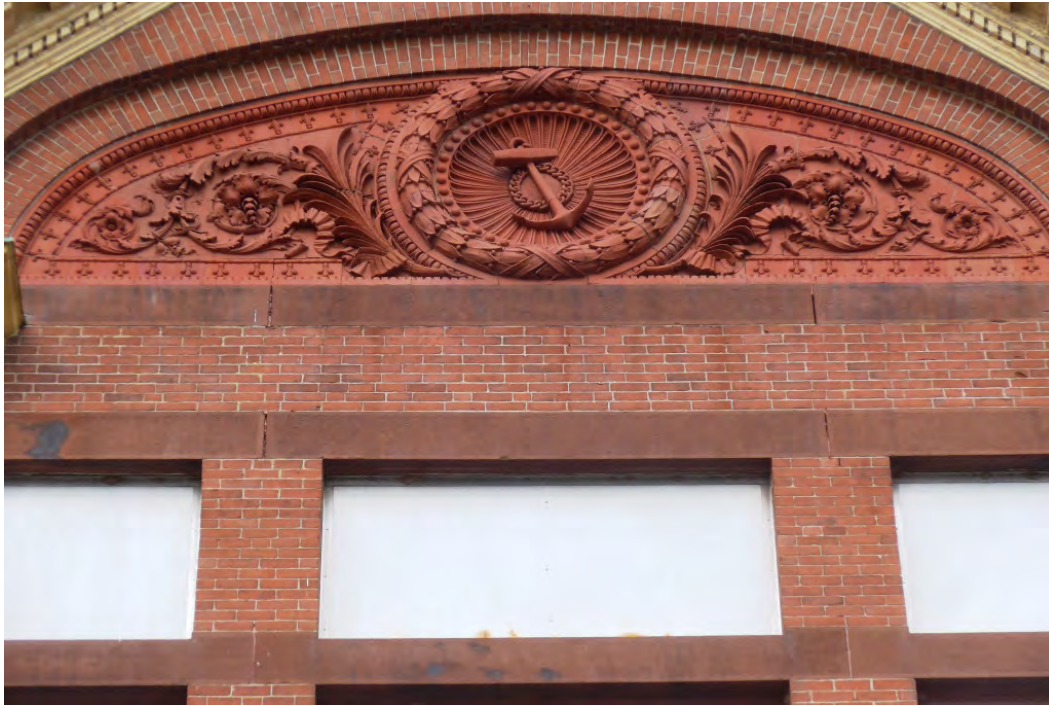
Cumberland Town Hall – Exterior - Masonry  
South Elevation – Central Pavilion – Third Floor (Currently Attic Level)  
Open Joints, Staining

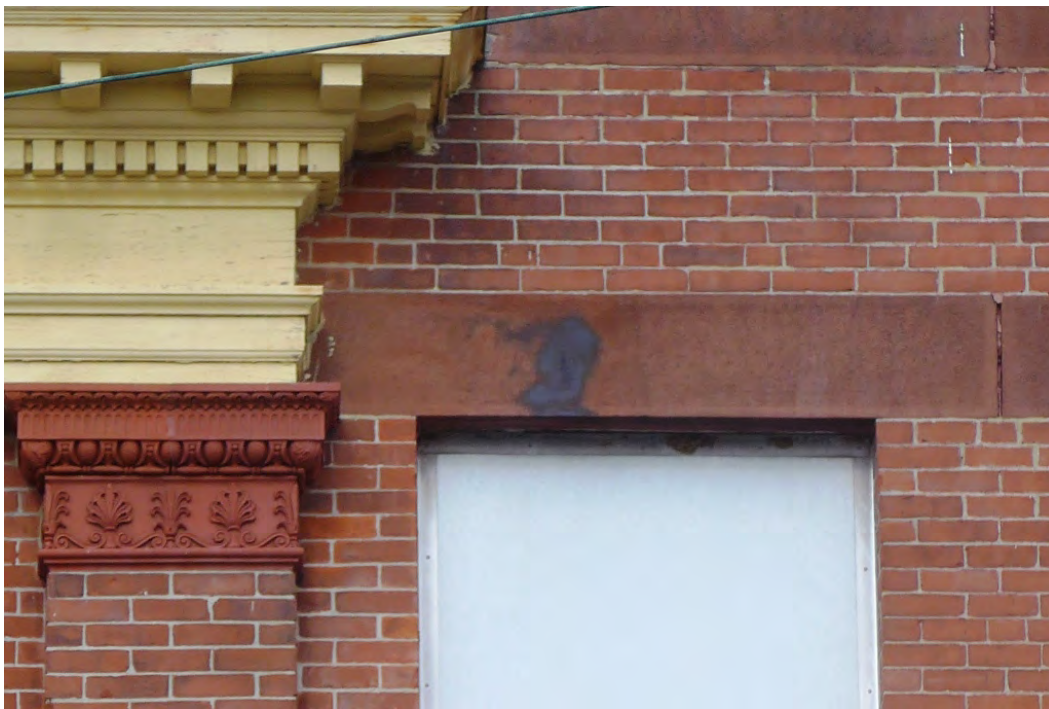
Cumberland Town Hall – Exterior - Masonry  
South Elevation – Central Pavilion – Second Floor (Currently Attic Level) - Detail  
Open Joints, Staining

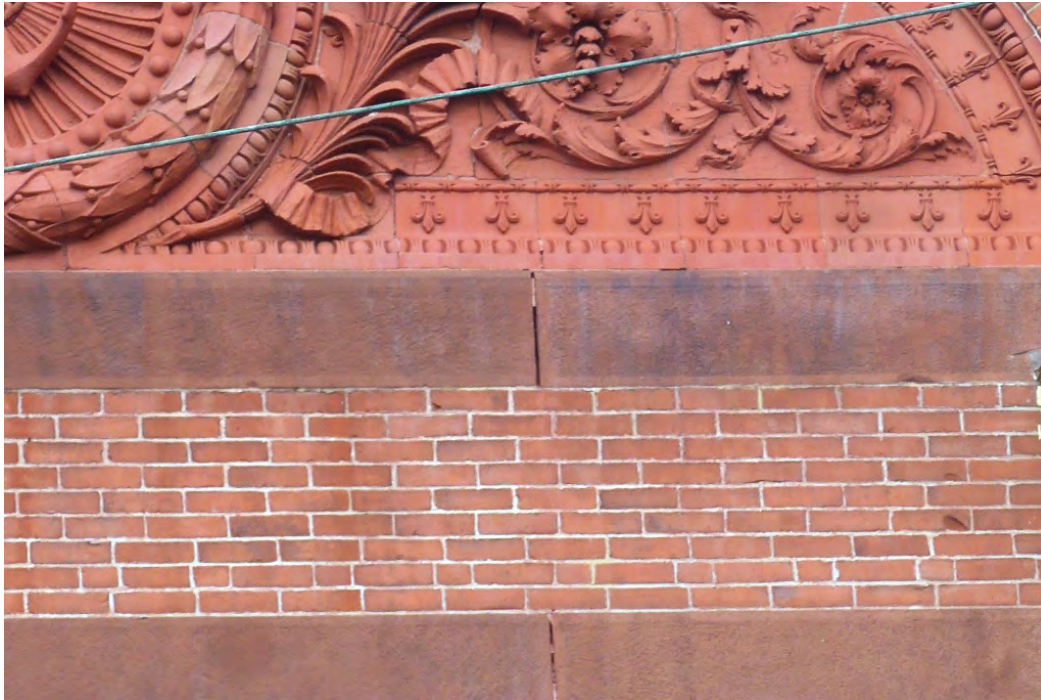
Cumberland Town Hall – Exterior - Masonry  
South Elevation – Central Pavilion – Second Floor (Currently Attic Level) - Detail  
Open Joints, Staining

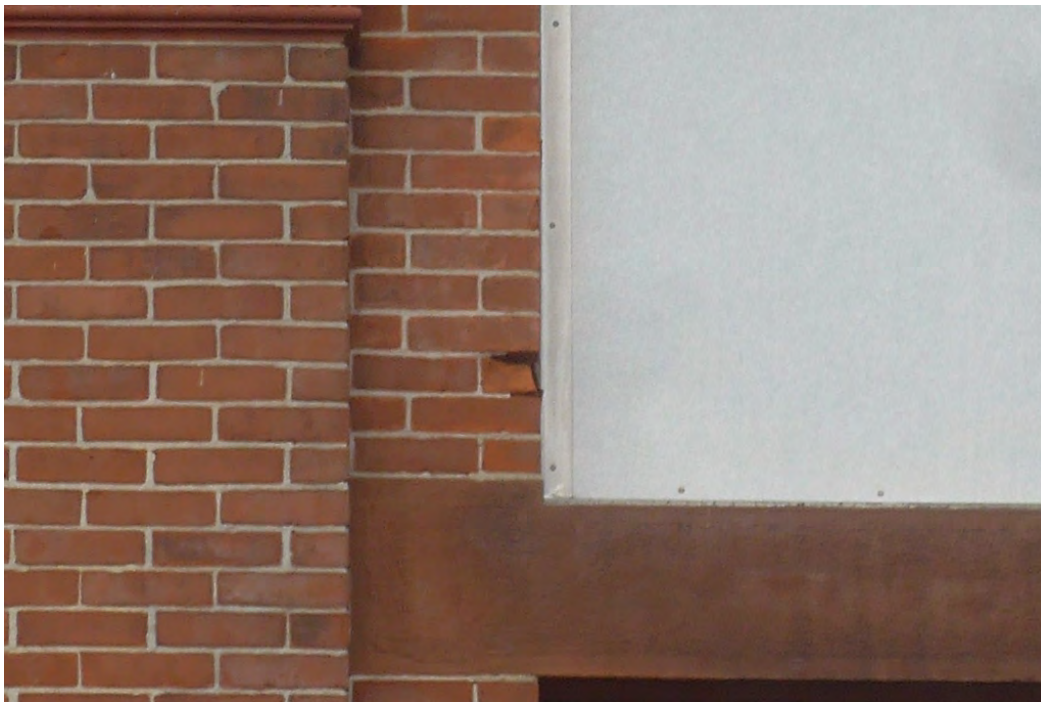
Cumberland Town Hall – Exterior - Masonry  
South Elevation – Central Pavilion - Third Floor (Currently Attic Level) - Detail  
Damaged Brick

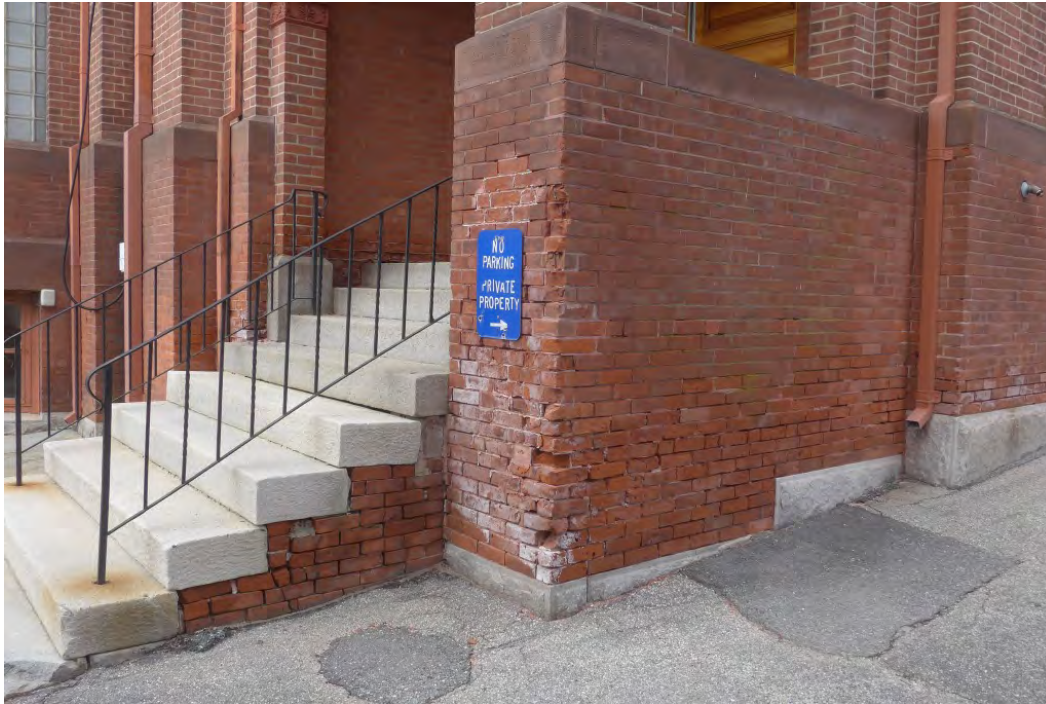
Cumberland Town Hall – Exterior - Masonry  
South and East Elevations - Southeast Corner – Entrance  
Open Joints, Deteriorated/Missing Brickwork; Staining

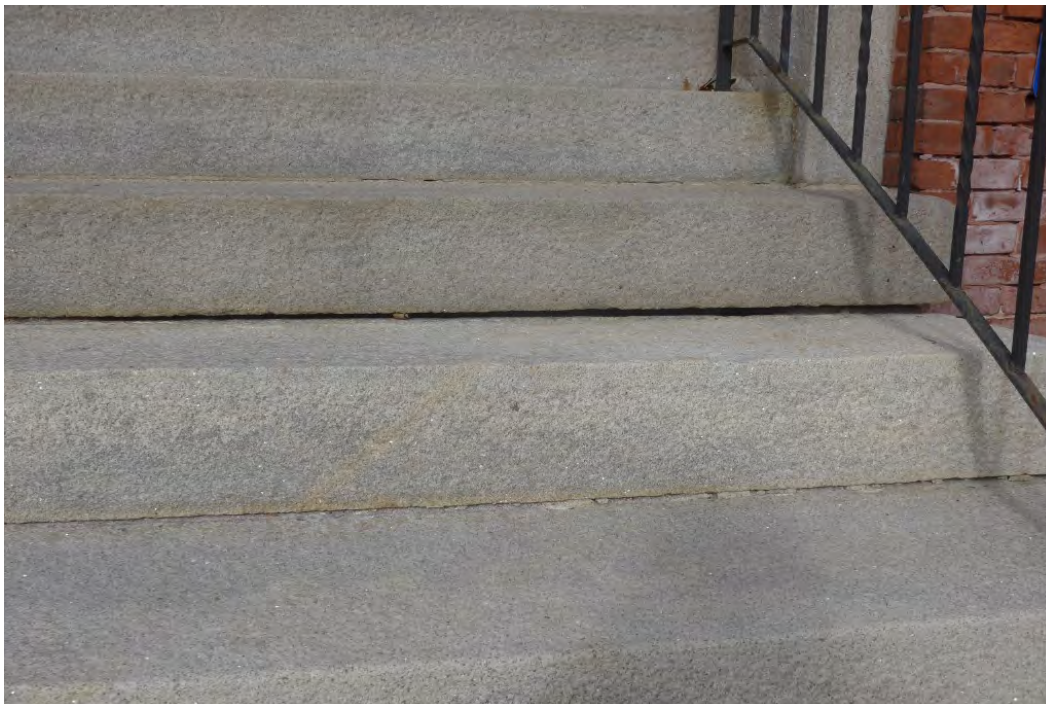
Cumberland Town Hall – Exterior - Masonry  
Southeast Corner – Entrance  
Open Joints at Granite Steps

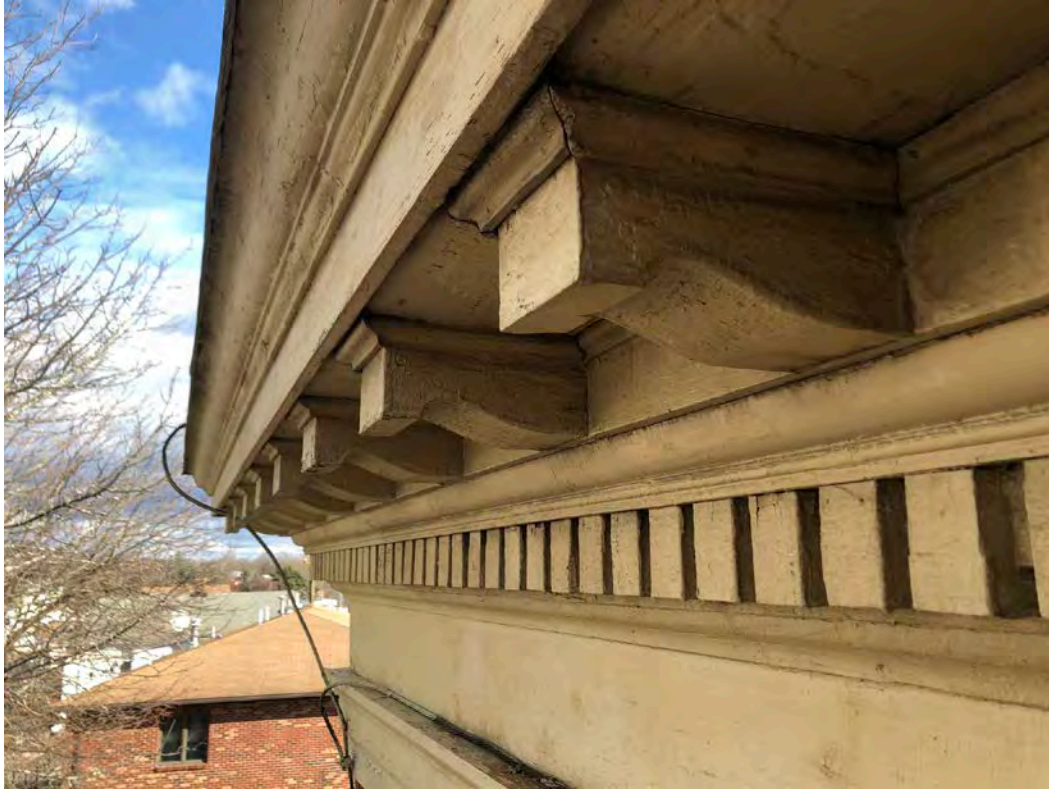
Cumberland Town Hall – Exterior – Wood Elements  
North Elevation – above Elevator Addition  
Worn Paint; Wood in Good Condition

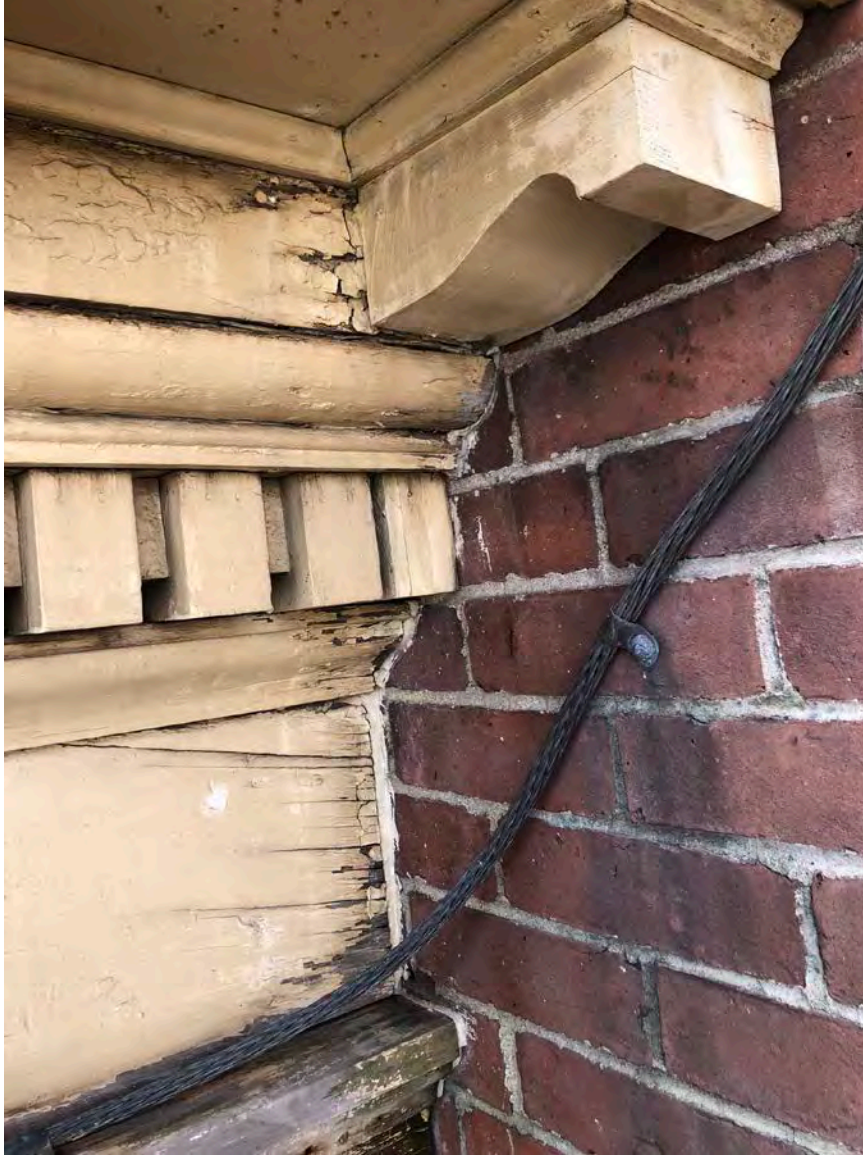
Cumberland Town Hall – Exterior – Wood Elements  
North Elevation – Inside Northeast Corner - above Elevator Addition  
Worn/Peeling Paint; Deteriorated Wood Elements

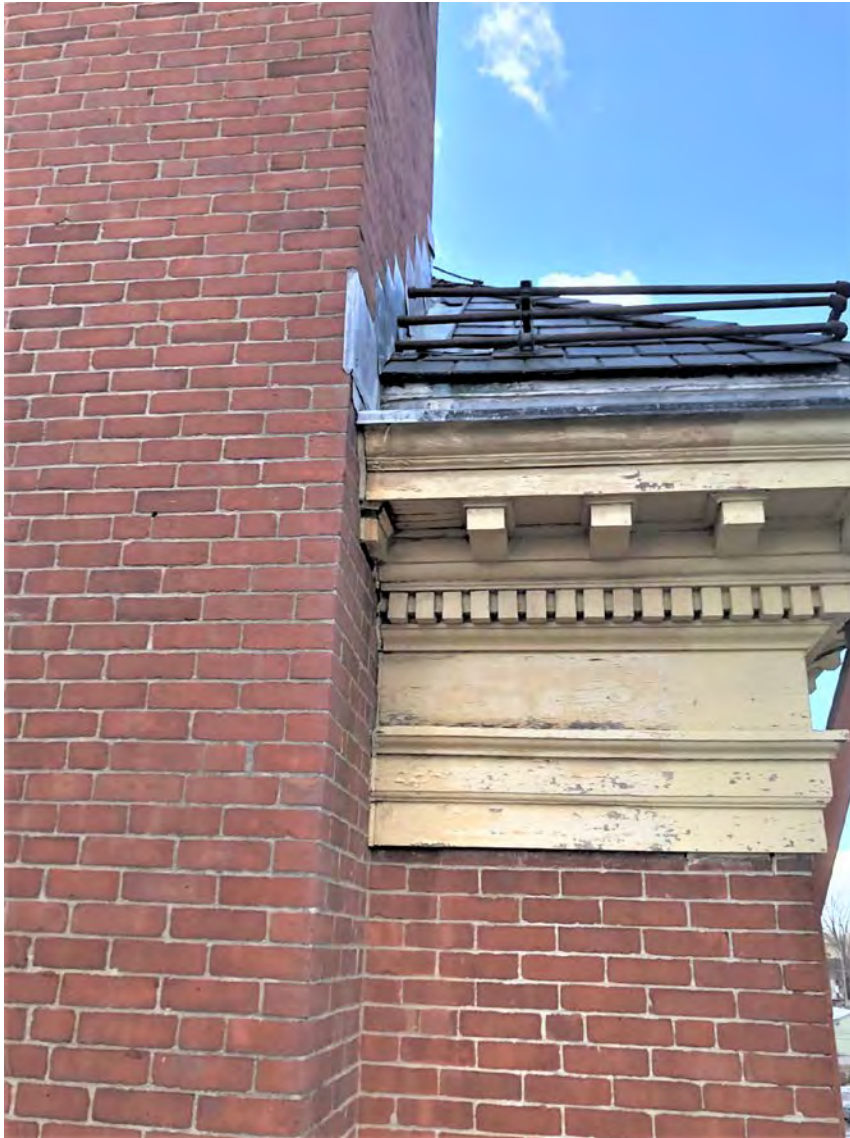
Cumberland Town Hall – Exterior – Wood Elements  
East Elevation – above Elevator Addition  
Worn/Peeling Paint; Deteriorated Wood Elements  
Bent Snow Guard Piping

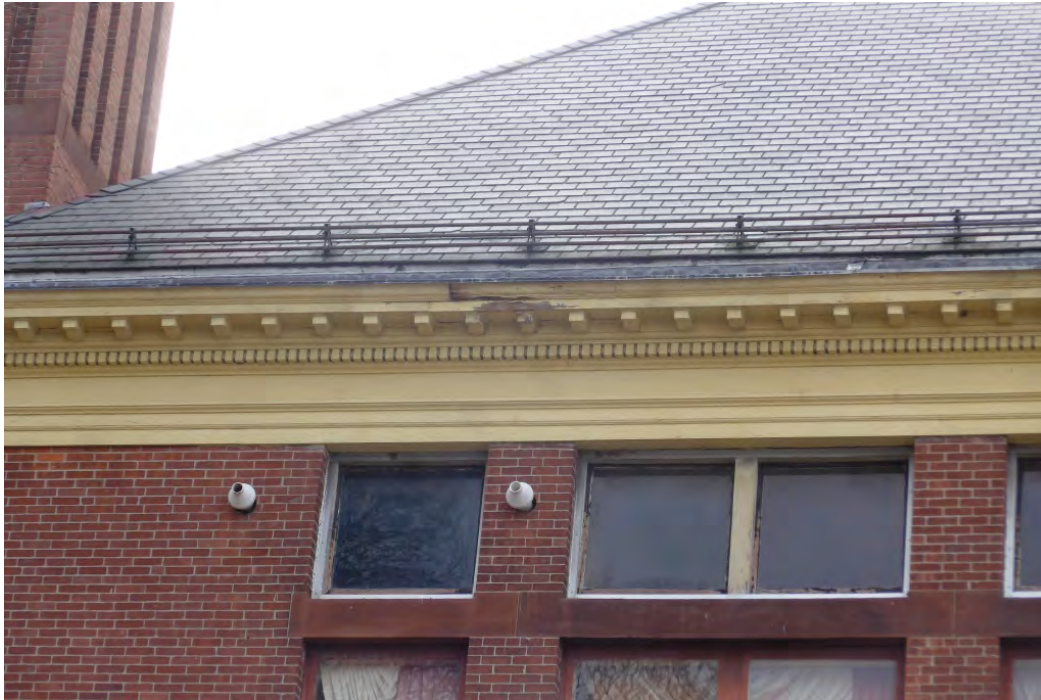
Cumberland Town Hall – Exterior – Wood Elements  
North Elevation – Central Pavilion - Cornice  
Worn/Peeling Paint; Deteriorated Wood Elements

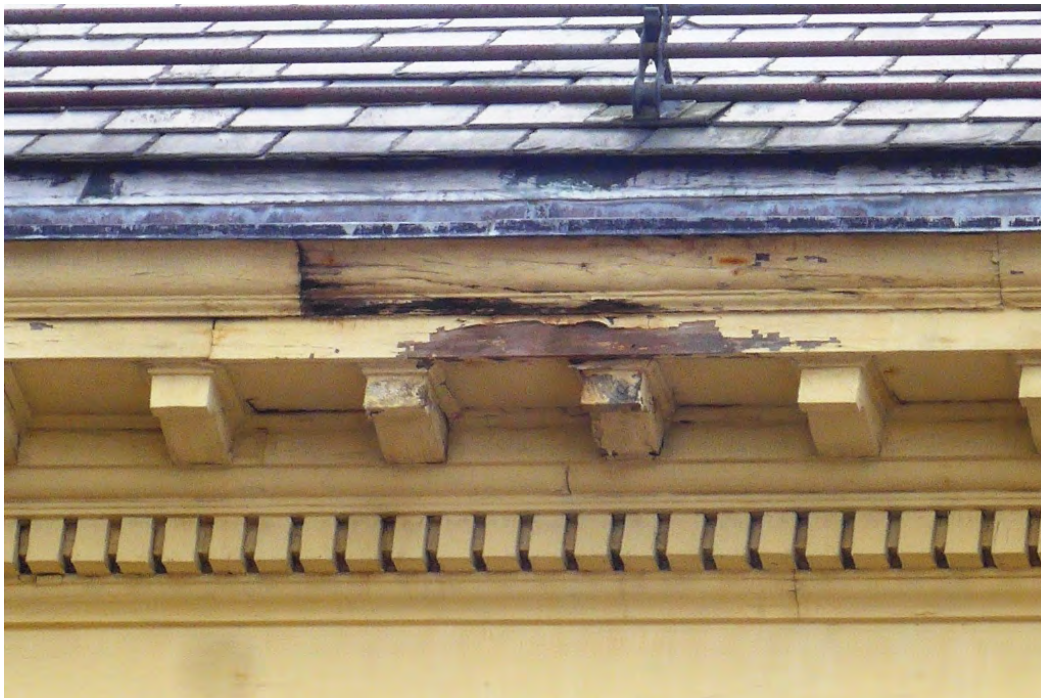
Cumberland Town Hall – Exterior – Wood Elements  
North Elevation – Central Pavilion – Cornice - Detail  
Worn/Peeling Paint; Deteriorated Wood Elements

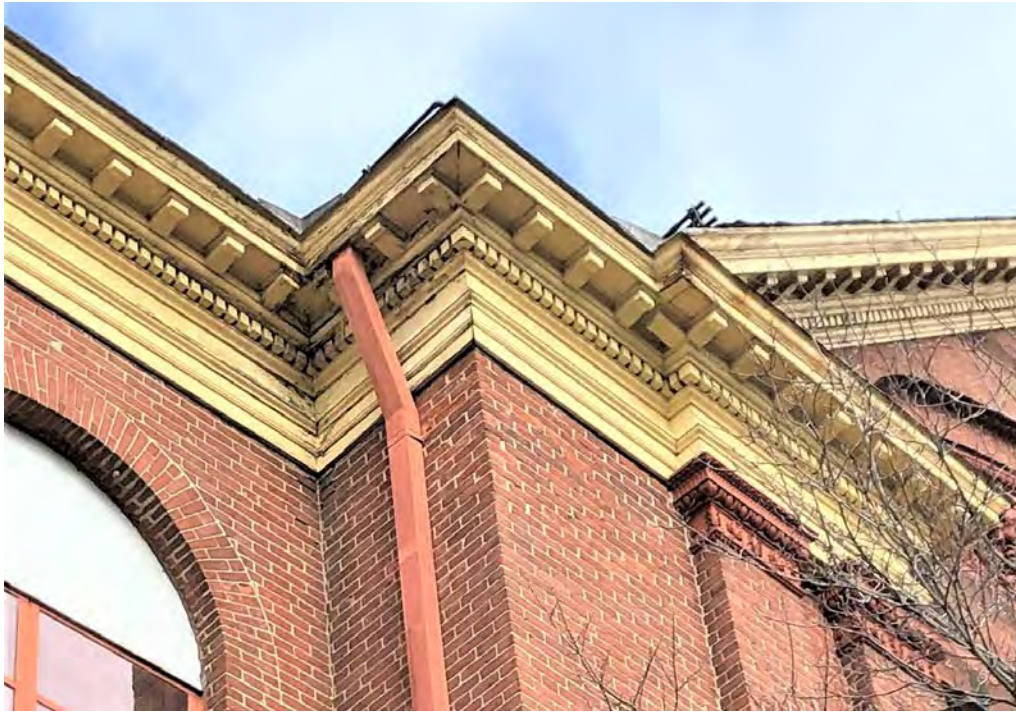
Cumberland Town Hall – Exterior – Wood Elements  
South Elevation – Return Between West and Central Pavilion - Cornice  
Worn/Peeling Paint; Deteriorated Wood Elements

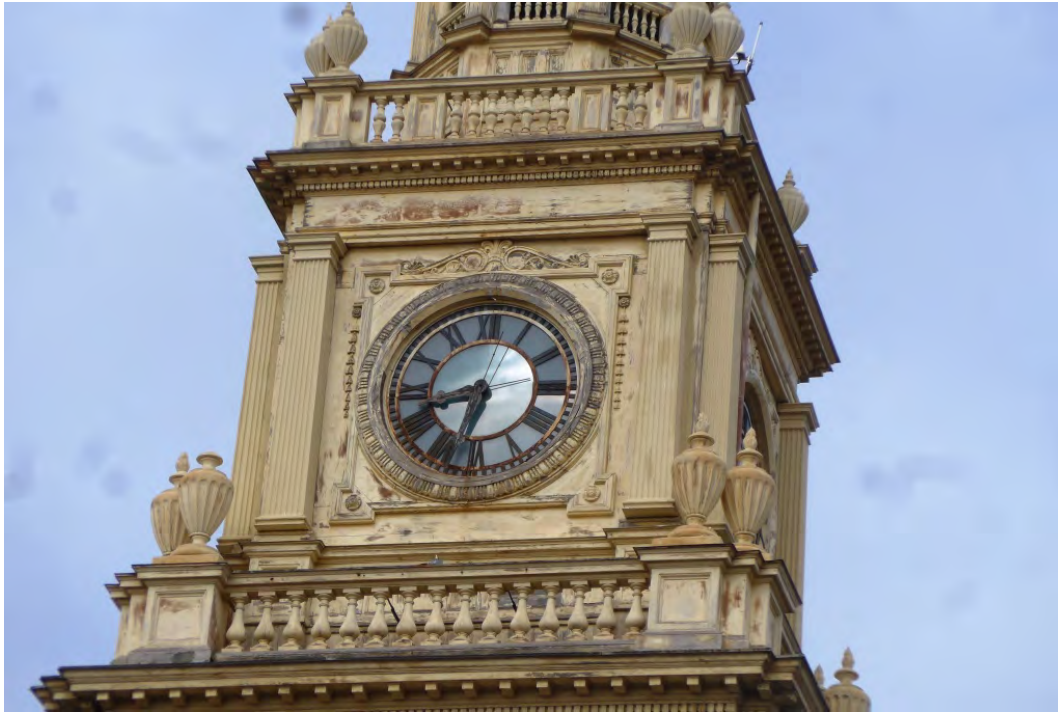
Cumberland Town Hall – Exterior – Wood Elements  
Tower – Clock Level (Sixth Floor)  
Overall View - Flaking and Deteriorated Paint – Some Deteriorated Wood

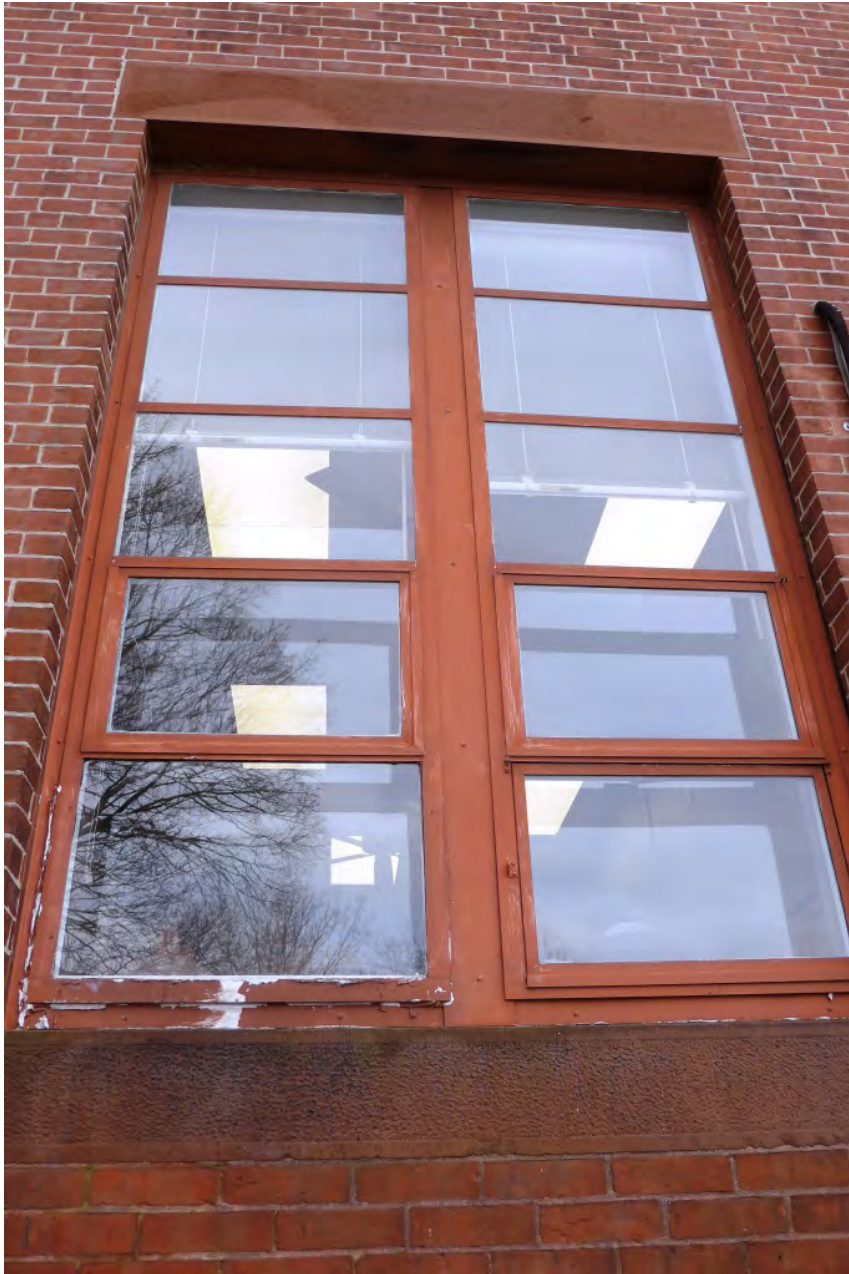
Cumberland Town Hall – Exterior - Windows, Doors and Hardware  
North Elevation – Central Pavilion - First Floor – Typical Replacement Window  
Historically Inappropriate Aluminum Hopper Replacement Window
