# CUMBERLAND TOWN HALL CONDITIONS ASSESSMENT

**45 BROAD STREET  
CUMBERLAND, RI 02864**

**ISSUED:**

18 June 2020

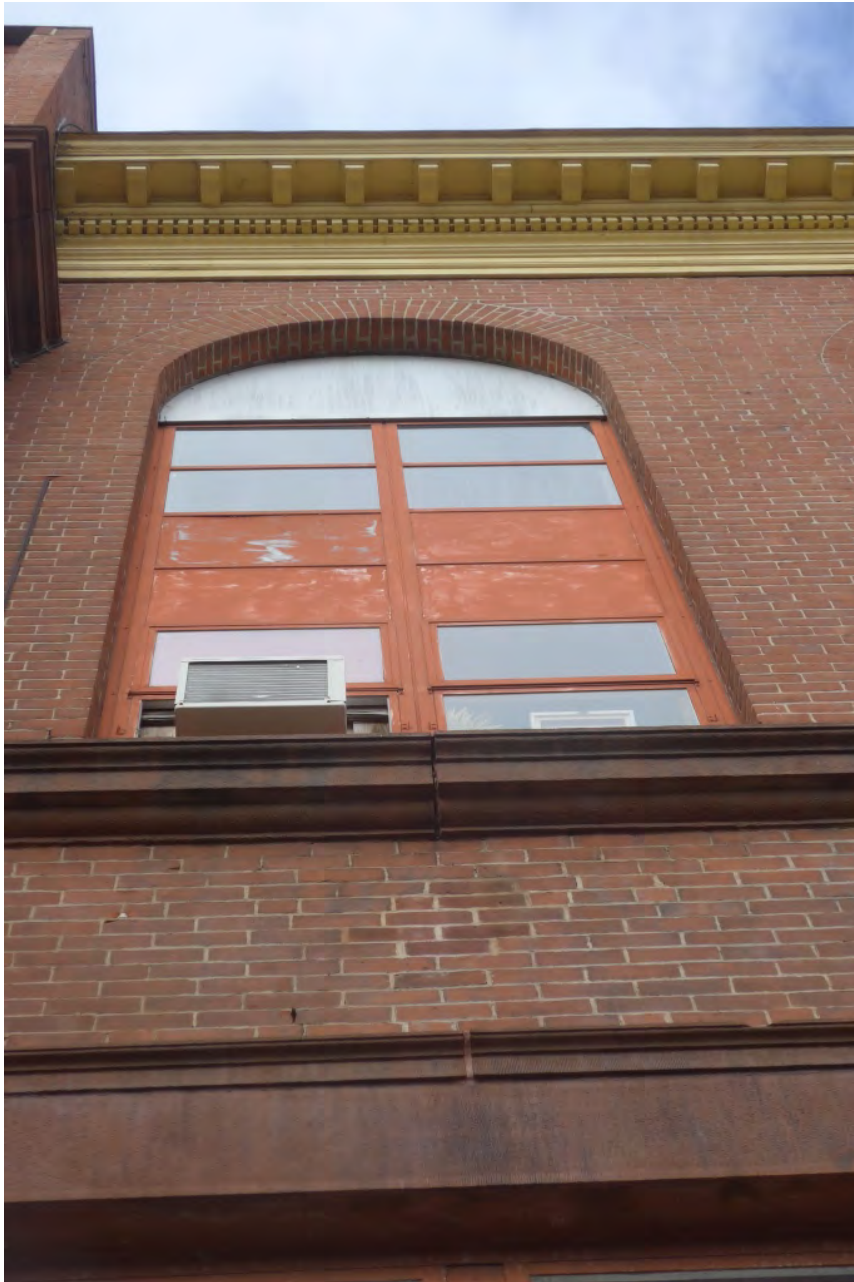
Cumberland Town Hall – Exterior - Windows, Doors and Hardware  
South Elevation – West Pavilion - Second Floor – Typical Replacement Window  
Historically Inappropriate Aluminum Hopper Replacement Window; Covering of Arched Transom

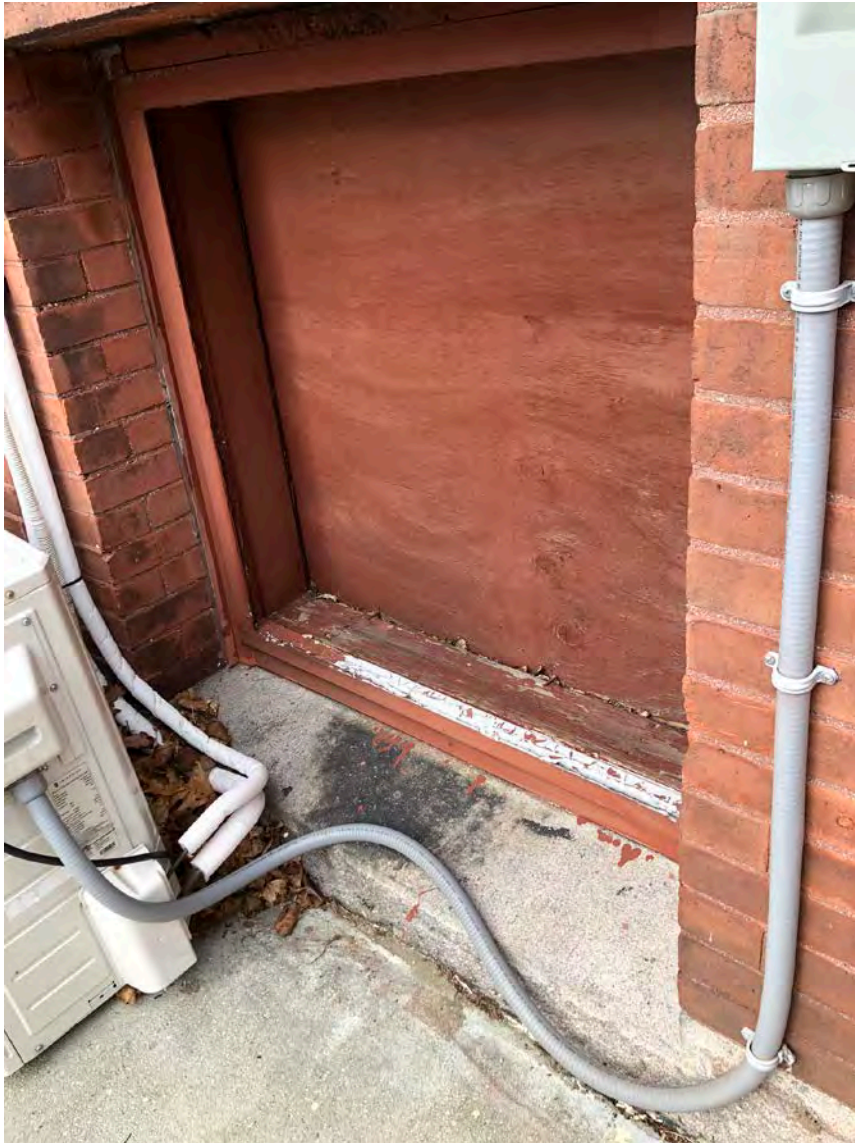
Cumberland Town Hall – Exterior - Windows, Doors and Hardware  
South Elevation – Basement Level  
Window Removed and Replaced with Plywood

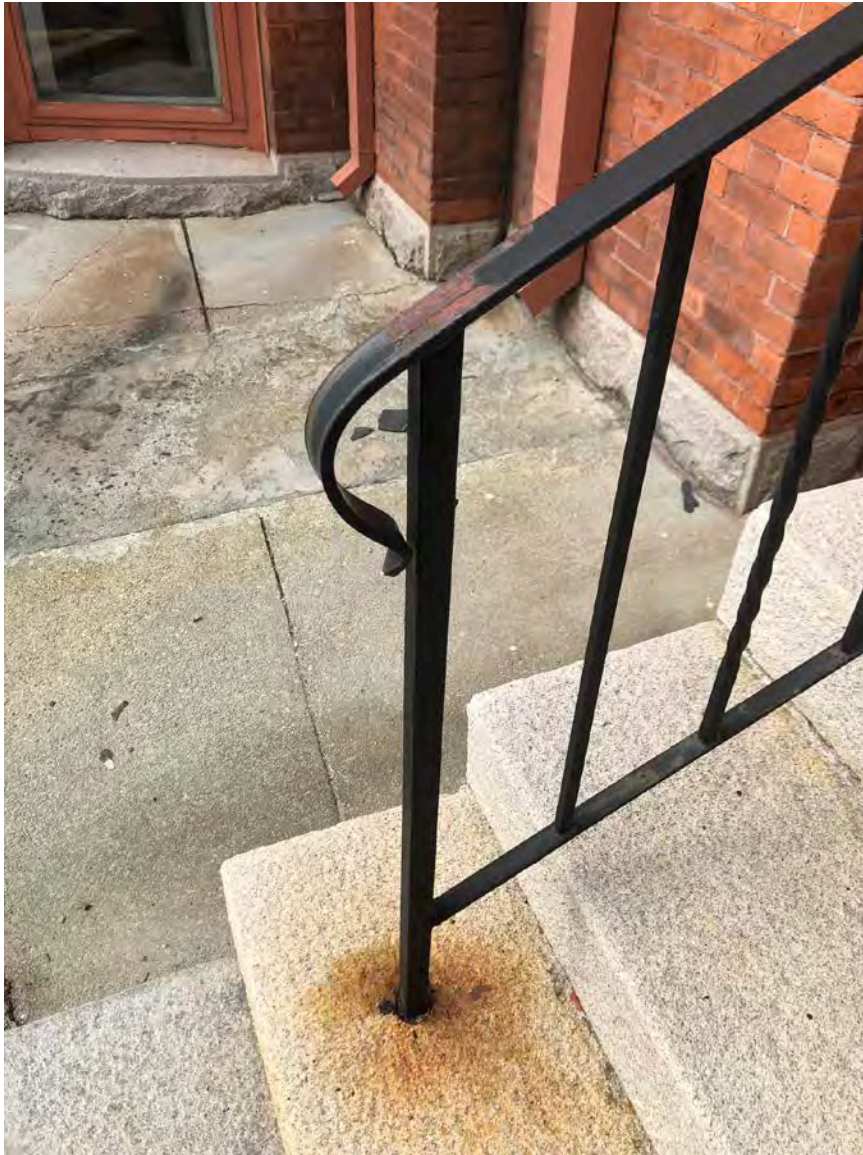
Cumberland Town Hall – Exterior – Metal Elements  
South Elevation – Entrance at Southeast Corner  
Worn Paint; Rusting; Staining Granite Steps

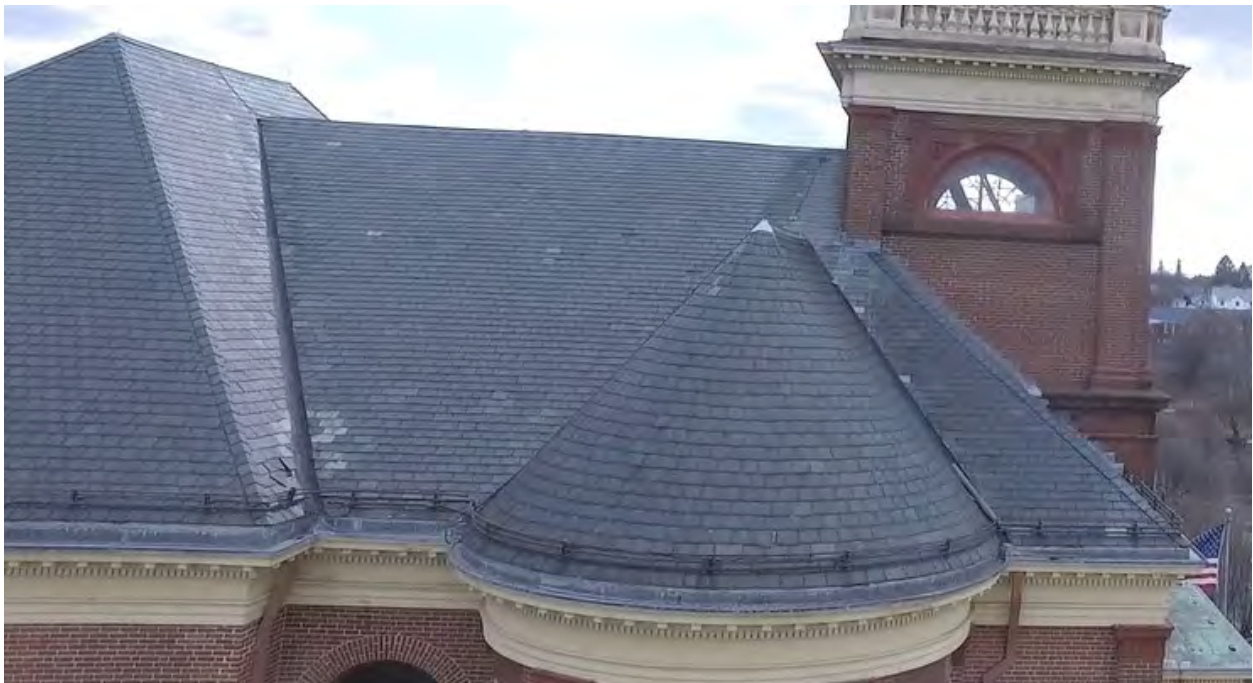
Cumberland Town Hall – Roofing, Flashing, Gutters, Leaders, Metal Trim and Roofing Elements  
View of North Slope, West End of Building  
Overall in Good Condition – Isolated Areas of Displaced, Damaged or Missing Slates

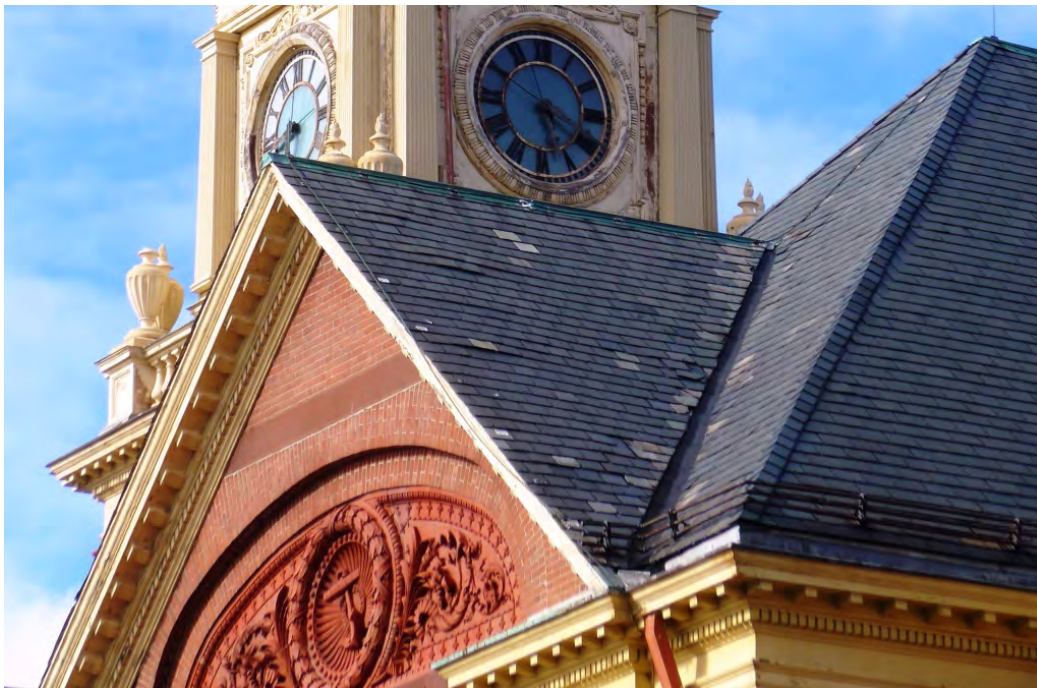
Cumberland Town Hall – Roofing, Flashing, Gutters, Leaders, Metal Trim and Roofing Elements  
East Slope over South, Central Pavilion  
Damaged, Lifted, Replacement Slates

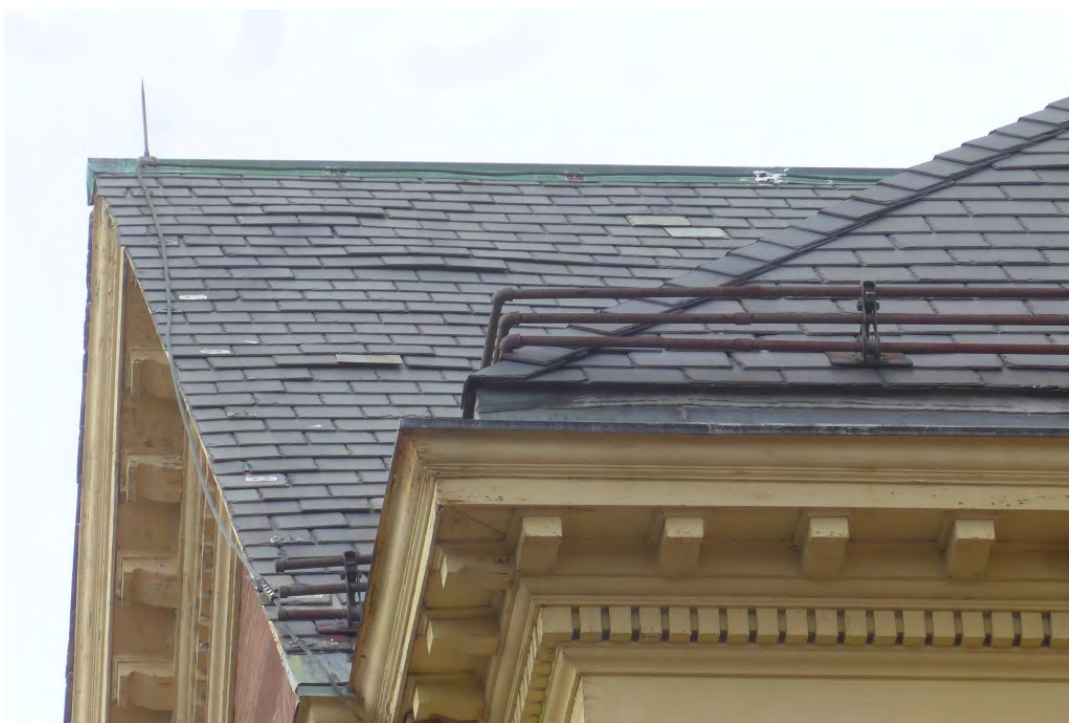
Cumberland Town Hall – Roofing, Flashing, Gutters, Leaders, Metal Trim and Roofing Elements  
East Slope over South, Central Pavilion - Detail  
Damaged, Lifted, Replacement Slates

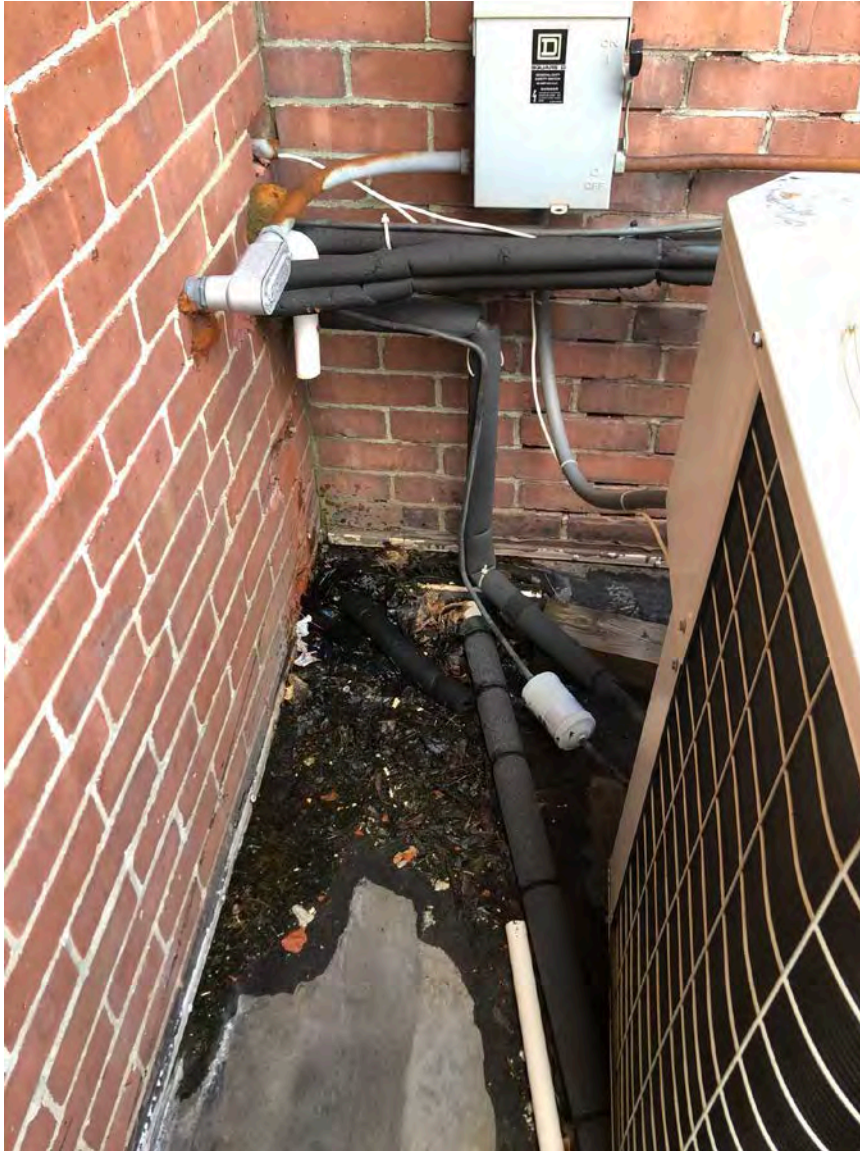
Cumberland Town Hall – Roofing, Flashing, Gutters, Leaders, Metal Trim and Roofing Elements  
Roof Above Elevator Addition  
Rubber Membrane Roof; Ponding and Debris in Corner; Open Joints in Brickwork

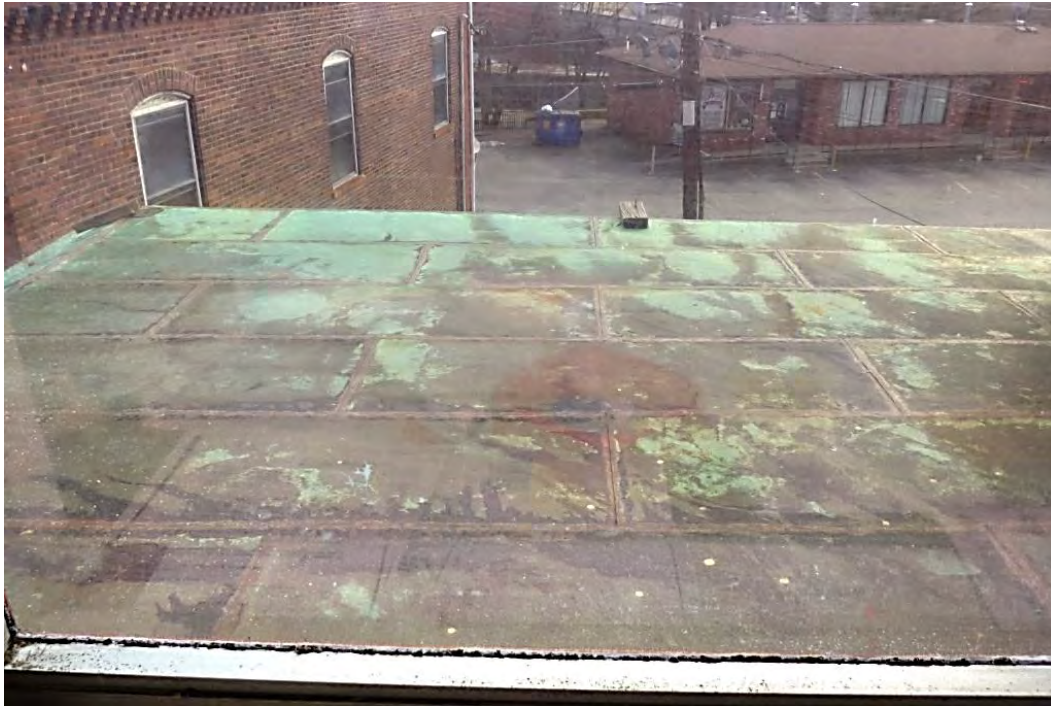
Cumberland Town Hall – Roofing, Flashing, Gutters, Leaders, Metal Trim and Roofing Elements  
Roof Above Southeast Entrance Porch  
Metal Roof in Good Condition Overall; Metal Lifting at Corner

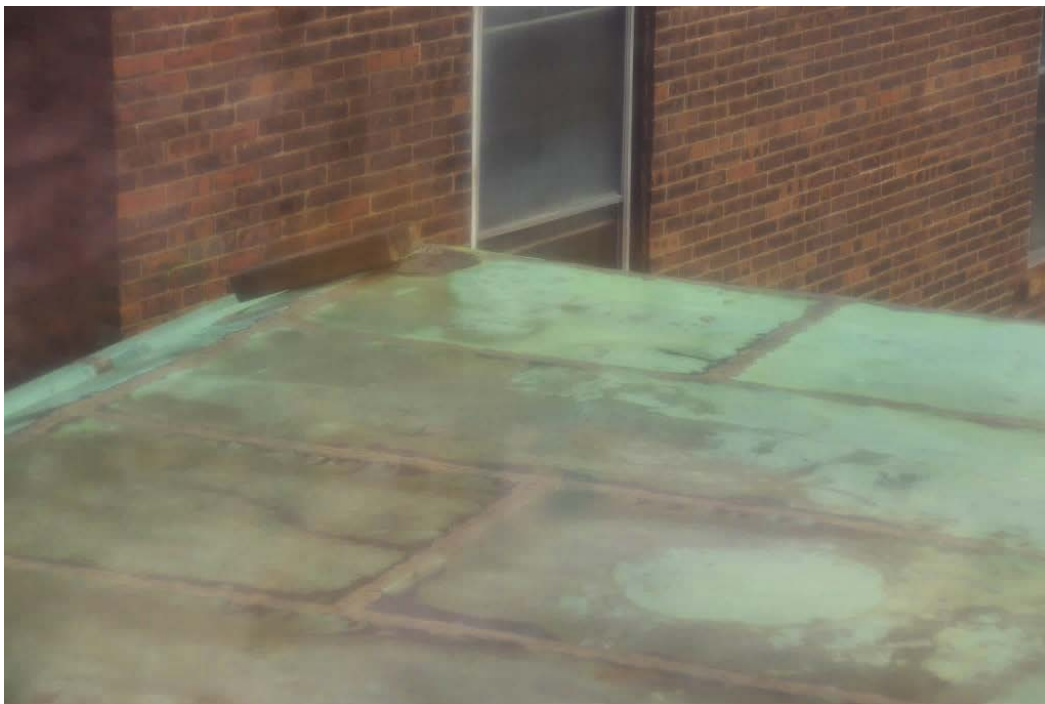
Cumberland Town Hall – Roofing, Flashing, Gutters, Leaders, Metal Trim and Roofing Elements  
Roof Above Southeast Entrance Porch - Detail  
Metal Roof in Good Condition Overall; Metal Lifting at Corner

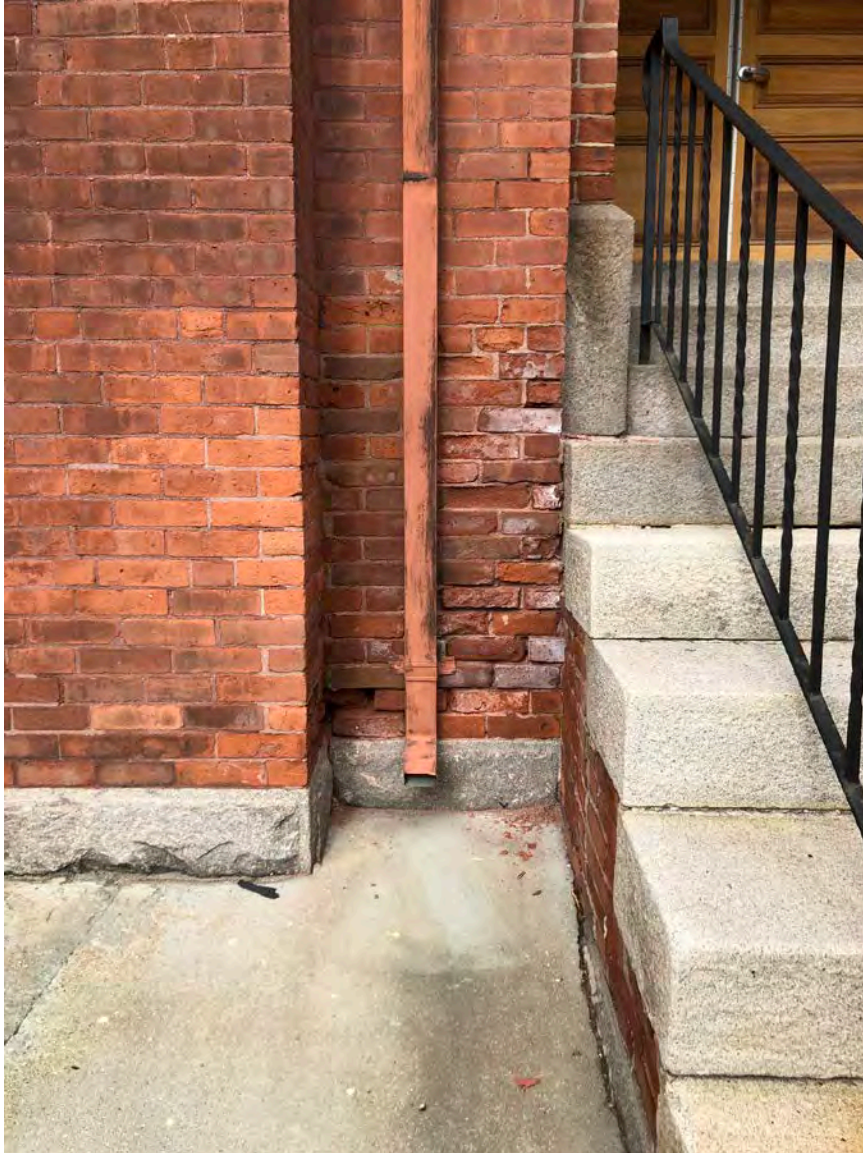
Cumberland Town Hall – Roofing, Flashing, Gutters, Leaders, Metal Trim and Roofing Elements  
South Elevation

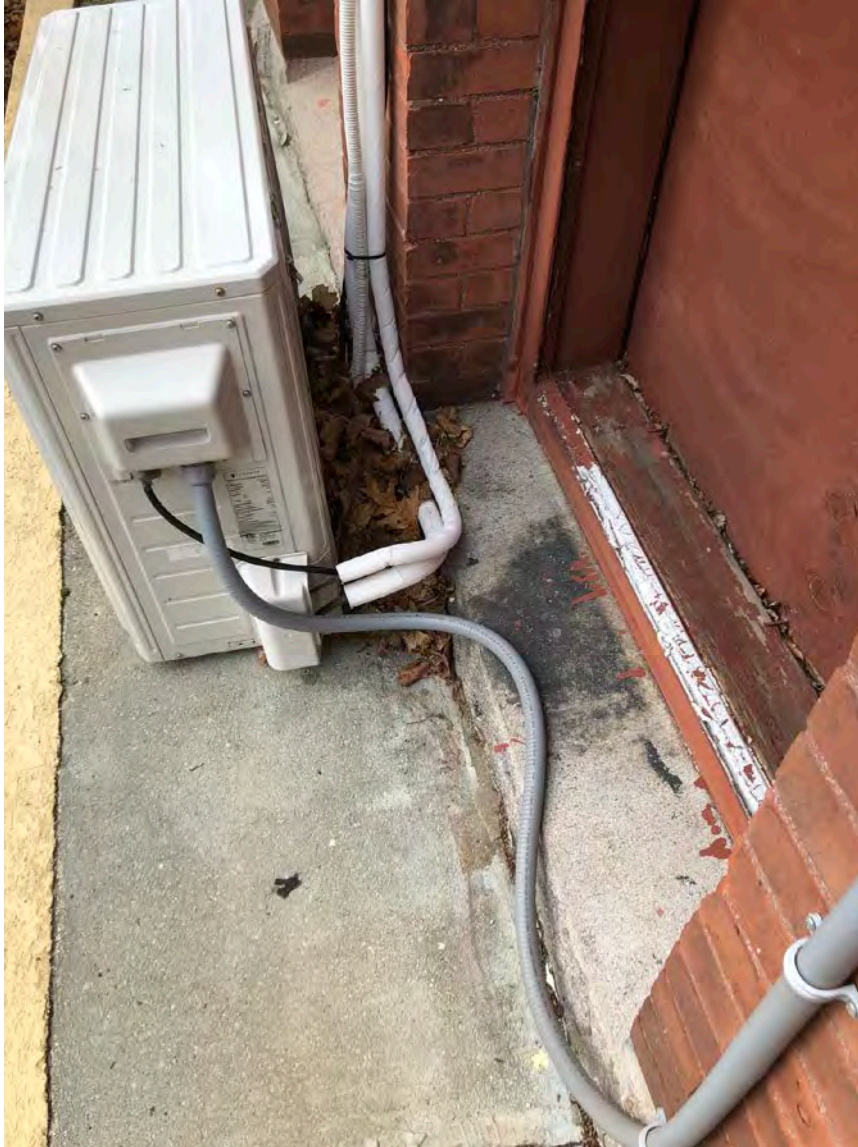
Cumberland Town Hall – Exterior – Landscaping Elements  
South Elevation – Concrete Pavement adjacent to Building  
Accumulate Debris behind AC Compressor

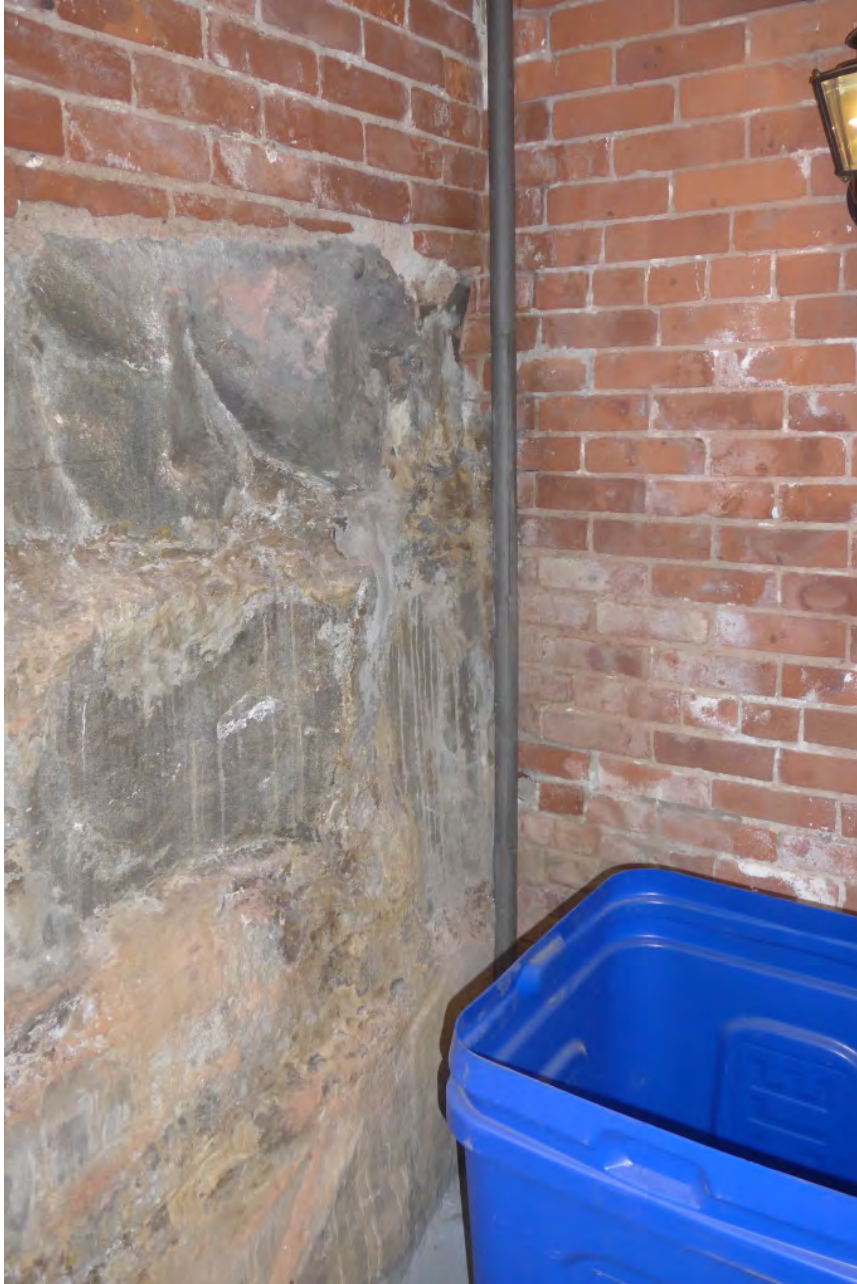
Cumberland Town Hall – Interior - Masonry  
Basement – Entrance Looking Toward Handicap Access  
Efflorescence Staining in Brick and Stone

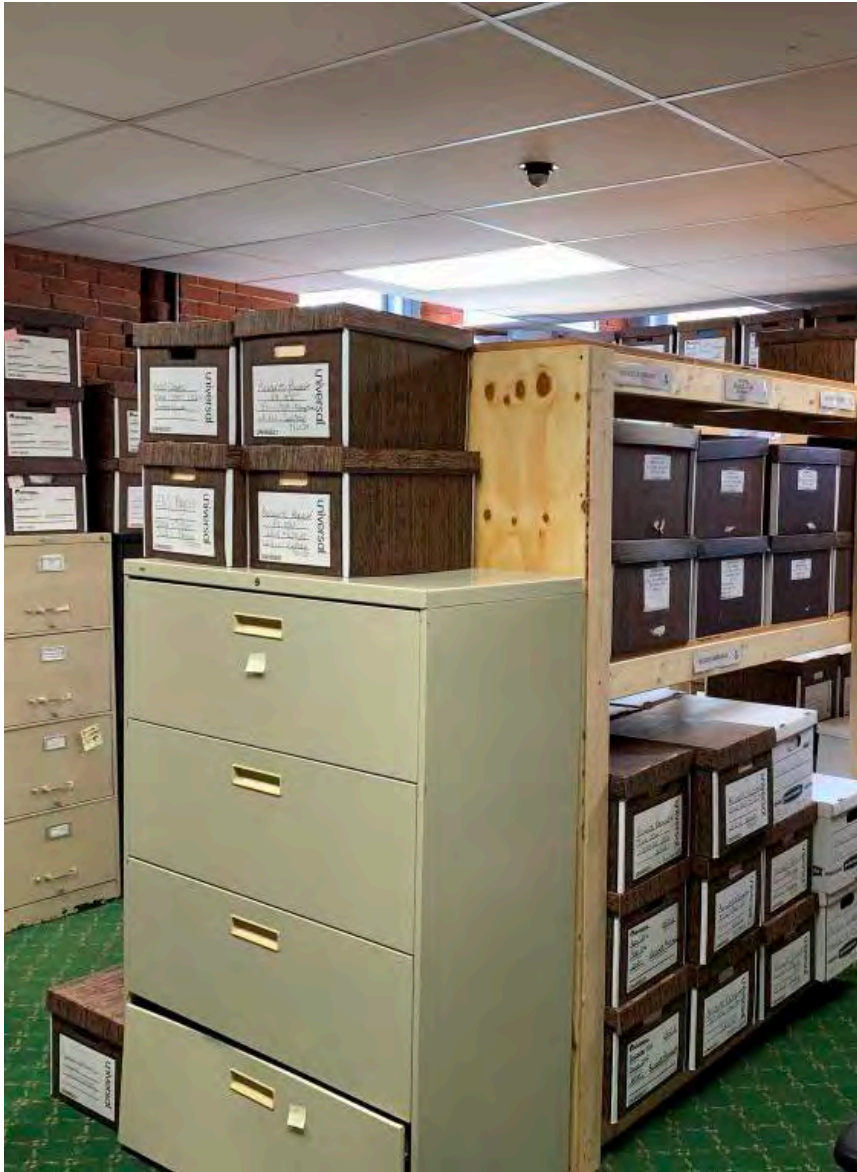
Cumberland Town Hall – Interior - Overall  
Basement – Storage Room in Northwest Corner  
Typical Conditions - Good

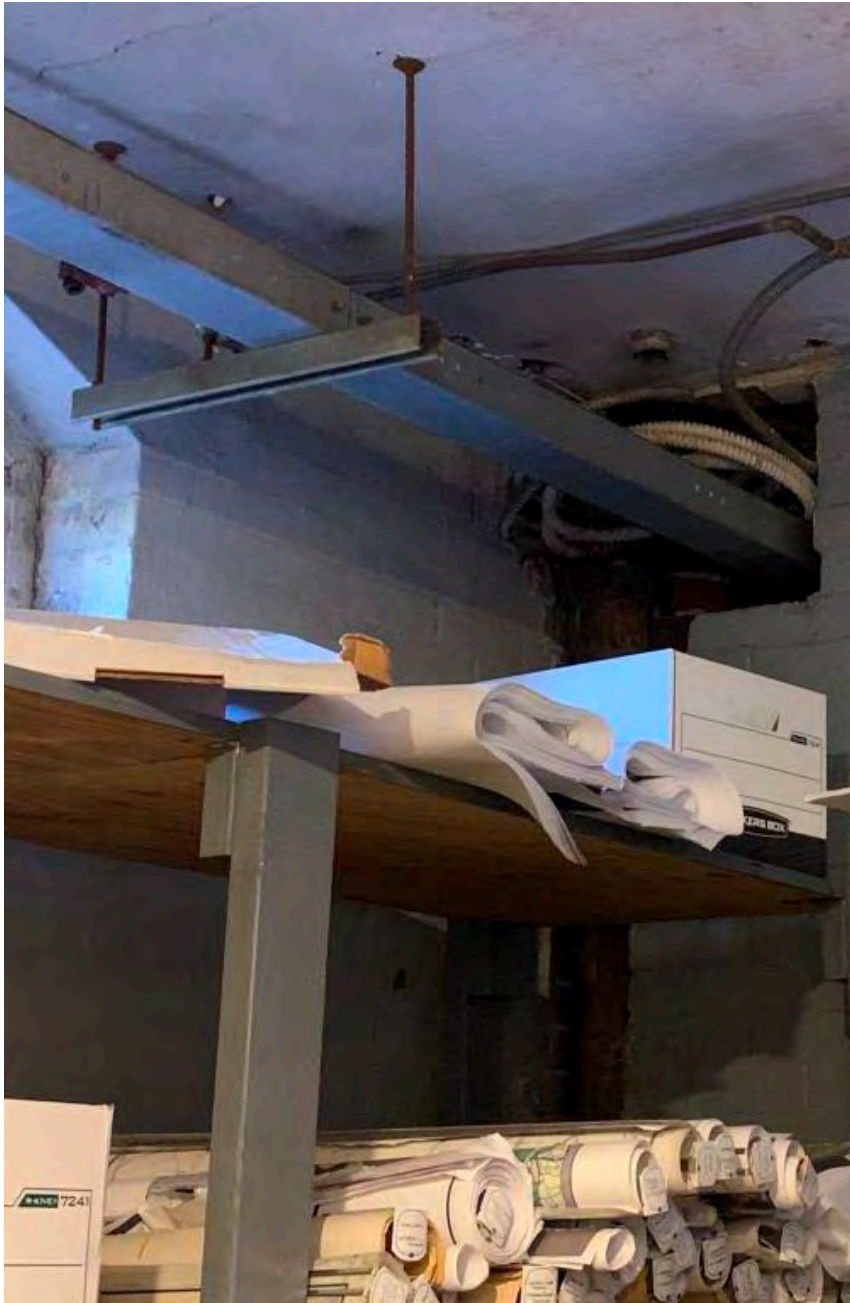
Cumberland Town Hall – Interior - Overall  
Basement – Storage Area Off Boiler Room  
Unsealed Penetrations; Papers Stored Inappropriately in Mechanical Areas

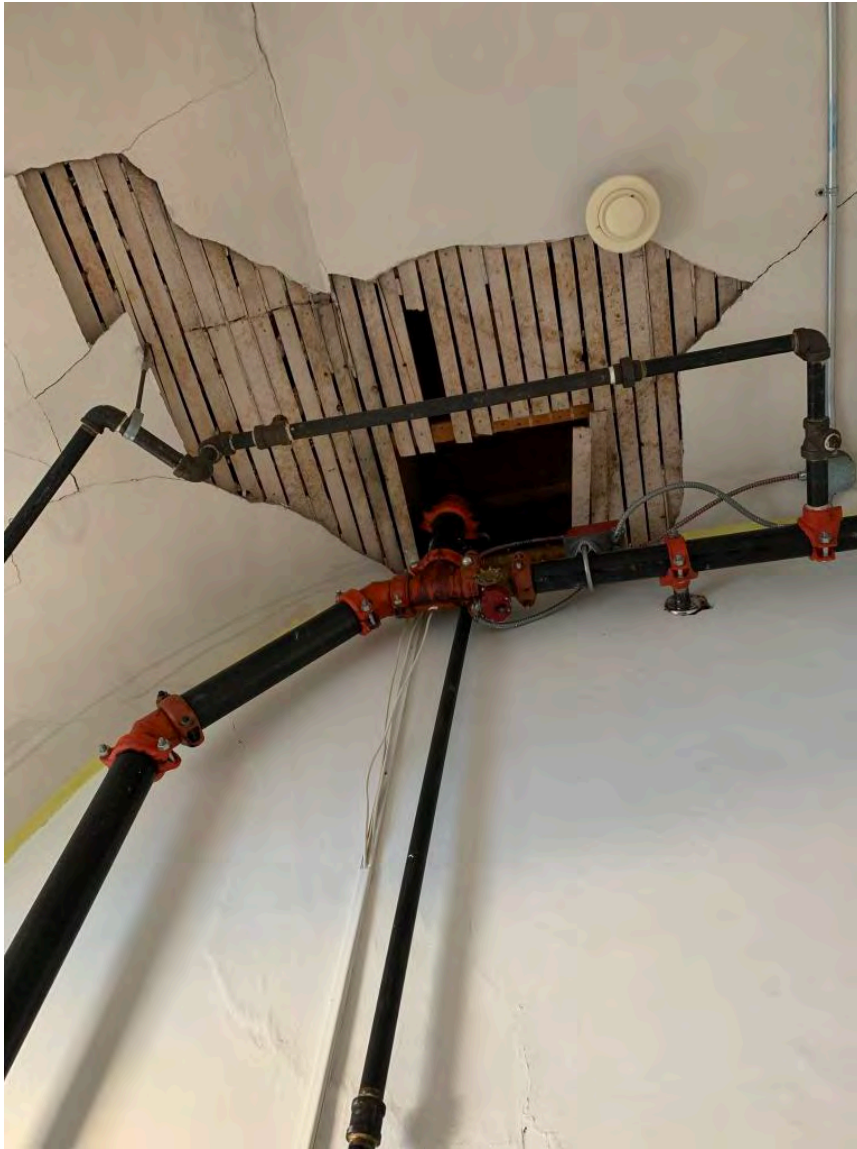
Cumberland Town Hall – Interior – Plaster Walls and Ceilings – Code Compliance  
Main Stair  
Cracked, Damaged and Missing Plaster on Walls and Ceiling; Unsealed Penetration

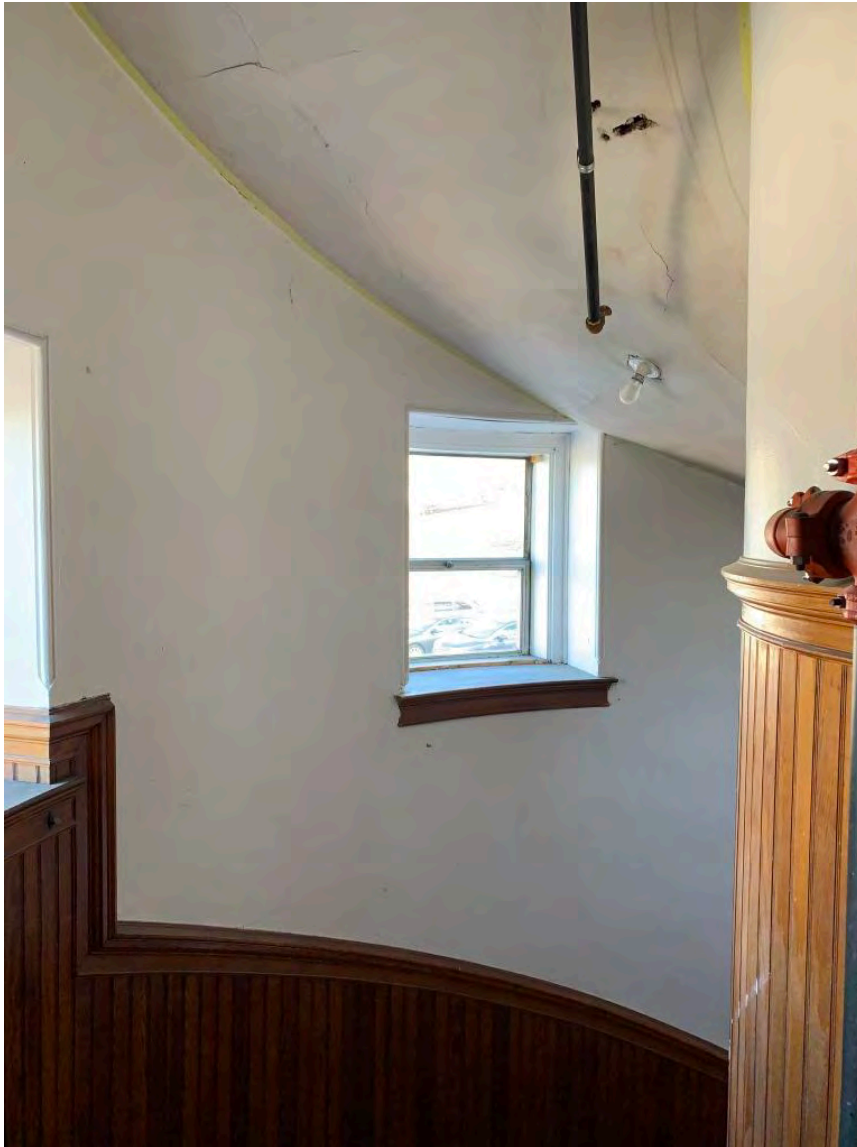
Cumberland Town Hall – Interior – Plaster Walls and Ceilings  
Main Stair  
Cracked, Damaged and Missing Plaster on Walls and Ceiling

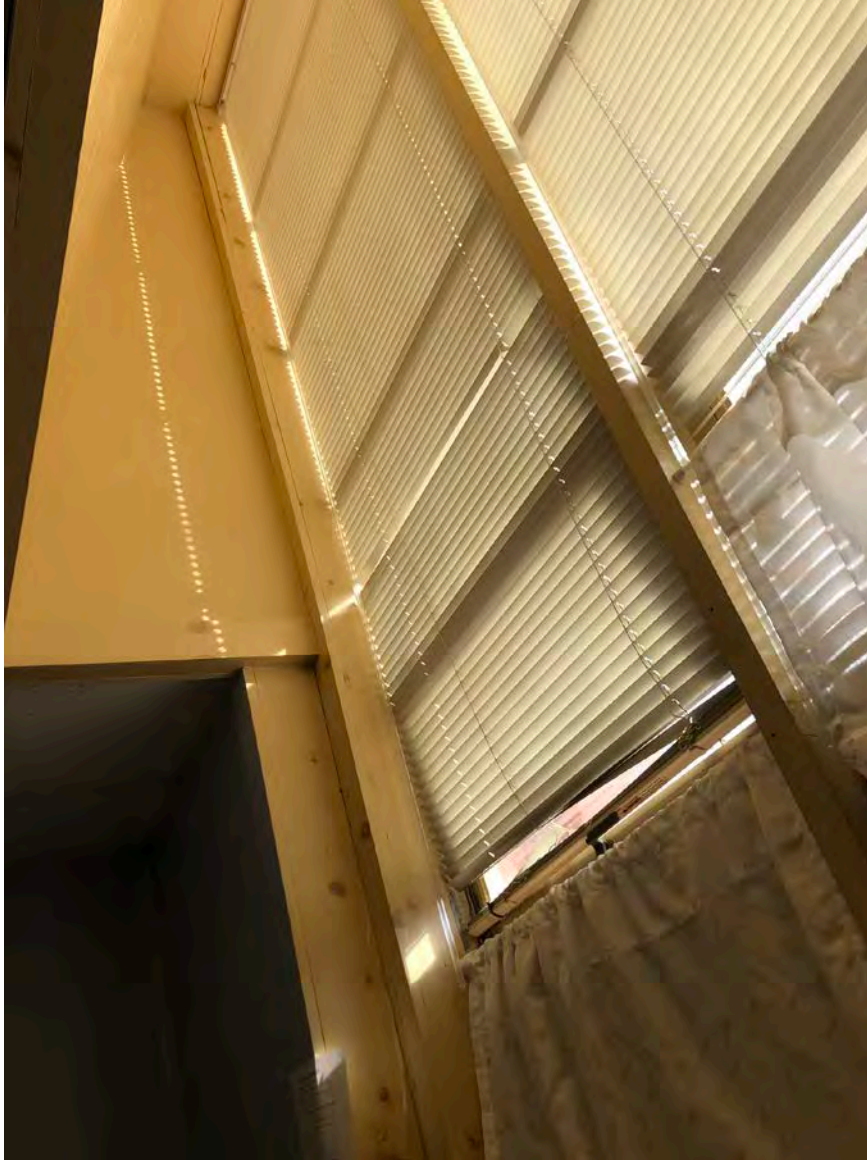
Cumberland Town Hall – Interior – Windows, Doors and Hardware  
Second Floor – Public Works Office  
Dropped Ceiling Bisects Original Windows; Inappropriate Replacement Windows; Transom Not Visible

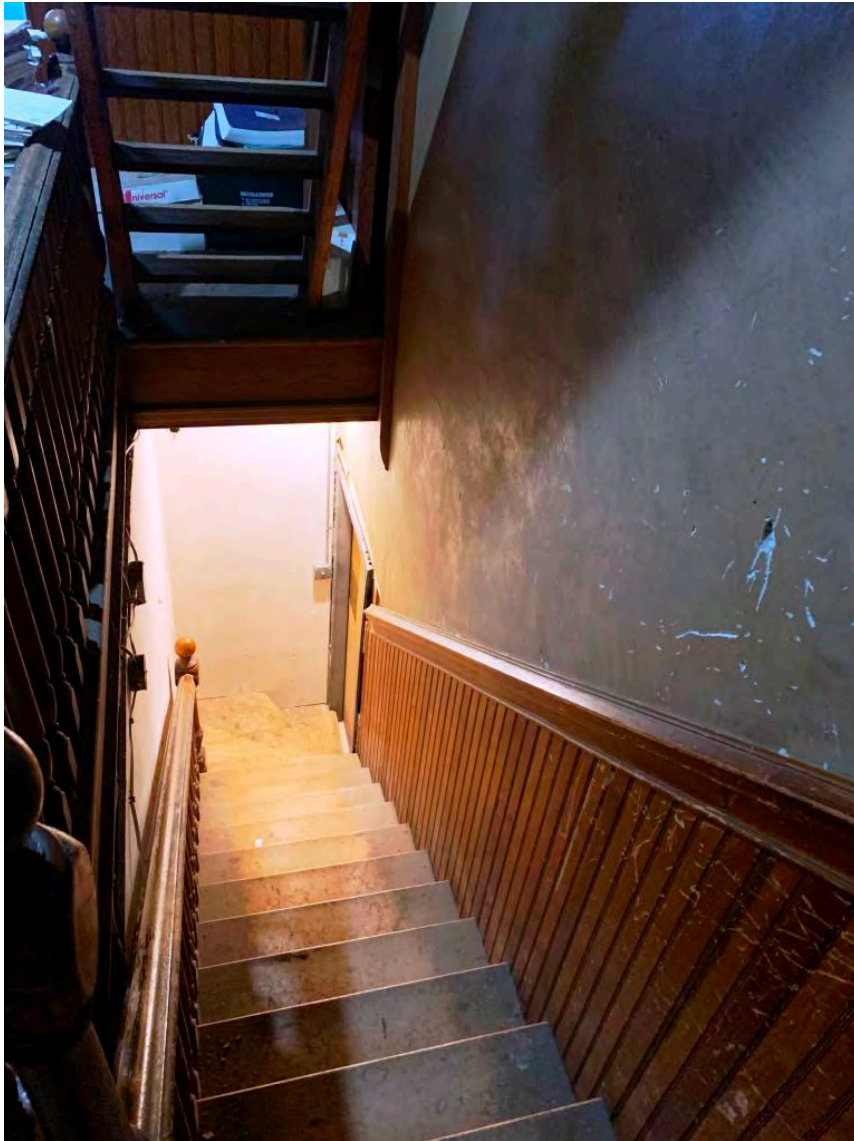
Cumberland Town Hall – Interior – Plaster Walls and Ceilings  
Third Floor – Base of Tower – Stair from Second to Third Floor  
Damaged Plaster and Wood Walls

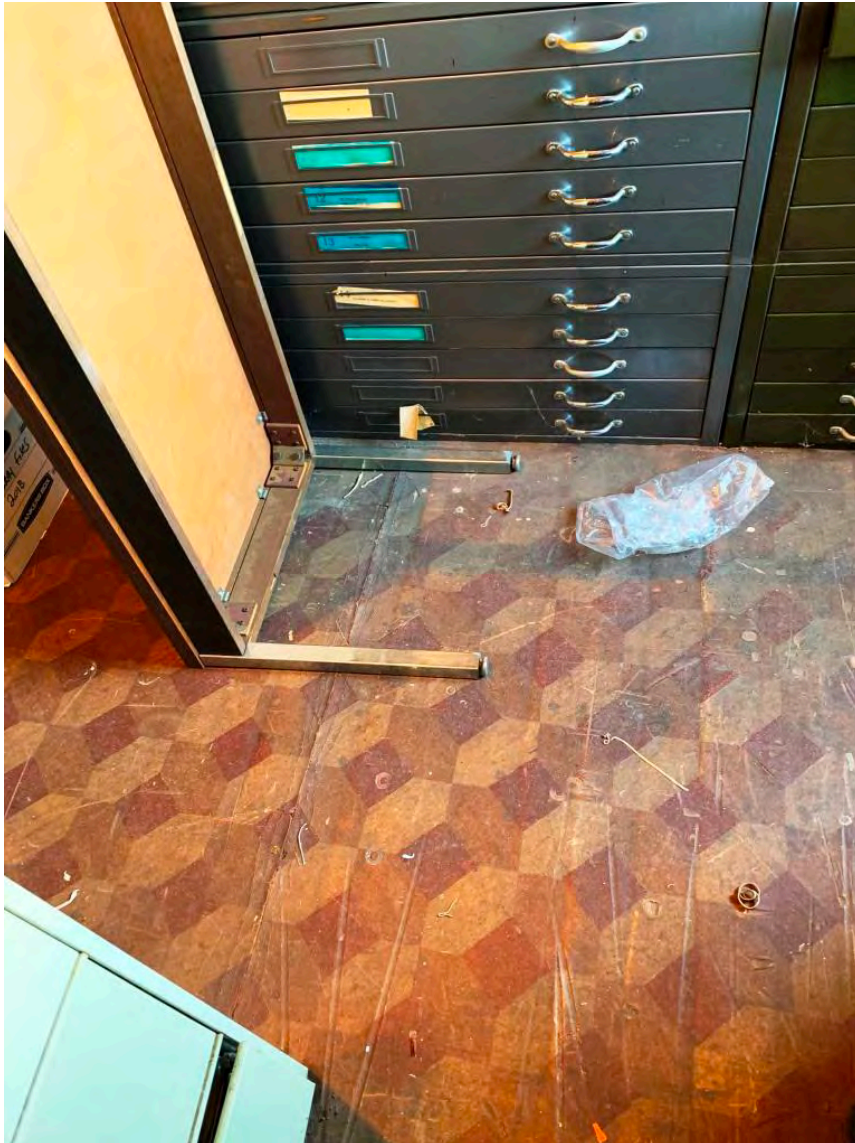
Cumberland Town Hall – Interior – Historic Finishes and Elements - Storage  
Third Floor – Southwest Corner Room  
1930s-era Inlaid Wood Floor Damaged from Storage-related Abuse  
Excessive Storage Creating Substantial Load

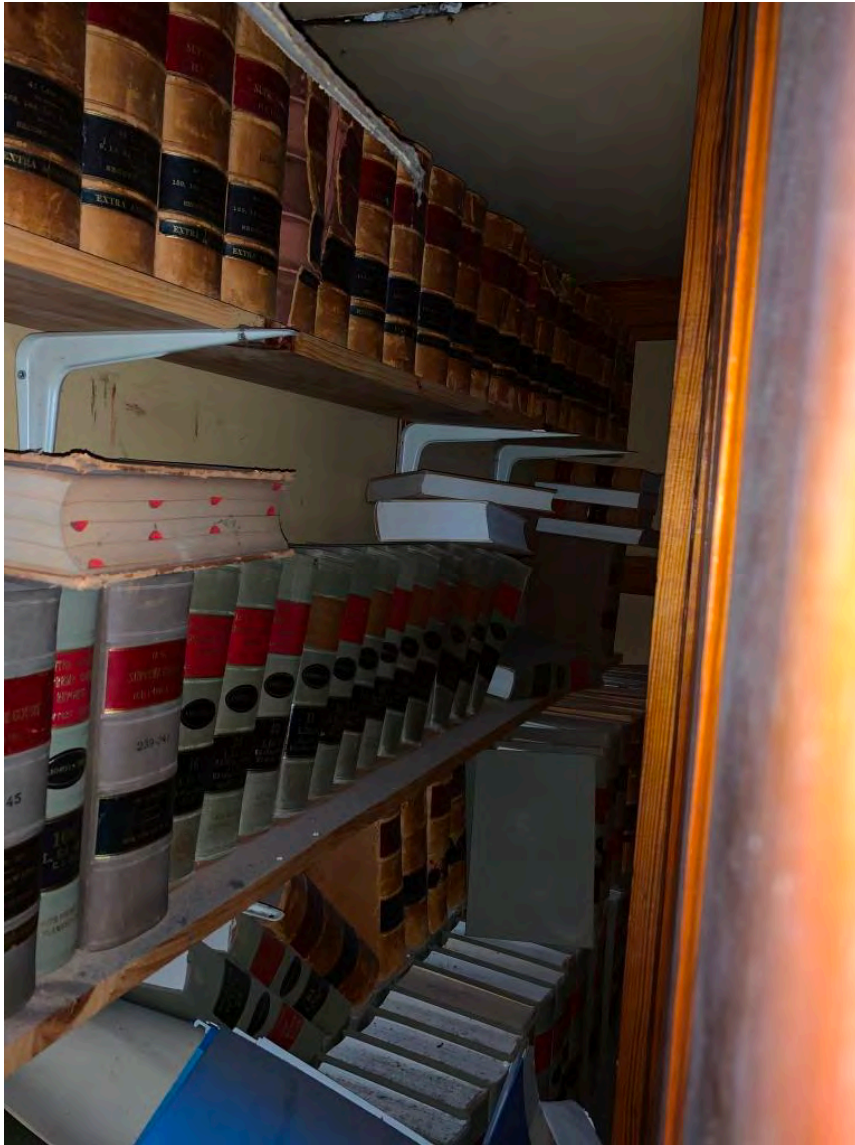
Cumberland Town Hall – Interior – Storage  
Third Floor – Stair Hall, Northwest Room  
Neglected Storage Area Behind Wall

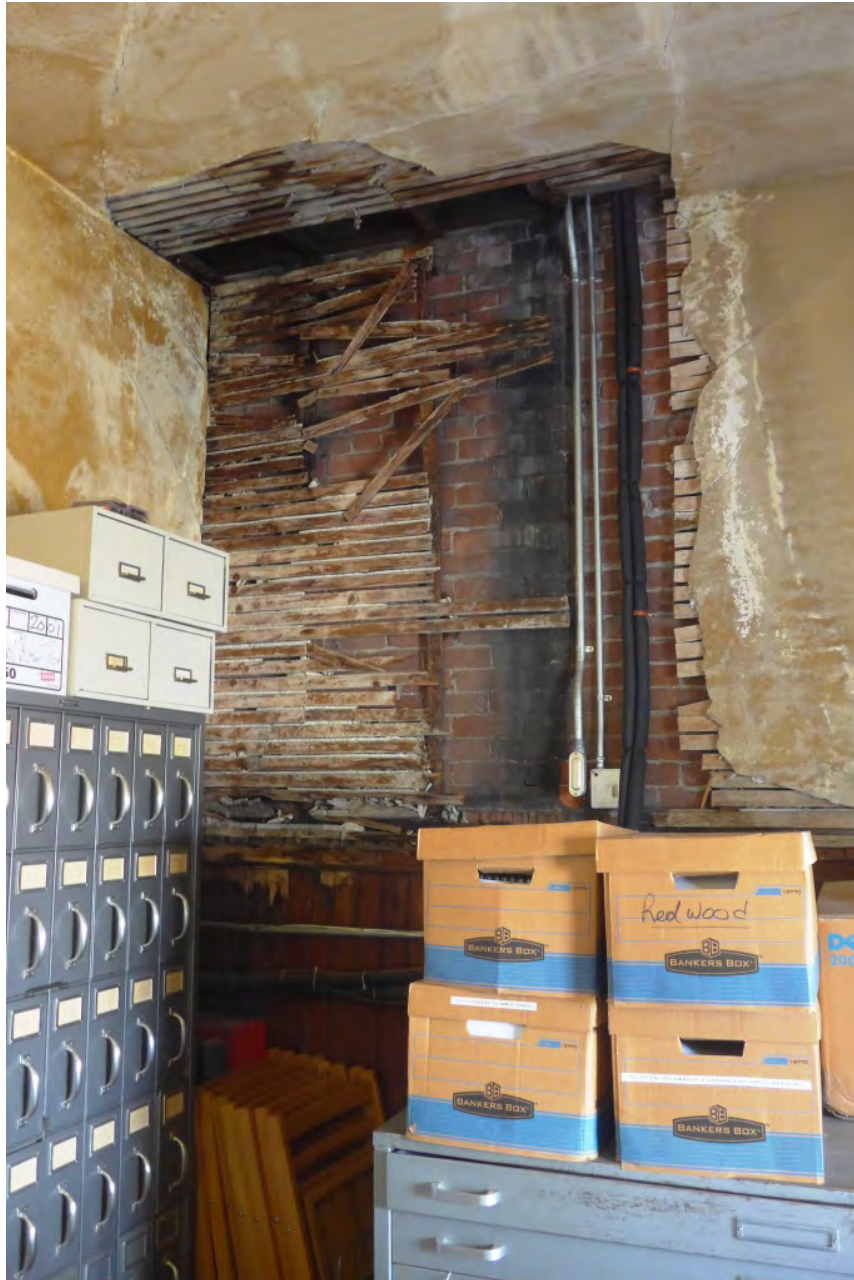
Cumberland Town Hall – Interior – Plaster Walls and Ceilings - Storage  
Third Floor – East Storage Area  
Severe Unrepaired Damage from Previous Leak; Excessive Storage Creating Substantial Load

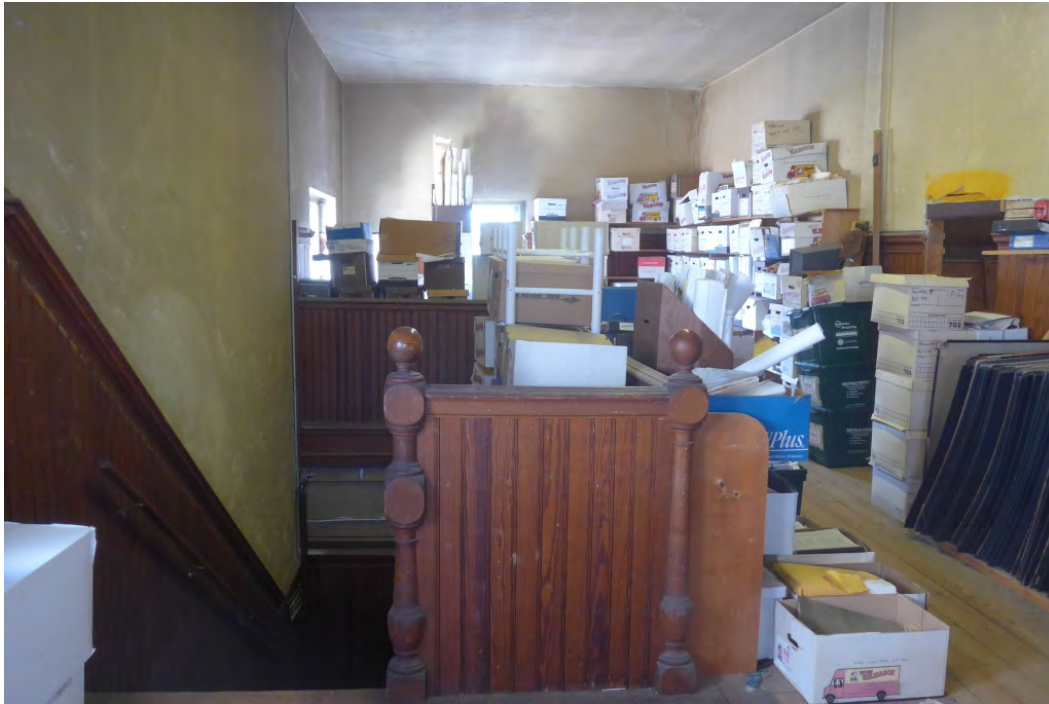
Cumberland Town Hall – Interior – Plaster Walls and Ceilings - Storage  
Third Floor – East Storage Area  
Excessive Storage Creating Substantial Load

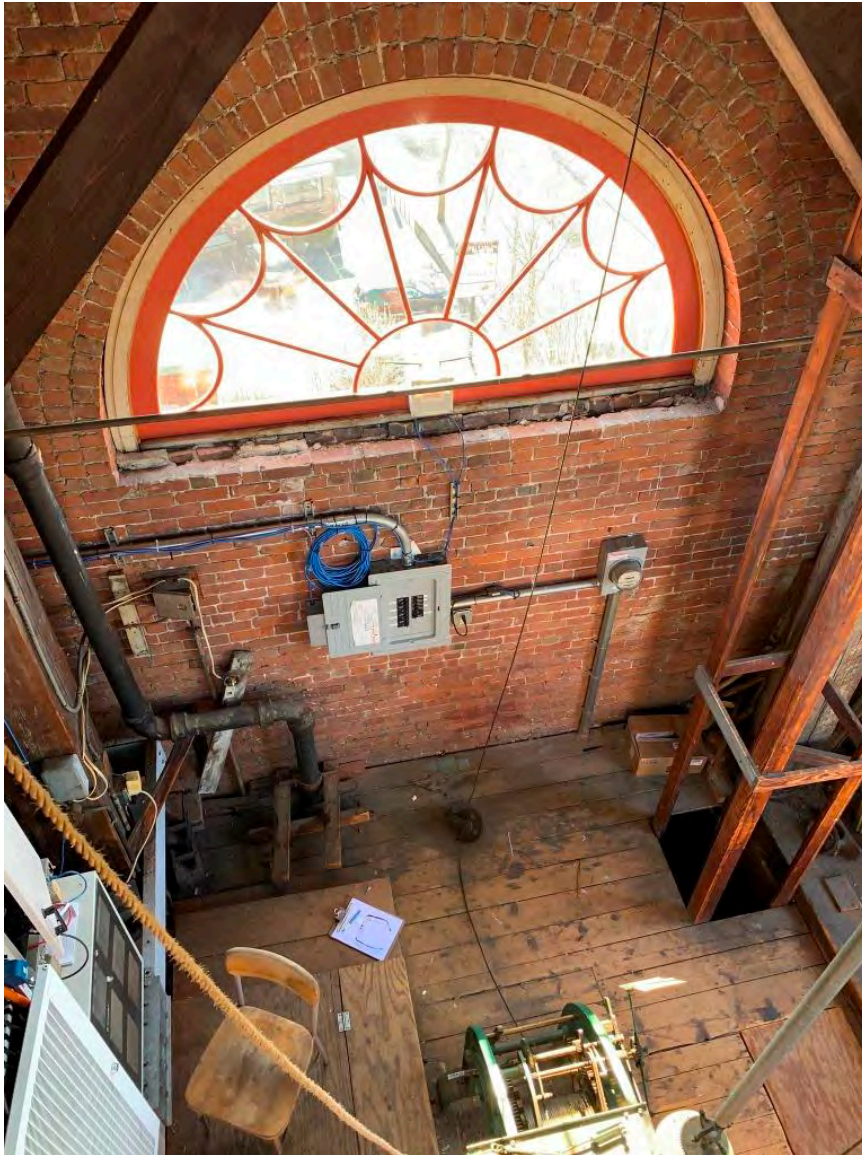
Cumberland Town Hall – Interior – Historic Finishes and Building Elements  
Tower – Overall View Looking Down to Fifth Floor  
Window Sill Missing Revealing Back-up Masonry
