# CUMBERLAND TOWN HALL CONDITIONS ASSESSMENT

**45 BROAD STREET  
CUMBERLAND, RI 02864**

**ISSUED:**

18 June 2020

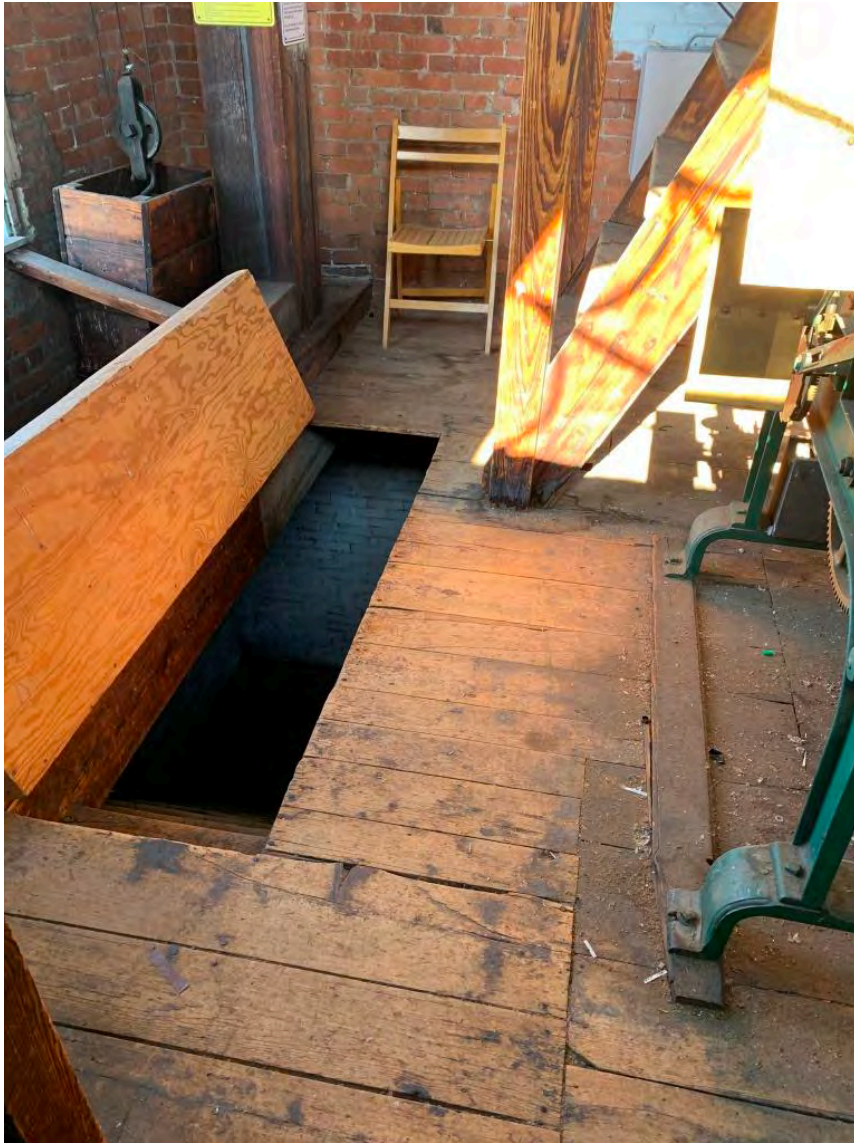
Cumberland Town Hall – Interior – Code Compliance  
Tower – Fifth Floor  
Open Stair Hatch with No Railing
