# MCKENNAN PARK BANDSHELL: FACILITIES CONDITION ASSESSMENT

SEPTEMBER 3, 2020

## EXECUTIVE SUMMARY

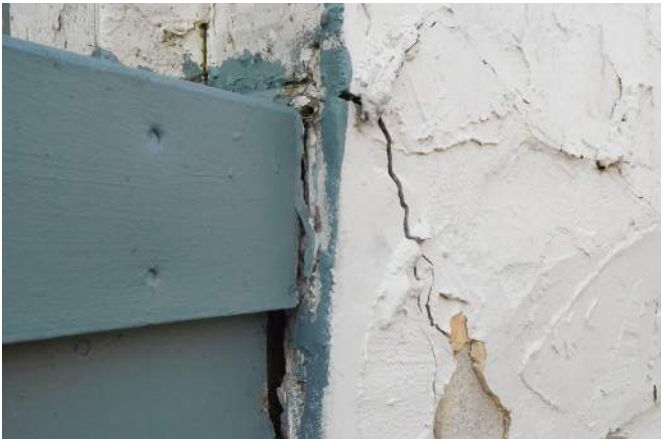
1.

| | | Priority I | Priority II |
|---|---|---|---|
| 1 | There is structural damage near each edge of the stage, likely due to high winds causing the structure to shift. This is among the more serious ongoing issues and needs structural attention. Adequate repair of this would be a part of removing much stucco and replacing structure. | ● | ● |

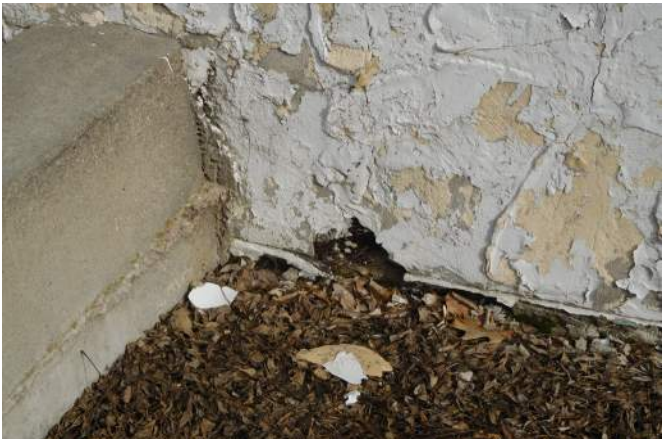
2.

| | | Priority I | Priority II |
|---|---|---|---|
| 2 | The stucco at the base of the building where it meets the foundation is deteriorating to the point where it is exposing the sheathing and or rim joist. | | ● |

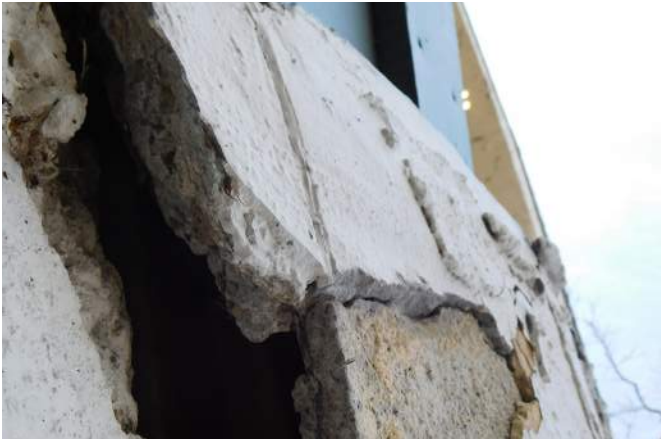
3.

| | | Priority I | Priority II |
|---|---|---|---|
| 3 | There is structural damage near each edge of the stage, likely due to high winds causing the structure to shift. This is among the more serious ongoing issues and needs structural attention. Adequate repair of this would be a part of removing much stucco and replacing structure. You can see in this picture the amount of shifting that has taken place at the wall sill plate. | | ● |

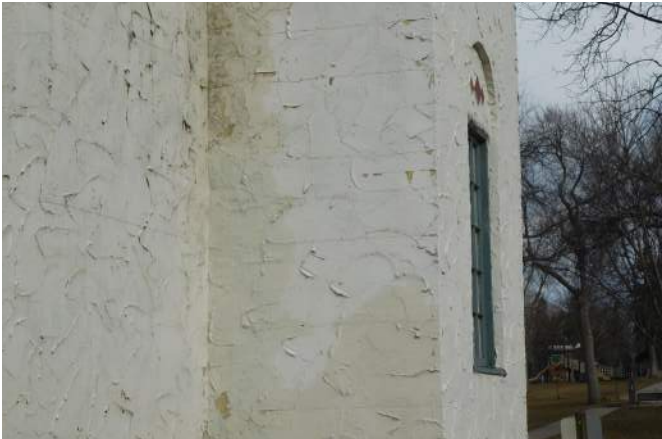
4.

| | | Priority I | Priority II |
|---|---|---|---|
| 4 | In this picture you can see horizontal cracks in the plaster at all the joints in the shiplap sheathing behind the plaster. This is a result of building movement probably caused by the shrinking and expansion of the wood materials. | | ● |

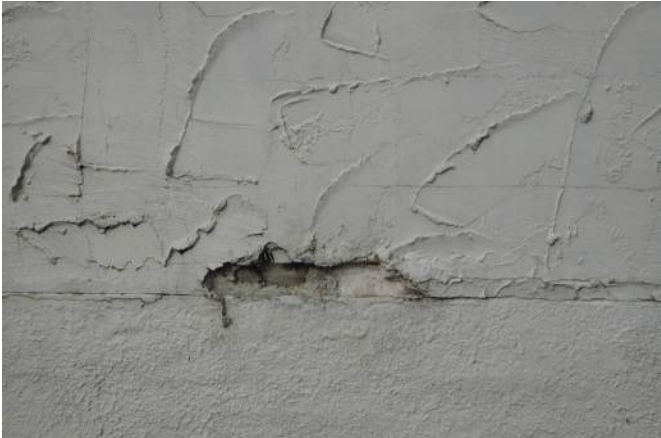
5.

| | | Priority I | Priority II |
|---|---|---|---|
| 5 | The stucco at the base of the building where it meets the foundation is deteriorating to the point where it is exposing the sheathing and or rim joist. | | ● |

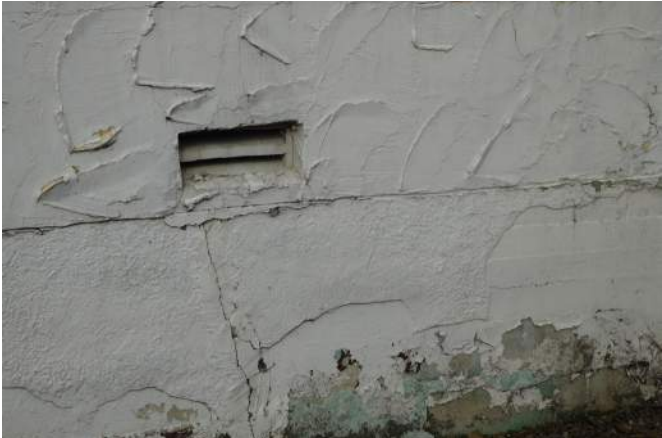
6.

| | | Priority I | Priority II |
|---|---|---|---|
| 6 | The stucco on the foundation wall is cracking. There were no signs of cracking in the concrete foundation wall. | | ● |

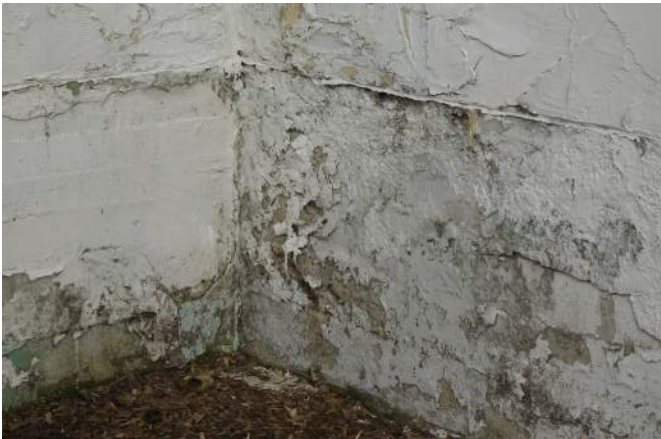
7.

| | | Priority I | Priority II |
|---|---|---|---|
| 7 | The exterior inside corners of the building have been exposed to large amounts of water discharge from the roof, causing infiltration of water through cracks in the stucco. | | ● |

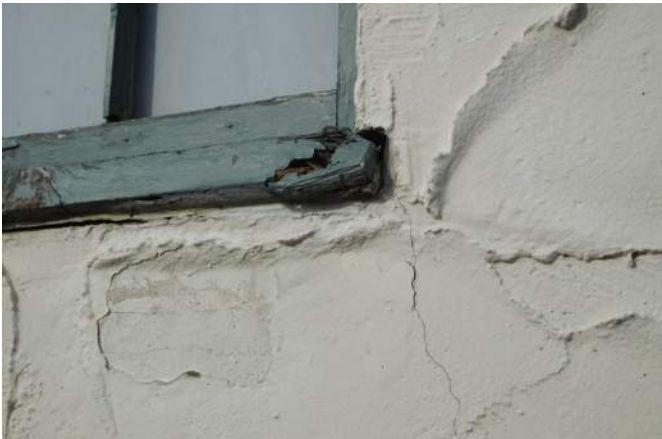
8.

| | | Priority I | Priority II |
|---|---|---|---|
| 8 | The simulated window trim and sills are rotting, allowing moisture penetration. The simulated windows should be replaced with new windows and installed with appropriate flashing and patching. | ● | |

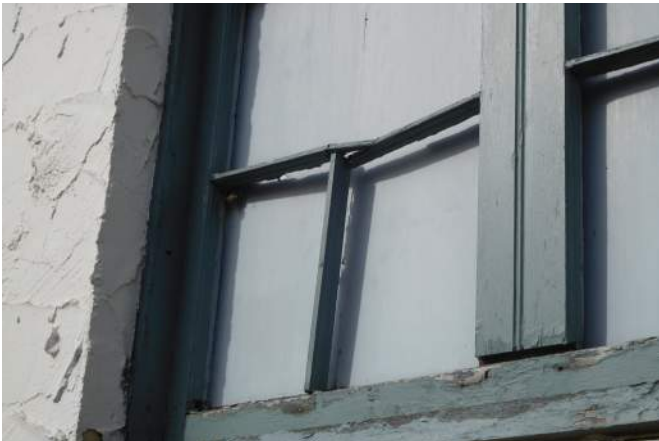
9.

| | | Priority I | Priority II |
|---|---|---|---|
| 9 | The simulated window trim and sills are rotting and or damaged. The simulated windows should be replaced with new windows and installed with appropriate flashing and patching. | ● | |

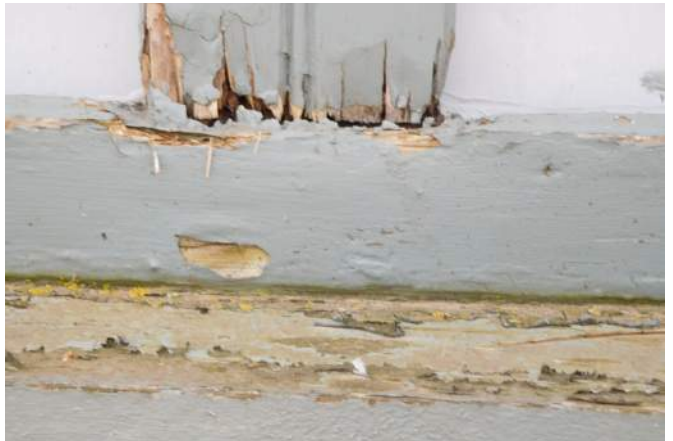
10.

| | | Priority I | Priority II |
|---|---|---|---|
| 10 | The simulated window trim and sills are rotting, allowing moisture penetration. The simulated windows should be replaced with new windows and installed with appropriate flashing and patching. | ● | |

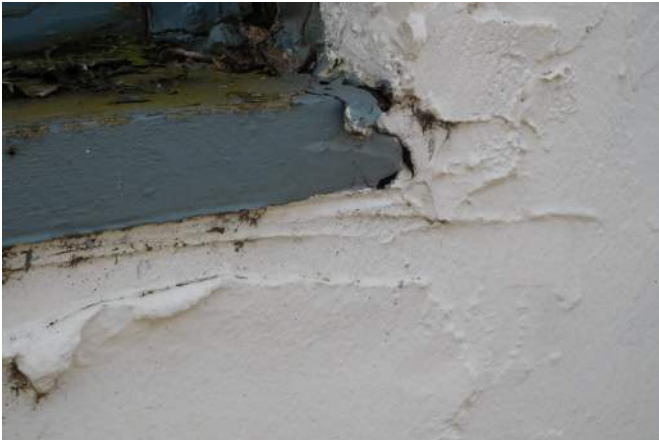
11.

| | | Priority I | Priority II |
|---|---|---|---|
| 11 | The simulated window trim and sills are rotting, allowing moisture penetration. The simulated windows should be replaced with new windows and installed with appropriate flashing and patching. | ● | |

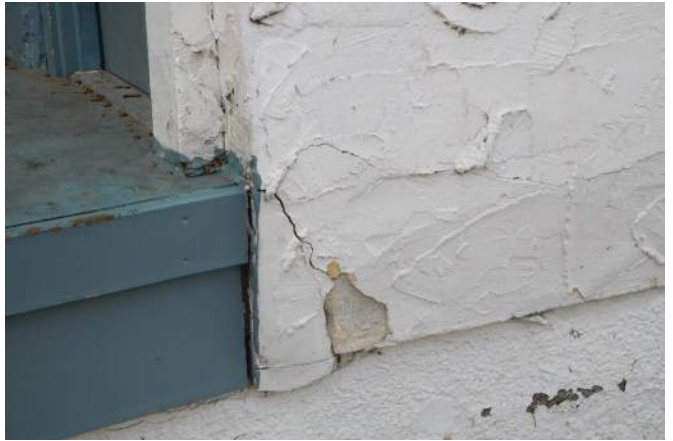
12.

| | | Priority I | Priority II |
|---|---|---|---|
| 12 | There is structural damage near each edge of the stage, likely due to high winds causing the structure to shift. This is among the more serious ongoing issues and needs structural attention. Adequate repair of this would be a part of removing much stucco and replacing structure. | | ● |

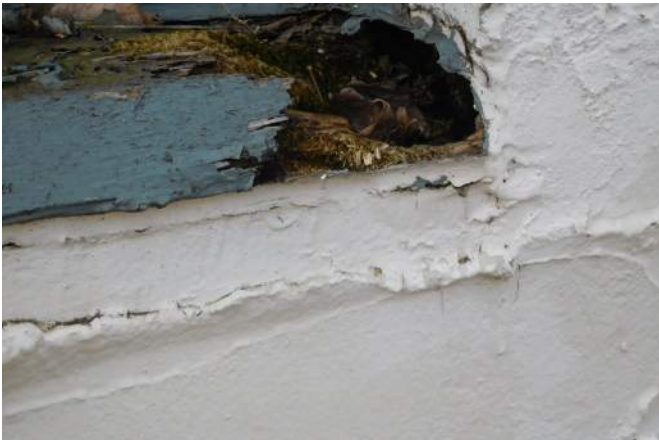
13.

| | | Priority I | Priority II |
|---|---|---|---|
| 13 | The simulated window trim and sills are rotting, allowing moisture penetration. The simulated windows should be replaced with new windows and installed with appropriate flashing and patching. | ● | |

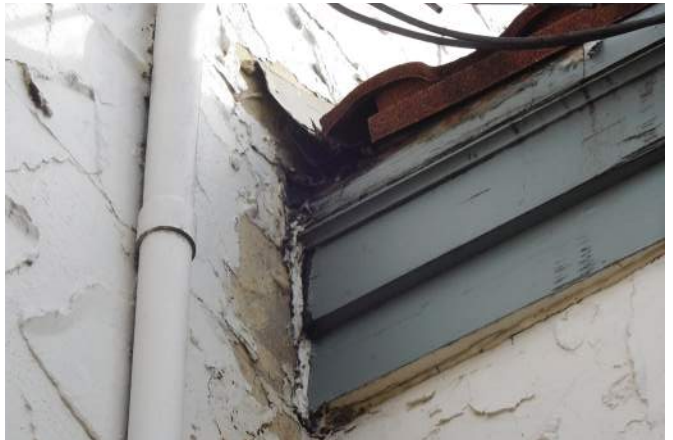
14.

| 14 | The exterior inside corners of the building have been exposed to large amounts of water discharge from the roof, causing infiltration of water through cracks in the stucco. New gutters and downspouts should be installed to prevent the infiltration of water that is causing significant rotting of the sheathing at these inside corners. | ● | |

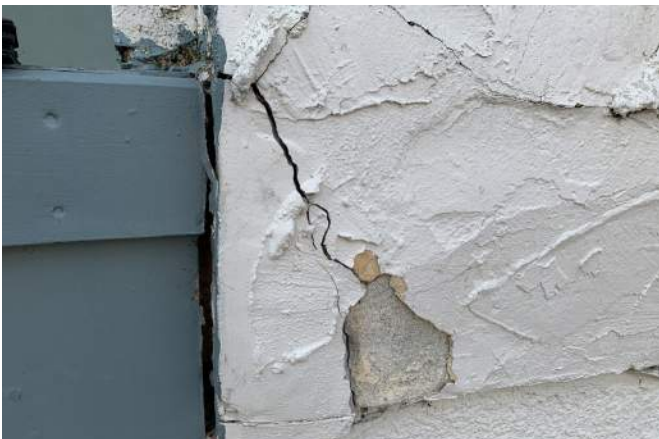
15.

| 15 | There is structural damage near each edge of the stage, likely due to high winds causing the structure to shift. This is among the more serious ongoing issues and needs structural attention. Adequate repair of this would be a part of removing much stucco and replacing structure. | | ● |

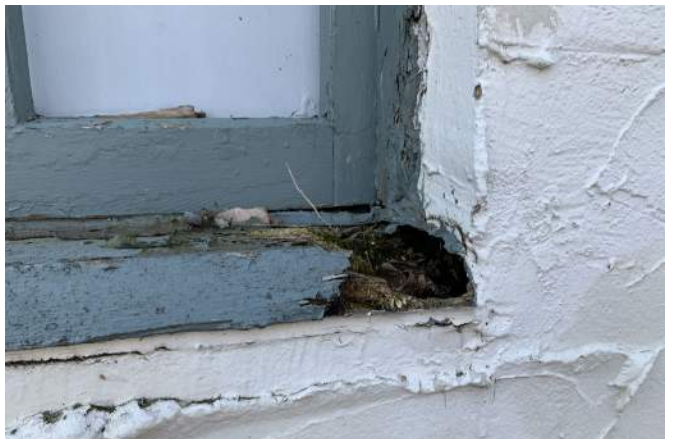
16.

| 16 | The simulated window trim and sills are rotting, allowing moisture penetration. The simulated windows should be replaced with new windows and installed with appropriate flashing and patching. | ● | |

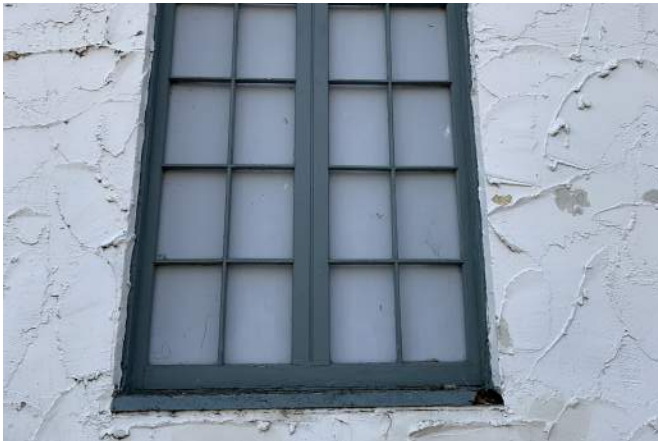
17.

| 17 | The simulated window trim and sills are rotting, allowing moisture penetration. The simulated windows should be replaced with new windows and installed with appropriate flashing and patching. | ● | |

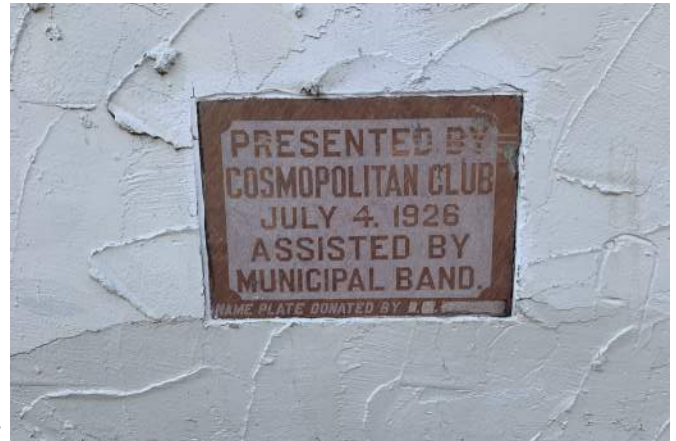
18.

| 18 | The existing plaque donor's name has been removed. | | ● |

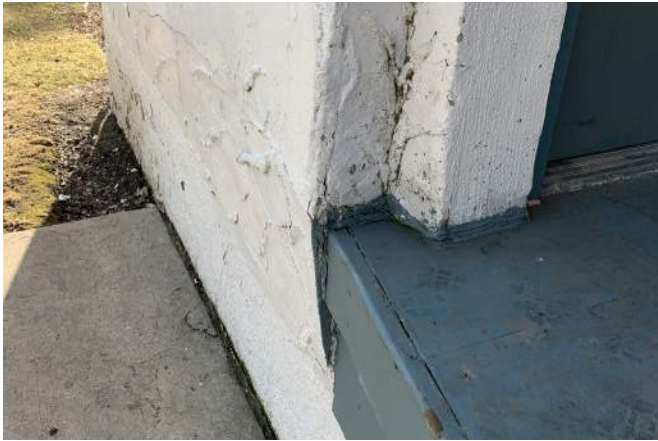
19.

| 19 | There is structural damage near each edge of the stage, likely due to high winds causing the structure to shift. This is among the more serious ongoing issues and needs structural attention. Adequate repair of this would be a part of removing much stucco and replacing structure. | | ● |

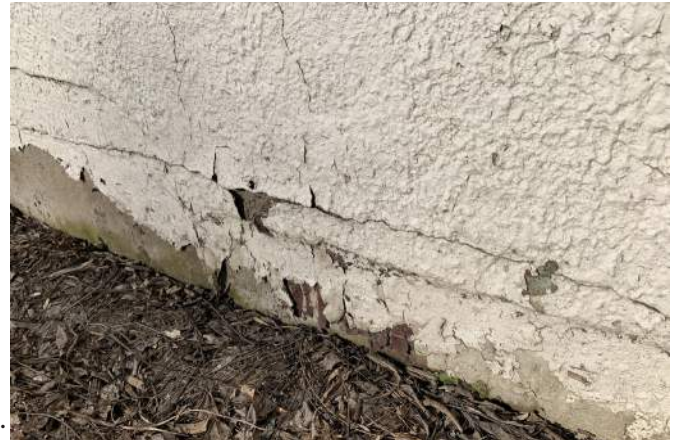
20.

| 20 | The stucco at the base of the building where it meets the foundation is deteriorating to the point where it is exposing the sheathing and or rim joist. | | ● |

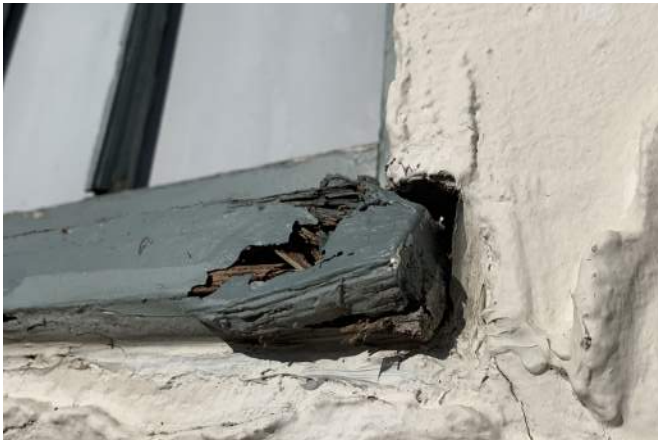
21.

| 21 | The simulated window trim and sills are rotting, allowing moisture penetration. The simulated windows should be replaced with new windows and installed with appropriate flashing and patching. | ● | |

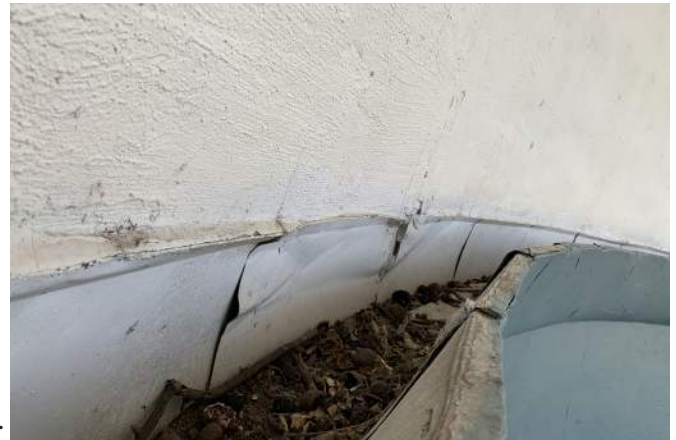
22.

| 22 | The light cove at the back of the band shell should be clean of debris and flashing should be fastened and resealed. | | ● |

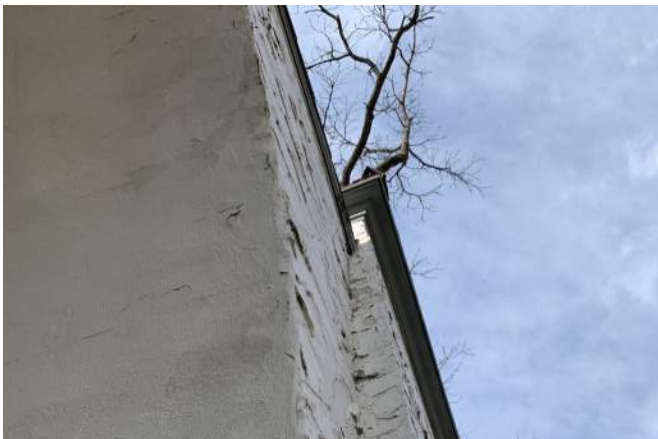
23.

| 23 | New gutters are recommended at all roof eaves. | ● | |

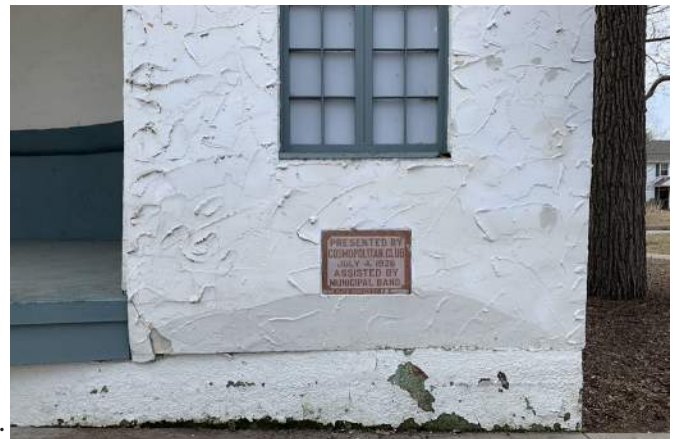
24.

| 24 | There is structural damage near each edge of the stage, likely due to high winds causing the structure to shift. This picture shows a better view of the bowing in the wall as a result of the sill plate moving out where it meets the stage. | | ● |

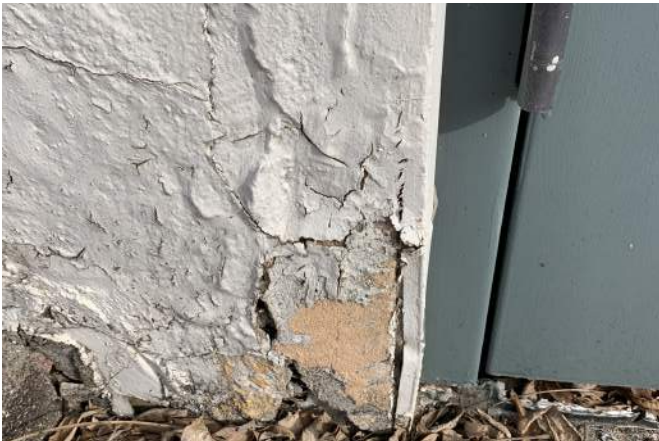
25.

| 25 | The stucco at the base of the building where it meets the foundation is deteriorating to the point where it is exposing the sheathing and or rim joist. | | ● |

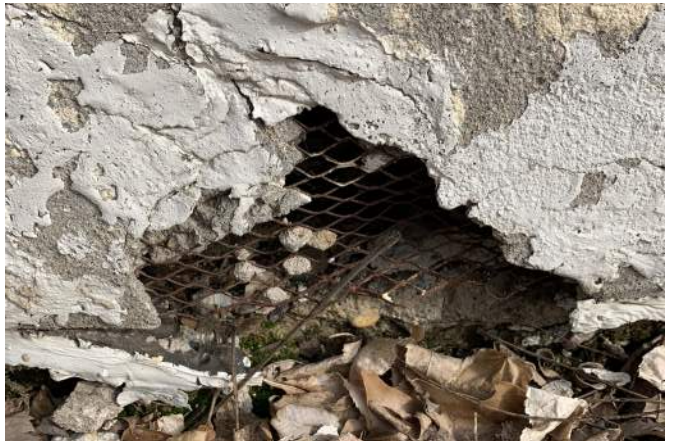
26.

| 26 | The stucco at the base of the building where it meets the foundation is deteriorating to the point where it is exposing the sheathing and or rim joist. | | ● |

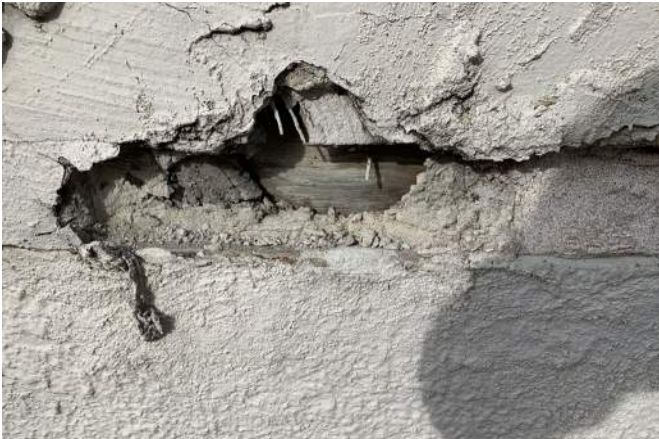
27.

| 27 | The stucco at the base of the building where it meets the foundation is deteriorating to the point where it is exposing the sheathing and or rim joist. | | ● |

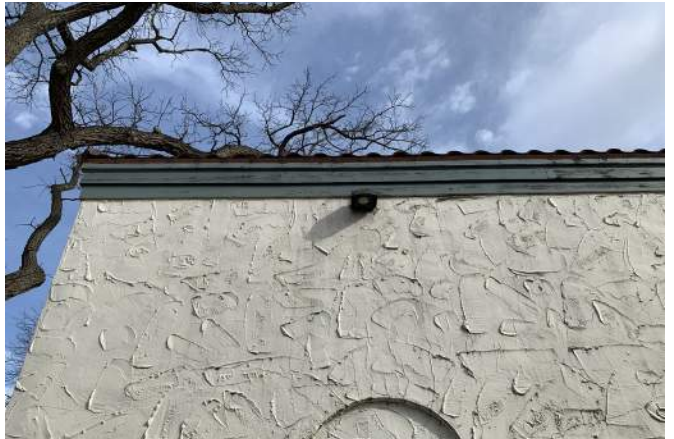
28.

| <b>28</b> | New gutters and downspouts are recommended at all roof eaves. | ● | |

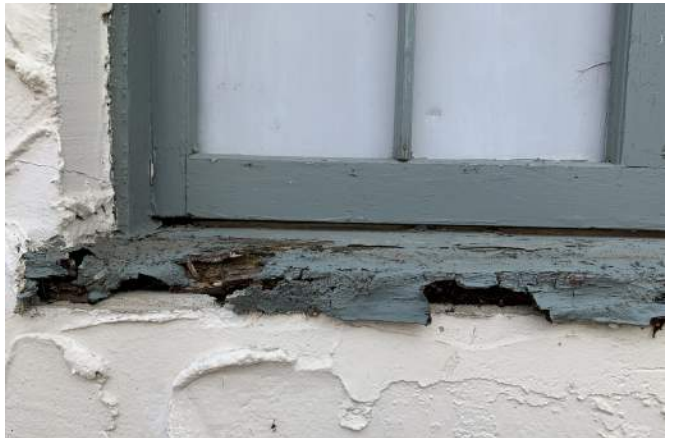
30.

| <b>30</b> | The simulated window trim and sills are rotting, allowing moisture penetration. The simulated windows should be replaced with new windows and installed with appropriate flashing and patching. | ● | |

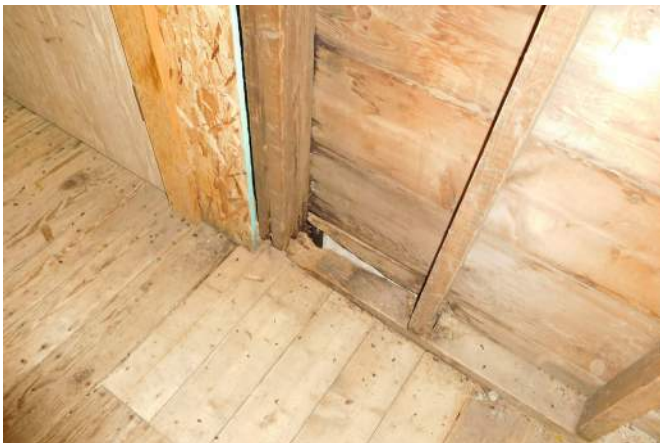
1.

| | | Priority I | Priority II |
|---|---|---|---|
| 1 | The sill plate is rotting in areas where water has gotten through the exterior plaster or entered through one of the window openings. | | ● |

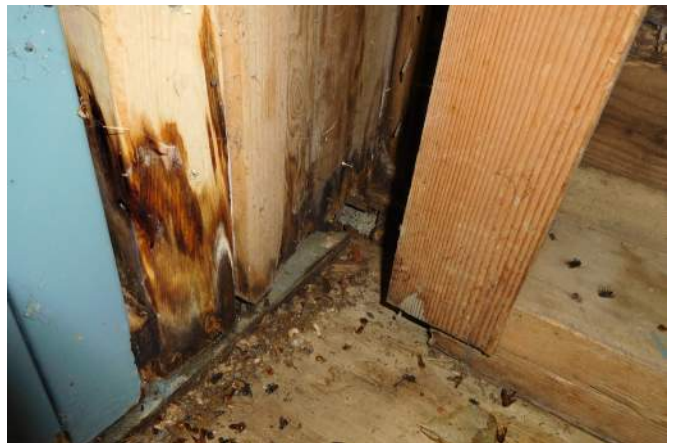
2.

| | | Priority I | Priority II |
|---|---|---|---|
| 2 | The door jamb is showing signs of water damage likely caused by sealant failure somewhere around the adjacent door frame. | ● | |

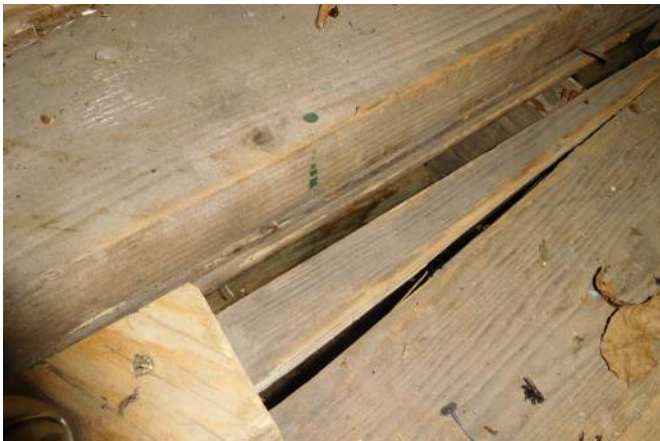
3.

| | | Priority I | Priority II |
|---|---|---|---|
| 3 | The floor boards are separating at this location near the north exterior wall where the sill plate has moved outward, likely due to high winds causing the structure to shift. | | ● |

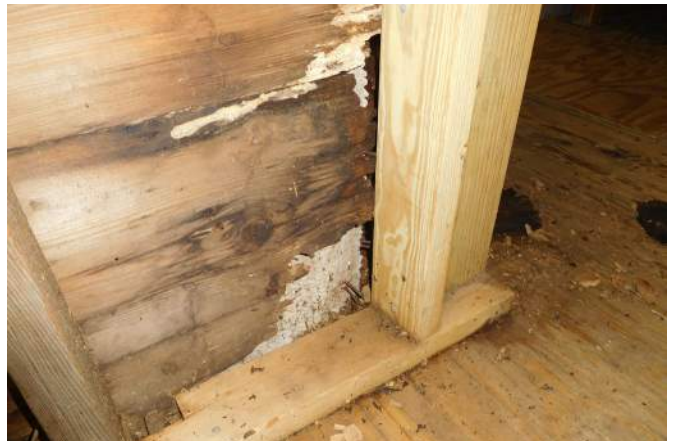
4.

| | | Priority I | Priority II |
|---|---|---|---|
| 4 | The exterior shiplap sheathing is rotting at the inside corners of the building. The exterior inside corners of the building have been exposed to large amounts of water discharge from the roof, causing infiltration of water through cracks in the stucco. New gutters and downspouts are recommended at all roof eaves. | | ● |

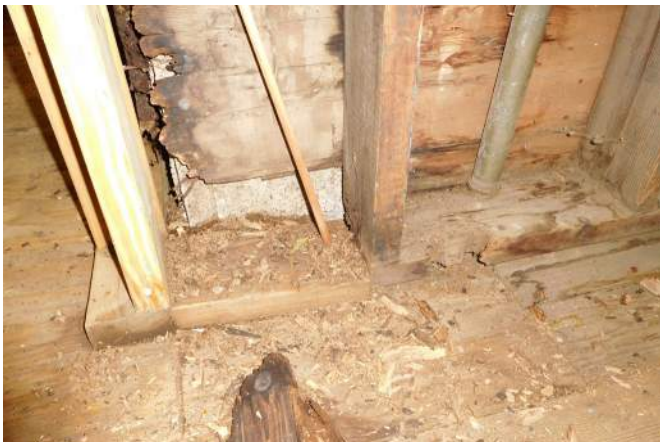
5.

| | | Priority I | Priority II |
|---|---|---|---|
| 5 | The exterior shiplap sheathing is rotting at the inside corners of the building. The exterior inside corners of the building have been exposed to large amounts of water discharge from the roof, causing infiltration of water through cracks in the stucco. New gutters and downspouts are recommended at all roof eaves. | | ● |

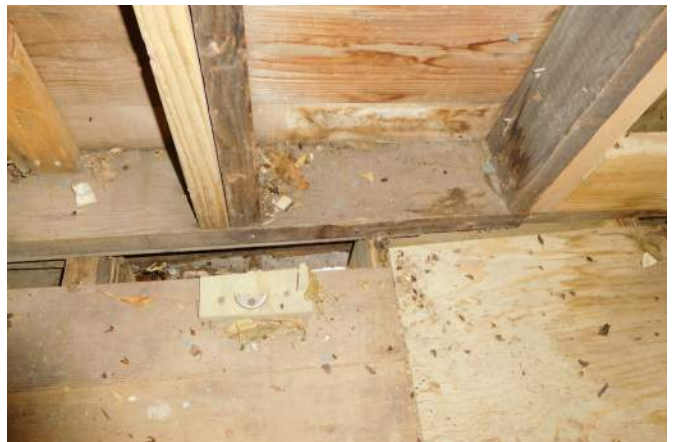
6.

| | | Priority I | Priority II |
|---|---|---|---|
| 6 | A gap in the floor is exposed at this location where the sill plate has moved outward, likely due to high winds causing the structure to shift. | | ● |

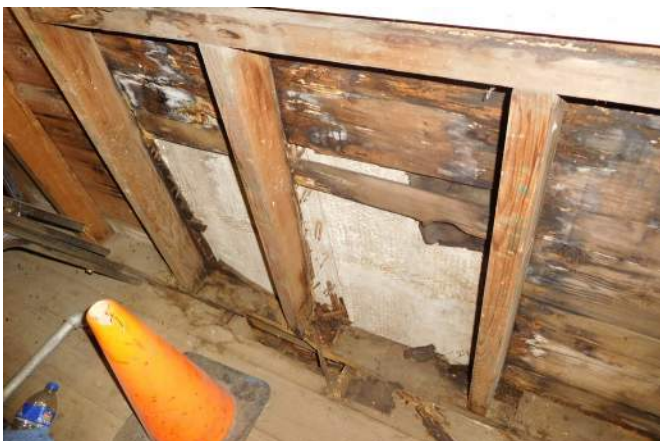
7.

| | | Priority I | Priority II |
|---|---|---|---|
| 7 | The exterior shiplap sheathing is rotting below the windows due to the infiltration of water through the simulated windows. All windows should be replaced and stucco removed to repair existing sheathing. | | ● |

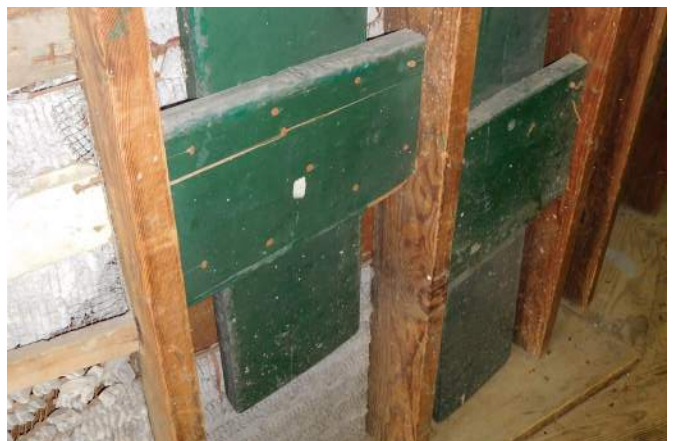
8.

| | | Priority I | Priority II |
|---|---|---|---|
| 8 | Blocking was observed at multiple locations on the curved wall of the band shell. It is believed that vandals kicked holes in the wall and this blocking was installed as backer for the patching of the holes. | | ● |

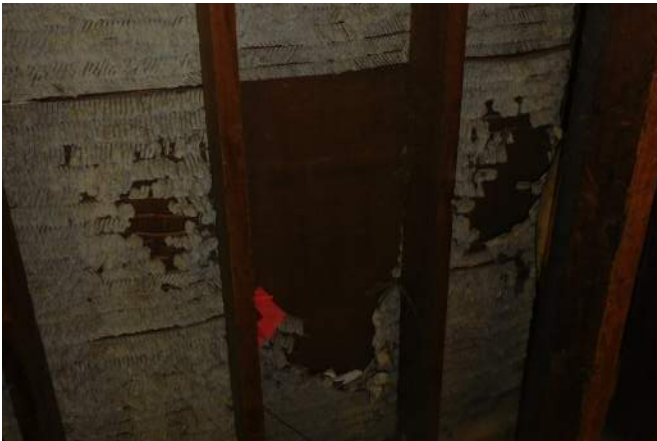
9.

| | | Priority I | Priority II |
|---|---|---|---|
| 9 | Patched plaster location. | | ● |

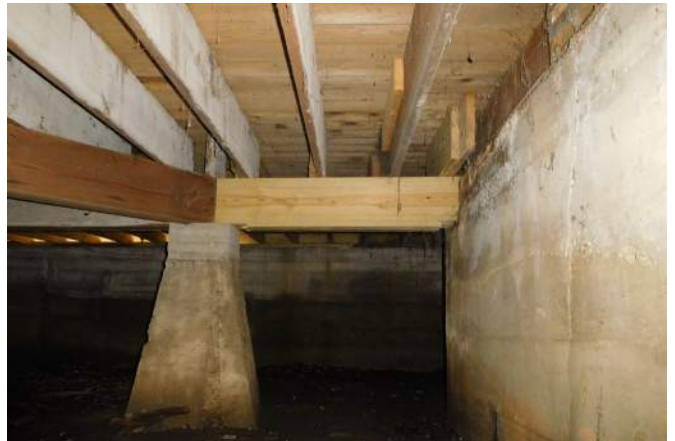
10.

| | | Priority I | Priority II |
|---|---|---|---|
| 10 | Some new beams and floor joists were observed in the crawl space. Overall, the existing foundations and wood structure are in good shape. Various joists may need attention. | | ● |

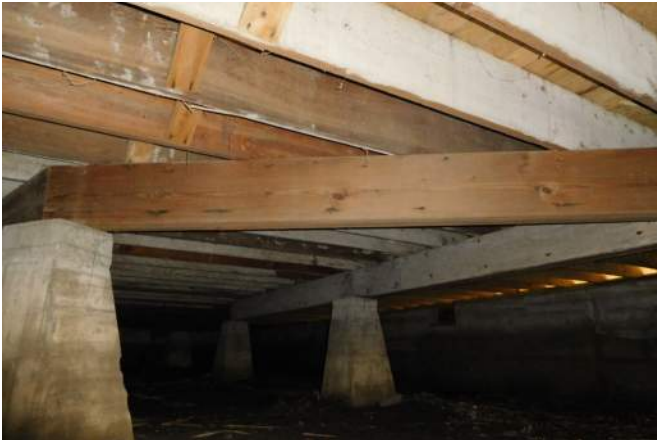
11.

| | | Priority I | Priority II |
|---|---|---|---|
| 11 | Some new beams and floor joists were observed in the crawl space. Overall, the existing foundations and wood structure are in good shape. Various joists may need attention. | | ● |

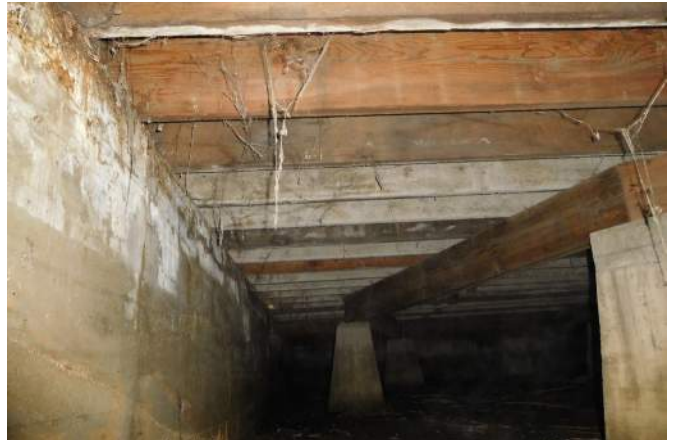
12.

| | | Priority I | Priority II |
|---|---|---|---|
| 12 | Some new beams and floor joists were observed in the crawl space. Overall, the existing foundations and wood structure are in good shape. Various joists may need attention. | | ● |

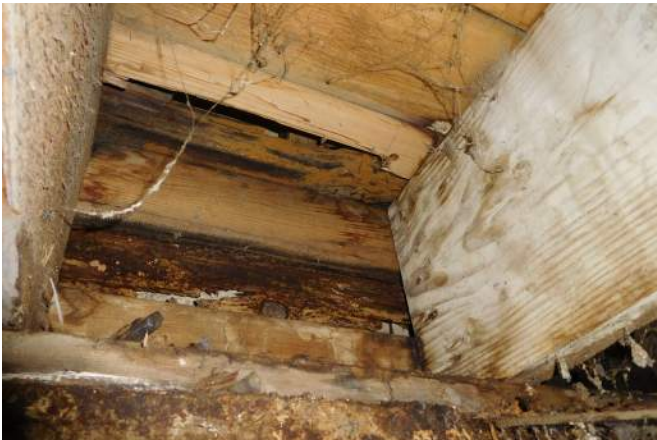
13.

| | | Priority I | Priority II |
|---|---|---|---|
| 13 | The rim joists were found to have some water damage and/or rotting. It is assumed that these locations mostly occur below the window openings above. | | ● |

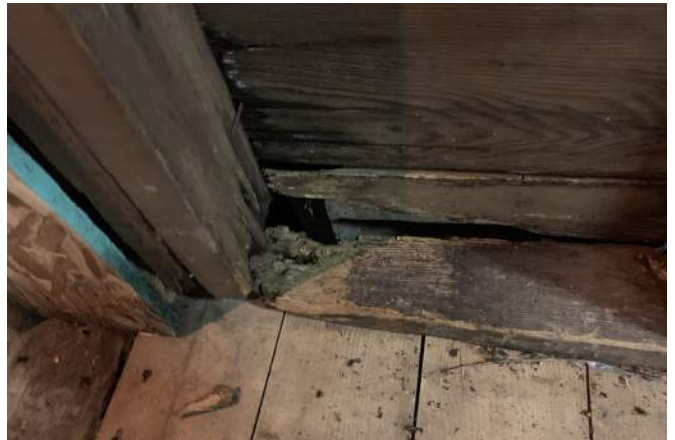
14.

| | | Priority I | Priority II |
|---|---|---|---|
| 14 | The sill plate is rotting in areas where water has gotten through the exterior plaster or entered through one of the window openings. | ● | |

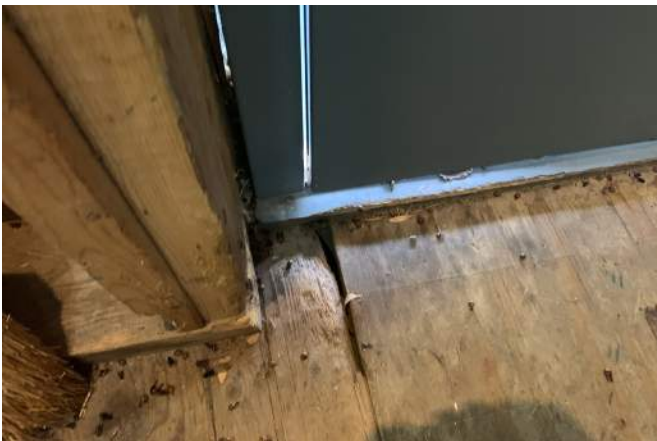
15.

| | | Priority I | Priority II |
|---|---|---|---|
| 15 | The door jamb is showing signs of water damage likely caused by sealant failure somewhere around the adjacent door frame. | ● | |

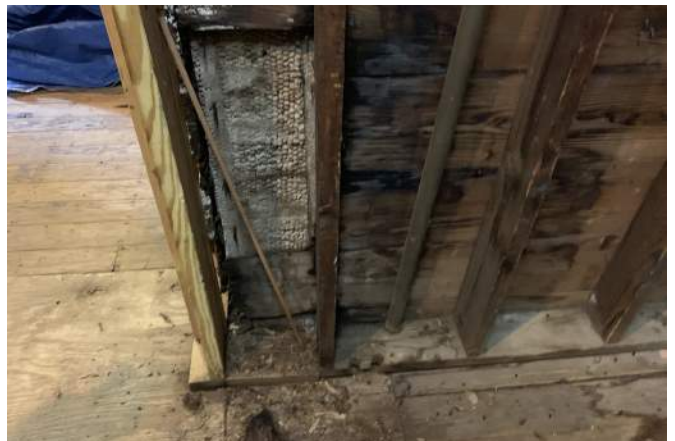
16.

| 16 | The exterior shiplap sheathing is rotting at the inside corners of the building. The exterior inside corners of the building have been exposed to large amounts of water discharge from the roof, causing infiltration of water through cracks in the stucco. New gutters and downspouts are recommended at all roof eaves. | ● | |

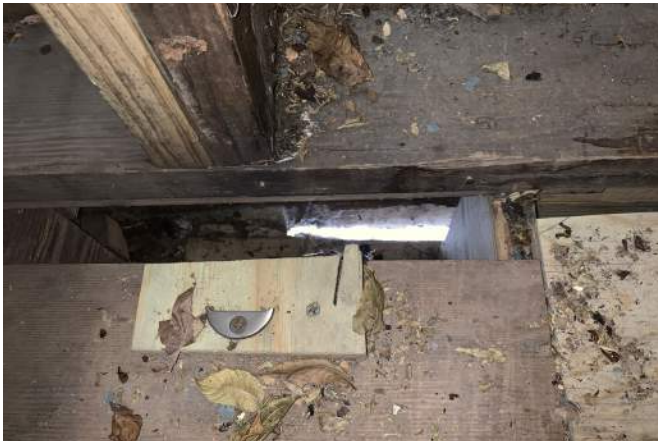
17.

| 17 | A gap in the floor is exposed at this location. | | ● |

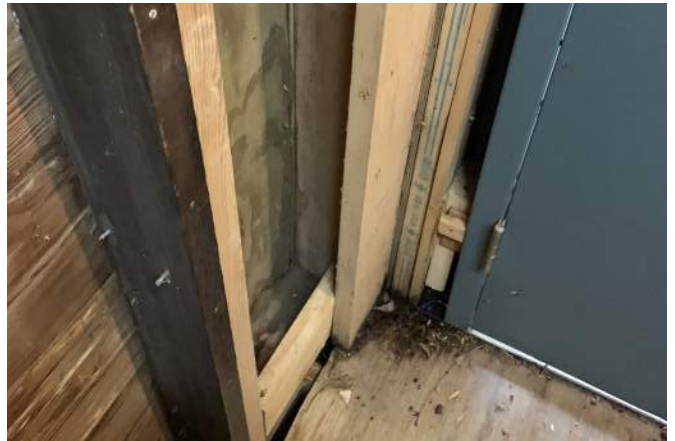
18.

| 18 | Additional blocking was added near the door frame to the stage where the north wall has shifted out. It appears that this was a stabilization in place effort and not a complete restoration repair. | | ● |

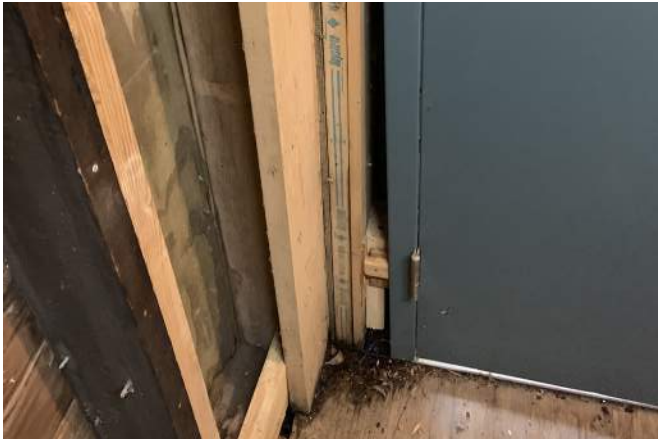
19.

| 19 | Additional blocking was added near the door frame to the stage where the north wall has shifted out. It appears that this was a stabilization in place effort and not a complete restoration repair. | | ● |

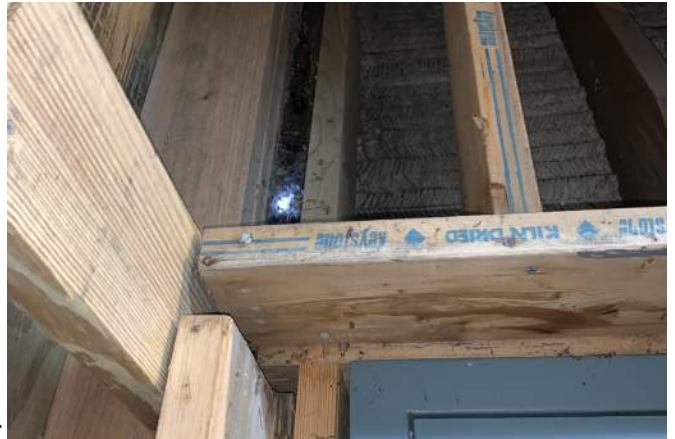
20.

| 20 | Additional blocking was added near the door frame to the stage where the north wall has shifted out. It appears that this was a stabilization in place effort and not a complete restoration repair. | | ● |

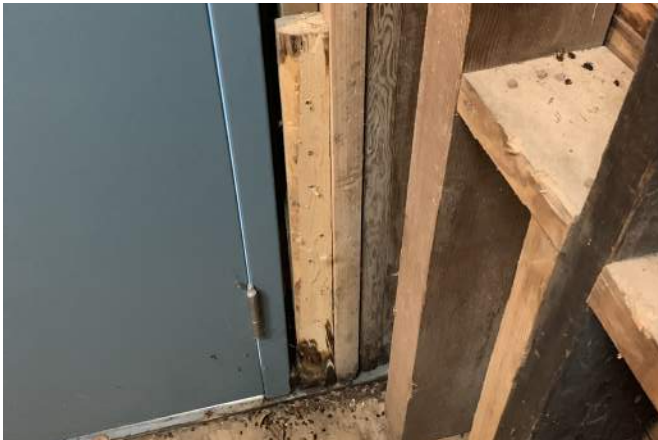
21.

| 21 | Additional blocking was added near the door frame to the stage where the north wall has shifted out. It appears that this was a stabilization in place effort and not a complete restoration repair. | | ● |
