# CAHOON MANSION

## ENVELOPE STABILIZATION ASSESSMENT

Entelen Design-Build, LLC. + FFKR Architects

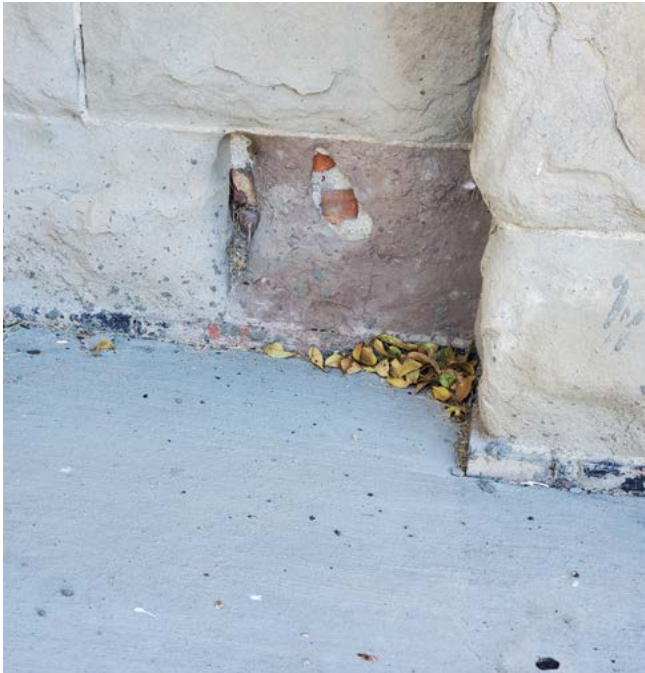
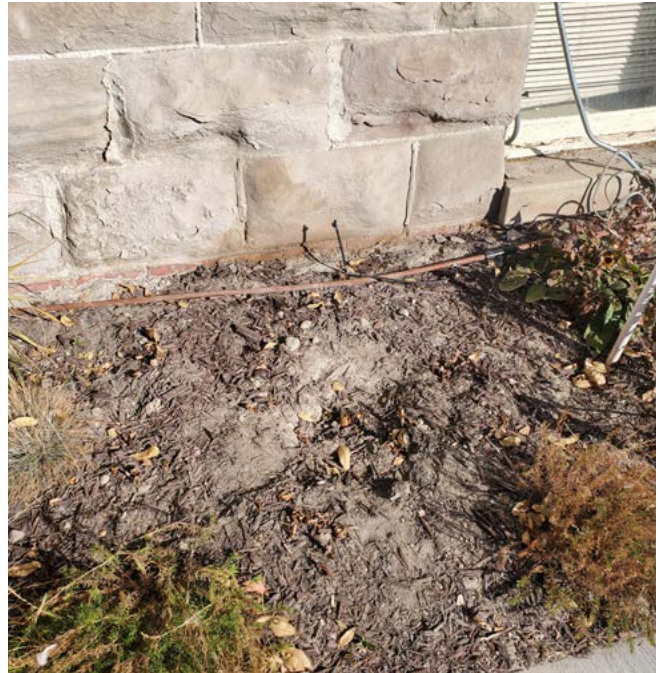
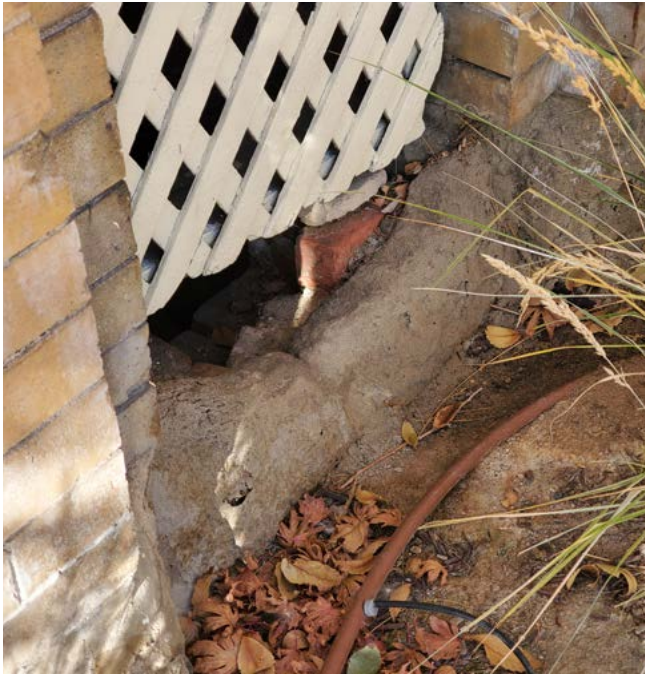
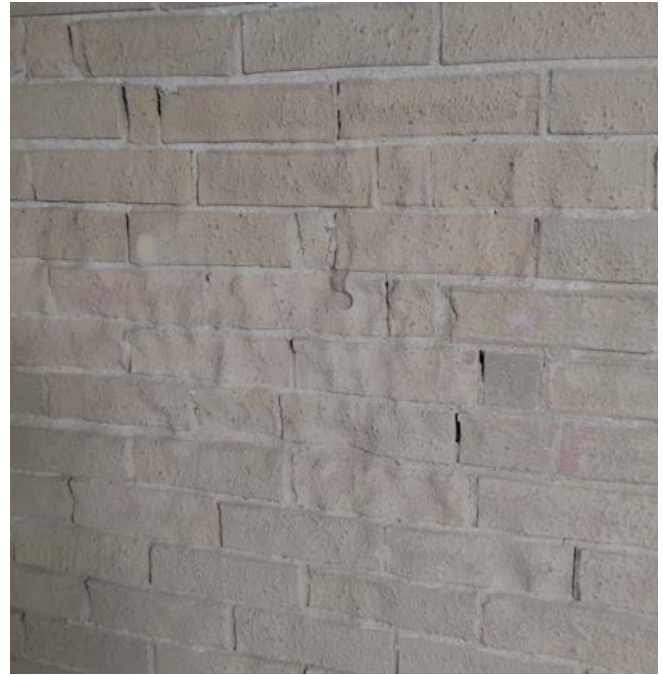
The exterior of the Cahoon Mansion is predominantly comprised of multi-wythe brick masonry walls on a sandstone foundation base extending to the level of the first-floor line. Prior to our field survey, it was expected that the visible sandstone foundations was constructed using full depth sandstone blocks but further investigation of the building has revealed that the visible sandstone is actually a thin veneer applied over a standard brick foundation. The brick masonry of the building is comprised of two types of fired clay bricks: a high-density reddish orange brick used at the foundation as the structural substrate for the sandstone stone veneer as is visible in the interior basement walls as well as a very smooth, light yellow brick comprising the main body of the building beginning at the main floor line and extending to the roof and chimneys.

The reddish-orange brick foundation will be addressed in two components – the portion exposed to view on the outside of the building and the brick exposed to view on the inside of the basement of the building. The exterior foundation bricks are not consistent in their condition due to varying degrees of exposure and weathering. The bricks covered by the sandstone veneer are expected to be in good condition, as there are no significant indicators of degradation. Note that our analysis is based upon visible observable conditions; no destructive examination, such as removal of sandstone surface materials, has taken

place. We would not recommend such testing at this time. However, there are two locations where the exterior sandstone veneer has deteriorated to the point where the brick foundation has become visible – one on the west of the building by the ADA ramp and one on the south side of the east porch. Both locations exhibit foundation bricks which are significantly weathered and are in poor condition. The foundation is also visible as a row of bricks at grade below the sandstone veneer. This course of bricks is in good condition, but the effects of the adjacent landscaping, irrigation and poor drainage discussed in Section 6 - Landscaping of this report are taking a toll and will contribute to further degradation if the conditions are not corrected.

The brick foundation visible from inside the basement of the building is in much poorer overall condition than the bricks visible at the exterior grade. The interior bricks which are exposed to view in most of the perimeter rooms of the basement have been sandblasted at some point in the history of the building. The sandblasting has removed the hard, outer layer of the fired clay and exposed the much softer interior of the brick. The soft interior has been subject to serious degradation in many locations and is in danger of further erosion.

The interior walls of the basement also exhibit significant calcification and efflorescence due to water leakage through the foundation wall (see Section 6 - Landscaping). The original plaster wall finish covering the brick in the southeast corner room has begun to fail and delaminate from the brick due to water infiltration. There is also significant efflorescence and calcification on the interior wall inside the kitchenette. This is likely a result of an internal plumbing leak and not likely to be caused by exterior weather infiltration as it is not an exterior wall and there is little evidence of weather damage on the corresponding walls on the floors above.

The only area in the basement which has not been sandblasted is in the coal bin and boiler room. The brick is in good condition in this area except immediately beneath the eastern most coal chute door – which has had a failure in the brick mortar, likely due to water infiltration through the chute door, resulting in the deterioration of the structural integrity of the wall resulting in the loss of a number of bricks. The wall in this location is significantly weakened and appears to only be a double wythe thick. The remaining brick walls should be cleaned with a gentle detergent power wash.

Implement the remediation recommendations identified in the Landscaping section of this report and clean the exposed exterior bricks and evaluate the need for repointing at grade. Repoint missing mortar at grade with a lime-based mortar.

Clean the exposed brick both inside and outside the building. Care should be taken on the interior brick to prevent further degradation of the bricks. Replace the heavily deteriorated bricks at the porch foundation and below the coal chute door.

Excavate around the perimeter of the foundation wall and evaluate the condition of the below-grade bricks and implement necessary remediation steps to stabilize the foundation – potential steps could include replacement of severely deteriorated bricks, repointing with lime-based mortar and installation of a drainage and protection board on the outside of the exposed foundation walls.

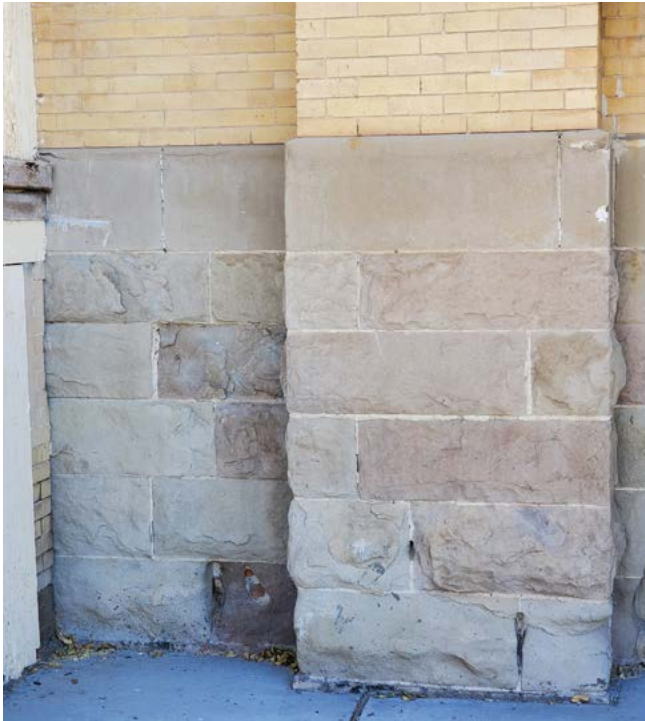
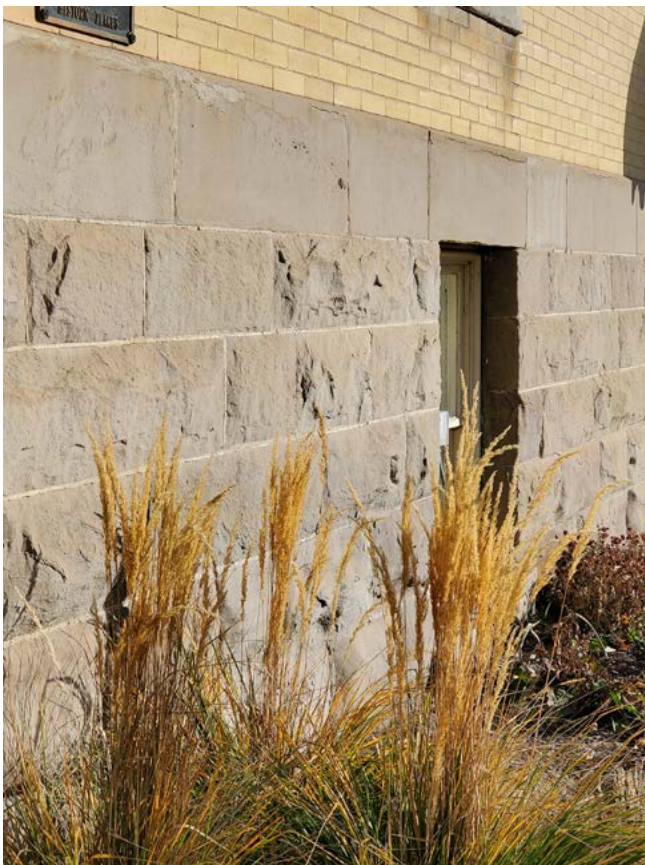
The exterior sandstone veneer condition varies, ranging from good to fair to poor depending on location. The effects of weathering and past repair efforts have contributed to severe weathering and deterioration of many of the stone blocks. The most significant deterioration has occurred at the base of the building and at the below grade entrances. These areas are severely deteriorated to the point that the sandstone facing is nearly or completely missing.

The most likely contributor to this deterioration is the landscaping and irrigation system. The section on Landscaping will address steps necessary to reduce further deterioration. The bulk of the stone veneer is in good condition with areas of spalling, bedding plane delamination and missing mortar. Past efforts to repoint the missing mortar with Portland cement are evident and have resulted in accelerated deterioration of the stone immediately adjacent to the repointed areas due to the nature of the Portland cement being much harder and more durable than the stone.

Remove the Portland cement repointing and replace with lime-based mortar. Clean the stone with a mild detergent. Re-tool the spalling areas to help reduce further deterioration.

Apply a penetrating chemical consolidant to help reduce the rate of deterioration. Re-profile the decorative watertable and stone lintels to control the drainage of surface water onto the stone veneer foundation. Install dutchman replacements for severely deteriorated areas of the stone

Replace the severely deteriorated stones with new stone replacements.

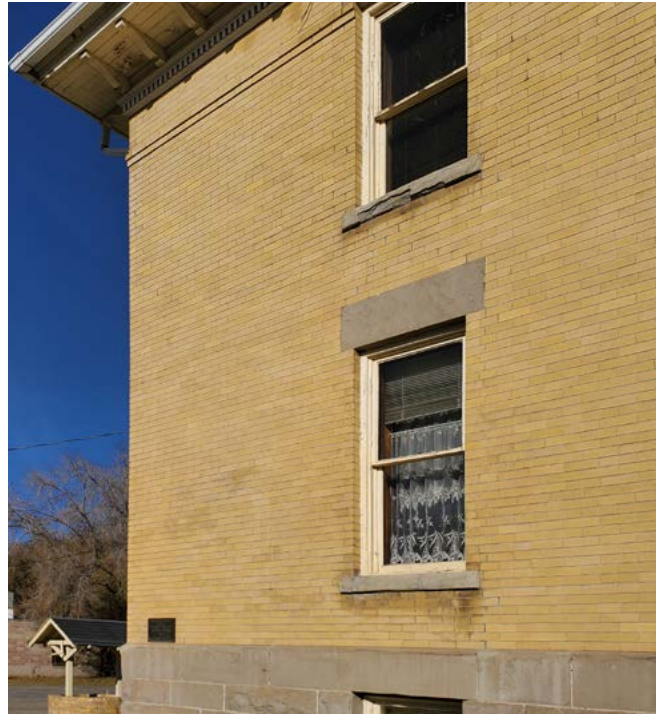
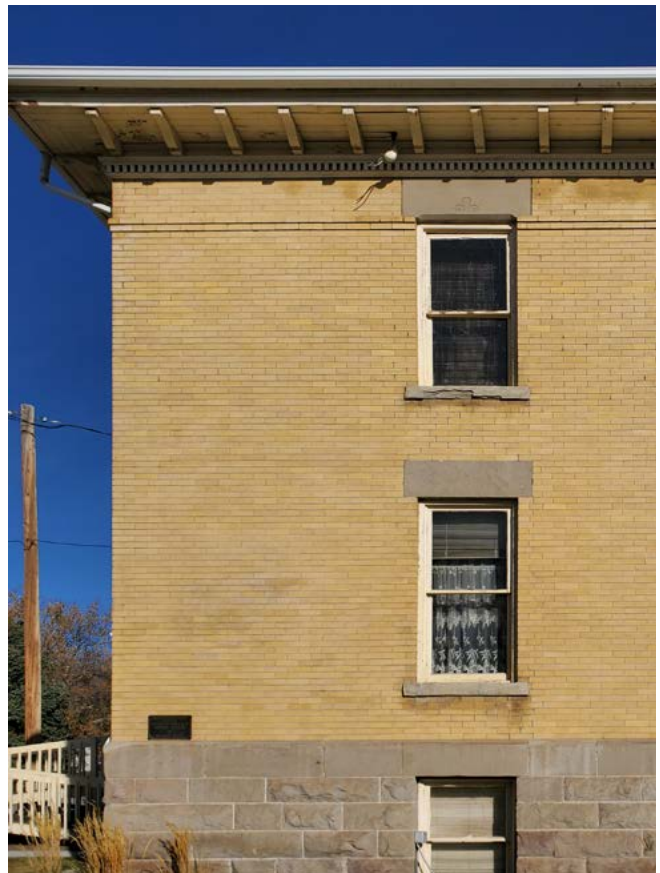
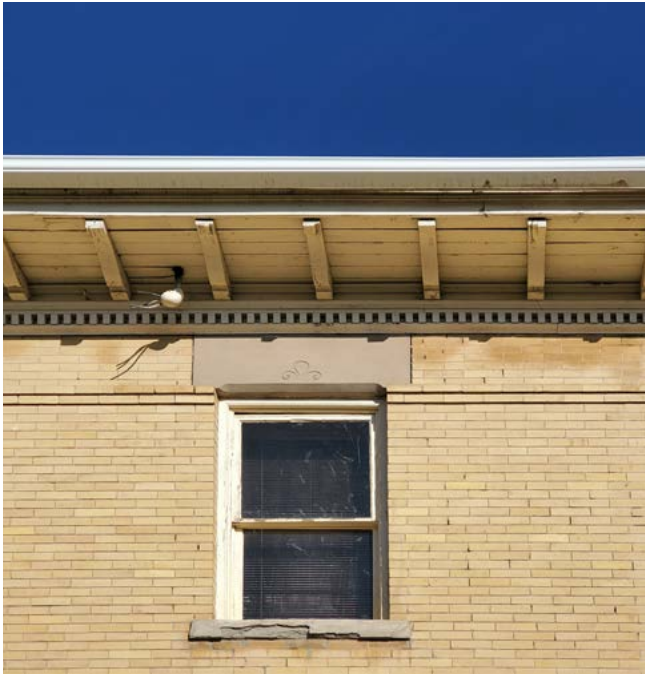
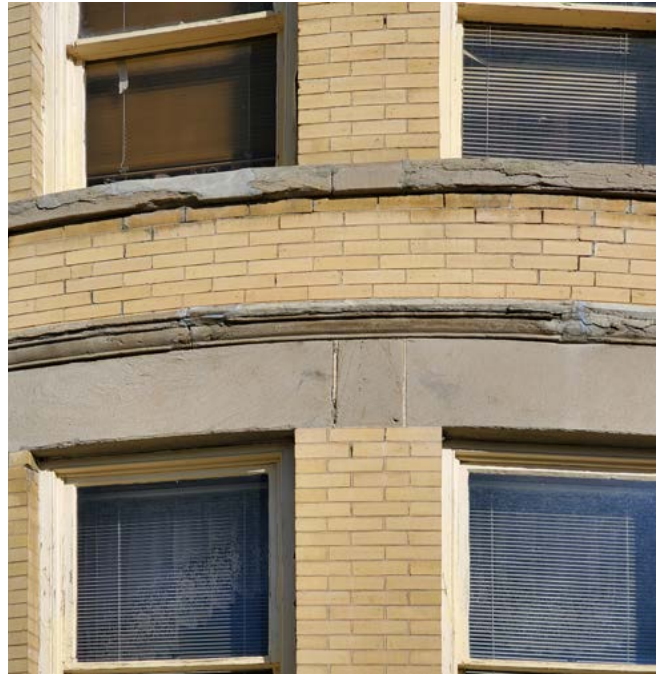
Each of the windows has a sandstone stone lintel and sill matching the stone veneer foundation. The lintels are of a simple, flat rectangular with a stylized Fleur-de-les carved in the lower center of the face. Some of the lintels at the upper windows have a carved, eased edge at the lowest outside edge. The sills are a rectangular block design with a shaped top to slope away from the window jambs and provide positive drainage off the sill. Neither the lintels over the windows nor the sills were constructed with a drip edge, cut into the underside of the sandstone element. While the lack of a drip channel does not seem to have an affect at the lintels themselves, it may be contributing to the deterioration of the wood window frames, sashes and brickmolds. Beginning at the main floor, the window lintels show signs of mild deterioration but are in good condition. The carved Fleur-de-lis are crisp and sharply defined. There is missing mortar at many of the head joints, but these do not appear to have been repointed with Portland cement. The sills are severely deteriorated and have been completely parged (coated) with Portland cement. The craftsmanship of the parging is quite poor and the sills are now irregular pieces of concrete.

Moving to the second floor, the lintels are in very good condition. It appears that the roof overhang has provided adequate protection from the elements and the sandstone exhibits little deterioration and the carved Fleur-de-lis are crisp and sharply defined. Just as the lower windows, there are many head joints which need to be repointed, but the overall condition on this level is remarkably good. The

windowsills on this level are also severely deteriorated, but probably due to the inaccessible location, the sills have not received a parge coat of Portland cement. The deterioration is quite prominent and large sections of the sills are either missing or badly spalling with significant bedding plane delamination. Deterioration, such as surface spalling and flaking of the stone, on the south facing stone elements seems to be significantly worse than other exposures, where such deterioration exists.

Clean the stone lintels and sills with a mild detergent. Repoint missing head joint mortar with lime-based mortar.

Remove the Portland cement parge and re-tool sills with enough material remaining to remove the loose and spalling sections. Apply a penetrating chemical consolidant. Note – Due to the degree of deterioration of the window sills, it is unlikely that these steps will accomplish much in the way of remediation or slowing the rate of deterioration and it is recommended from a cost/benefit basis that the city implement the steps in the Best category.

Replace all window sills with new stone carved to match the original.

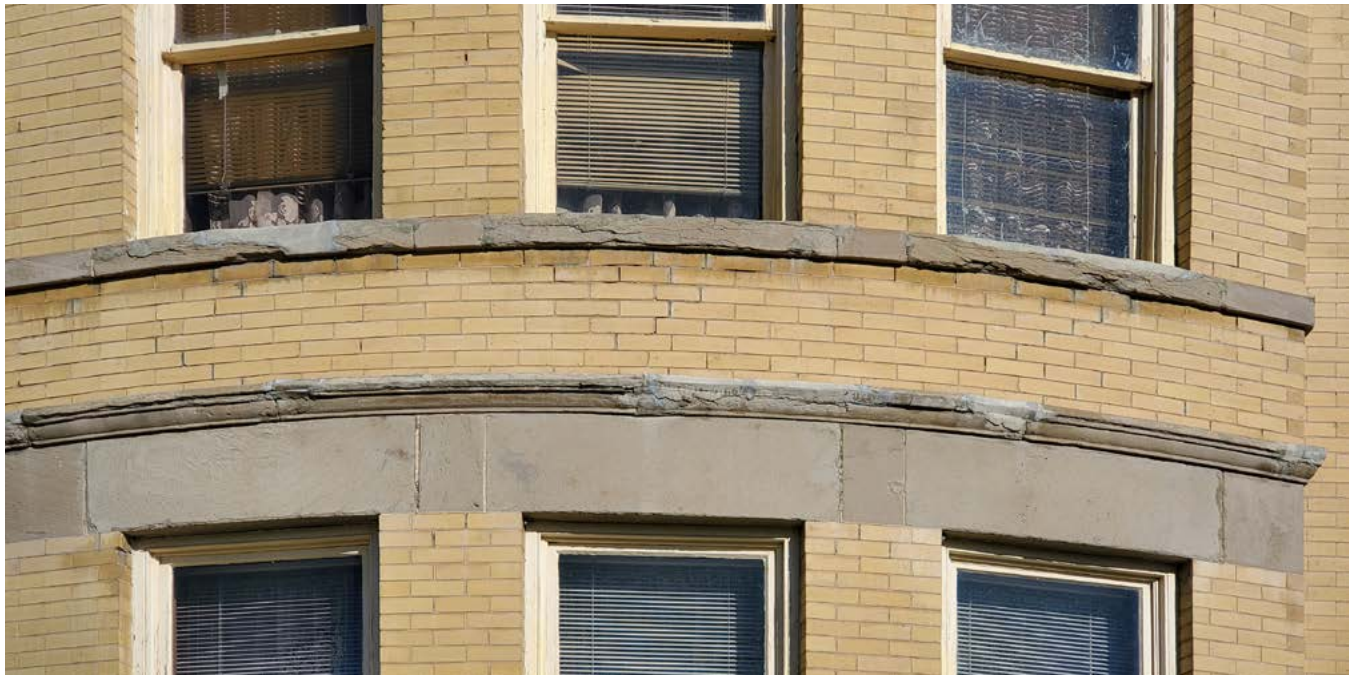
Above the main floor window lintels of the bay window on the south elevation and the east elevation is a decorative sandstone trim. The trim profile is a typical ovolo with an additional step at the upper surface. The trim, like the stone sills, is very weathered and significantly degraded. The ovolo profile is severely deteriorated on the south elevation and has been parged with Portland cement. The parge is poorly executed and the profile has been completely obscured.

Clean the stone trim with a mild detergent. Repoint missing head joint mortar with lime-based mortar.

Remove the Portland cement parge and re-tool trim pieces with enough material remaining to remove the loose and spalling sections. Apply a penetrating chemical consolidant. Note – Due to the degree of deterioration of the trim, it is unlikely that these steps will accomplish much in the way of remediation or slowing the rate of deterioration and it is recommended from a cost/benefit basis that the city implement the steps in the Best category.

Replace all decorative stone trim with new stone carved to match the original.

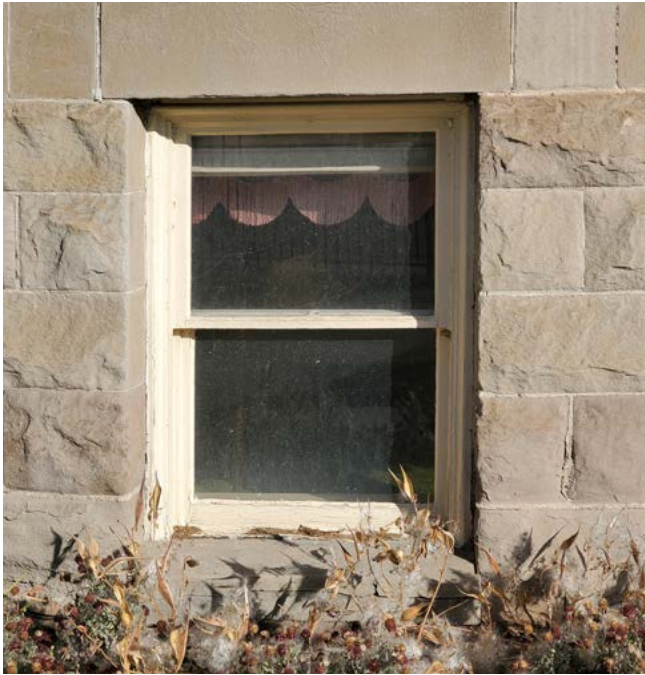
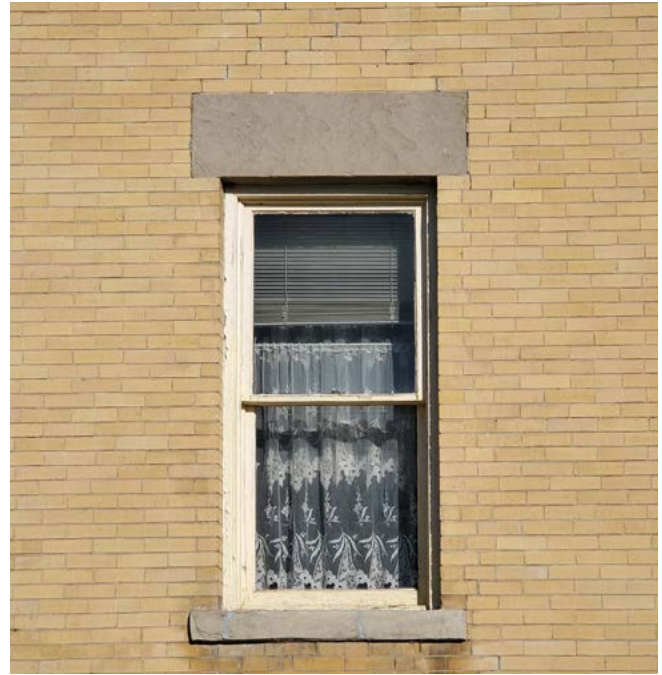
Most of the exterior windows are a simple, vertically oriented, rectangular double hung wood window with one over one single pane lites. The wood brickmold, frames and sashes are in generally fair condition. Multiple coats of paint have been applied to all elements of the brickmold, frames and sashes with little care to maintain the function of the operating ropes and weight mechanism, and most of the windows have effectively been “painted shut”. The ropes and weights are intact in many cases and one can hear the weight move inside the sash when the rope is pulled, while a few windows have had their ropes cut. Still it appears the pulley is functional and it is further assumed that the weight has freely fallen to the bottom of the pocket. The windows appear to be weathertight and little evidence is present of the infiltration of water. The single pane glazing will continue to provide poor thermal performance. Historic photos of the building show what appears to be a window screen applied to the exterior side of the lower operable sash.

Clean the windows with a mild detergent. Remove loose and flaking paint, repaint brickmold, frames and sashes with a high-quality exterior primer and paint. Thermal performance of the window could be marginally improved by the addition of an exterior applied storm window.

Chemically strip the paint from the inside of the wood frames and sashes. Repair the operating ropes and weight mechanisms to return the functionality of the double-hung mechanism. Repaint the exterior brickmold, frame and sashes with a high-quality exterior primer and paint, stain the interior wood sash and frame. One of the thermal improvements in the “Best” section should be implemented.

Remove the window from the wall, restore the wood frames and replace the window sashes with high-performance insulated glazing units. Rebuild the weight pocket with a larger weight to rebalance the heavier sash. Paint the exterior brickmold, frames and sashes with a high-performance coating system, stain the interior wood sash and frame. Note - depending on the degree of restoration required, an entirely new wood window may be more practical. If so, care should be taken to ensure that the new windows are as near as possible identical replacements of the original. A composite or aluminum clad window will provide a real wood interior and a maintenance free exterior while preserving the historic aesthetic.

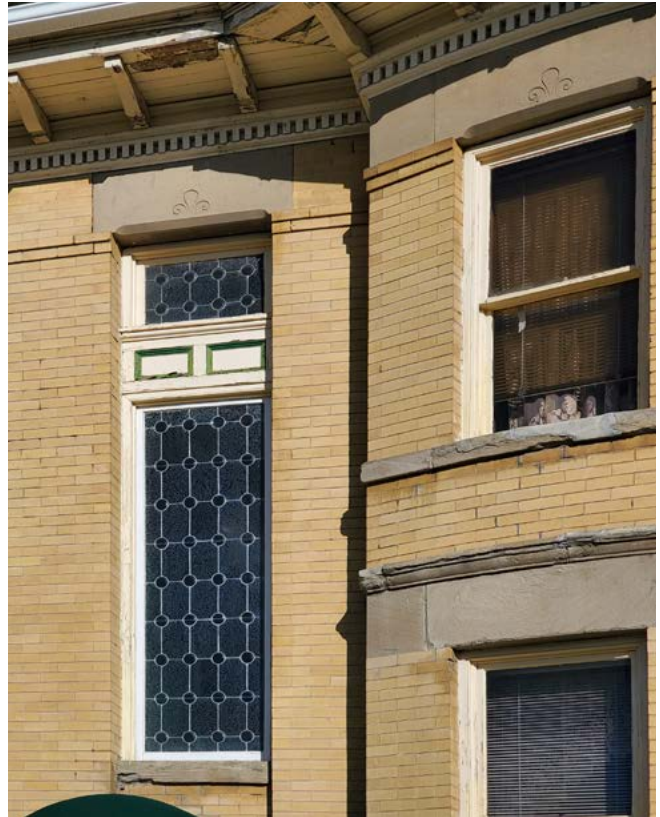
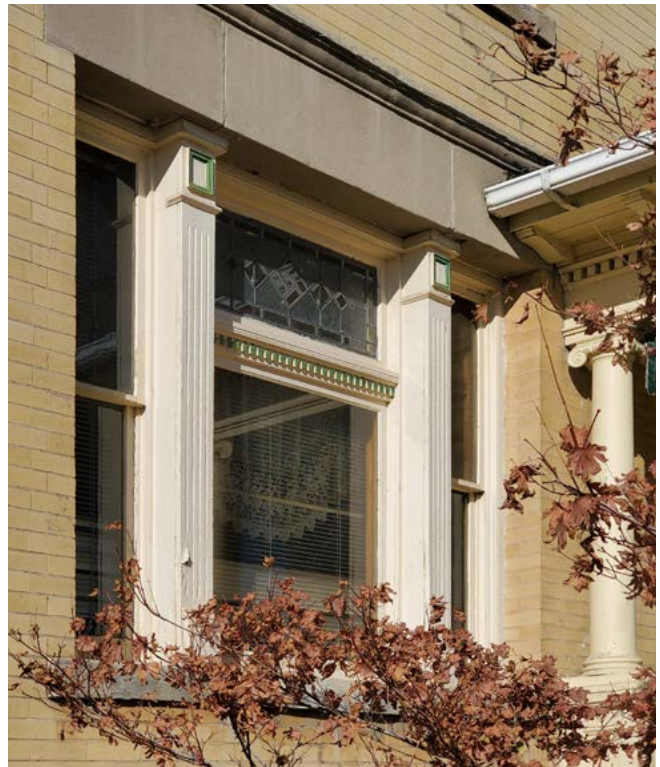
The large window in the south wall of the main stairwell and the transom window in the on the east elevation are leaded art glass. The window in the stairwell appears to be a replacement window as the art glass pattern of a textured rectangular grid interrupted with clear rounds at the intersections, and detailing is different than the Parlor window and the sash is painted a different color than the adjacent brickmold and other windows. The art glass is also reinforced with interior stiffener rods that are inconsistent with the period of the mansion. The glazing is in good condition. The brickmold and frame exhibit the same degree of paint weathering as the other windows on this elevation. The window is capped with a paneled transom and a smaller art glass window to match.

The Parlor window has a more detailed art glass pattern with an outer border of beveled glass tiles with a similar textured rectangular grid as the stairwell window but with beveled diamonds at the intersections. A round jewel is also present at the right and left of the diamonds. The glazing in this window is also in good condition and the frame has a consistent level of paint failure.

Clean the windows with a mild detergent. Remove loose and flaking paint, repaint brickmold, frames and sashes with a high-quality exterior primer and paint. Thermal improvements to the decorative windows are challenging as any additions to the exterior of the window will obscure the art glass pattern.

Chemically strip the paint from the inside of the wood frames and sashes. Repaint the exterior brickmold, frame and sashes with a high-quality exterior primer and paint, stain the interior wood sash and frame.

Remove the window from the wall, restore the wood frames and replace the window sashes and add a high-performance insulated glazing unit with the art glass as the exterior pane. Paint the exterior brickmold, frames and sashes with a high-performance coating system, stain the interior wood sash and frame. Note – If new windows are installed, they should be capable of accepting an insulated glazing unit with the art glass as the exterior pane to maintain a consistent look to all the windows.

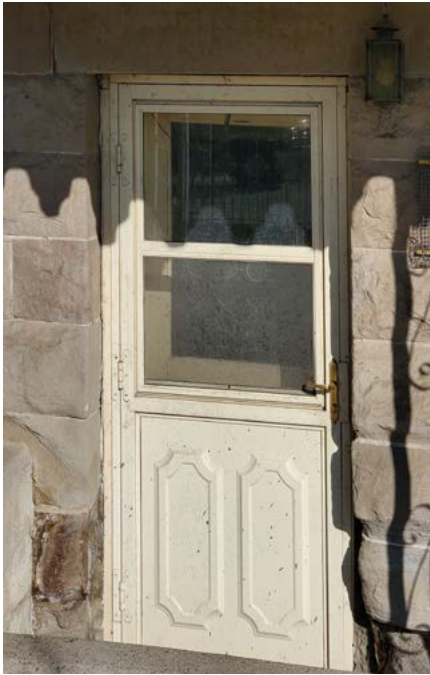
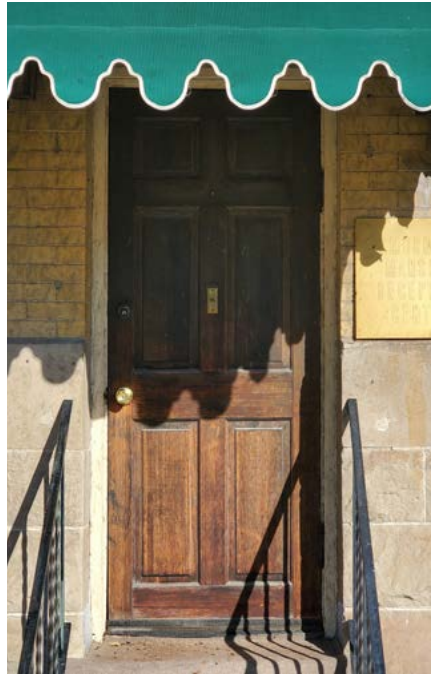
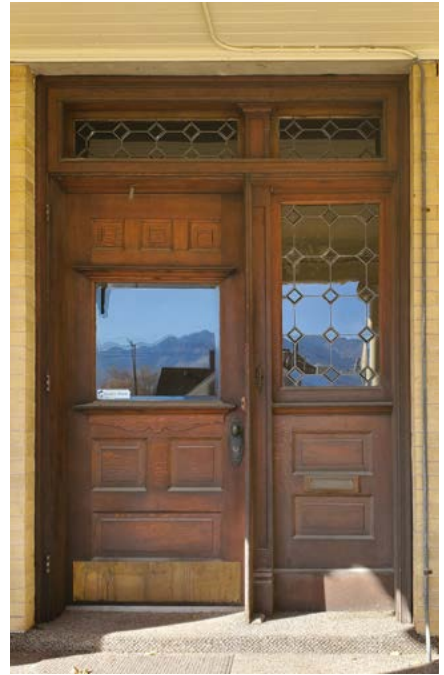
The mansion has 5 doors to allow access to the interior: 2 in the basement and 3 on the main floor. Only one door – at the northwest corner of the main floor could be considered accessible – and this is only via a wooden ramp system that does not appear to be fully ADA compliant. This ramp will be addressed in greater detail in Section 5 - Porches.

The basement is accessed by wood doors on the west and southeast. These are recessed below grade and have a concrete porch / stair. Neither of the stairwells appears to have provisions for drainage as both landings are full of debris. The doors are both in poor condition due to weather intrusion.

The main floor is accessed through a door at the ramp on the northwest corner, a door on the south elevation into the stairwell and the main door on the east porch. The northwest door is protected by a small porch and is in fair condition. The south door is in fair condition and has suffered greatly from weathering and exposure. The door on the main porch is a large paneled door with a large art glass sidelight and matching transom – curiously, the detailing of the art glass in this door is similar to but does not match the art glass in either of the decorative windows discussed above. The door is in reasonably good condition and appears to be weathertight.

The doors are accessed by concrete steps on the west, south and east elevations. It is suspected that the original stone steps had weathered to the point that they needed replacement and they were replaced with formed concrete. The door for the basement coal chute on the north elevation has deteriorated to the point that it is crumbling and should be replaced.

Clean the main entry door with a mild detergent. The northwest door should be treated by removing loose and flaking paint, repaint brickmold, frame and leaf with a high-quality exterior primer and paint. The other doors should be replaced with new doors. Replace the coal chute door with a new reproduction.

Main entry door - Prepare the wood for re-staining by thorough sanding. Re-stain the door. Northwest door - chemically strip the paint from the wood brickmold, frame and leaf. Repaint the brickmold, frame and leaf with a high-quality exterior primer and paint.

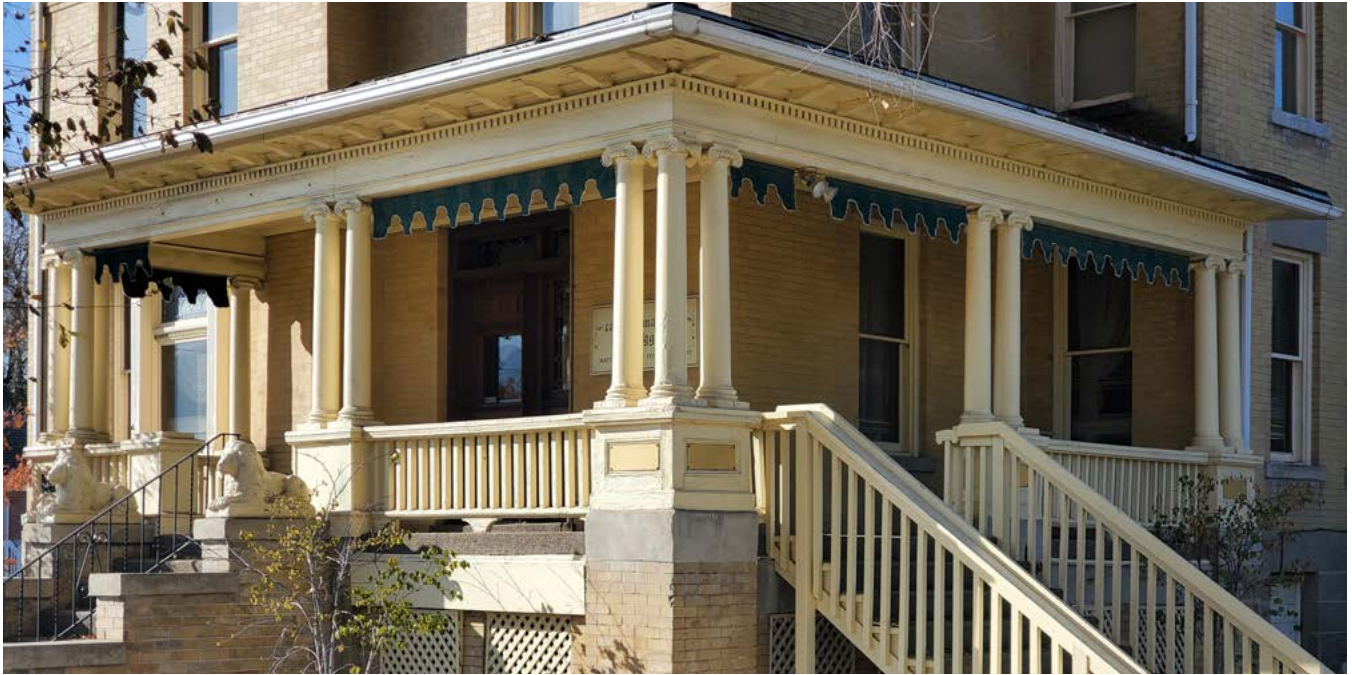
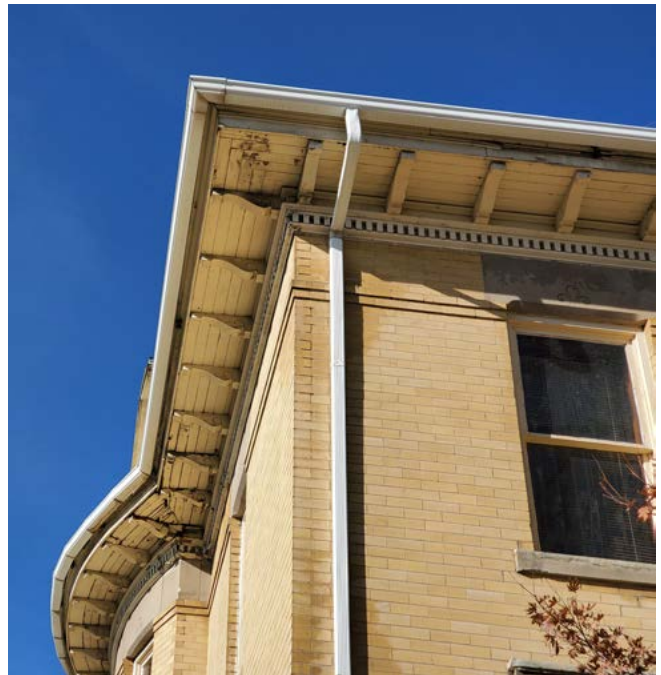
The roof line of the building is marked by a painted wood dentiled frieze and bracketed soffit and fascia. The wood of the frieze, soffit, fascia and decorative dentils and brackets appear to be in mostly fair condition, except for a few areas directly aligned with the leaking gutters and downspouts, this is particularly problematic in the NE and NW corners of the building. The wood window sills and jambs in the all the dormers are severely deteriorated and should be replaced. The paint is peeling off the wood in most areas around the entire building.

Clean the wood elements with a mild detergent. Scrape the loose and flaking paint. Repair or replace any damaged soffit, brackets or dentils. Repaint the wood with a high-quality exterior primer and paint.

Chemically strip the paint from the wood elements. Repair or replace any damaged soffit, brackets or dentils. Repaint the wood with a high-quality exterior primer and paint.

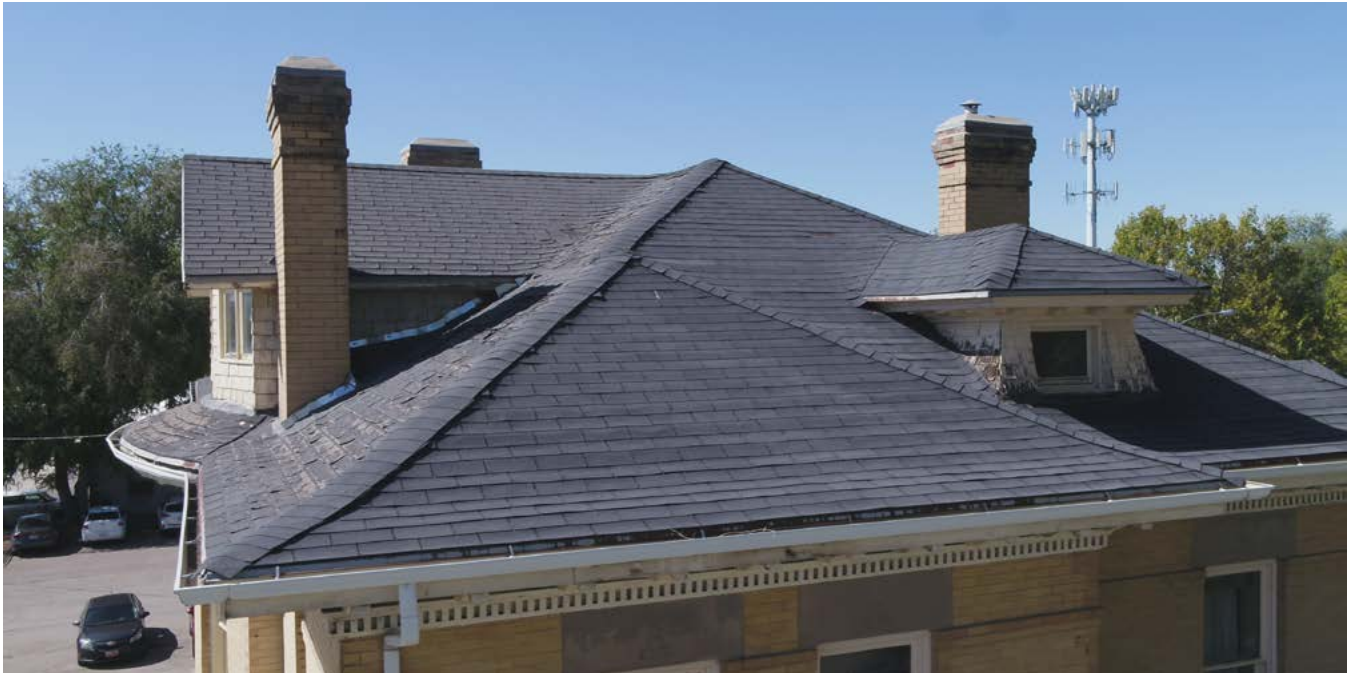
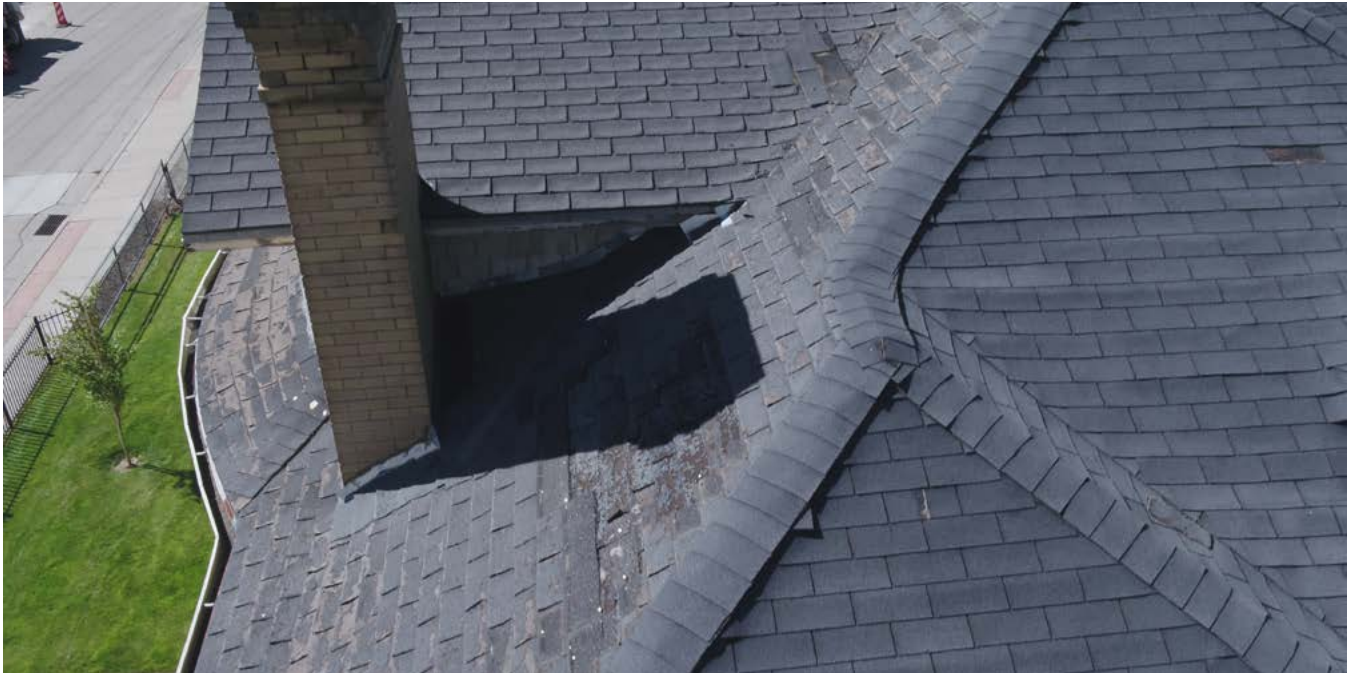
The original integral gutters have been abandoned and the roof sheathing appears to have been extended to the eave. The extension of the roof sheathing creates a "flattening" of the roof slope at the eave.

Re-roof the building with slate for a 75-100 year roof. If this option is selected, it is recommended that a structural evaluation be conducted to determine if the roof framing can support the additional weight of a slate roof. Note: If the historic appearance of a slate roof is deemed important but the cost is prohibitive, there are a number of synthetic slate products which may be investigated for use.

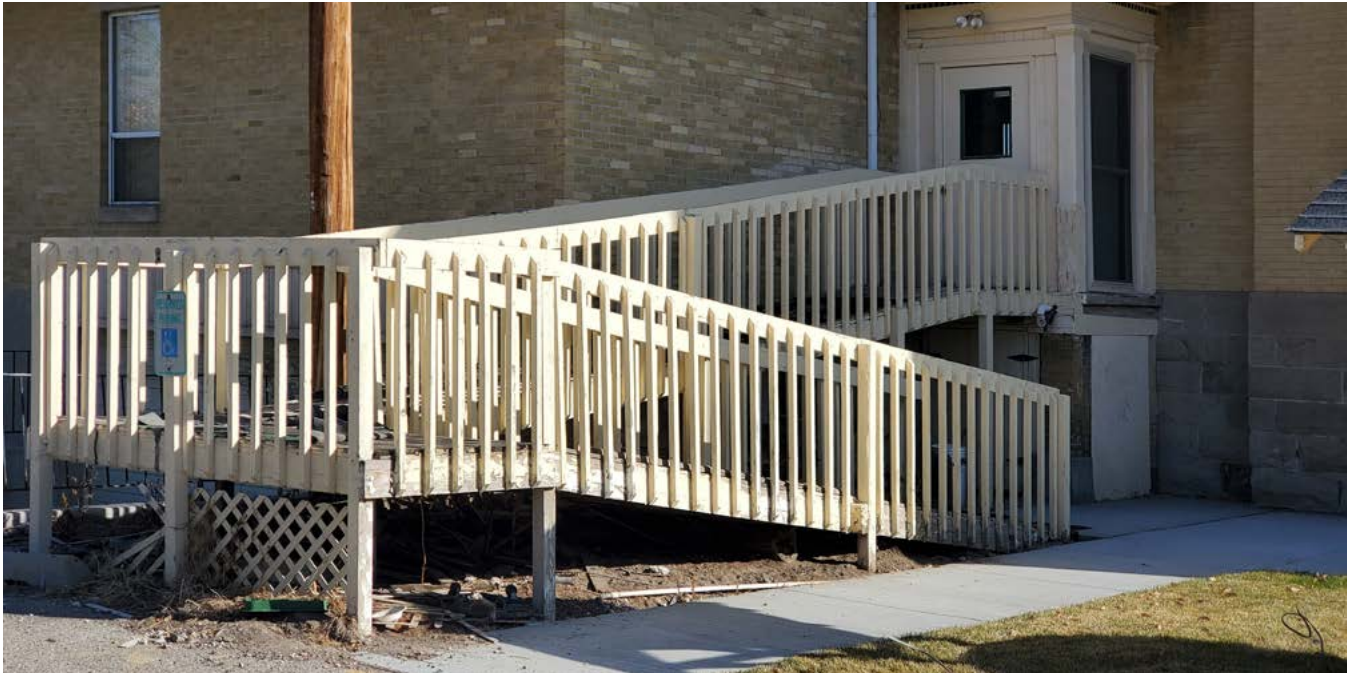
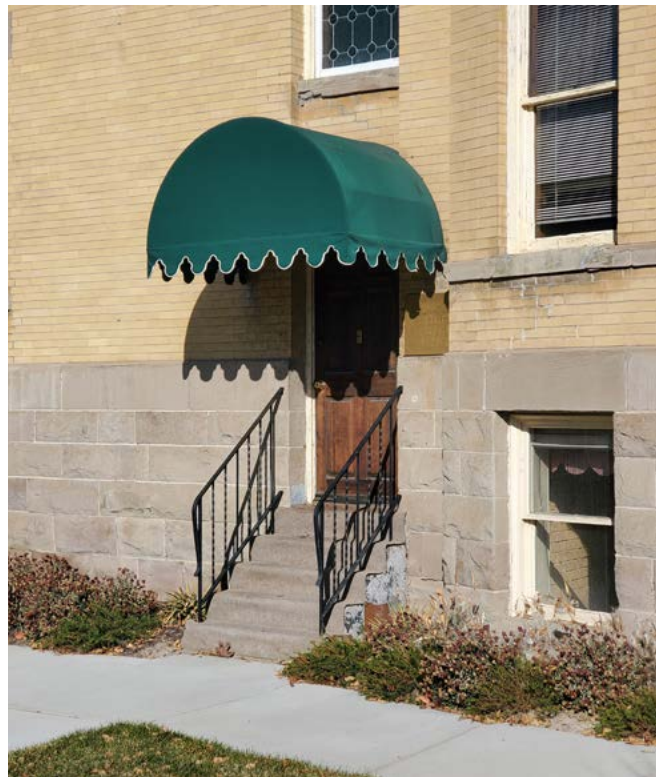
The entrance door on the south elevation is accessed via a small concrete porch with a metal guardrail. The porch is covered with the same outdoor carpeting as on the main entry porch. The historic photos of the Mansion do not depict an historic porch at the location of the current concrete porch. The view of the south elevations is oblique in both photos, which makes it impossible to determine if the existing door was an original door or an extension of the windows above.

Remove and replace the porch and railing with a scaled down design similar to, but distinguishable from the original main entry porch.

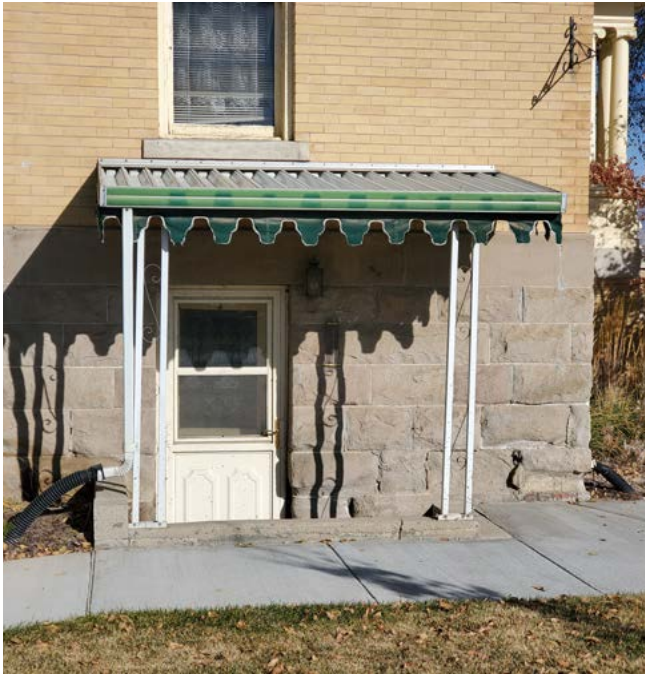
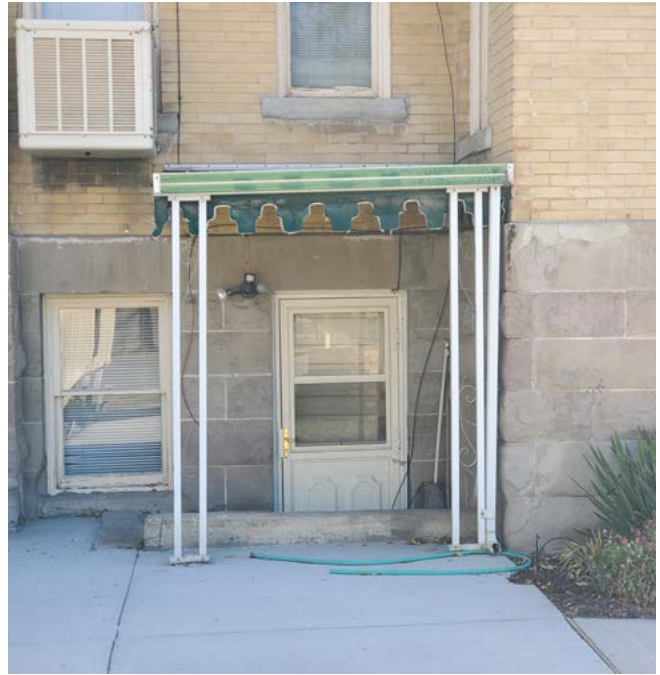
The entrances to the basement on the south and west elevations have a non-historic decorative metal canopy system. These canopy systems were likely originally installed in the 1960's-1970's and have possibly been replaced at least once. The historic photos of the Mansion do not indicate that the canopies are replacements for lost historic components, but a contemporary addition to the building. The canopies are providing important weather protection of the basement entrances, but detract from the historic aesthetic of the associated facades. The decorative metal supports and light gauge roofing are in fair condition. The canopies have a dark green and white canvas scalloped festoon along the perimeter edge. The canopy on the south entrance is a barrel shaped metal framework covered with a green canvas matching the festoon on the basement entrance canopies.

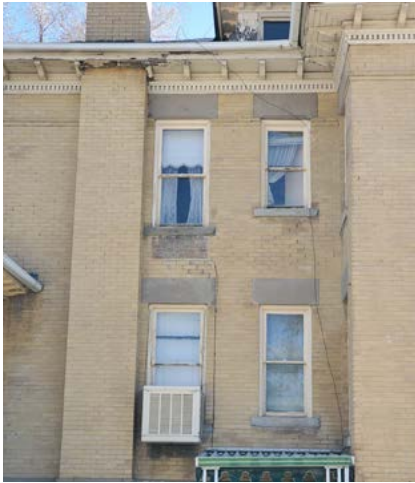
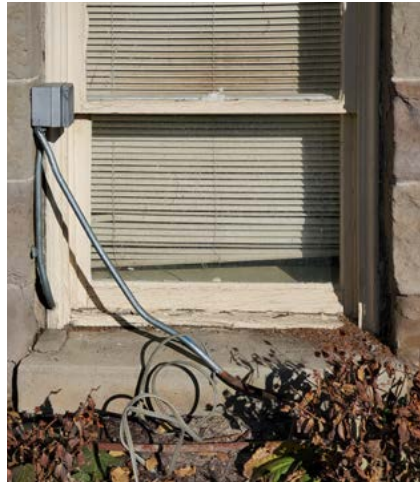
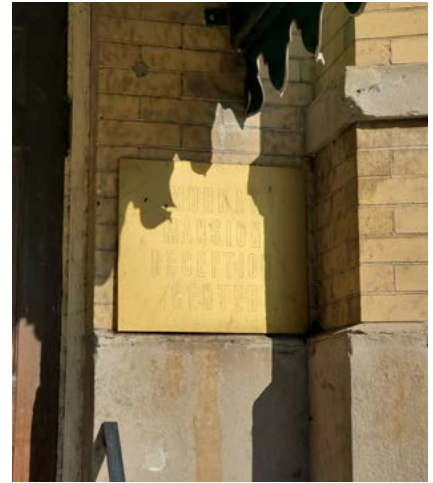
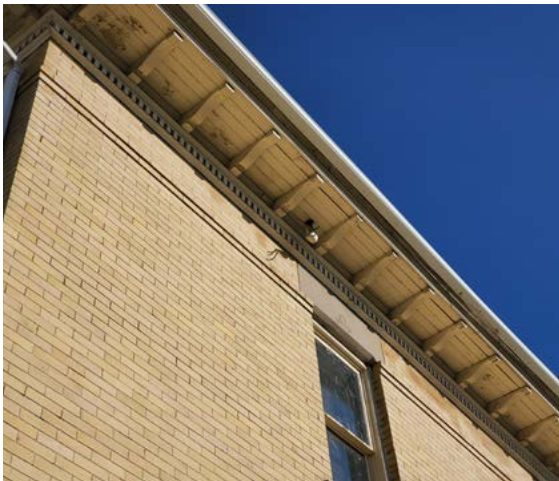
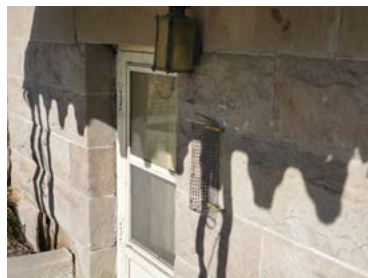
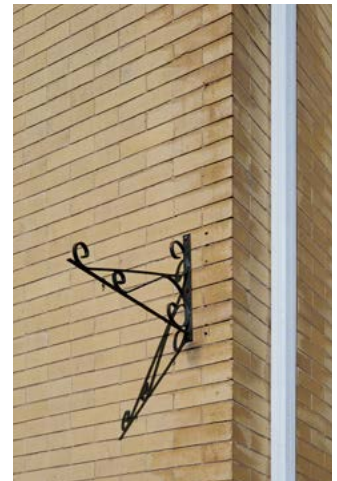
There are a number of miscellaneous items attached to the building which should be removed during the work on the stone foundation, brick masonry and soffits. The majority of the items are residual electrical or signage for previous businesses in the Mansion. Beginning on the west façade, the window swamp cooler on the main floor is exhibiting leakage that is damaging the brick and stone. Removal of this cooler should be a high priority. On the southwest corner of the soffit, there is an electrical weatherhead projecting through the soffit that should be removed.

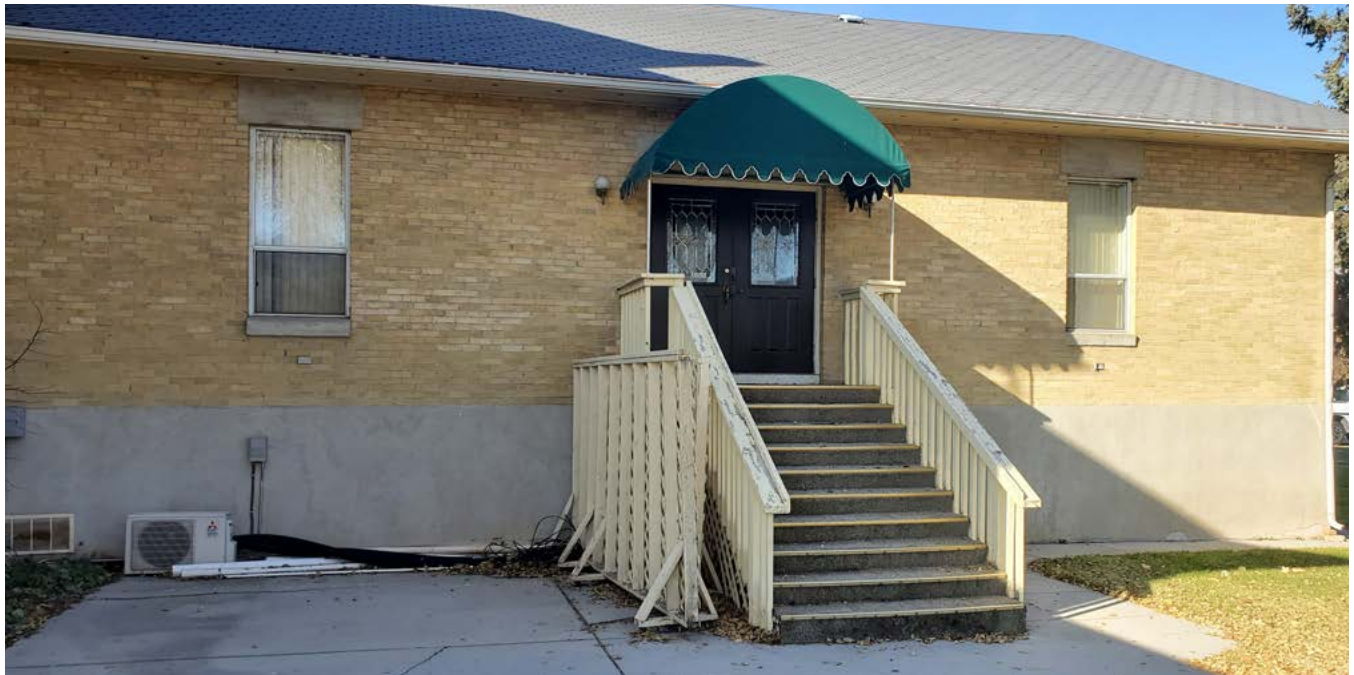
The addition to the north of the historic mansion appears to have been completed in the 1980's. The brick masonry is a recycled brick which is a reasonable match to the historic brick. The mortar joints are wider than the historic joints and the mortar is a Portland cement-based mortar. The masonry and mortar are in good condition. The high exposed foundation wall is parged with Portland cement and is in good condition. The irrigation system on the north elevation is spraying the wall.
