# Climate Station Maintenance in the Arctic Network

## *2018 Summary*

Natural Resource Data Series NPS/ARCN/NRDS—2021/1316

Ken Hill and Pamela Sousanes

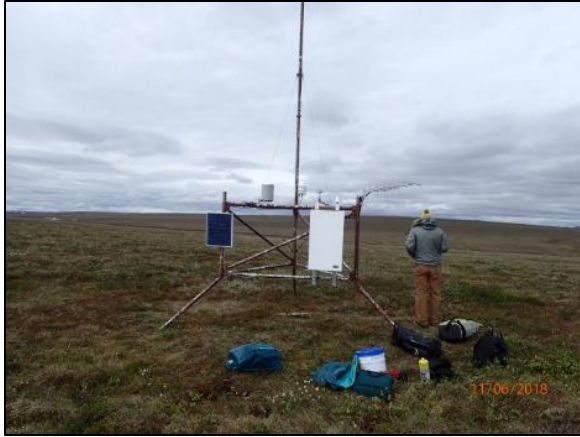
The Noatak fire RAWS station (Figure 2) was accessed via helicopter from Dahl Creek. The GOES cable had been damaged, presumably by wildlife. The AT-RH sensor was replaced for routine calibration. The GOES cable was replaced. The 20 cm and 50 cm soil temperature sensors were replaced and an SDI expansion cable was added for these sensors. All data were downloaded from the datalogger. The cumulative rainfall was reset to zero inches. Photos were taken from the four cardinal and four intercardinal directions both towards and away from the station.

**Figure 2.** Noatak fire RAWS station June 11, 2018.

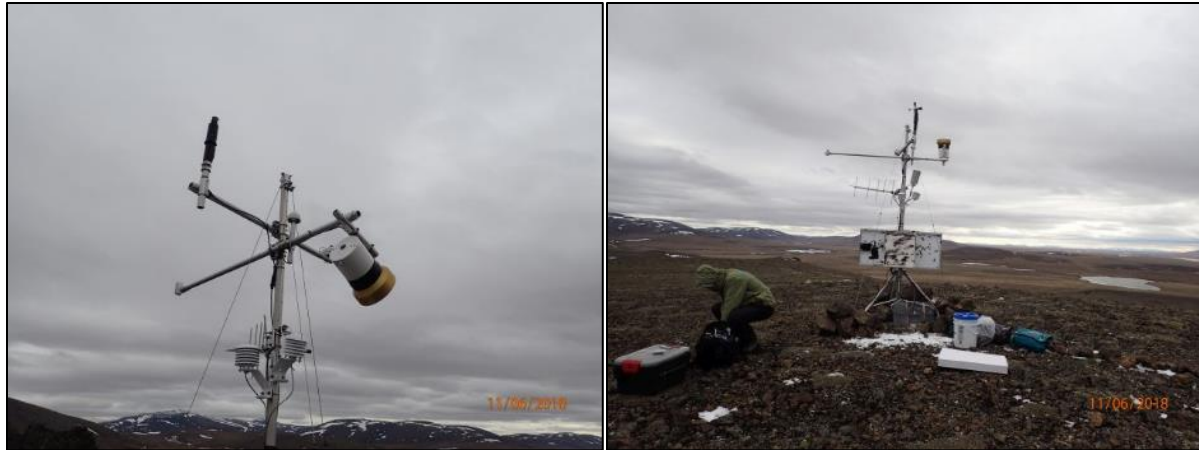
The Howard Pass climate station (Figure 3) was accessed from Dahl Creek by helicopter. The station had been damaged in September 2017, possibly by either high winds and/or wildlife. The AT-RH radiation shield was damaged and the sensor cable was severed. The RNIN tipping bucket was out of level on arrival. The WS-WD sensor was destroyed. The damaged AT-RH and WS-WD sensors were replaced and the tipping bucket was re-leveled. All data were downloaded from the datalogger. The cumulative rainfall was reset to its observed value of 2.39 inches. The desiccant packets were replaced in the enclosure. Photos were taken from the four cardinal and four intercardinal directions both towards and away from the station.

**Figure 3.** Howard Pass climate station before (left) and after (right) repairs June 21, 2018.

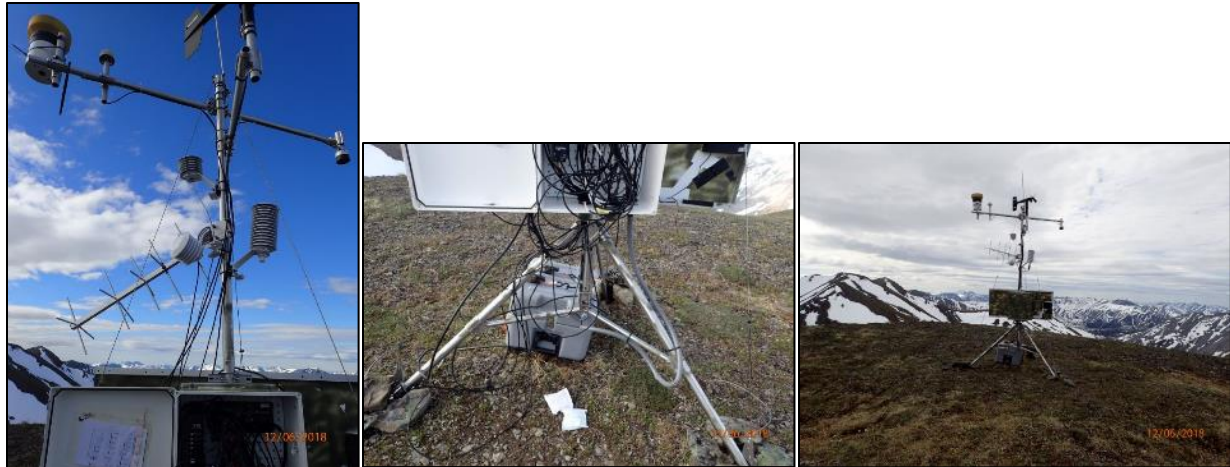
The Imelyak climate station site (Figure 4) was accessed by helicopter from Dahl Creek. The station had been damaged by a bear on May 11, 2018. The GOES cable, AT-RH cable, and RNIN cable had been severed. The solar panel cable was disconnected. The battery cable and conduit had been chewed and damaged. The YAGI antenna was bent. All data were downloaded from the datalogger. The solar panel cable was reconnected. The battery cable was replaced and the damaged conduit was removed. The AT-RH, WS-WD, and RNIN sensors were replaced. The antenna was realigned. The cumulative rainfall was reset to 0.00 inches. One driver element from the antenna is missing and a few elements are bent. At the next field visit, the power cable should be replaced with terminal ends prepared and pre-housed in 2 to 3 feet of conduit. Also, consider replacing the YAGI antenna and adding an electric fence. The desiccant packets were replaced in the enclosure. Photos were taken from the four cardinal and four intercardinal directions both towards and away from the station. Note that the station was revisited in the evening to change the datalogger program (Imelyak\_2018.CR1) and account for the 5108 Alpine HD WS\_WD sensor.

**Figure 4.** Imelyak climate station shown before (left, middle) and after (right) repairs June 28, 2017.

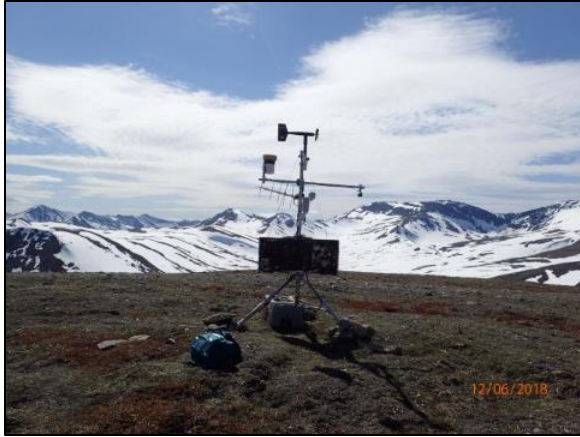
The Kaluich climate station (Figure 5) was accessed by helicopter. The station had been damaged by a bear. The solar panel wires were not connected at the panel. The coax cable was damaged and the wind vane was cracked and broken off. The AT-RH (HMP155), SR, and WS-WD (5108 Alpine HD) sensors were replaced for routine calibration. The coax cable was repaired by taping. All data were downloaded and a new program (Kaluich2018.CR1) was sent to the datalogger to account for the updated wind sensor. The height of the snow depth sensor was entered into the public table at 80.0 inches. The cumulative rainfall was reset to its observed value of 1.21 inches. The desiccant packets were replaced in the enclosure. Photos were taken from the four cardinal and four intercardinal directions both towards and away from the station. At the next field visit, the coax cable should be replaced. Consider adding an electric fence.

**Figure 5.** Kaluich climate station June 12, 2018.

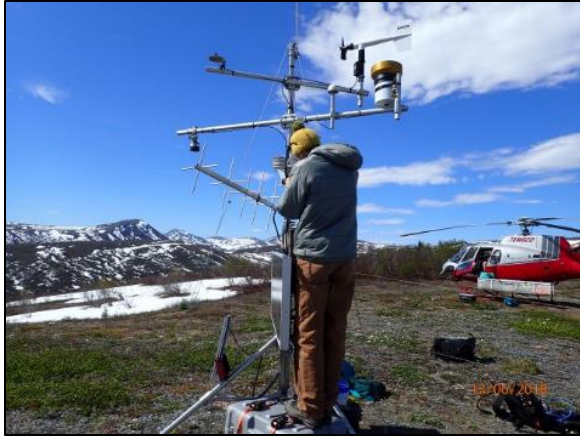
The Salmon River station (Figure 6) was accessed by helicopter. The station was in good condition upon arrival. The AT-RH sensor was replaced for routine calibration. All data were downloaded from the datalogger. The cumulative rainfall was reset to its observed value of 2.86 inches. The electric fence was in good condition and minor repairs were made by restringing the polywire and replacing one t-post mount. The SD card in the phenology camera was exchanged. The desiccant packets were replaced in the enclosure. Photos were taken from the four cardinal and four intercardinal directions both towards and away from the station.

**Figure 6.** Salmon River climate station June 12, 2018.

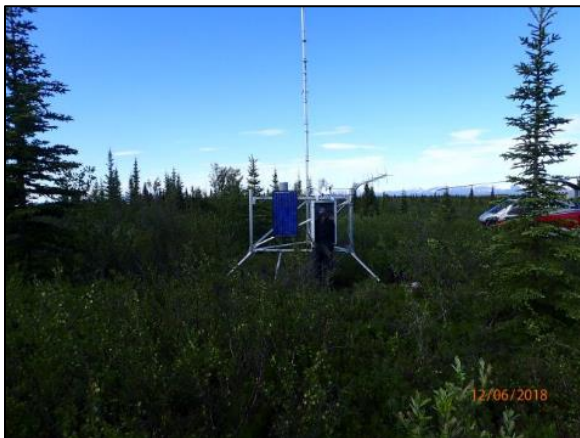
The Kavet Creek fire RAWS station (Figure 7) was accessed via helicopter. All data were downloaded from the datalogger. The AT-RH sensor was replaced and re-leveled for routine calibration. All sensors were scanned and operational. Photos were taken from the four cardinal and four intercardinal directions both towards and away from the station.

**Figure 7.** Kavet Creek fire RAWS station June 12, 2018.

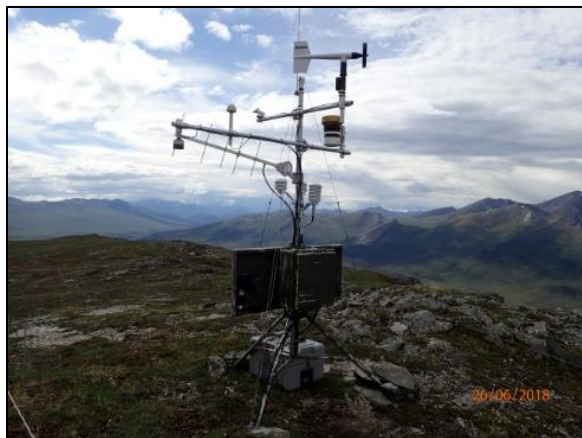
The Chimney Lake station (Figure 8) was accessed by helicopter from Bettles. The station was in good condition. All data were downloaded from the datalogger. The AT-RH, SR, and WS-WD sensors were replaced for routine calibration. The SR50a sensor looked okay, but was returning -99.9 values since October 2017. The sensor was replaced and should be tested in the office. The cumulative rainfall was reset to its observed value of 3.83 inches and the snow depth sensor height was changed from 79 to 78 inches. The electric fence was in good condition and maintained as needed. Dave Swanson completed a soil characterization at the site. The desiccant packets were replaced in the enclosure. Photos were taken from the four cardinal and four intercardinal directions both towards and away from the station.

**Figure 8.** Chimney Lake climate station June 26, 2018.

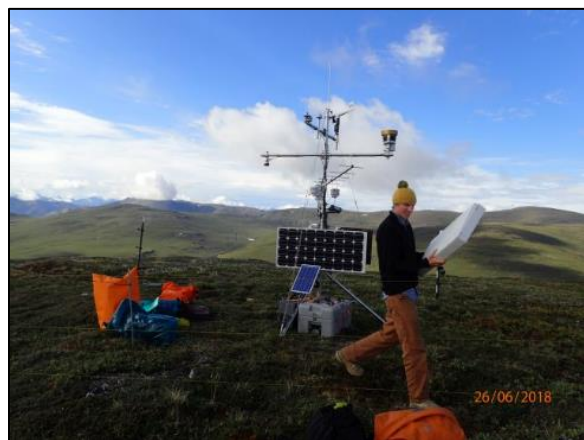
The Pamichtuk Lake station (Figure 9) was accessed by helicopter from Bettles via Chimney Lake. The station was in good condition. All data were downloaded from the datalogger. The AT-RH sensor was replaced for routine calibration. The cumulative rainfall was reset to its observed value of 3.88 inches. The electric fence was repaired by replacing five T-post connectors and replacing the polywire. The ST1 (10 cm) soil temperature sensor had heaved out 2–3 cm and was pushed back into place. This is a persistent problem. Consider re-installing sensor horizontally (?) and/or burying cable completely. The images from the phenology camera were downloaded and the SD card was exchanged. The desiccant packets were replaced in the enclosure. Dave Swanson completed a soil characterization at the site. High precision GPS coordinates were obtained with the Trimble unit. Photos were taken from the four cardinal and four intercardinal directions both towards and away from the station.

**Figure 9.** Pamichtuk climate station June 26, 2018.

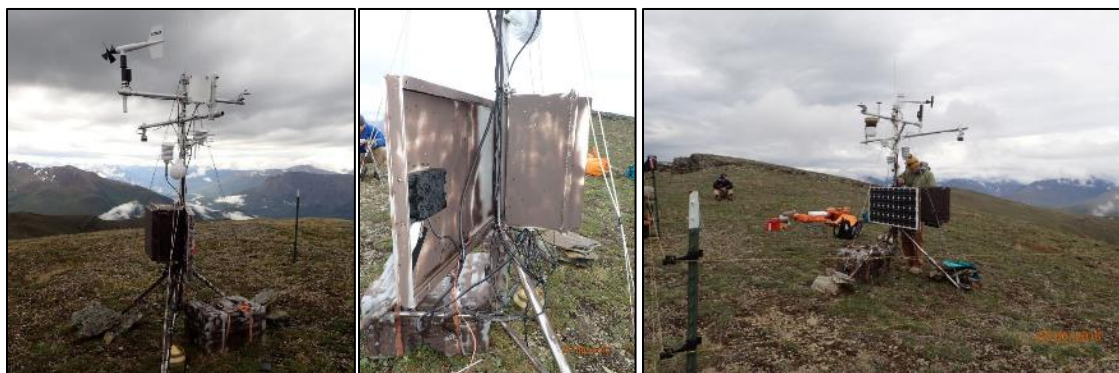
Ram Creek climate station (Figure 10) was accessed by helicopter from Bettles. All data were downloaded from the datalogger. The station had been damaged, presumably by a bear on October 11, 2017. Cables were damaged on the 109 air temperature sensor, all three soil temperature sensors, the solar radiation sensor, and the tipping bucket. These sensors were all replaced. Additionally, the AT-RH sensor was replaced for routine calibration. The radiation shield for the 109 sensor was damaged and replaced. The electric fence was heavily damaged with bent posts, missing connectors, and a damaged charger. Repairs were completed and the charger and polywire were both replaced. The long crossarm with the tipping bucket and snow depth sensor was re-leveled. The red solar panel cable was reconnected to the charging regulator. The solar panel voltage was reading 13.5 volts. The battery was reading 11.7 volts on arrival and increased to 12.2 volts by time of departure. The cumulative rainfall was reset to zero inches. Dave Swanson completed a soil characterization at the site. The desiccant packets were replaced in the enclosure. Photos were taken from the four cardinal and four intercardinal directions both towards and away from the station.

**Figure 10.** Ram Creek climate station before (left, middle) and after (right) repairs June 27, 2018.

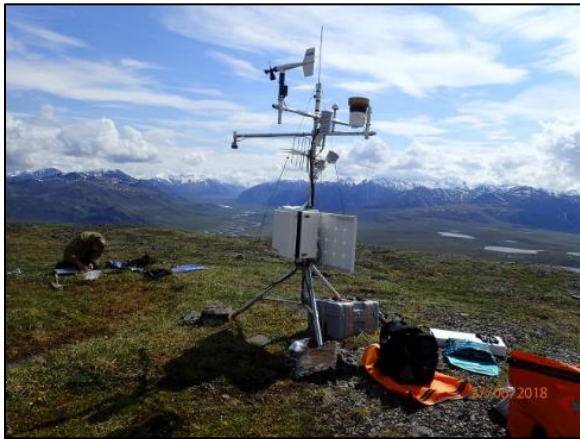
Killik Pass climate station (Figure 11) was accessed by helicopter from Bettles via Ram Creek. The station was in good condition. All data were downloaded from the datalogger. The AT-RH and WS-WD sensors were replaced for routine calibration. The station had recorded many erroneous values in snow depth measurements over the winter and therefore the SR50a sensor was replaced with a newer

SR50a-3165S model. The cumulative rainfall was reset to its observed value of 2.34 inches. Dave Swanson completed a soil characterization at the site. The desiccant packets were replaced in the enclosure. Photos were taken from the four cardinal and four intercardinal directions both towards and away from the station. *Note: the SR sensor was scheduled to be replaced but was not because spare sensors were used for emergency repairs at other sites. The SR sensor should be replaced in 2019.*

**Figure 11.** Killik Pass climate station June 27, 2018.

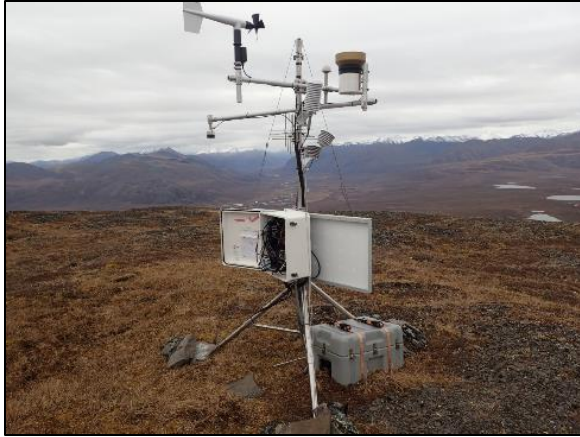
Killik Pass climate station (Figure 12) was accessed by fixed wing and hiking ~1.5 miles from a nearby lake. All data were downloaded from the datalogger. The AT-RH sensor was damaged and both the sensor head and the sensor cable were replaced. The new cable is a 7-wire version and a new program was uploaded to reflect the change in wiring. The cumulative rainfall was reset to its observed value of 11.13 inches. The ground wire on the WS-WD sensor was reconnected which resolved the erroneous wind direction readings. The desiccant packets were replaced in the enclosure. Photos were taken from the four cardinal and four intercardinal directions both towards and away from the station.

**Figure 12.** Killik Pass climate station September 18, 2018.

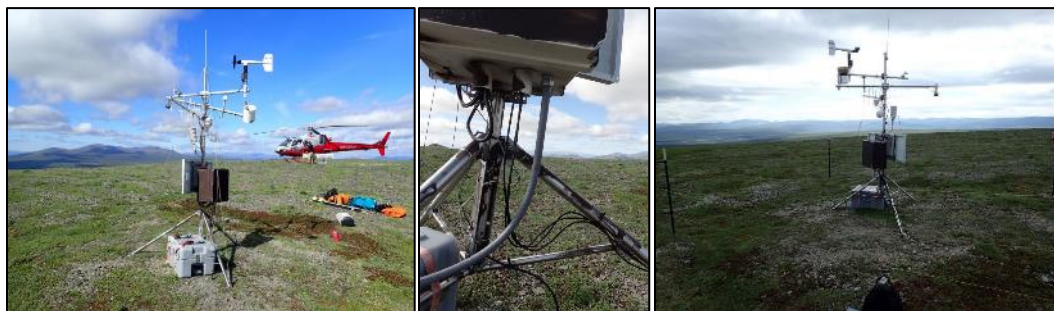
The Sisiak station (Figure 13) was accessed from Kotzebue by helicopter. The station had been damaged, presumably by a bear. The long crossarm (RNIN, SDI) was out of level and the rain gage funnel was on the ground and damaged. The soil temperature sensors had been pulled on and were loose, but not damaged. The funnel was repaired in the field and the crossarm was re-leveled. One white nut on the AT-RH shield was tightened. The mast remains slightly damaged, but was not replaced at this visit. The AT-RH and SR sensors were replaced for routine calibration. All data were downloaded from the datalogger. The height of the snow depth sensor is 82.2 inches. The cumulative rainfall was reset to 0.00 inches. An electric fence was installed at the station. The desiccant packets

were replaced in the enclosure. Photos were taken from the four cardinal and four intercardinal directions both towards and away from the station.

**Figure 13.** Sisiak climate station July 21, 2018. Upon arrival at the site the long crossarm was out of level, the tipping bucket funnel was missing (left). The soil temperature cables have been pulled on, but not damaged (middle). The station was repaired, and an electric fence was installed (right).

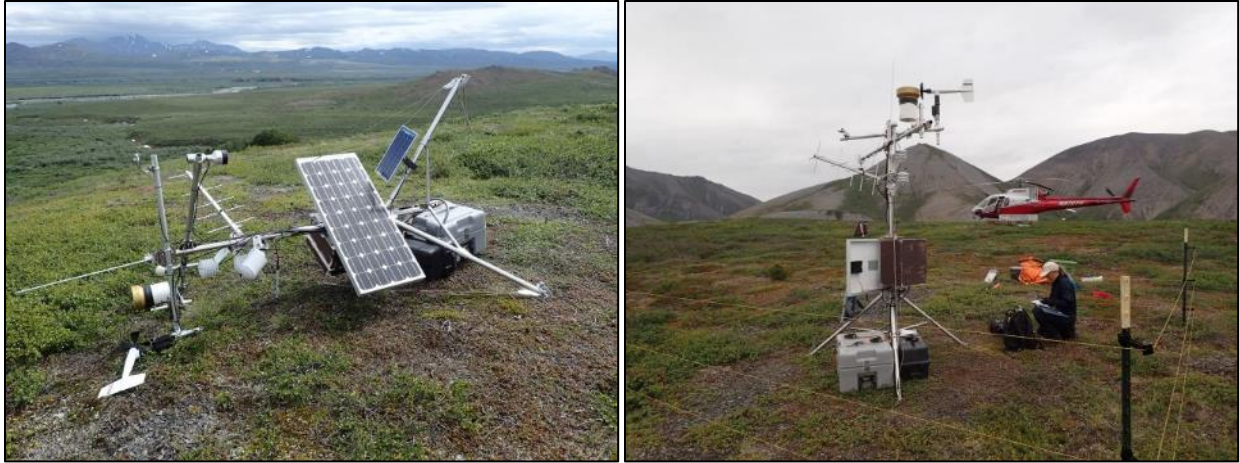
The Kugururok station (Figure 14) was accessed by helicopter from Kotzebue. The station had been damaged by a bear on July 19, just two days prior to the field visit. The bear completely toppled the station and it was lying flat on the ground. After righting the station, the only damaged sensor was the WS-WD sensor. The AT-RH (HMP45) and SR sensors were replaced for routine calibration. The damaged WS-WD sensor was replaced. The ST1 sensor had either heaved out of the ground or was pulled out as a result of the damage. All data were downloaded from the datalogger. The height of the snow depth sensor is 81 inches. The cumulative rainfall was reset to its observed value of 5.55 inches. The desiccant packets were replaced in the enclosure. The guy wires were tightened and the station was leveled. The SD card in the CC5MPX digital camera was exchanged. An electric fence was installed. Photos were taken from the four cardinal and four intercardinal directions both towards and away from the station. A moose and calf were seen near the site on departure.

**Figure 14.** Kugururok climate station had been damaged by a bear (left). The station was repaired on July 21, 2018, only two days after the damage occurred (right).

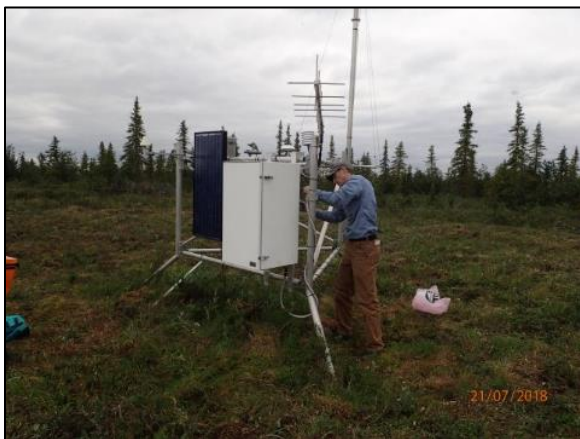
The Kelly fire RAWS station (Figure 15) was accessed via helicopter. The helispot was cleared by the fire crew. The station looked good upon arrival. The AT-RH sensor was replaced for routine calibration. All sensors were scanned and confirmed to be working. Photos were taken from the four cardinal and four intercardinal directions both towards and away from the station.

**Figure 15.** Kelly fire RAWS station July 21, 2018.

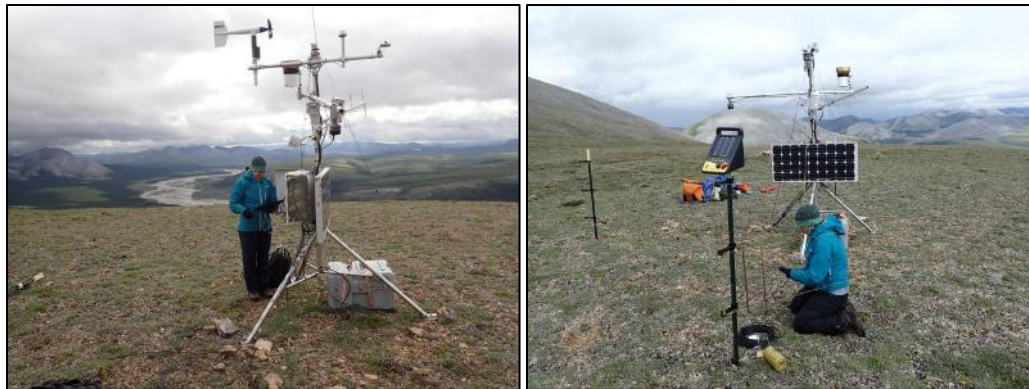
The Asik station (Figure 16) was accessed from Kotzebue by helicopter. The station had been damaged, presumably by a bear on May 18th. All soil sensors were damaged. ST1 and ST2 sensors were cut and repaired by splicing. ST3 sensor was intact, but near the surface. ST3 was reinstalled at 50 cm. The SDI and RNIN sensors were re-leveled. There were teeth marks on the battery box and one guy wire was detached. An electric fence was installed at the station. The AT-RH and SR sensors were replaced for routine calibration. All data were downloaded from the datalogger. The height of the snow depth sensor was measured at 73.5 inches after re-leveling the crossarm. The cumulative rainfall was reset to its observed value of 1.29 inches. The desiccant packets were replaced in the enclosure. Photos were taken from the four cardinal and four intercardinal directions both towards and away from the station. *Note: the WS-WD sensor had been scheduled for replacement, but due to the emergency replacement at Kugururok, no additional sensors were available. The Asik WS-WD sensor should be replaced at the next field visit. Also, field notes indicate that a white screw/nut is missing from the AT-RH radiation shield and should be replaced at the next visit.*

**Figure 16.** Asik climate station before (left) and after (right) maintenance July 22, 2018.

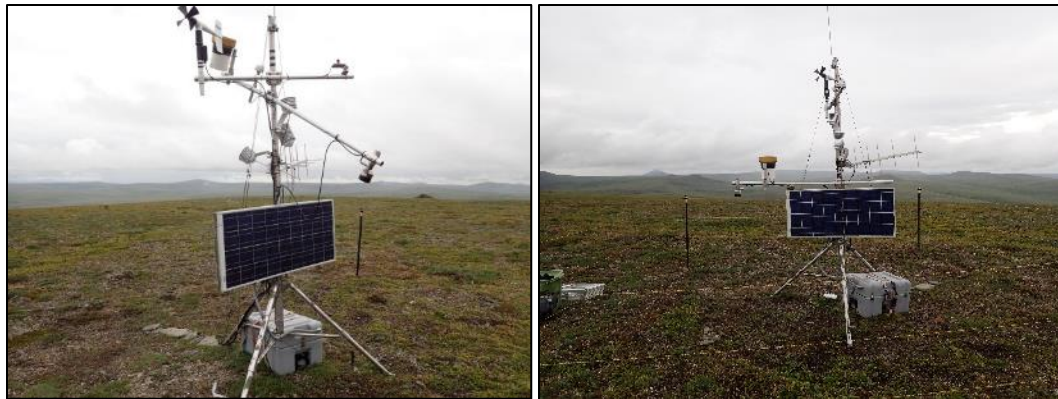
The Tahinichok station (Figure 17) was accessed from Kotzebue by helicopter. The station had some damage: both crossarms were out of level, the wind sensor was pegged against the tipping bucket, and the HMP45 AT-RH sensor was damaged and not functioning. The damaged AT-RH sensor was replaced with a new cable and sensor. The lower crossarm holding the snow depth and tipping bucket sensors was moved down to rest on the solar panel, and releveled. All data were downloaded from the datalogger. The electric fence was repaired by re-stringing polywire and replacing two post connectors. The height of the snow depth sensor height was measured and entered into the public table at 49.5 inches. The antenna was realigned and damaged elements were replaced. The desiccant packets were replaced in the enclosure. Photos were taken from the four cardinal and four intercardinal directions both towards and away from the station.

**Figure 17.** Tahinichok climate station July 22, 2018 shown before (left) and after (right) repairs.

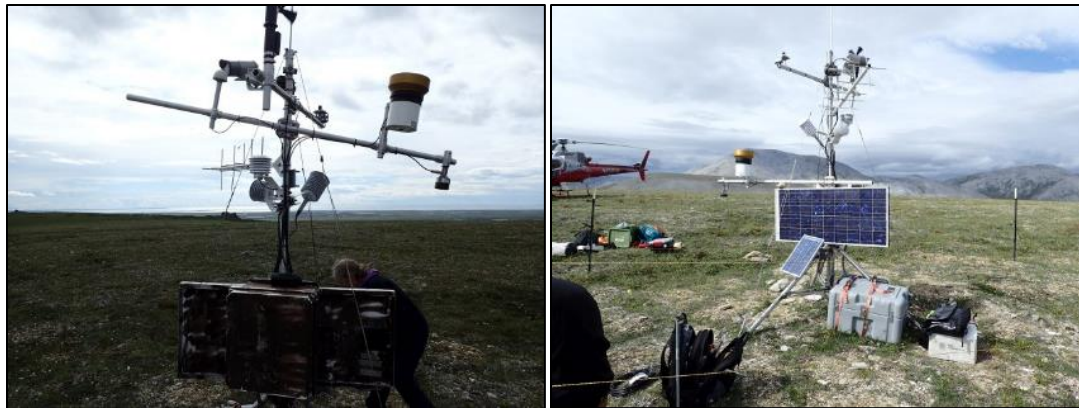
The Mt. Noak station (Figure 18) was accessed from Kotzebue by helicopter. The station had minor damage: the RNIN and SDI sensors were out of level, four antenna elements were damaged, and there were teeth/claw marks on the battery box and enclosure. The lower crossarm (RG-TB, SD) was moved down to rest on top of the solar panel and the rain gage was moved next to the snow depth sensor. The AT-RH sensor was replaced for routine calibration. All data were downloaded from the datalogger. The height of the snow depth sensor was entered into the public table at 44.9 inches. The cumulative rainfall was left at its value of 4.45 inches. The YAGI antenna was replaced. The desiccant packets were replaced in the enclosure. A new 100 amp-hour battery was installed for the CC5MPX camera. After installation, the camera was tested and oriented. An electric fence was installed at the station. Photos were taken from the four cardinal and four intercardinal directions both towards and away from the station.

**Figure 18.** Mt. Noak climate station July 22, 2018 before (left) and after (right) repairs.

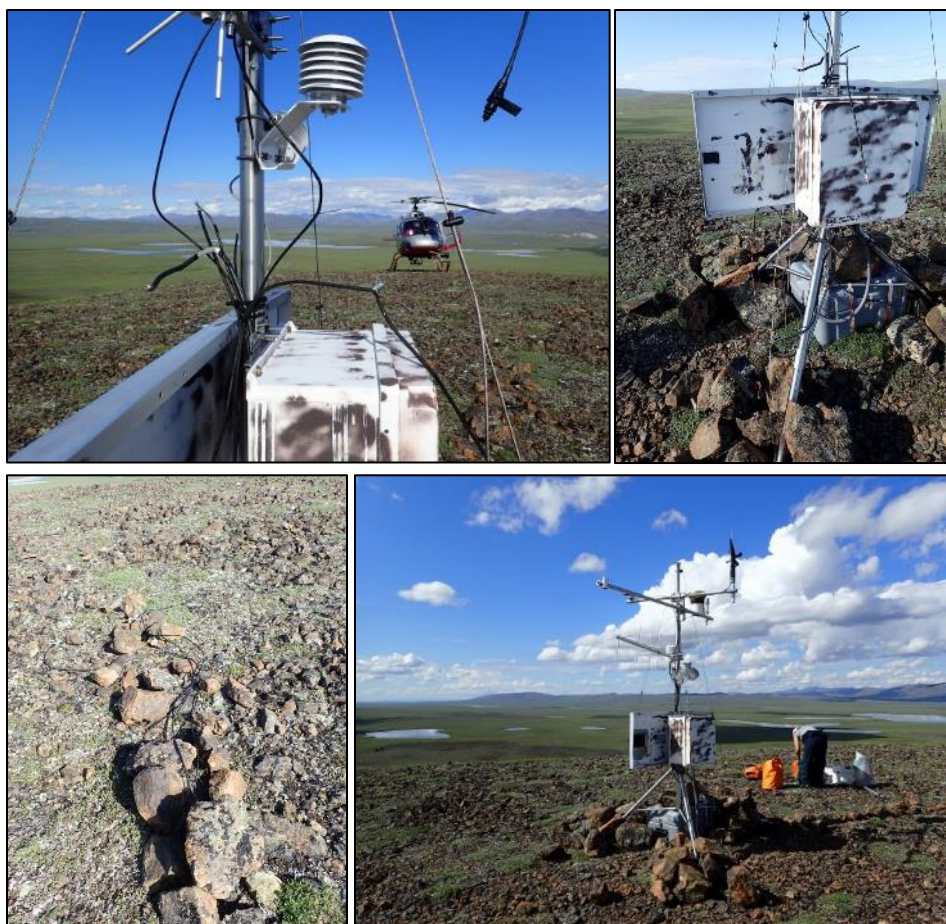
The Howard Pass climate station (Figure 19) was accessed from Kotzebue by helicopter for a repair visit. The station had been damaged, presumably by a bear on June 19. Almost all cables were severed. The datalogger was damaged and unable to connect to the field computer. The HMP155 was replaced with an HMP45 along with a new 10-plate radiation shield. The program was updated accordingly. The SR and AT (109) sensors were replaced. The cable for the WS-WD sensor was replaced, but the sensor was undamaged. The coax cable had pulled out at the antenna end, but was intact and repaired by re-inserting and adding mastic. The YAGI antenna was replaced. The soil temperature sensors were reinstalled to the appropriate depths at 10, 20, and 50 cm. The solar panel charging box had been ripped off of the back of the panel. The panel connection was repaired by wiring the cables from the black box back into the solar panel. The station should be monitored leading up to the next field visit, particularly the battery voltage and GOES transmissions. *Consider adding an electric fence, replacing the solar panel, and/or replacing the coax cable at the next visit. Photos were taken from the four cardinal and four intercardinal directions both towards and away from the station.*

**Figure 19.** Howard Pass climate station: severed cables (upper left), damaged solar panel (upper right), displaced soil temperature sensors (bottom left), and post-repairs (bottom right) on July 23, 2018.

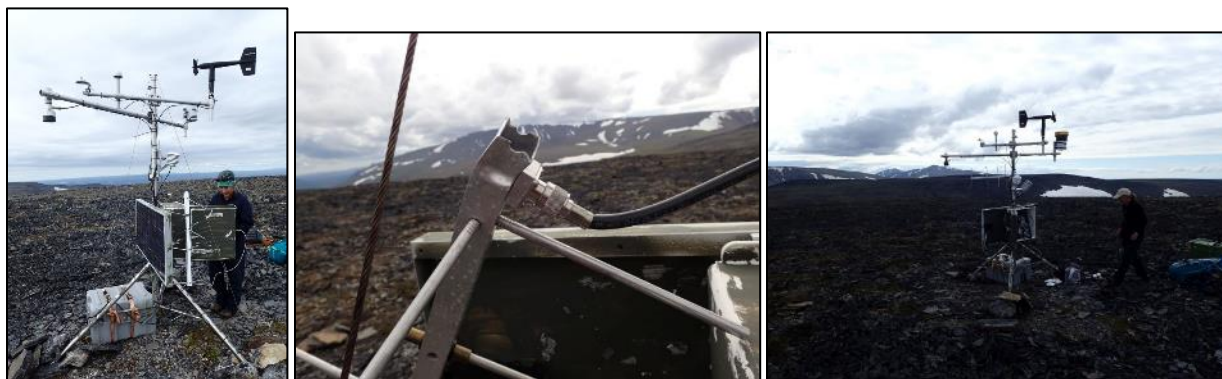
The Ella Creek station (Figure 20) was accessed from by helicopter in transit from Kotzebue – Hoodoo Hills. The station had been damaged, presumably by icing. Transmissions ended in April 2018. The AT-RH (HMP45) and SR sensors were replaced for routine calibration. The YAGI antenna was broken at the mast connection, pointing northwest towards the ground, and twisted around the station. The replacement antenna was in Nome, and therefore staff returned to the station on July 25 to replace the antenna. The tipping bucket funnel was missing and replaced. There was some corrosion on the HMP45 sensor cable and therefore it was replaced. The SD sensor was not recording and therefore it was replaced. The new height of the snow depth sensor was measured as 76.5 inches. All data were downloaded from the datalogger. The cumulative rainfall was reset to its previous value of 8.68 inches, but data previous to the field visit is suspect and may need to be removed. The desiccant packets were replaced in the enclosure. Photos were taken from the four cardinal and four intercardinal directions both towards and away from the station.

**Figure 20.** Ella Creek climate station July 24, 2018 before (left, middle) and after (right) station maintenance.

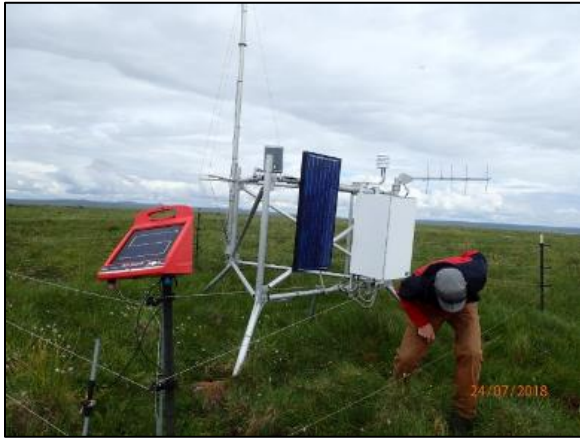
The Hoodoo Hills fire RAWS station (Figure 21) was accessed via helicopter while transiting from Kotzebue to Nome. The AT-RH sensor was replaced for scheduled calibration. The ST1 and ST2 sensors were not working and therefore replaced. There was not visible damage on these sensors or

other indications of failure. The electric fence was repaired and the polywire was replaced. An additional 3-to-1 SDI cable was added for sensor connections. Photos were taken from the four cardinal and four intercardinal directions both towards and away from the station. The station is slightly out of level and possibly sinking. Future site visits should consider addressing this problem. All bolts and guy wires were tightened.

**Figure 21.** Hoodoo Hills fire RAWS station July 24, 2018.

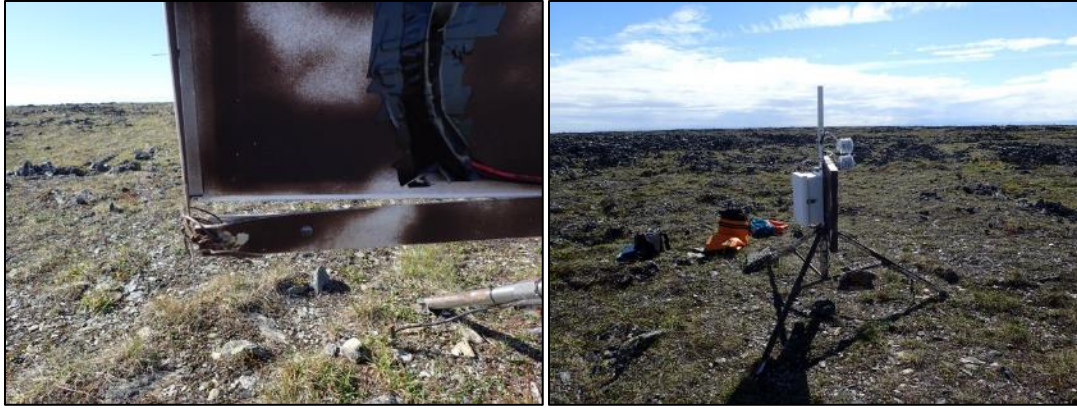
Midnight Mountain (Figure 22) was accessed by helicopter. Because of heavy rime ice buildup in winter months, only air temperature is measured at this site and data are not transmitted. The station was in good condition. All data were downloaded from the datalogger. The AT-RH shield was moved so that both are now on the south side of the mast. The solar panel is damaged and the frame is pulling away from the panel. It was field repaired with bailing wire. *Consider replacing the solar panel at the next field visit.* Photos were taken from the four cardinal and four intercardinal directions both towards and away from the station.

**Figure 22.** Midnight Mountain climate station July 25, 2018.

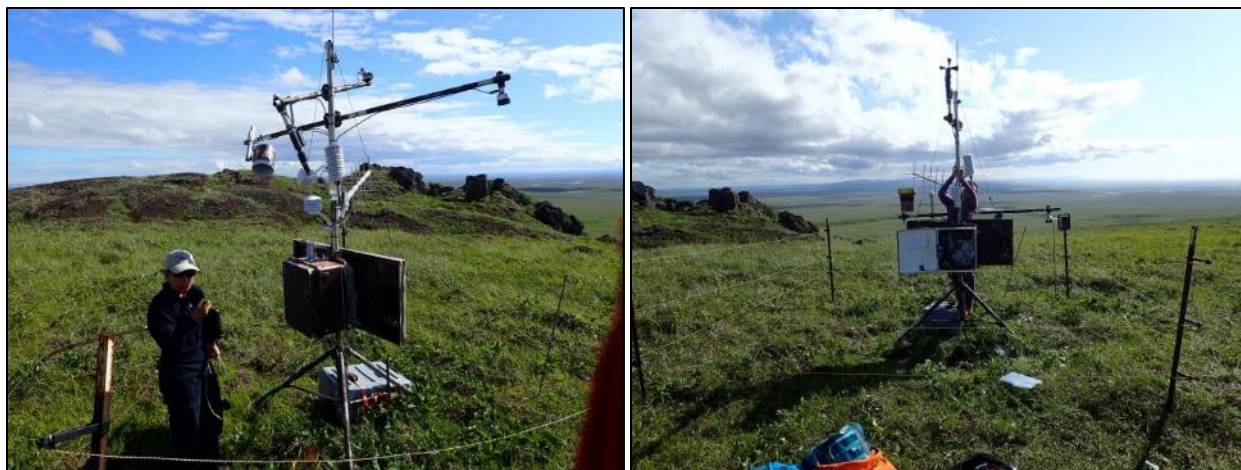
The Devil Mountain station (Figure 23) was accessed by helicopter. The station had some damage: both crossarms were out of level, the wind sensor was broken with the nu-rail connection facing downwards, the nu-rail connection for the tipping bucket was also twisted and the funnel was on the ground. The AT-RH (HMP45) and WS-WD (05103) sensors were replaced for routine calibration. The lower crossarm with the GPS antenna, snow depth sensor, and rain gage was reset to rest on the solar panel in order to minimize seasonal damage by icing. The ThermX sensor was repositioned to face south and avoid direct solar heating. The electric fence was repaired by straightening the T-posts, installing a new charger, and replacing the polywire. All data were downloaded from the datalogger. The height of the snow depth sensor was measured and entered into the public table at 50.5 inches. The desiccant packets were replaced in the enclosure. Photos were taken from the four cardinal and four intercardinal directions both towards and away from the station.

**Figure 23.** Devil Mountain climate station before (left) and after (right) maintenance July 25, 2018.

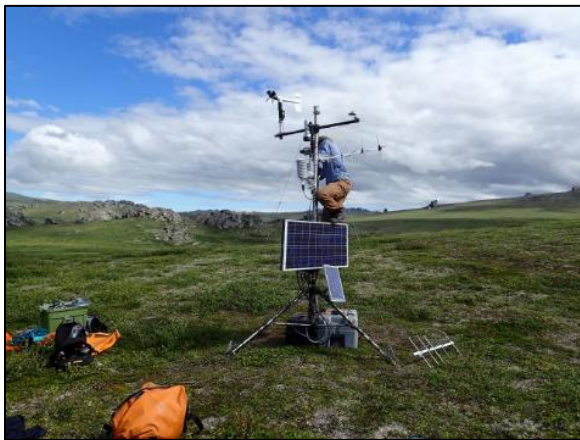
The Serpentine station (Figure 24) was accessed by helicopter. The station was in good condition with a few notable exceptions: ST1 and ST2 were at the same depth on arrival, the snow depth sensor was corroded (copper film damaged), and the battery for the camera had drained to 11.3 volts. The AT-RH sensor (HMP155) was replaced for routine calibration. The ST2 soil temperature sensor was re-inserted to 20 cm depth. The remainder of the copper film on the SR50a snow depth sensor was removed and the sensor stopped recording any values (before removal the sensor was returning the height of the sensor). The sensor was removed and replaced by Dave Swanson at a later visit on August 8. The previously damaged (see 2017 report) YAGI antenna was replaced. The tipping bucket was re-leveled.

Camera images ceased in early June, presumably due to power supply issues. After connecting to the camera the CC5MPX software indicated a mandatory reset due to either 1) power fluctuation resulting in a firmware crash, 2) power switching on and off frequently causing the device to switch to safe mode, 3) failure during firmware update, or 4) power down during firmware update. Besides the low voltage measured on the battery supply, there were no indications of power disruption. It appears that the camera was “stuck on” and required a manual reset. After resetting the camera, the Blue River battery (power supply for camera) was swapped with a Sun Extender battery from the

climate station. The camera firmware was updated from version 16 to version 25. There was some condensation on the inside of the camera lens. The lens was removed for drying during the field visit and the desiccant was replaced. The SD memory card in the camera was exchanged. The tipping bucket was repaired, leveled, and a rubber gasket was added. The camera cable and the desiccant in the camera was replaced and the camera was realigned. A subsequent visit by Dave Swanson in August indicated that the camera was functioning properly.

All data were downloaded from the datalogger. The cumulative rainfall was reset to 4.63 inches. The desiccant packets were replaced in the enclosure. Photos were taken from the four cardinal and four intercardinal directions both towards and away from the station. *Note: Dave Swanson re-visited the site on 8/8/2018. He installed a new snow depth sensor and confirmed good battery voltages for both the climate station and camera. The camera was functioning properly. The power supply for the station is now the Blue River and Sun Extender batteries connected in parallel. As of September 2018, the station power supply appears to be adequate and stable.*

**Figure 24.** Serpentine climate station July 25, 2018.
