# Climate Station Maintenance in the Arctic Network

## *2019 Summary*

Natural Resource Data Series NPS/ARCN/NRDS—2021/1317

Ken Hill and Pamela Sousanes

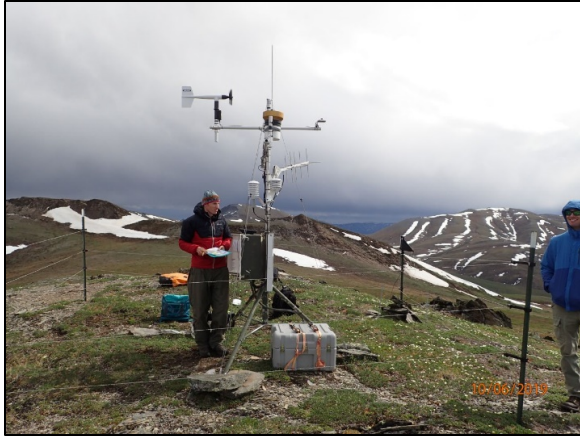
**Figure 2.** Chimney Lake climate station June 10, 2019.

The Chimney Lake station (Figure 2) was accessed by helicopter from Bettles. The station was in good condition. All data were downloaded from the datalogger. The AT-RH sensor was replaced for routine calibration. The electric fence was in good condition. Seth Adams took photos of the site visit (NPS contract photographer). Active thunderstorms were in the vicinity. The desiccant packets were replaced in the enclosure. Photos were taken from the four cardinal and four intercardinal directions both towards and away from the station.

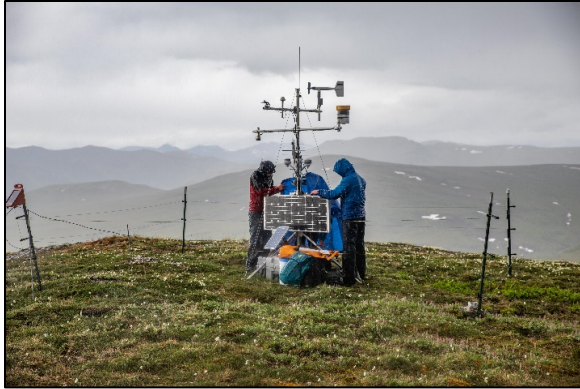
**Figure 3.** Pamichtuk climate station June 10, 2019.

The Pamichtuk Lake station (Figure 3) was accessed by helicopter from Bettles via Chimney Lake. The station was in good condition. All data were downloaded from the datalogger. The AT-RH, SR, and WS-WD sensors were replaced for routine calibration. The electric fence was maintained as needed. The soil temperature sensors were inspected and looked good. The images from the phenology camera were downloaded and the SD card was exchanged. The desiccant packets were replaced in the enclosure. High precision GPS coordinates were obtained with the Trimble unit. Photos were taken from the four cardinal and four intercardinal directions both towards and away from the station. *Note that the anemometer was incorrectly installed (180 degrees off) on June 10. Transmissions were turned off at WFMI on June 13. The transmissions will need to be turned back on and the data will need to be corrected after the next download. Additionally, the SR50a snow depth sensor is logging many errors. Consider replacing sensor and/or transducer at the next site visit.*

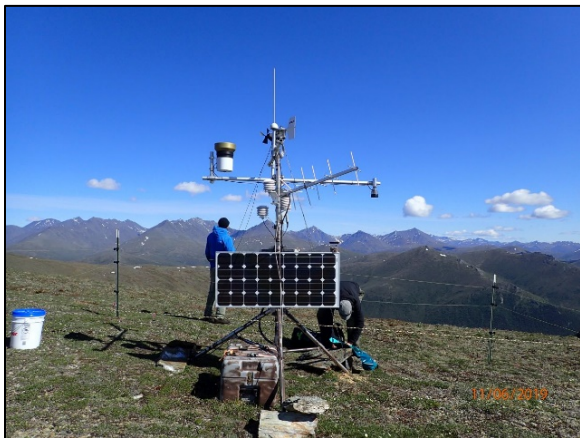
**Figure 4.** Ram Creek climate station June 11, 2019.

Ram Creek climate station (Figure 4) was accessed by helicopter from Bettles. All data were downloaded from the datalogger. The station was in good condition. The AT-RH sensor was replaced for routine calibration. One connector on the electric fence was replaced and the polywire was tightened. The datalogger lithium battery was checked and deemed suitable (3.05 V). It should be replaced if it drops below 2.7 V. The desiccant packets were replaced in the enclosure. Photos were taken from the four cardinal and four intercardinal directions both towards and away from the station.

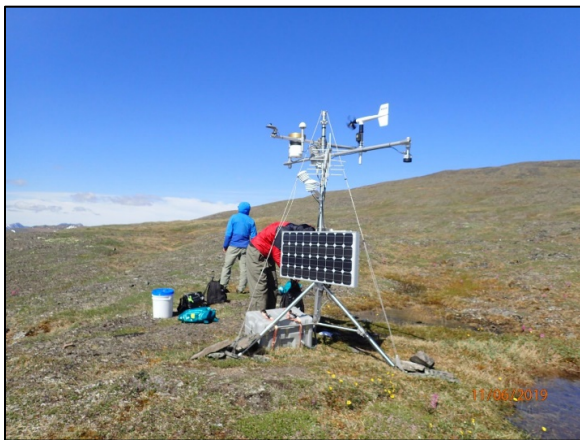
**Figure 5.** Killik Pass climate station June 11, 2019.

Killik Pass climate station (Figure 5) was accessed by helicopter from Bettles via Ram Creek. The station was in good condition. All data were downloaded from the datalogger. The AT-RH and SR sensors were replaced for routine calibration. One YAGI antenna element was on the ground upon arrival and was reinstalled. The desiccant packets were replaced in the enclosure. Photos were taken from the four cardinal and four intercardinal directions both towards and away from the station. *The U-bolt mount for the lightning rod is missing. It should be replaced and reinstalled at the next field visit.*

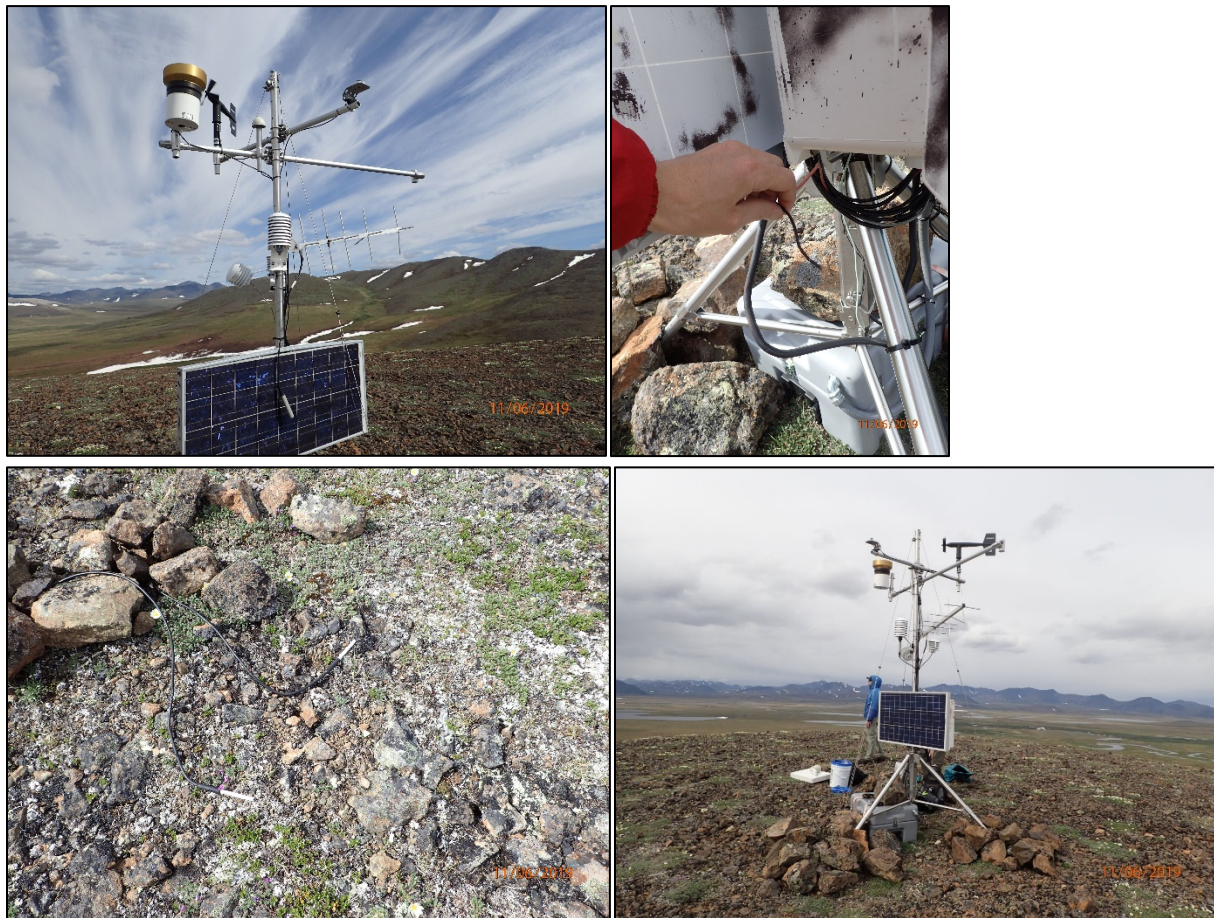
The Howard Pass climate station (Figure 6) was accessed from Bettles via Killik Pass. The station had been damaged in November 2018, possibly by high winds. The AT-RH HMP45 sensor was destroyed. The 05108 anemometer cable had been disconnected (ground only). The solar panel wire had been disconnected. The ST1 and ST2 soil temperature sensors were on the surface upon arrival; they were reinstalled at the appropriate depths. The damaged AT-RH sensor was replaced with a 7-wire model and a new program was sent to the datalogger to accommodate the change. The anemometer and solar panel cables were reconnected. The solar panel was replaced (the U-bolts had to be cut to fit on the frame). The coax cable for the YAGI antenna was damaged and replaced. All data were downloaded from the datalogger. The cumulative rainfall was reset to its observed value of 1.32 inches. The desiccant packets were replaced in the enclosure. Photos were taken from the four cardinal and four intercardinal directions both towards and away from the station.

**Figure 6.** Howard Pass climate station, June 11, 2019. Clockwise from top left: damaged AT-RH sensor, disconnected solar panel cable, after repairs, soil temperature sensors on surface.

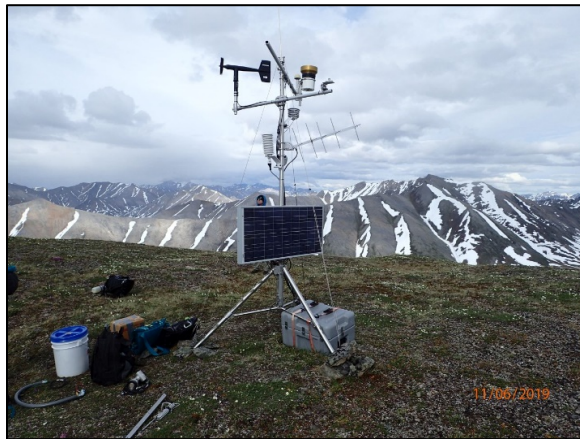
**Figure 7.** Imelyak climate station June 11, 2019.

The Imelyak climate station site (Figure 7) was accessed by helicopter from Bettles via Ram Creek-Killik Pass-Howard Pass. All data were downloaded from the datalogger. The AT-RH and SR sensors were replaced for routine calibration. The RG-TB sensor was replaced (had not been working since previous field visit). The SD sensor was removed due to persistent erroneous data at this wind scoured location. The YAGI antenna was replaced (bent in 2018). *At the next field visit, the power cable should be replaced with terminal ends prepared and pre-housed in 2 to 3 feet of conduit (1/2" not 3/4").* The desiccant packets were replaced in the enclosure. Photos were taken from the four cardinal and four intercardinal directions both towards and away from the station.

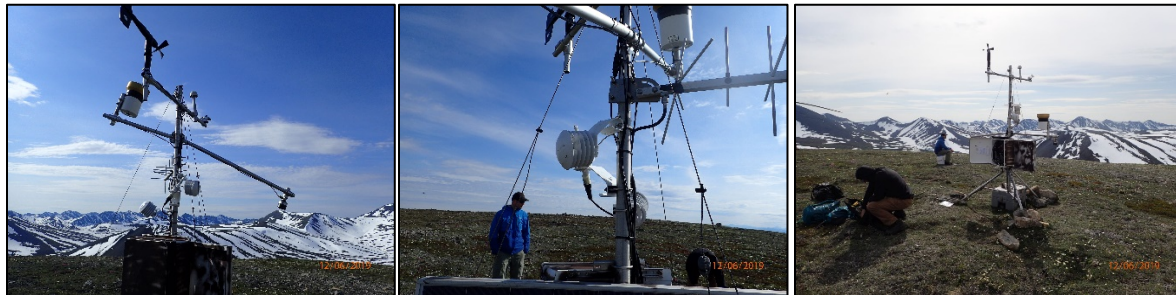
The Kaluich climate station (Figure 8) was accessed by helicopter. The station had been damaged (bear?). The AT-RH (HMP155) sensor was damaged and the radiation shield was on the ground. Two driver elements on the YAGI antenna were on the ground. The crossarm with the RG-TB and SD sensors was out of level and bent. The other air temperature radiation shields were bent, but not damaged otherwise. The WS-WD (05108) bearings were somewhat noisy. The HMP155 sensor was replaced with a HMP45 AT-RH sensor. The coax cable was replaced (damaged/corroded 2018). The YAGI antenna was replaced, but not the mounting U-bolt assembly. All data were downloaded and a new program (Kaluich2019.CR1) was sent to the datalogger to account for the HMP45 7-wire sensor. The bent crossarm was moved down on the mast and the level part was used for the RG-TB and SD sensors. The new height of the snow depth sensor was entered into the program at 49.0 inches. The cumulative rainfall was reset to 2.50 inches. The desiccant packets were replaced in the enclosure. Photos were taken from the four cardinal and four intercardinal directions both towards and away from the station. *At the next field visit, the radiation shield for the ThermX sensor should be replaced. Consider adding an electric fence.*

**Figure 8.** Kaluich climate station June 12, 2019. Before (left, middle) and after (right) repairs.

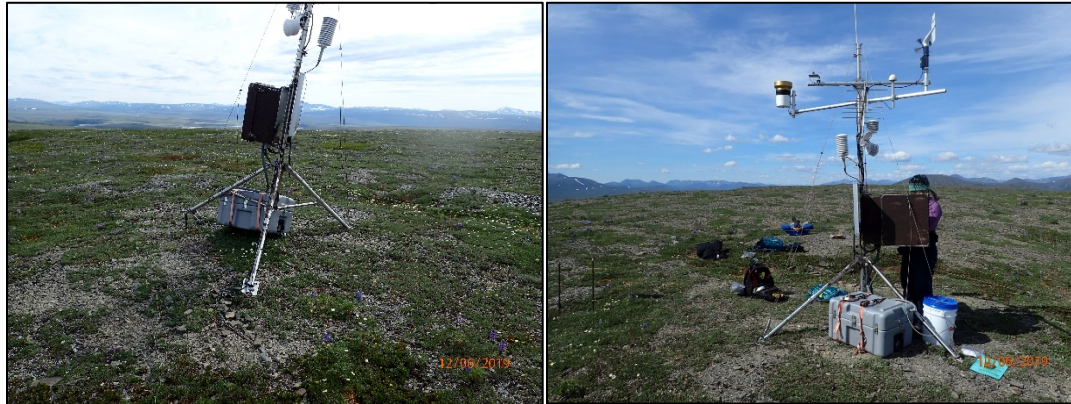
**Figure 9.** Sisiak climate station June 12, 2019 before (left) and after (right) repairs.

The Sisiak station (Figure 9) was accessed from Dahl Creek via Kaluich. The station had been damaged, presumably by a bear. The station was out of level and the tripod was tipped up to the northwest. All sensors were out of level upon arrival. The ST3 sensor was damaged (had been spliced) and was replaced at 50 cm. An ST4 soil temperature sensor was added at 75 cm. The electric fence was badly damaged with wire strung out and most posts bent. The fence charger was okay. The AT-RH sensor (HMP45) was replaced for routine calibration. All data were downloaded from the

datalogger and a new program was sent to the datalogger. The snow depth sensor was removed due to persistent erroneous measurements at this wind scoured location. The cumulative rainfall was reset to 1.53 inches. The electric fence was repaired. The desiccant packets were replaced in the enclosure. Photos were taken from the four cardinal and four intercardinal directions both towards and away from the station.

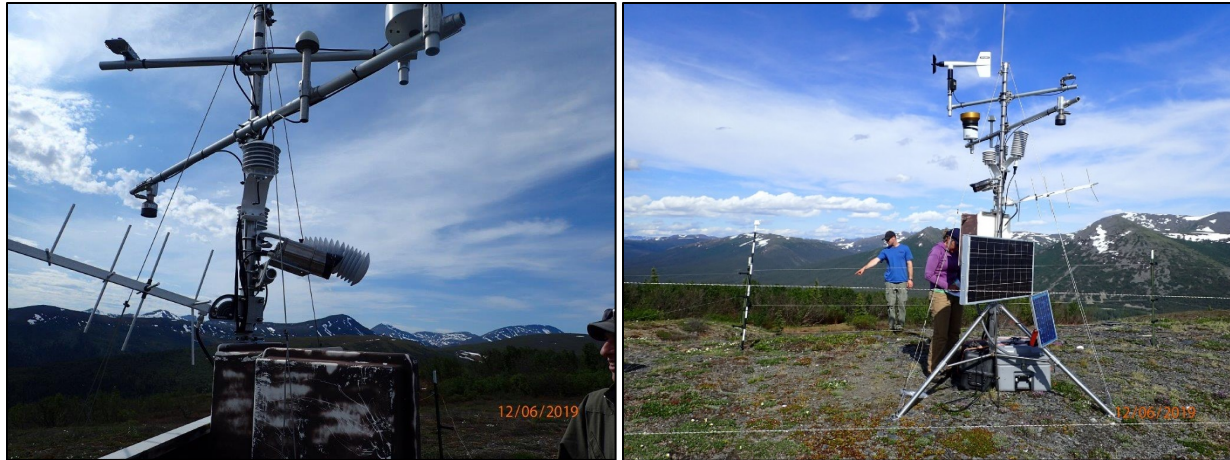
**Figure 10.** Salmon River climate station June 12, 2019 before (left) and after (right) repairs.

The Salmon River station (Figure 10) was accessed by helicopter. The HMP155 shield and sensor had been damaged, presumably by a bear in May. The tip of the sensor was broken. The bent shield had partially blocked the CC5MPX camera image. Field notes indicate that the RG-TB sensor was under the SD sensor upon arrival. All data were downloaded from the datalogger. The AT-RH radiation shield was replaced. The coax recoiled and secured to the solar panel. The CC5MPX camera image was refocused. The conduit for the camera power cable was re-taped at the enclosure. The SD card in the phenology camera was exchanged. One YAGI antenna element was missing. The electric fence wire was down along with many connectors, but the charger was not damaged. The fence was repaired. The AT-RH and SR sensors were replaced for routine calibration. The desiccant packets were replaced in the enclosure. Photos were taken from the four cardinal and four intercardinal directions both towards and away from the station.

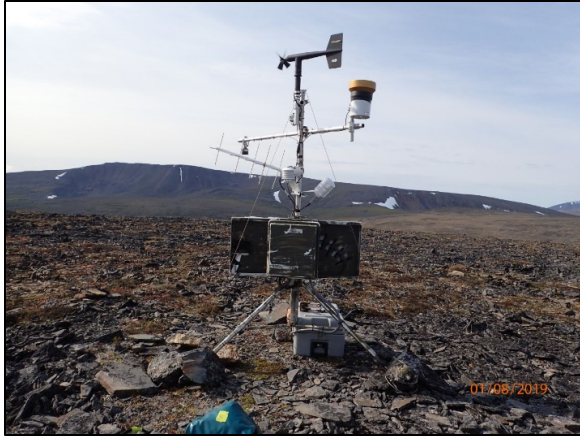
**Figure 11.** Ella Creek climate station August 1, 2019.

The Ella Creek station (Figure 11) was accessed by helicopter from Nome. The station had been damaged, presumably by icing and/or wind in March 2019. The AT-RH (HMP45) sensor was replaced for routine calibration. The YAGI antenna was replaced—many elements were broken and/or missing. The tipping bucket funnel was missing and replaced. The ST1 cable had been severed and it was replaced. The small radiation shield was cracked and therefore replaced. The south guy wire was tightened. All data were downloaded from the datalogger. The desiccant packets were replaced in the enclosure. Photos were taken from the four cardinal and four intercardinal directions both towards and away from the station.

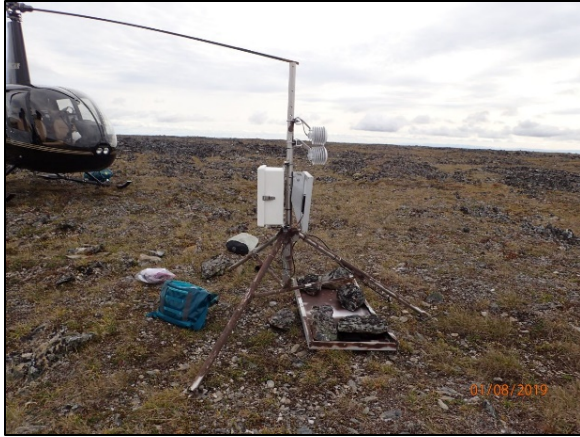
**Figure 12.** Midnight Mountain climate station August 1, 2019.

Midnight Mountain (Figure 12) was accessed by helicopter. Because of heavy rime ice buildup in winter months, only air temperature is measured at this site and data are not transmitted. The station was in good condition. All data were downloaded from the datalogger. The large 75 W solar panel was replaced with a 20 W panel. The new panel was mounted with hose clamps. The mechanism is bulky and its survival in the harsh conditions is questionable. *The large solar panel was left on site because it could not fit in the R44.* It should be retrieved at the next site visit. Photos were taken from the four cardinal and four intercardinal directions both towards and away from the station.

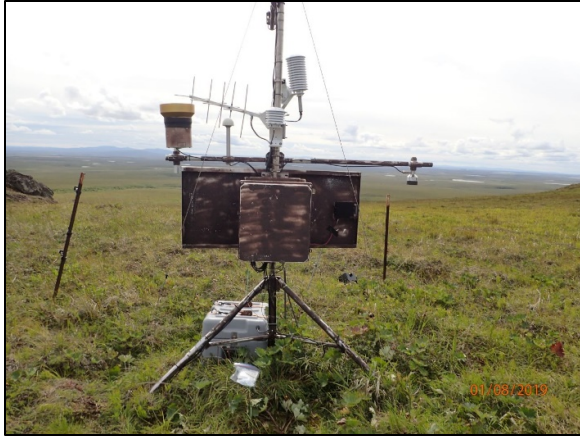
**Figure 13.** Devil Mountain climate station after maintenance August 1, 2019.

The Devil Mountain station (Figure 13) was accessed by helicopter. The station had some damage: the RG-TB sensor was 90 degrees out of level and one fence post and all polywire were missing. The AT-RH (HMP45) and SR (Li200x) sensors were replaced for routine calibration. The RG-TB sensor was righted and leveled. The fence was removed. The solar panel power cables were replaced (looked corroded). All data were downloaded from the datalogger. The desiccant packets were replaced in the enclosure. Photos were taken from the four cardinal and four intercardinal directions both towards and away from the station.

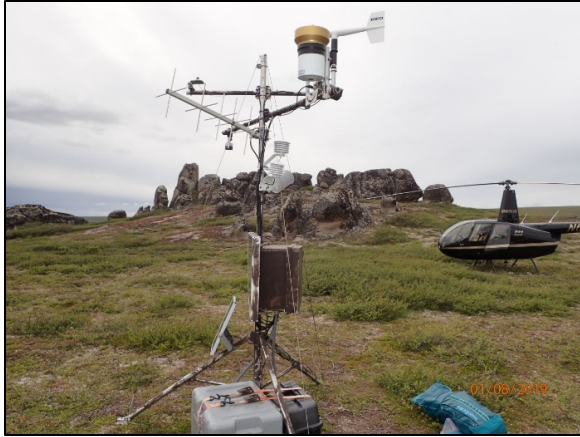
**Figure 14.** Serpentine climate station August 1, 2019.

The Serpentine station (Figure 14) was accessed by helicopter. The station was in good condition except for the CC5MPX phenology camera. Camera images ceased on 7/13/2019, presumably due to power supply issues. The battery voltage was checked and okay, but the camera would not power on. The camera was replaced and configured appropriately.

The AT-RH sensor (HMP155) was replaced for routine calibration. All data were downloaded from the datalogger. The desiccant packets were replaced in the enclosure. Photos were taken from the four cardinal and four intercardinal directions both towards and away from the station. *Note: Pam Sousanes revisited the station on 9/22/2019 because the station was not transmitting. The transmitter failsafe had tripped. The TX321 was replaced with a new TX321. All data were downloaded. The camera was checked and had been functioning properly since the last visit. The power supply for both the camera and station should be checked extensively during the next field visit.*

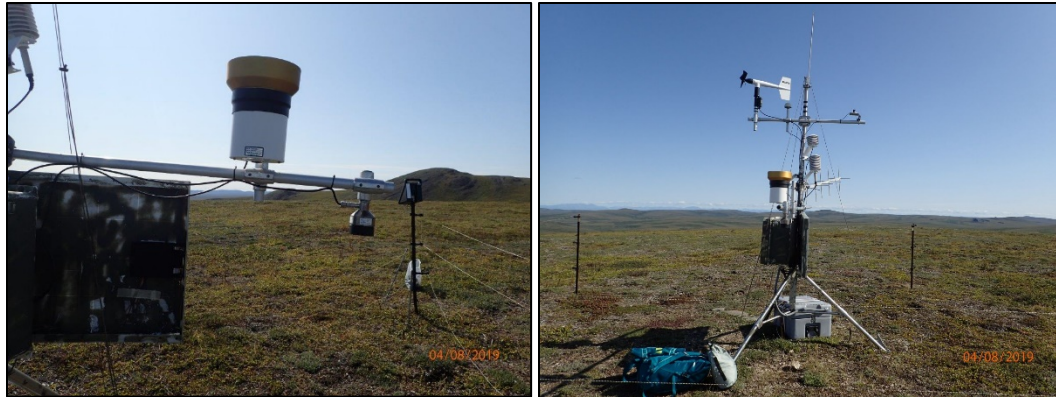
**Figure 15.** Tahinichok climate station August 4, 2019 shown before (left) and after (right) repairs.

The Tahinichok station (Figure 15) was accessed from Kotzebue by helicopter. The station had minor damage. The long crossarm was out of level on arrival. The polywire on the electric fence was down. All data were downloaded from the datalogger. The electric fence was repaired. A guy wire was replaced. The height of the snow depth sensor height was adjusted –1.0 inches to 48.5 inches. The desiccant packets were replaced in the enclosure. Photos were taken from the four cardinal and four intercardinal directions both towards and away from the station. *The SR sensor was not replaced because the small set screw on the mount was stripped and could not be removed. A new sensor and leveling base should be installed at the next site visit. Also, the small radiation shield for the ThermX sensor is damaged and should be replaced at the next visit.*

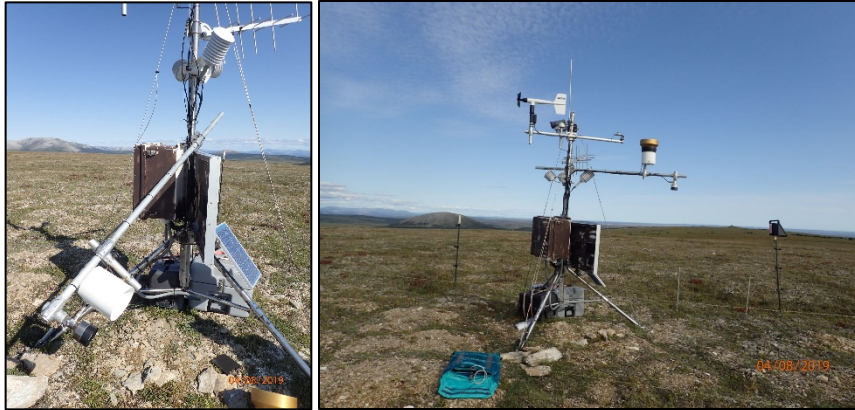
**Figure 16.** Mt. Noak climate station August 4, 2019 before (left) and after (right) repairs.

The Mt. Noak station (Figure 16) was accessed from Kotzebue by helicopter. The station had some damage: the RG-TB and SD sensors were out of level and the bracket on the RG-TB mount was broken. The SD and AT (109) sensors were damaged. The lower crossarm (RG-TB, SD) was moved back up on the mast because one U-bolt was missing and it was stressing the solar panel. The AT-RH and SR sensors were replaced for routine calibration. All data were downloaded from the datalogger. The SD and AT109 sensors were replaced. The solar panel box was re-taped. The guy wires were tightened. The height of the snow depth sensor was re-entered into the program at 66.7 inches. The cumulative rainfall was left at its value of 1.15 inches. The desiccant packets were replaced in the enclosure. The camera SD memory card was swapped and the camera was tested. The electric fence was repaired. Photos were taken from the four cardinal and four intercardinal directions both towards and away from the station.

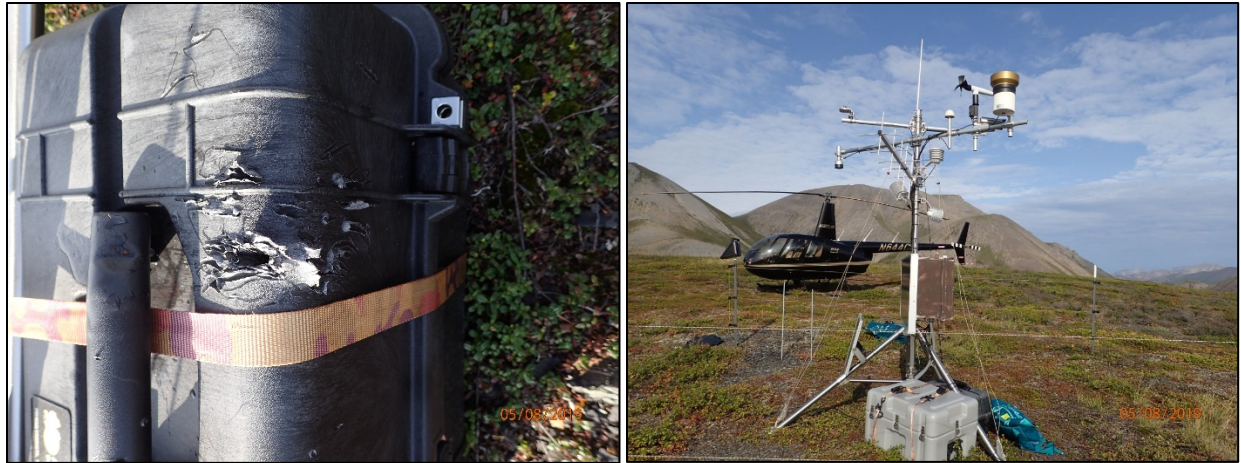
The Kugururok station (Figure 17) was accessed by helicopter from Kotzebue. The station had minor damage and it is suspected that something may have snuck in through the fence (porcupine?). Based on tipping bucket data, it appears the damage occurred on July 30, 2019. There were chew marks on the camera battery box. The RG-TB cable had been severed. The GPS cable was pulled out slightly from the enclosure. The inside of the enclosure was a bit wet and one of the desiccant packets was saturated. It is unknown how liquid entered the enclosure. The AT-RH (HMP45) sensor was replaced for routine calibration. All data were downloaded from the datalogger. The RG-TB cable was repaired by splicing and tested. The solar panel cables were taped to the back of the panel. The enclosure was wiped out and dried and putty was added to the small holes in the door of the enclosure. The desiccant packets were replaced in the enclosure. The SD card in the CC5MPX digital camera was exchanged. Photos were taken from the four cardinal and four intercardinal directions both towards and away from the station.

**Figure 17.** Kugururok climate station August 5, 2019 before (left) and after (right) maintenance. Porcupine damage suspected.

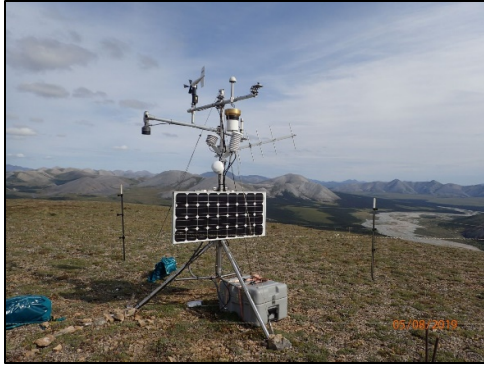
**Figure 18.** Asik climate station August 5, 2019.

The Asik station (Figure 18) was accessed from Kotzebue by helicopter. The station looked good. The AT-RH and WS-WD sensors were replaced for routine calibration. All data were downloaded from the datalogger. The ST2 sensor was replaced (previously repaired by splicing). The AT 109 sensor was placed in the better radiation shield (swapped with ThermX). The RG-TB sensor was inspected and looked good. The electric fence was repaired. The desiccant packets were replaced in the enclosure. Photos were taken from the four cardinal and four intercardinal directions both towards and away from the station.
