Sandy Hook Unit  
Gateway National Recreation Area  
New Jersey

**Structural Conditions Assessment**

Mortar Battery Tunnel Complex

February 8, 2006

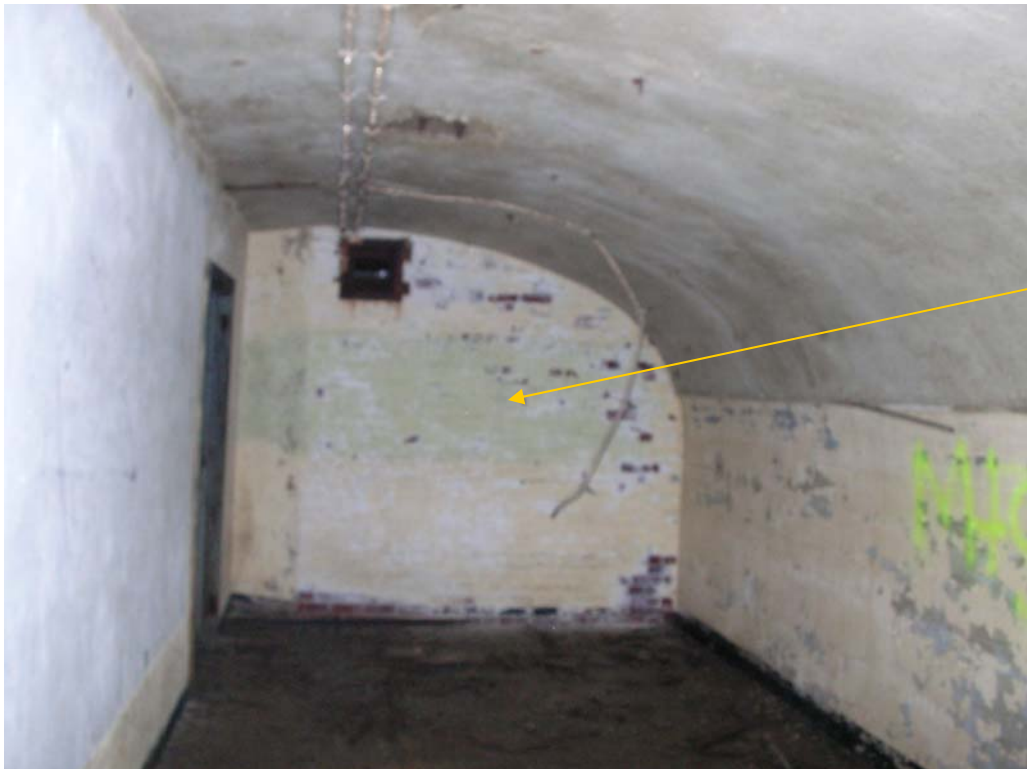
**Longitudinal Gallery  
(A)**

Brick partition  
wall

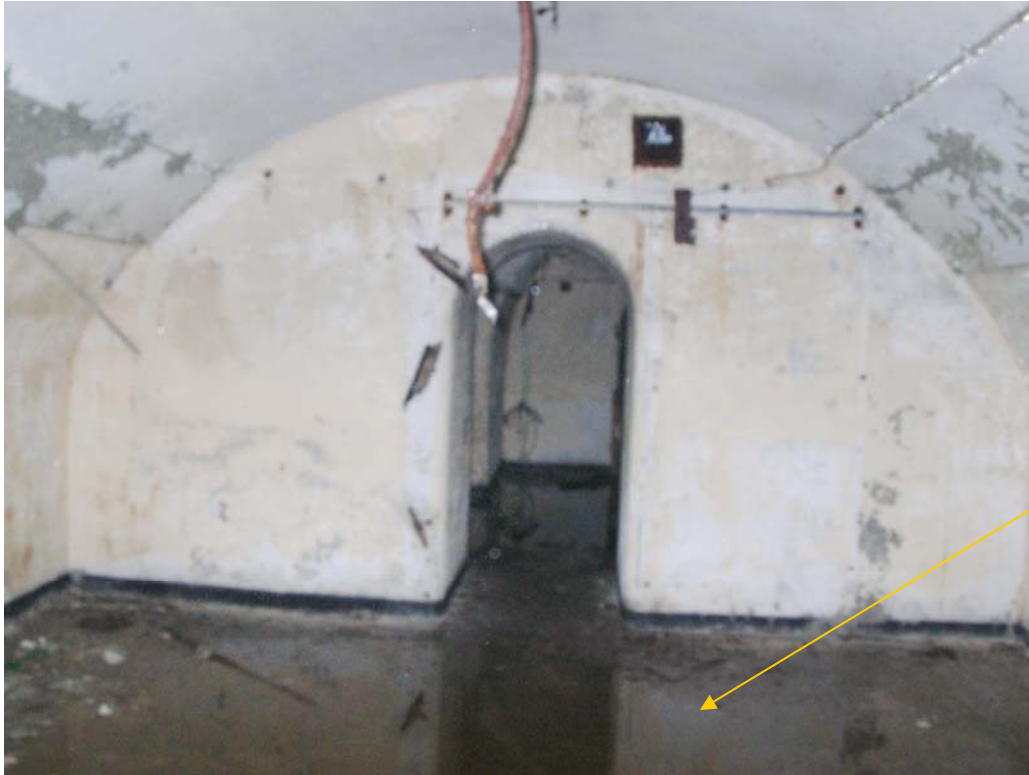
**Magazine Tunnel  
(J)**

Standing water

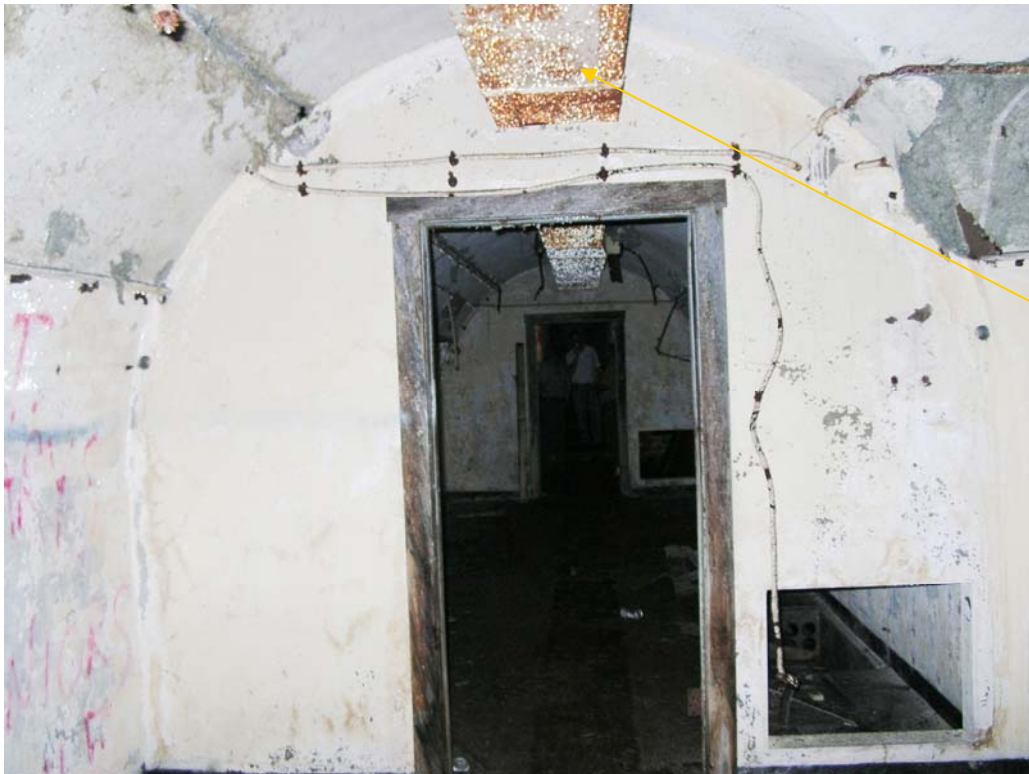
**Magazine Tunnel  
(I—H)**

Condensation  
on metal duct

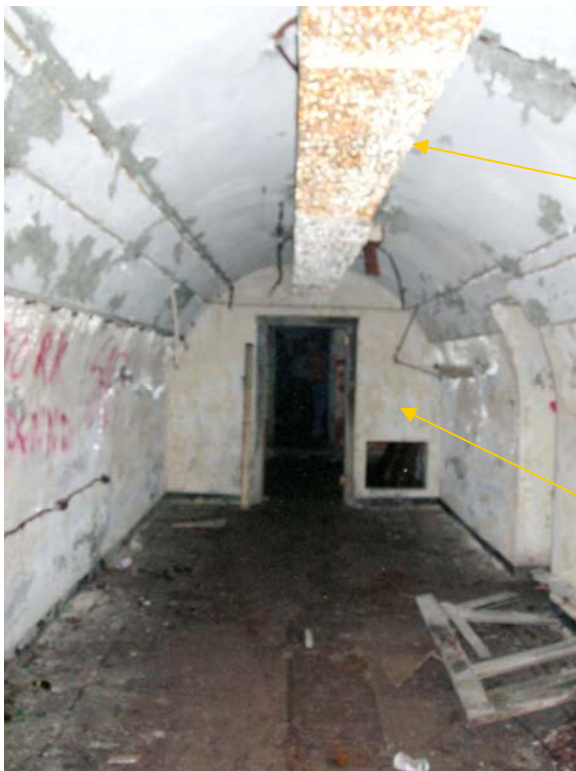
**Magazine Tunnel  
(M)**

Condensation  
on metal duct

Clay tile parti-  
tion with plaster  
finish

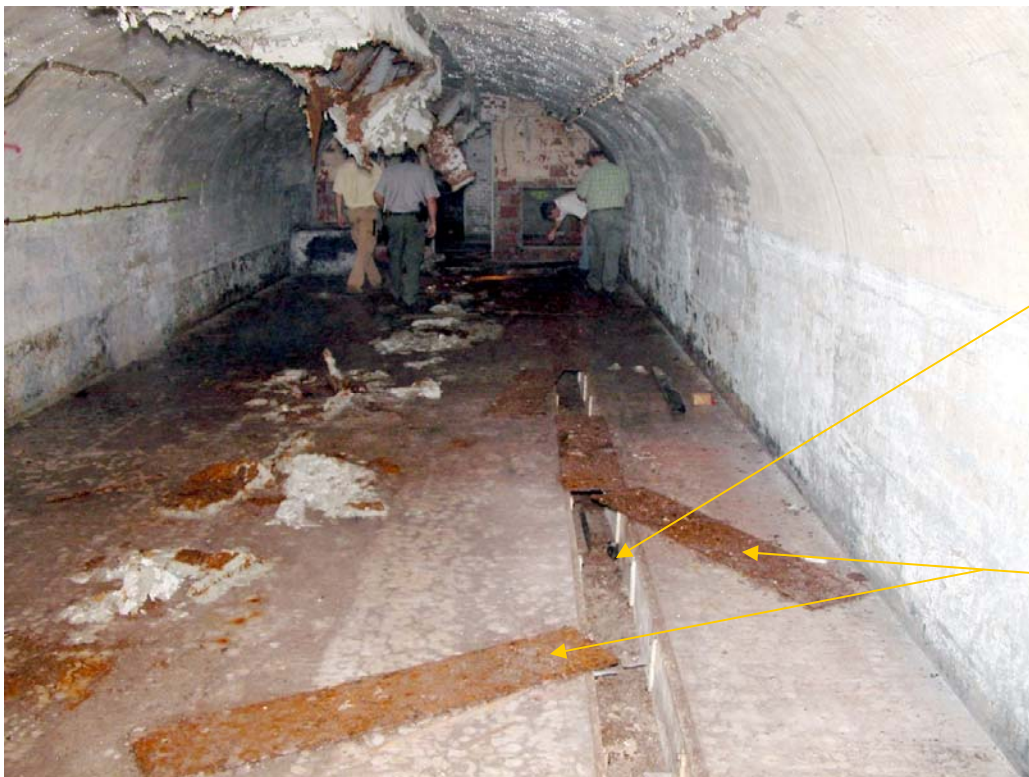
**Longitudinal Gallery  
(T)**

- **Tripping Hazards:** The existing 12”X12” floor tiles, which are partially broken and buckled, will be removed as part of the Hazardous Materials Abatement Project. The most significant tripping hazard is the presence of trenches in the floors, with many areas of the steel plate covers missing or displaced.

Floor trench

Metal plate  
trench cover

- **Tripping Hazards – High:** Removal of adhesives down to the structural slab should be part of the floor tile abatement project. Depending upon the condition of the exposed concrete surface, the treatment is likely to be minor patching; if the condition warrants, placing a new concrete top coat may be necessary. New steel “checker plate” can be replace missing cover plates for the trench systems. Due to the uncontrolled environment, replacement covers could be resistant to corrossions (figure Existing plating that has been displaced can be cleaned, painted and reinstalled.

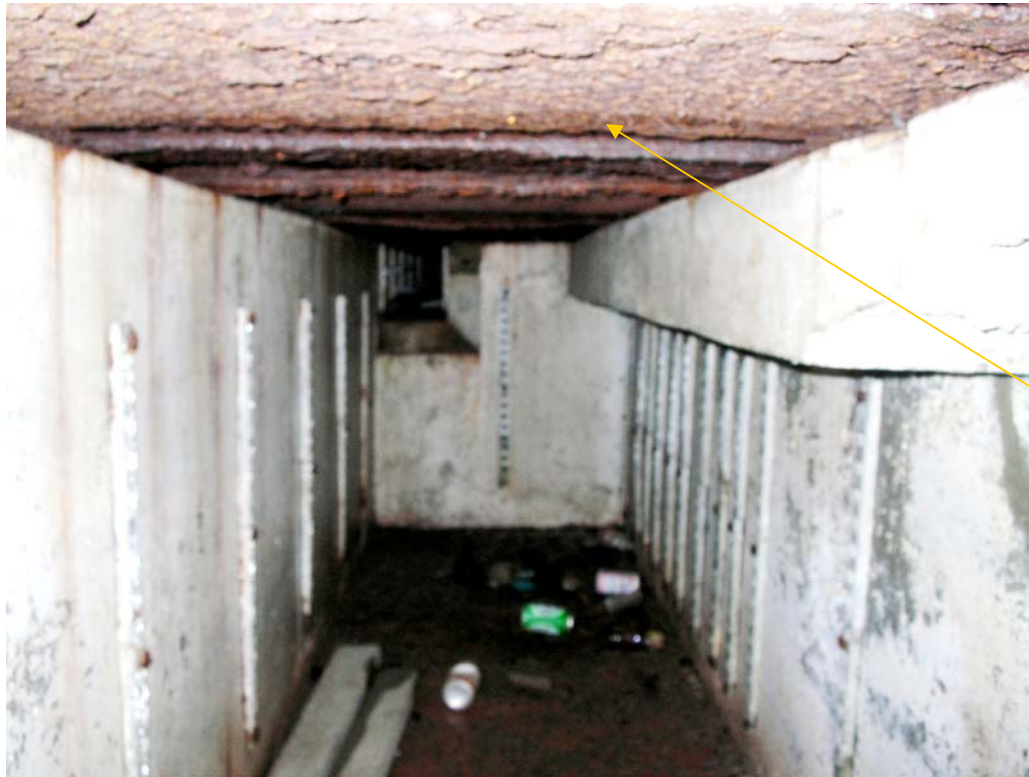
**Floor Trench  
(T-Y)**

Steel cover plate

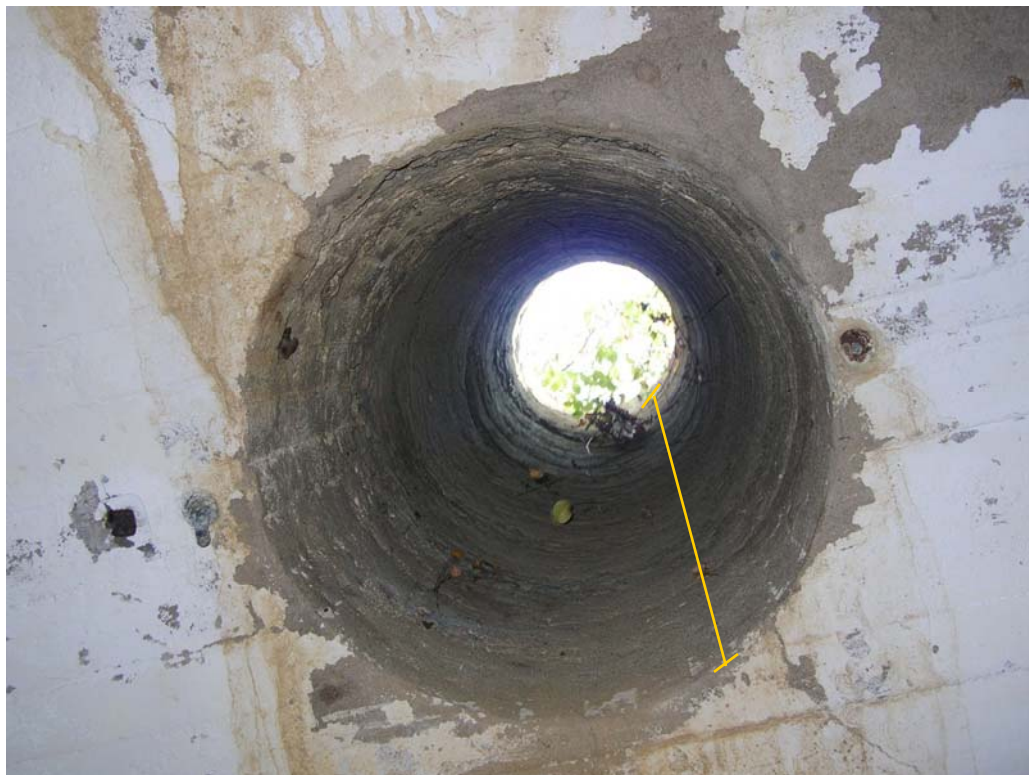
**North Transverse  
Gallery (Y)**

- **Water Infiltration and Ventilation:** The tunnel complex is extremely damp with very limited air turnover. This condition was noted by the military early on in the life of the structure and was addressed in 1912 with the addition of air ventilator shafts. Subsequent use during WWII included a fairly elaborate ventilation and dehumidification system. It is unknown how effective the ventilation was after the 1912 modification, but the installation of gasproof doors in 1942-44 would have adversely affected any natural draft effect intended by the installation of the shafts.

Ventilation shaft cut  
through concrete arch  
(7 feet +/-)

- **Water Infiltration and Ventilation - High:** It appears that rain water is entering the tunnel complex through exterior doors, ventilation penetrations in the concrete arches, and possibly ground water. The existing shafts should be cleaned and capped to increase air flow through the spaces while reducing water infiltration. Figure 5 is a sketch based on a 1911 drawing in the Gateway Museum Collection (Catalog #10674), “Ventilating Flues for Magazines Mortar Batteries Reynolds and McCook.” The doors to the pits can be retrofitted or replaced to increase air circulation and reduce water infiltration
