# **GATEWAY NATIONAL RECREATION AREA SANDY HOOK, NJ**

HISTORIC WATER PLANT BUILDING 341  
PMIS NO. 152823A

## **LIMITED STRUCTURAL INVESTIGATION & REPORT**

NATIONAL PARK SERVICE  
*January 14, 2014*

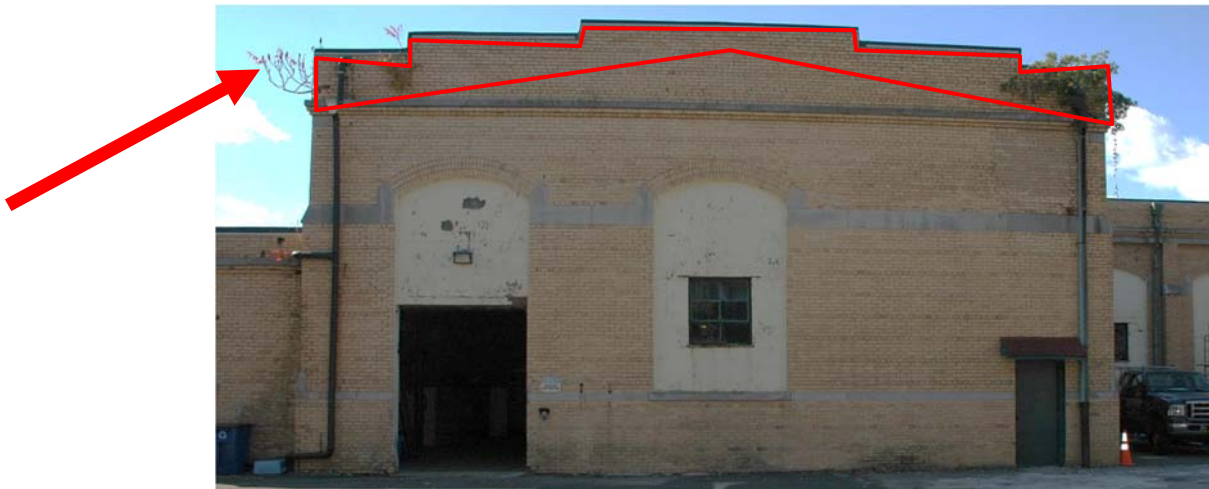
*Figure 1: This photograph shows the north elevation of the 1910 building. The masonry parapet appears to be rotating, and is structurally unstable.*

In all areas where the masonry walls are deteriorating, each section will need to be disassembled and the bricks in good condition shall be salvaged. Approximately 20% of the bricks will need to be replaced, however existing bricks shall be reused where possible. The parapet will need to be rebuilt, replicating all details. For locations and quantities of brick to be rebuilt, refer to drawings on pages 23-25.

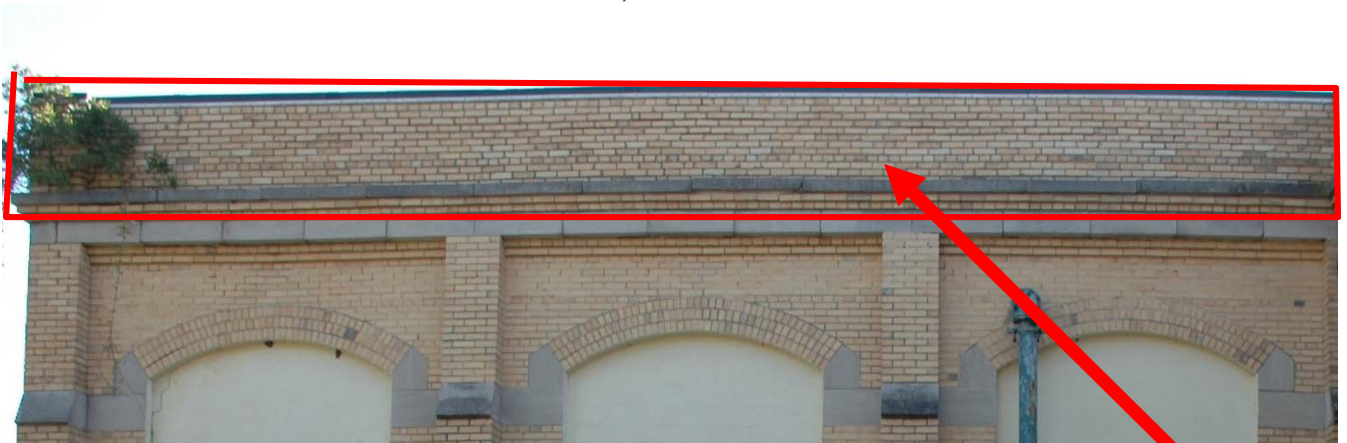
*Figure 2: This photograph shows the west elevation of the 1910 building. The masonry parapet is in very poor condition and will need to be completely rebuilt from the large limestone band course up.*

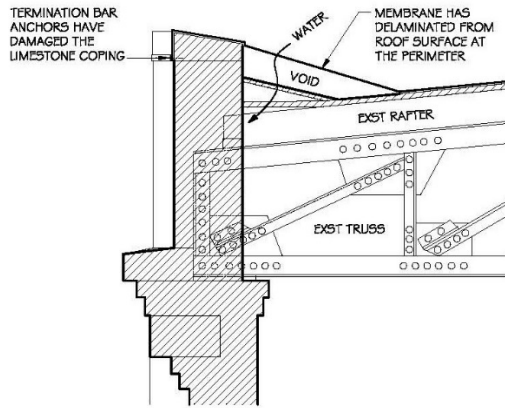
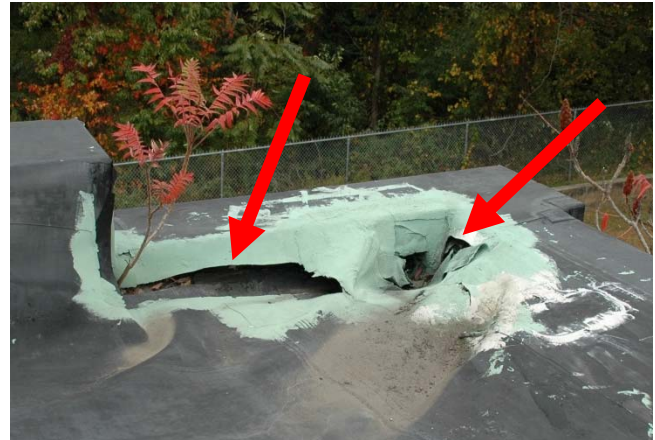
Figure 3: Diagram of the Parapet wall and the southeast corner of Building A showing typical large holes in roof membrane near scupper.

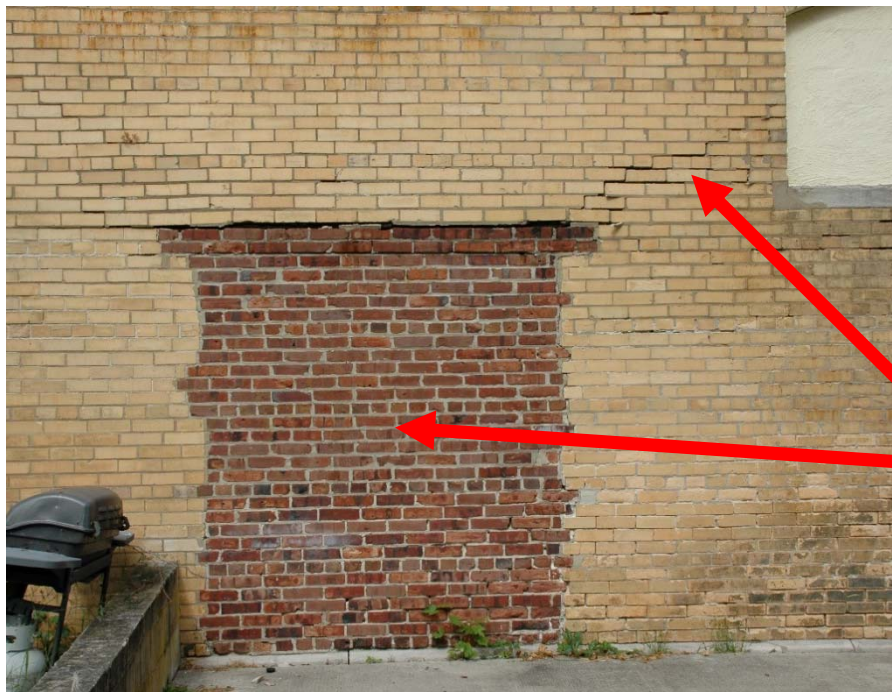
Figure 4: A large area on the east elevation of the 1910 extension has been infilled with red bricks and the surrounding bricks are structurally unstable. These areas will need to be rebuilt.

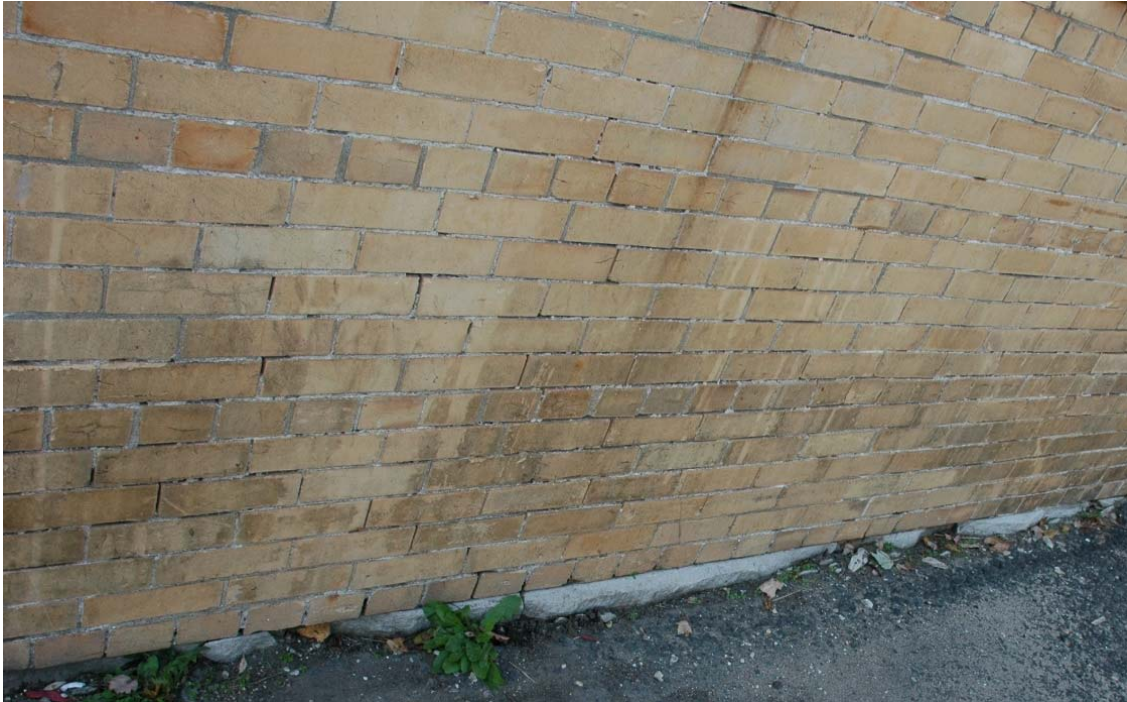
*Figure 5: This photograph shows the west end of the north elevation of the 1910 building. The mortar in this area has deteriorated and will need to be repointed.*

The existing deteriorating mortar should be raked back to sound mortar and repointed with approved mortar. Mortar samples were taken and will be used to specify pointing (Appendix B). For locations and quantities of brick to be repointed, refer to drawings on pages 23 -25.

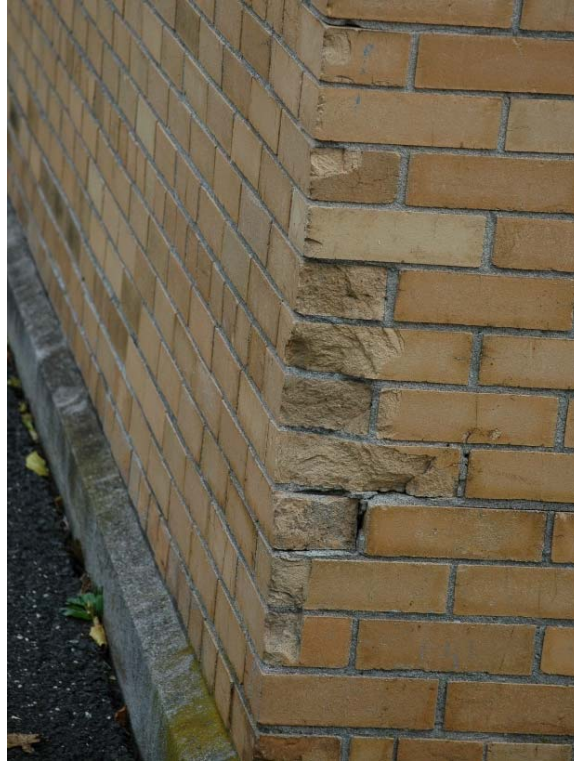
*Figure 6: This photograph shows broken bricks on the the southwest corner of the 1913 addition. Broken and missing bricks will need to be replaced.*

The broken bricks should be carefully removed and replaced with bricks to match the color and size of existing bricks. Missing bricks should also be replaced. A total of 35 bricks need to be replaced on the west elevation, 20 bricks on the east elevation, 15 bricks on the north elevation and 42 on the south elevation. For locations of bricks to be replaced, refer to drawings on pages 23-25.

It is also recommended that bollards be installed in several locations of the building to protect the corners and prevent future damage. On the 1910 building, bollards should be installed on the east and west corners of the north elevation and on each side of the overhead door. On the 1910 lower extension, a bollard should be installed on the east corner of the north elevation. On the 1913 addition, bollards should be installed on the north and south corners of the west elevation and on each side of the center door.

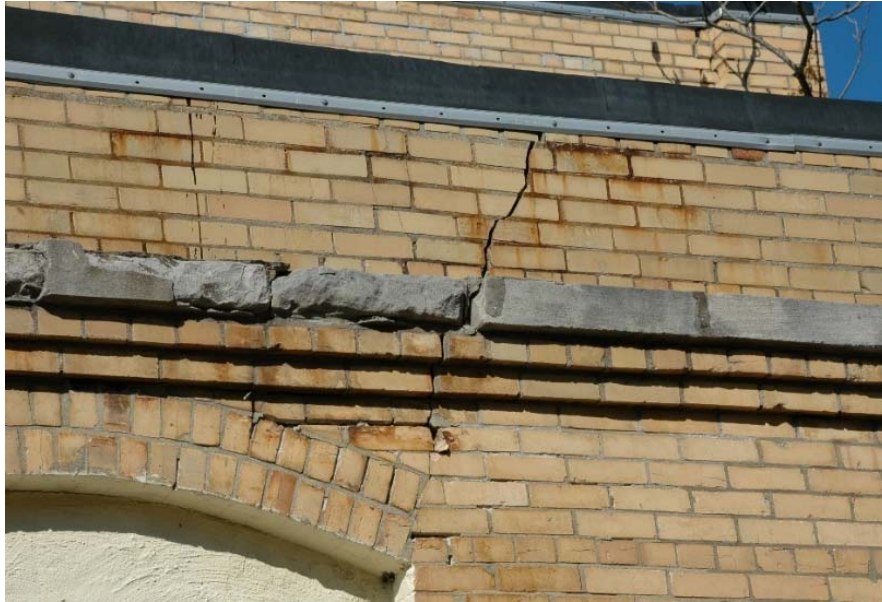
*Figure 7: This photograph shows a crack in the masonry on the north side of the east elevation of the 1910 extension. The crack has resulted in broken bricks and a crack in the limestone belt course.*

Cracks in the mortar joints will need to be repaired by raking and repointing the area. If the crack is wide, crack stitching with stainless steel pins should be installed on every third course. Broken bricks as a result of the crack will need to be cut out and replaced with new bricks. For locations and quantities of brick cracks to be repaired, refer to drawings on pages 23- 25.

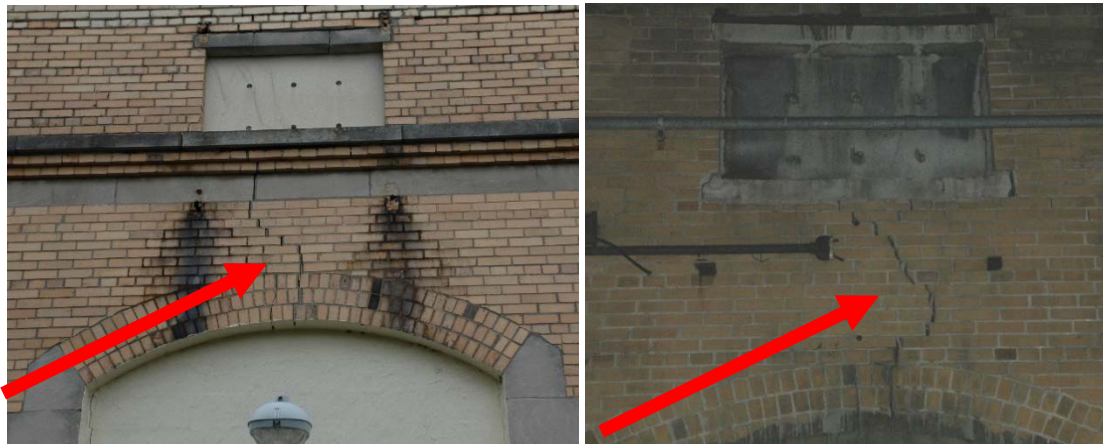
*Figure 8: This photograph shows an exterior and interior crack in the bricks and mortar joint above the central door on the west elevation of the 1913 addition. This demonstrates the expansion and contraction of CMU vs. the expansion and contraction of brick.*

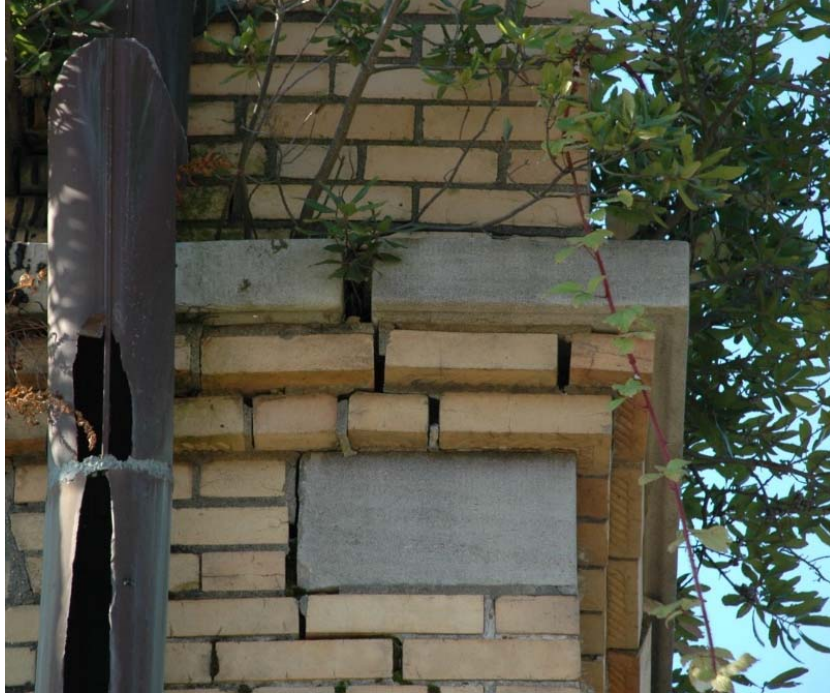
*Figure 9: This photograph shows the west corner of the north elevation of the 1910 building. The limestone has shifted due to vegetation. The stone is in good condition but will need to be reset.*

In several areas, the belt course will need to be reset, as will the corbelled brick courses below. For locations and quantities for resetting the limestone belt course, refer to drawings on pages 23-25.

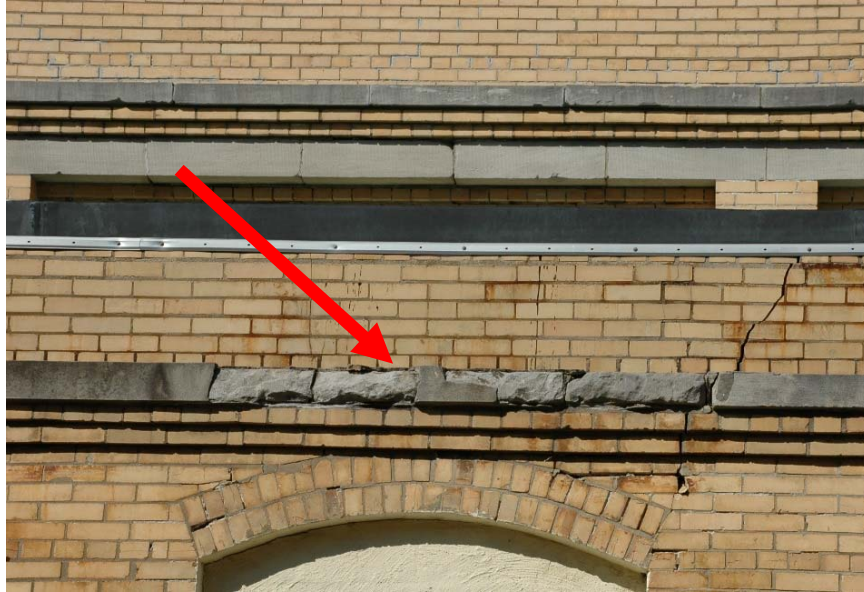
*Figure 10: This photograph shows the limestone belt course on the north side of the east elevation of the 1910 building. This section of the belt course has severely deteriorated and will need to be replaced.*

In locations where the limestone belt course is damaged beyond repair, sections will need to be replaced. Removal of existing stone and installation of new stone to match will be required. For locations and quantities of replacing limestone belt course, refer to drawings on pages 23-25.

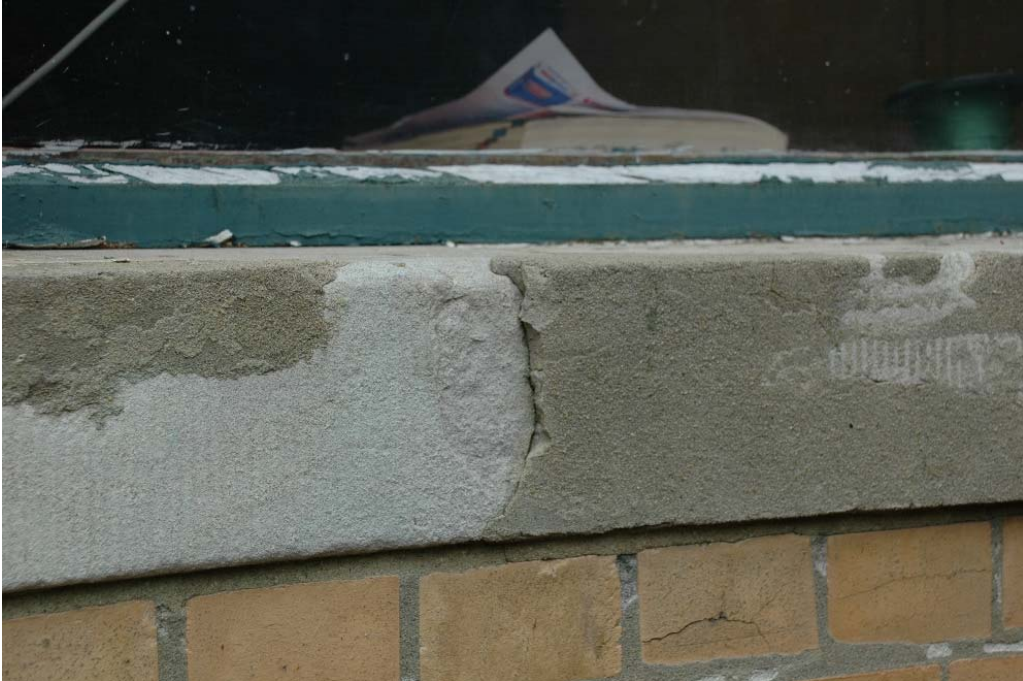
*Figure 11: Some of the limestone is in fair to poor condition and has been previously patched, as seen here. Old failing patches will need to be removed and new patches installed. This photograph shows the south window of the east elevation of the 1910 extension.*

Another area of concern with the limestone is damage due to failed existing patches, spalls and stone losses. Repairs range from small patches less than 12 square inches and large patches more than 12 square inches. The existing patches need to be removed and loss area will be prepared and filled with approved mortar. New spalling and holes will also need to be patched with approved mortar. The repair of spalls, failed patches and losses is similar; all damaged material will first be removed. Loss area will be prepared and approved patch material will be installed. For locations and quantities of patching limestone, refer to drawings on pages 23-25.

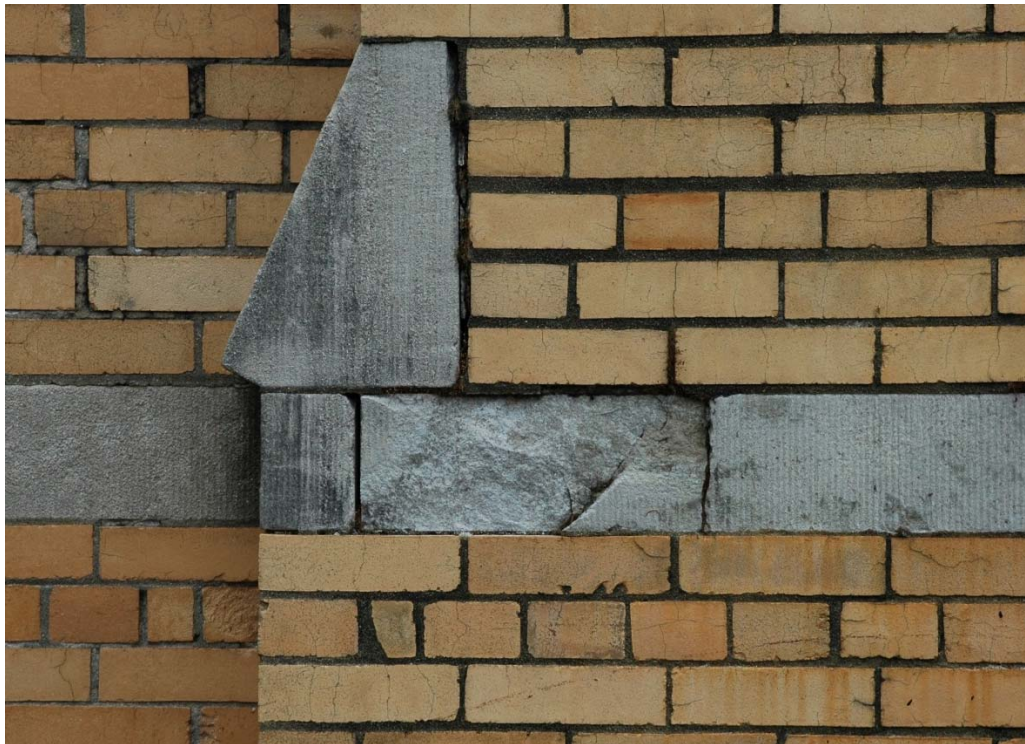
*Figure 12: Much of the limestone is in fair to good condition with specific areas of damage. These damaged areas should be patched. This photograph shows the west end of the south elevation of the 1910 building.*

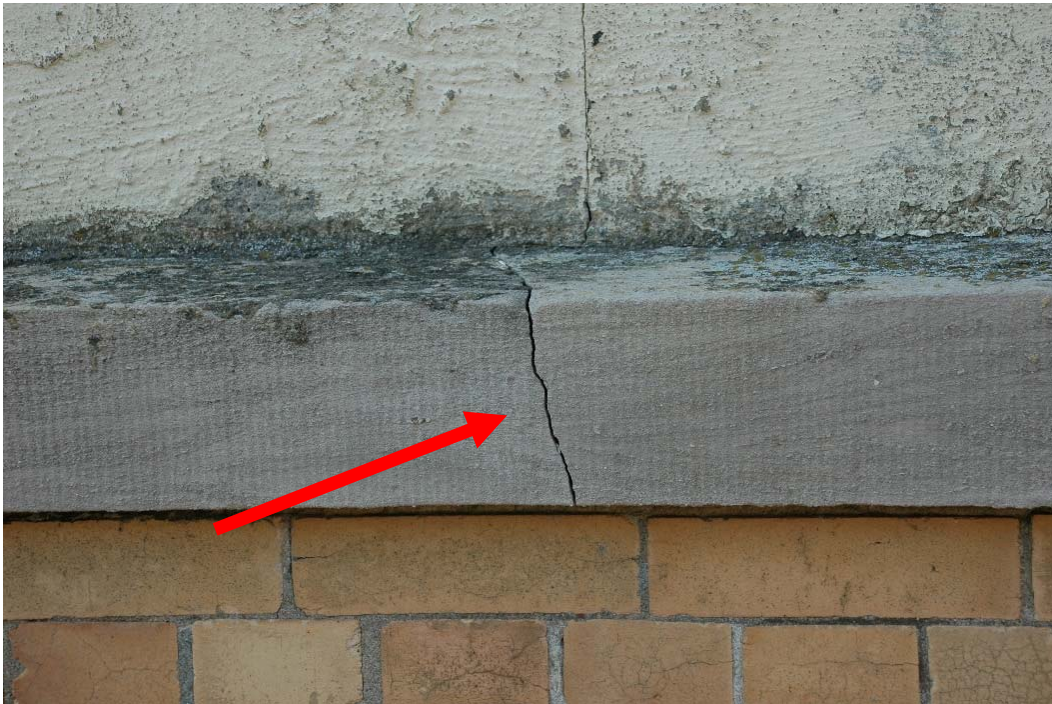
*Figure 13: Typical limestone crack in a window sill that will need to be repaired. This sill is located on the west side of the north elevation of the 1910 extension.*

Each elevation has several cracks in the limestone; especially in the belt course and water table. Cracks will be routed out and patched, and deep cracks will have stainless steel pins installed in epoxy. For locations and quantities of limestone cracks to be repaired, refer to drawings on pages 23-25.

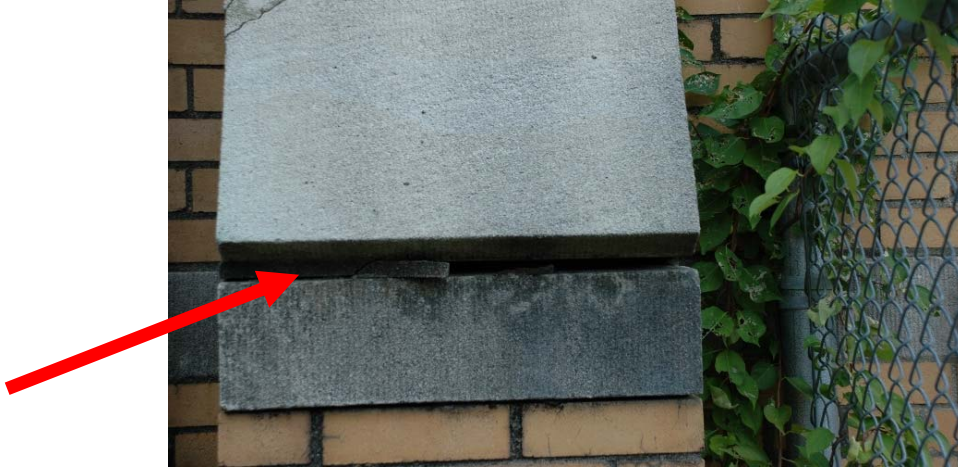
*Figure 14: Mortar is missing between two pieces of limestone. This photograph shows the east pier of the south elevation of the 1913 addition.*

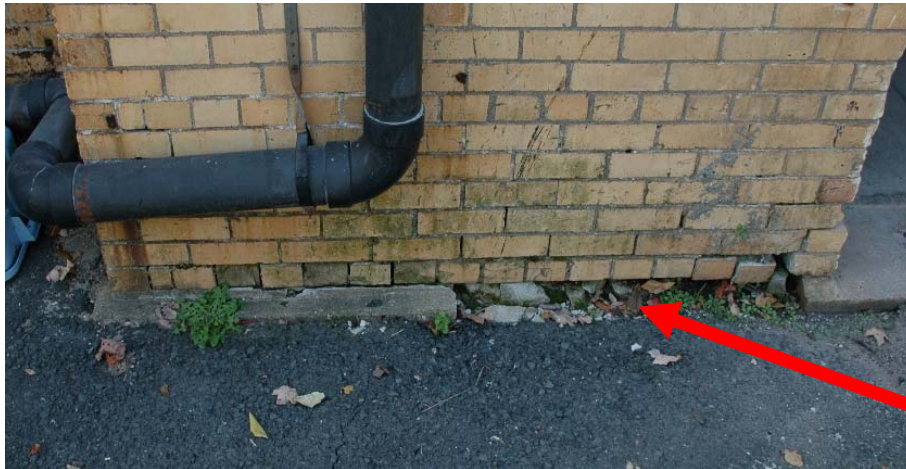
*Figure 15: Parts of the limestone base are severely deteriorated. This photograph shows the east end of the north elevation.*

Large areas of the limestone base have deteriorated as a result of their contact with the ground and/or pavement. The areas that are deteriorated should be cut back and new stone Dutchman should be installed to replicate the existing stone. Dutchman will be set in epoxy adhesive and secured in place with stainless steel anchors set in epoxy. For locations and quantities of Dutchman limestone, refer to drawings on pages 23-25.

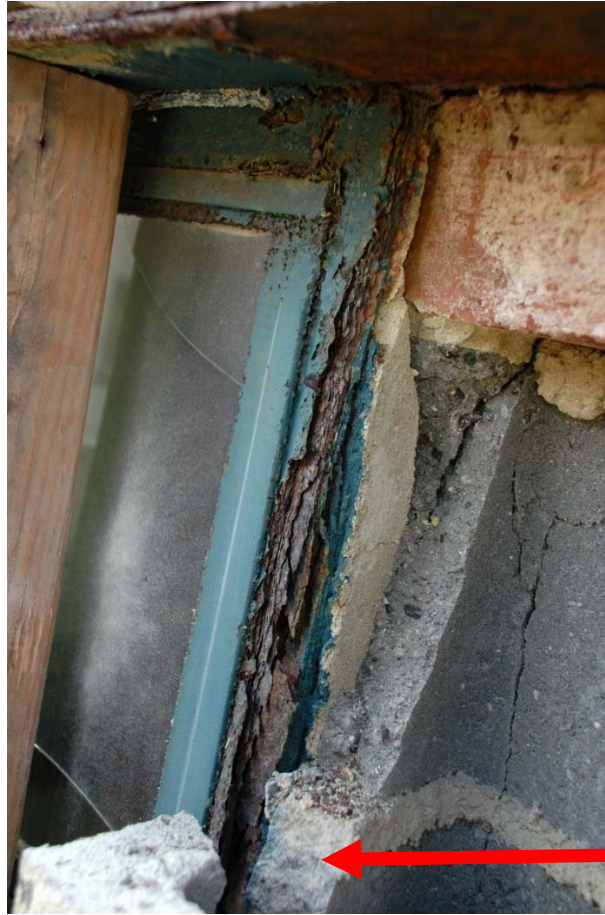
*Figure 16: The delaminating steel on the window has caused the CMU infill to crack and split. This window is located on the west end of the north elevation of the 1913 addition.*

In places where the damage is more significant than hairline cracks or holes, the CMU will need to be rebuilt. Some of the CMU infills have been fractured by steel jacking and need to be replaced. For locations and quantities of rebuilding CMU, refer to drawings on pages 23-25.

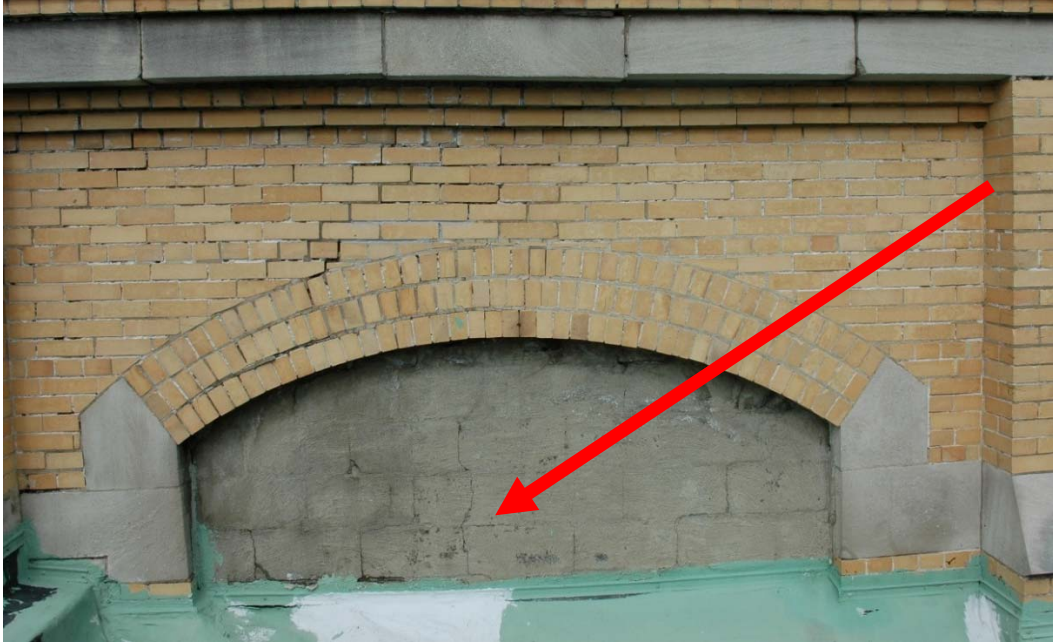
*Figure 17: Moisture has penetrated the CMU infill and has caused cracks in the joints. This is the south infill of the 1910 building above the extension.*

CMU infill should be coated with three coats stucco system installed over galvanized expanded metal lathe to prevent water from penetrating the CMU. A sealant joint should be installed at the perimeter of the infill. It is recommended that all work pertaining to CMU crack repairs on the section above the

lower extension be coordinated with roof work. For locations and quantities for CMU repair, refer to drawings on pages 23-25.

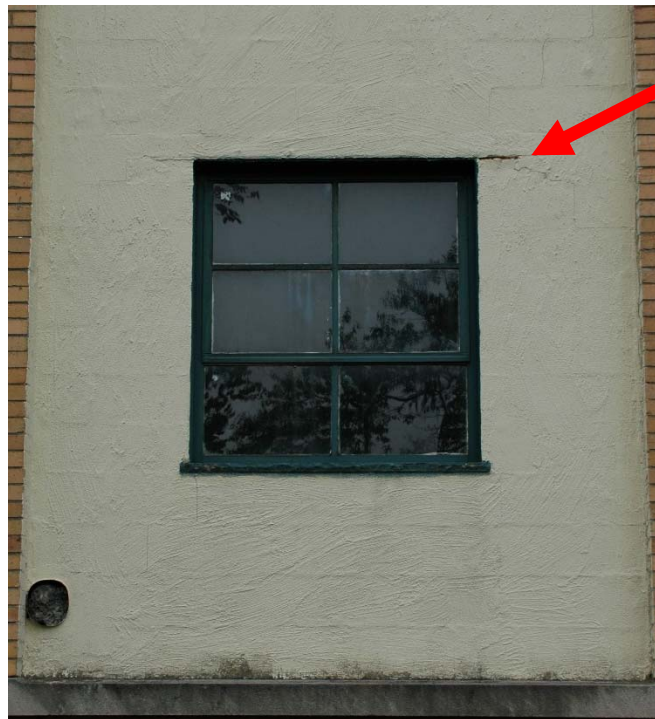
*Figure 18: This deteriorating steel window, located in the south opening of the north elevation, has expanded and caused cracks in the CMU infill.*

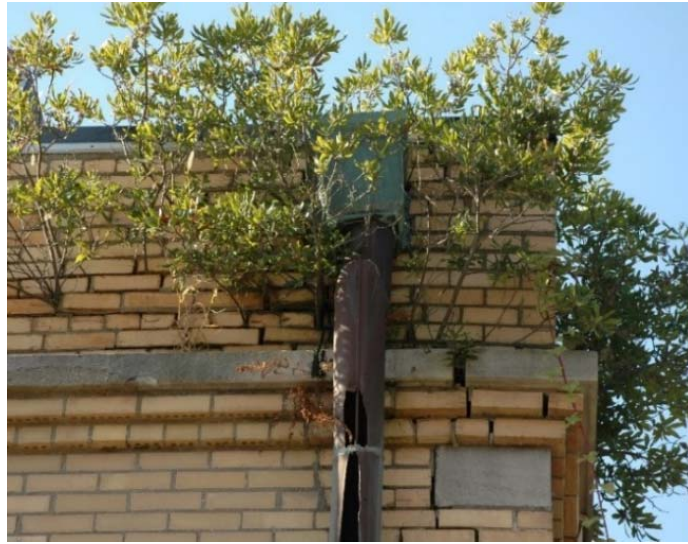
*Figure 19: Infiltrating moisture has caused cracks and openings in the masonry, providing a place for vegetation. This photograph shows the west corner of the north elevation of the 1910 building.*

The vegetation should be carefully removed and the masonry and pointing should be replaced or repaired as needed. Removal of vegetation should be done in conjunction with the rebuilding of the parapet walls. For locations and quantities of vegetation to be removed, refer to drawings on pages 23-25.

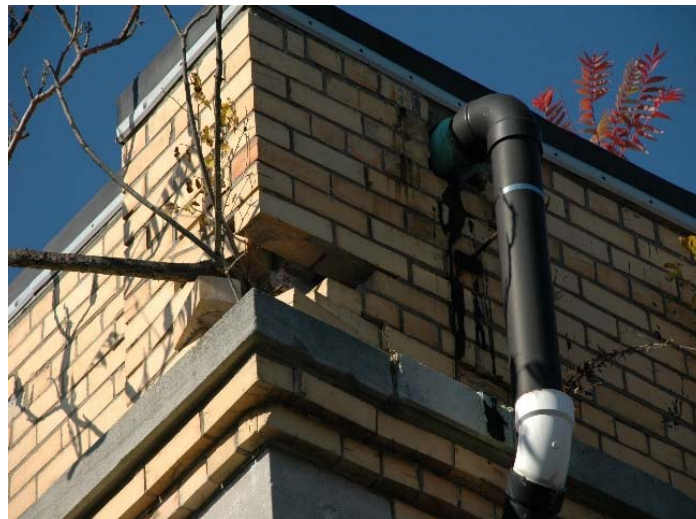
*Figure 20: Water infiltration has resulted in openings in the mortar where vegetation is growing, damaging more bricks as a result. This is the east corner of the north elevation of the 1910 building.*

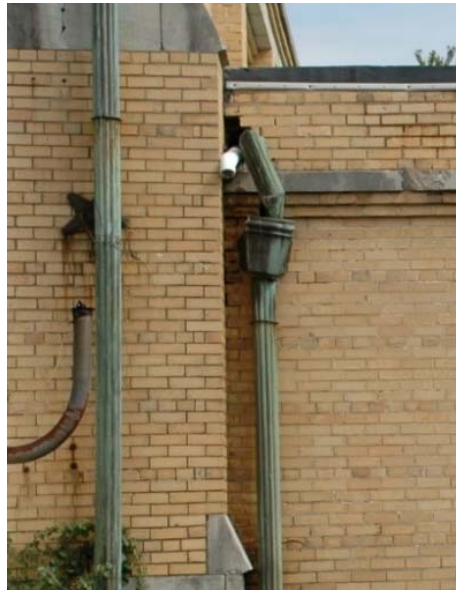
*Figure 21: Typical downspout in need of replacement, located on the east end of the south elevation of the 1910 building.*

It is recommended that all of the downspouts, leader boxes and scuppers on the building be replaced with copper RWCs. This should be coordinated with the roof replacement (part of a separate contract).

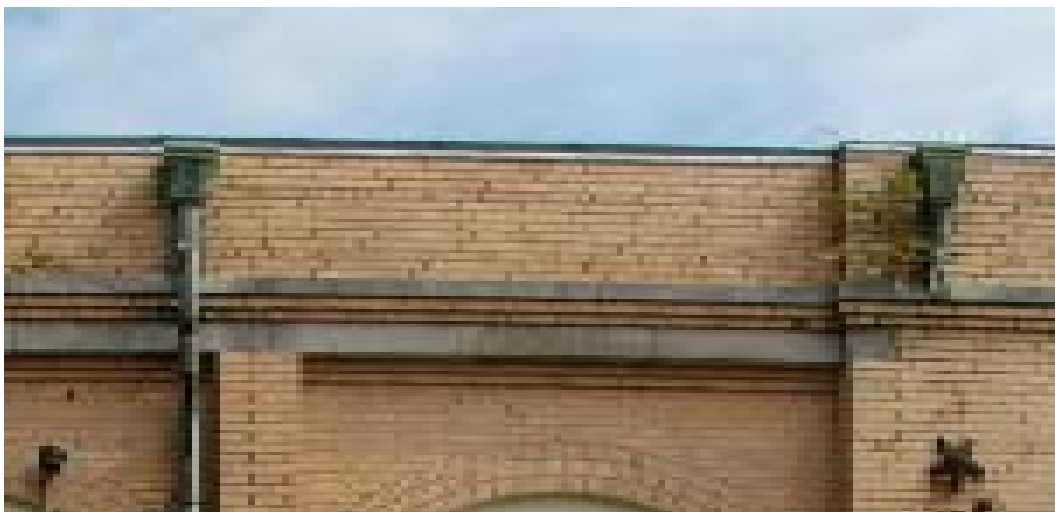
*Figure 22: Typical deterioration of leader boxes and downspouts in need of replacement. These downspouts are located on the south elevation.*

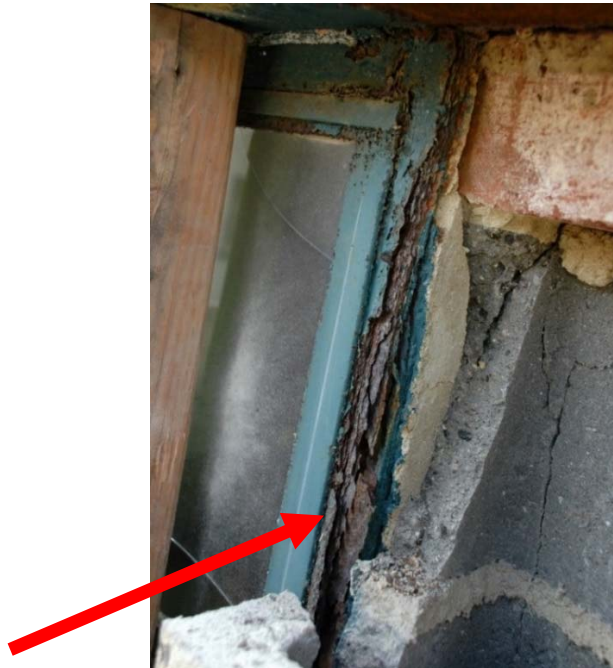
*Figure 23: Delaminating steel of a typical window due to moisture. This window is located on the west end of the north elevation of the 1913 addition.*

All windows should be removed from CMU infill and restored (this will require removal of CMU at the jambs). All rust is to be mechanically removed, and any damaged members should be replaced. Windows are to have glass removed and be primed and painted. Glass will be reinstalled as will the unit. Work is to be coordinated with lintel replacement or repair (see structural report). Windows damaged beyond repair are to be replaced. According to the *Asbestos Containing Building Material Survey*, prepared by PRIZIM (2009), samples of glazing and caulking materials were not collected or tested. However, it is reasonable to assume that they may contain asbestos or Polychlorinated Biphenyls (PCBs), and as a consequence all window removal procedures will need to follow state guidelines for hazardous material removal. For locations and quantities of windows to be repaired or replaced, refer to drawings on pages 23-25.

Alternate: Replace all windows with new aluminum units. Factory-finished aluminum (or fiberglass) windows would be more durable in the shore environment than steel windows. The replacement windows installed in 1971 are not character-defining, and an alternate material such as aluminum should be acceptable.

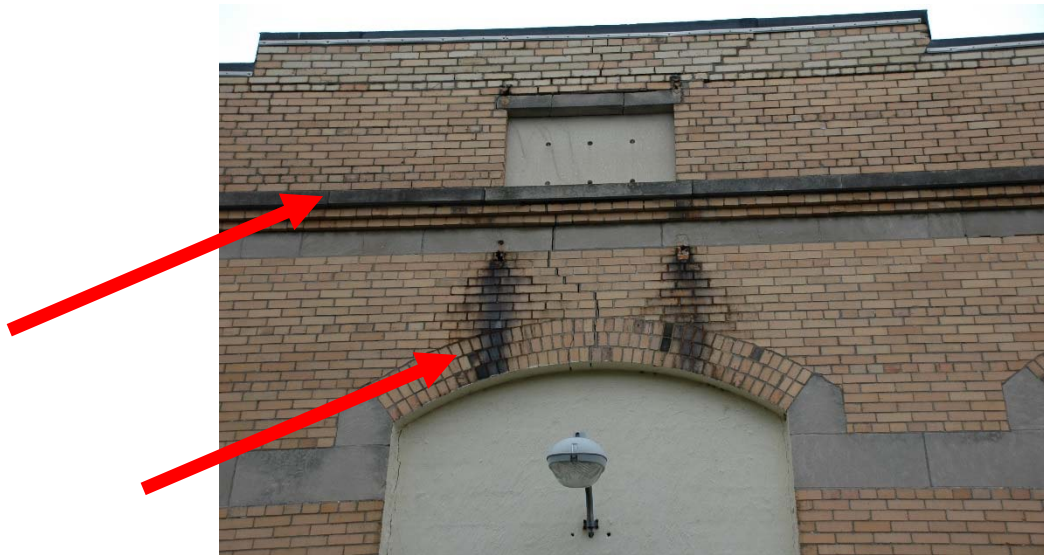
*Figure 24: The top arrow shows atmospheric stains and the bottom arrow shows rust stains. This shows the center bay of the west elevation of the 1913 addition.*

The entire building should receive a general cleaning. Several locations will require special attention to remove heavy biological, atmospheric and rust stains in the masonry. These areas should be cleaned, starting with water and a soft bristle brush, the least aggressive method of cleaning. If water isn't a sufficient cleaner, a mild detergent should be used. The last option would be to use a masonry cleaner if absolutely necessary. After cleaning, application of a biocide may be considered to prevent stains from reoccurring in the future.

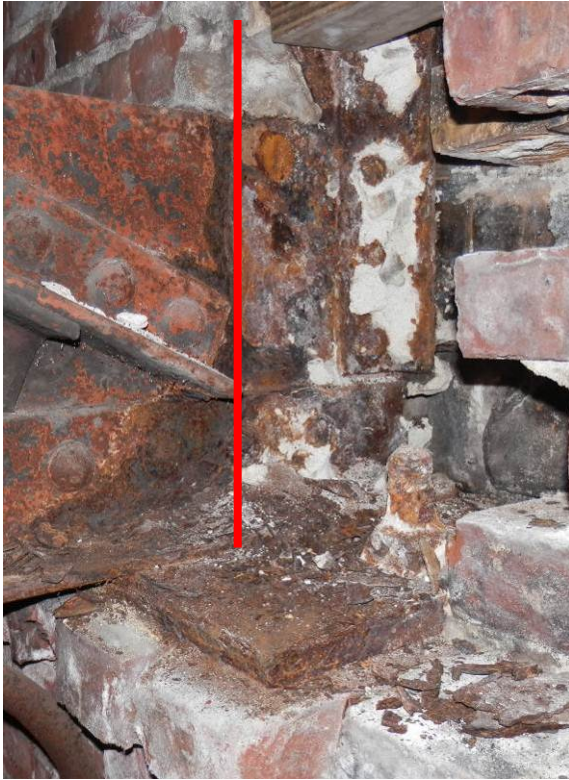
*Image 6 – At locations T-3 & T-4, red line indicates extent of brick wall. Dark portions of the truss to the left are areas of high section loss due to corrosion, likely from water running down wall and truss.*

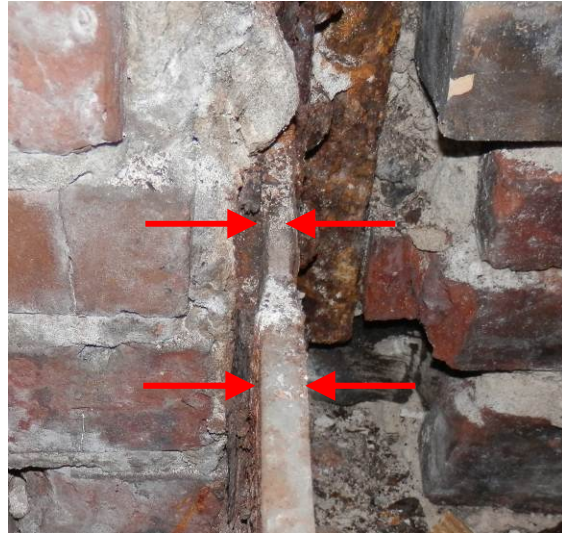
*Image 7 – Section loss (top arrows) compared to intact section (bottom arrows) of bottom chord at probe location T-3 (see Image 16).*

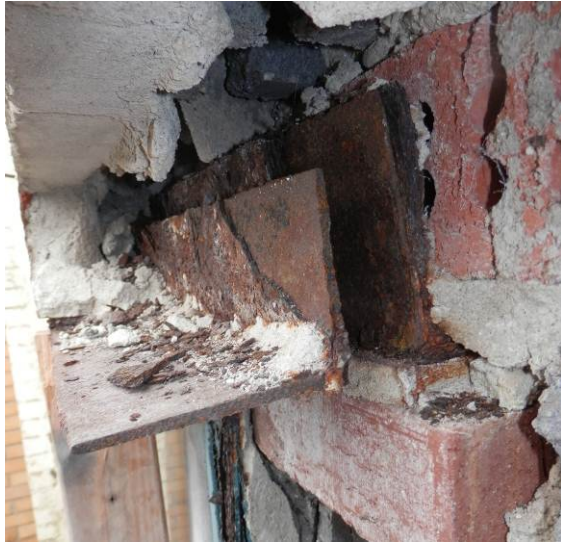
*Image 8 – Two angles supported window opening at probe location W-1 (see Image 16). Outer angle is turned on its long side.*

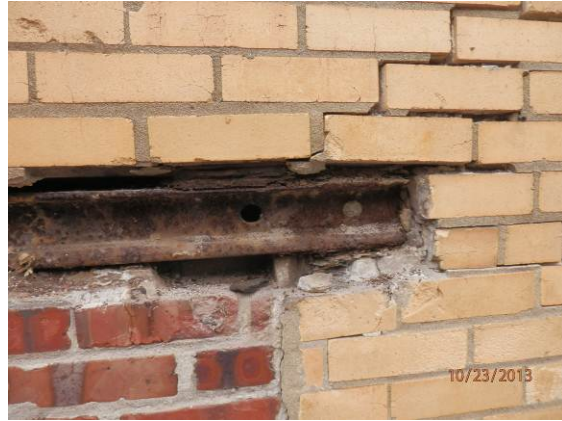
*Image 9 – At W-4 probe location, railroad track sections used as a lintel.*

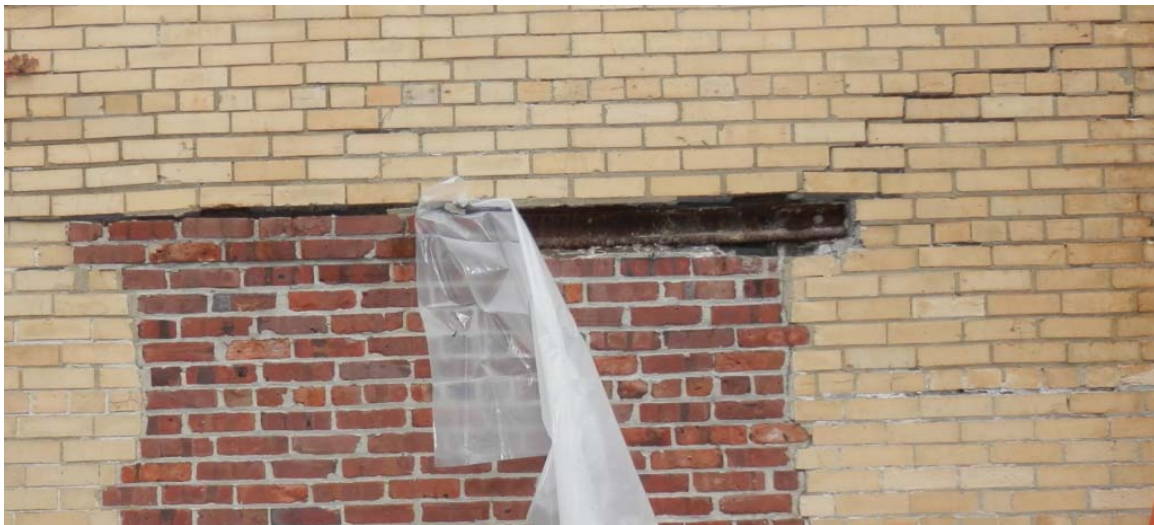
*Image 10 – Probe location W-3 (see Image 16), showing masonry deterioration from rust-jacking.*

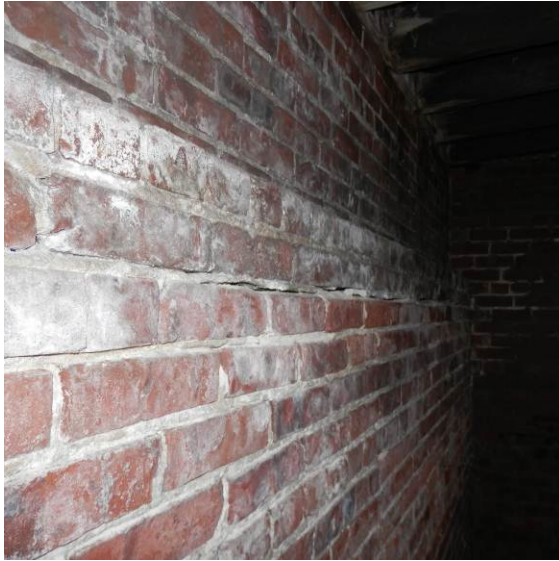
*Image 11 – Horizontal crack running two courses below truss as seen at probe location T-3 (see Image 16).*

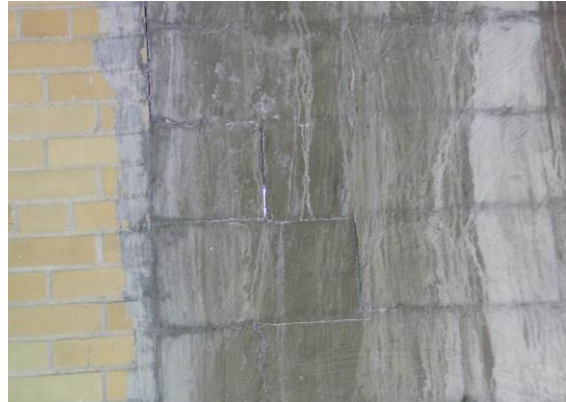
*Image 12 – Crack through CMU infill on south wall of addition. Day light is visible through the crack.*

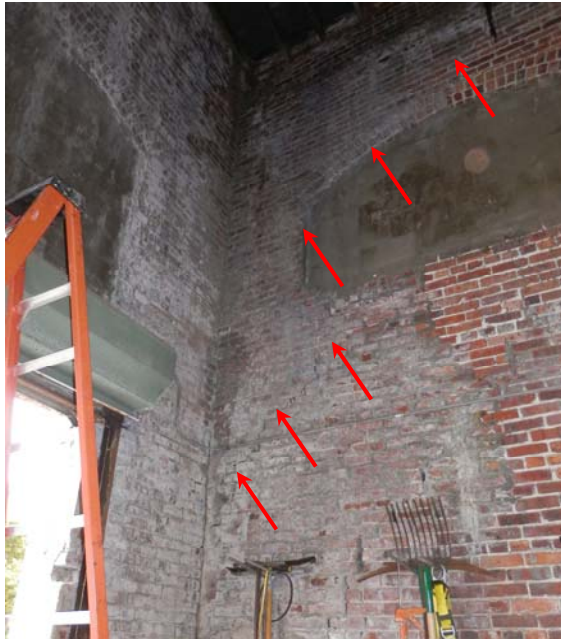
*Image 13 – Crack in east wall at northeast corner of the original building.*

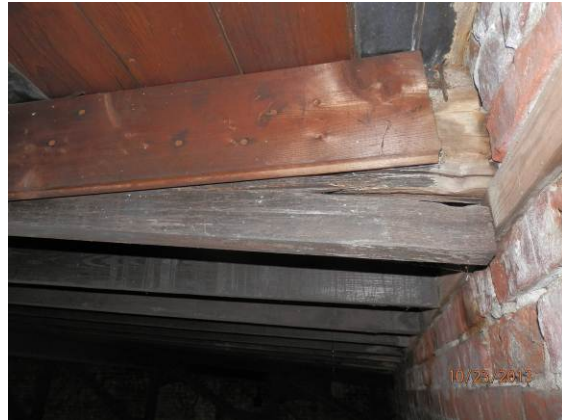
*Image 14 – Split wood roof joist at sill with previous repairs as seen at probe location T-3 (see Image 16).*

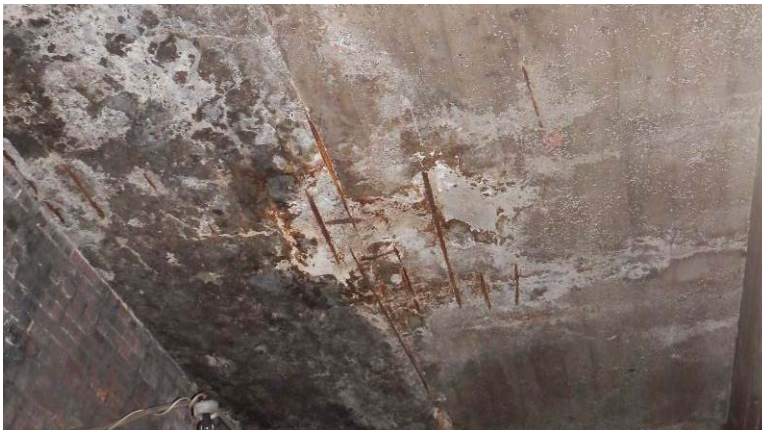
*Image 15 – The underside of the concrete slab exhibits spalling and corroding reinforcing steel; shown location is just inside the east addition of the north portion of the original building.*
