# A Geotechnical Investigation of Pretty Rocks Landslide, Mile 45.4, Denali Park Road, Denali National Park, Alaska

Natural Resource Report NPS/DENA/NRR—2022/2365

March 2022

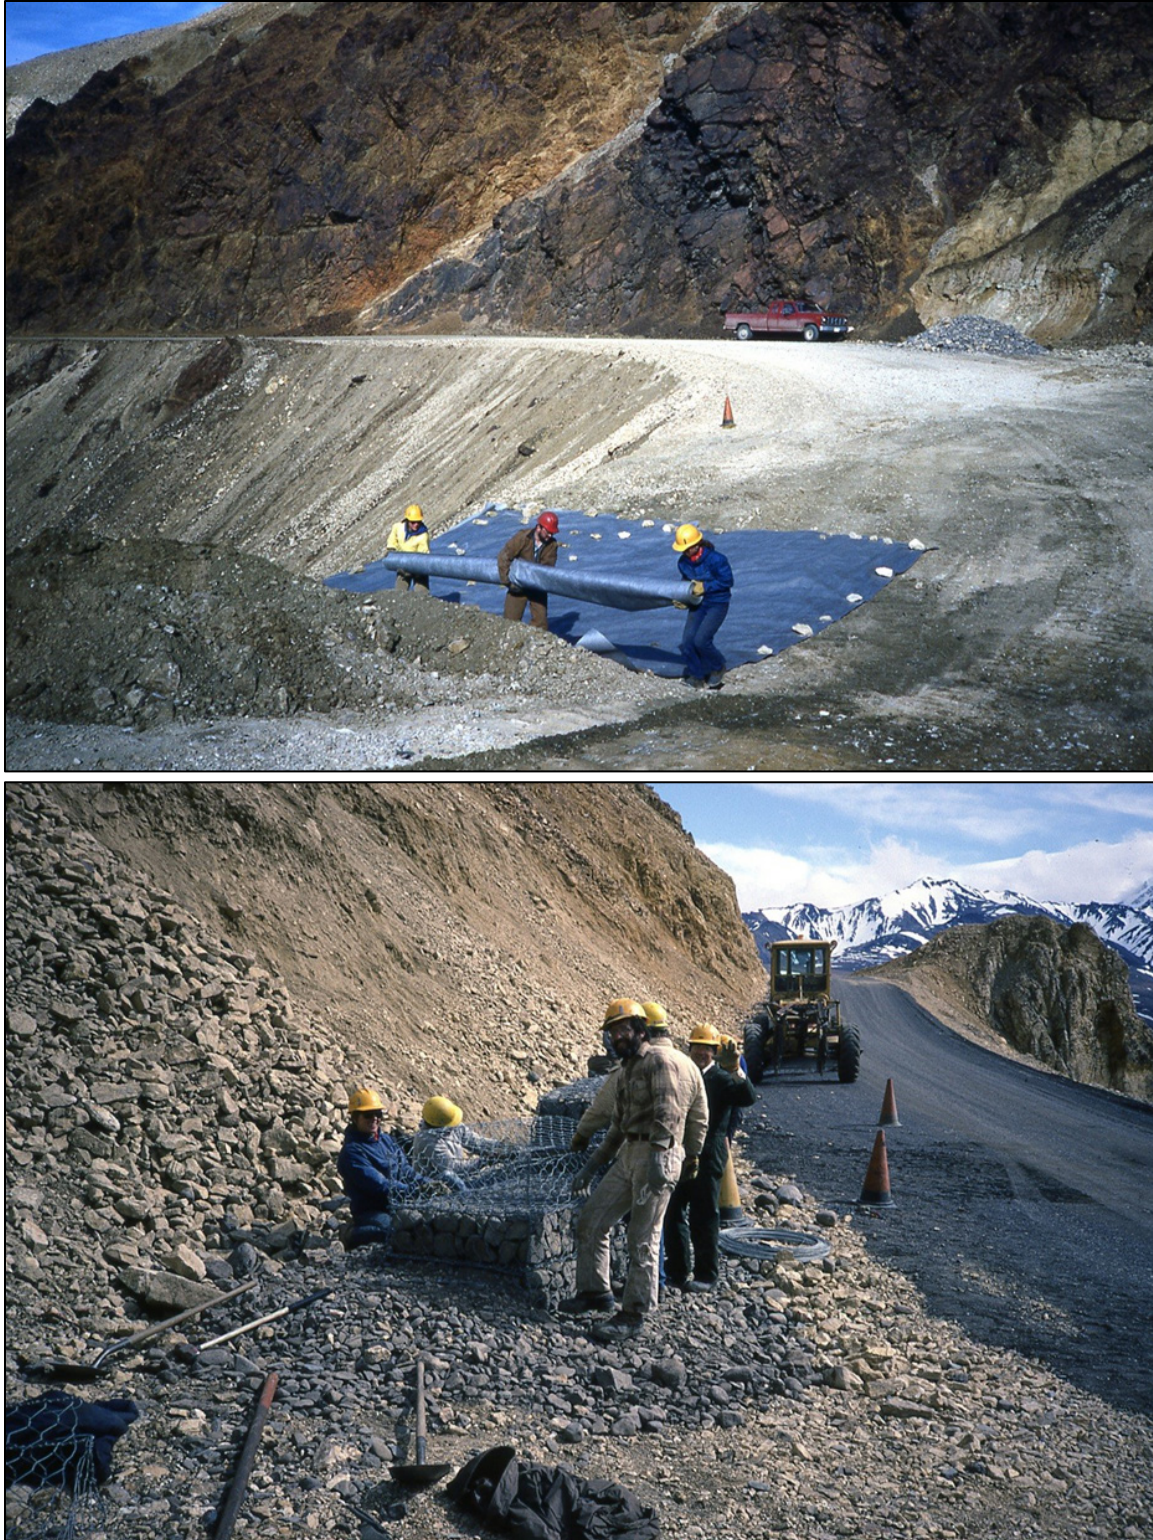
**Figure 2.** (TOP) Installing geosynthetic layer reinforcement along the road surface which cross cuts the landslide. Photo taken 1987. (BOTTOM) Installing a French drain near the northwestern lateral scarp (i.e. road crack) location. Photo taken 1987.

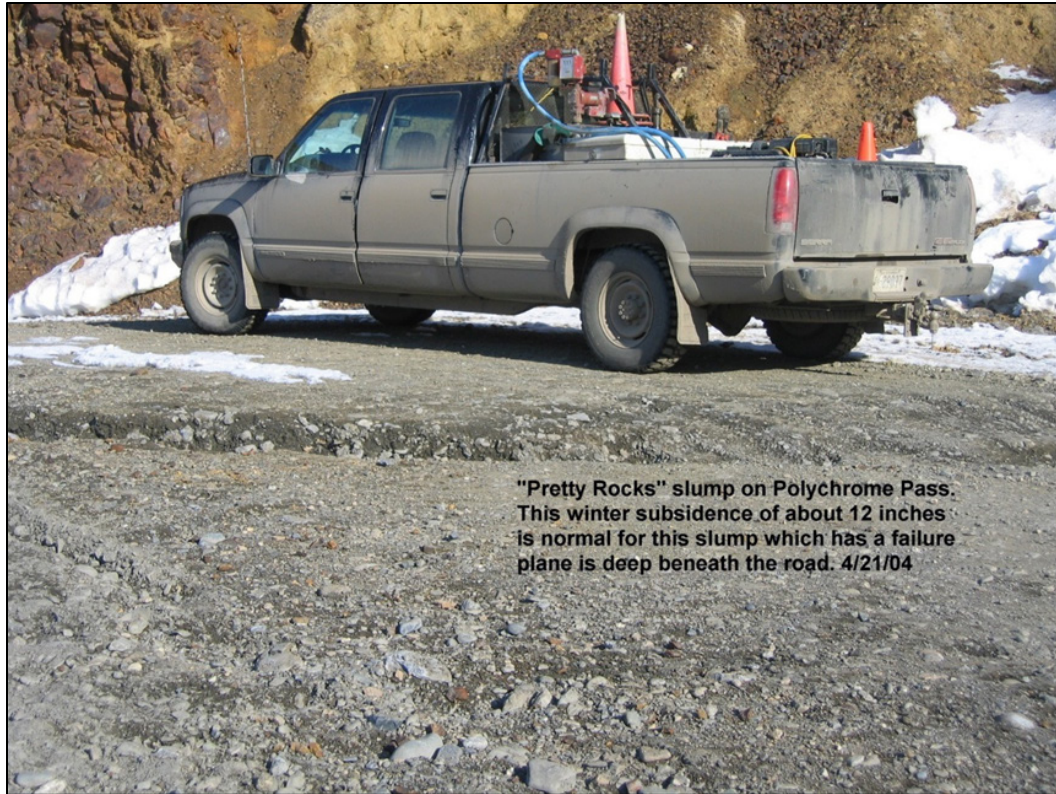
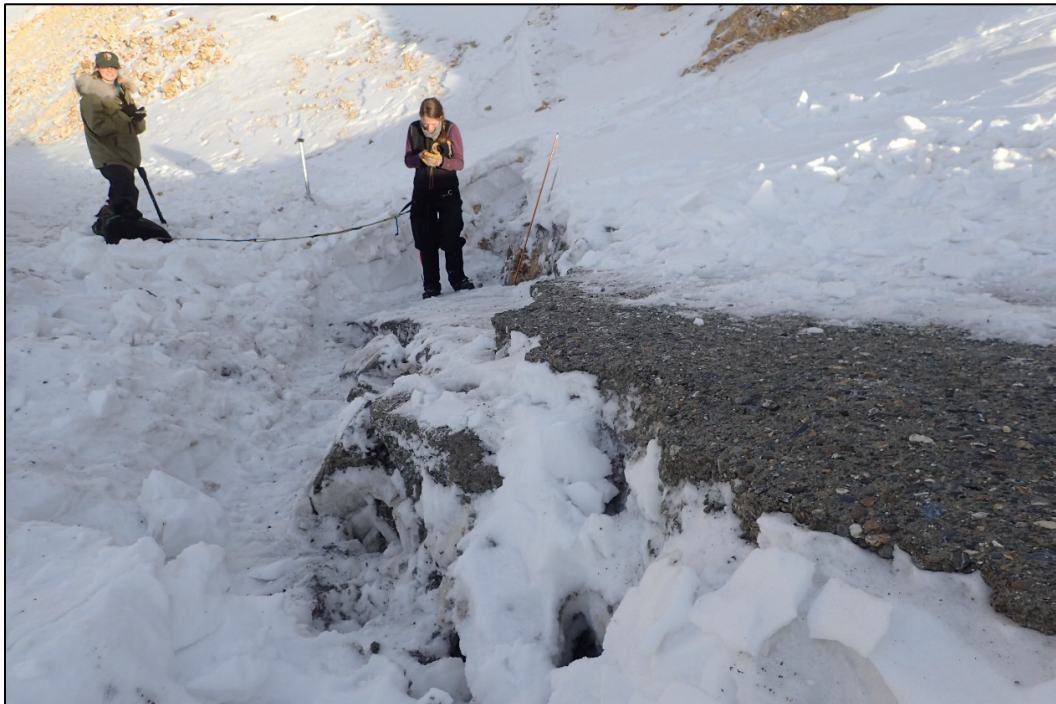
**Figure 3.** (TOP) Vertical offset along northwestern lateral scarp (i.e., road crack) in April 2004. (BOTTOM) Vertical offset along southeastern lateral scarp (i.e., road crack) in March 2018.

According to the NPS, the northwestern and southeastern road tension cracks have been present for many years. Historically, these lateral landslide scarps have experienced changes in offset and aperture up to 10 cm during the open summer road season. The road is closed past Mile 3 during the winter which prevents regular observation. When the road is cleared in late spring, maintenance crews often find significant vertical road displacement within the landslide limits although the offset has rarely been measured and documented.

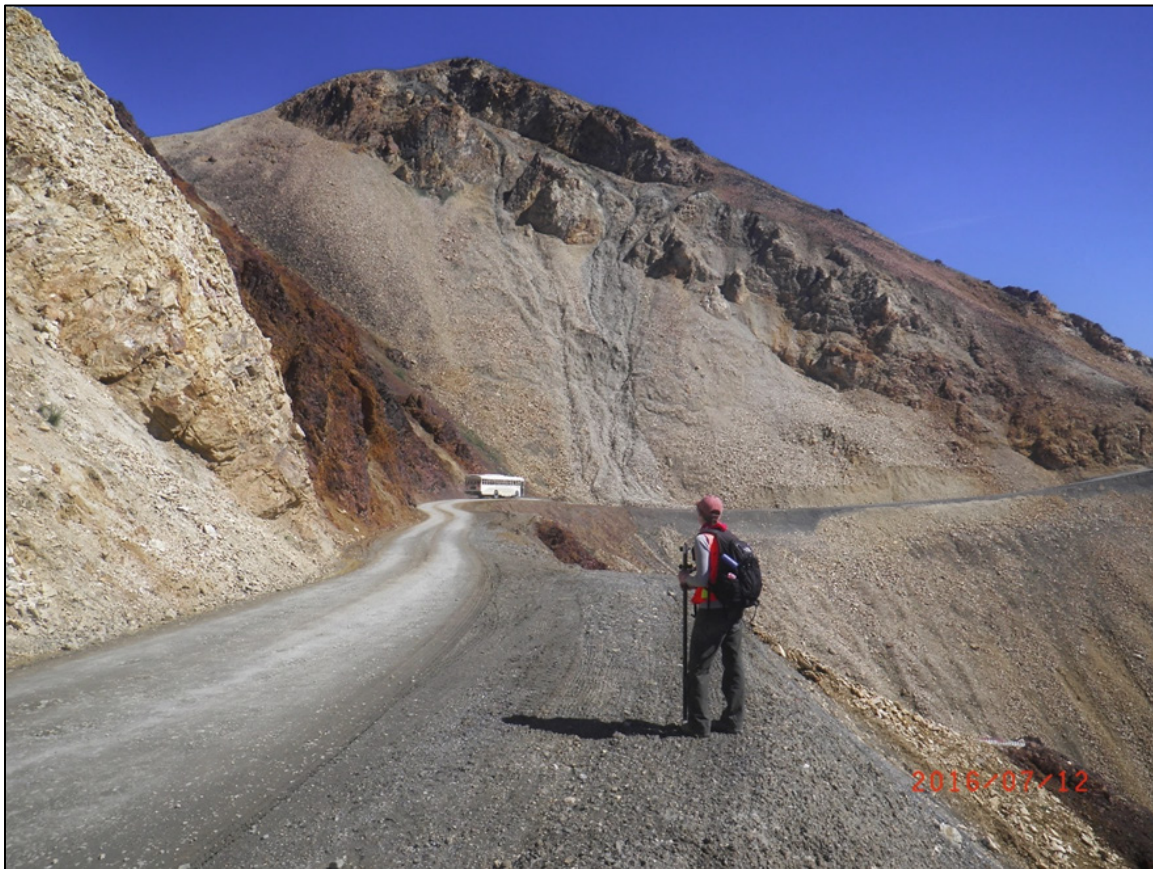
**Figure 5.** Pretty Rocks colluvium slope. Note the drainage of dark, perlite-derived material in the slope's center, and the more homogenous, weathered colluvium in the upper left. Photo taken looking northeast.

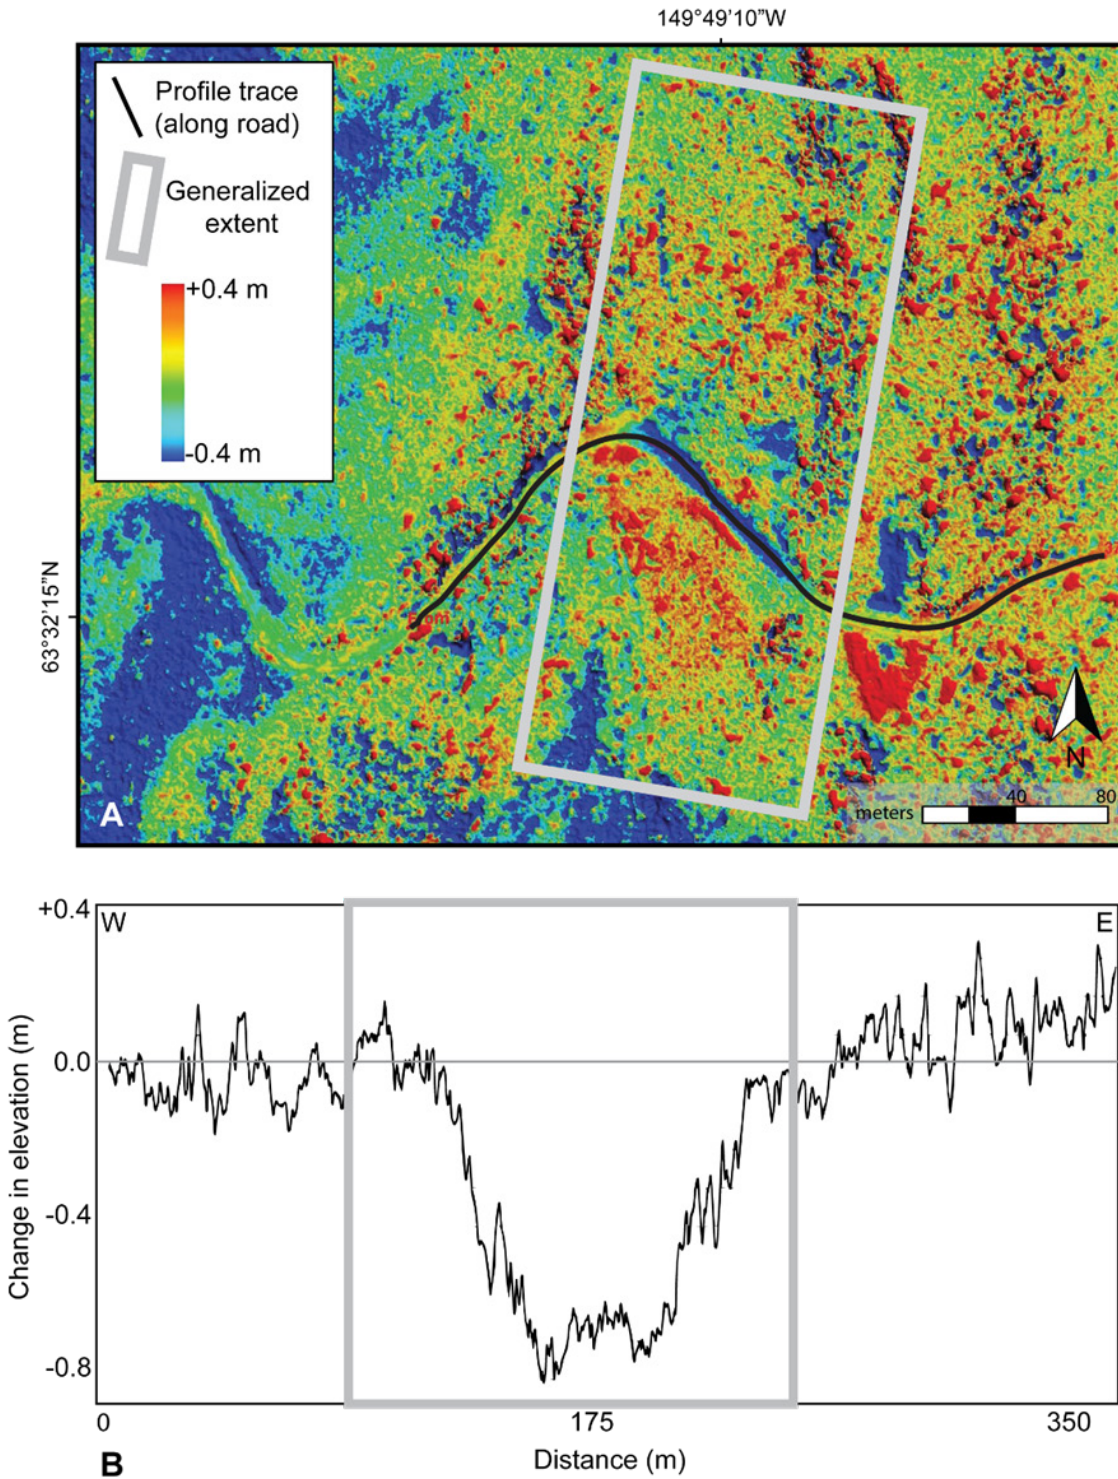
**Figure 7.** (A) Elevation change map created by subtracting June 2015 SfM imagery from June 2016 SfM imagery. Note decrease in elevation along and above the road within the slide area and the increased elevation below the road caused by bulging. (B) Road profile from west to east.

The SfM-derived DoD quantified changes in elevation over an 11-month period from June 2015 to May 2016. The most concentrated, dramatic subsidence (>80 cm) occurred along the road surface (Figure 7). We interpret the relatively large road surface subsidence as magnification of downhill movement by a strong vertical landslide displacement component. This magnified displacement could be attributed to addition of externally derived road fill, traffic loads along the road corridor, and/or changes in permafrost. Recently, road maintenance staff have used onsite colluvium material to maintain the roadway rather than importing denser, heavier fill materials from external sites. They also no longer use vibratory methods to compact the road fill within the landslide area. Even with this approach, it is likely that these repeated efforts to maintain the roadway section for passage by buses are exacerbating landslide movement. However, there is little else that can be done without a thorough geotechnical investigation resulting in conceptual design alternatives in such an active landslide mass.

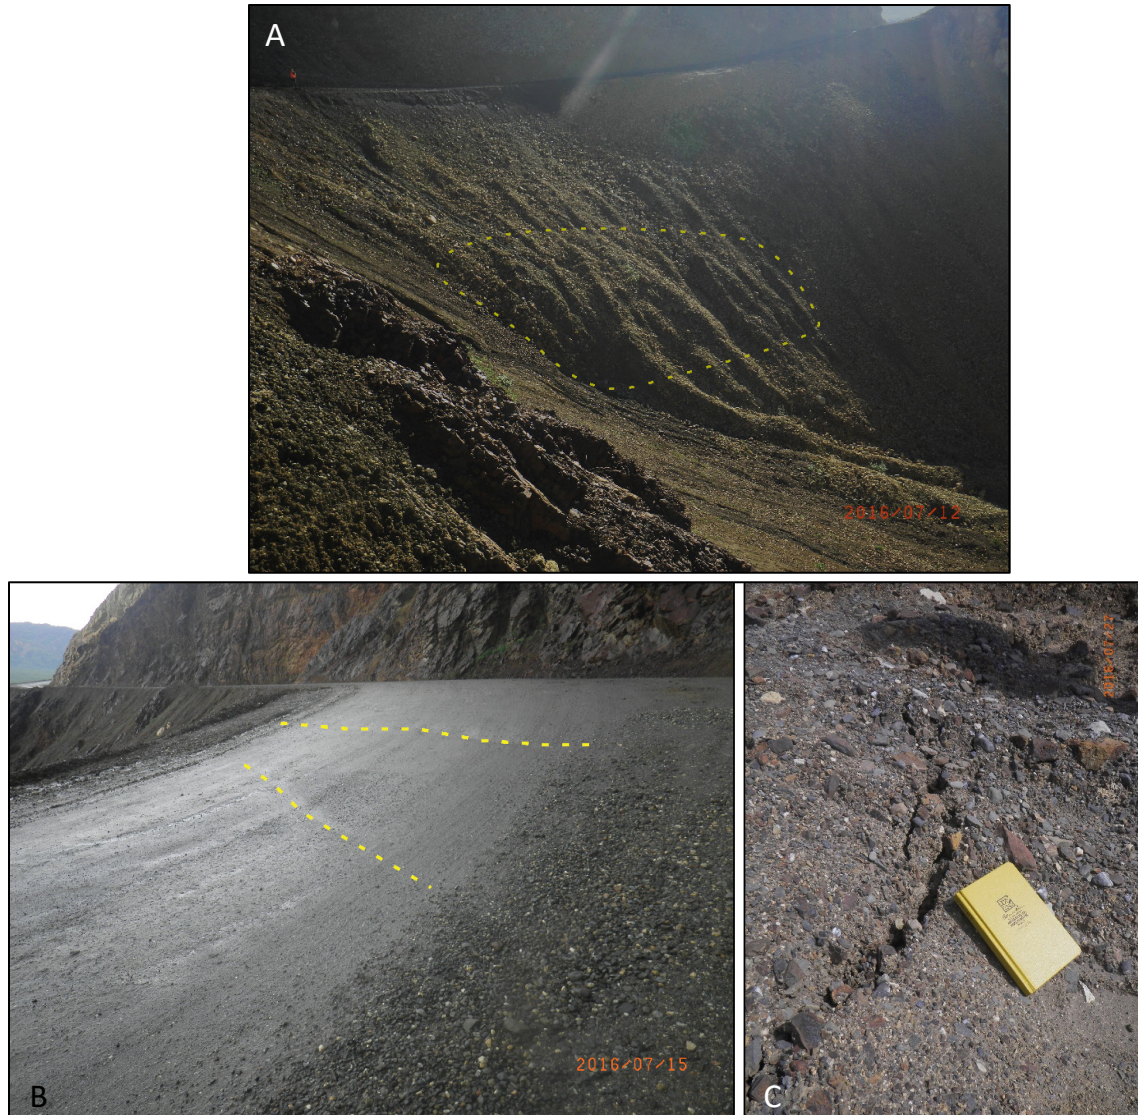
**Figure 8.** (A) Convex morphology downslope of the road. Numerous debris flow levees also visible. Person for scale (top left, wearing orange.) Photo taken looking northeast. (B) Northwestern road cracks. The westernmost crack (above, in this view) is longer, more prominent, and was visible more often during field work in July 2016. Highlights added for clarity, but do not represent full extent of cracks. Photo taken looking southwest. Road is one lane wide, for scale. (C) Detail of crack immediately upslope of northwestern road crack. Offset magnitude and aperture varied based on road maintenance interval and precipitation amount.

The landslide mass’s proposed surficial extent can be seen in Figure 8. We base this interpretation on several lines of evidence. First, we correlate the southeastern and northwestern extents along the road corridor to the location of the respective road (tension) cracks. Second, we establish the lowermost boundary using the convex morphology below the road (Figure 6B, Figure 9A). This morphology is interpreted as the surface expression of the failure plane’s lower boundary, where it extends over the original ground level (Cruden and Varnes, 1996; Hungr et al., 2014). Third, we base the upper boundary on three features. To the west, it is defined by multiple patches in the talus slope which lack the characteristic cobble- to boulder-sized clasts. These patches generally align and proceed uphill to the east, dividing the homogenous upper talus from the dissected slope below (Figure 20). To the east, we define the extent by the southeastern road cracks’ continuation along the boundary between talus and bedrock (Figure 10C). Third, these extents correlate with the outline of significant elevation changes observed in the DoDs (Figure 7).

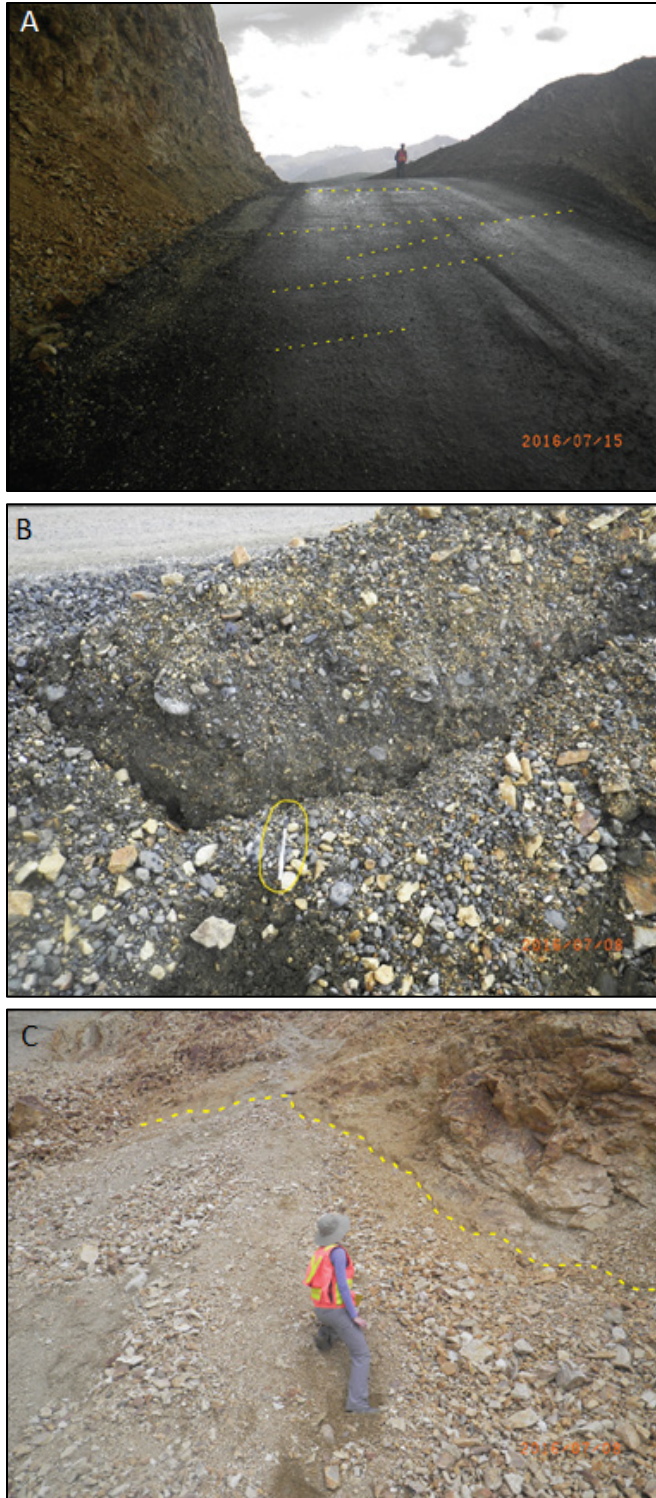
Ground truthing and field observations confirm these data. During field work, tension cracks in the road were observed at the northwestern and southeastern landslide boundaries (Figure 8, Figure 9, Figure 10). To the northwest, one dominant tension crack stretches from ~1.5–3 m upslope of the road to ~1 m downslope of the road. Occasionally, other en echelon tension cracks were observed depending on the road maintenance interval and on precipitation (Figure 9). To the southeast, tension cracks in the road surface were typically comprised of en echelon lineations with negligible horizontal and vertical offset (Figure 10). One tension crack extended ~1 m downslope of the road, turning easterly, paralleling the road's edge (Figure 10). Another tension crack extended over 30 m upslope of the road, following the boundary between the rhyolitic bedrock and the colluvium slope (Figure 10). Field-measured vertical offset was 30 cm and horizontal lineations were visible in the exposed landslide head scarp soils (Figure 11). Lastly, in July 2016, the ridge of increased elevations directly downslope of the road developed a tension crack on the downhill side, which paralleled the road.

**Figure 10.** (A) Southeastern, en echelon road cracks. Highlights added for clarity. Photo taken looking southeast. (B) Detail of southeastern road crack where it continues below the road and turns easterly to propagate parallel to the road surface. Photo taken looking northeast. Pen for scale. (C) Outline of southeastern slide boundary upslope as defined by the crack between bedrock and colluvium. Crack is a continuation of southeastern road crack. Highlight added for clarity.

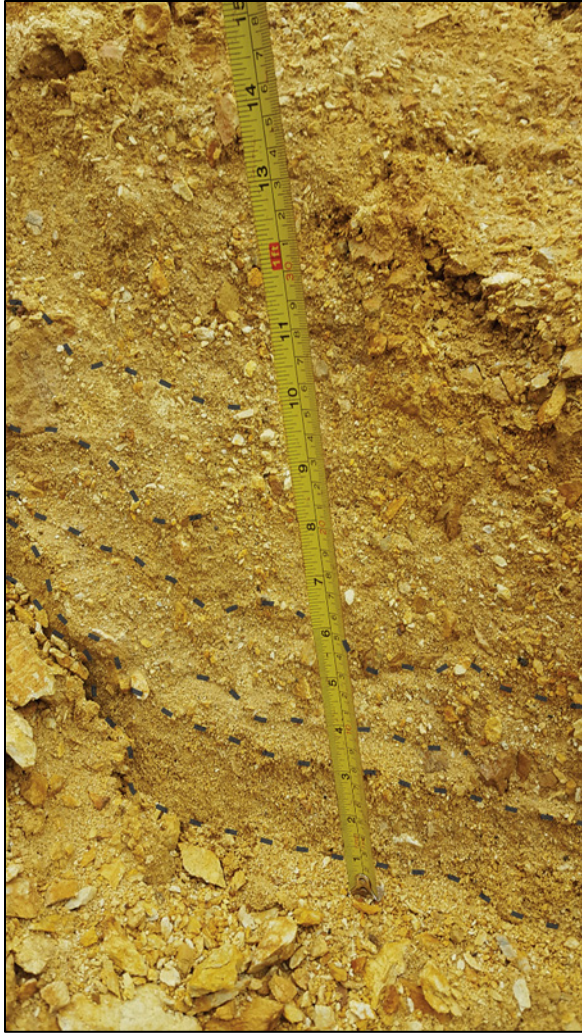
**Figure 11.** Lineations visible in a scarp upslope of the southeastern road crack (Figure 10C). Features highlighted for clarity. Tape measure in photo is extended ~38 cm (red mark on the measuring tape indicates 1 foot).

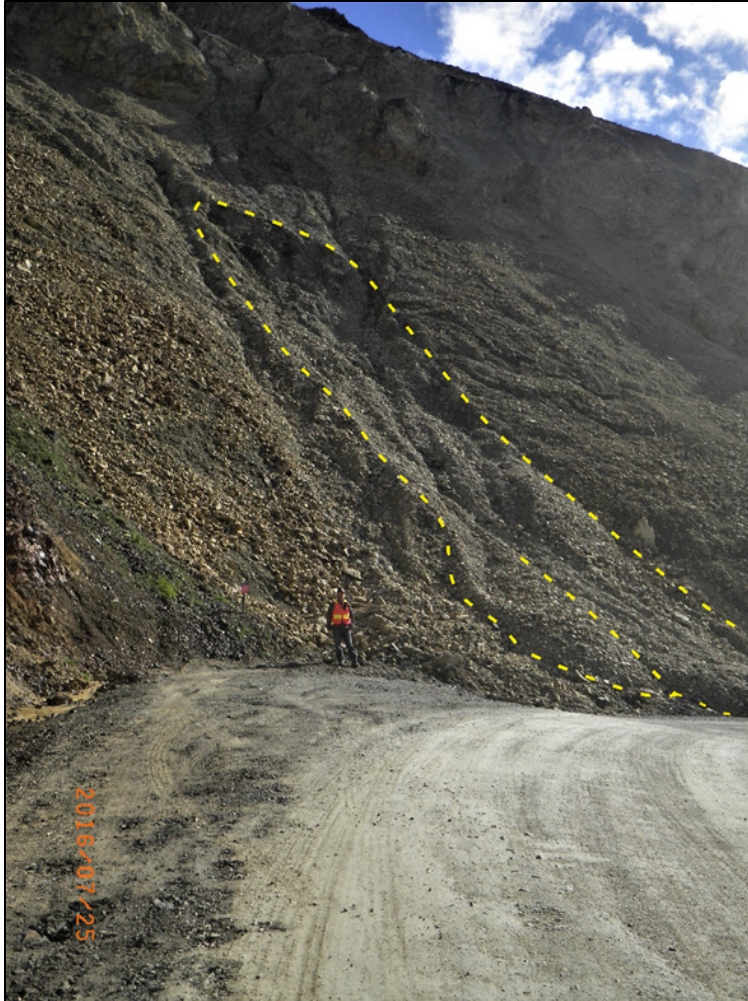
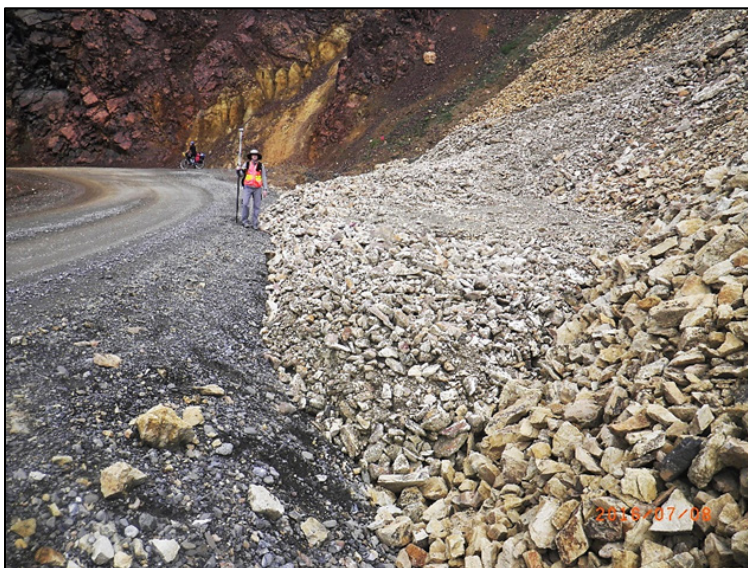
In addition to the large-scale downhill motion, the Pretty Rocks colluvium slope above the road experiences smaller debris flows and rockfall. Two debris flows occurred on June 30, 2016 just prior to a spike in precipitation on July 1, 2016 (Figure 12). Both originated in the colluvium slope above the road, in the area affected by the perlite material drainage (Figure 13). The larger of the two flows terminated in the ditch on the road's north (uphill) side, and the smaller flow ended just above it on the colluvium slope. Additionally, 1996 aerial photography reveals a large debris flow which crossed the road and deposited on the southeastern portion of the lower southeastern lobe (Figure 8). We mapped numerous older debris flow deposits on the tri-lobed landslide deposits at the slope's base. Older deposits are assumed to be masked by vegetation and covered by more recent debris flows.

**Figure 13.** (TOP) Debris flow paths and deposits seen looking northeast. Scarp and deposits highlighted for clarity. Eastern lobe extends beyond photo frame, see B. (BOTTOM) Larger (eastern) debris flow's lobe deposit as diverted by ditch. Photo taken looking northwest.

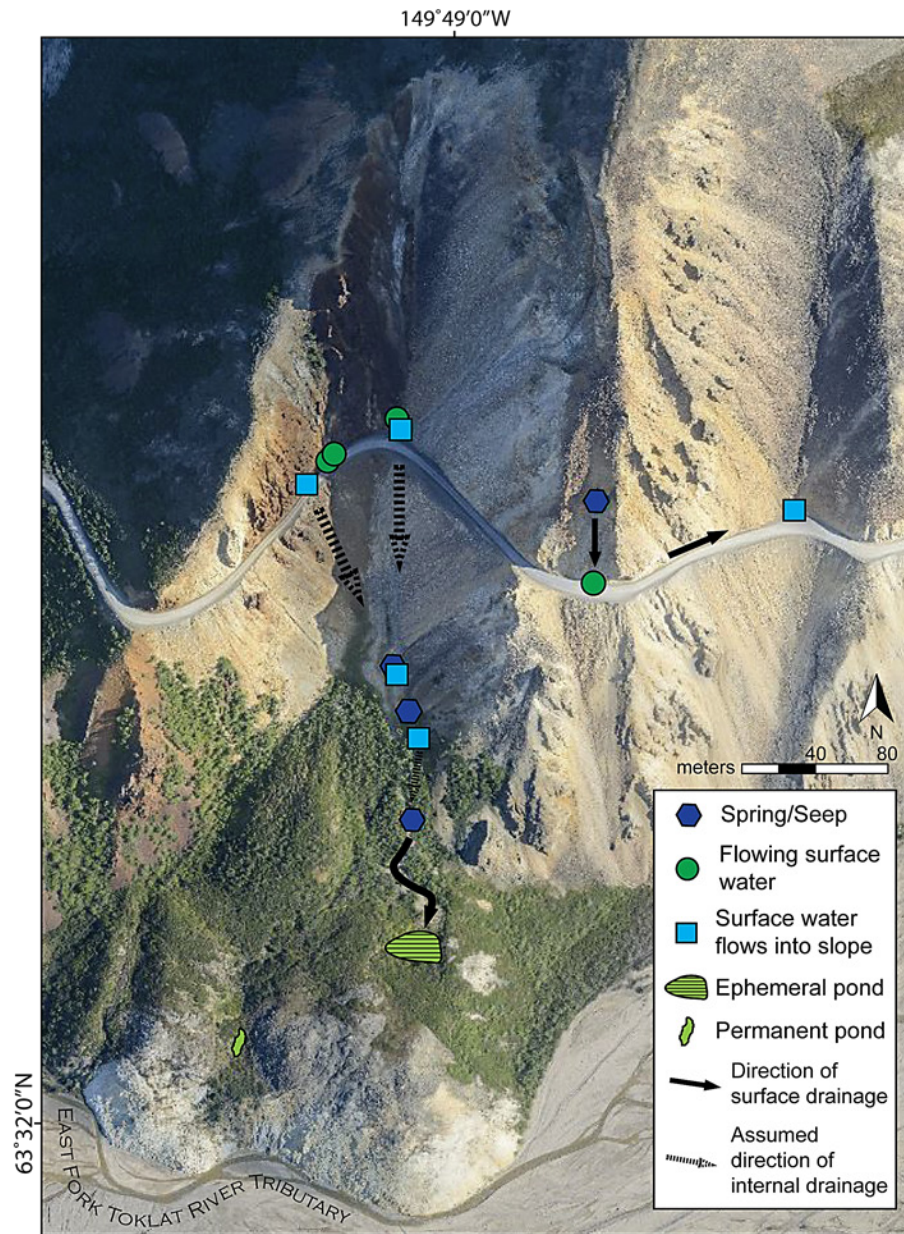
**Figure 14.** Surface water drainage observed in July 2016. Mapping above the road was prevented by Critical Wildlife Habitat Closure. See Discussion section. Map background image 2015 orthophoto.

Several days of heavy precipitation allowed us to observe and map the surface water flow patterns on the Pretty Rocks slopes (Figure 14). Most water above the road followed the topography to the southwest, arriving at the topographic low near the road's inside turn. In the road's uphill ditch, the water drained directly into the slope at, or near the northwestern lateral landslide scarp tension crack on the road. Another drainage existed west of the colluvium slope where the road abuts the basaltic bedrock (Figure 14). Sediment-laden water flowing down the basaltic bedrock southwest of the Pretty Rocks slope disappeared into this drainage. We also observed water draining down the July 2016 debris flow channels, and heard water draining just below the ground surface in this same location on days without precipitation.

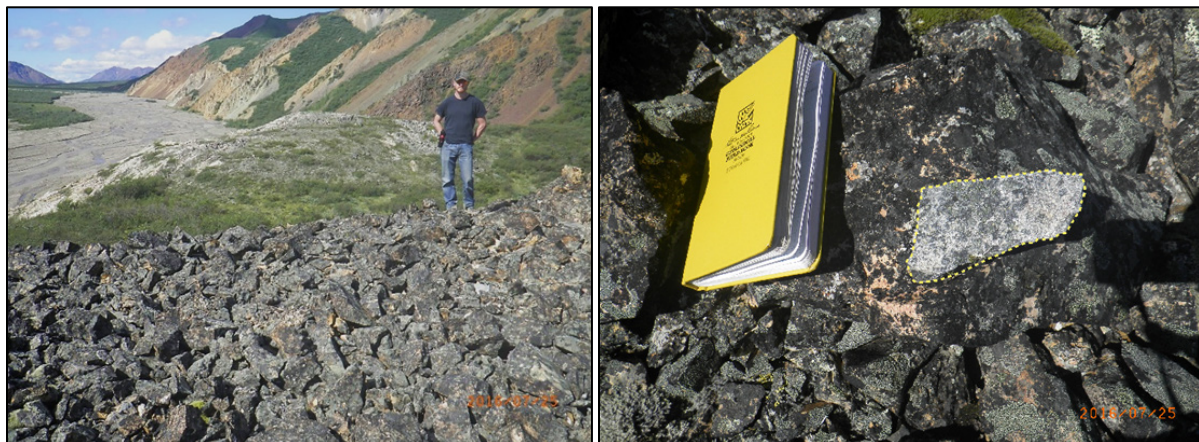
**Figure 15.** (LEFT) Predominantly rhyolitic lobes at the base of the Pretty Rocks slope. Southeastern lobe in the foreground, southwestern lobe in the background. Note differences in surface coloration due to lichen coverage. Photo taken looking west. (RIGHT) Qualitative comparison of lichen coverage. Highlighted rock is representative sample from the southwestern lobe. All other rocks are in place on the southeastern lobe.

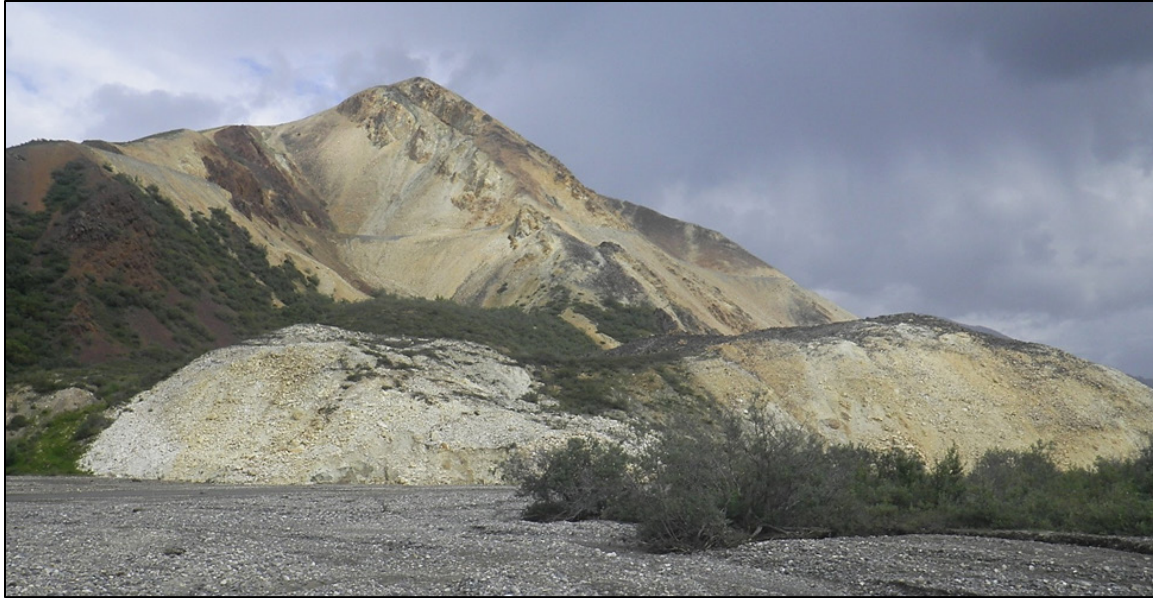
**Figure 16.** Pretty Rocks Landslide and associated lobe deposits seen from the East Fork Toklat River tributary. Road visible in upper slope for scale. Photo taken looking north.

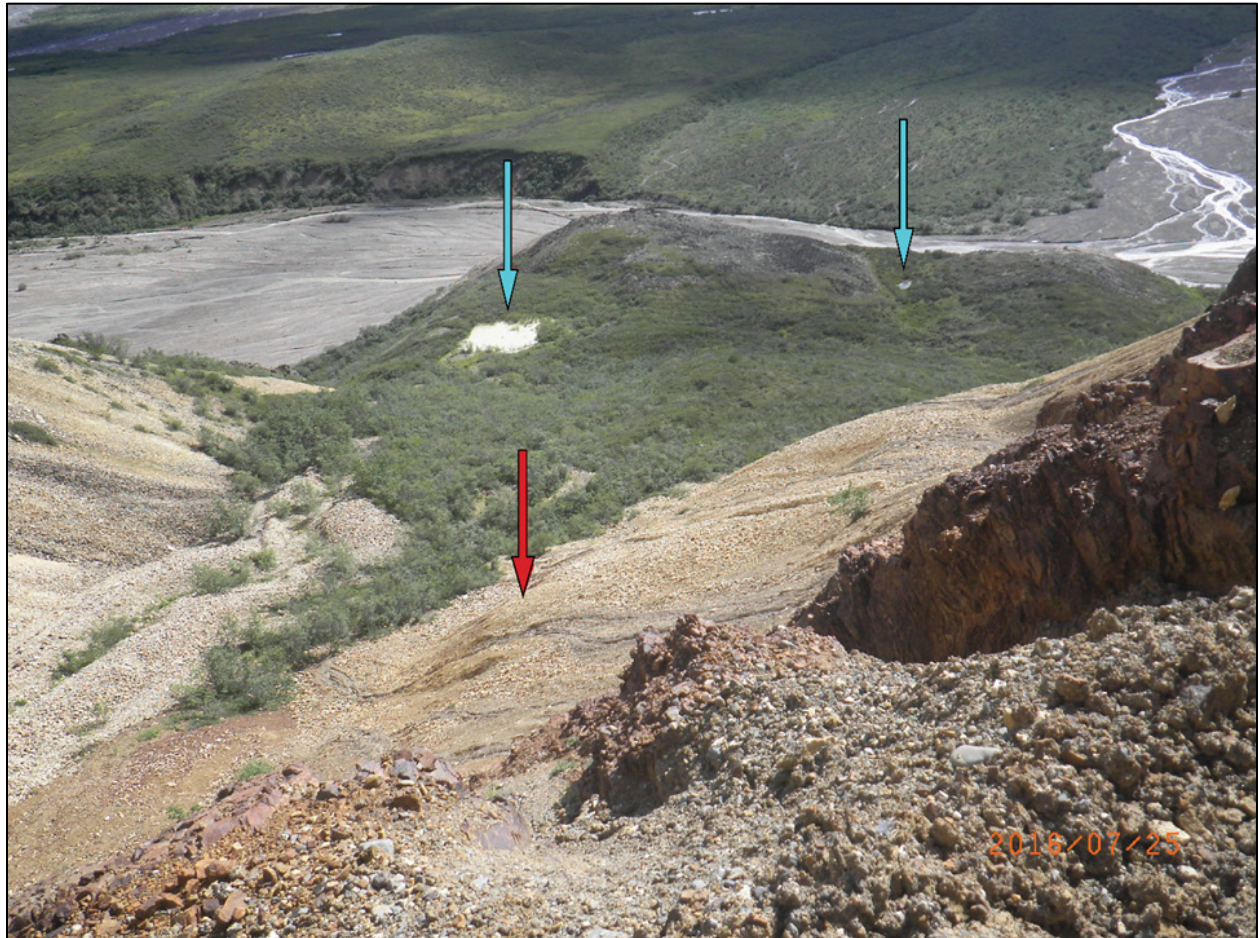
Water reappeared at the colluvium slope's base to the southeast (Figure 14). It appeared to be controlled by levees and previous debris flow channels rather than following topographic lows. At one point it was observed to be elevated between two levees which may indicate a perched water table due to the high clay content in the debris flow deposits. This small stream disappeared into the ground and reappeared several times before pooling on the southeastern lobe. According to historic aerial photography, the water collects in the lobe deposit of a large debris flow that occurred prior to 1996 (it appears fresh in the 1996 aerial photography and is not seen in the 1988 imagery). The ephemeral sediment-laden pond drains and/or evaporates approximately one week after precipitation (Figure 17).

**Figure 17.** View looking down at the lobes from the road (facing southeast). Left blue arrow indicates sediment-laden ephemeral pond which develops on the southeastern lobe after heavy precipitation. Right blue arrow indicates small permanent pond. Red arrow indicates large bulge which stretches up and to the right, across the basaltic colluvium slope.

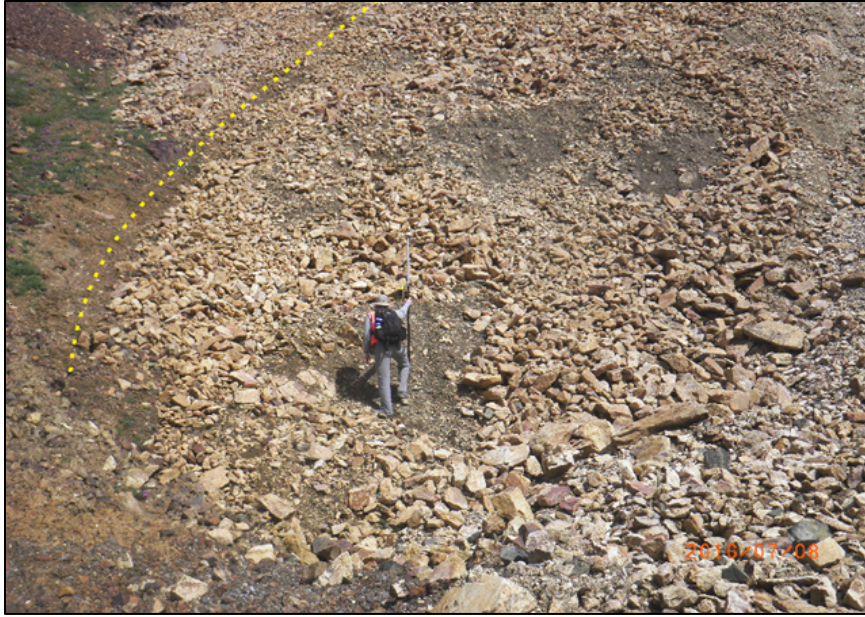
**Figure 20.** Northwestern boundary of failure area which divides the homogenous upper talus from the dissected slope below, and patches of slope which lack cobble- to boulder-sized clasts. Photo taken above the location of the northwestern road crack, looking north.

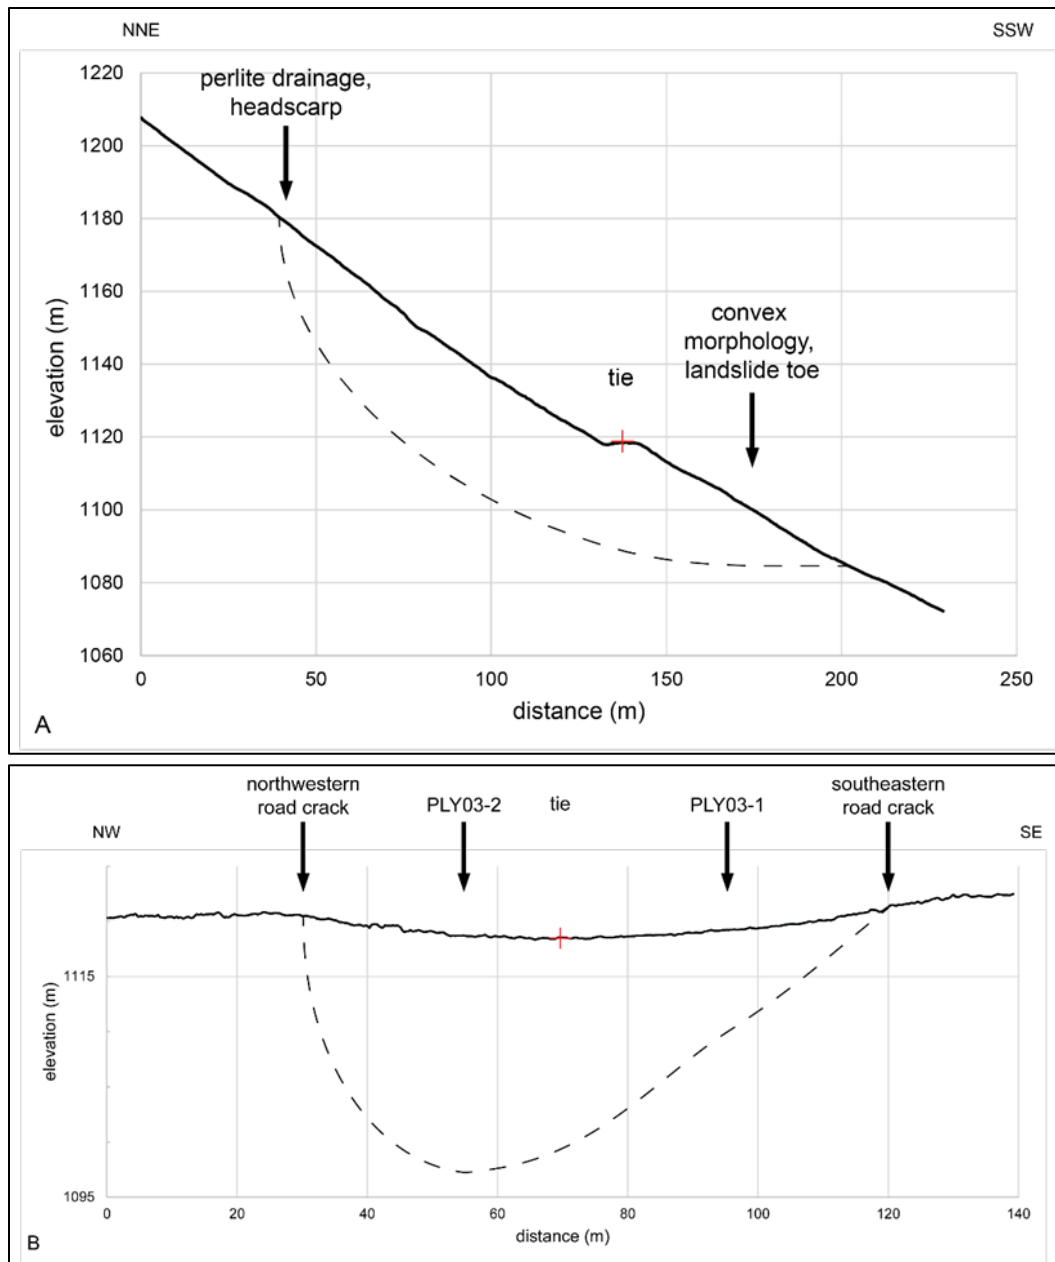
We interpret the underlying failure-surface to be parabola shaped, thinning at the top, bottom, and sides of the landslide (Figure 21). The apparent failure surface follows the highly weathered sediment/bedrock interface at the landslide head scarp and along the lateral margins that cross the roadway. Near the bottom of the embankment slope there appears to be a landslide toe that bulges out of the embankment slope and deposits material onto the colluvium below, as evidenced by the convex morphology (Figure 6 B). The northwestern-most limb of the parabola shape likely has a steeper limb than the others, as it gets pinched by non-planar topography there.

**Figure 21.** Idealized failure surface geometry. The tie point indicates the location at which these perpendicular profiles intersect one another in map view. (A) Long profile drawn along slope. Upper and lower boundary based on the slide's surficial extent. Depth at tie based on road profile depth at corresponding location. (B) Cross profile drawn along road. Extents based on location of respective road cracks. Depths based on depth to bedrock in PLY03-1 and PLY03-1.
