National Park Service  
Cultural Landscapes Inventory

2013

Humpback Rocks Visitor Center  
Blue Ridge Parkway

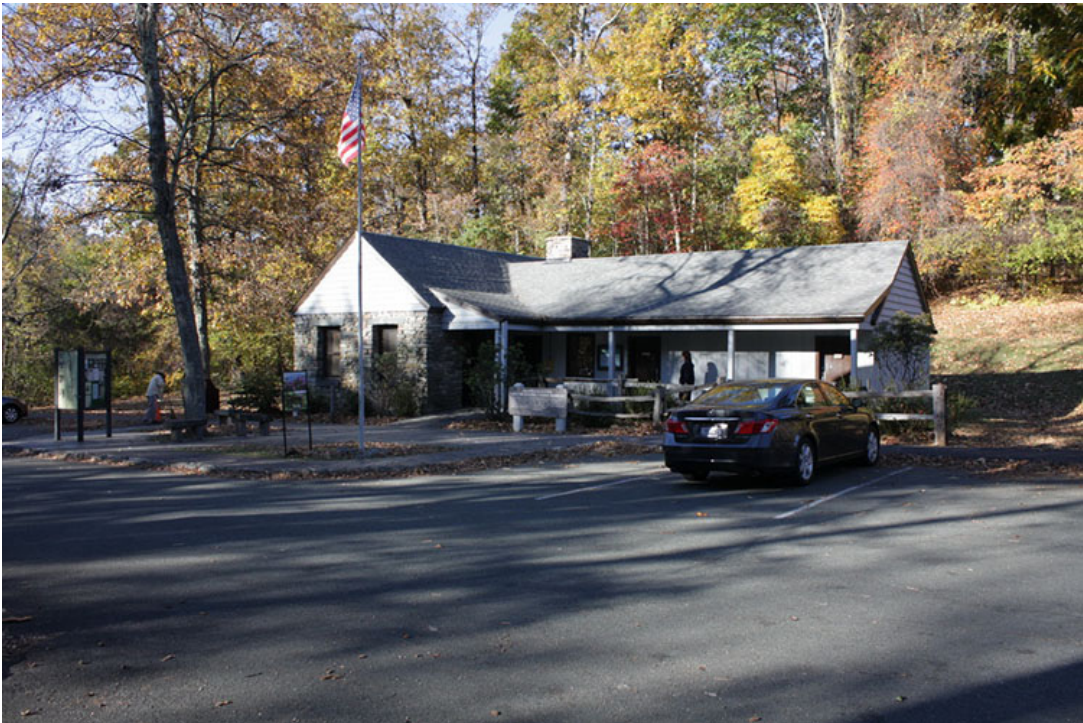
FIGURE 19. Visitor center planting, 2010. View shows changes to the front of the visitor center, including the addition of the information board, the loss of the stone drinking fountain and trees, and replacement of the VC (2012 Humpback Rocks CLR).

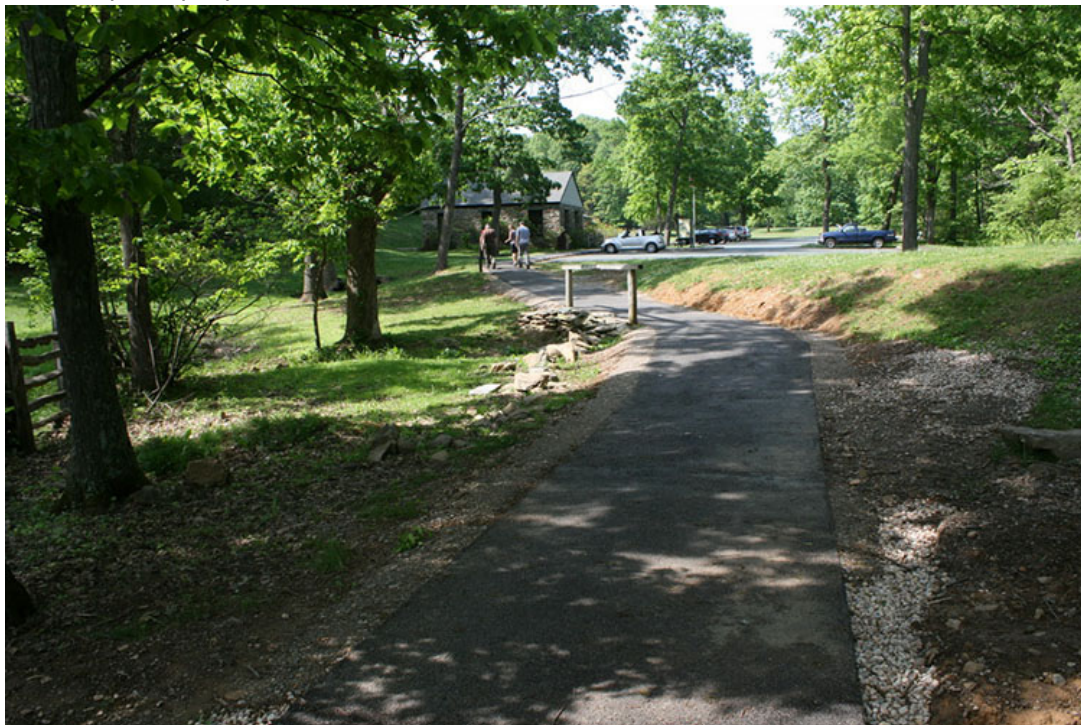
*FIGURE 21. An asphalt walk leads between the visitor center and the Mountain Farm exhibit (2012 Humpback Rocks Cultural Landscape Report).*

The asphalt sidewalk lining the visitor center parking area is in fair condition due to cracking and patches that may create trip hazards. Additionally, tree trunks and roots have caused the sidewalk to heave in a number of locations. These problems are proposed to be addressed by the National Park Service as part of existing repaving projects, which include removal of two hickory trees and replacement farther away from the paved surface. (Proposed plans also include reorganization and improvement of the plaza and parking, and installation of new interpretive signage in the grassed area.) Another asphalt sidewalk is located along the side of the parking lot opposite the visitor center. It is in fair condition due to cracking and moss growth in some areas, which could result in trip hazards. The junctions between the stone curb and the sidewalk, and between the sidewalk and adjacent turf, are characterized by jagged uneven edges.

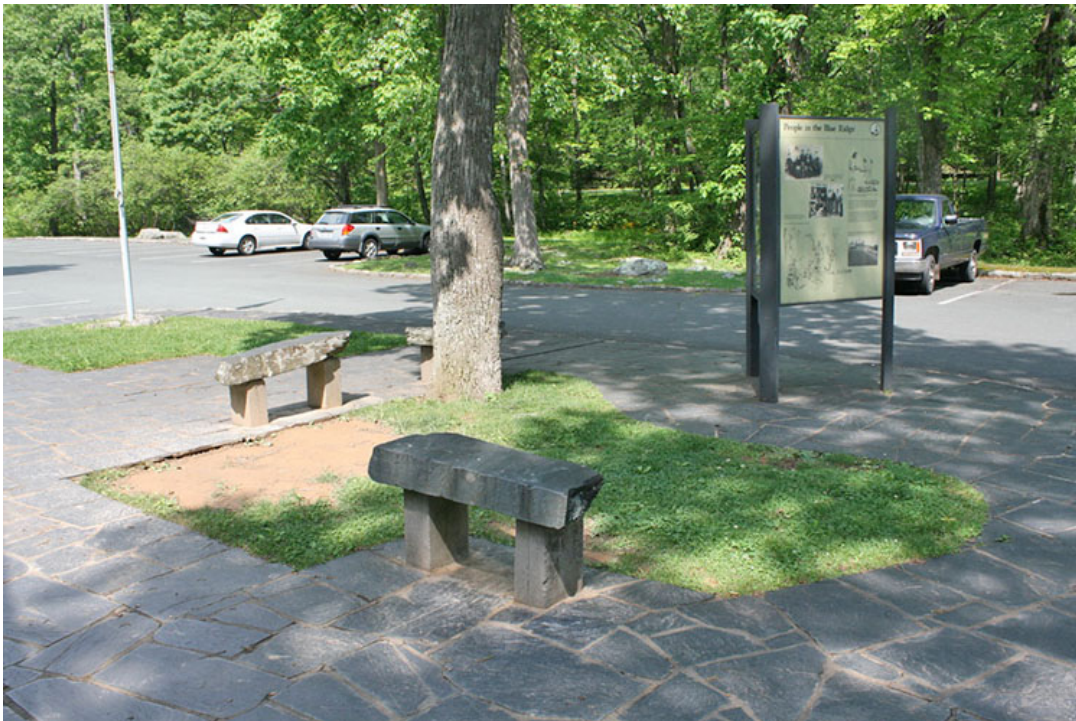
Site Furnishings. Four benches are located along the margins of the flagstone terrace in front of the visitor center. Three of these benches are fashioned from a slab of stone set on two rectangular concrete bases. The benches are approximately 3 feet 2 inches wide and 18 inches tall. The benches are backless, set in concrete, and are in good condition. A fourth bench is located near the entrance to the restrooms and is constructed of wood planking set atop concrete supports. It is 5 feet wide and 18 inches tall. The three stone slab benches contribute to the significance of the component landscape. The wood and concrete bench postdates the period of significance and do not contribute to the historic landscape.

*FIGURE 31. Benches and signage outside the visitor center (2012 Humpback Rocks Cultural Landscape Report).*

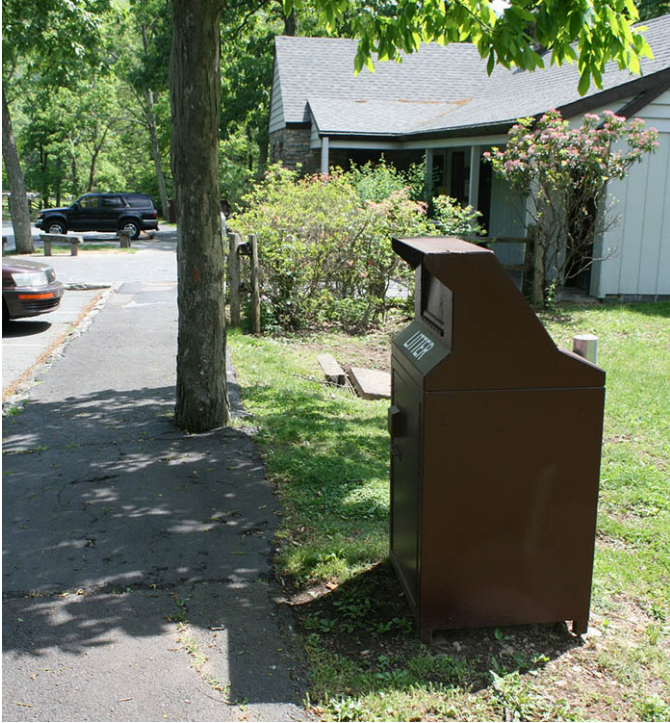
Most of the trash receptacles located within the Humpback Rocks developed area are bear-proof, brown powder-coated steel, approximately 3 feet square and 4 feet tall, with large chute-like openings that overhang the unit by about 1 foot. They are generally in good condition. The receptacles are secured by round concrete-set metal poles. Three of these trash receptacles are located along the margins of the visitor center parking area. The current receptacles likely postdate the period of significance.

*FIGURE 32. A bear-proof metal trash receptacle near the visitor center (2012 Humpback Rocks Cultural Landscape Report).*

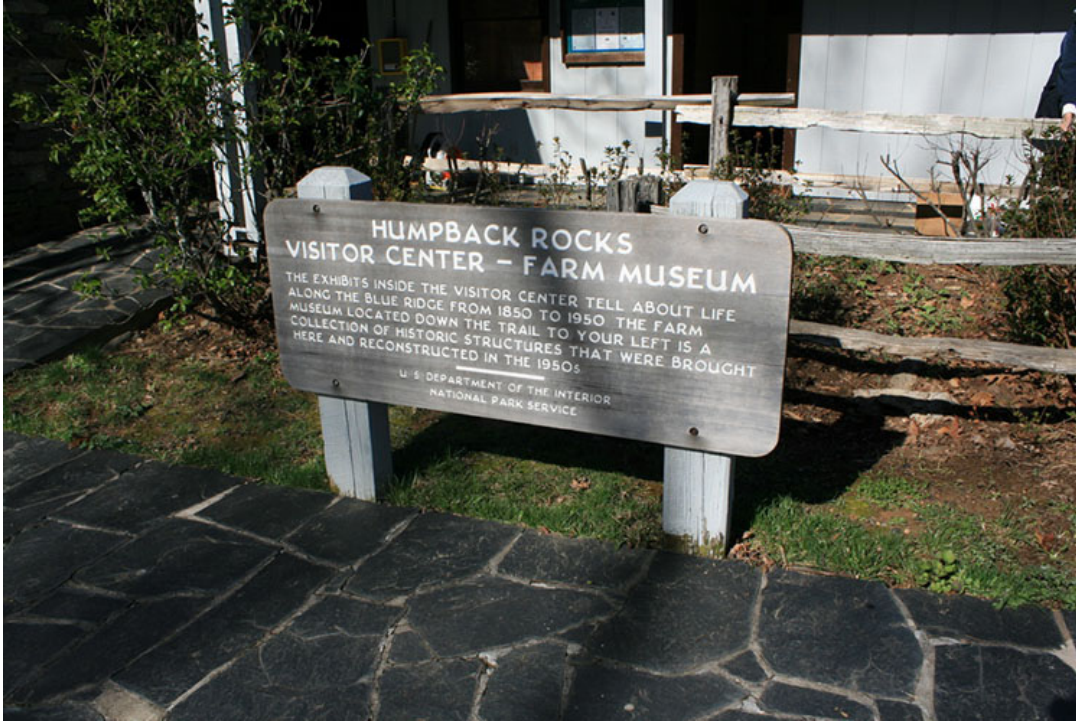
A wood identity sign indicating the Humpback Rocks Visitor Center and Farm Museum faces the walkway in front of the building. The large billboard-style sign is supported by two 8 inch by 6 inch wood posts. The posts are painted grey, but the wood boards of the face are stained a natural wood color. The text is routed into the boards and painted white. While the sign shows some evidence of weathering, it is generally in good condition. It appears to have been replaced since the period of significance, as photographs available from the 1950s indicate that the original sign in front of the visitor center contained more extensive text.

FIGURE 36. The wood identity sign in front of the visitor center (2012 Humpback Rocks Cultural Landscape Report).
