# Santa Rosa Life-Saving Station and Coast Guard Garage Restoration Feasibility Study

**Restoration Feasibility Report**

**JKOA**

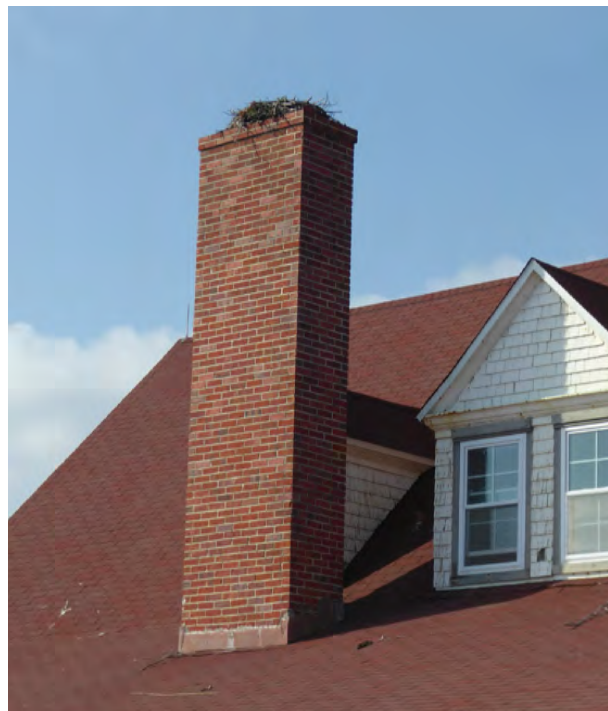
constructed of red-orange brick and has a simple corbeled cap. The unfortunate placement of the chimney partially obstructs the westernmost second-floor dormer.

**Figure 2.31.** Brick chimney on south elevation.

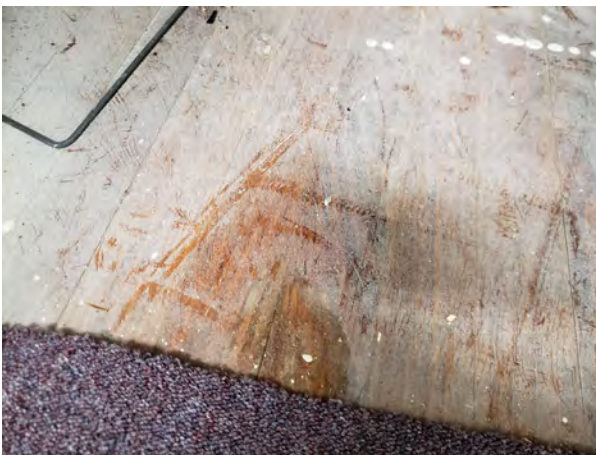
**Figure 2.99.** Wood flooring in closet of Room 204. Note paint overspray.

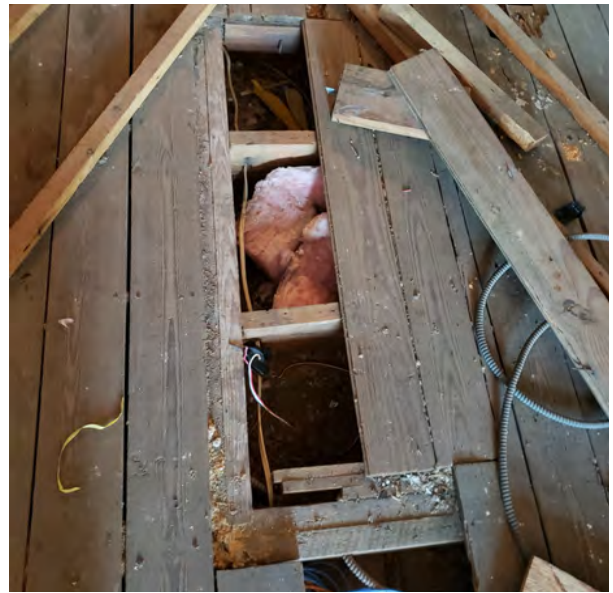
**Figure 2.114.** Partially exposed opening where chimney extended through floor. Newer blocking now spans the opening.

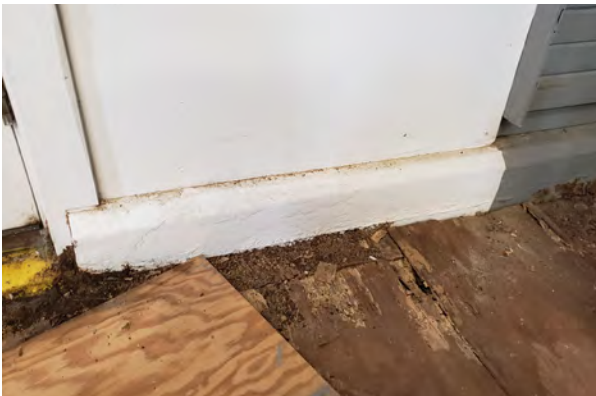
**Figure 2.148.** Plywood flooring in Room 103. Note termite and water damage.
