# Historic Structure Report

March 2004

## Oakland Plantation South Tenant Cabin Cane River Creole National Historical Park Natchitoches, Louisiana

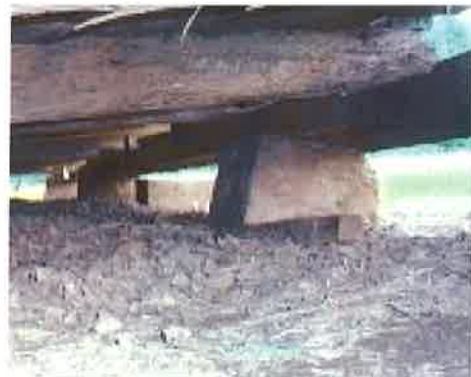
Foundation piers

Sixteen-inch logs, sawn flat on two opposite sides, were turned horizontally and installed on top of the remaining brick at grade. Deteriorated interior supports for the floor framing were replaced by wood blocks resting directly on the ground as well as by modern concrete supports installed by the National Park Service to stabilize the building.

- Stabilize and secure existing historic building foundations. This may require resetting some historic piers using their existing materials. Replace missing

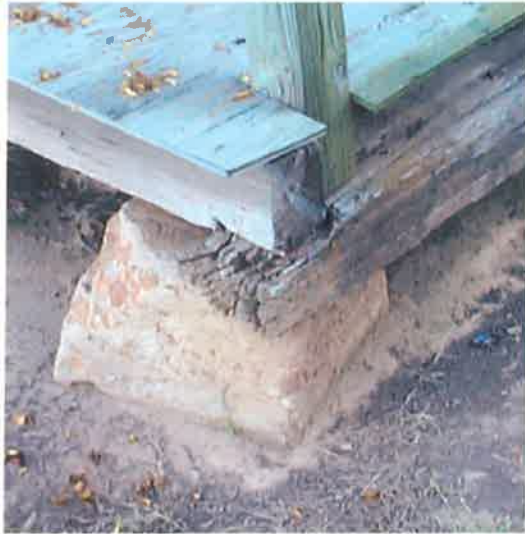
Foundation pier, front gallery

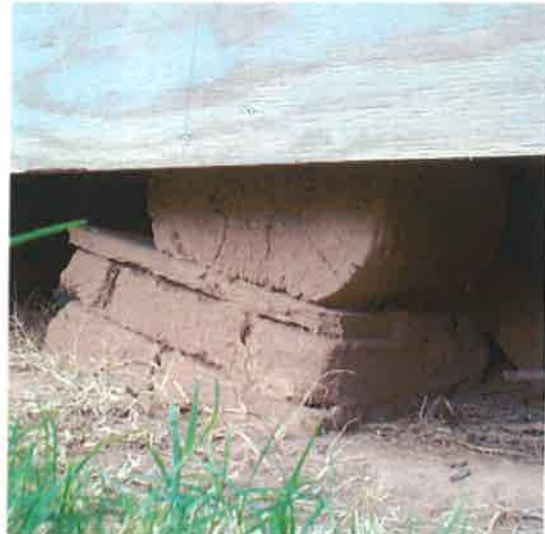
Foundation pier, main building

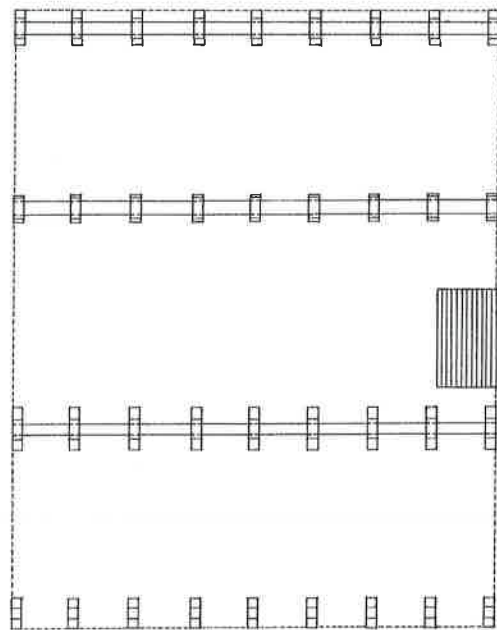
Figure 1

During the National Park Service stabilization work, several supplemental concrete piers were installed under the cabin to reduce the unbraced length of floor beams and joists.

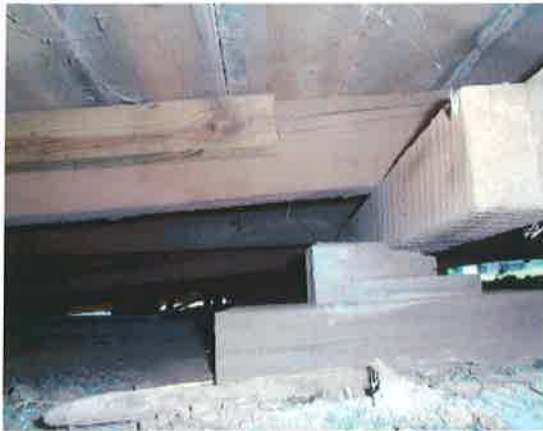
Wood shoring under building

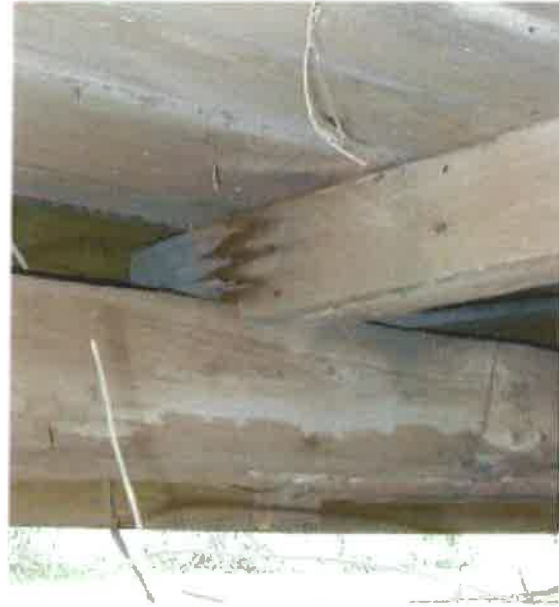
The rear gallery floor structure is comprised of 5" by 3½" circular-sawn joists spaced at 36" on center framed into a ledger at the original hewn beam. The west beam at the rear of the gallery is a circular-sawn member supporting the joists. Wire nails were used to attach the joists to the rear beam.

Rear gallery floor framing

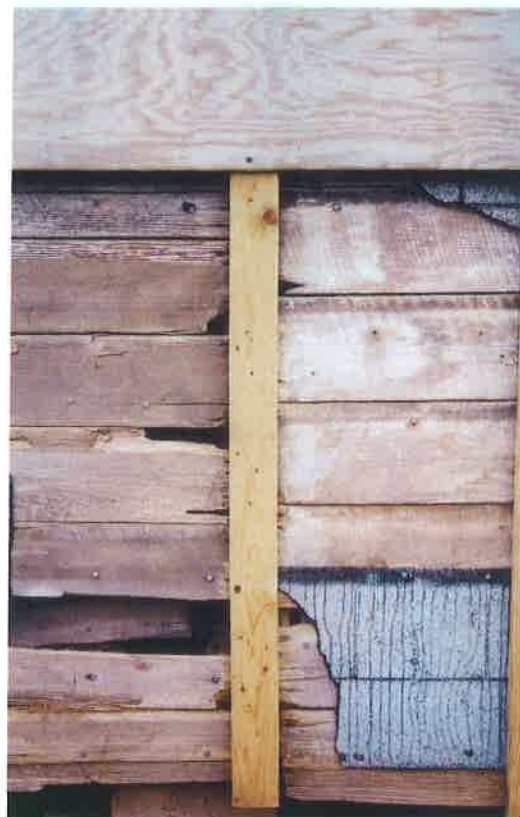
*North:* The north elevation is covered with protective plywood with aluminum vents. However, the removal of one of the plywood panels between the chimney and the rear gallery revealed that there is horizontal butt-jointed, board siding on both the main building and the rear gallery. There is a joint between the siding on the main building and the rear gallery, suggesting the two were sided at different times. The siding is  $\frac{3}{4}$ " by  $5\frac{1}{2}$ " and is attached with wire nails. The tops of the boards on the rear gallery exhibit evidence of having once been installed as lap siding and whitewashed. Remains of the 18" wide, asphalt, rolled siding were observed in the exposed area. Given the butt-jointed, horizontal boards and the absence of evidence of any other protective covering, the conditions support the conclusion that the siding was originally installed as clapboards and later removed and relaid flat as sheathing for the rolled asphalt siding, likely in the 1940s or 1950s. No *bousillage* remains in the exposed wall area of the main building.

Detail of north exterior siding

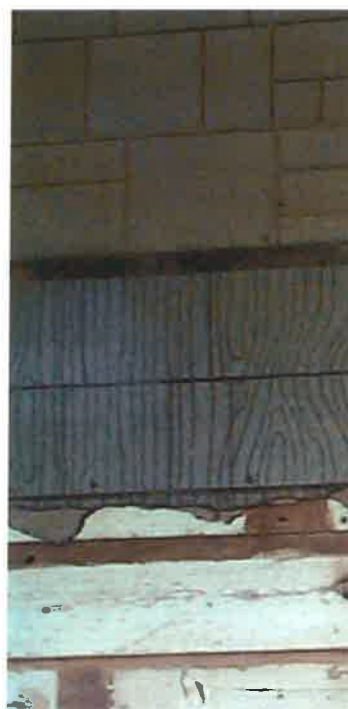
*East:* The front wall under the gallery is primarily finished with granulated, asphaltic, exterior rolled siding in two patterns. The exterior layer is patterned to simulate stone. The simulated stone pattern is achieved with gray granules. The simulated mortar joints are achieved with black granules. The pattern on the underlying rolled asphalt siding is a simulated slate using gray granules for the slate and darker gray granules to achieve a simulation

Detail of asphalt siding on the east elevation

- Where the asphalt siding is missing, install siding to match existing in pattern, color, and width.
- Where the asphalt siding is missing, and if an exact match cannot be acquired, install an unpatterned, granulated, rolled siding of 18" width and a complementary color on the unprotected wall surfaces of the cabin. This will focus the interpretation on the appropriate overall appearance of the cabin and on the historic rolled asphalt siding.

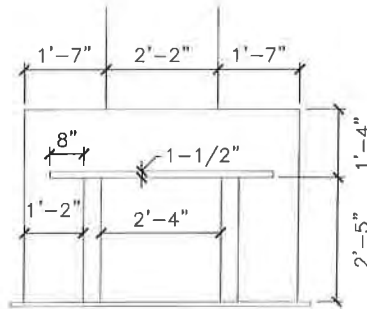
masonry 8" on each side of the firebox. The metal bar is an unusual feature for fireplace construction. It may be a remedial modification for a previous header that failed. The fireplace exhibits considerable cracking and has received some supplementary support installed by the National Park Service to stabilize it prior to restoration. Overall, the fireplace is in poor condition.

Elevation of fireplace

- Stabilize the foundation of the chimney.
- Secure the head condition of the firebox.
- Rebuild the chimney to its circa 1960 profile above the roof with materials matching the existing, including matching the new mortar to that which is existing and historic.

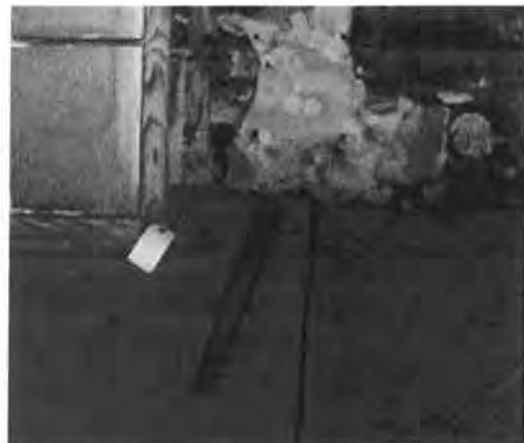
The flooring is comprised of 7" wide boards running north to south with a joint at 6'-0 1/2" from the north wall. There is no appreciable difference in the floorboards, but the joint is pronounced. Although there is little difference between the floorboards on each side of the joint, the presence of a joint suggests that the flooring was replaced at some point in the past.

Flooring joint, Room 103

- The floors of the cabin are substantially intact. Once the floor framing conditions are addressed, the floorboards will likely need only isolated patching and supplemental treatment at door thresholds to accommodate ADA access. To retain the historic character of the cabin, the focus of structural treatments should be to achieve the desired floor load capacity. Otherwise, the historic floor conditions should be retained. It is recommended that no attempt be made to make them as firm and level as would be expected in new construction.

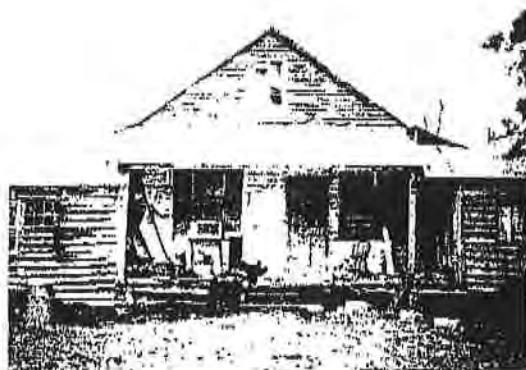
1-35. West elevation of the Store/Post Office prior to work. Note decayed porch deck.

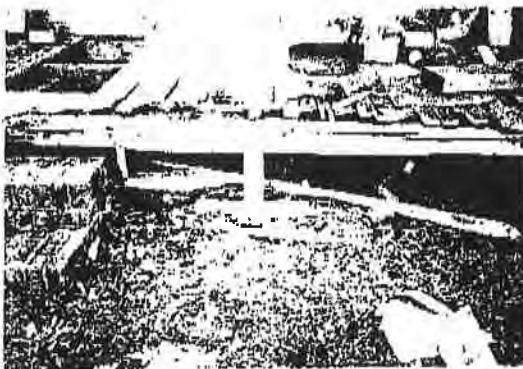
13-22. Temporary treated 4x4" joist and post augmenting the deck @ back of PO/Store.

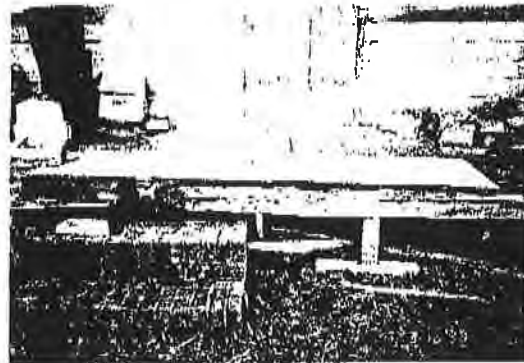
13-19. Back deck of Post Office/Store after repair and covered with treated plywood.

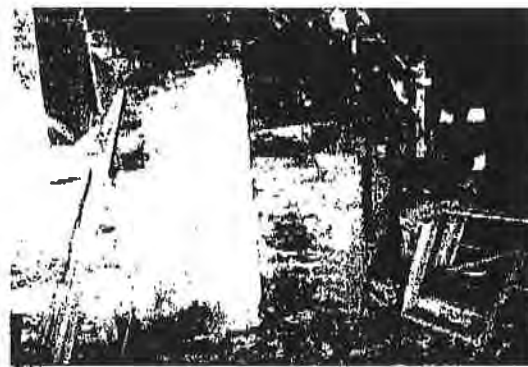
6-19. North Slave Quarter's. Chimney propped up and being dismantled and stored.

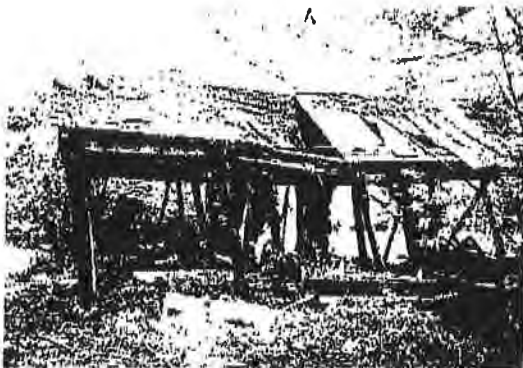
3-18. The Wagon Shed prior to stabilization work. Note the deteriorated condition.

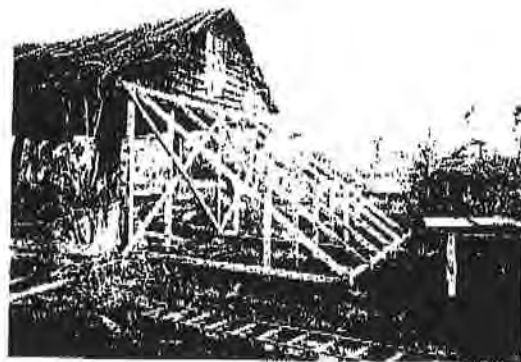
5-1. The Wagon Shed during structural stabilization work. Note diagonal cribbing.

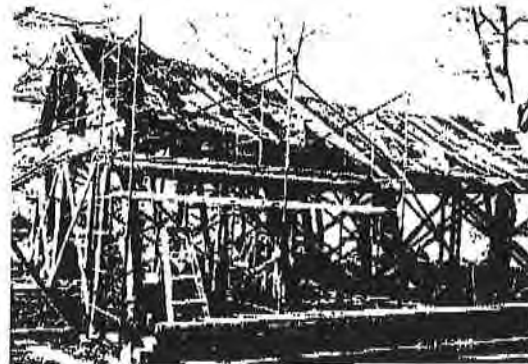
7-19. The Wagon Shed, north slope of roof during stabilization. Note int. augmentation.

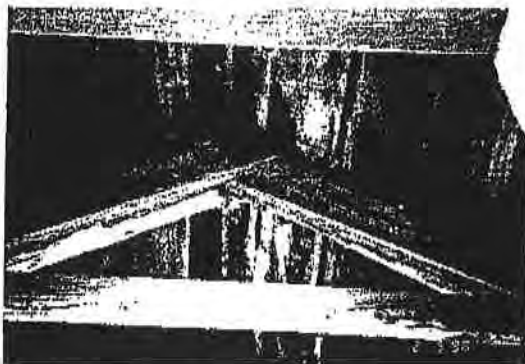
7-23. The Wagon Shed. Interior truss fabricated to support roof during stabilization.

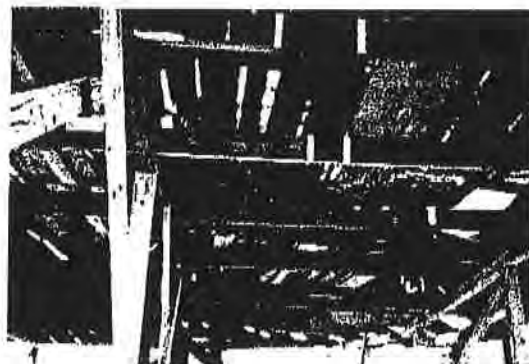
7-29. The Wagon Shed. Notice temp. interior cribbing and bracing supporting roof.

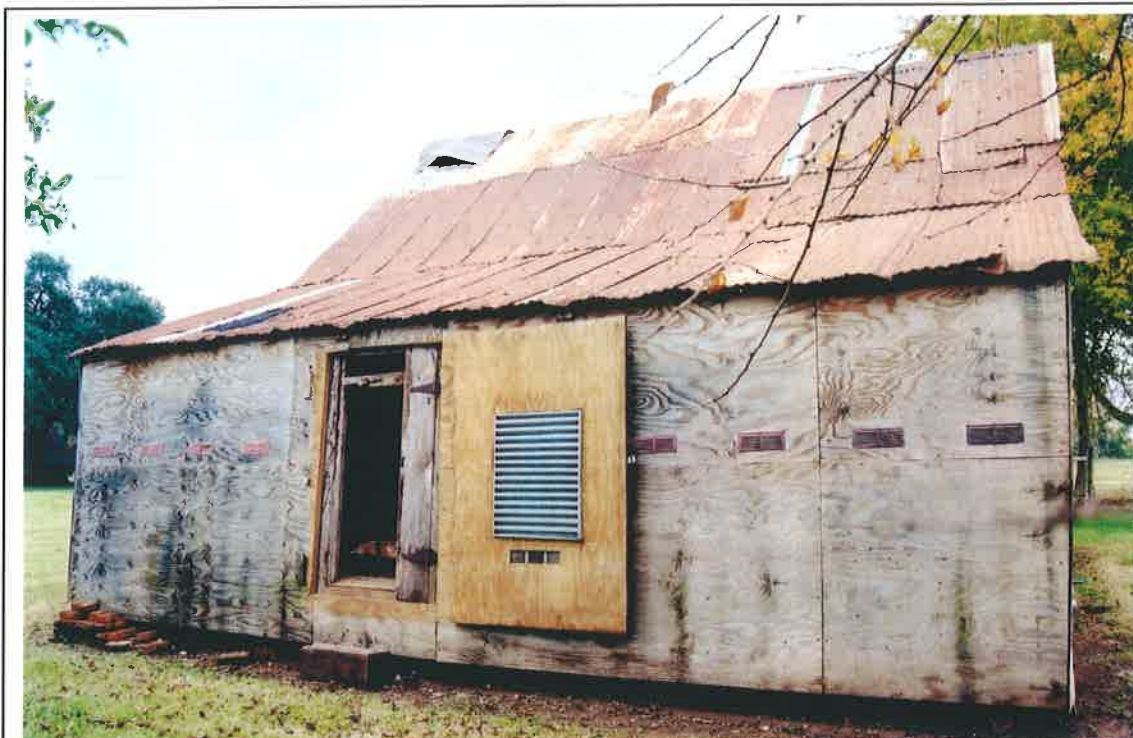
*Image 82: Oakland Plantation. South Tenant Cabin, west elevation, 2002. Remnants of Door D5.*

- Interpret the doors in their present condition with the exception of Door 1, which should be reconstructed based on the remaining evidence of the historic rear door on the North Tenant Cabin.
- Supplement remaining hardware with materials to match the historic.

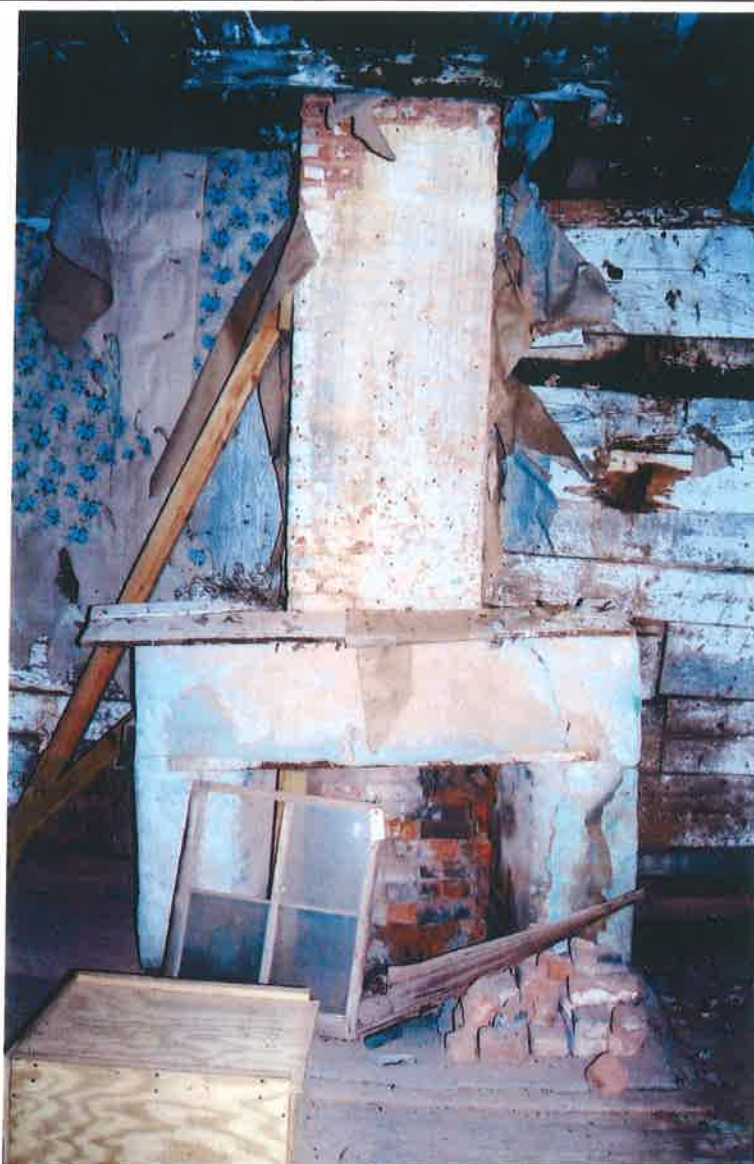
*Image 87:* Oakland Plantation. South Tenant Cabin, Room 102, 2002. The chimney has *bousillage* plaster on it while the mantle is made of hard cement with modern blue paint.
