## Doris Leeper House Cape Canaveral National Seashore

This report is based on a site visit to the Doris Leeper House on 25-26 March 2002. The purpose of the visit was to evaluate the integrity of the 1.63-acre site, which lies on the western shore of the barrier island at the northern end of Mosquito Lagoon. The site includes three buildings---a house and garage, both apparently built in 1927; a combination guesthouse and artist's studio, built in 1969; an asphalt tennis court, which may also date to the 1960s; and a wooden dock of indeterminate age.

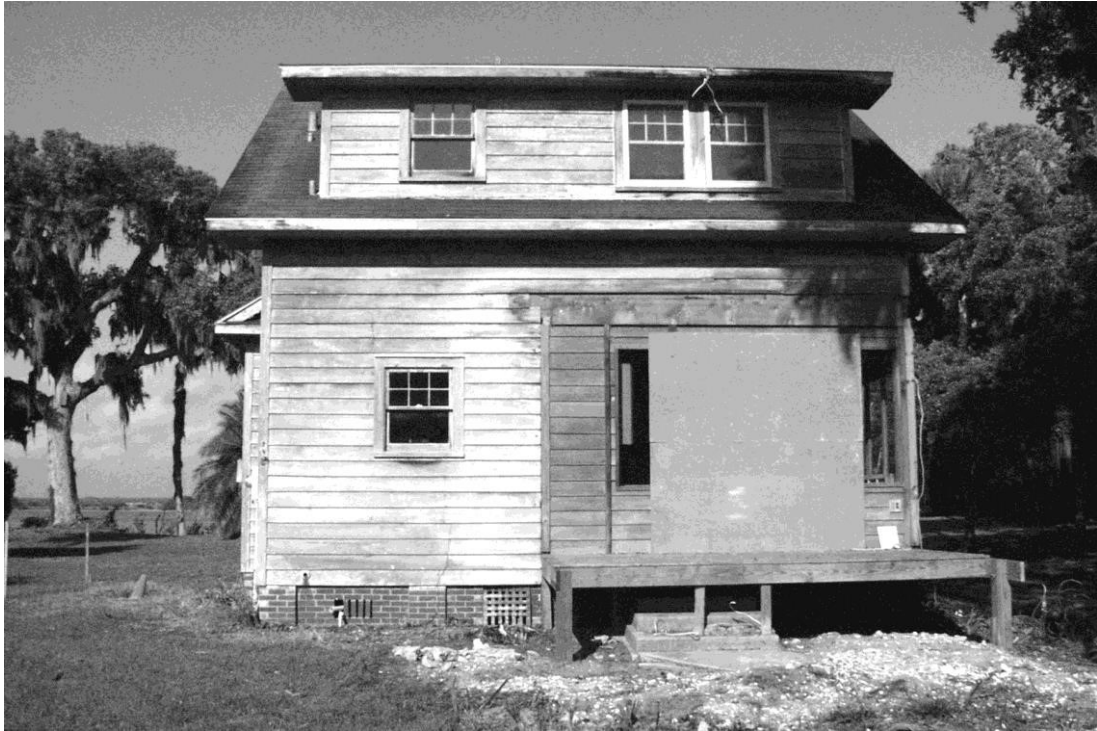
**Figure 6** View of rear (east) side of house. The modern deck, which has been partially dismantled, was built over the original brick-and-concrete steps and stoop at the back door. (NPS-SERO-CRS, 2002)

Providing handicapped access to the house may be necessary, depending on how the building is to be used. The modern deck at the rear of the house has been partially dismantled and should be completely removed to expose the original brick and concrete stoop and steps. A handicapped ramp could then be installed to the stoop, as indicated on the attached plan. Handicapped access to the second floor of the house is not feasible and the program of use for the house should be developed accordingly.

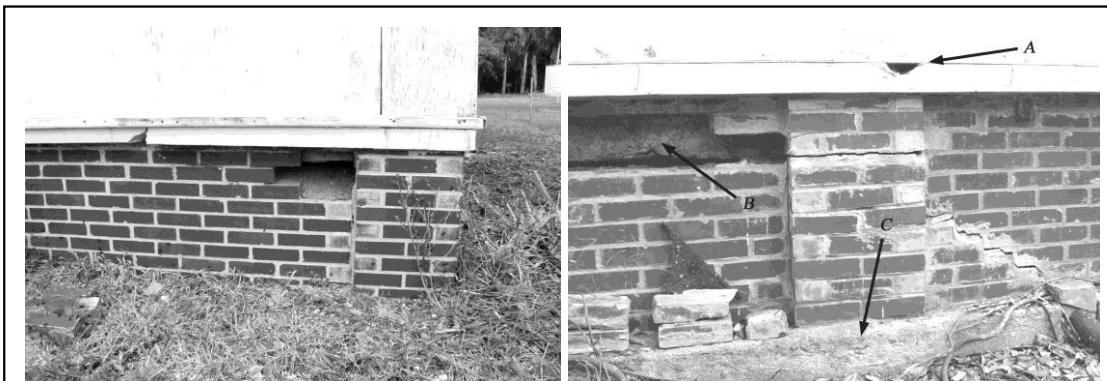
*Foundation:* The wood frame of the house, which is elevated around 18" above grade, rests on brick foundation piers and walls that were built on a poured concrete footing that extends a few inches above grade. Most of it is in excellent condition except around the southwest corner of the front porch where now-removed vegetation is reported to have caused some heaving of the foundation. A few bricks have also been lost from the foundation wall in that area, which has allowed the loss of some of the fill on which the porch floor slab rests and may have contributed to the cracks that have developed in the slab. In addition, the foundation has settled and cracked along the north side of the house in the vicinity of the abandoned cistern beneath the back porch.

**Figure 7** Above, view of southwest corner of front porch showing missing brick in that location. Below, view of northeast corner of foundation at back porch. "A" indicates original inlet for cistern through floor slab; "B" indicates slab covering top of cistern; "C" indicates raised concrete footing that continues around the perimeter of the house. (NPS-SERO-CRS, 2002)

**Main House:** The only evident structural problems with the house relate to the brick foundation and concrete floor slabs at the south end of the front porch and on the north side of the back porch. At the front porch, heaving of the floor slab and foundation cracks probably relate to large vegetation that was recently removed from that end of the porch. Three or four bricks are missing from the front of the foundation at that end of the porch, allowing loss of some of the fill material. These should be replaced, but the other cracks and slight displacement of the floor slab should be left alone and simply monitored to insure there is no further movement.

On the north side of the back porch, the source of the cracking of the foundation at that location is not clear. It, too, may relate to overgrown vegetation. As with the front foundation, missing brick should be reinstated, cracked joints repointed, and the entire area simply monitored for any further movement or cracking of the masonry.

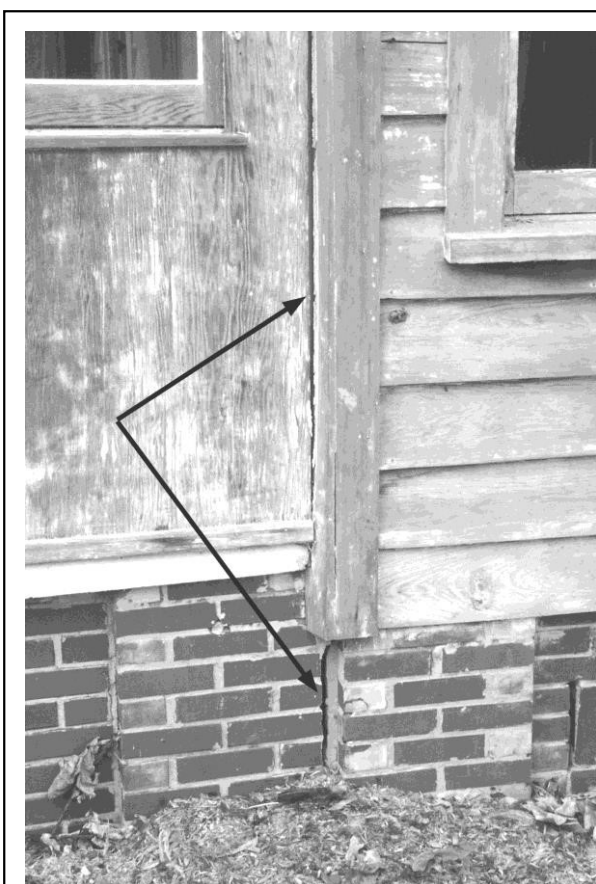
**Figure 8** View of juncture of front porch foundation and pier at southwest corner of the house; arrows indicate separation probably as the result of heaving caused by a recently-removed tree next to the house at this location. (NPS-SERO-

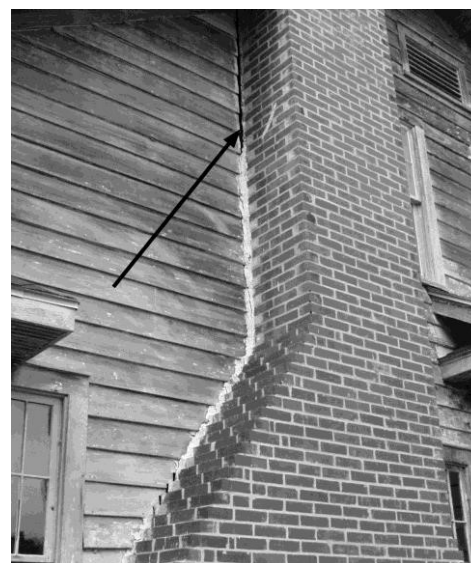
It is not clear if the chimney has been rebuilt or simply cleaned but it remains in excellent condition. Of some concern is the partially-filled gap visible on the exterior between the masonry and the wall of the house. However, there is no corresponding cracking of the masonry or deflection of woodwork where the chimney stack goes through the eaves,

indicating that the condition may simply be a result of the manner in which the chimney was constructed.

**Figure 9** View of chimney; arrow indicates gap between masonry and the wall of the house. (NPS-SERO-CRS, 2002)

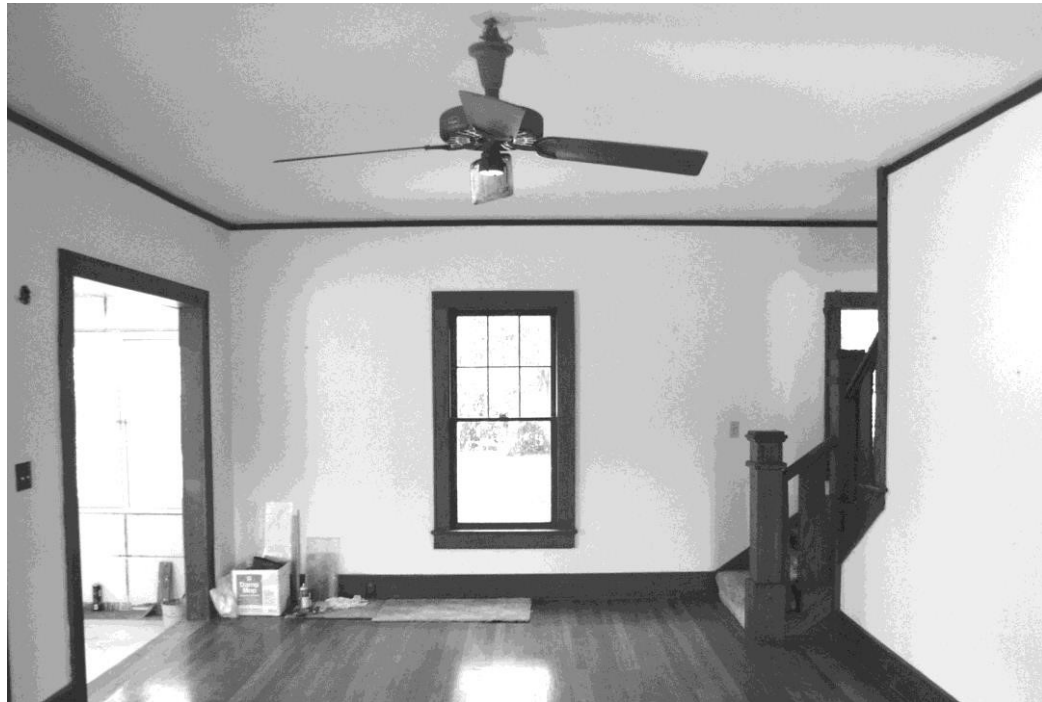
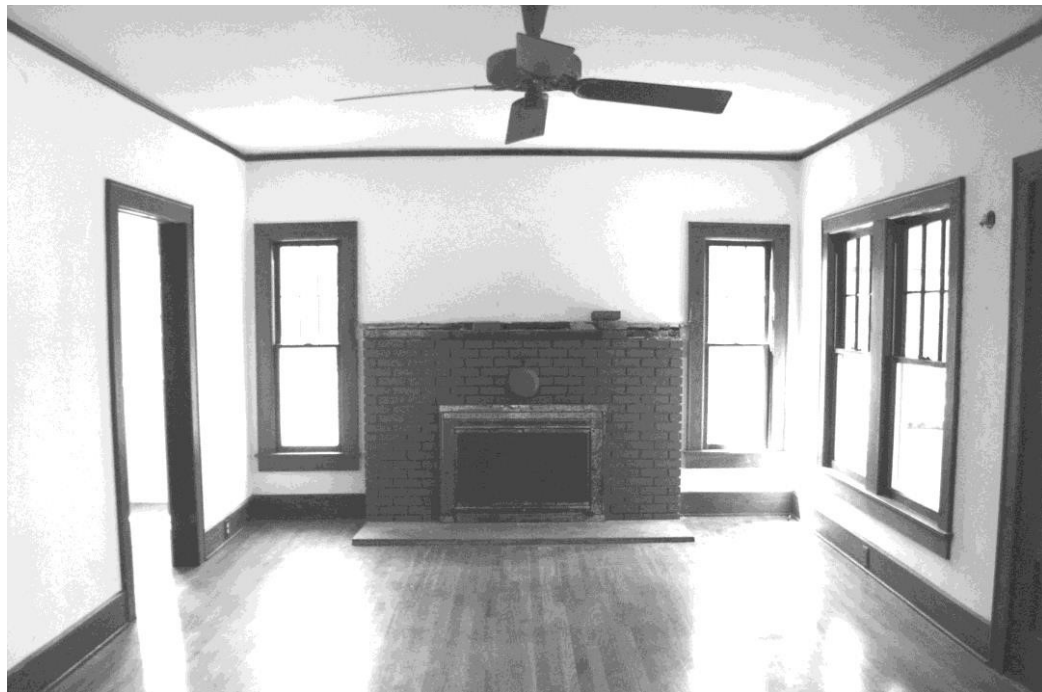
**Figure 14** Top, view to north of living room (101). Bottom, view to south of living room. Except for missing sconces and mantle shelf, this room is in excellent condition. (NPS-SERO-CRS, 2002)

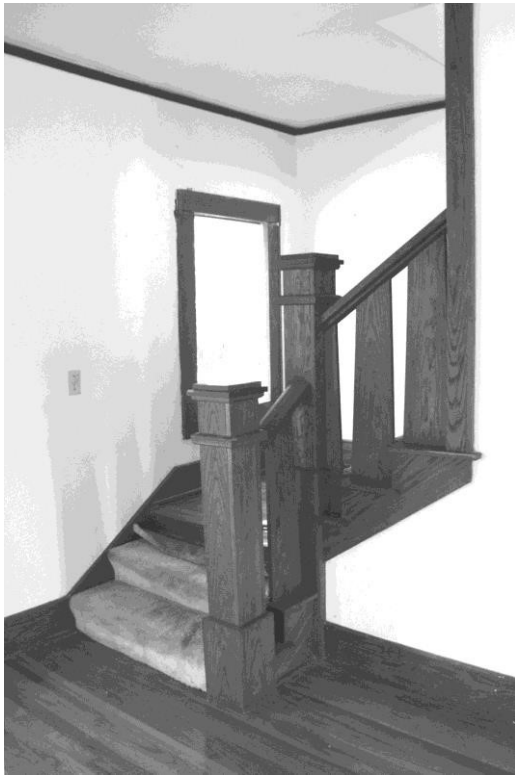
**Figure 15** View of staircase; window on landing originally held a stained-glass window. (NPS-SERO-CRS, 2002)

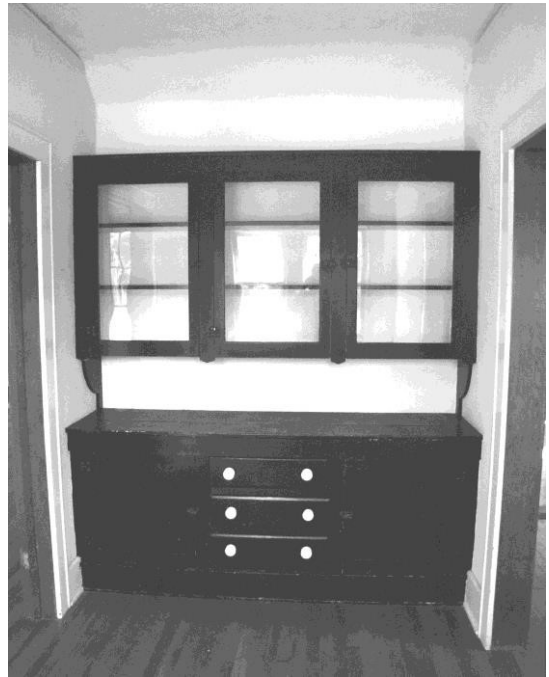
**Figure 16** View of butler's pantry at north end of dining nook (102); cabinetry is oak, originally varnished but now painted black; remainder of woodwork in this room was probably always painted. (NPS-SERO-CRS, 2002)
