Robert Cravens House & Dairy  
Chickamauga and Chattanooga National  
Military Park  
**Historic Structure Report**

**Historic Structure Report**

**Joseph K. Oppermann–Architect, P.A.**

2012  
Historic Structure Report  
Robert Cravens House & Dairy  
Chickamauga and Chattanooga National Military Park

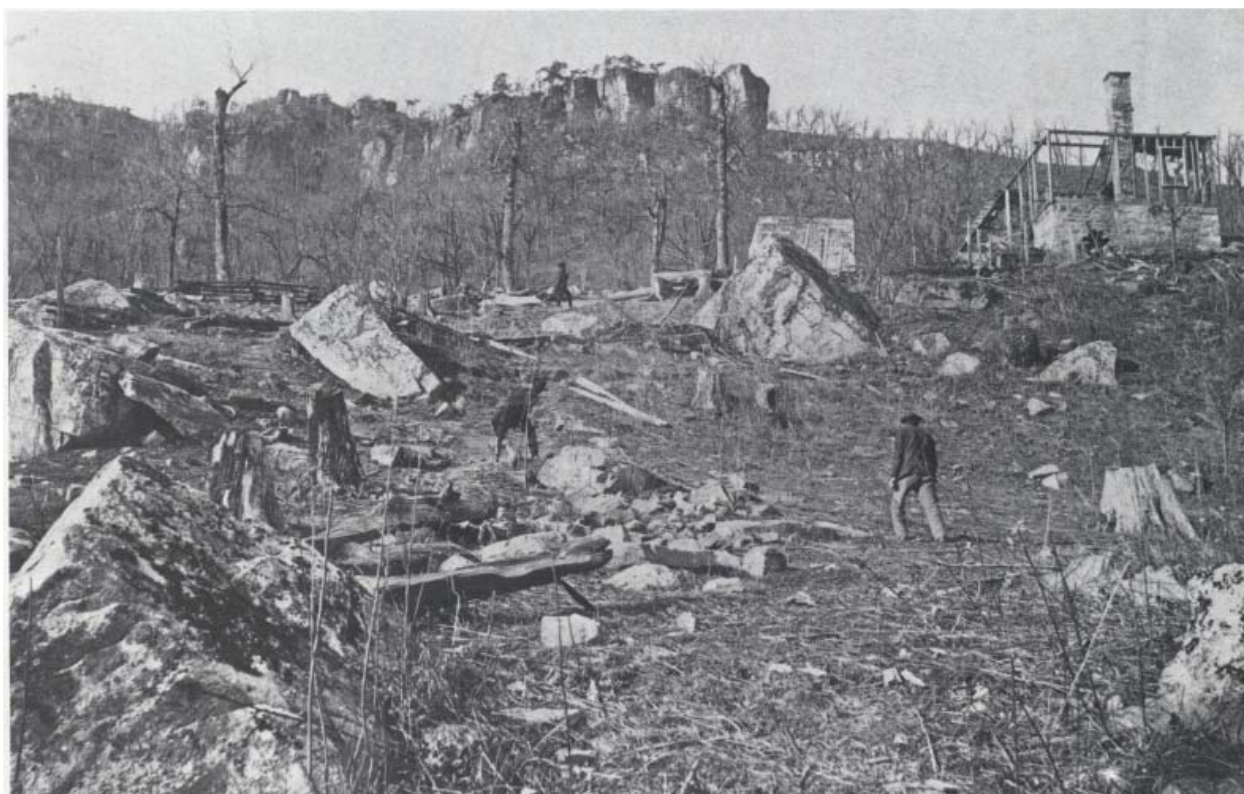
**Figure 17.** Ruins of the 1856 Cravens House seen from the southeast; photograph believed taken in 1864. (CHCH Collection)

all but the ell. The view is from the southeast, well below the house looking uphill. In this view, the smaller chimney is clearly centered on a short end wall of an ell, the window frame again visible to its north. A large hole, perhaps from Union artillery, can be seen in the foundation.

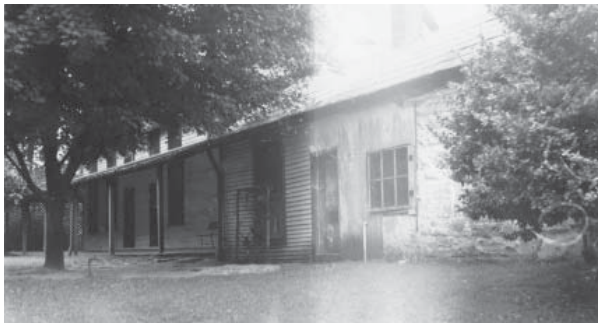
**Figure 31.** Photograph accompanying 6/18/1946 Quarters Report showing the poor condition of the house. (CHCH Acc 212, Folder 38)

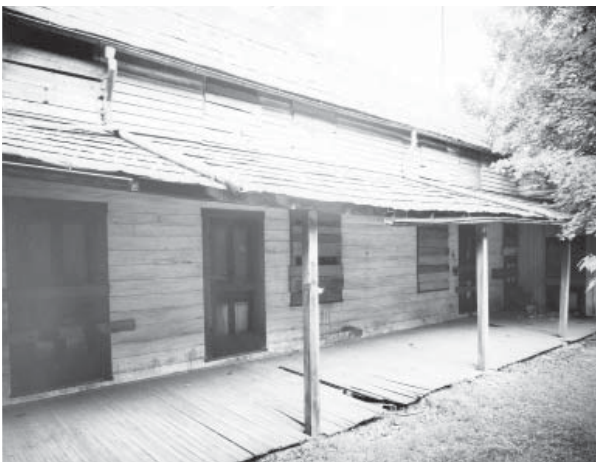
**Figure 36.** Pre-restoration photograph taken in 1956 showing west elevation of the connector. Doors and windows are boarded over. Porch and gutter system in poor condition. (CHCH Collection)

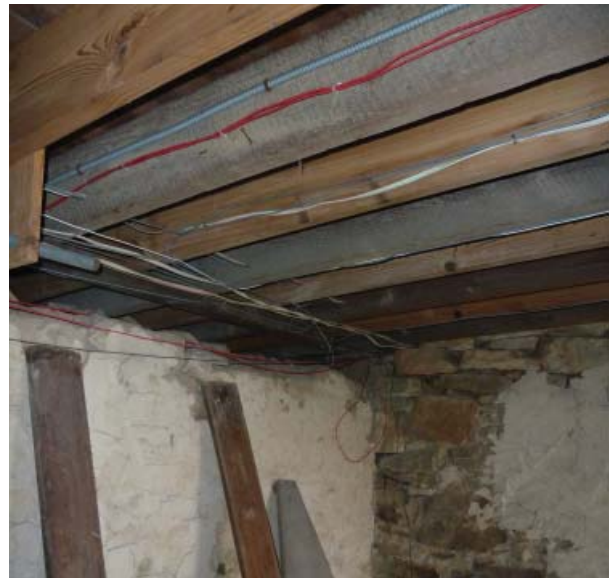
**Figure 70.** Alternating 1866 floor joists and 1956-57 joists.

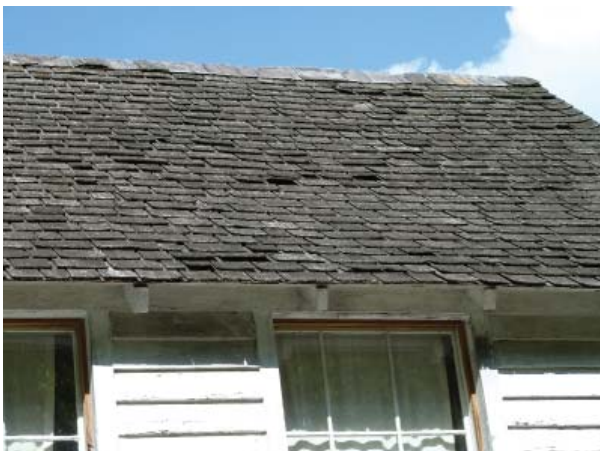
And finally, the Cravens House and Dairy do have pressing maintenance needs. The roofs and chimney flashing of both buildings are in failure and need immediate replacement. There are no gutters or downspouts. Their absence on the upper roof of the house is causing needless but severe damage from runoff to the second-floor windows and thereby the plastered walls and ceilings; gutters and downspouts should be installed, at least at the upper roof. The second-floor windows need repair to be made weathertight. The damaged interior plastered surfaces need repair and repainting. Ground water continues to enter the basement through foundation walls; roof runoff and perhaps other ground water need to be contained and directed away from the house. With timely repairs, the Cravens House and Dairy will be prepared to receive and inform another generation of visitors.

There are no roof gutters or downspouts. Their absence is a major contributing factor to two

**Figure 77.** Failing shingles of the main roof.

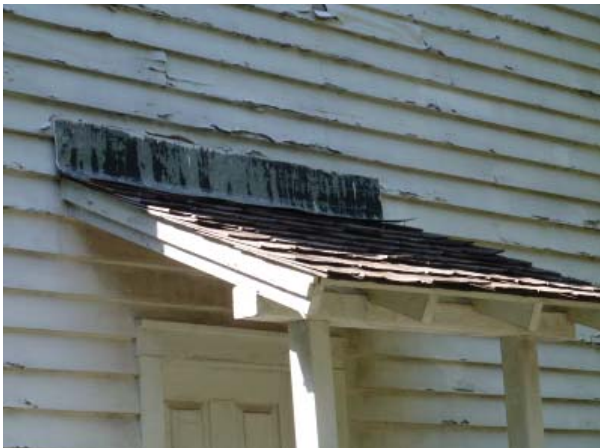
**Figure 78.** Flashing of south elevation shed roof attached to exterior of weatherboard.

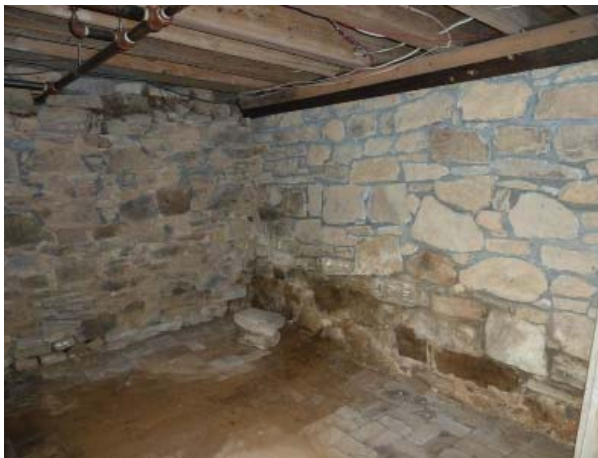
**Figure 96.** Southwest oblique of Room 001 showing moisture problem on west wall.
