**PRE-RENOVATION  
LEAD-BASED PAINT INSPECTION REPORT**

**NIKE MISSILE SITE  
ADMINISTRATION AND CONTROL AREA  
AND  
LAUNCH AREA  
EVERGLADES NATIONAL PARK  
HOMESTEAD, FLORIDA**

March 4, 2010  
Revised August 27, 2010  
EE&G Project No. 2009-2333

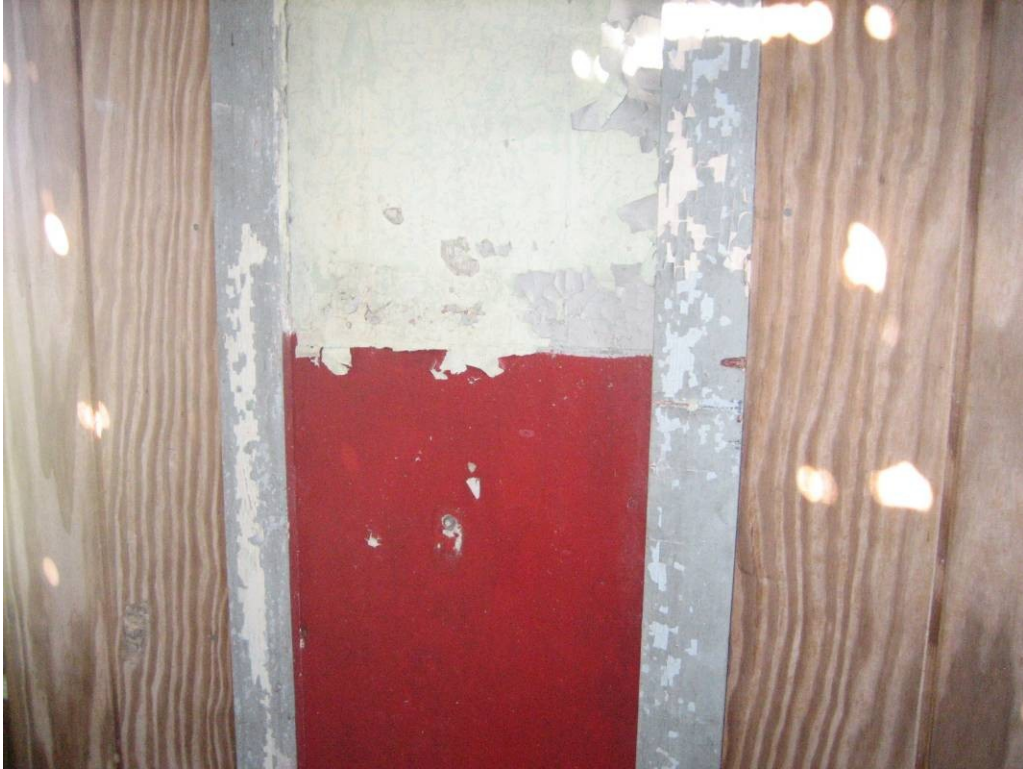
Sign/Generator Building 190A: Intact red paint on concrete block wall.

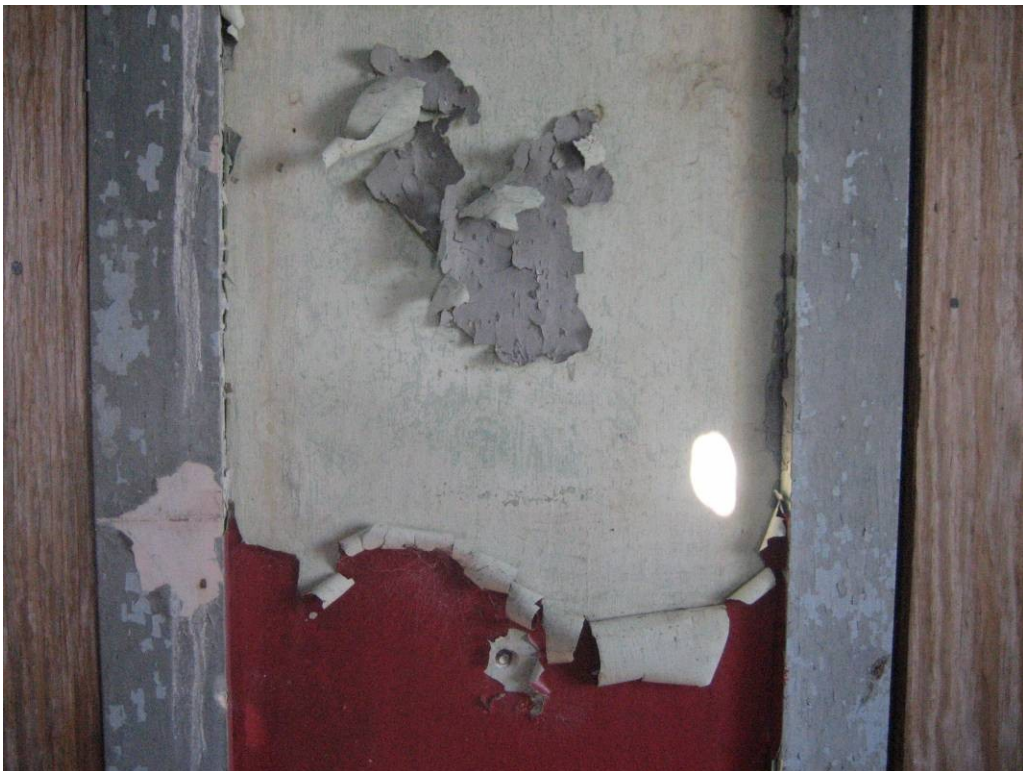
Sign/Generator Building 190A: Peeling green paint on concrete block.

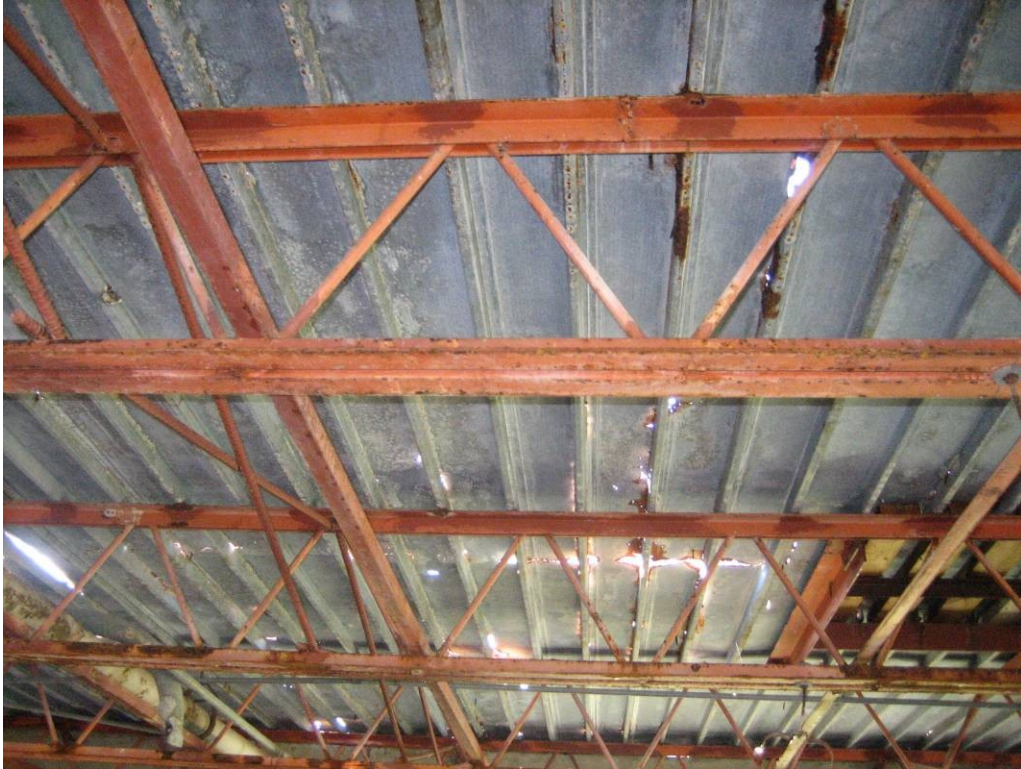
Sign/Generator Building 190A: Red paint on interior metal support beams.

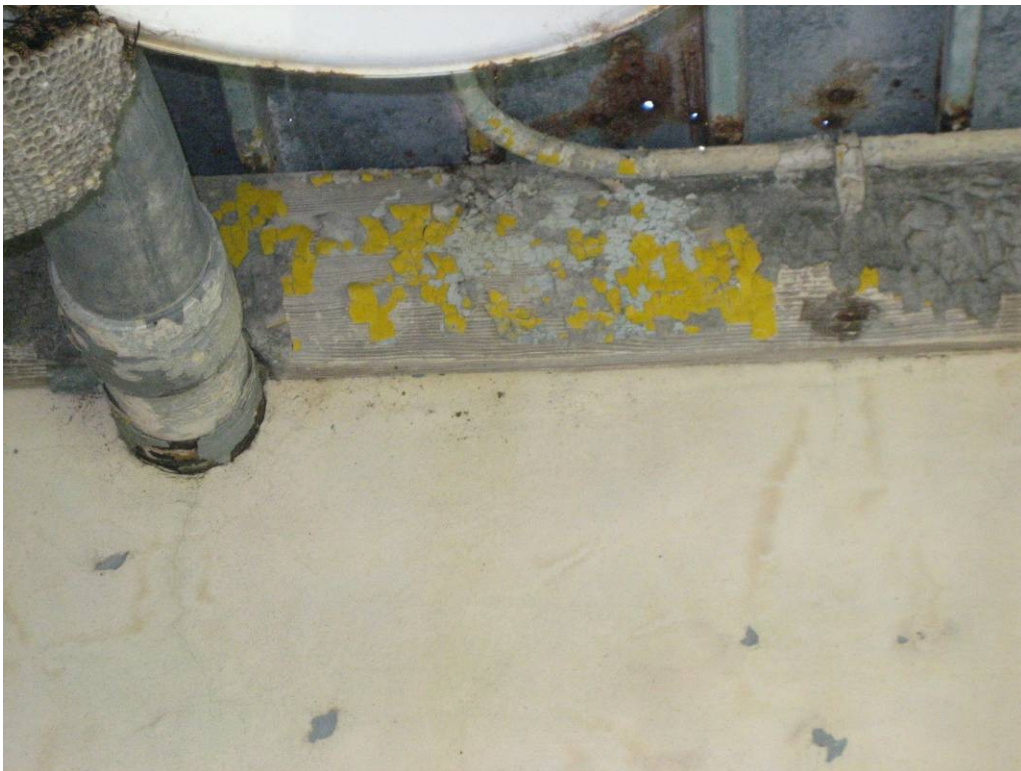
Sign/Generator Building 190A: Peeling yellow paint on wood header above bathroom door.

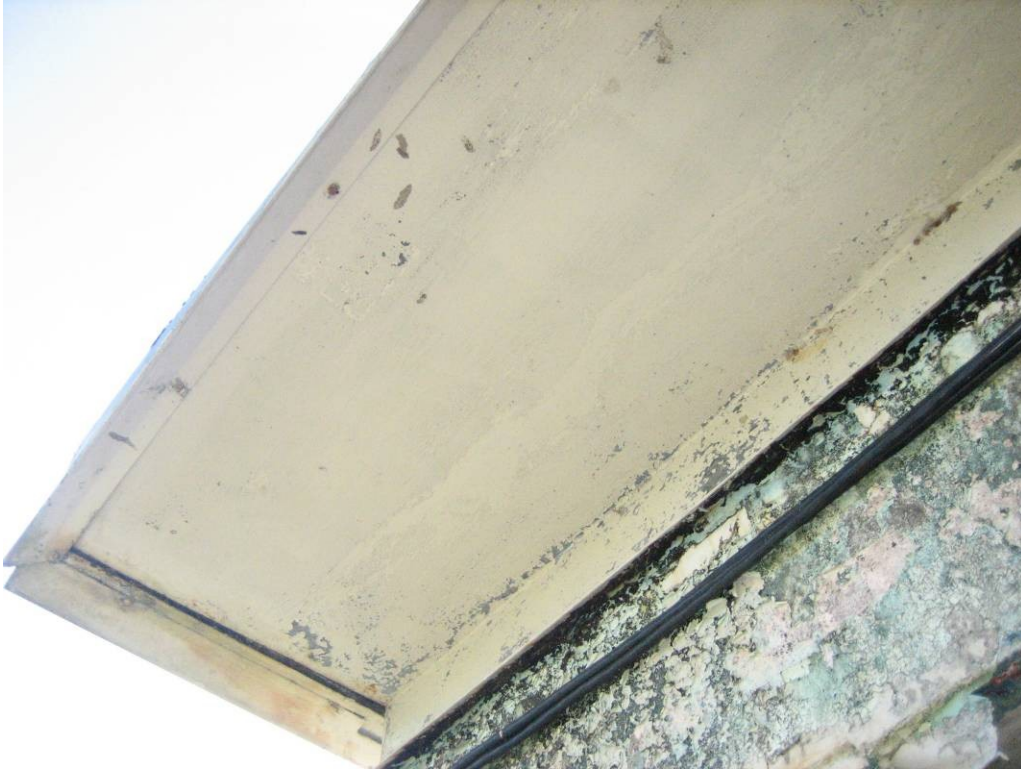
Sign/Generator Building 190A: Cracked beige paint on metal eve soffit.

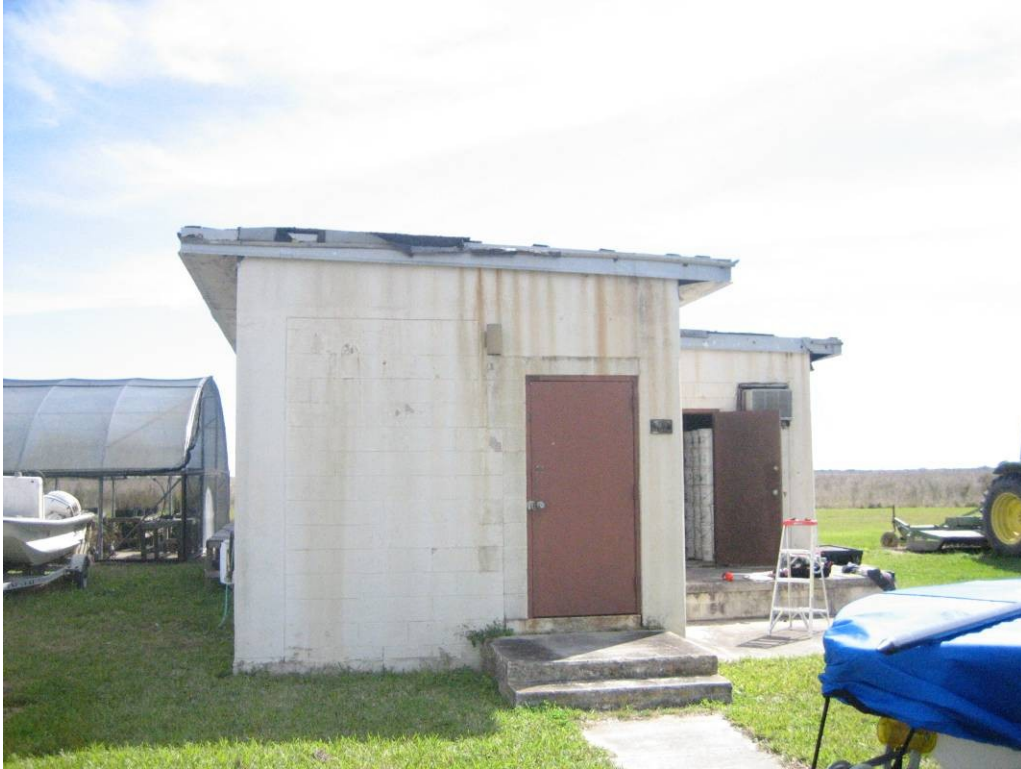
190B Building: Intact beige paint on exterior concrete block walls.

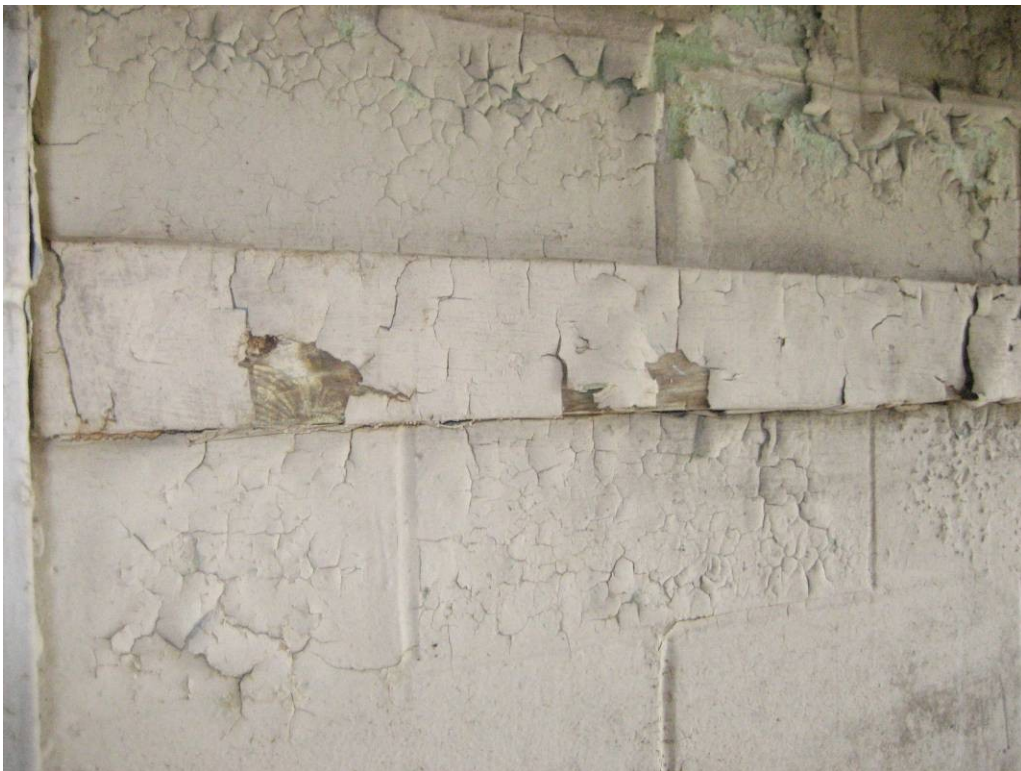
190B Building: Cracked/peeling beige paint on interior concrete block walls.

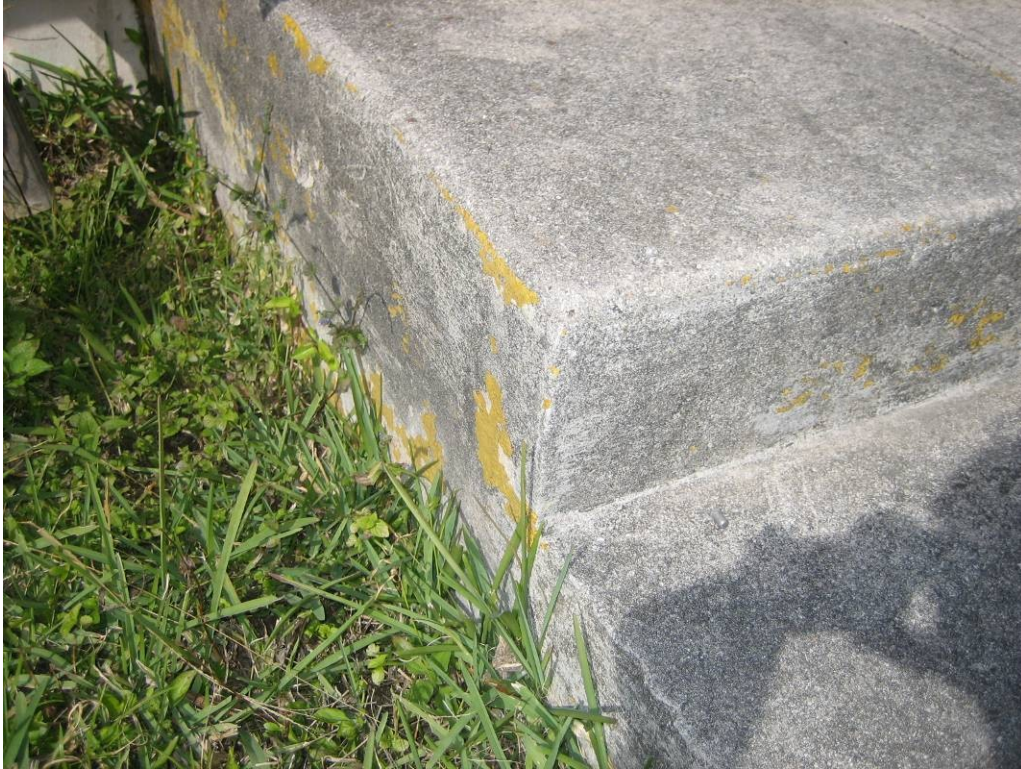
190B Building: Cracked yellow paint on concrete steps.

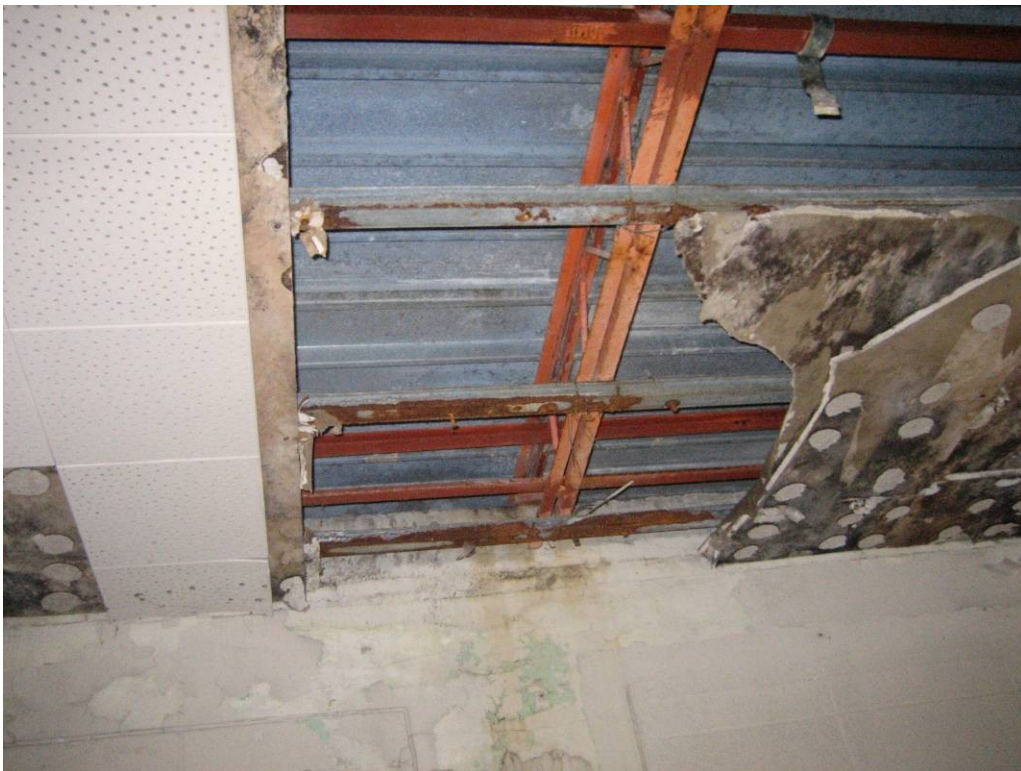
190B Building: Intact red paint on metal support beams.

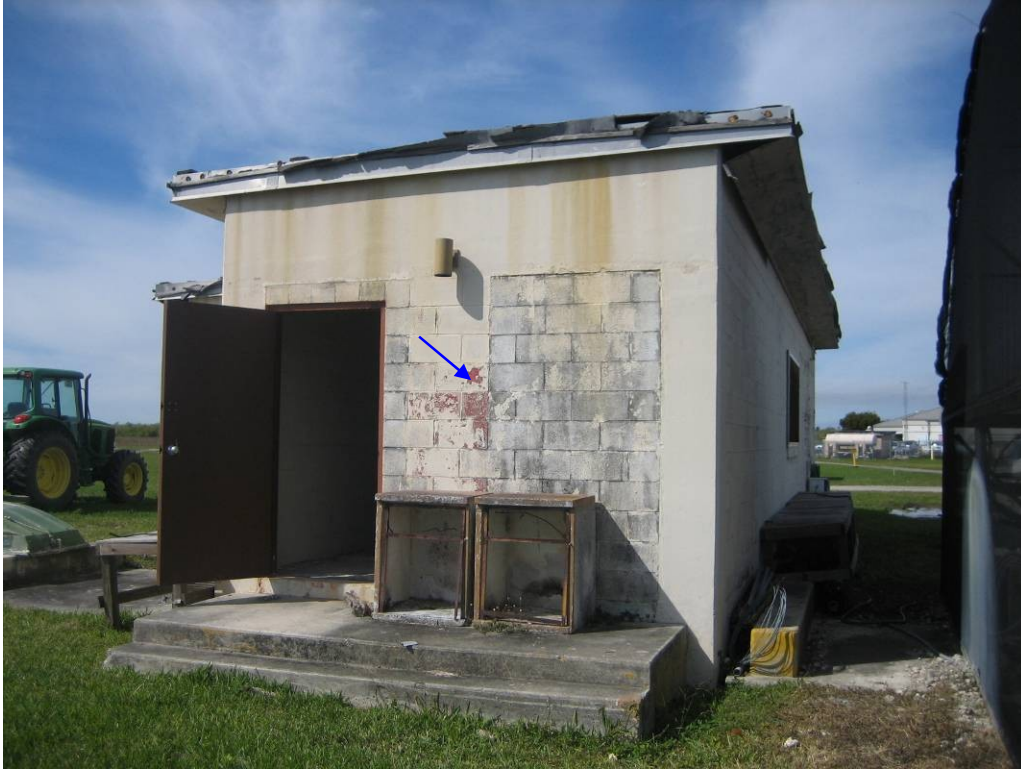
190B Building: Peeling red paint on exterior concrete block wall.

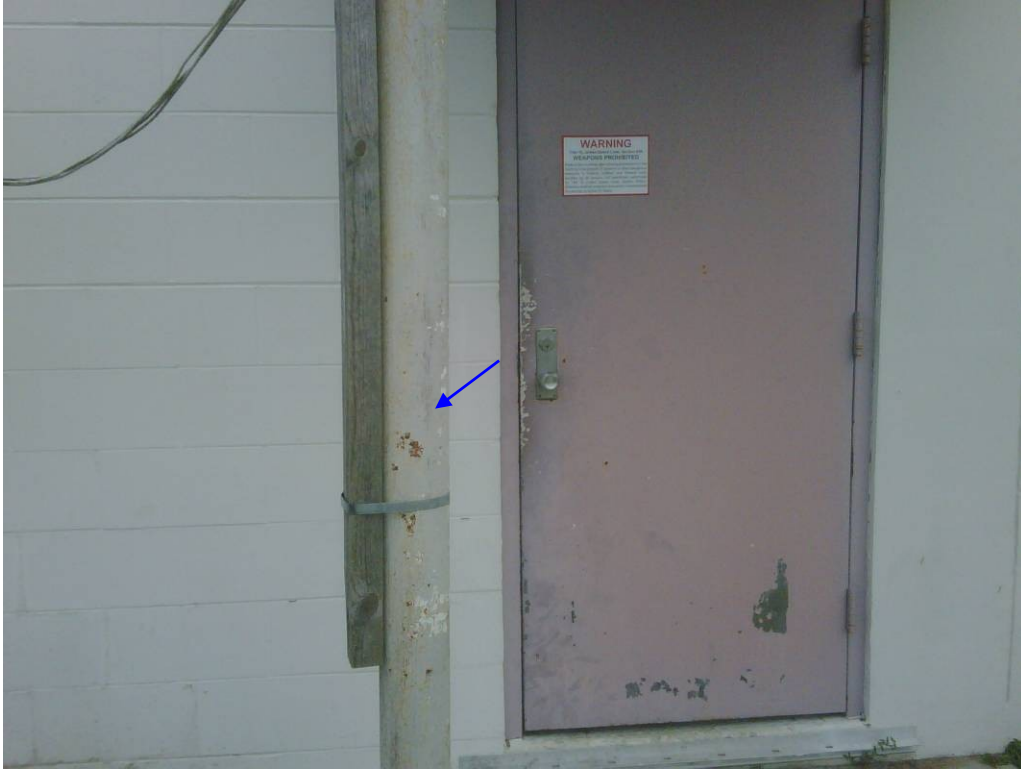
Administration Building: Beige paint on exterior metal column.

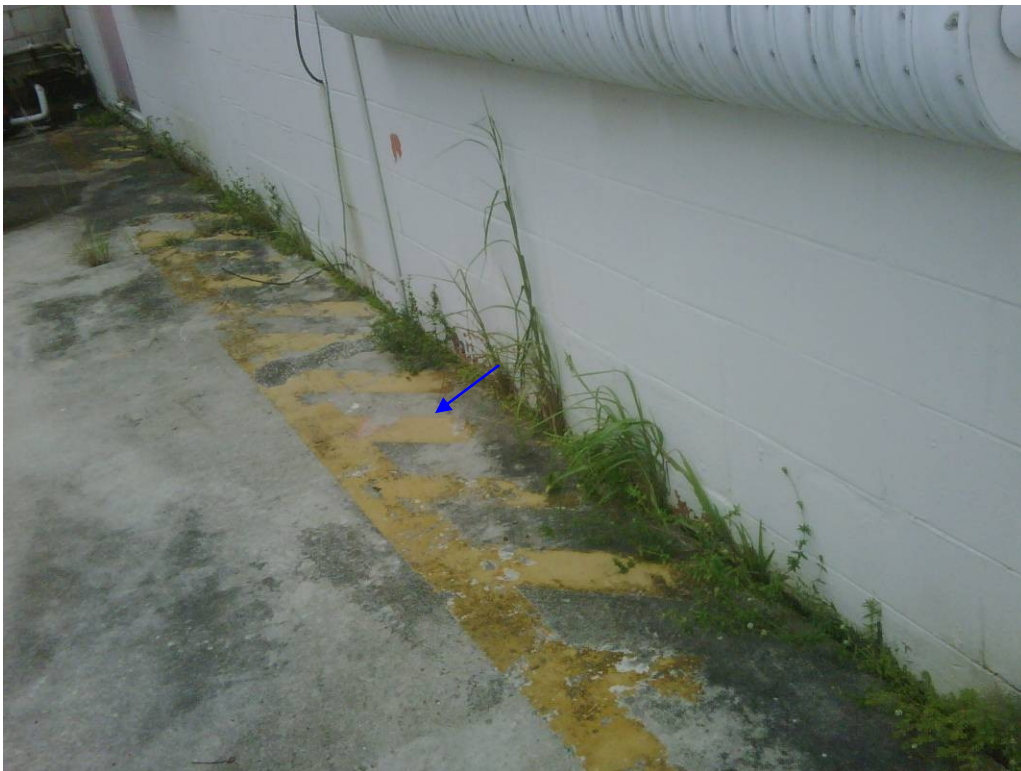
Administration Building: Yellow caution paint on sidewalk.

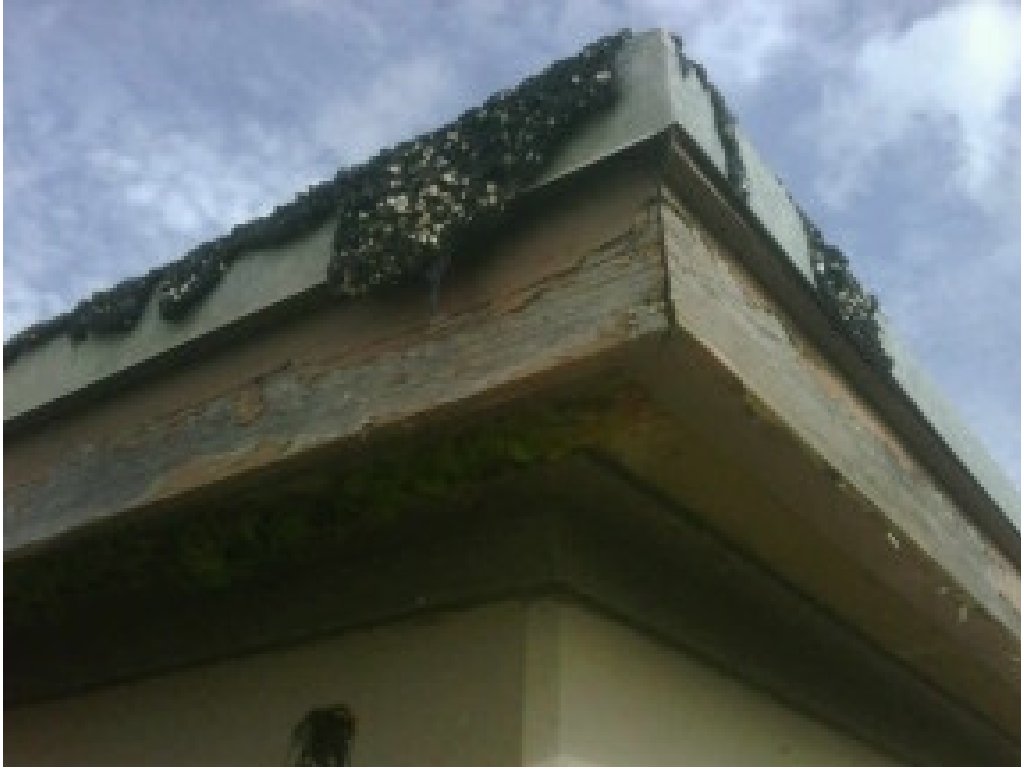
Water Pump House: Brown paint on wood soffit.

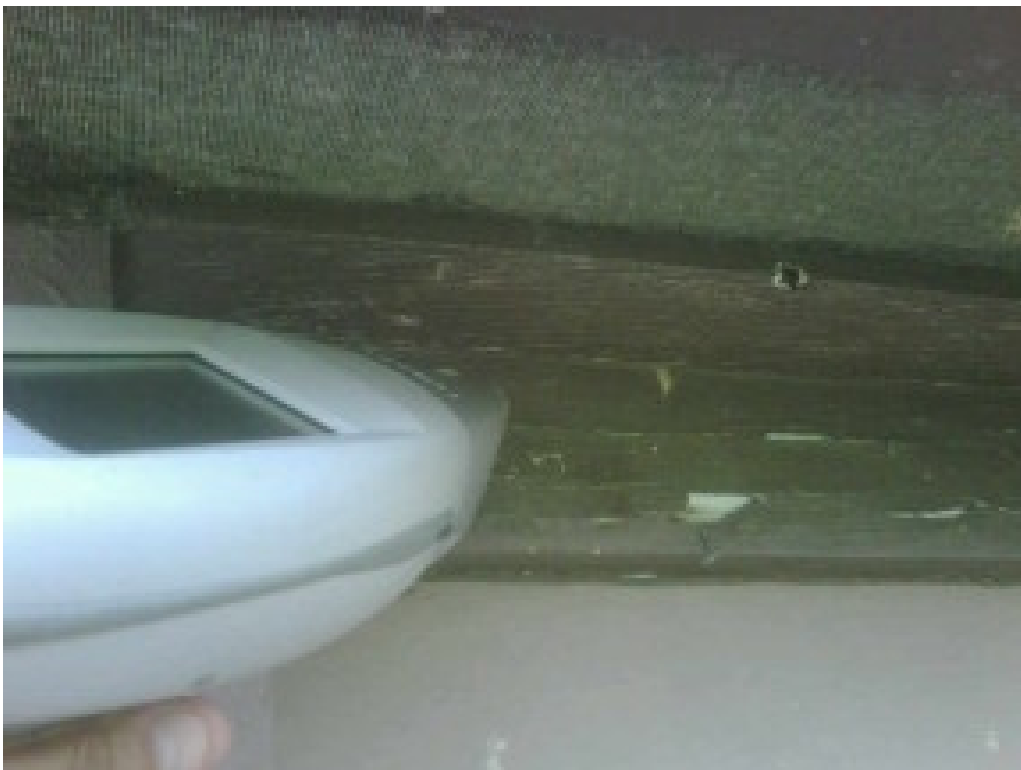
Water Pump House: Brown paint on wood header.

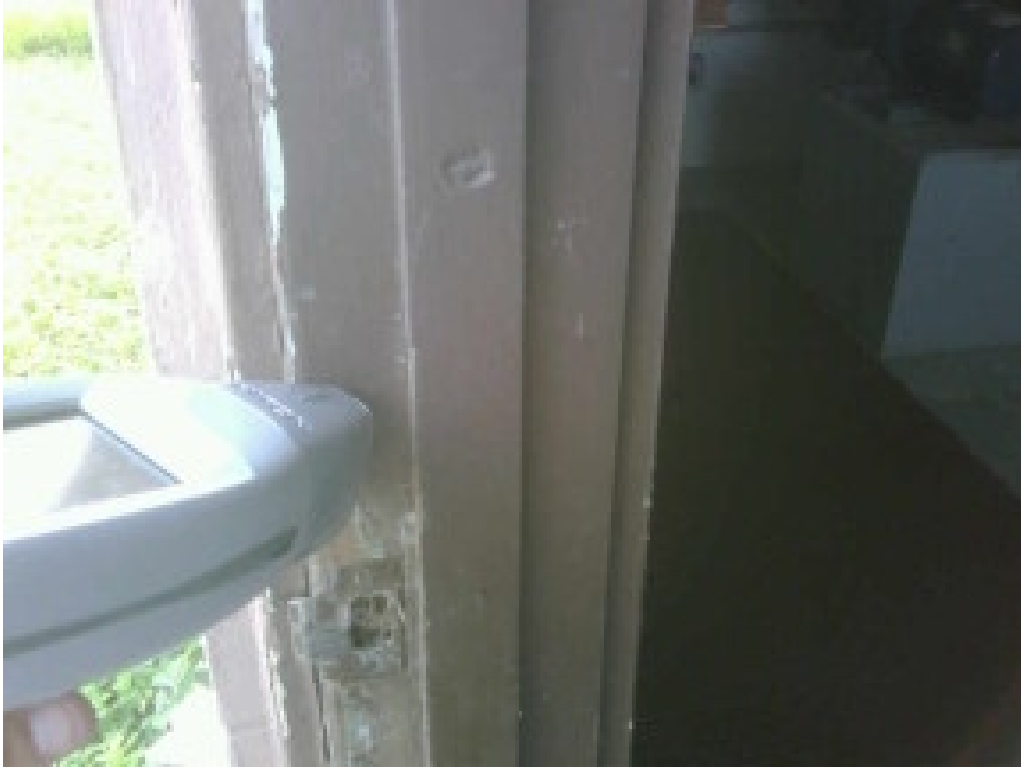
Water Pump House: Brown paint on wood door jamb.

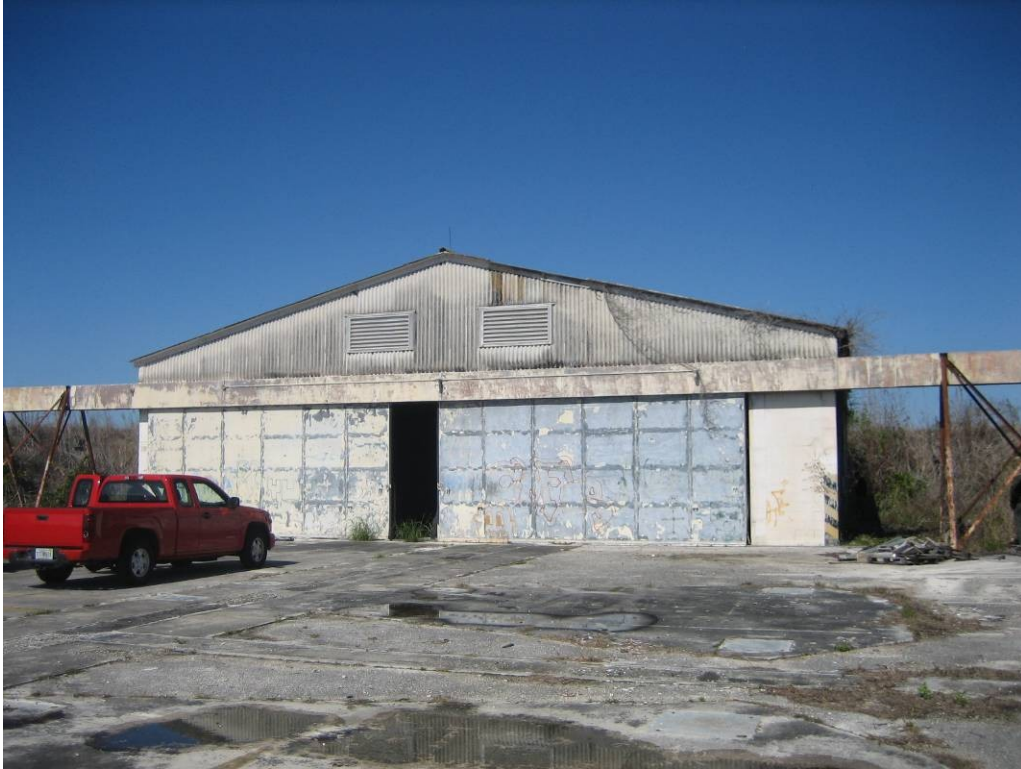
Missile Barn A: Peeling pink paint on exterior metal barn doors.

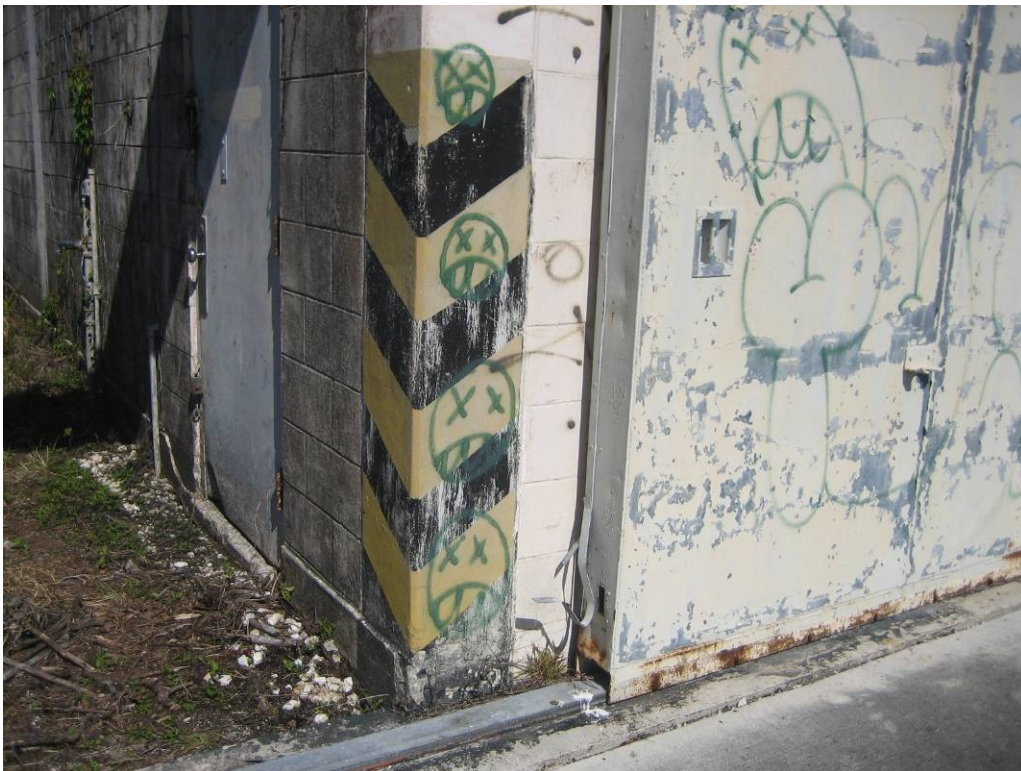
Missile Barn A: Peeling yellow paint on concrete block.

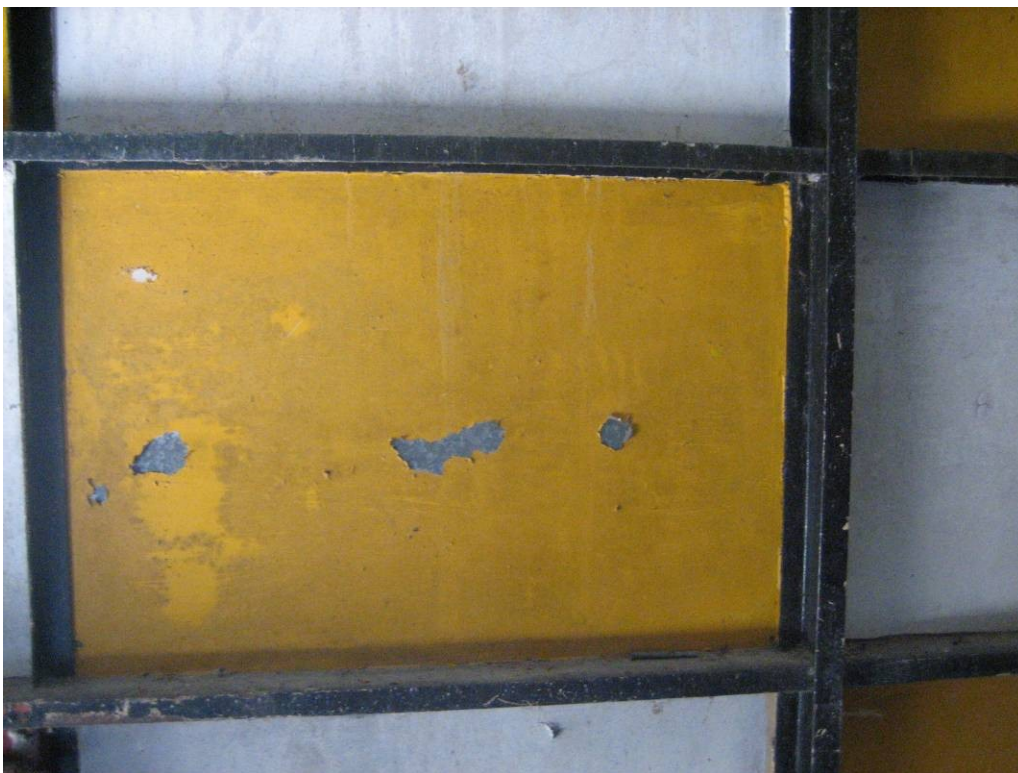
Missile Barn A: Chalking yellow paint on interior of barn door.

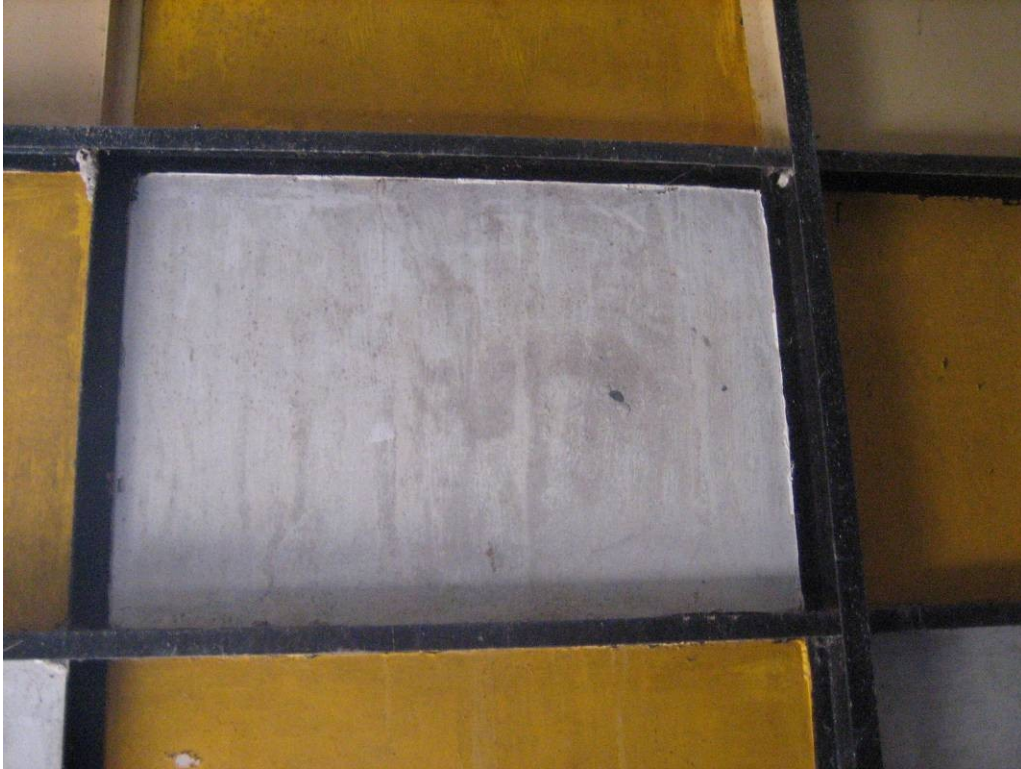
Missile Barn A: Chalking white paint on interior of barn door.

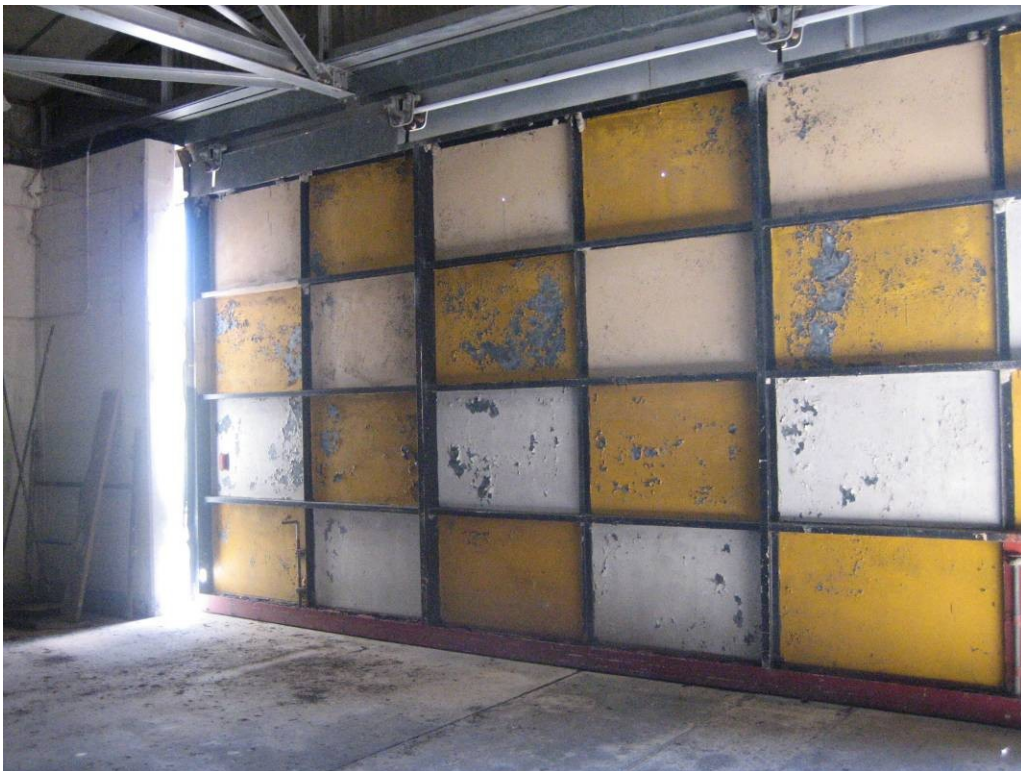
Missile Barn A: Chalking yellow and white paint on interior of barn door.

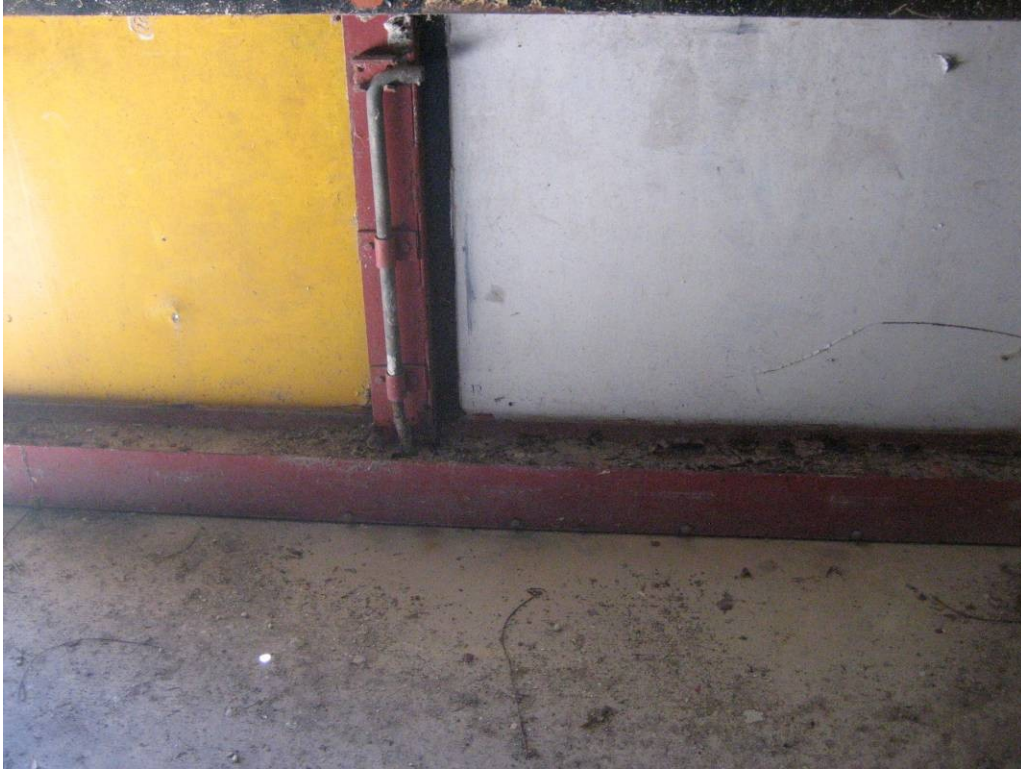
Missile Barn A: Chalking red paint on trim of interior barn door.

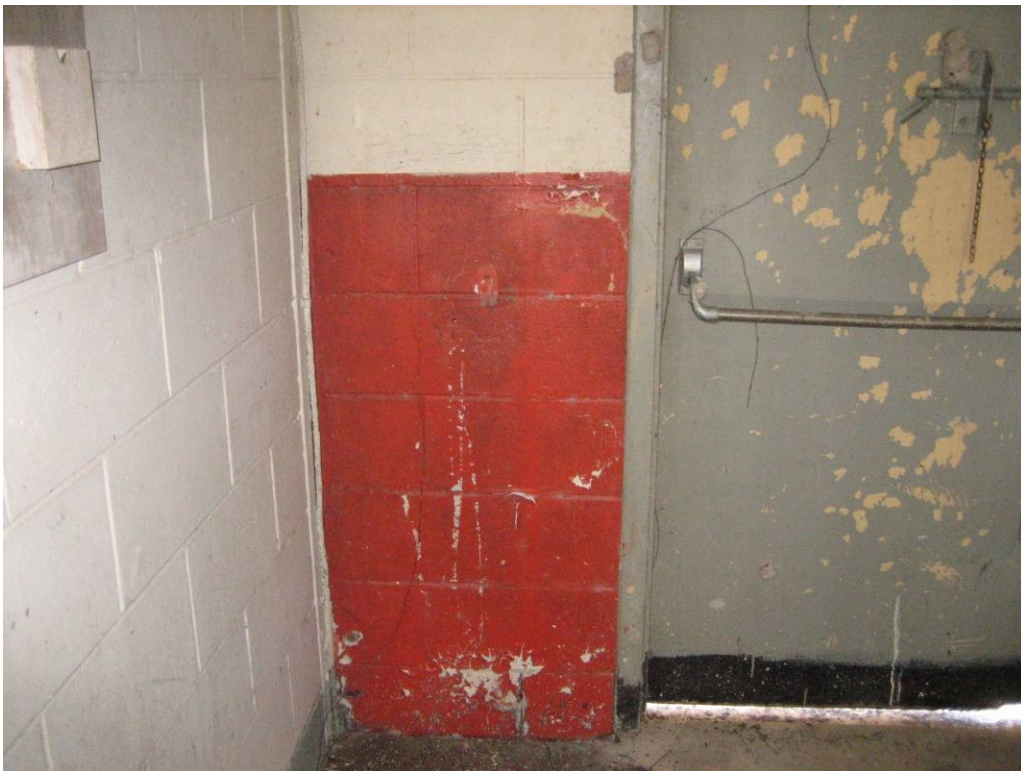
Missile Barn A: Peeling red paint on interior concrete block.

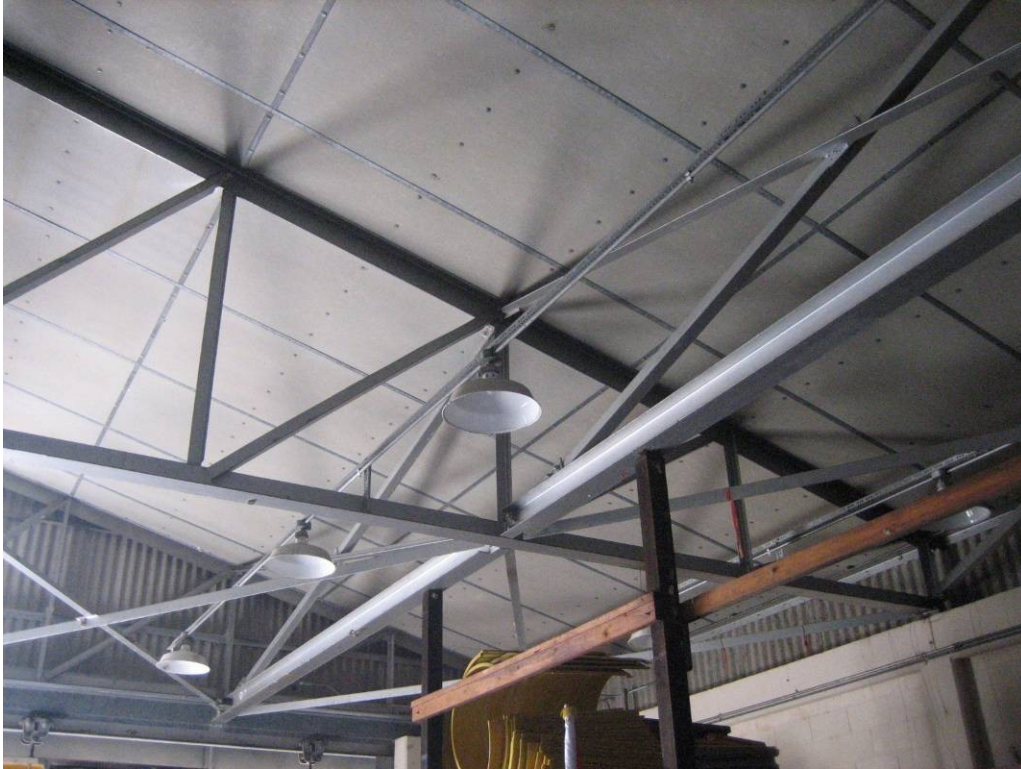
Missile Barn A: Intact gray paint on interior metal beams.

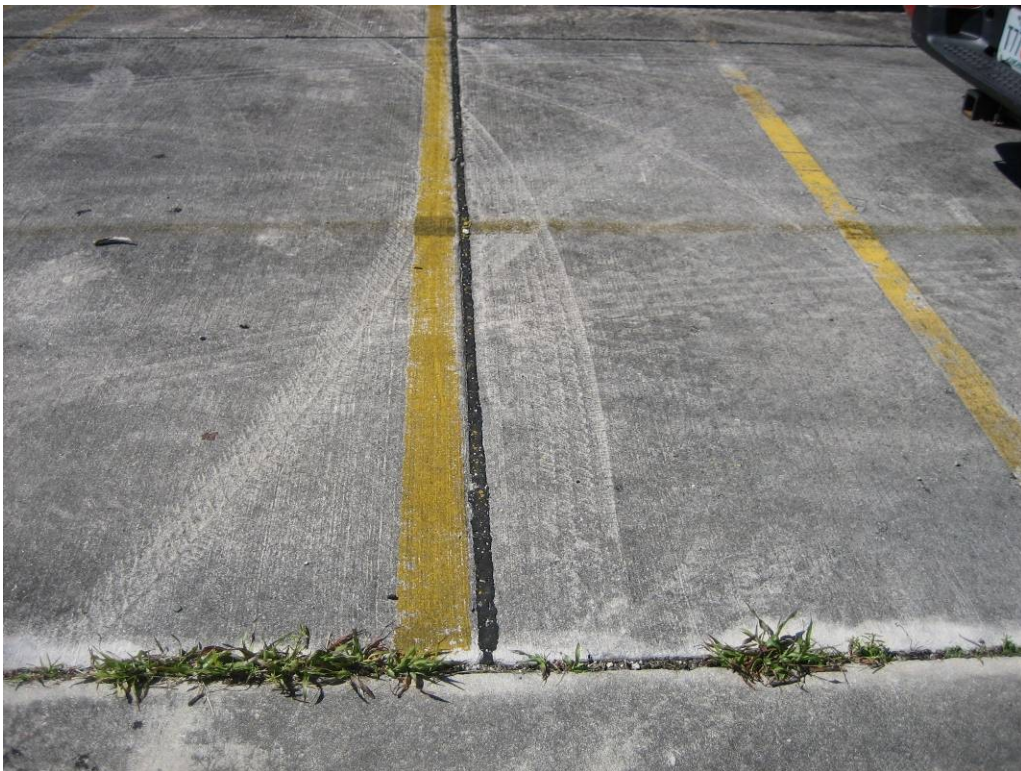
Missile Barn A: Intact yellow paint on exterior concrete slab.

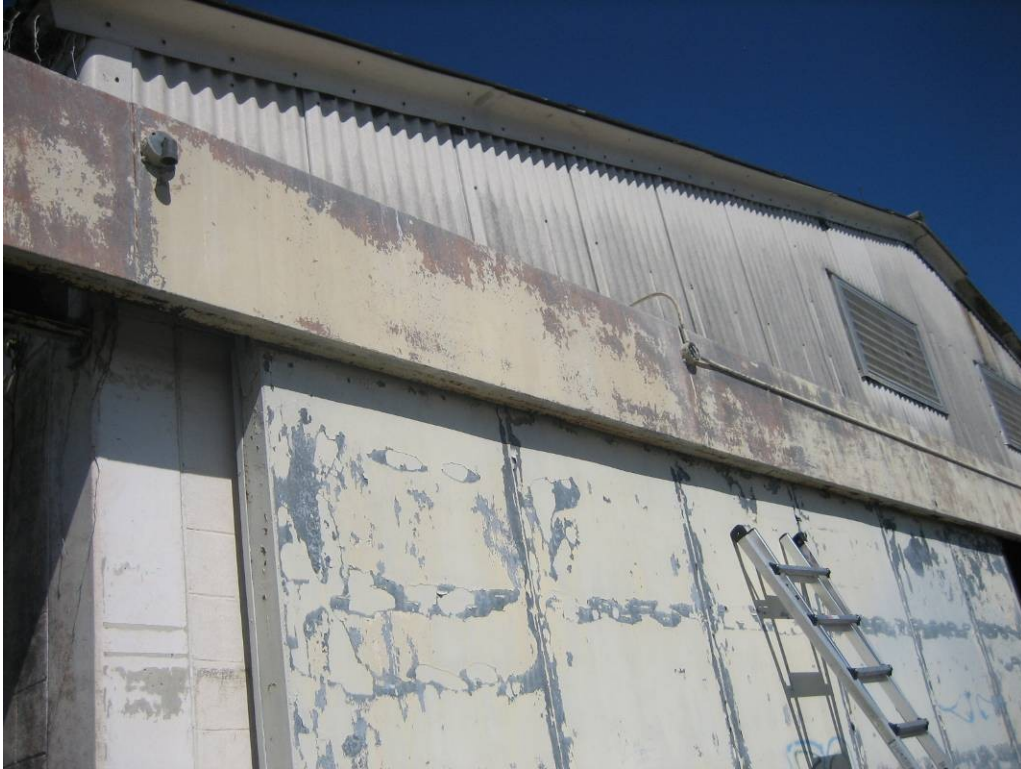
Missile Barn A: Intact pink paint on metal rail beam on barn door.

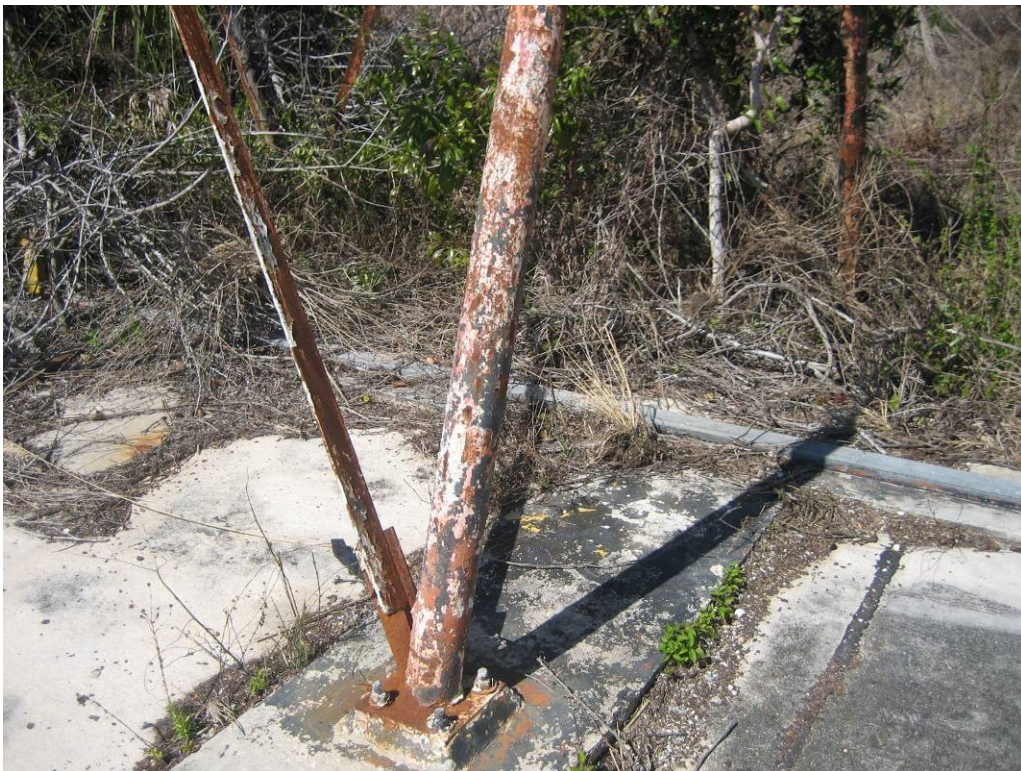
Missile Barn A: Intact pink paint on supports for rail beam on barn door.

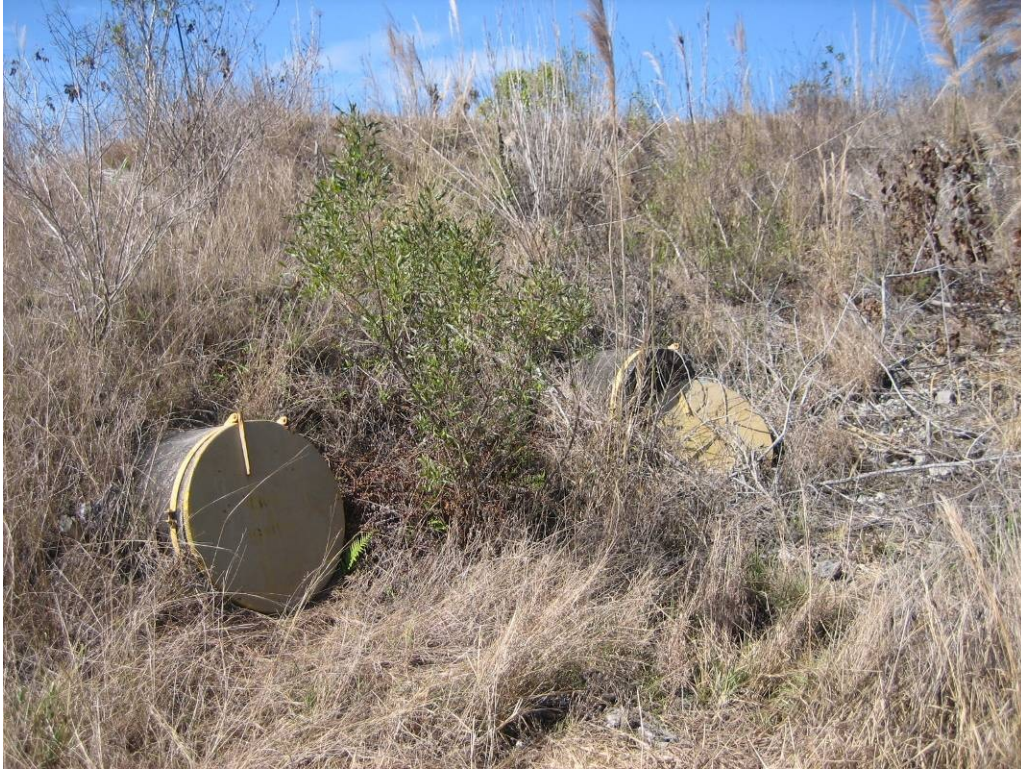
Missile Barn A: Intact yellow paint on manhole covers near bunker.

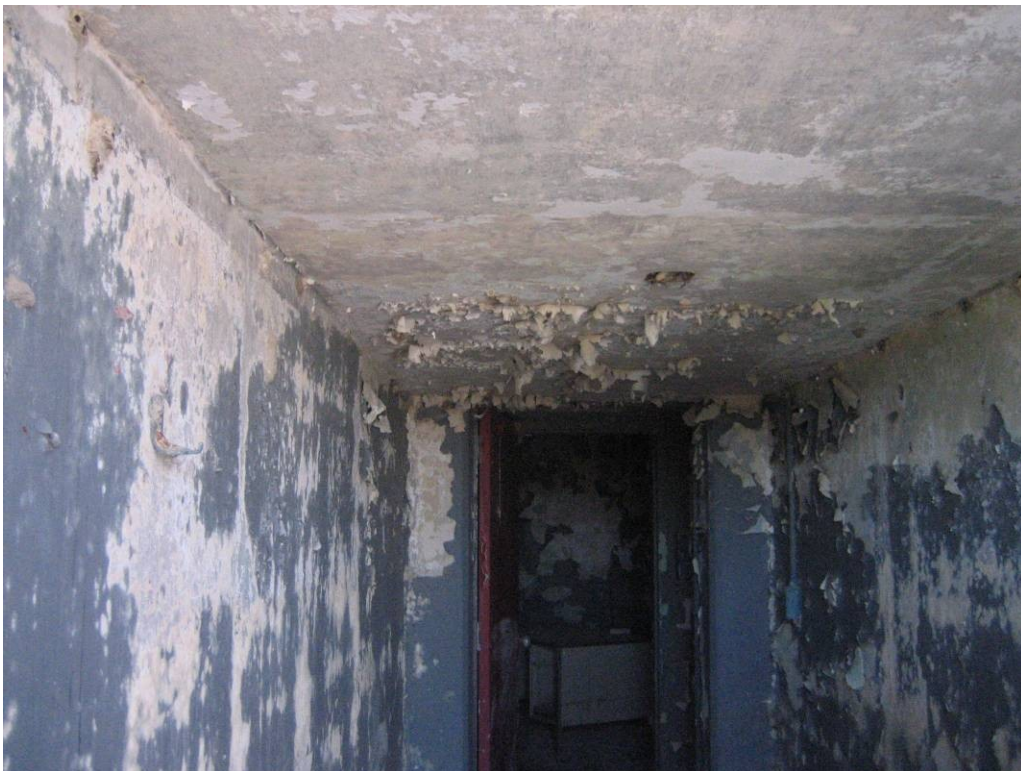
Fire-control Bunker A: Peeling gray paint on interior concrete walls.

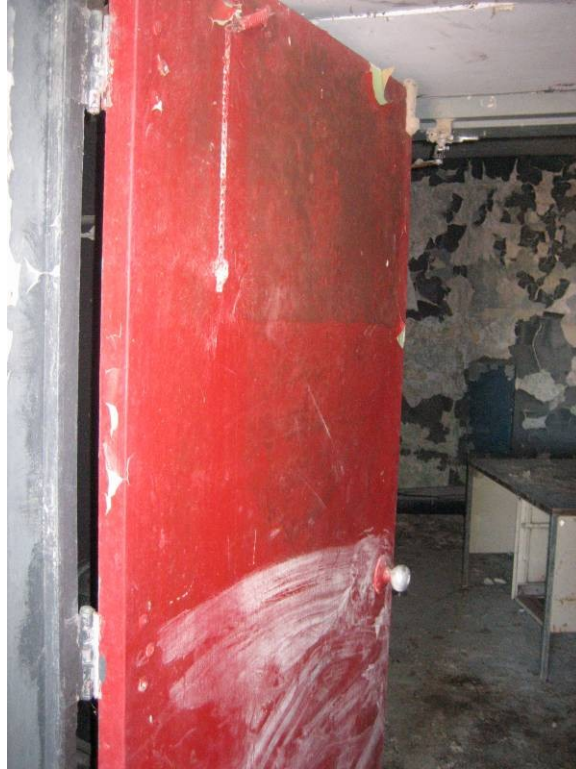
Fire-control Bunker A: Cracked red paint on interior metal door.
