**PRE-RENOVATION  
LEAD-BASED PAINT INSPECTION REPORT**

**NIKE MISSILE SITE  
ADMINISTRATION AND CONTROL AREA  
AND  
LAUNCH AREA  
EVERGLADES NATIONAL PARK  
HOMESTEAD, FLORIDA**

March 4, 2010  
Revised August 27, 2010  
EE&G Project No. 2009-2333

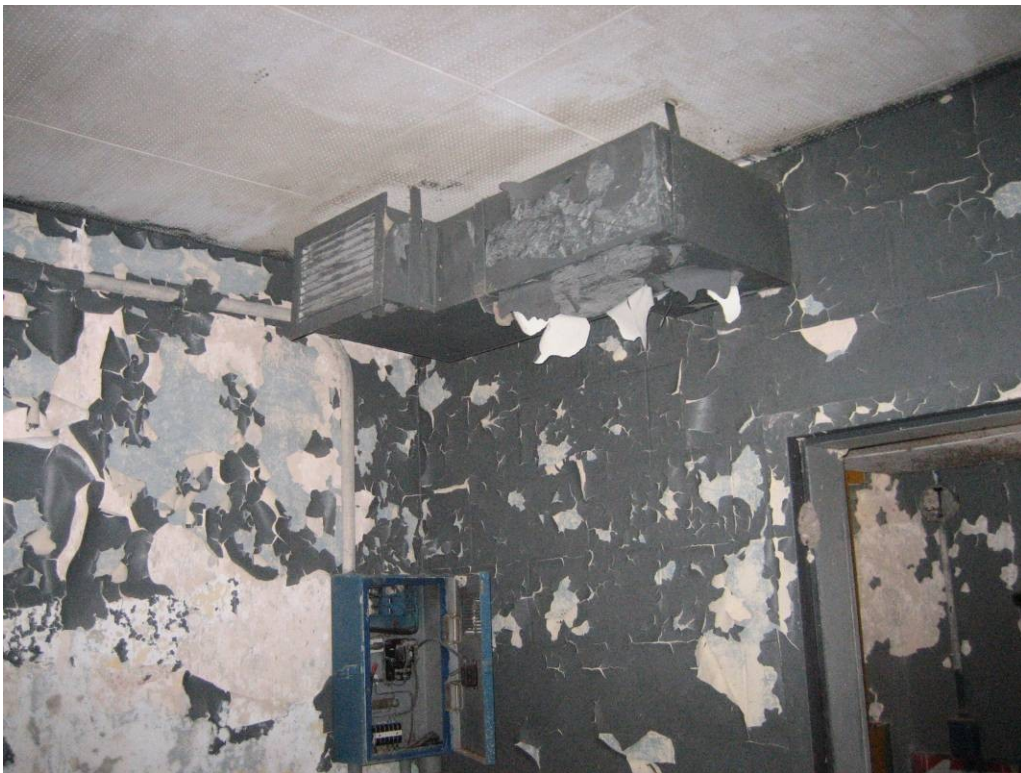
Fire-control Bunker A: Peeling gray paint on concrete walls.

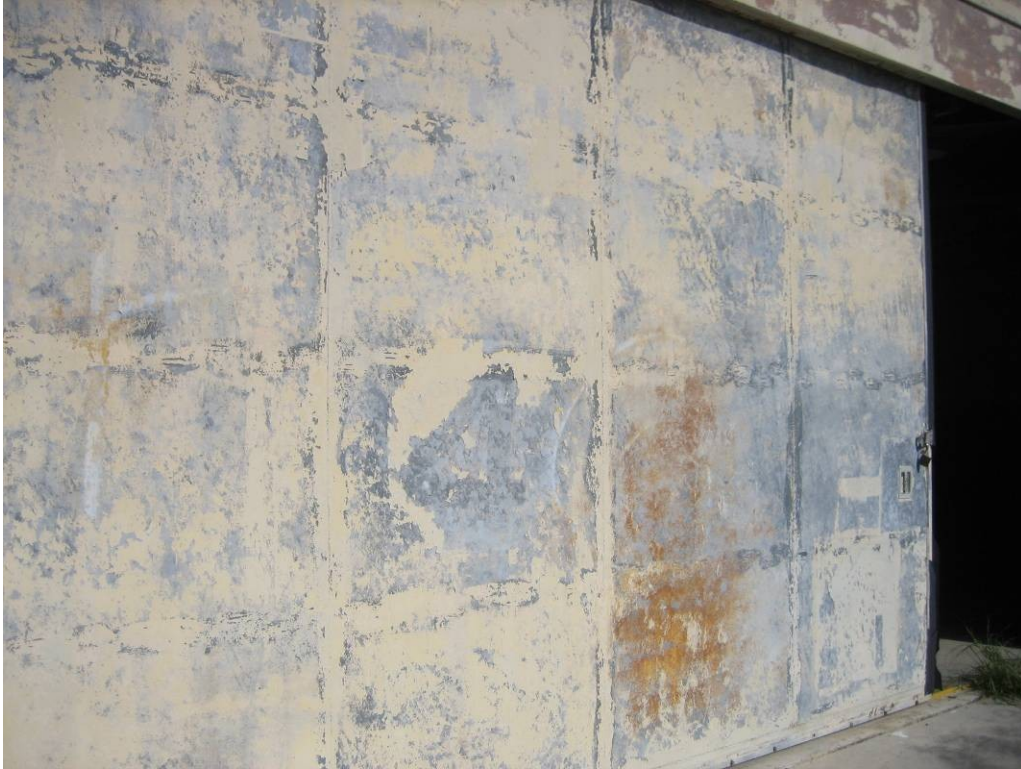
Missile Barn B: Peeling pink (beige) paint on exterior metal barn doors.

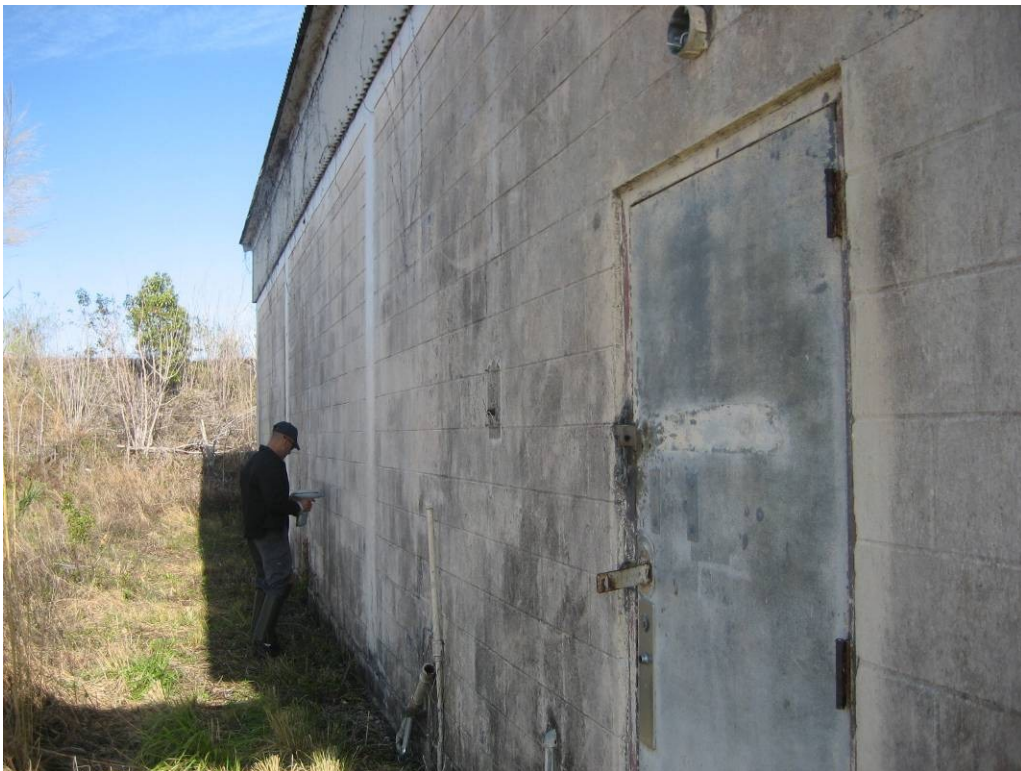
Missile Barn B: Chalking pink exterior paint on concrete walls and columns.

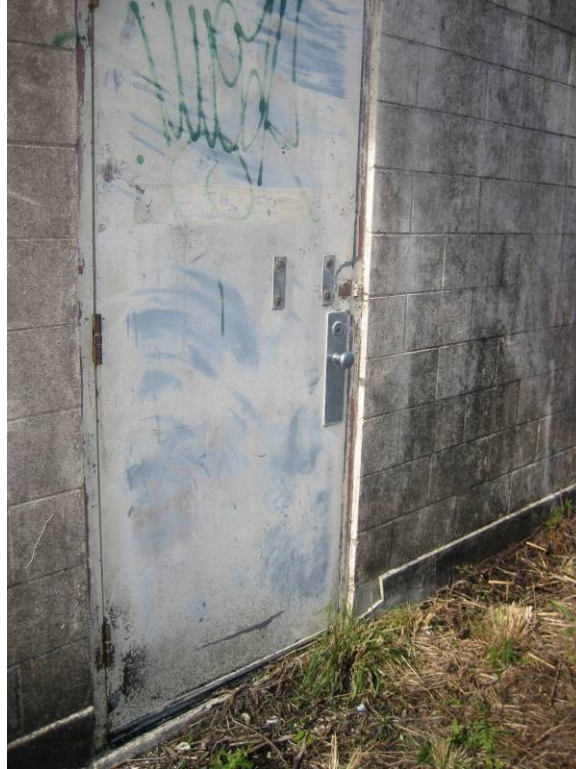
Missile Barn B: Cracked pink paint on exterior metal exit door.

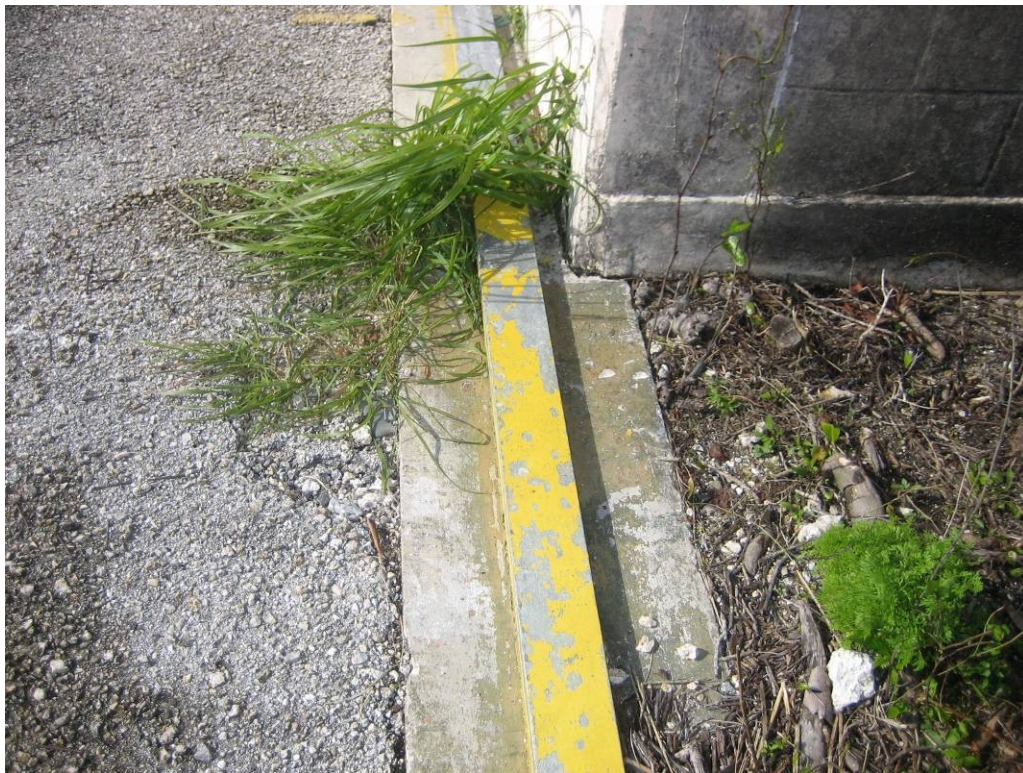
Missile Barn B: Cracked yellow paint on base rail of barn door.

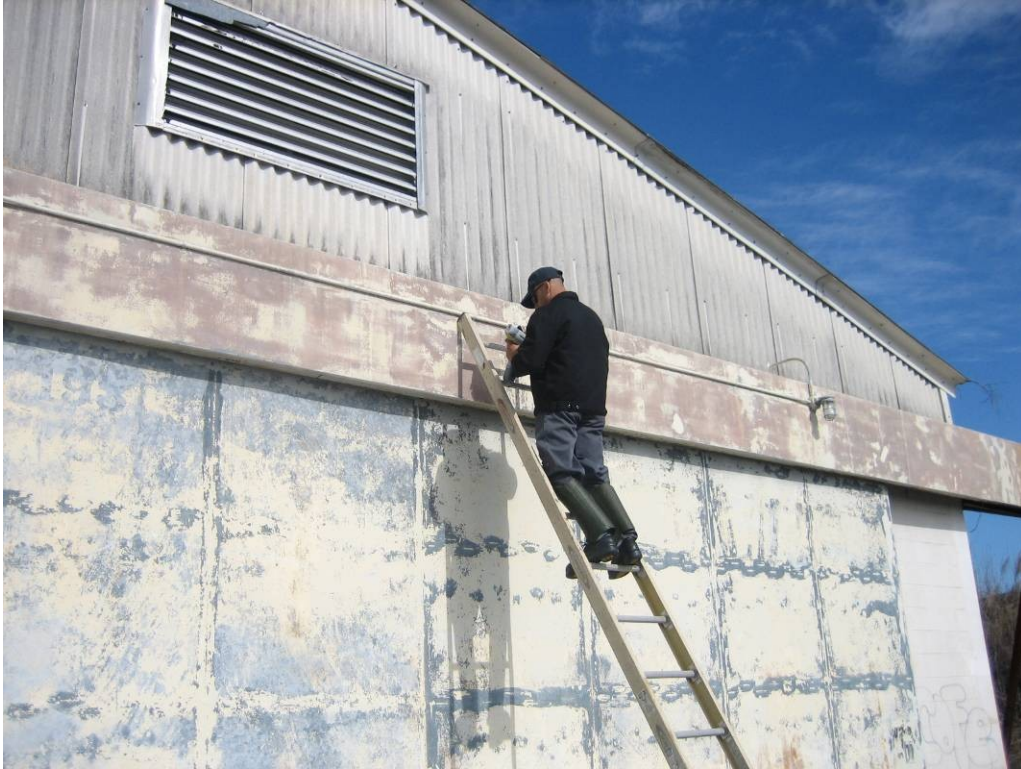
Missile Barn B: Cracked pink paint on metal rail beams on barn door.

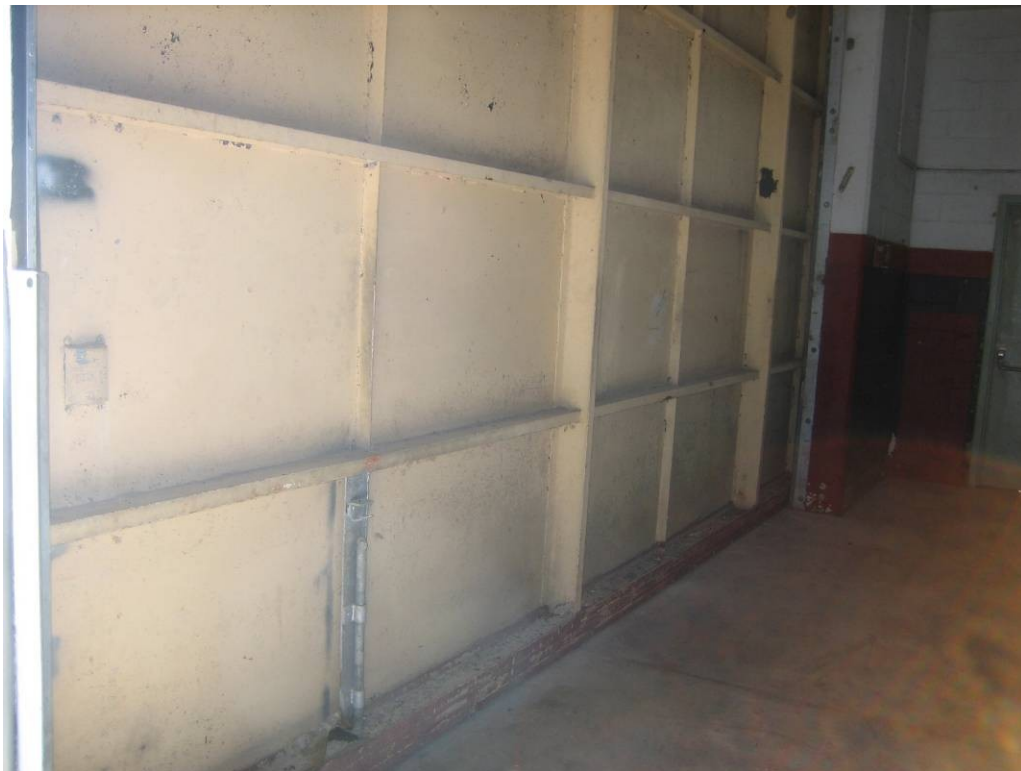
Missile Barn B: Peeling pink paint on interior of barn door.

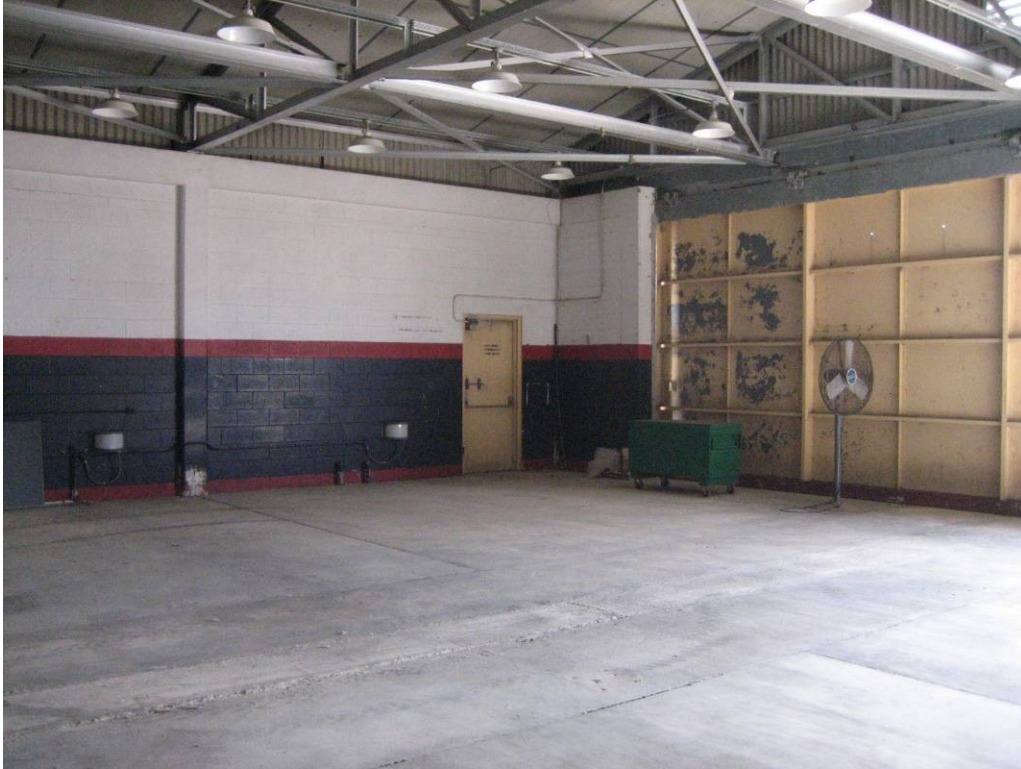
Missile Barn B: Blue paint on concrete block walls.

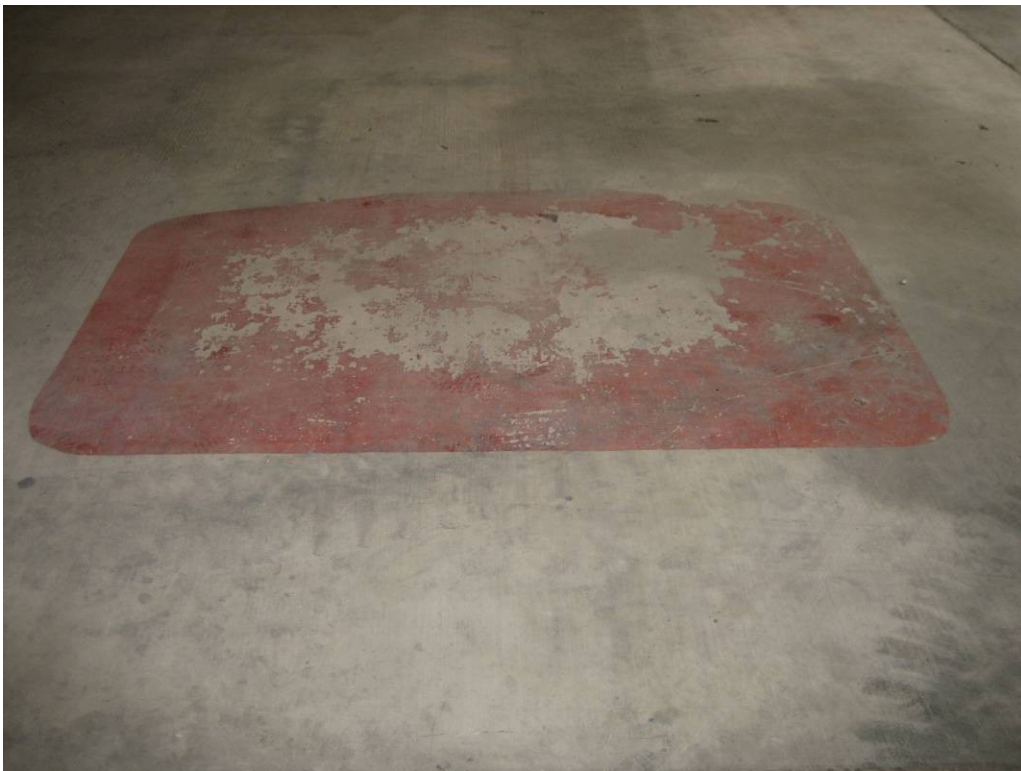
Missile Barn B: Red paint on concrete floor.

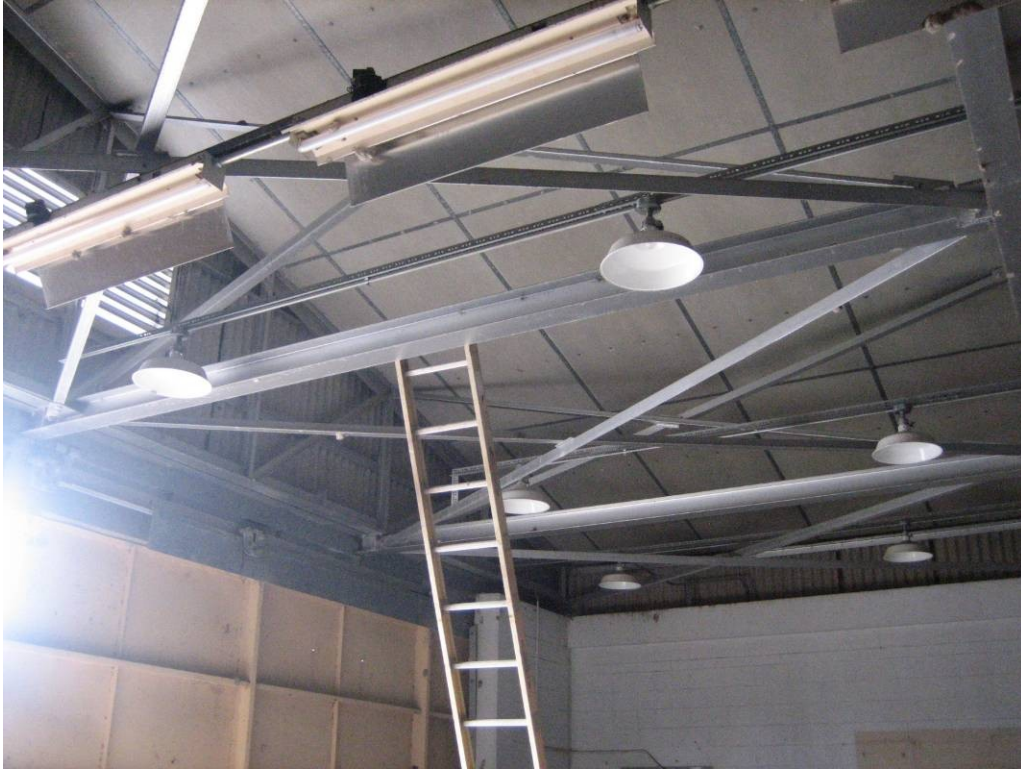
Missile Barn B: Intact gray paint on interior support beams.

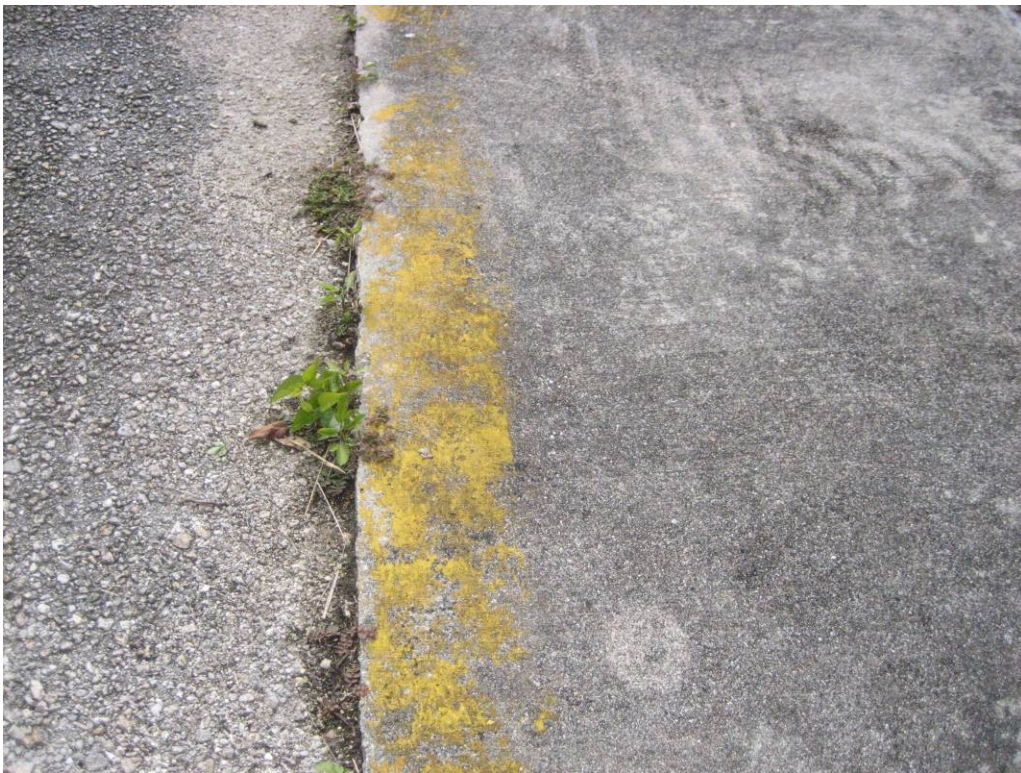
Missile Barn B: Intact yellow paint on exterior concrete slab.

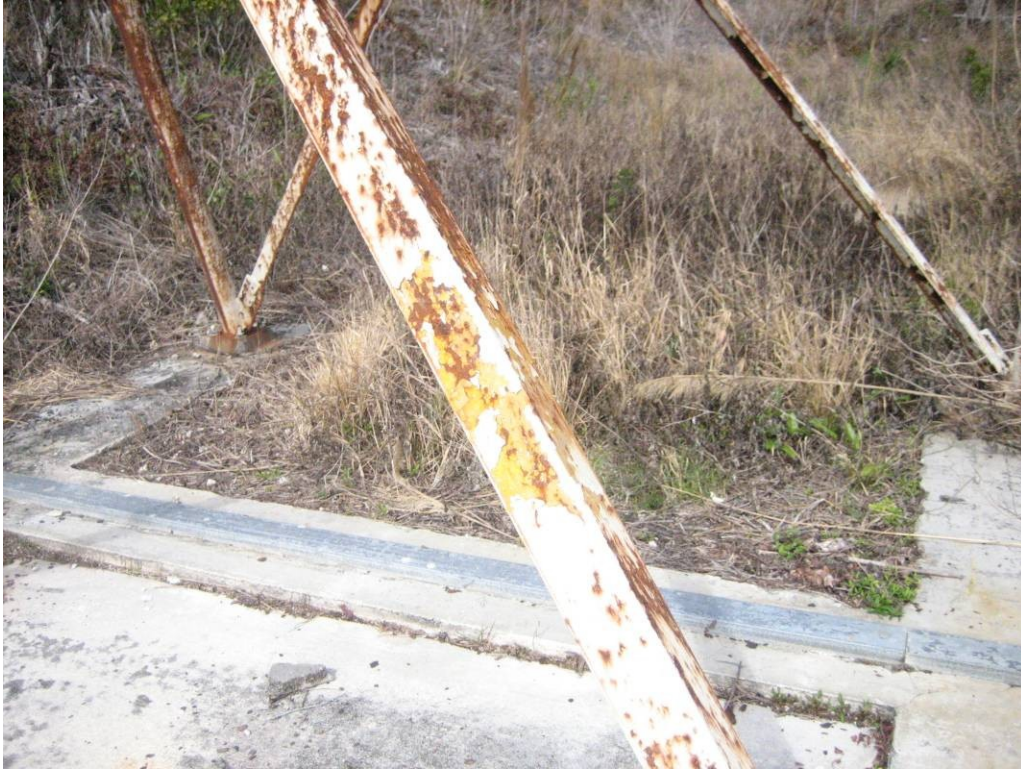
Missile Barn B: Cracked beige (yellow) paint on supports for rail beam on barn door.

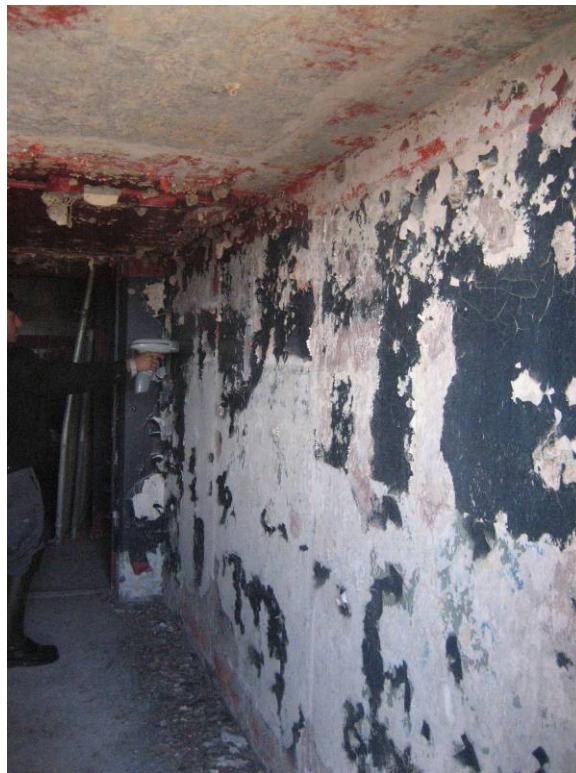
Fire-control Bunker B: Peeling blue paint on interior concrete walls.

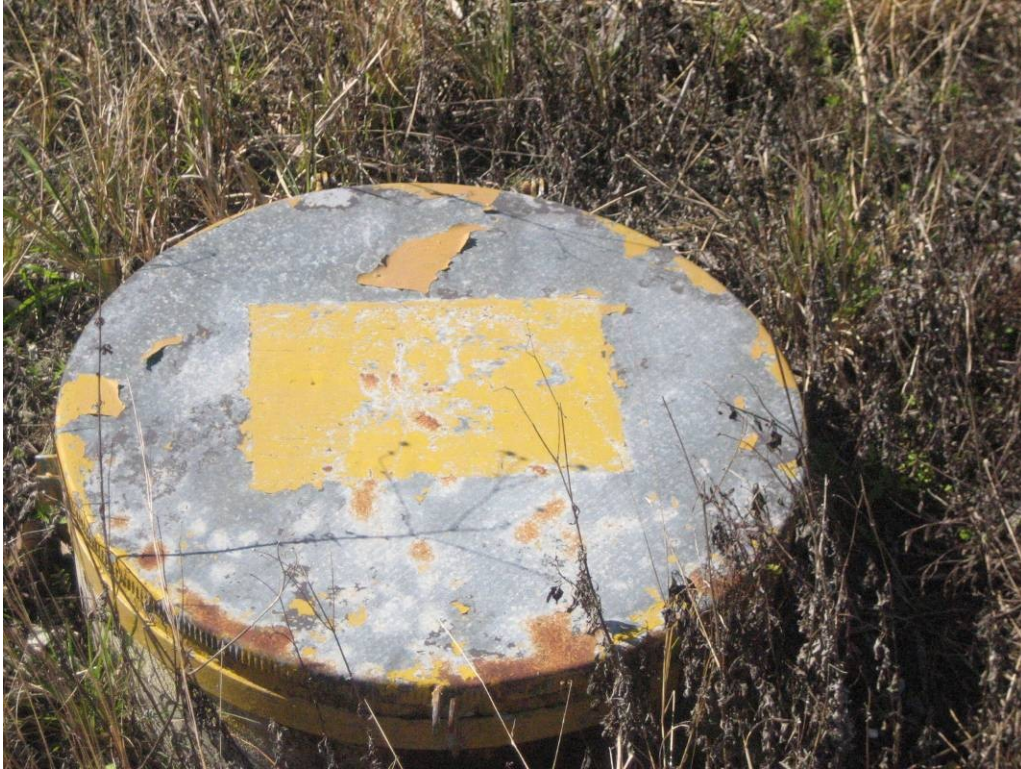
Missile Barn B: Intact yellow paint on manhole cover near bunker.

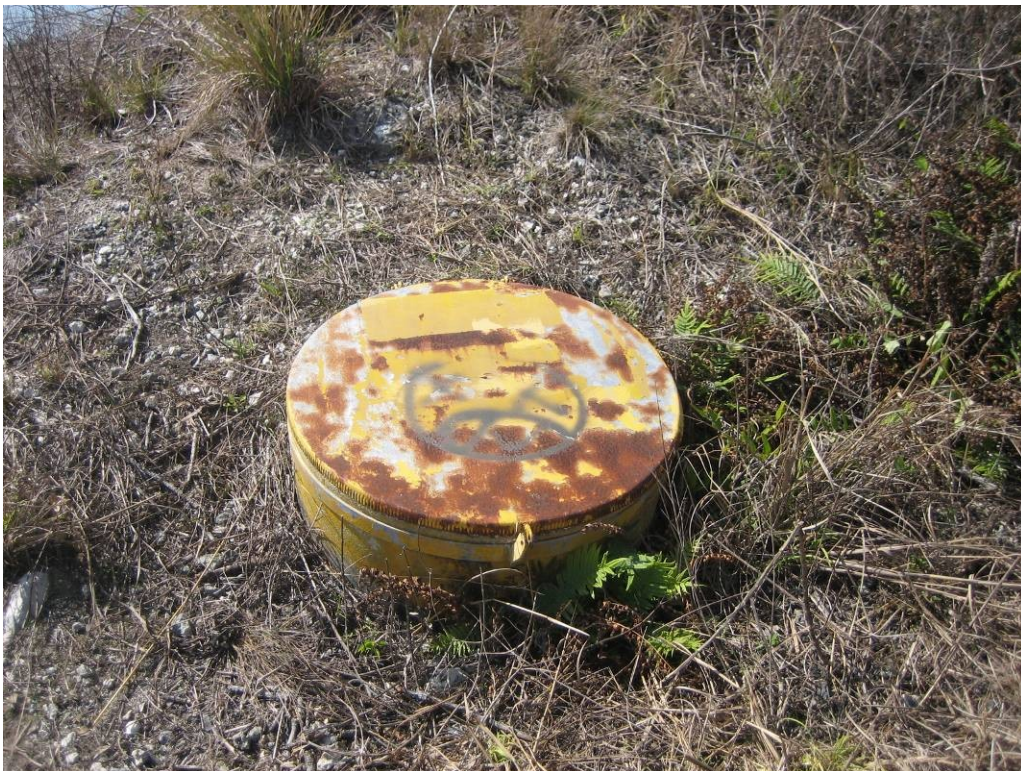
Missile Barn C: Peeling yellow paint on manhole cover near bunker.

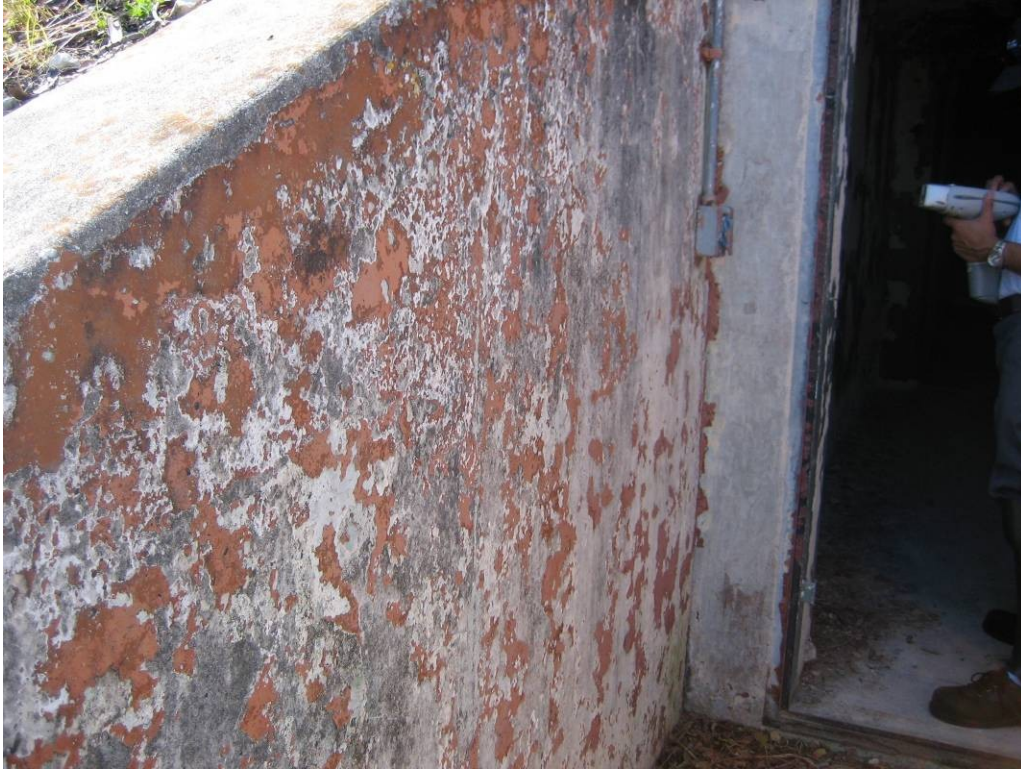
Fire-control Bunker C: Peeling red paint on exterior wall to bunker.

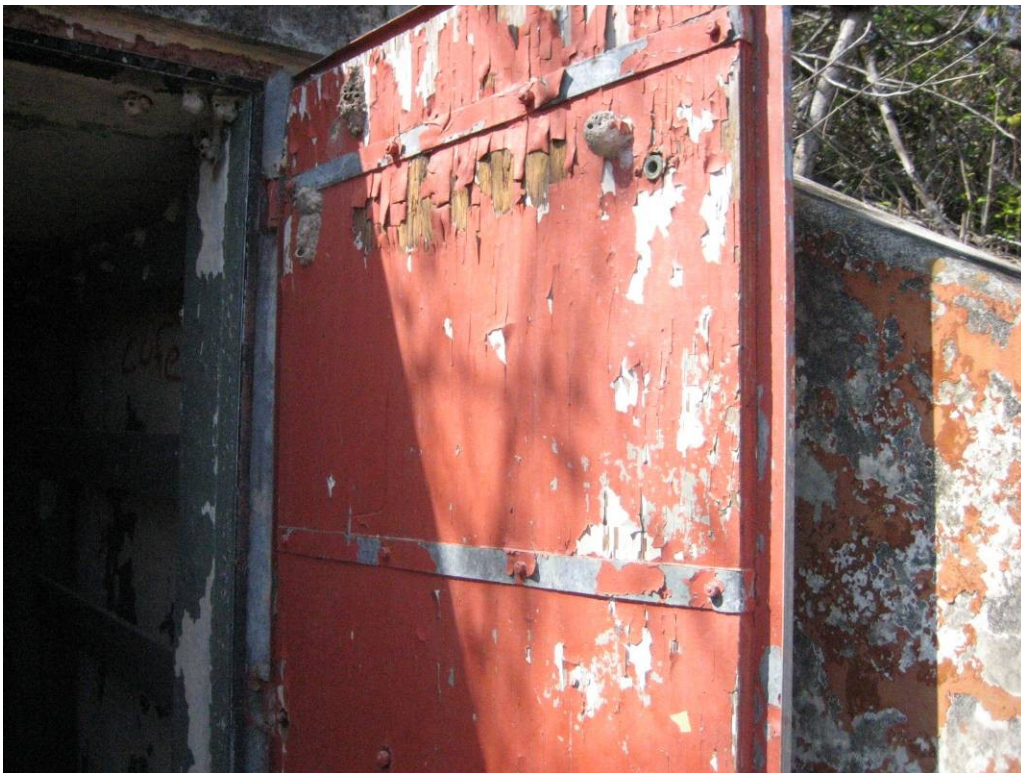
Fire-control Bunker C: Peeling red paint on exterior metal door.

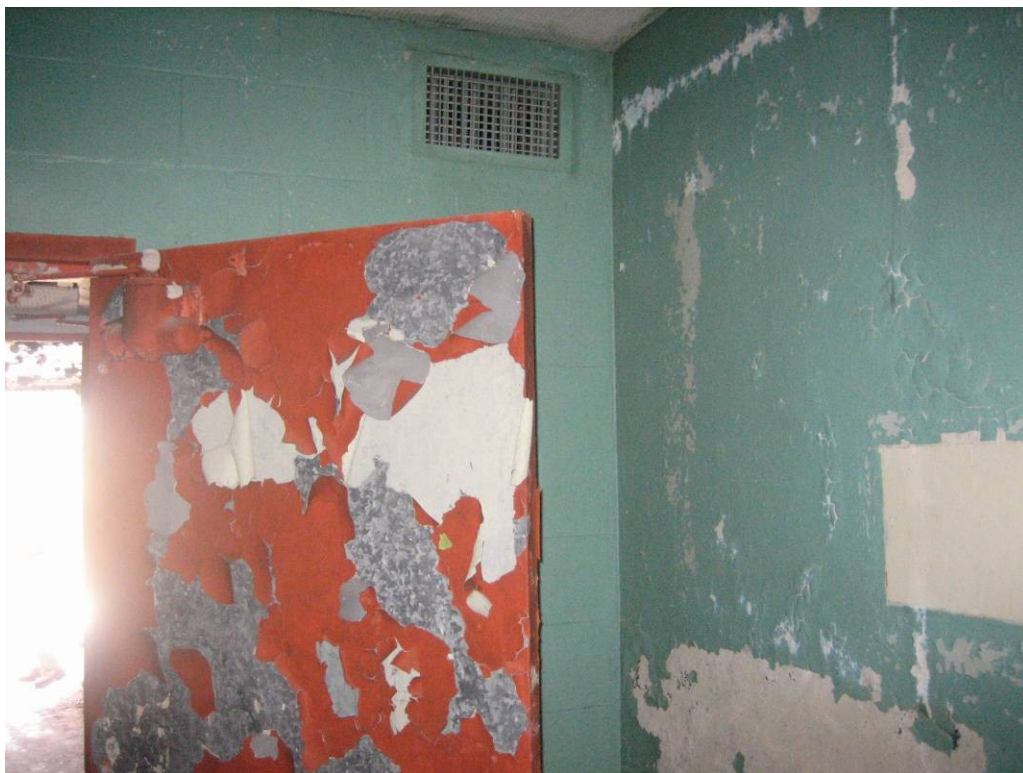
Fire-control Bunker C: Peeling red paint on metal door.

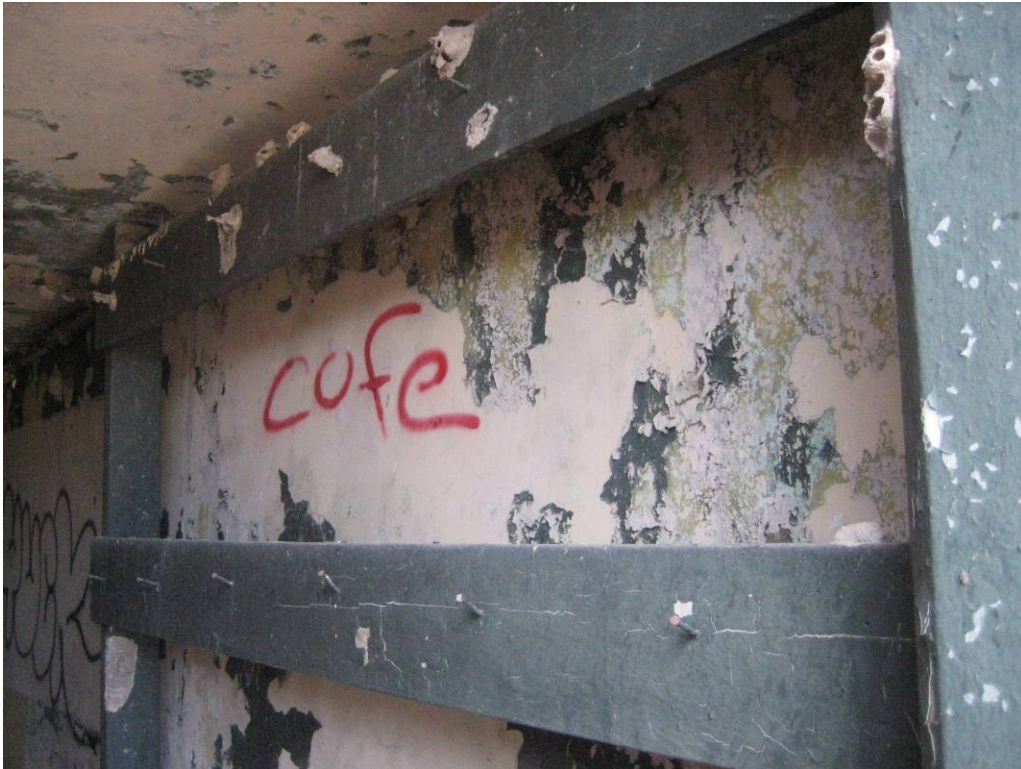
Fire-control Bunker C: Intact green paint on wood rack inside bunker.

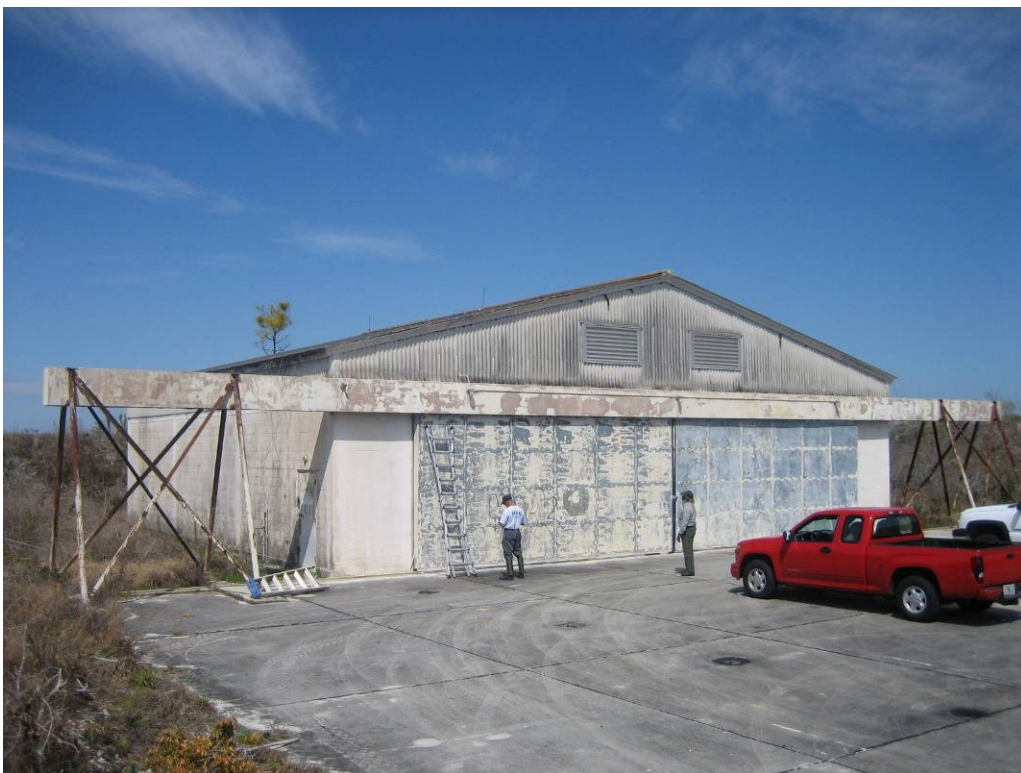
Missile Barn C: Intact beige paint on exterior barn door.

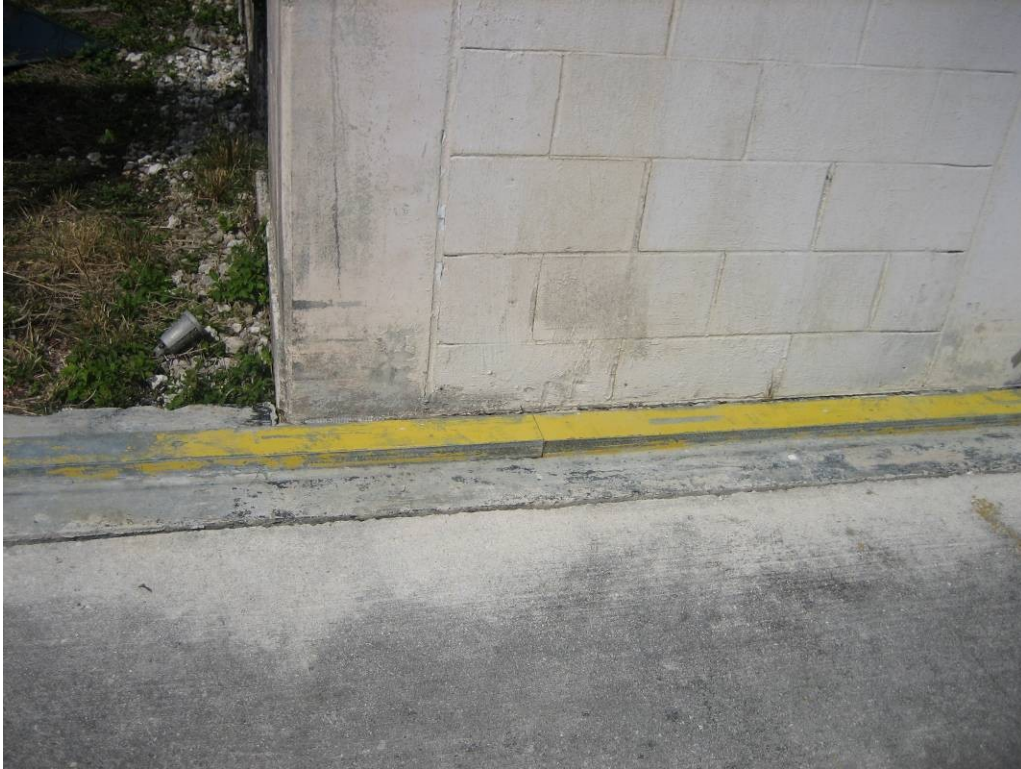
Missile Barn C: Intact yellow paint on exterior base rail for barn door.

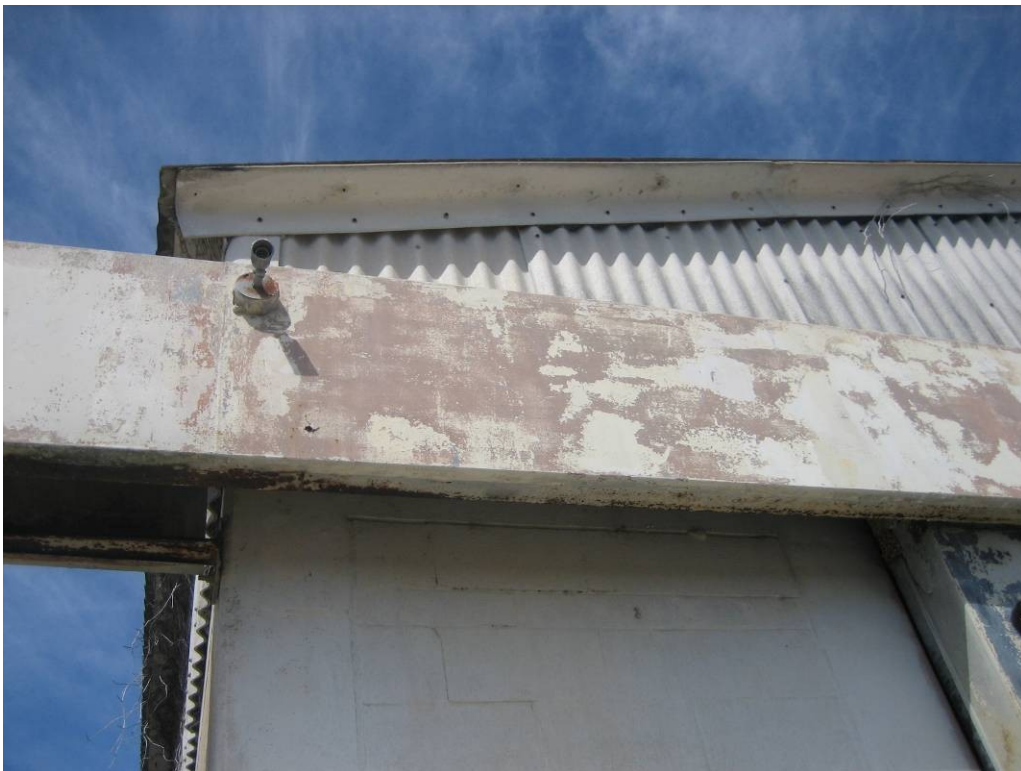
Missile Barn C: Intact beige paint on metal rail beam on barn door.

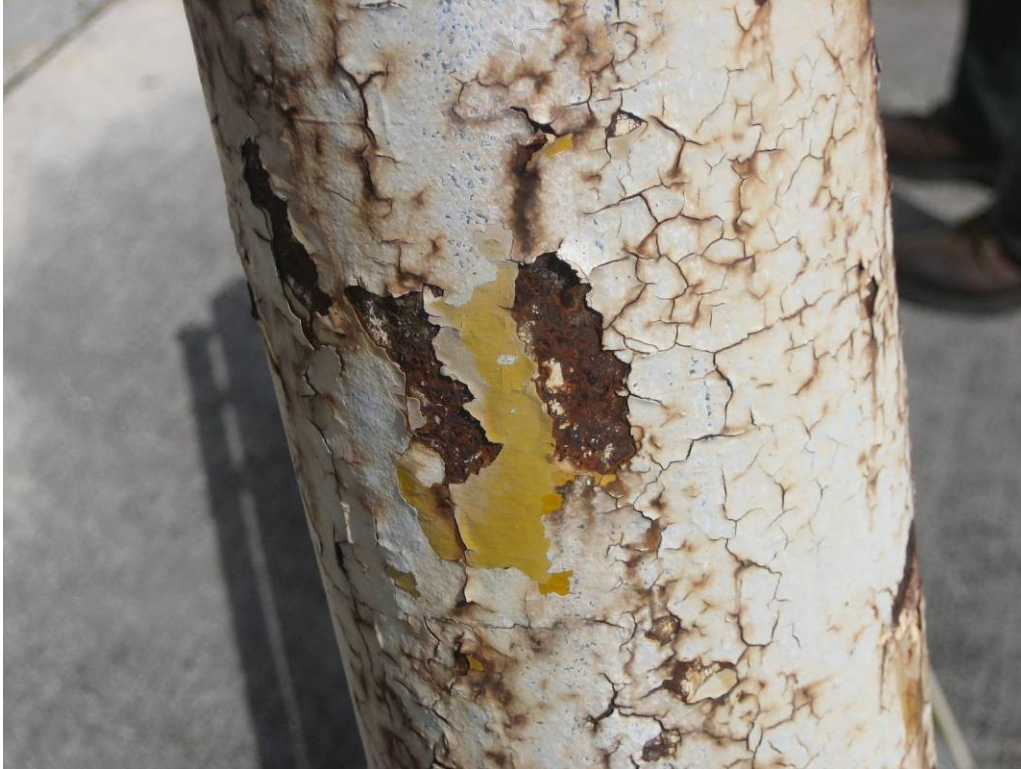
Missile Barn C: Cracked beige (yellow) on supports for rail beam on barn door.

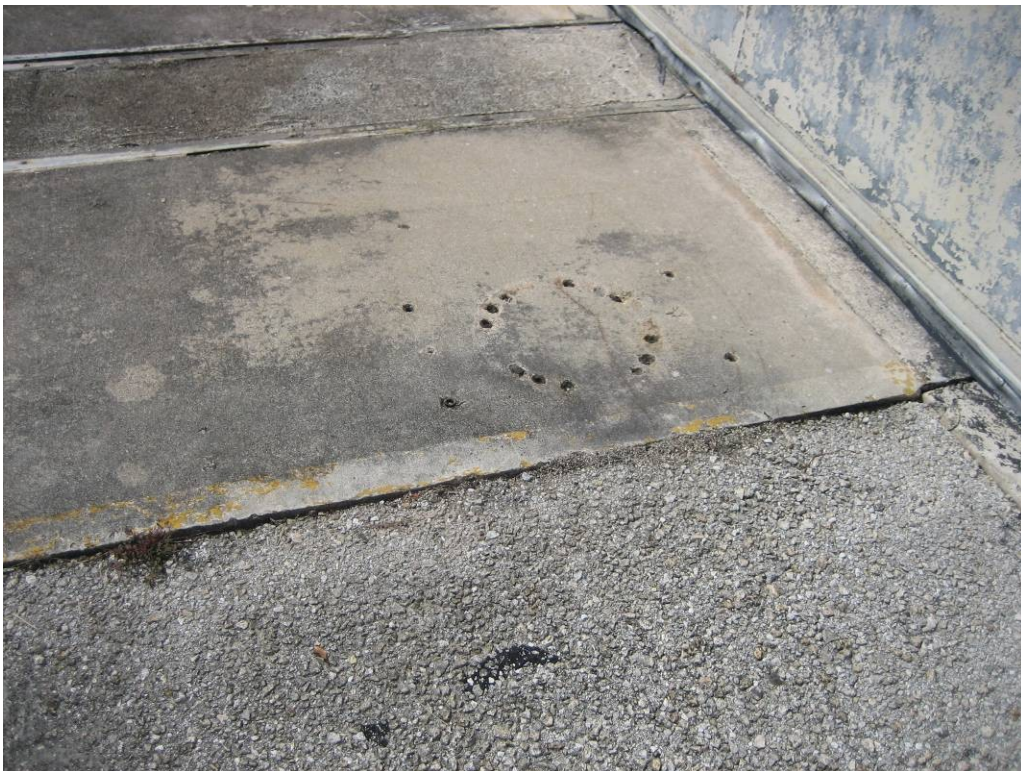
Missile Barn C: Chalking yellow paint on concrete slab.

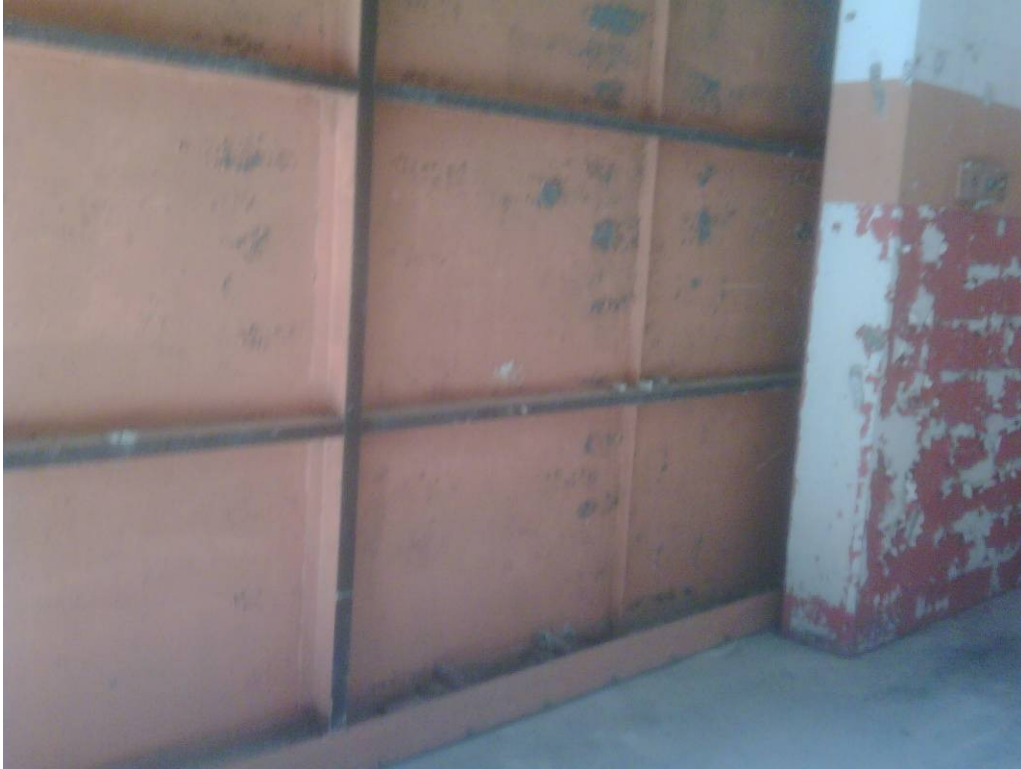
Missile Barn C: Intact orange and black paint on interior of barn door.

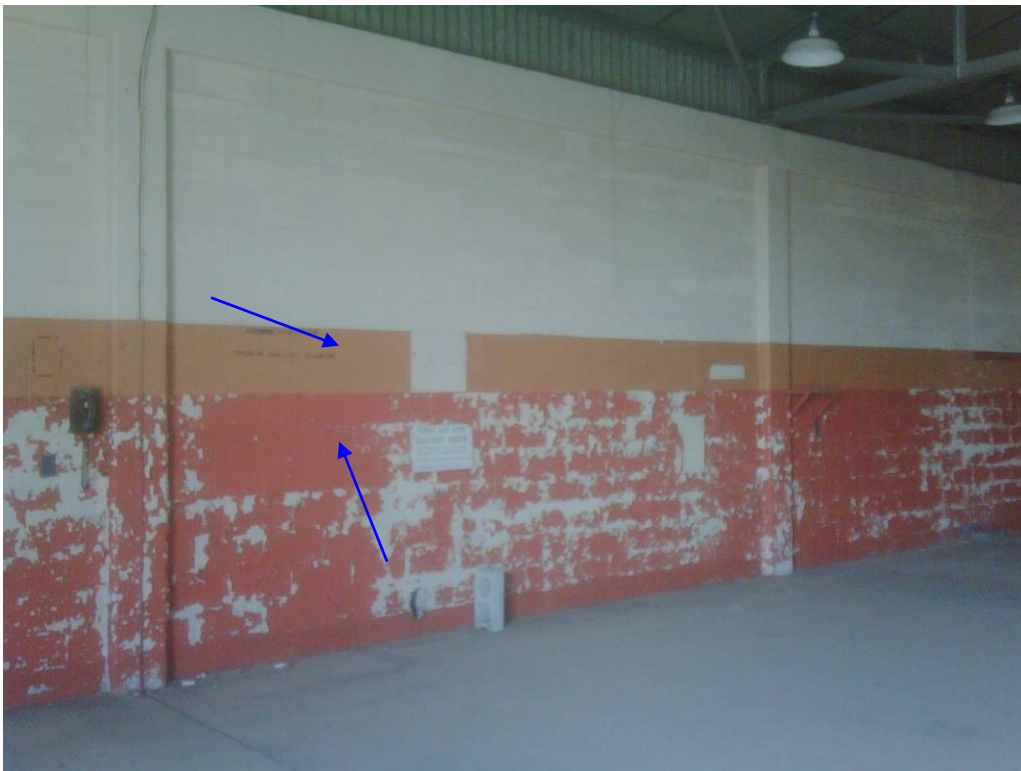
Missile Barn C: Peeling red and orange paint on concrete block wall.

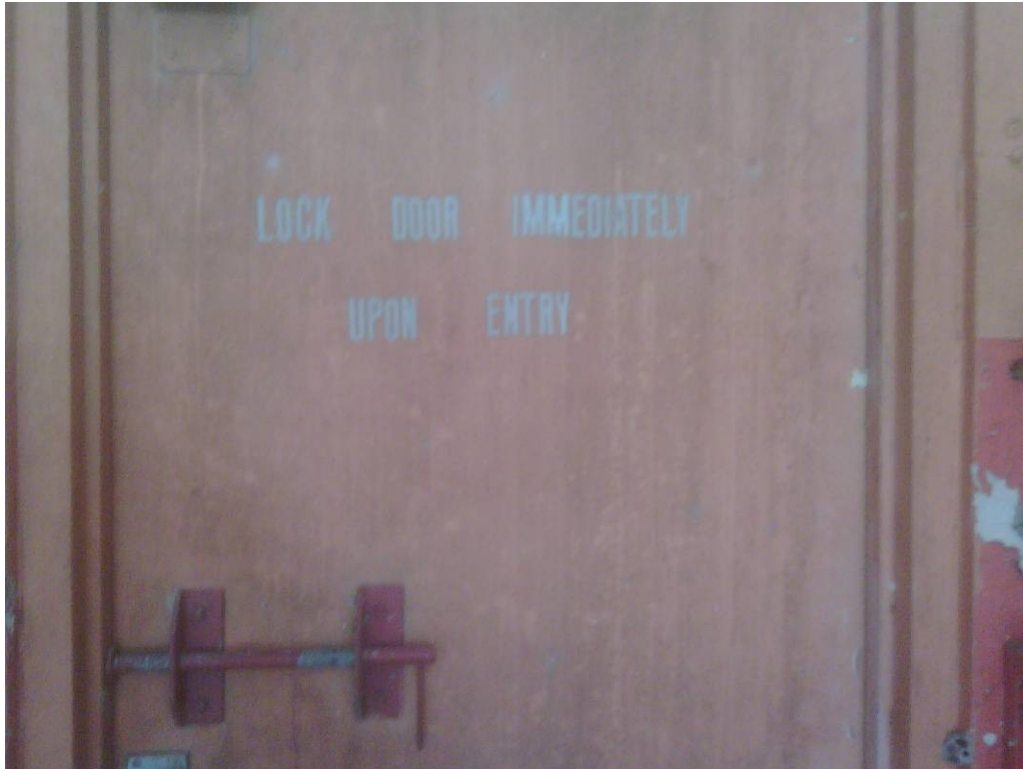
Missile Barn C: Intact orange paint on interior metal exit door.

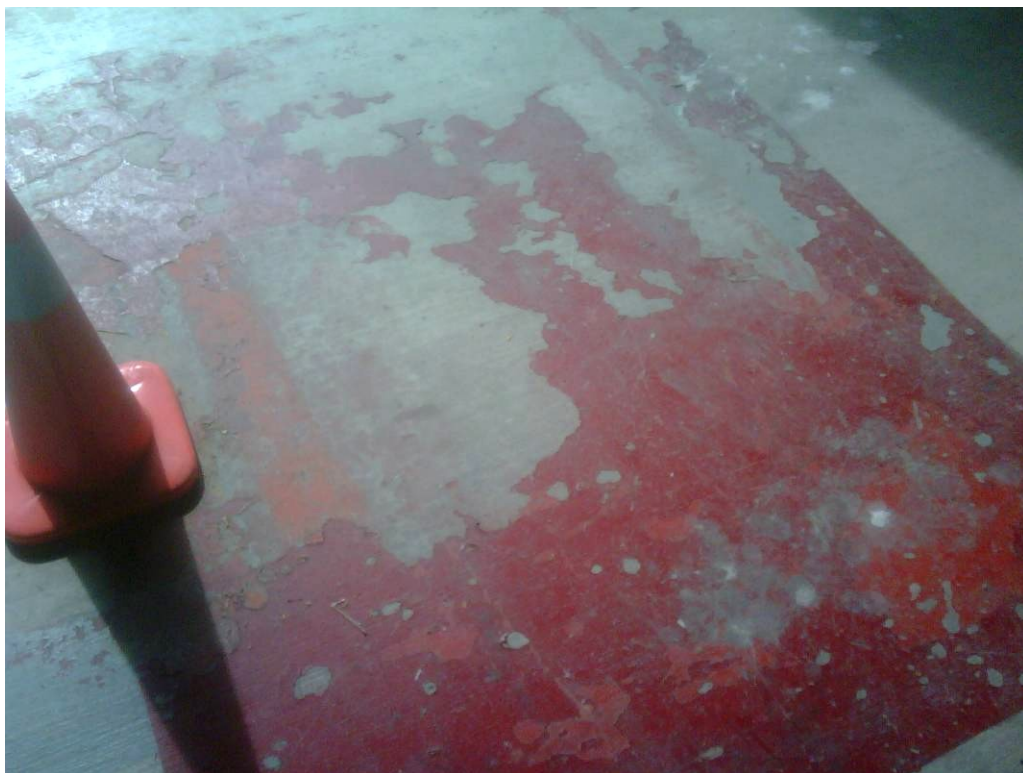
Missile Barn C: Intact red paint on concrete floor of barn interior.

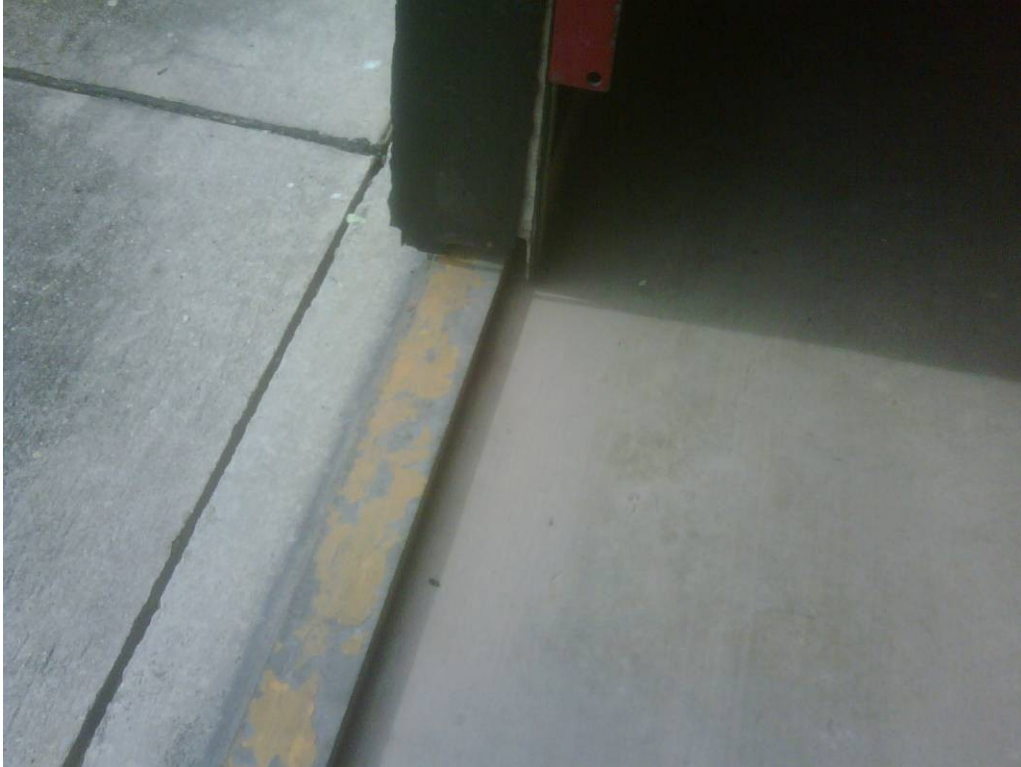
Missile Barn C: Intact yellow paint on base rail of barn door.
