**PRE-RENOVATION  
LEAD-BASED PAINT INSPECTION REPORT**

**NIKE MISSILE SITE  
ADMINISTRATION AND CONTROL AREA  
AND  
LAUNCH AREA  
EVERGLADES NATIONAL PARK  
HOMESTEAD, FLORIDA**

March 4, 2010  
Revised August 27, 2010  
EE&G Project No. 2009-2333

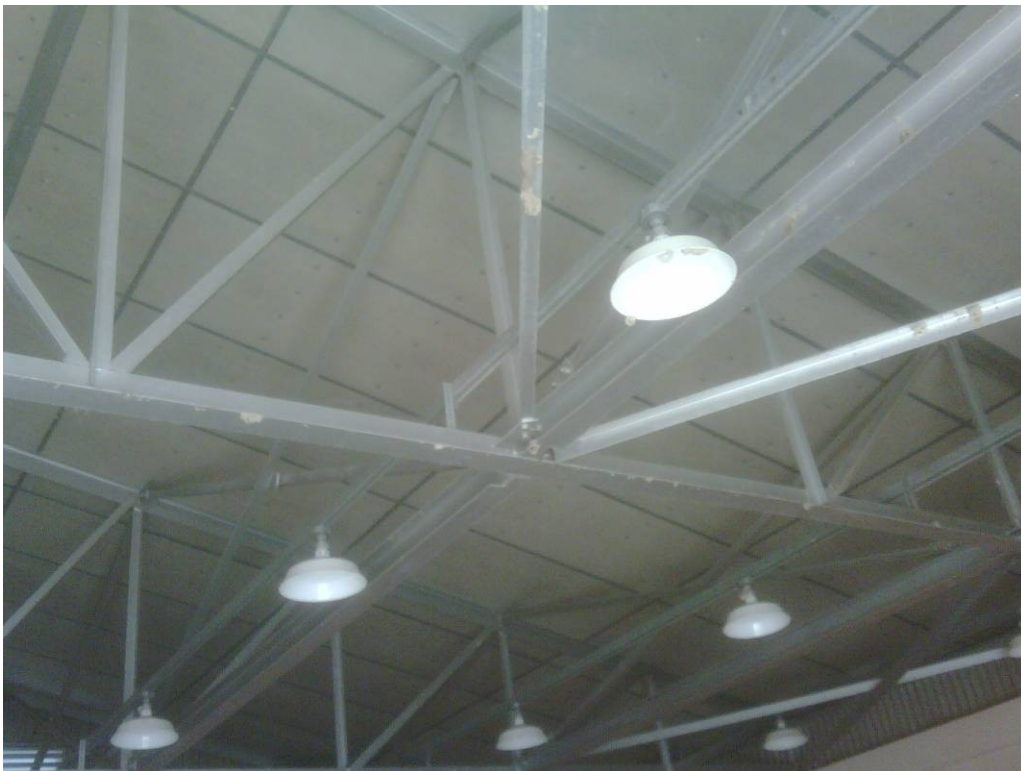
Missile Barn C: Intact gray paint on interior metal support beams.

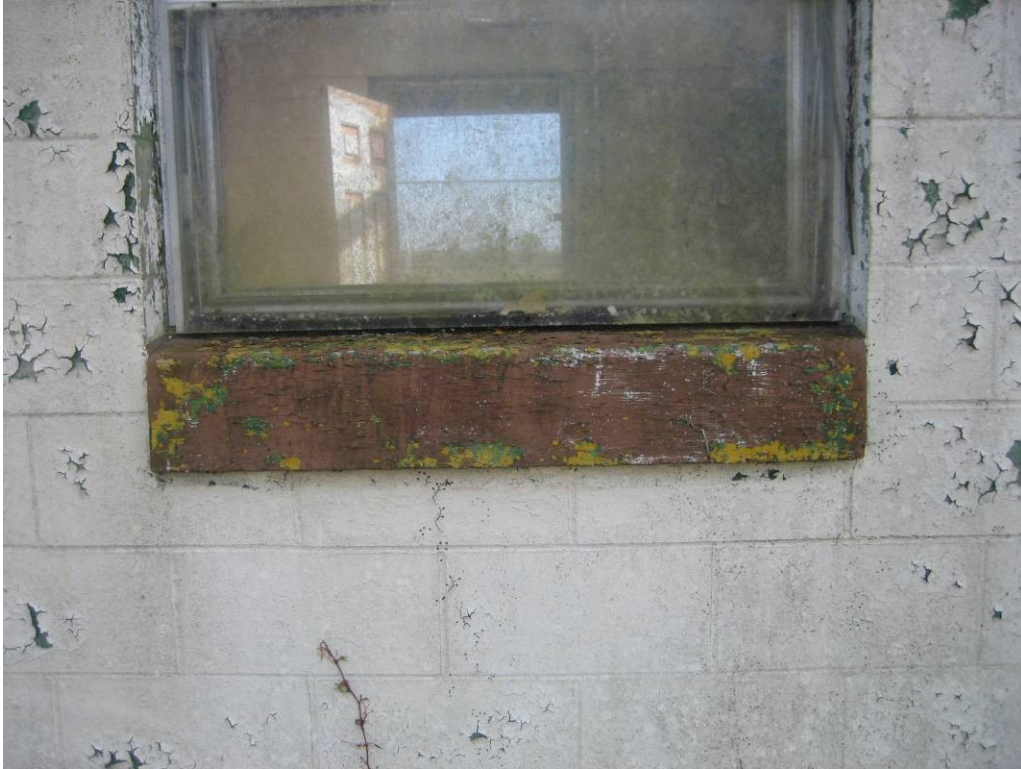
Kennel Building: Peeling brown (yellow) paint on exterior window sill.

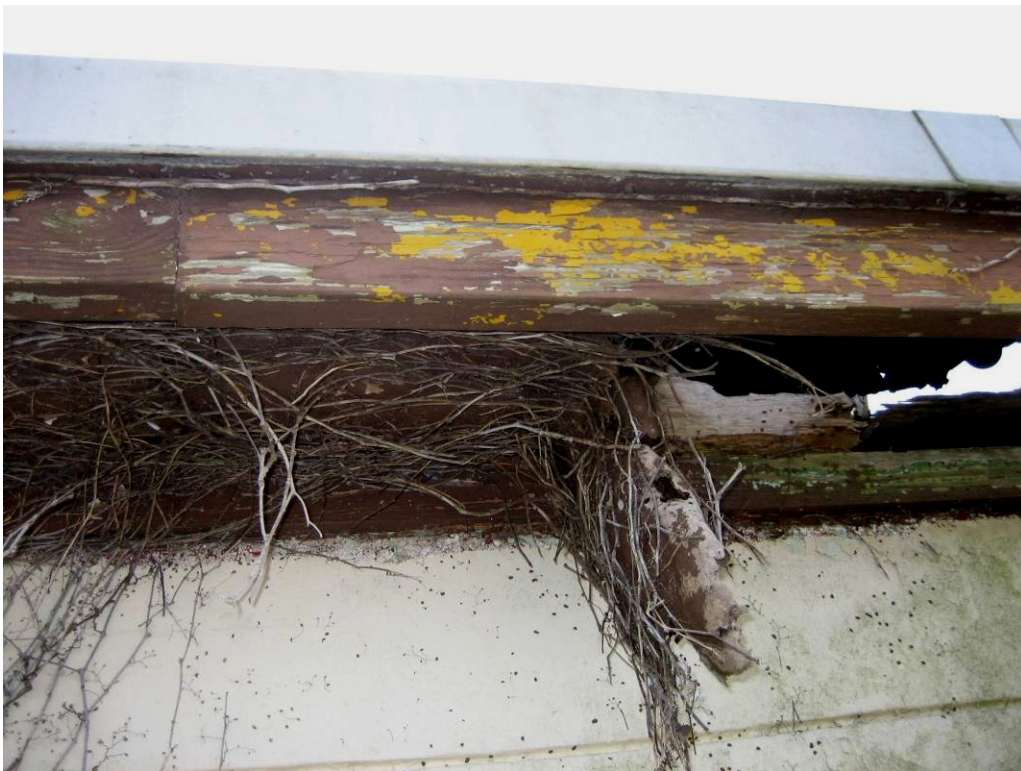
Kennel Building: Peeling brown (yellow) paint on exterior soffit trim.

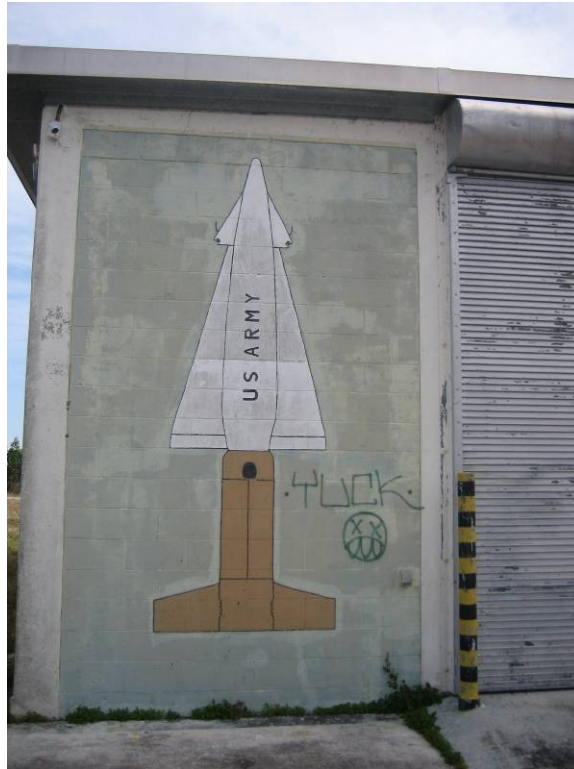
Missile Assembly Building: Exterior insignia with cracked beige and black paint.

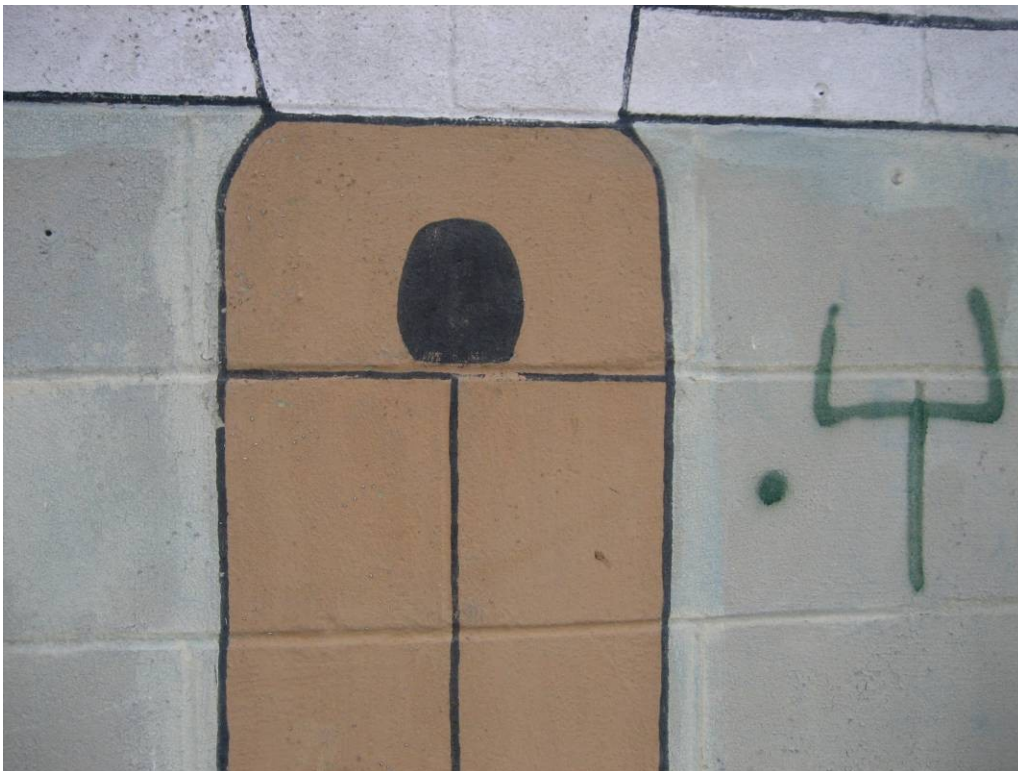
Missile Assembly Building: Detail of cracked beige and black paint on insignia.

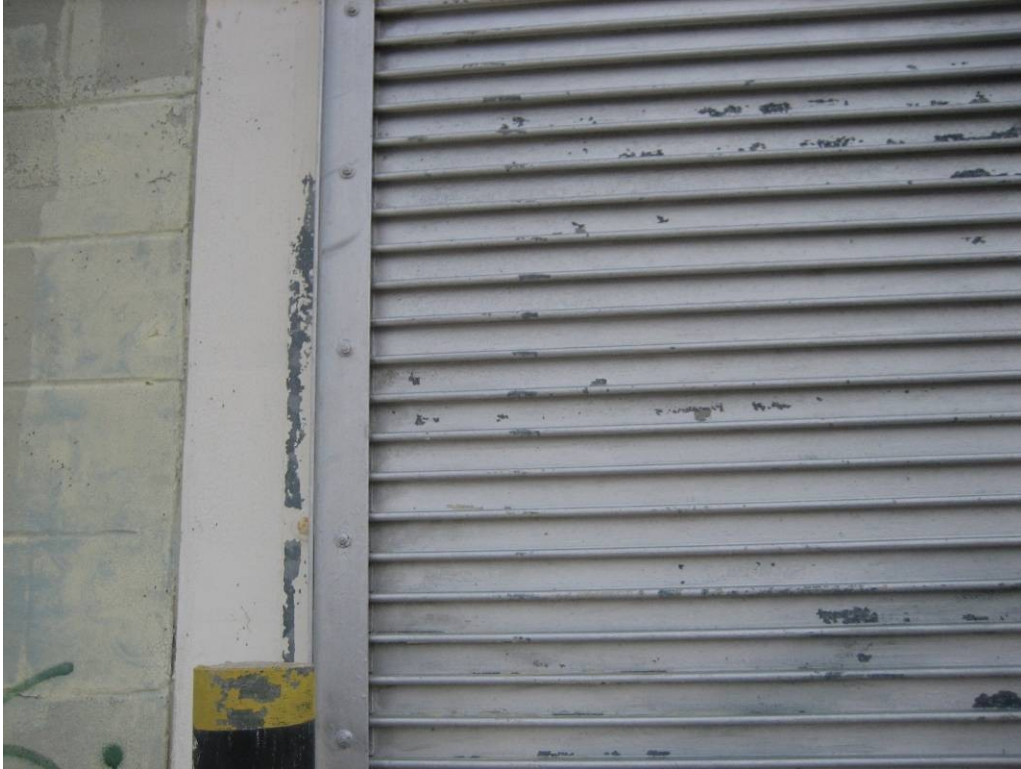
Missile Assembly Building: Cracked gray paint on exterior metal door and rails.

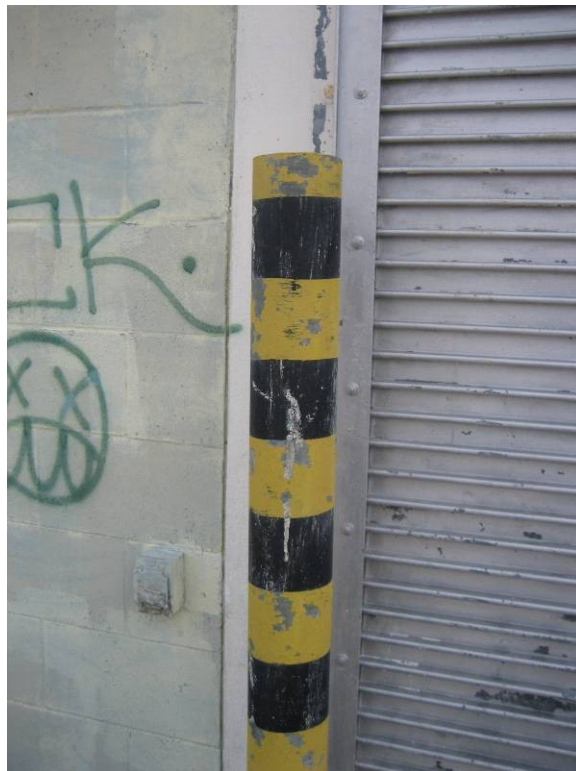
Missile Assembly Building: Cracked yellow paint on concrete bumper.

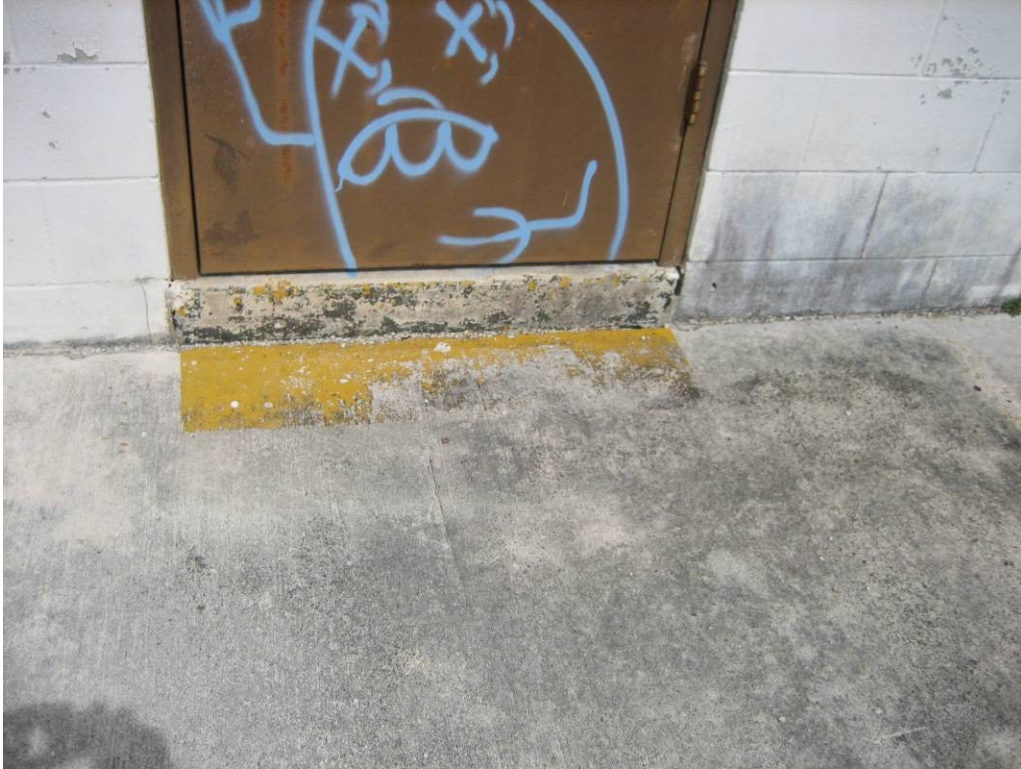
Missile Assembly Building: Peeling yellow paint on exterior concrete slab.

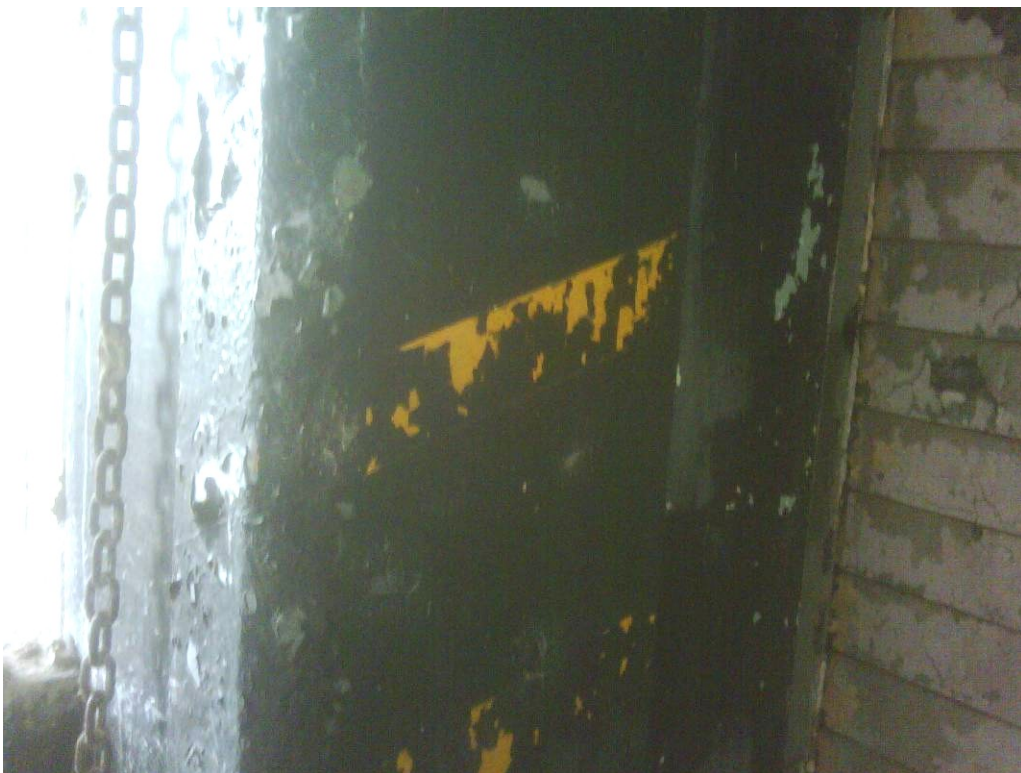
Missile Assembly Building: Peeling black paint on interior metal door and rail.

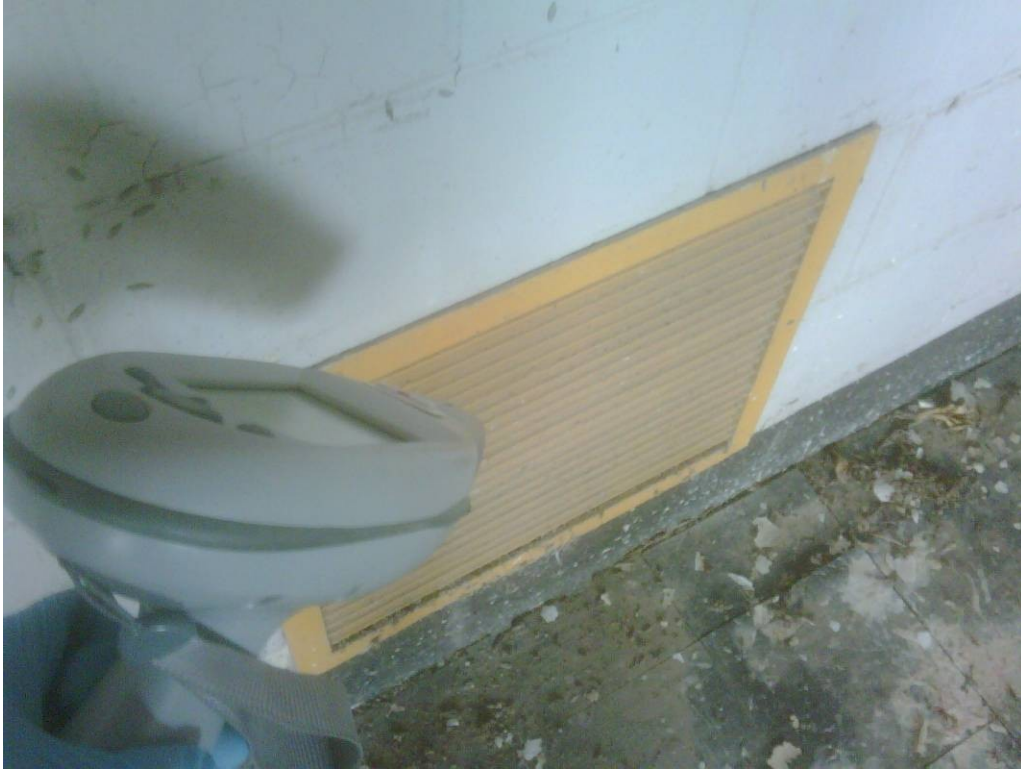
Missile Assembly Building: Peeling yellow paint on air conditioning vent.

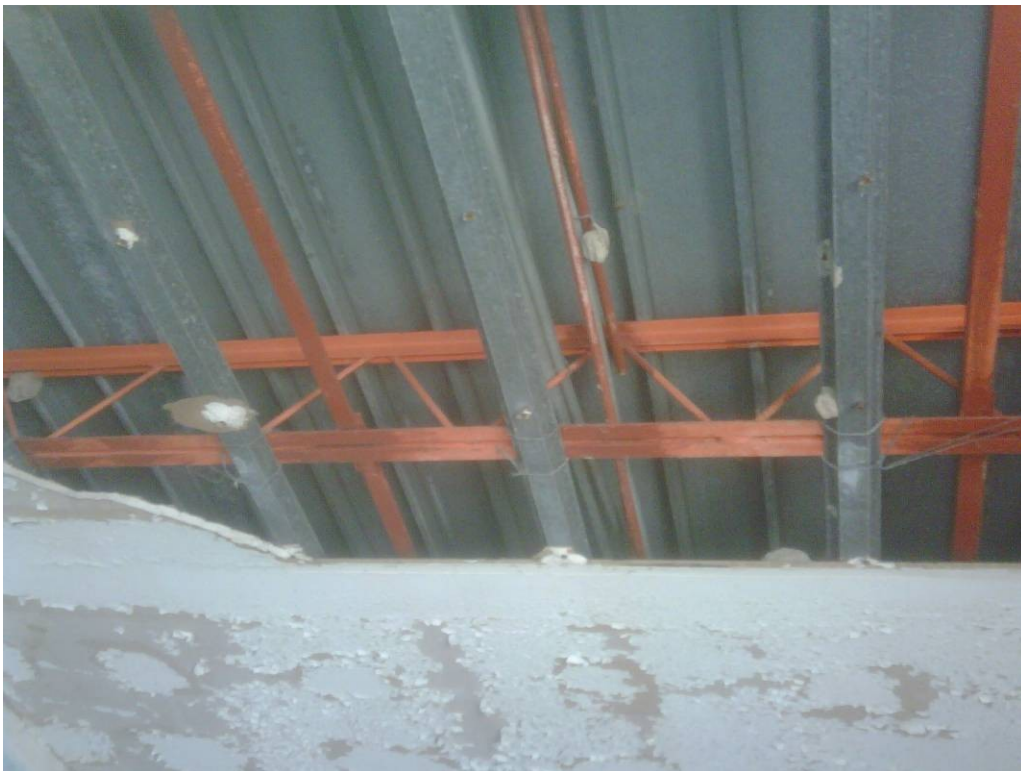
Missile Assembly Building: Intact red paint on red iron metal support beams.

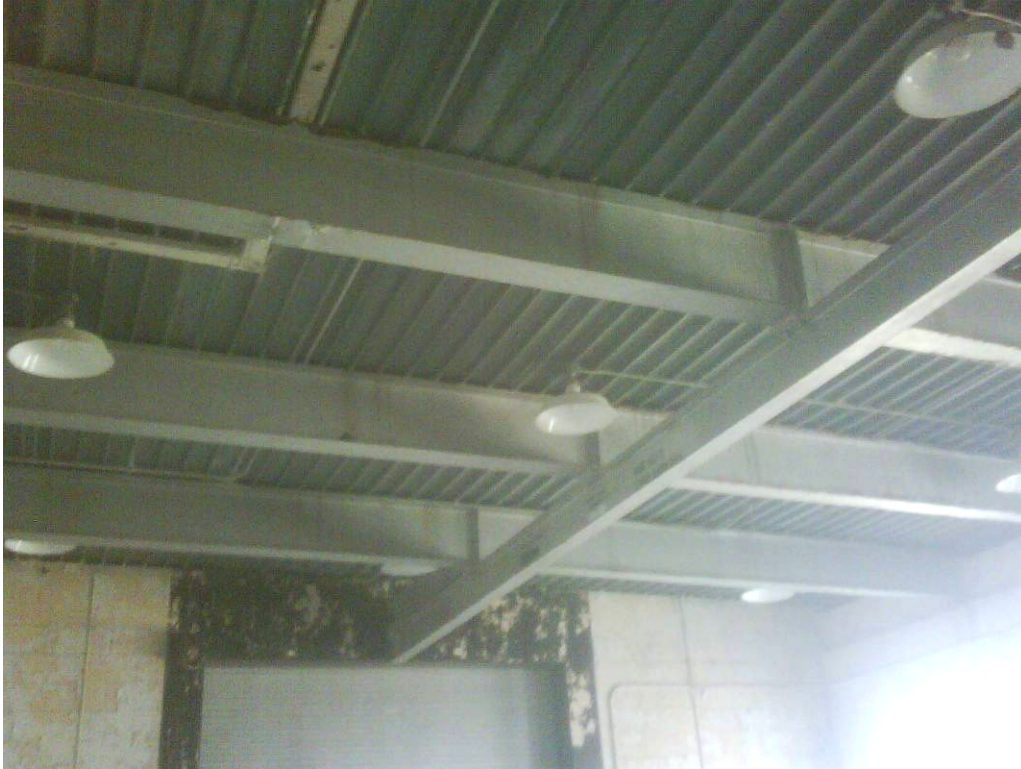
Missile Assembly Building: Intact gray paint on metal support beams.
